Teven Quarry Biodiversity & Rehabilitation Management

Holcim Australia
November 2021 Update

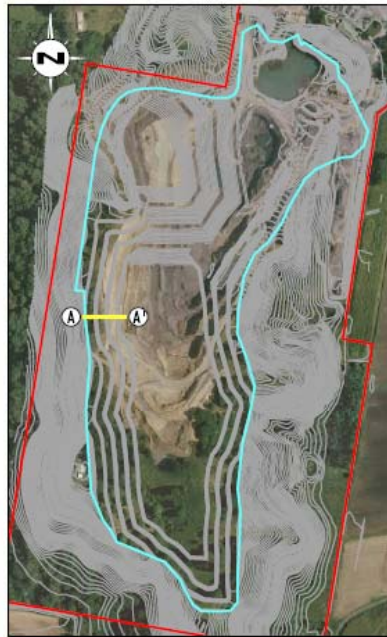
Figure 6

Conceptual final landform
