**Report on Preliminary Site Investigation with  
Limited Sampling**

**Proposed Warehouse and Distribution Centre**

**200 Beech Road, Casula NSW**

**Project 226958.00**

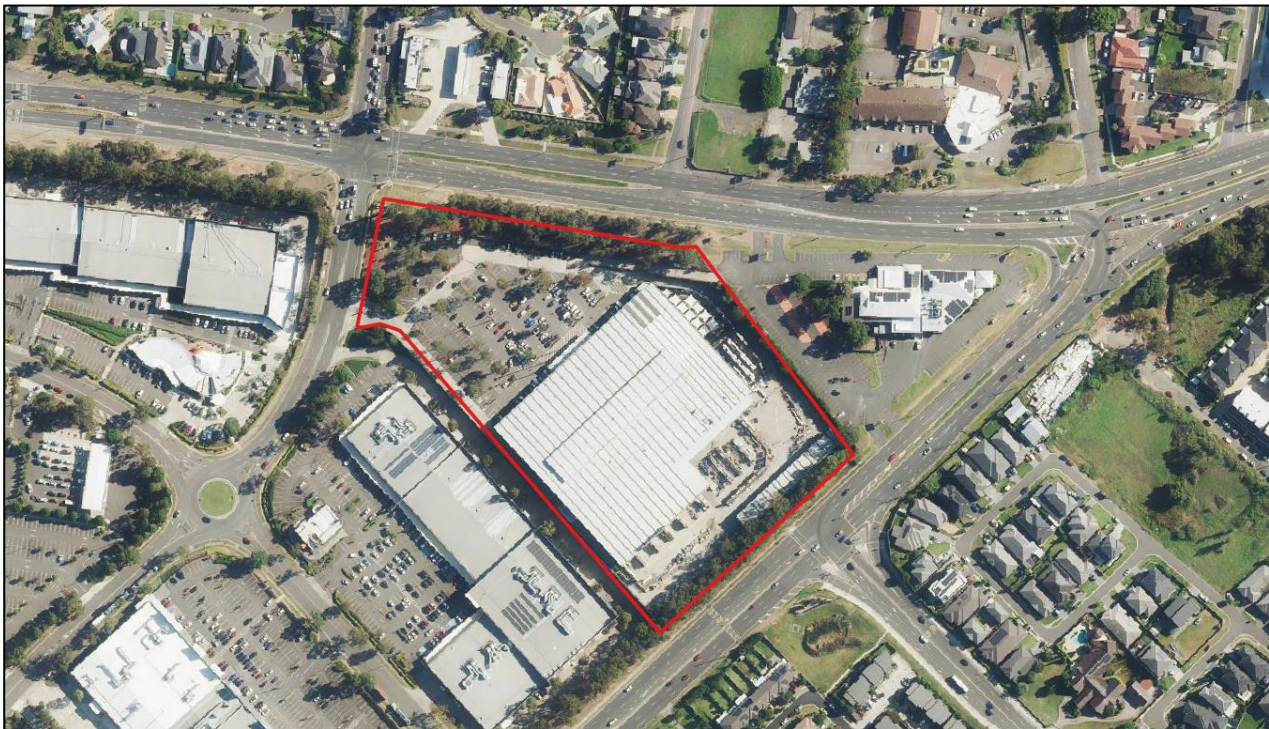
**Figure 1: Site boundary (as shown in red outline)**

The site boundary is shown on Figure 1.

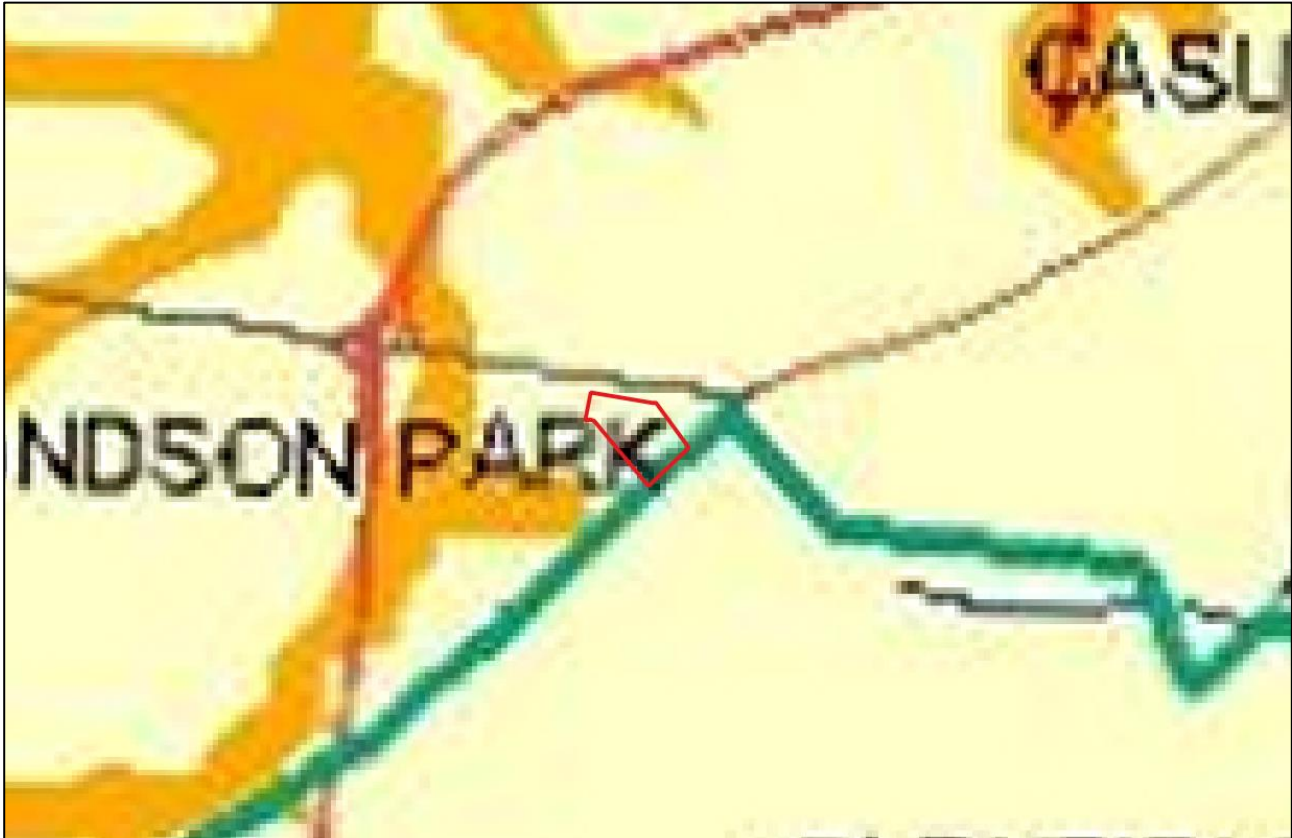
**Figure 2: Extract of salinity potential mapping (NSW Department of Infrastructure, Planning and Natural Resources, 2002).**

Salinity	Reference to the Department of Infrastructure, Planning and Natural Resources Salinity Potential in Western Sydney (2002) indicates that the site is mapped as having a moderate salinity potential (pale yellow). Mapping indicates that a high salinity potential (orange) northwest, west and southwest of the site, aligning with the creek lines. Salinity potential mapping is shown in Figure 2 below.
----------	---

Site boundary is denoted by the red outline.  
 Orange shaded area = High salinity potential  
 Pale yellow shaded area = Moderate salinity potential

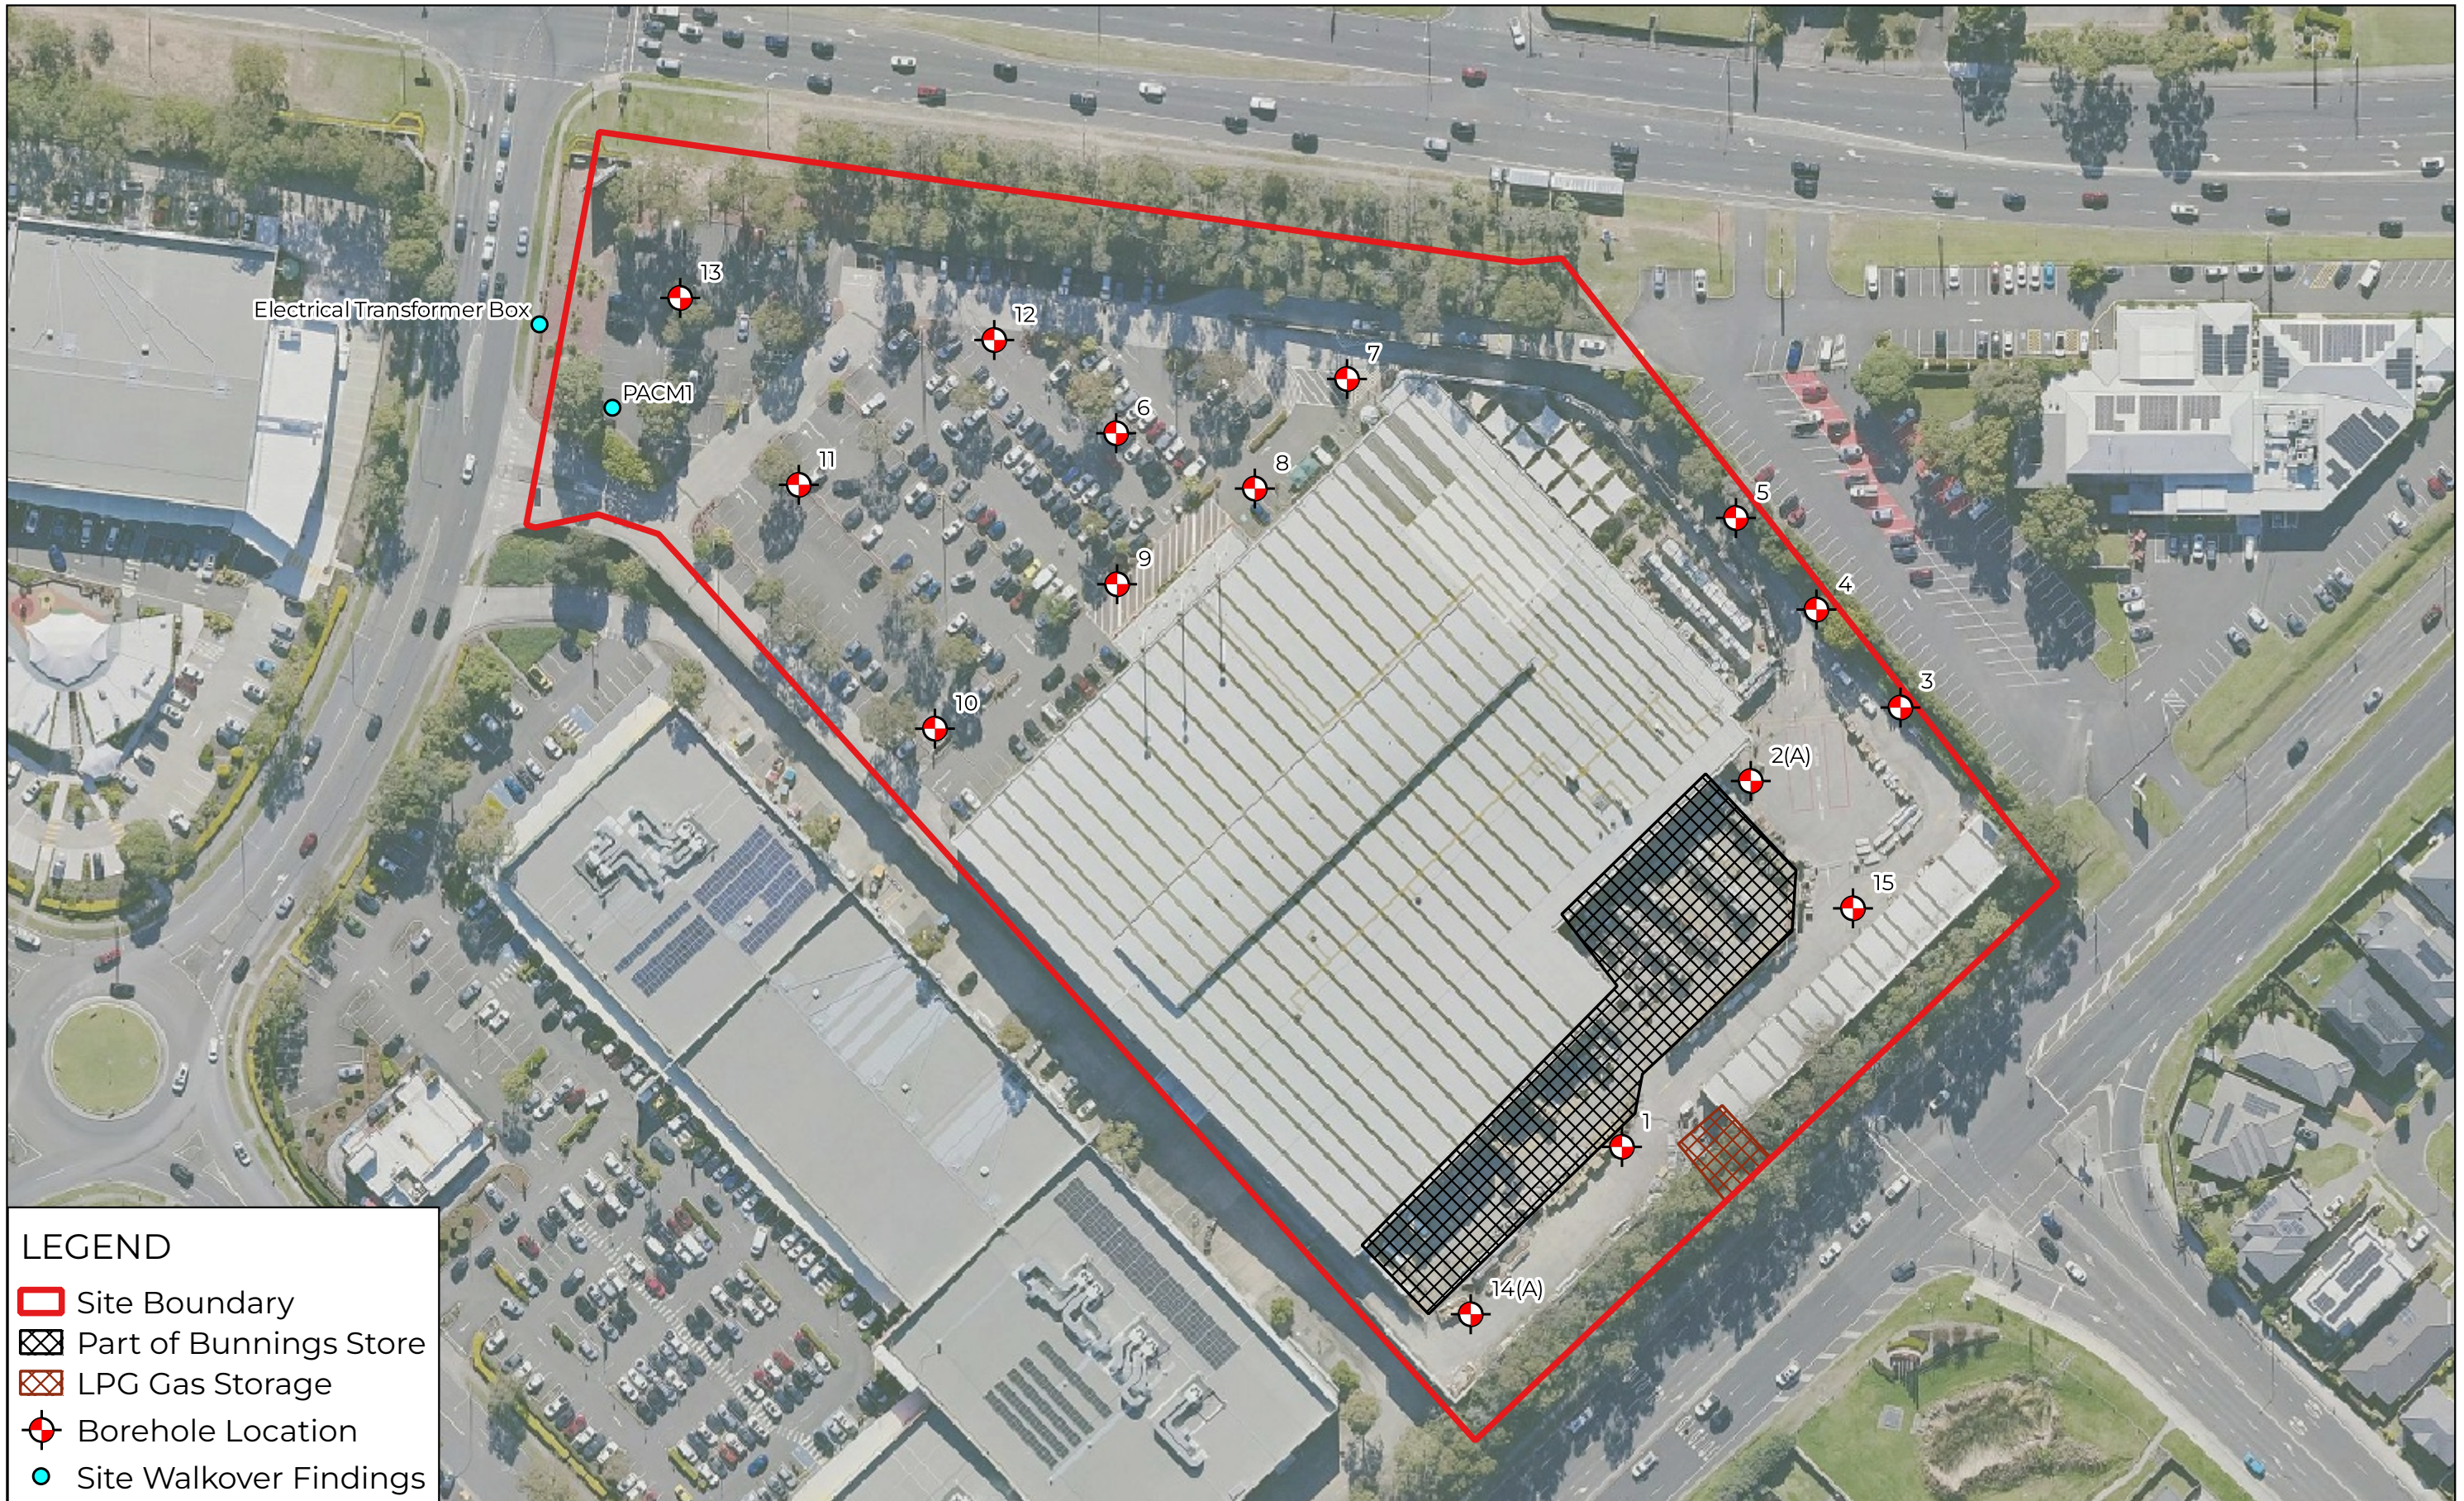
A site walkover was undertaken by an Environmental Scientist from Douglas on 23 May 2024. The general site topography was consistent with that described in Section 4. The site layout appears to have remained unchanged from the 2024 aerial photograph. The following key site features pertinent to the PSI were observed (refer to Drawing 10, Appendix A and photographs in Appendix D).

- ▭ Site Boundary
- ▣ Part of Bunnings Store
- ▣ LPG Gas Storage
- ⊕ Borehole Location
- Site Walkover Findings

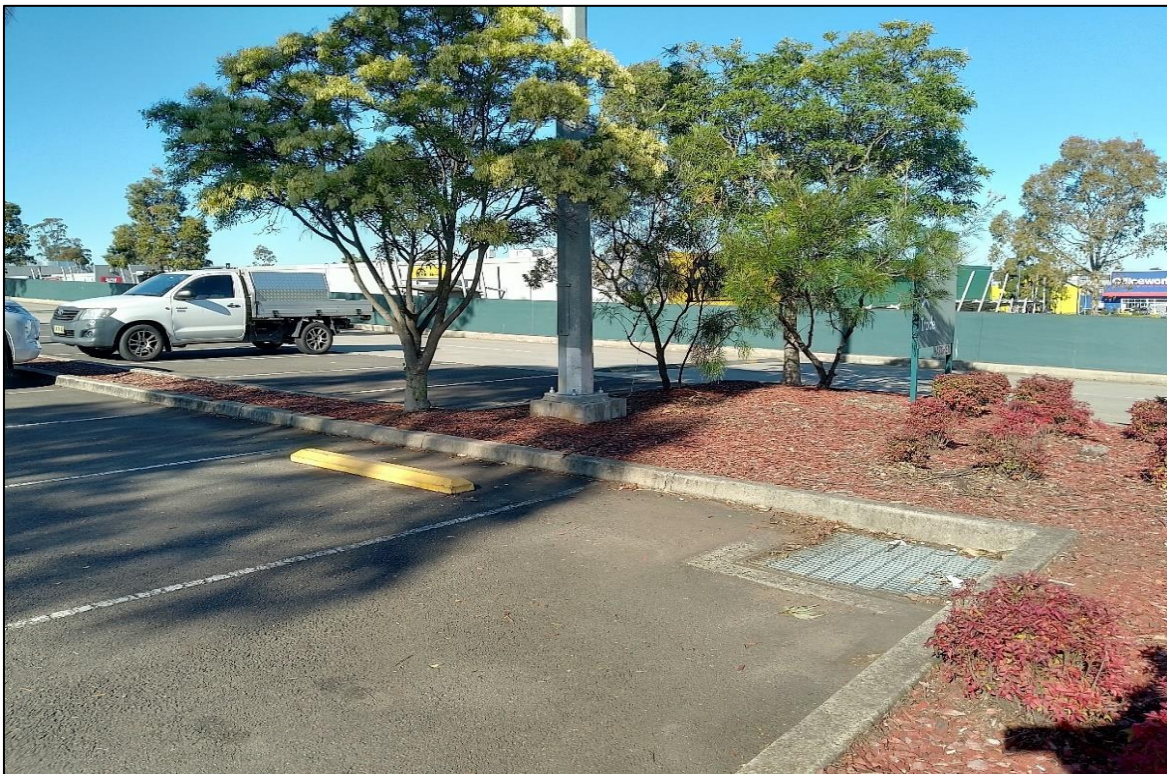
- Multiple garden beds were observed throughout the carpark area. The garden beds generally comprised trees/shrubs/hedges with woodchips (mulch) and silty clay fill/topsoil (Photographs 4 and 5);

Photograph 4 - Garden beds in carpark area in north western portions of the site.

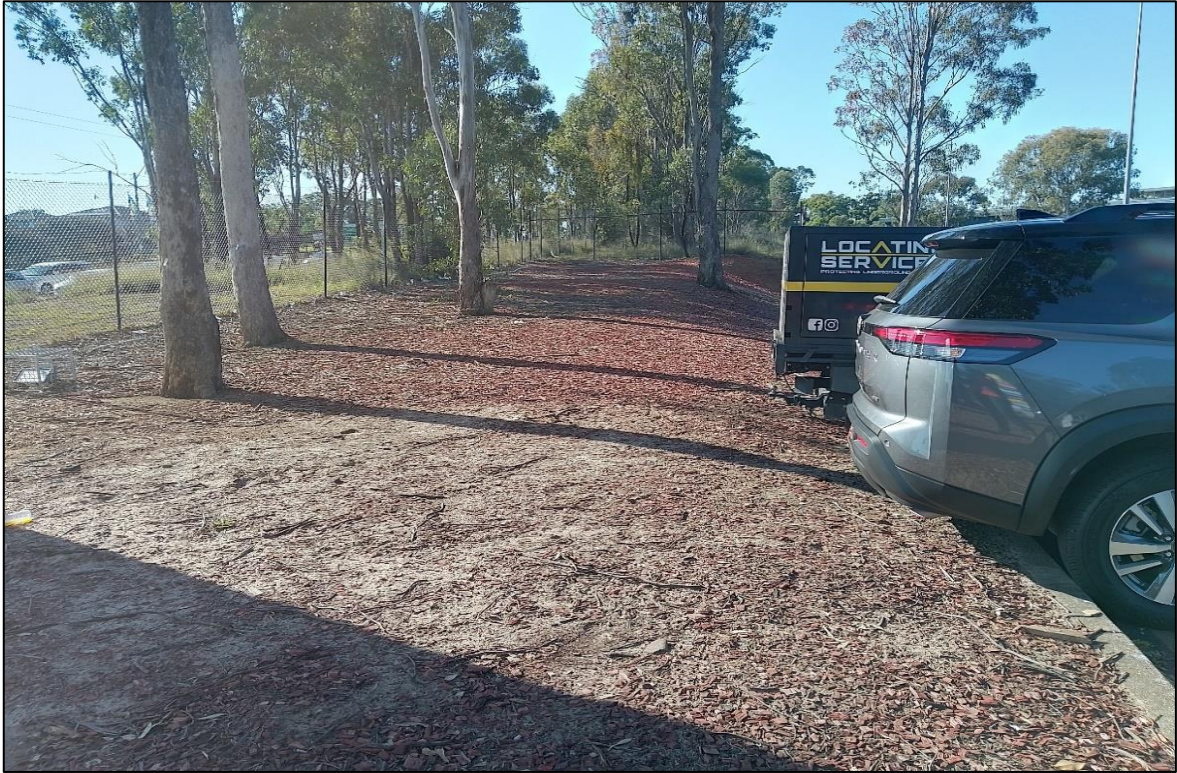
Photograph 5 - Garden beds in carpark area in north western portions of the site.

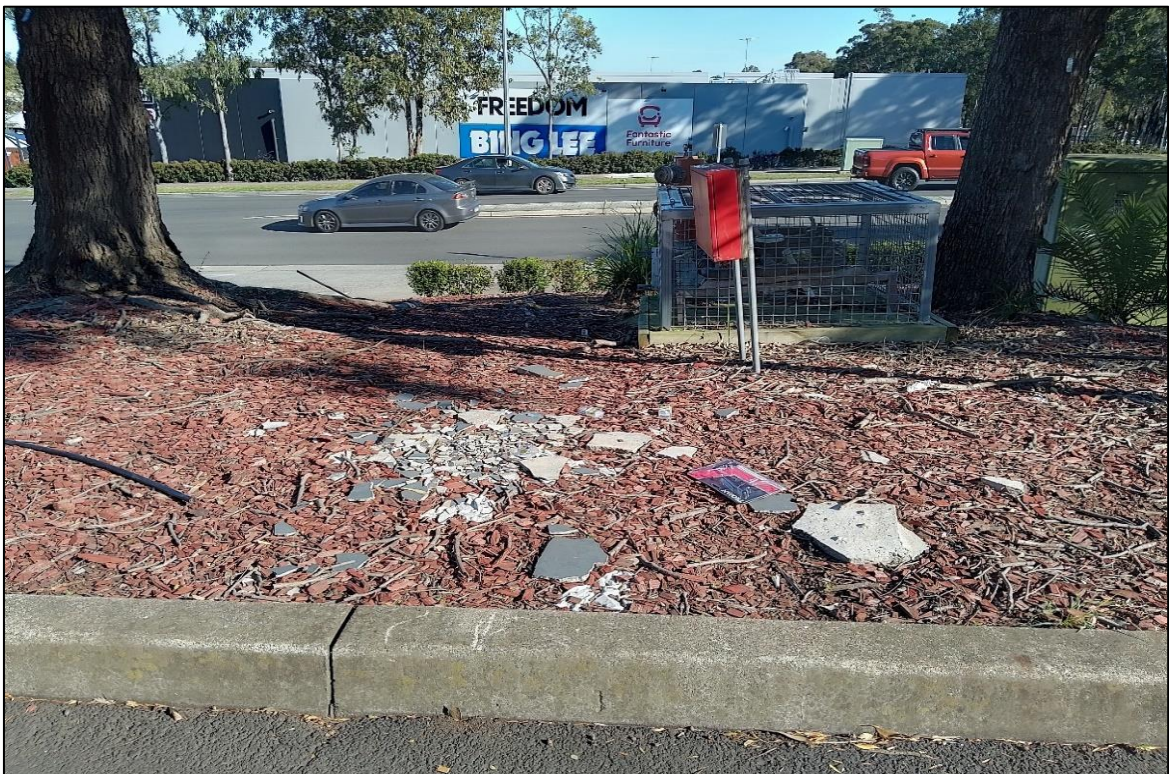
- Fly-tipping of refuse material comprising cement sheeting and/or concrete, was observed in the north western portion of the site (a sample of the material [PACM1] was collected – Photographs 6);

Photograph 6 - Fly-tipping of refuse material comprising cement sheeting and / or concrete observed in the north western portion of the site.

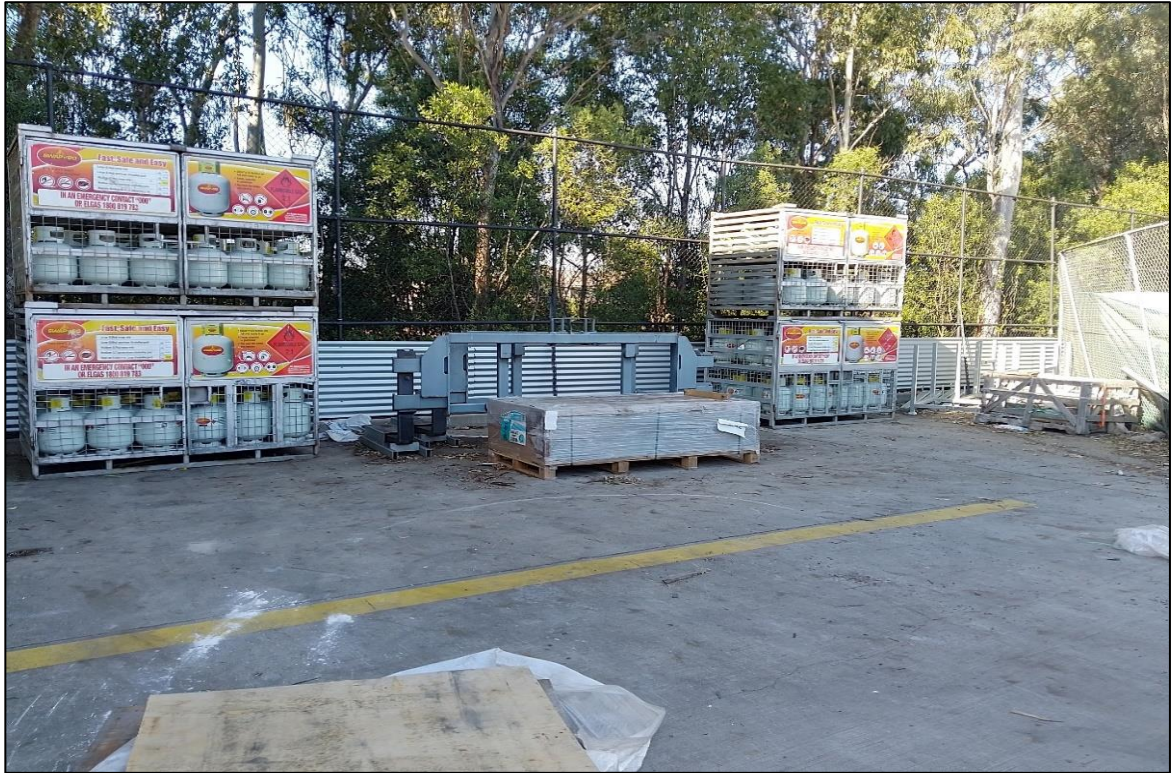
- Liquid petroleum gas (LPG) bottle storage was observed in the south eastern portion of the site (Photograph 7);
- The eastern to southern portions of the site were utilised as loading docks/storage of various hardware items/outdoor aisles with goods (timbers, metals, gravels, sand etc.) for sale with high truck and forklift activity (Photographs 8, 9 and 10);

Photograph 7 - Liquid petroleum gas (LPG) storage observed in the south eastern portion of the site.

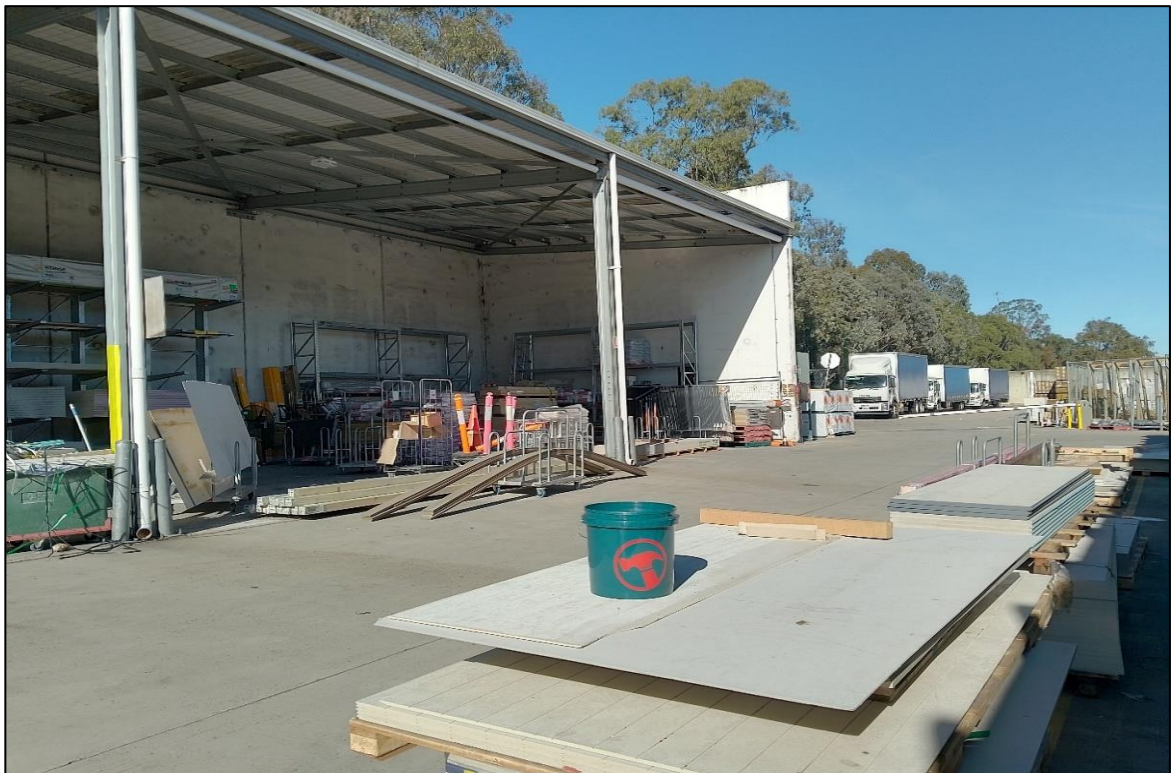
Photograph 8 - Loading docks / storage of various hardware items observed in the eastern to southern portions of the site.

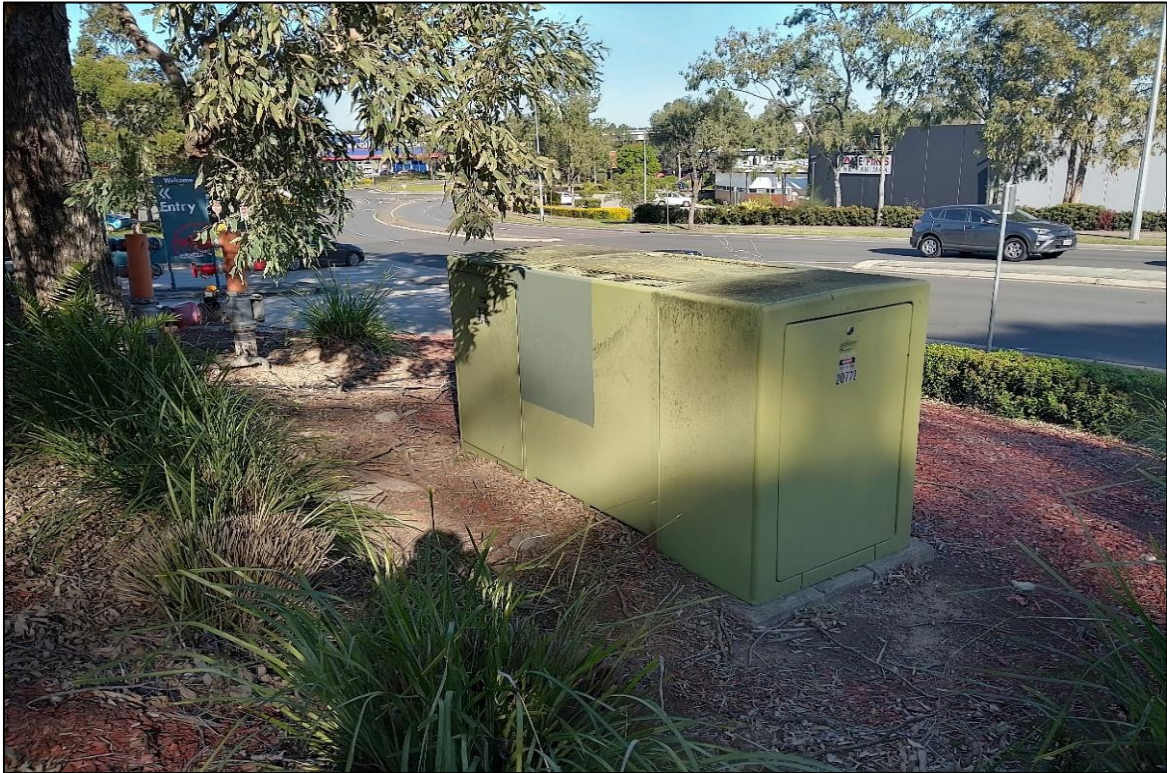
- A pad-mounted transformer was identified west of the boundary (Photograph 11); and
- Two petrol/service stations – BP (located approximately 480 m southwest of the site and Costco Petrol Station (also known as Costco Fuel Casula, located approximately 240 west of the site) – were observed to be operational at the time of inspection.

Whilst electrical transformers were observed adjacent the western boundary of the site, given that they were likely constructed sometime between the mid-1990s and 2003, after the period of PCB phase out in the early-1980's, and were constructed upon a concrete slab, the transformers were not considered to be a potential source of on-site contamination.

Photograph 11 - Pad-mounted transformer identified west of the boundary.

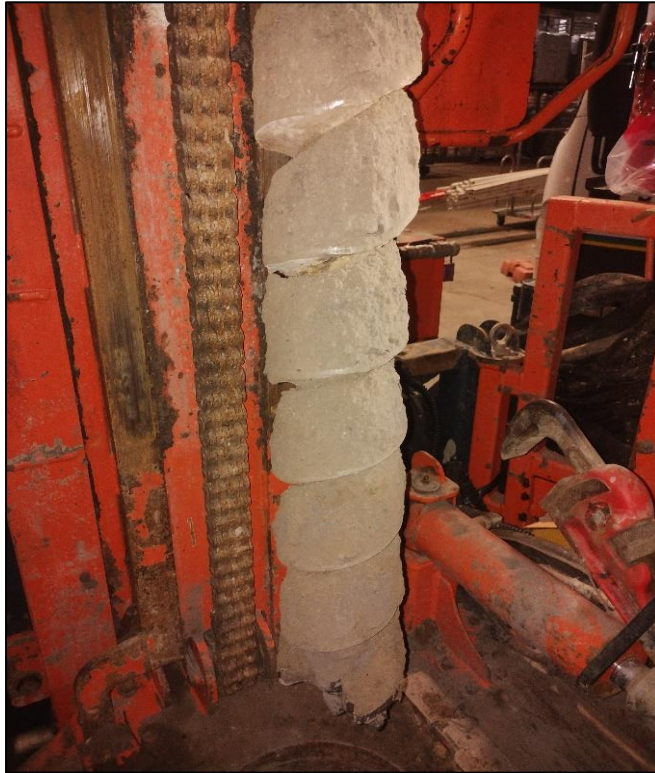
Photograph 15 - Gravelly clay fill material observed at BH2A.

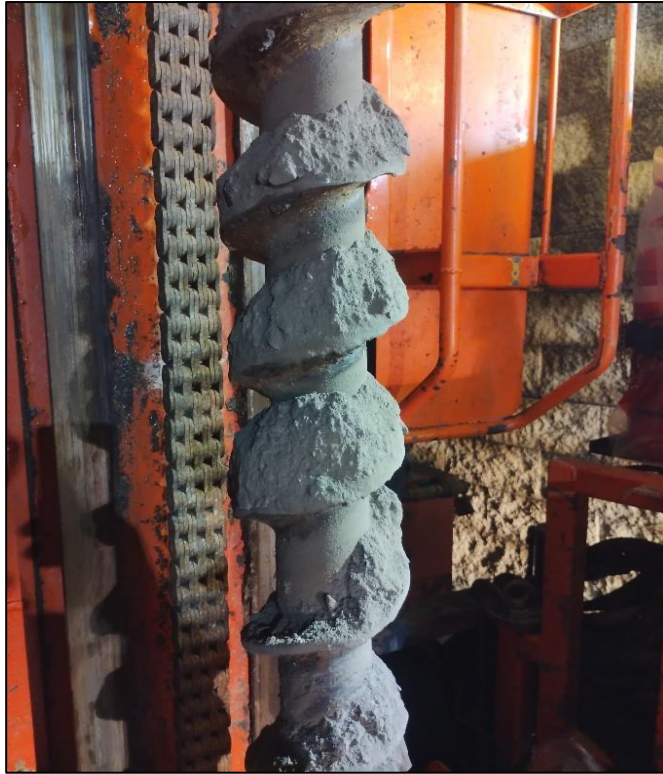
Photograph 19 - Gravelly clay fill material encountered at BH5.

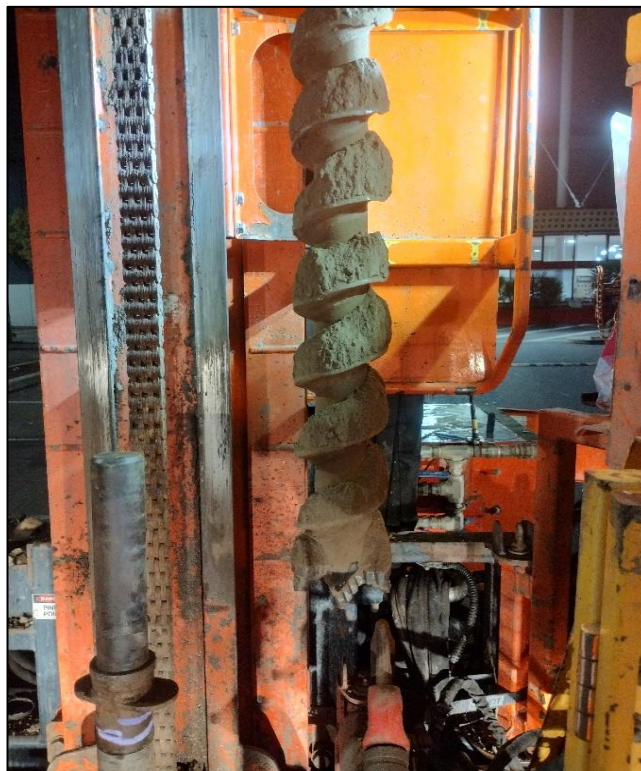
Photograph 24 - Gravelly sand material encountered at BH9.

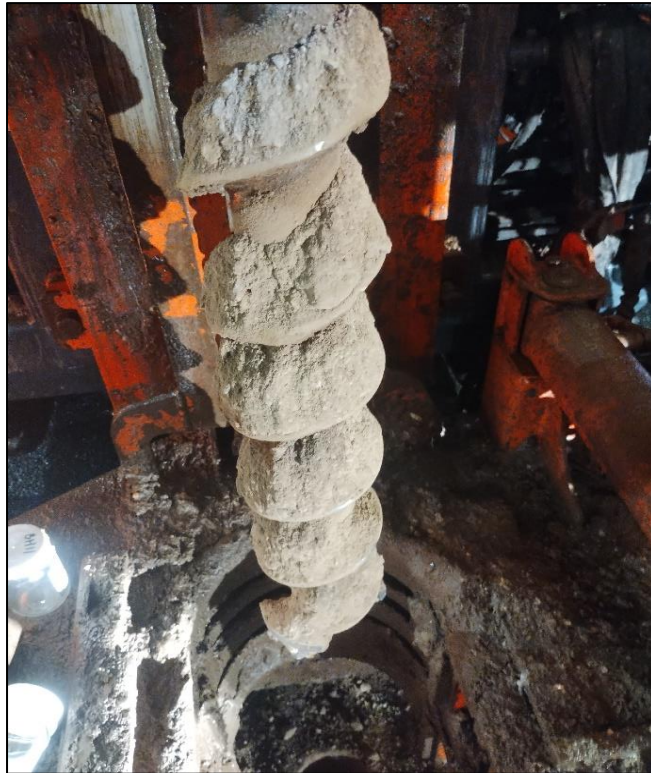
Photograph 27 - Shale encountered at BH11.
