Historical Archaeological Impact Assessment

1A Lyons Road, Drummoyne
Wangal Country

Prepared for
Scalabrini Village Pty Ltd
August 2024

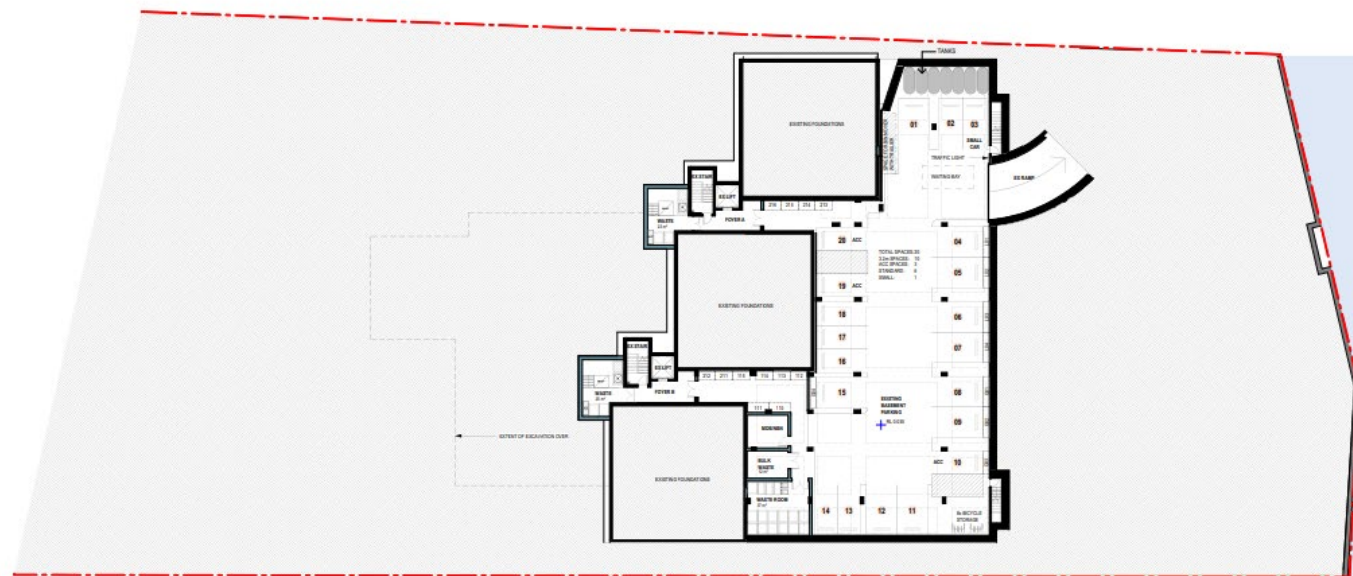
Figure 3 – Floor plan of proposed basement level.
 Source: Jackson Teece, Drawing Number: DA-108, Revision P17

PARKING LEGEND
 [Symbol] RESIDENT PARKING
 [Symbol] VISITOR PARKING
 [Symbol] STAFF PARKING

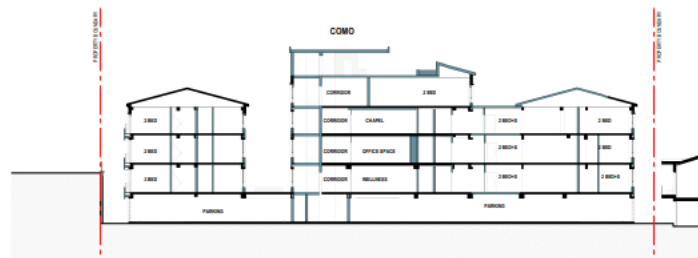
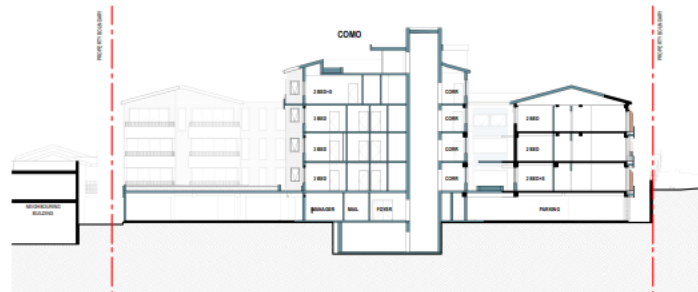
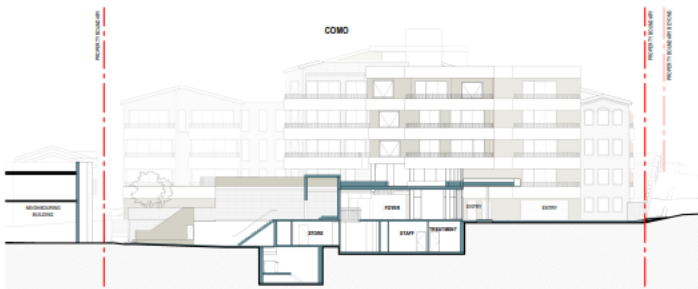
Figure 7 – Sections 02

3 SECTION 3
1 : 200

4 SECTION 4
1 : 200

5 SECTION 5
1 : 200

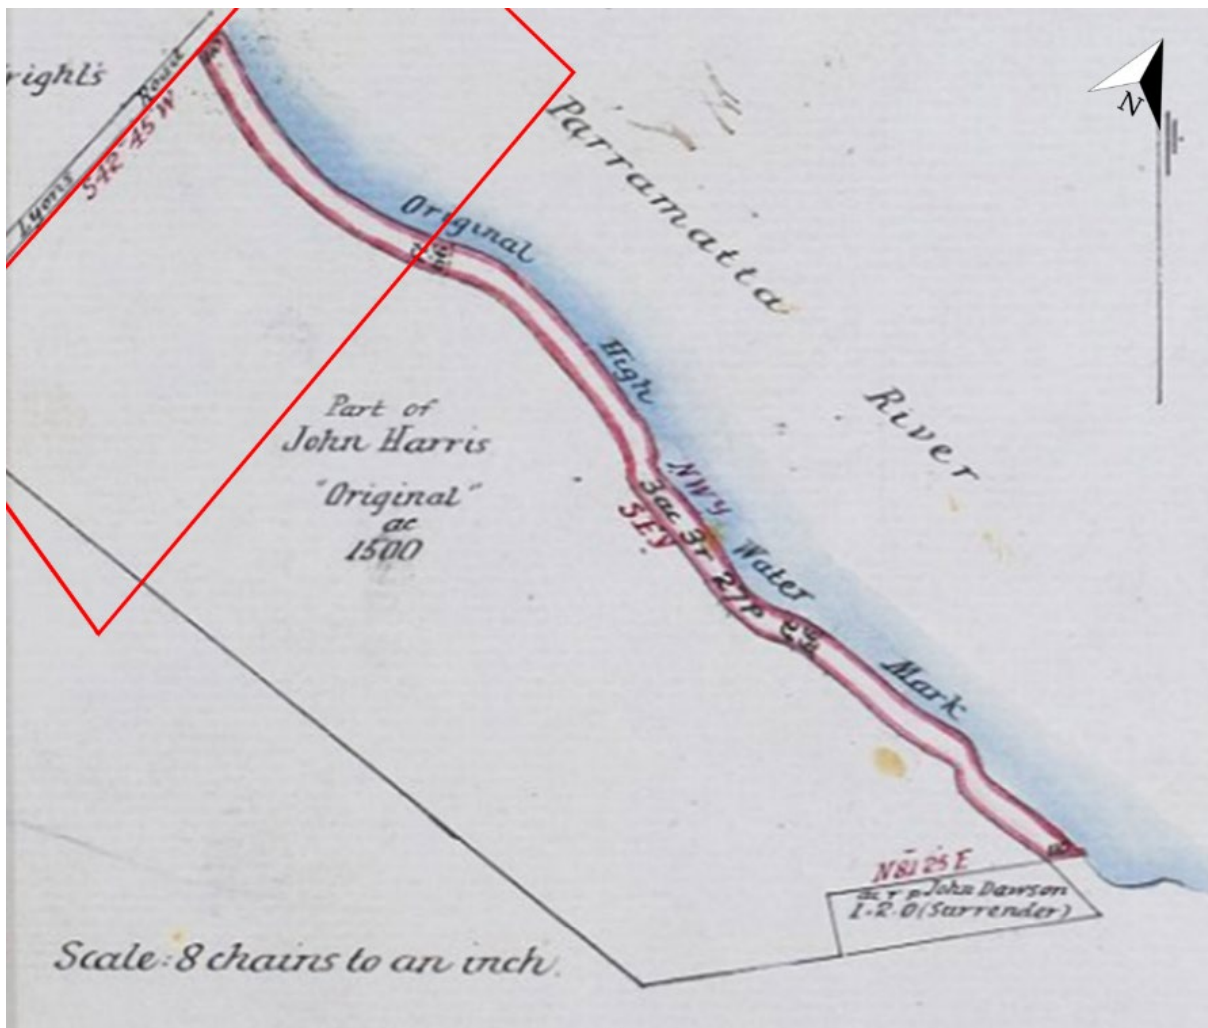
Figure 9 – Transfer to John Harris on 1 January 1808 with the approximate location of the subject site in red outline.

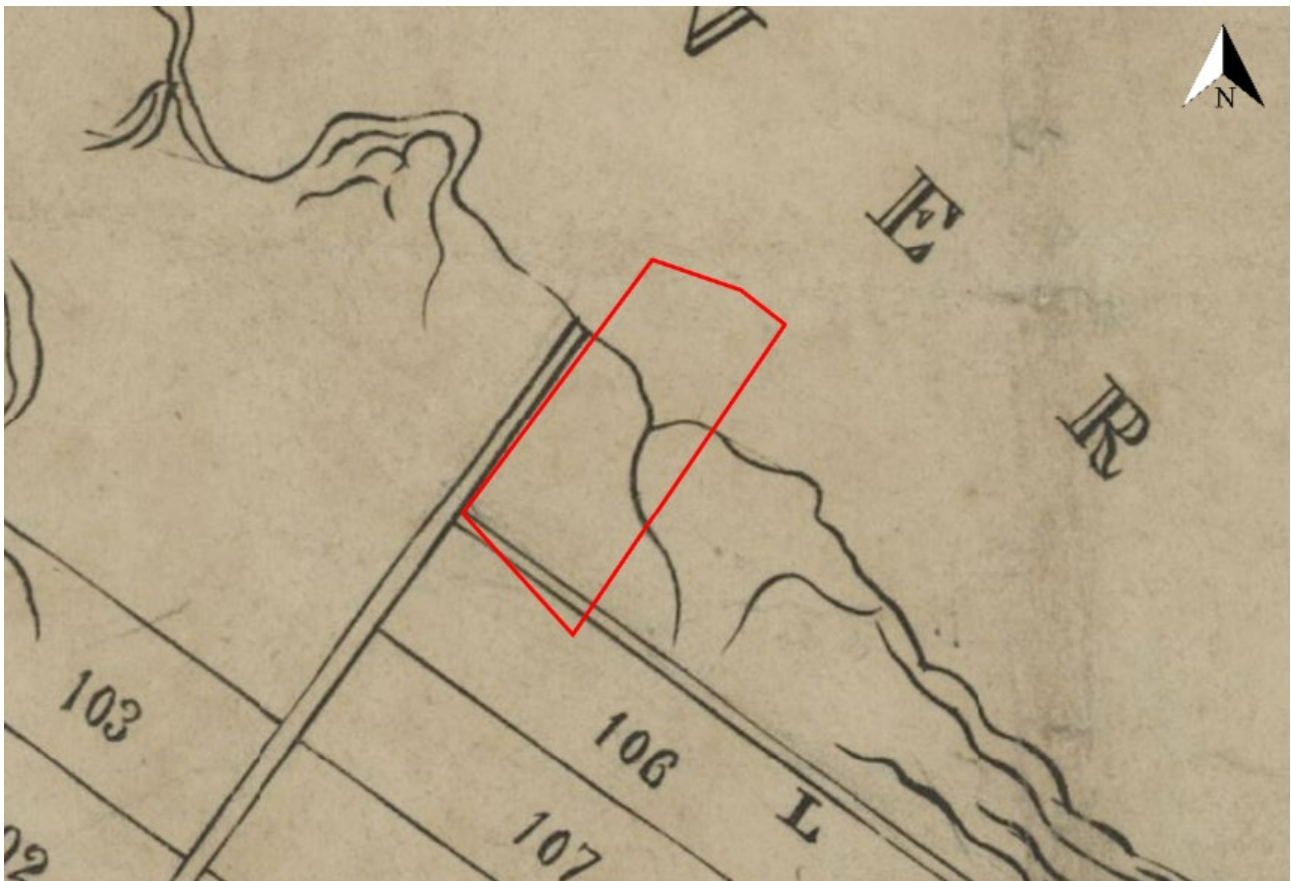
Figure 10 – Map of Five Dock Farm in 1837 drawn and published by E.D. Barlow. The map pictures the site next to Lyons Road and next to a waterway to the east.

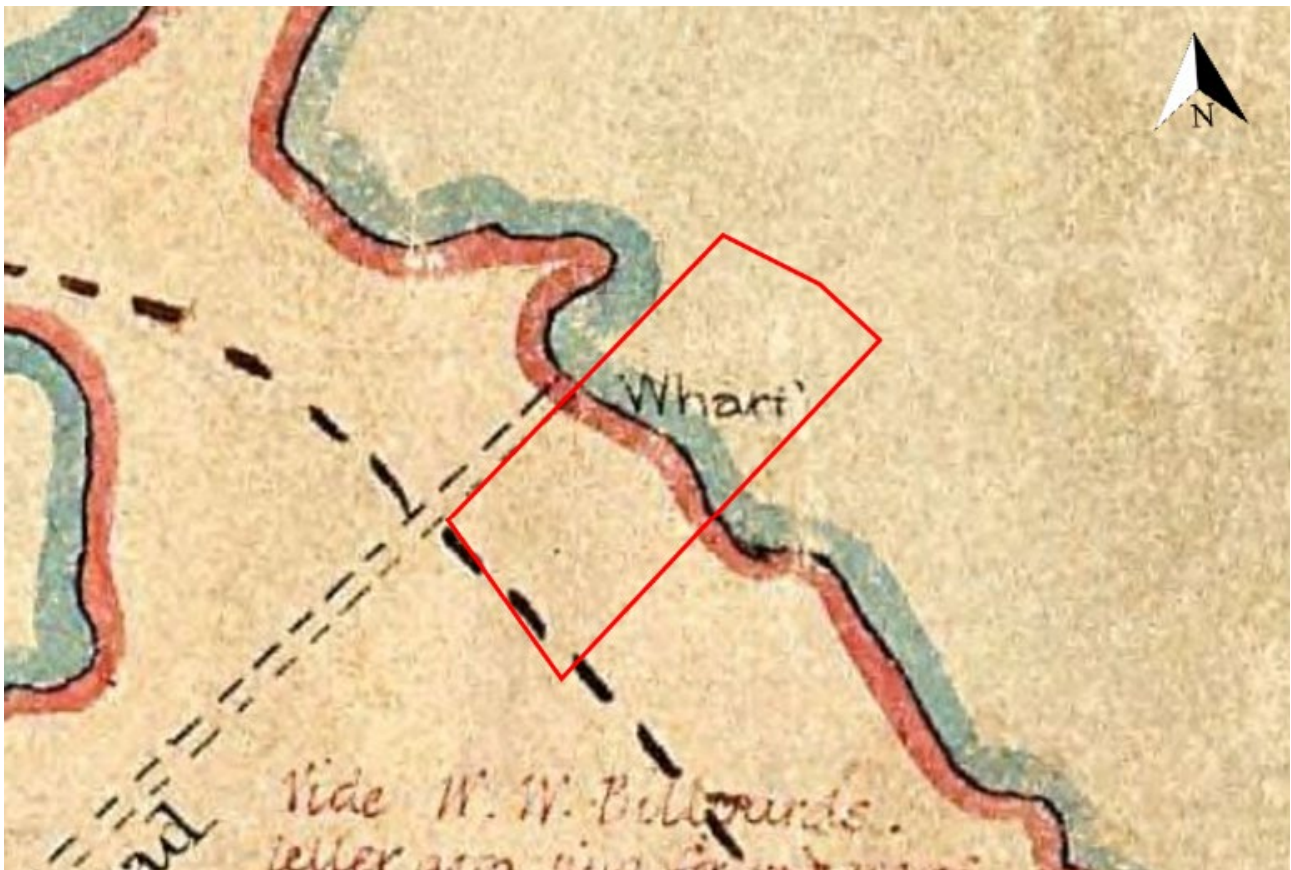
Figure 11 – Extract of an undated parish map likely to date from the late 19th Century showing a wharf as labelled within the subject site.

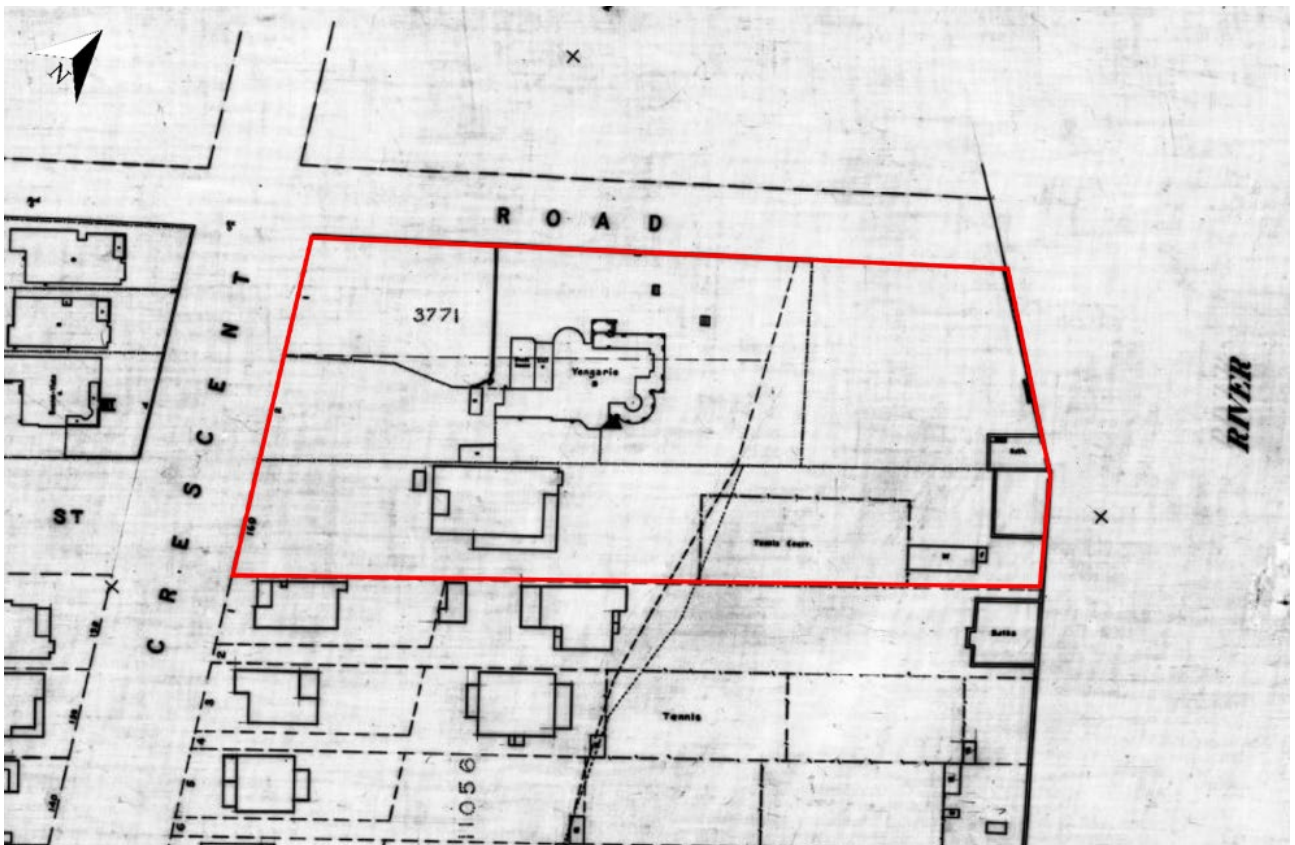
Figure 14 – Undated Metropolitan Board of Water Supply and Sewerage (M.W.S & D.B) map of Drummoyne (Sheet 381 subject site (outlined in red))

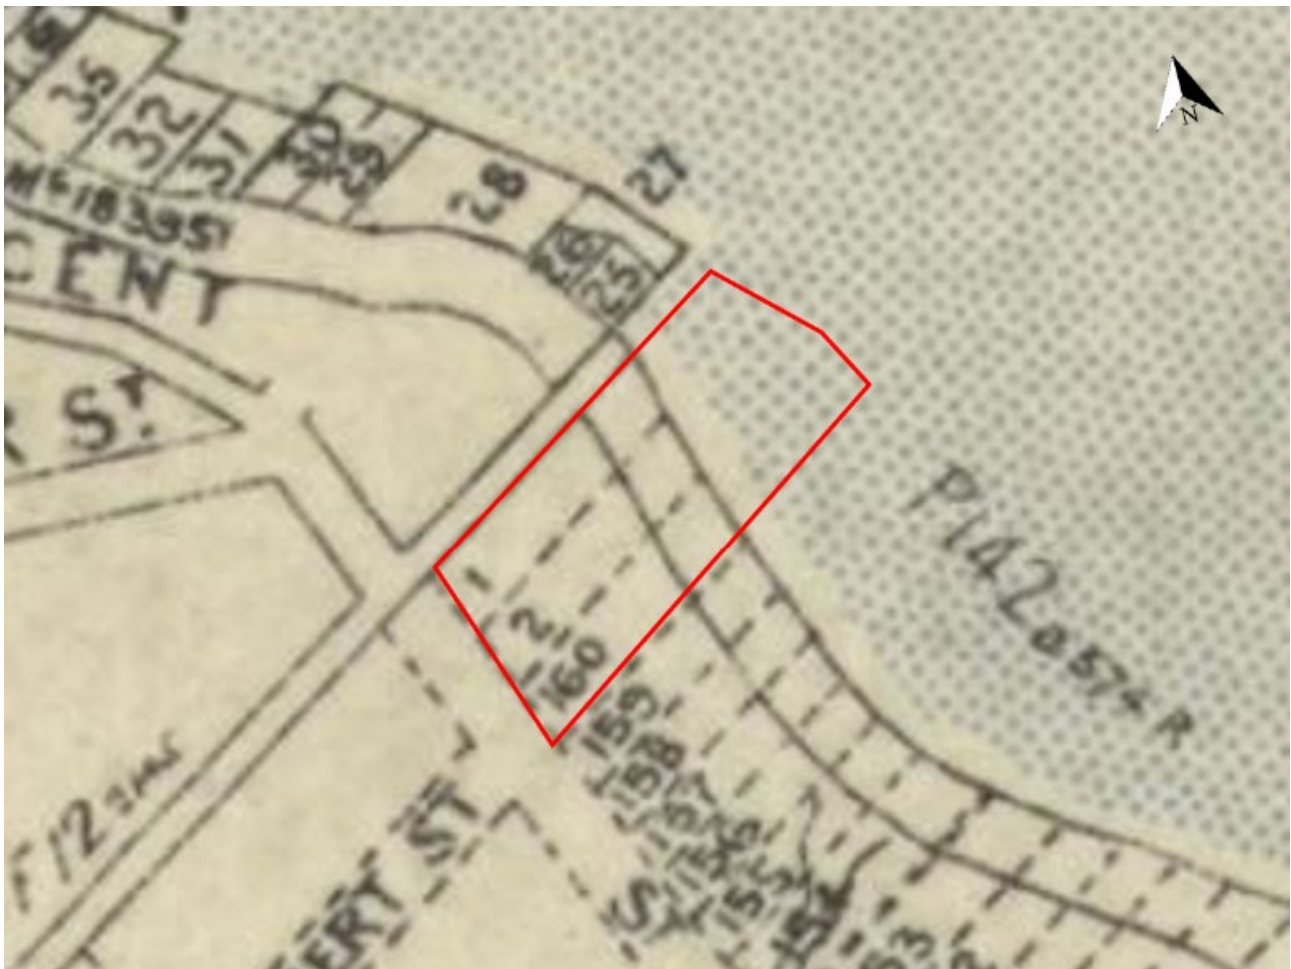
Figure 15 – Map of the Drummoyne area in 1914 showing the subject site as having been further subdivided.
Source: State Library NSW, Call number: Z/Parish map - County Cumberland - Parish Concord (1914)

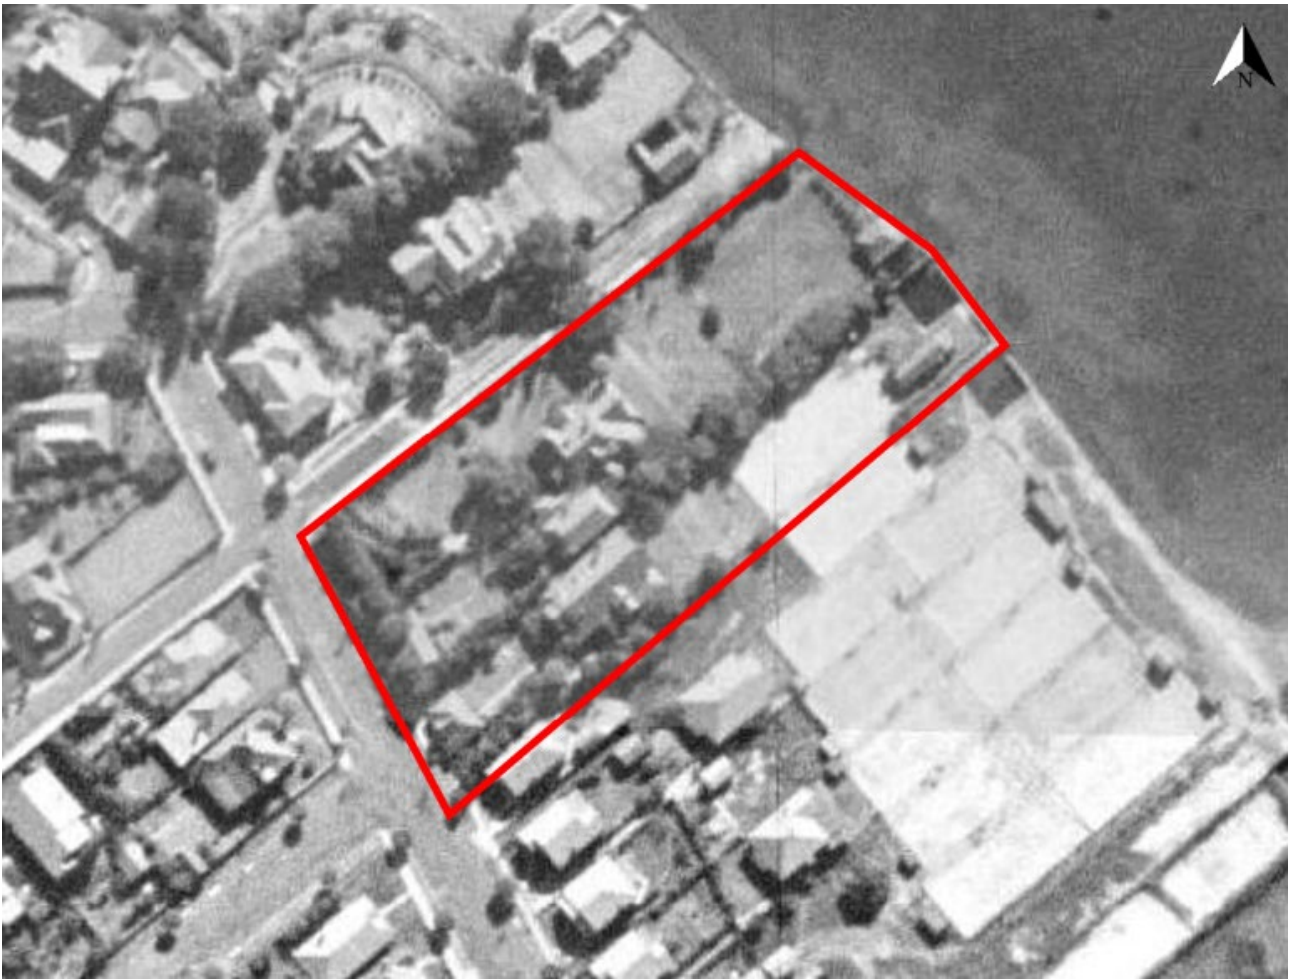
Figure 17 – Aerial image c.1943 with the subject curtilage outlined in red.

The villa structures including the 'Yengarie' house can be observed in aerial photographs from 1943 (Figure 17) and are still present in 1955 (Figure 18).

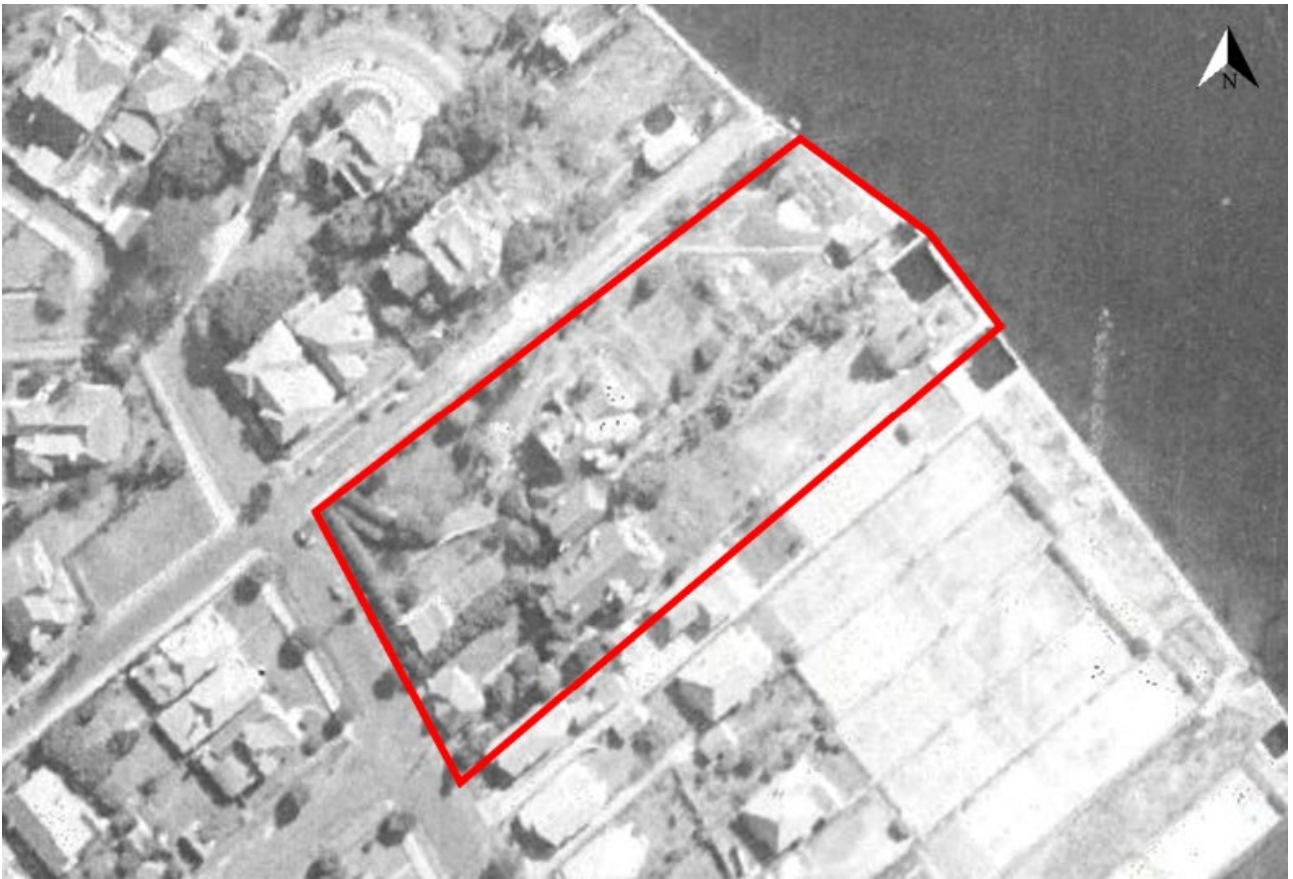
Figure 18 – Aerial image c.1955 with the subject curtilage outlined in red.

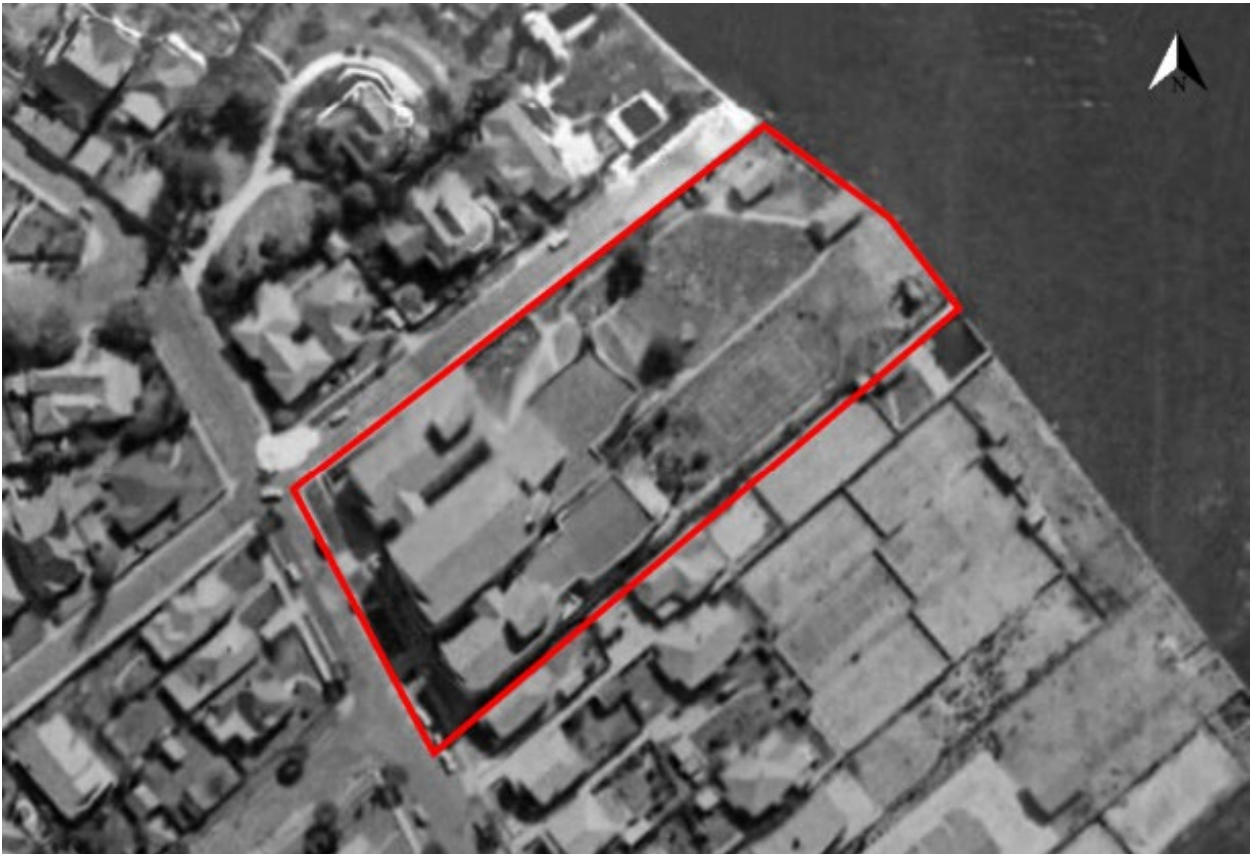
Figure 20 –Aerial image c.1965 with the subject curtilage outlined in red.

By 1966, modifications took place with three new buildings constructed centrally within the site set in a continuous design, two additional smaller wings set to the rear of off the principal buildings (Figure 21). The construction of the three central buildings likely involved the bulk excavation of the basement level that is still extant within the subject site. By 1986 the same buildings are still present as evidenced in the aerial (Figure 22). The excavation of the second separate basement level may have occurred during this period of the redevelopment.

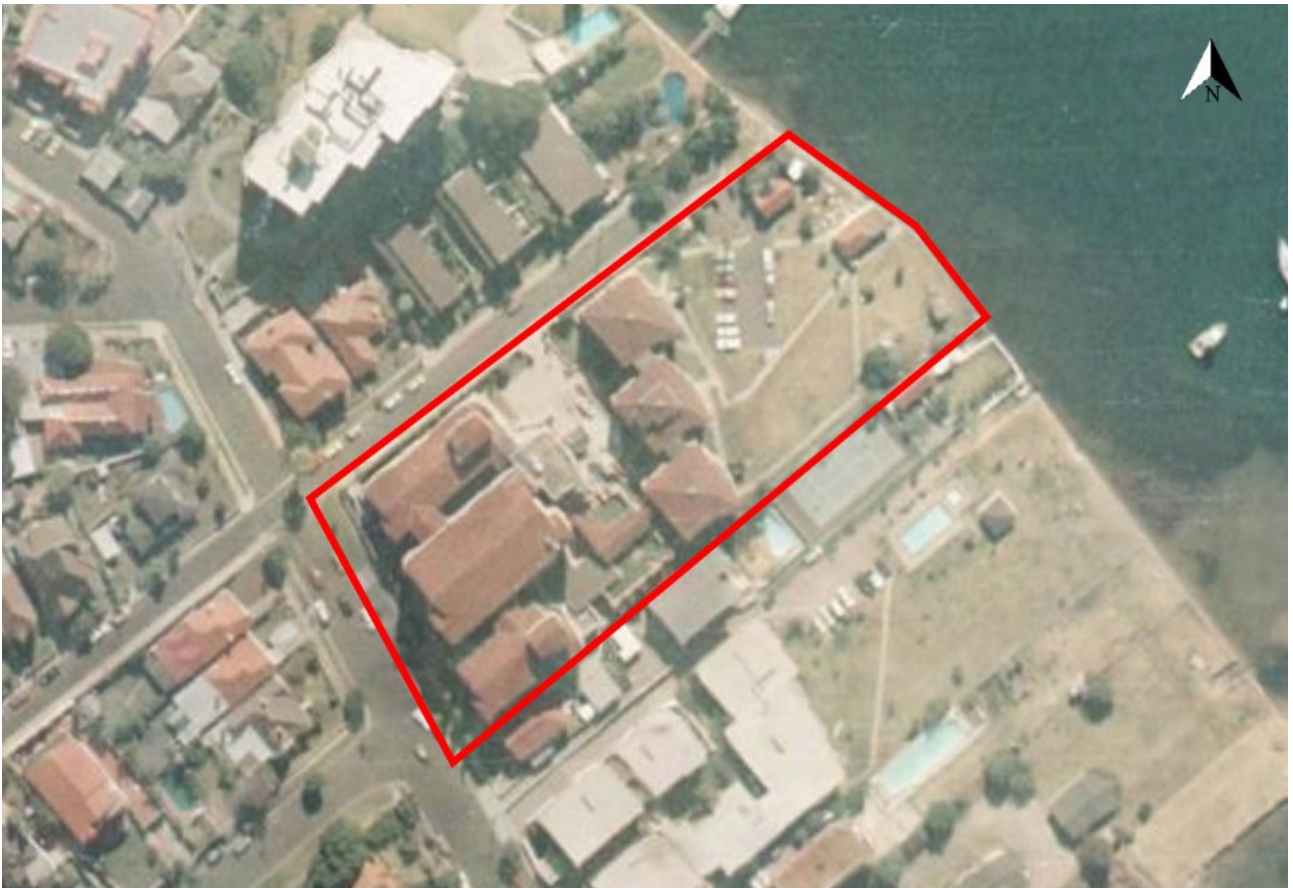
Figure 22 – Aerial image c.1986 with the subject curtilage outlined in red.

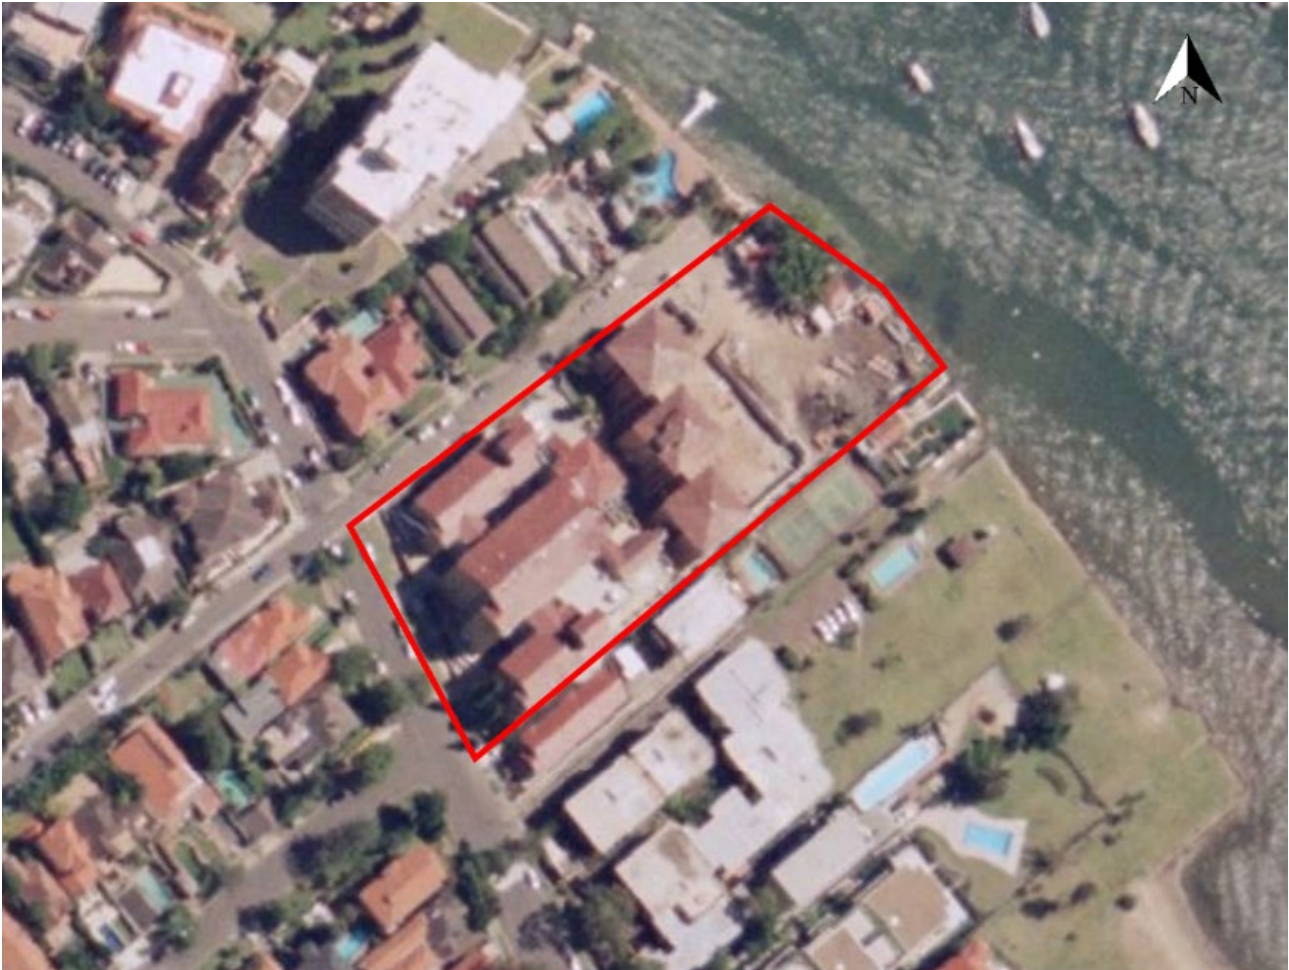
Figure 23 - Aerial image c.2005 with the subject curtilage outlined in red.

On the 12 November 1999 ownership of the subject site was transferred to ‘Scalabrini Village’, a religious based aged care facility. By 2005, a third building was expanded and redeveloped, with a larger new building centrally located within the subject site, replacing a smaller wing. Additionally, the rear garden had been impacted by cut and fill activities. These areas were developed into further hardstand areas to accommodate parking amenity.

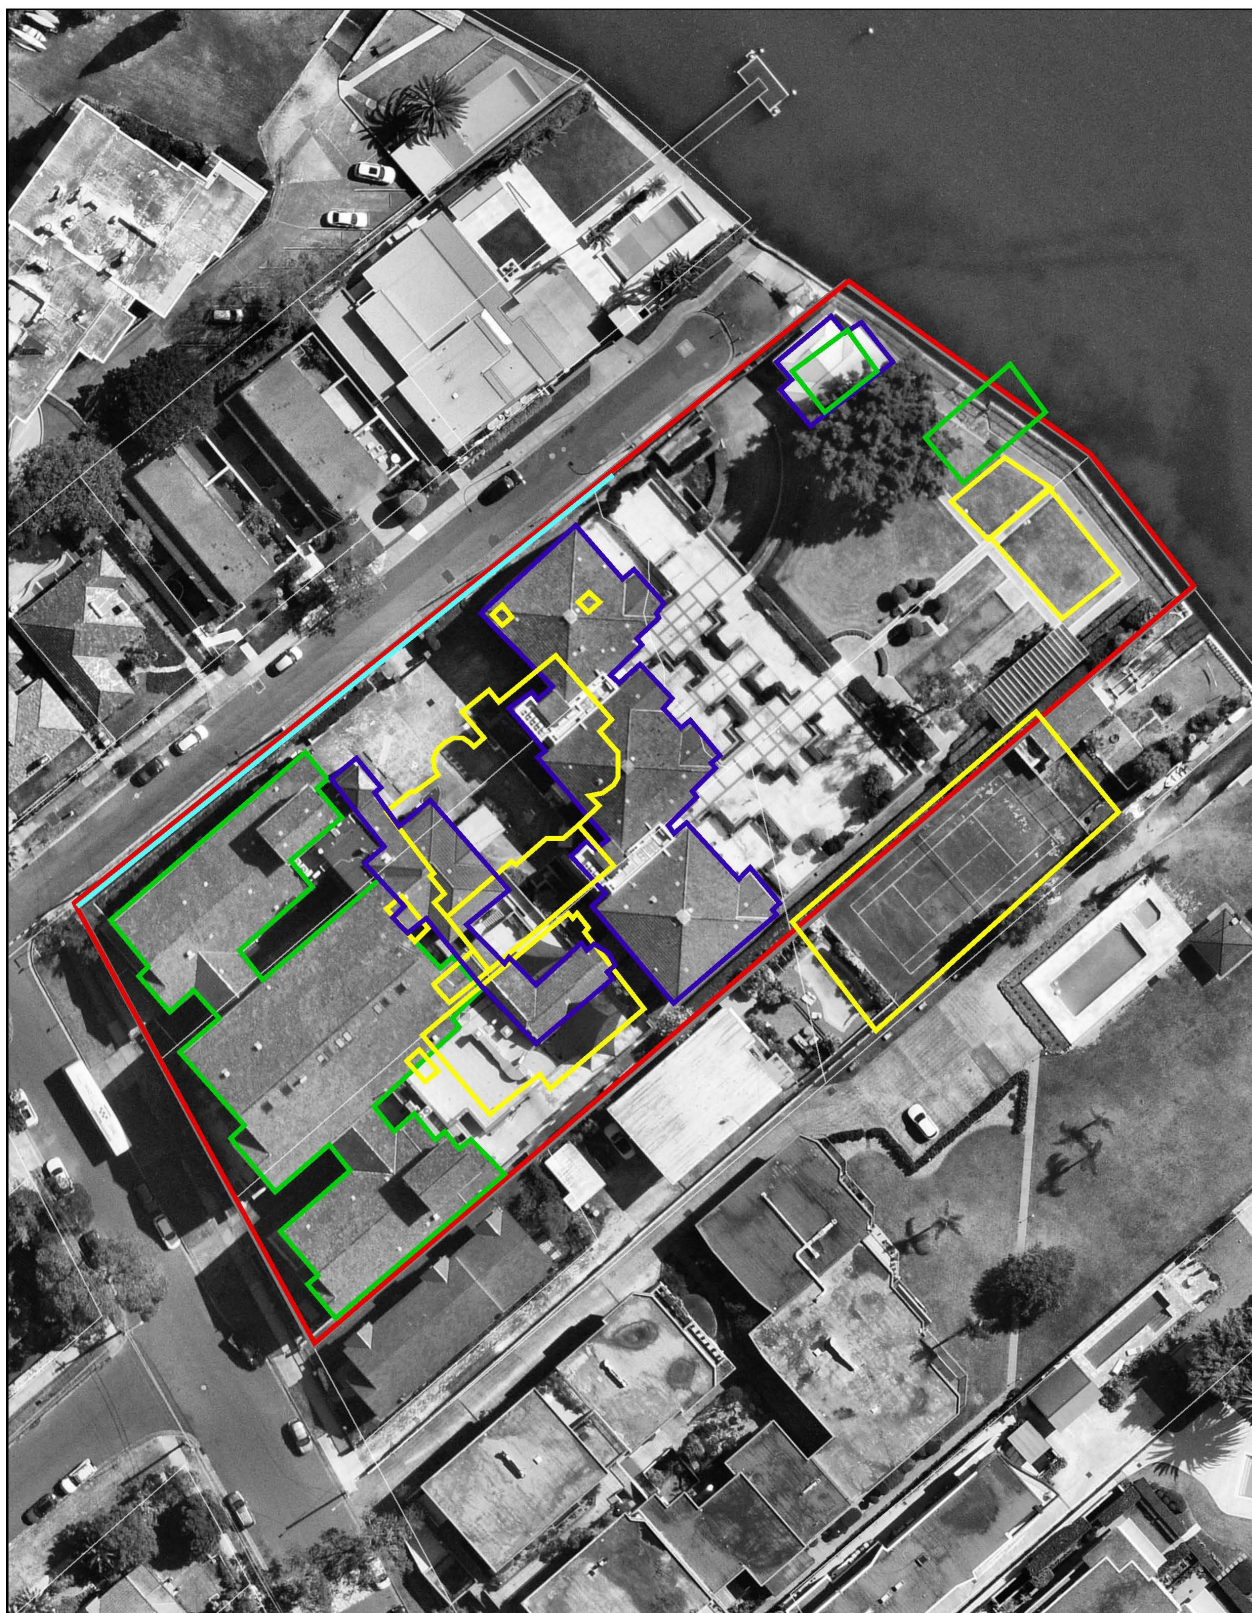
Based on the historical overview, as detailed within Section 3.1, the key phases of historical (structural) development within the subject site are summarised in Figure 24 below.

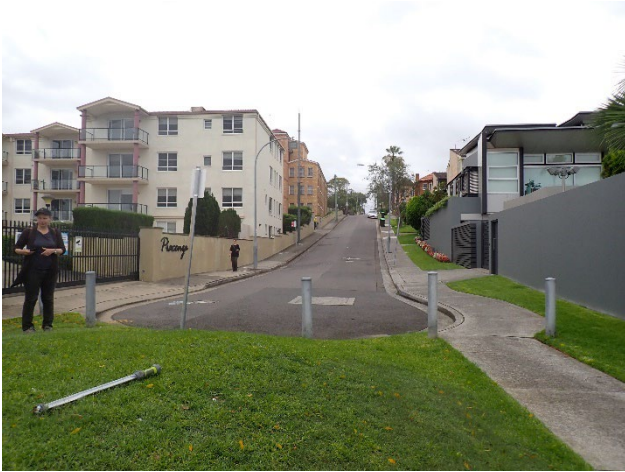
Figure 25 - View of the subject site from the north end of Lyons Road showing two sets of apartment complexes in the foreground and background (facing south-west).

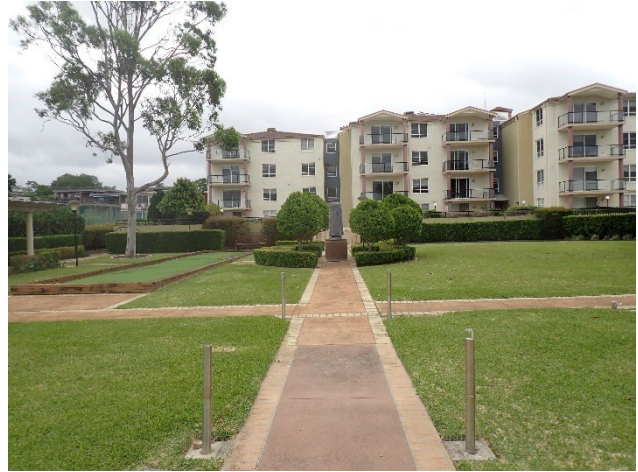
Figure 26 - Northern portion of the subject site showing gardens, paths and northern apartment complexes (facing south-west).

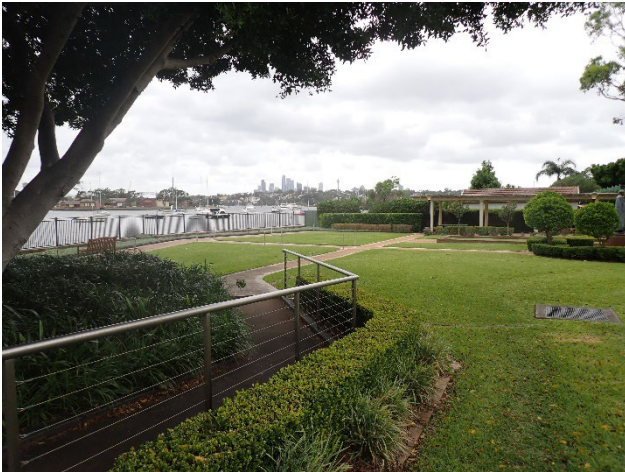
Figure 27 - Northern portion of subject site showing garden and north-eastern boundary which faces onto Parramatta River (facing east).

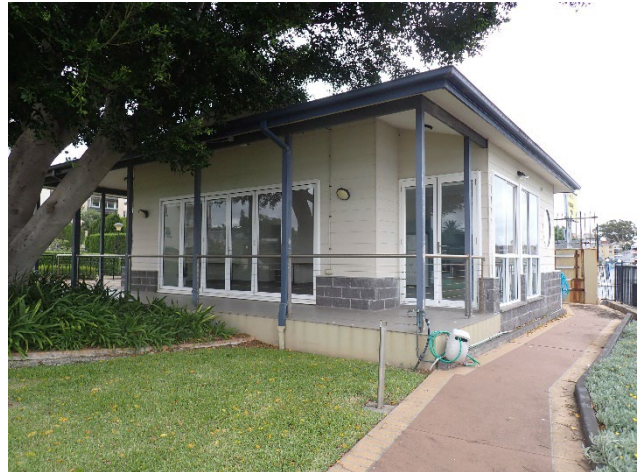
Figure 28 - Northern corner of subject site showing extant café building (facing north-west).

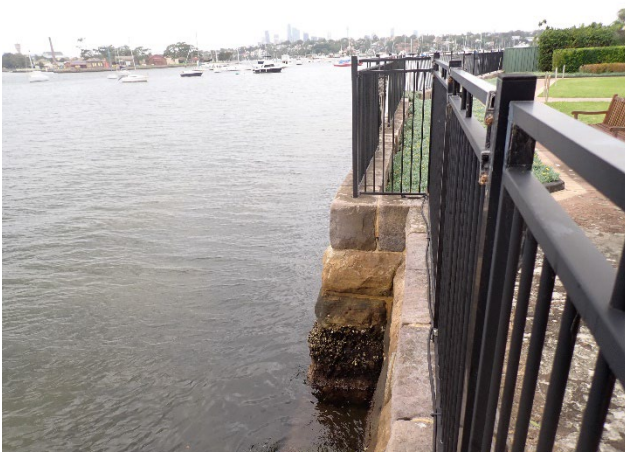
Figure 29 – North-eastern boundary of subject site showing the sea wall for Parramatta River (facing south-east). Note height difference between sea level and ground level.

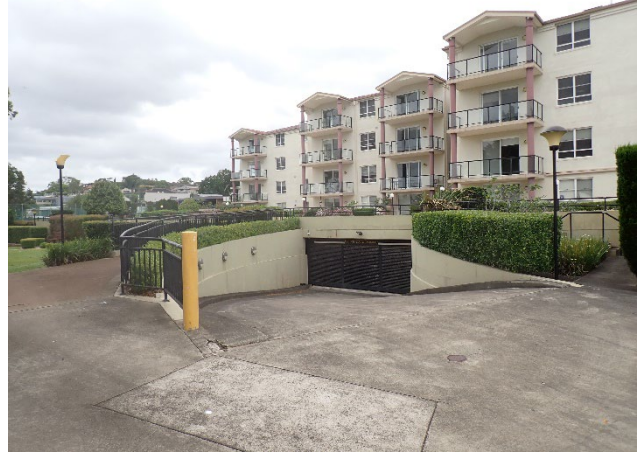
Figure 30 – Northern portion of the subject site showing the road to the underground car park area (facing south).

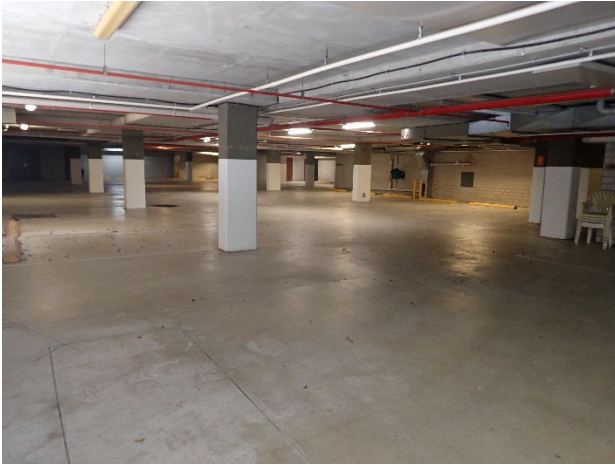
An underground carpark also exists (Figure 31 & Figure 32) immediately to the south-west of the northern gardens and extends across the width of the subject site and corresponds with the approximate location of the original pre-1958 shoreline (Figure 36). This demonstrates significant excavation activity has occurred in this location. Additionally, a basement was inspected beneath the southeastern apartment buildings (Figure 33 & Figure 34). Natural sandstone was not identified within the basement. The presence of the underground basement further suggests that significant excavation activity has occurred in the areas below the extant apartments.

Figure 31 – View of underground carpark which extends across a midsection of the subject site (facing south).

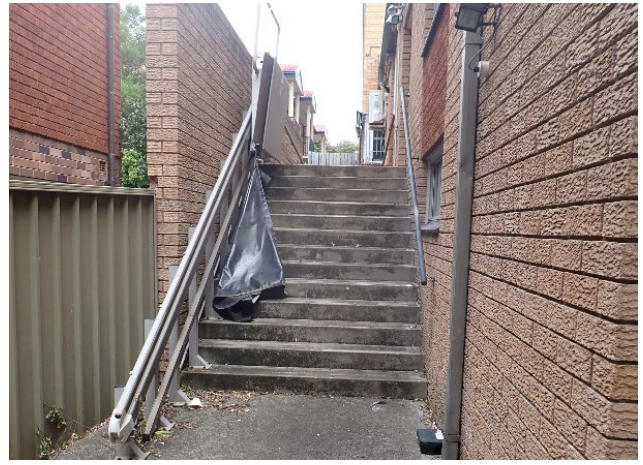
Figure 32 – View of western boundary of the subject site showing corner of the western square roofed apartment block (facing south-west). This is where the team accessed the basement area.

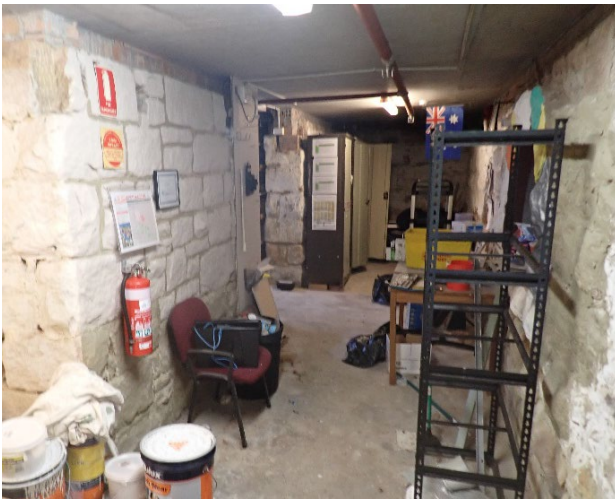
Figure 33 – View of the basement (facing north-west). Note the stone walls appear to be man made rather than natural sandstone.

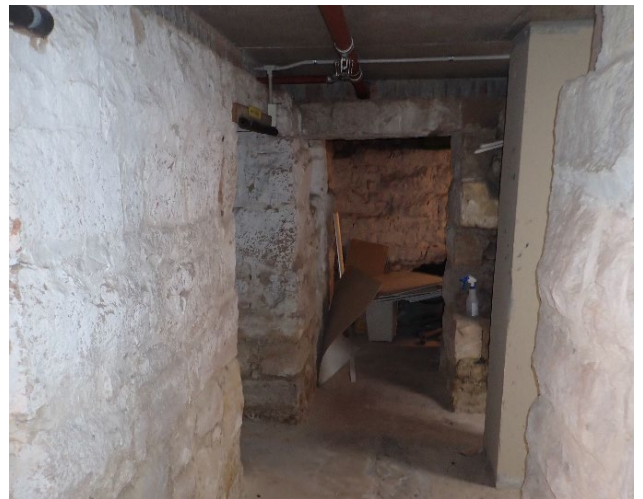
Figure 34 – View of the basement (facing south-west). Note the stone walls appear to be manmade rather than natural sandstone.

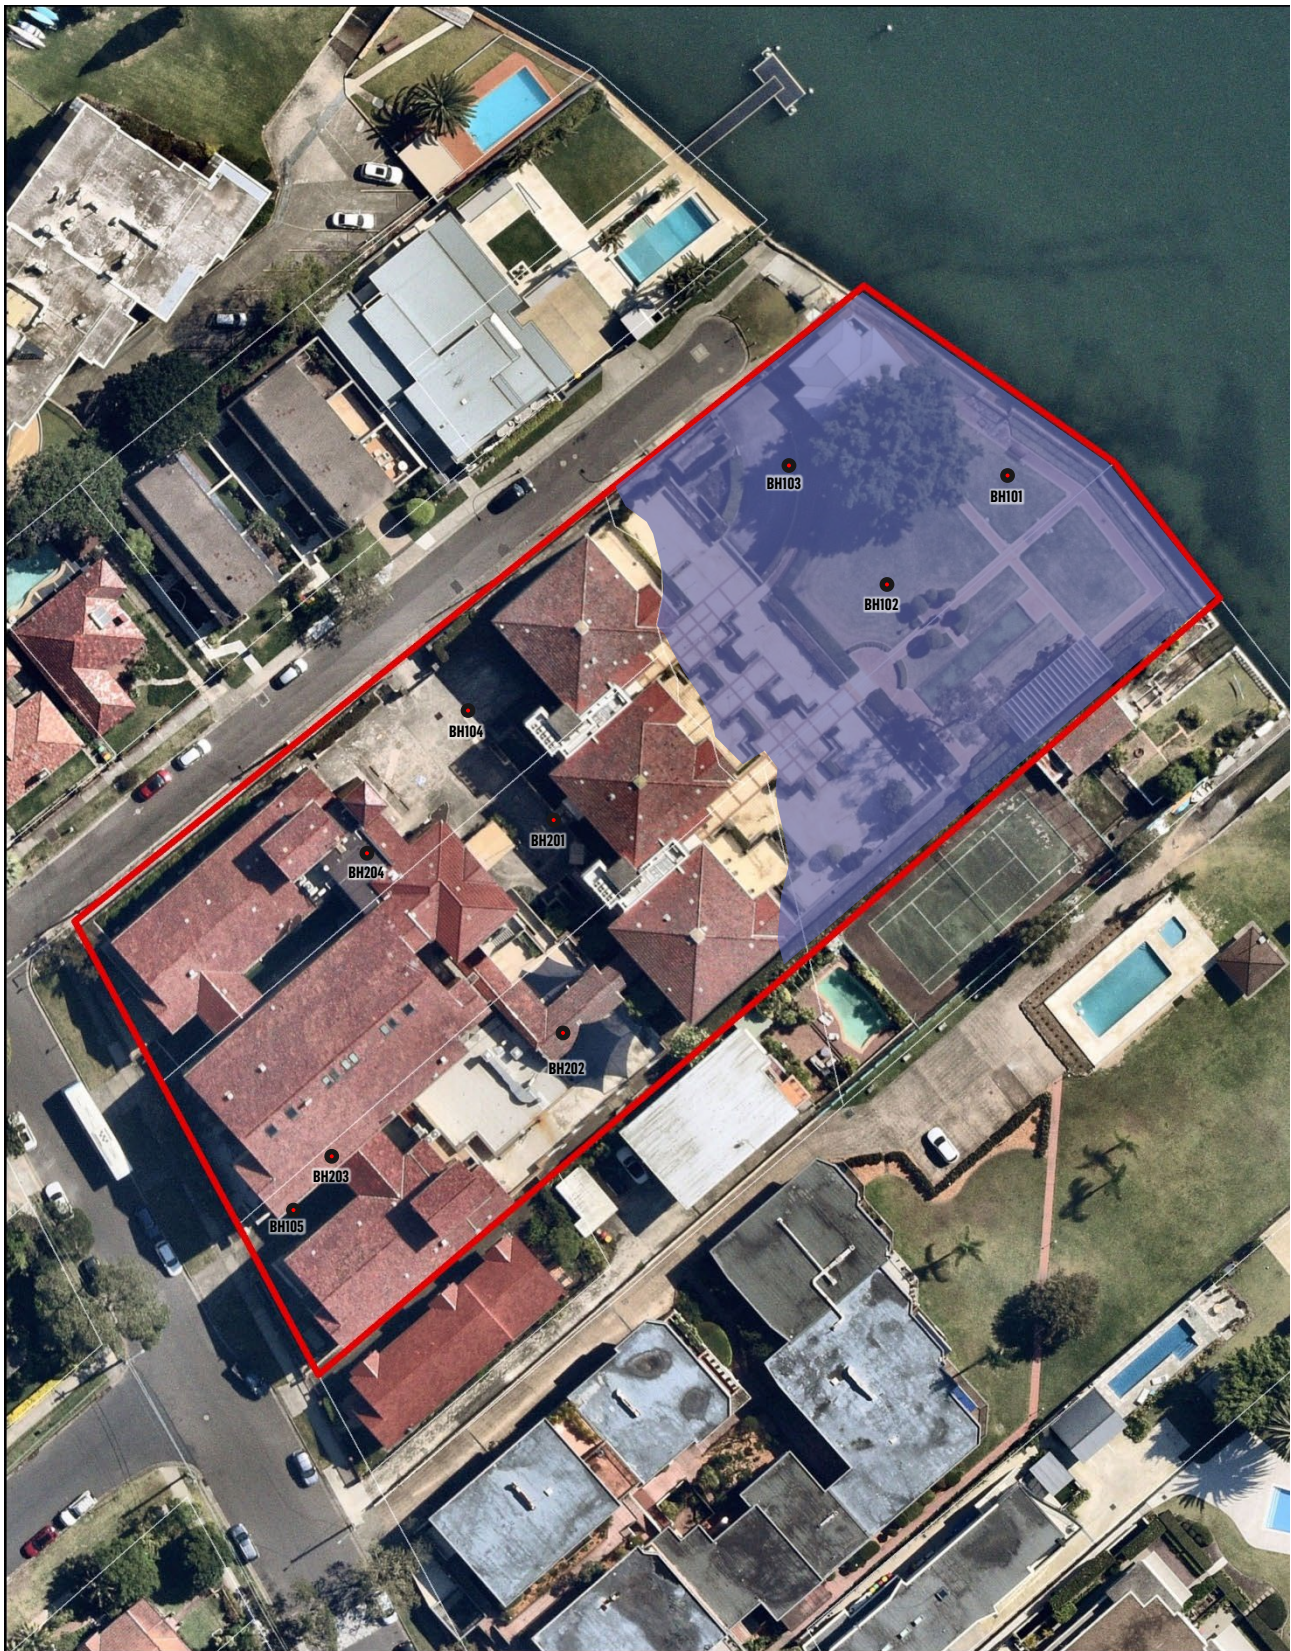
Three boreholes (BH101, BH102, BH103) were drilled in areas where land reclamation has occurred (Figure 35 – Borehole locations within the subject site). The subsurface profile consisted of fill overlying 0.1-0.4 m of red brown; low to medium plasticity clay with fine sand overlying sandstone. No natural soils were identified in the three boreholes. The results of the geotechnical investigation aligned with the assessed historical disturbance of the site (Section 3.5) which found that the area where land reclamation occurred to be disturbed soils.

BH201 and BH202 were drilled in the location of the Phase 3 Waterside villas (Section 3.1.4). BH202 core data was lost during the investigation. The subsurface profile of BH201 consisted of concrete overlying fill which included brick fragments and clay nodules with refusal at 2.2 m depth. Within the fill layer, bricks and sandstone were identified at 1.65 metres. The bricks are likely not in situ with the original foundations and were moved after the demolition of the villa structures.

All other boreholes generally comprised fill overlying sandstone. One borehole (BH105) located in the south of the subject site close to Saint George Crescent, contained fill/silty sand with no identified historical material (Figure 38). While this indicates it is possible that the fill in this borehole is actually natural soils, the surrounding material from boreholes indicates that this is unlikely.

The geotechnical results indicated there was predominantly fill overlying across the subject site with limited potential for natural soils to be encountered. Only one location in the southern portion of the subject site was identified to possibly contain natural soils. Additionally at one location brick and sandstone was identified 1.65 metres below the surface.
