Historical Archaeological Impact Assessment

1A Lyons Road, Drummoyne
Wangal Country

Prepared for
Scalabrini Village Pty Ltd
August 2024

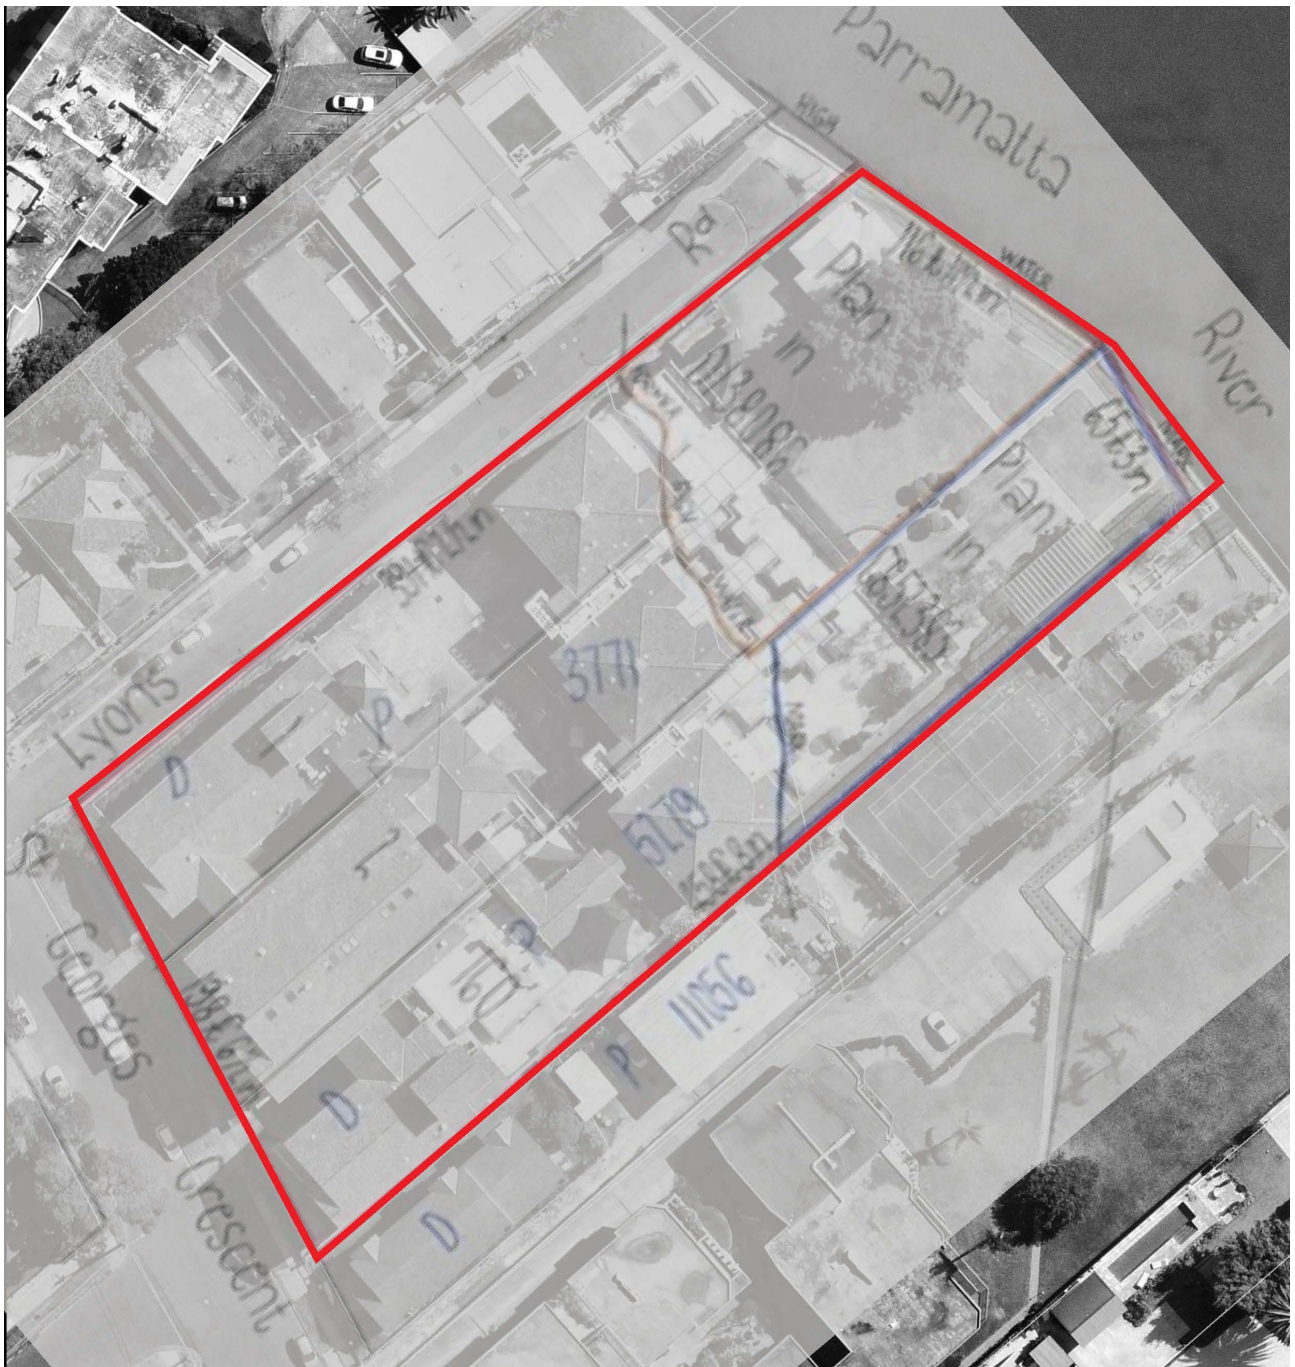
An overlay of the boundary indicated the extent of the land reclamation is shown in Figure 36.

Figure 36 – Overlay of 1958 land titles map on current aerial photograph indicating location of “former high water mark” and extent of land reclamation.

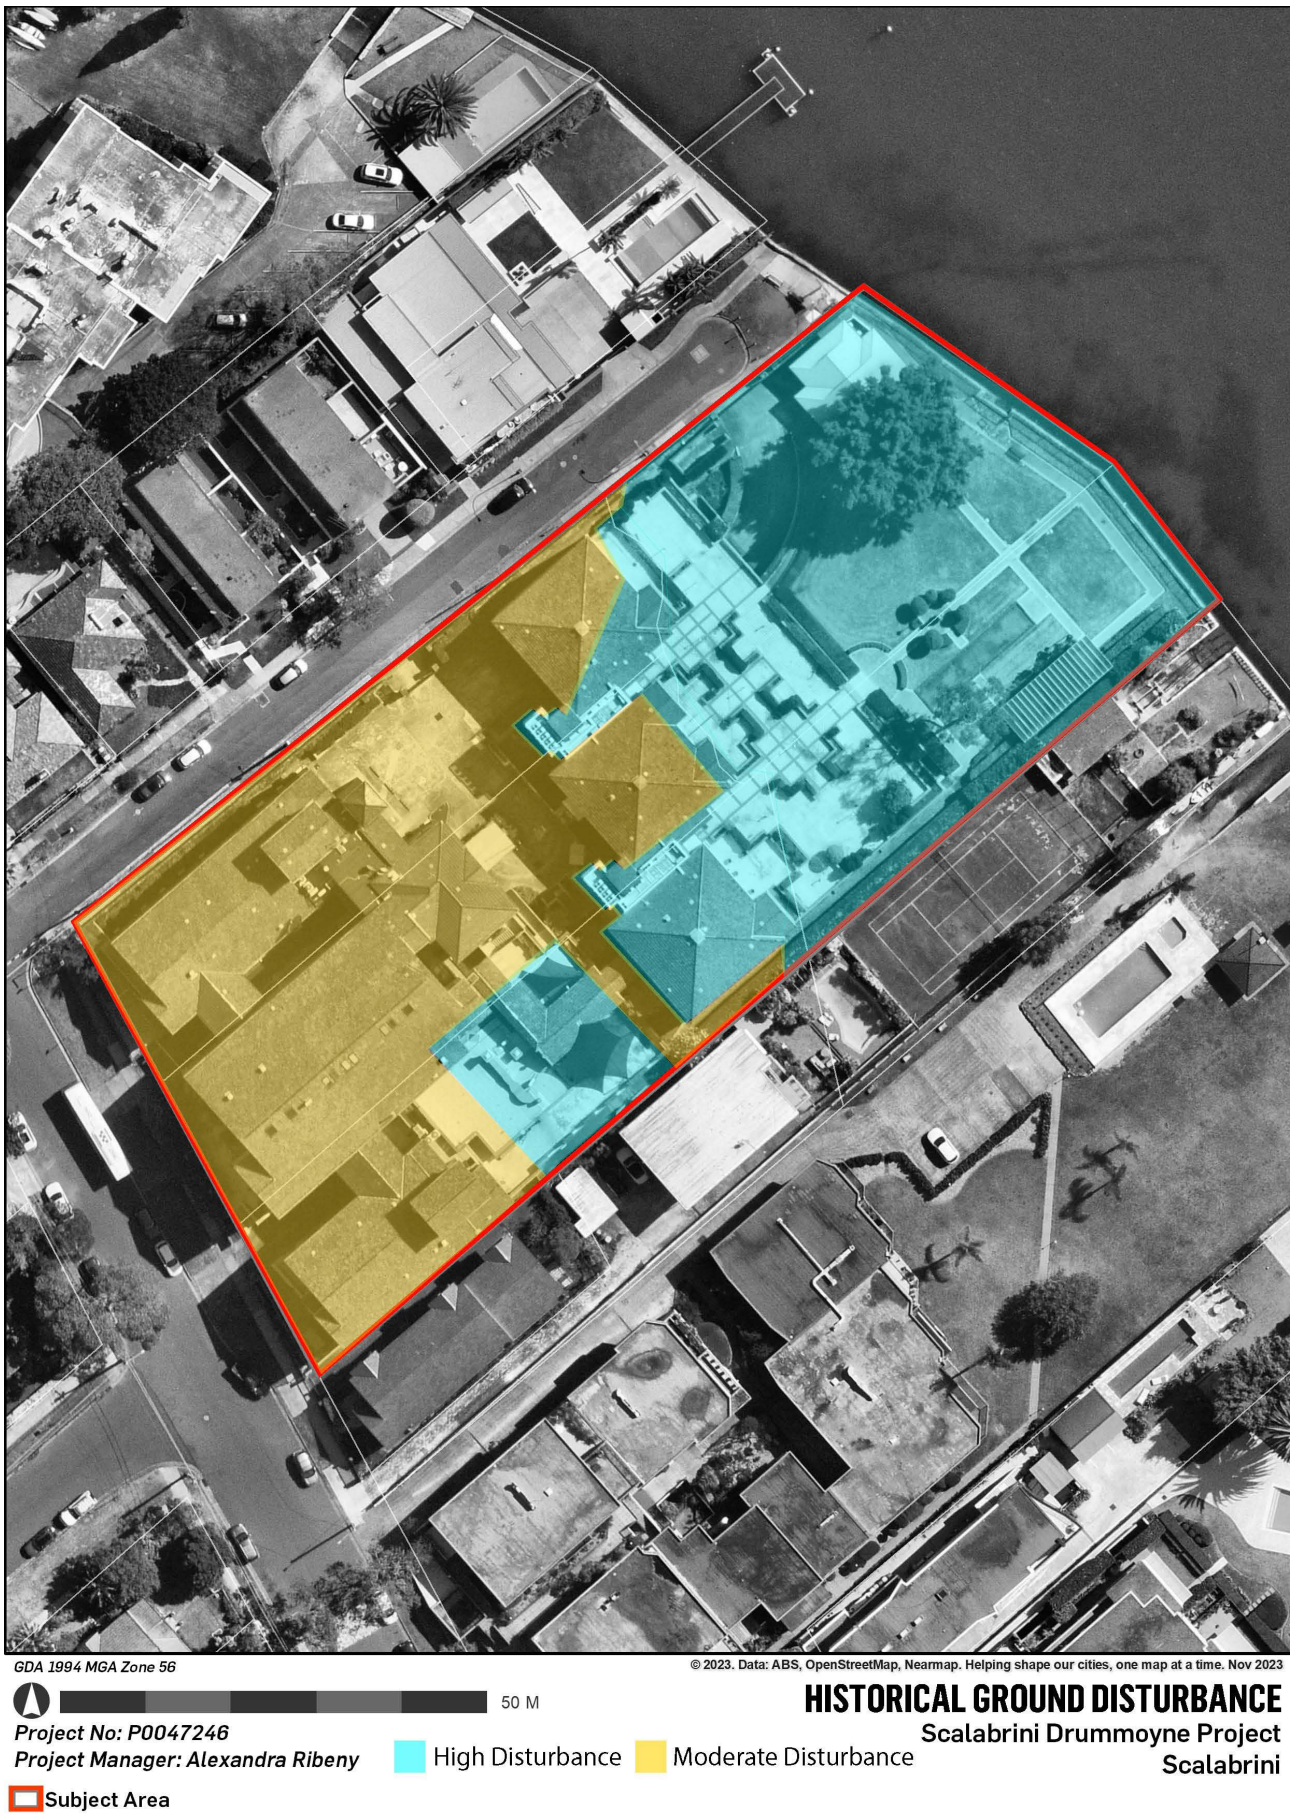
Figure 37 – Map of historical disturbance

The level of historical disturbance across the subject site is shown in Figure 37.

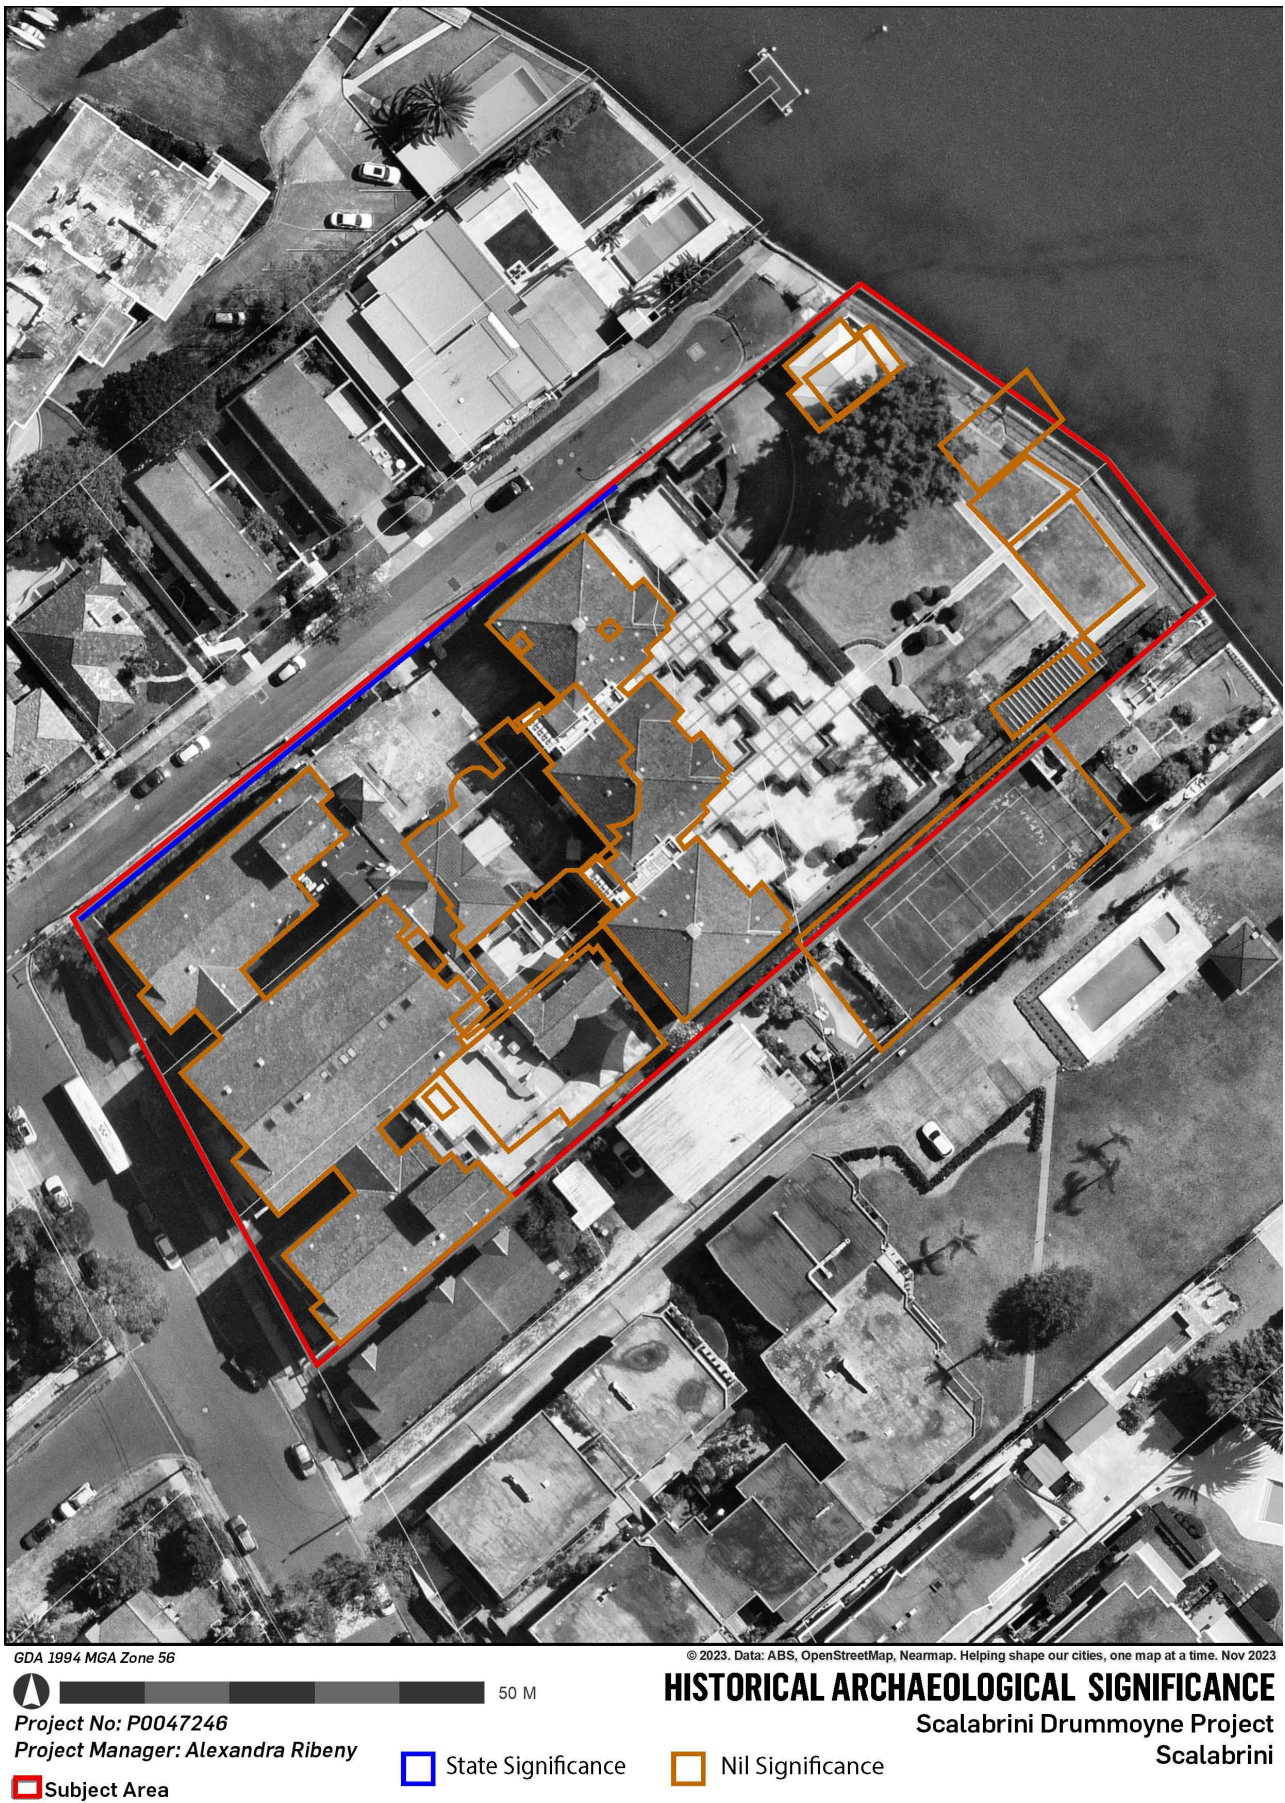
Figure 39 – Archaeological Significance

Historical Phase	Potential	Potential Significance
Phase 1 Early Land Grants (1788-1806)	South-western portion of the site: Low North-eastern portion of the site: Nil	State
Phase 2 Five Dock Farm (1806-1890)	South-western portion of the site: Low North-eastern portion of the site: Nil	State
Phase 3 Development of the Subject Curtilage (1890-1958)	Structural remains of the former villas: Low Structural remains of the former tennis court, toilet block and baths: Nil	Nil
Phase 4 Little Sisters of the Poor (1958-1999)	Brick institutional buildings: High (extant). Structural remains of ancillary buildings: Low	Nil
Phase 5 Scalabrini Village (1999-Present)	Nil	Nil
