Mount Thorley Warkworth

2020 Annual Review

Mount Thorley Warkworth (MTW) is an integrated operation of two open cut coal mines, Warkworth Mining Limited (WML) and Mount Thorley Operations (MTO). This Annual Review reports on the environmental performance of MTW for the period 1 January 2020 to 31 December 2020.

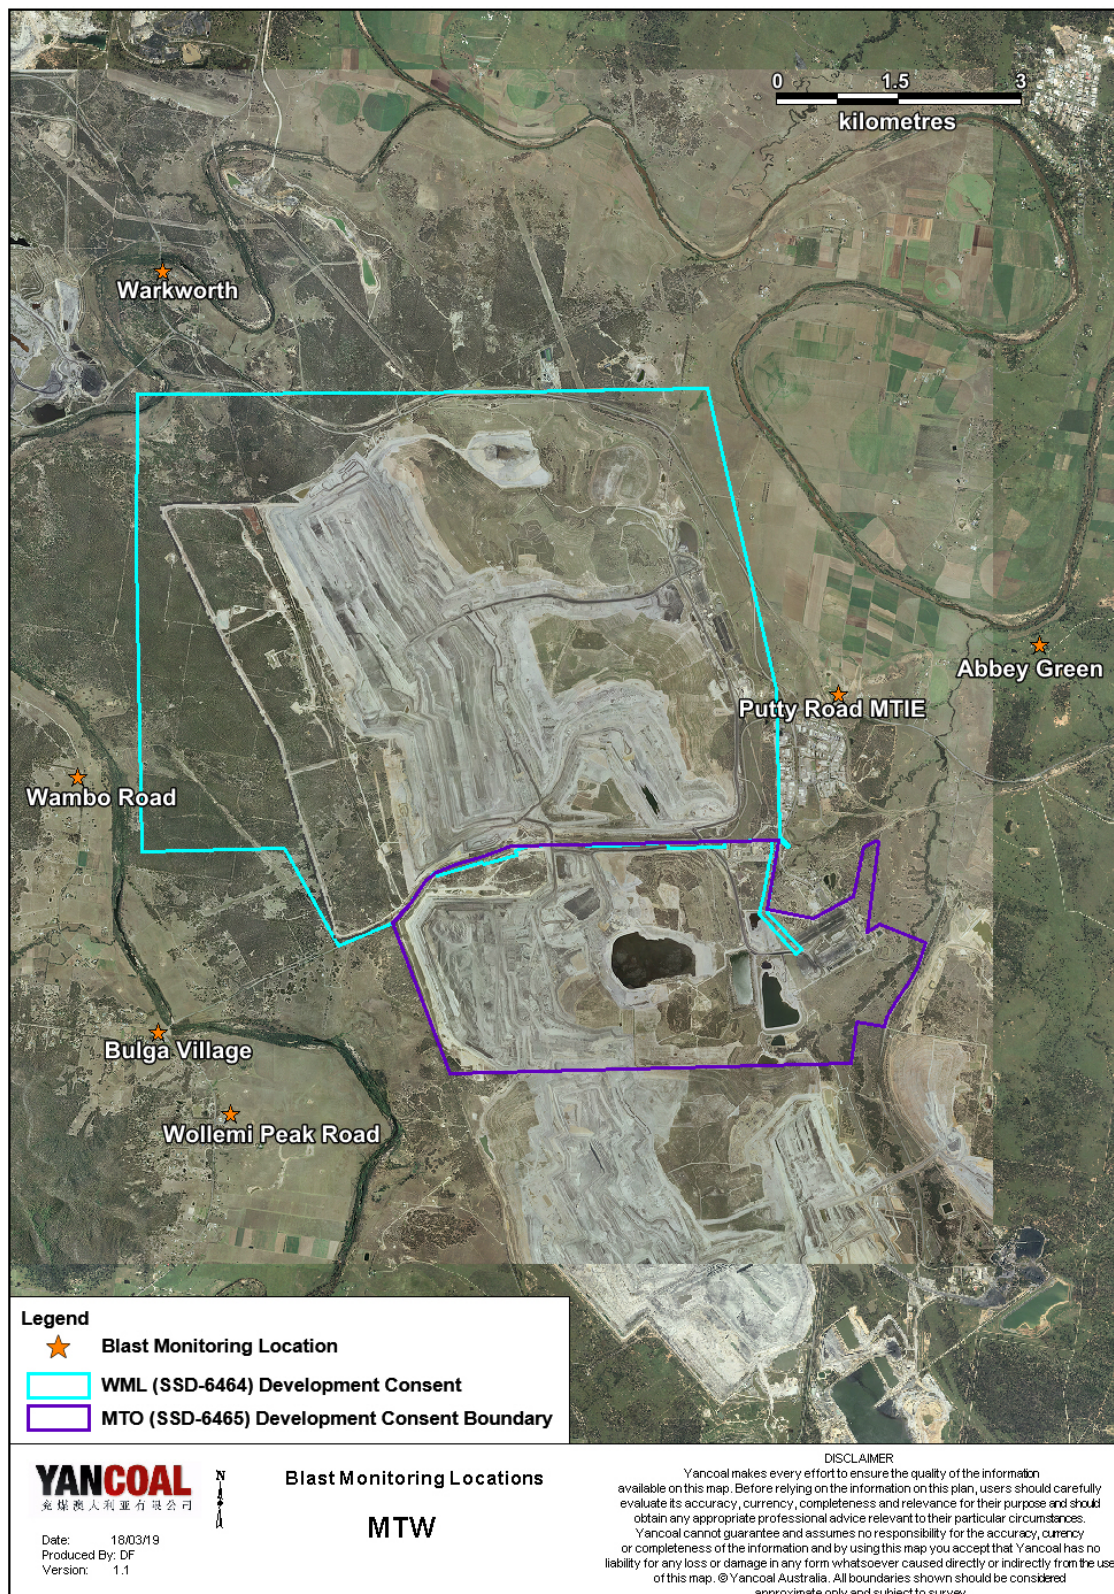
FIGURE 4: BLAST MONITORING LOCATIONS

These locations are shown on **Figure 4** below.

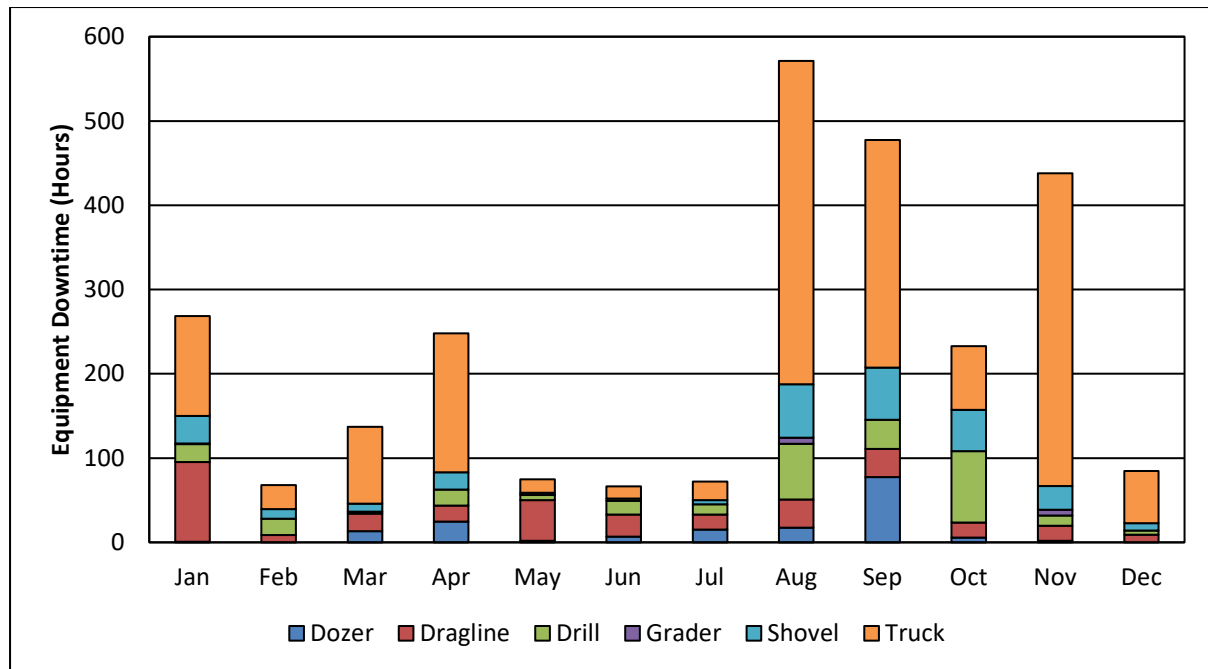
FIGURE 11: EQUIPMENT DOWNTIME FOR DUST MANAGEMENT BY MONTH (2020)

2,566 real-time alarms for air quality and wind conditions were received and acknowledged during 2020. In response, **1,526** hours of equipment downtime was recorded due to air quality management. A detailed breakdown of air quality related equipment stoppages (per month, per equipment type) is presented in **Figure 11**.

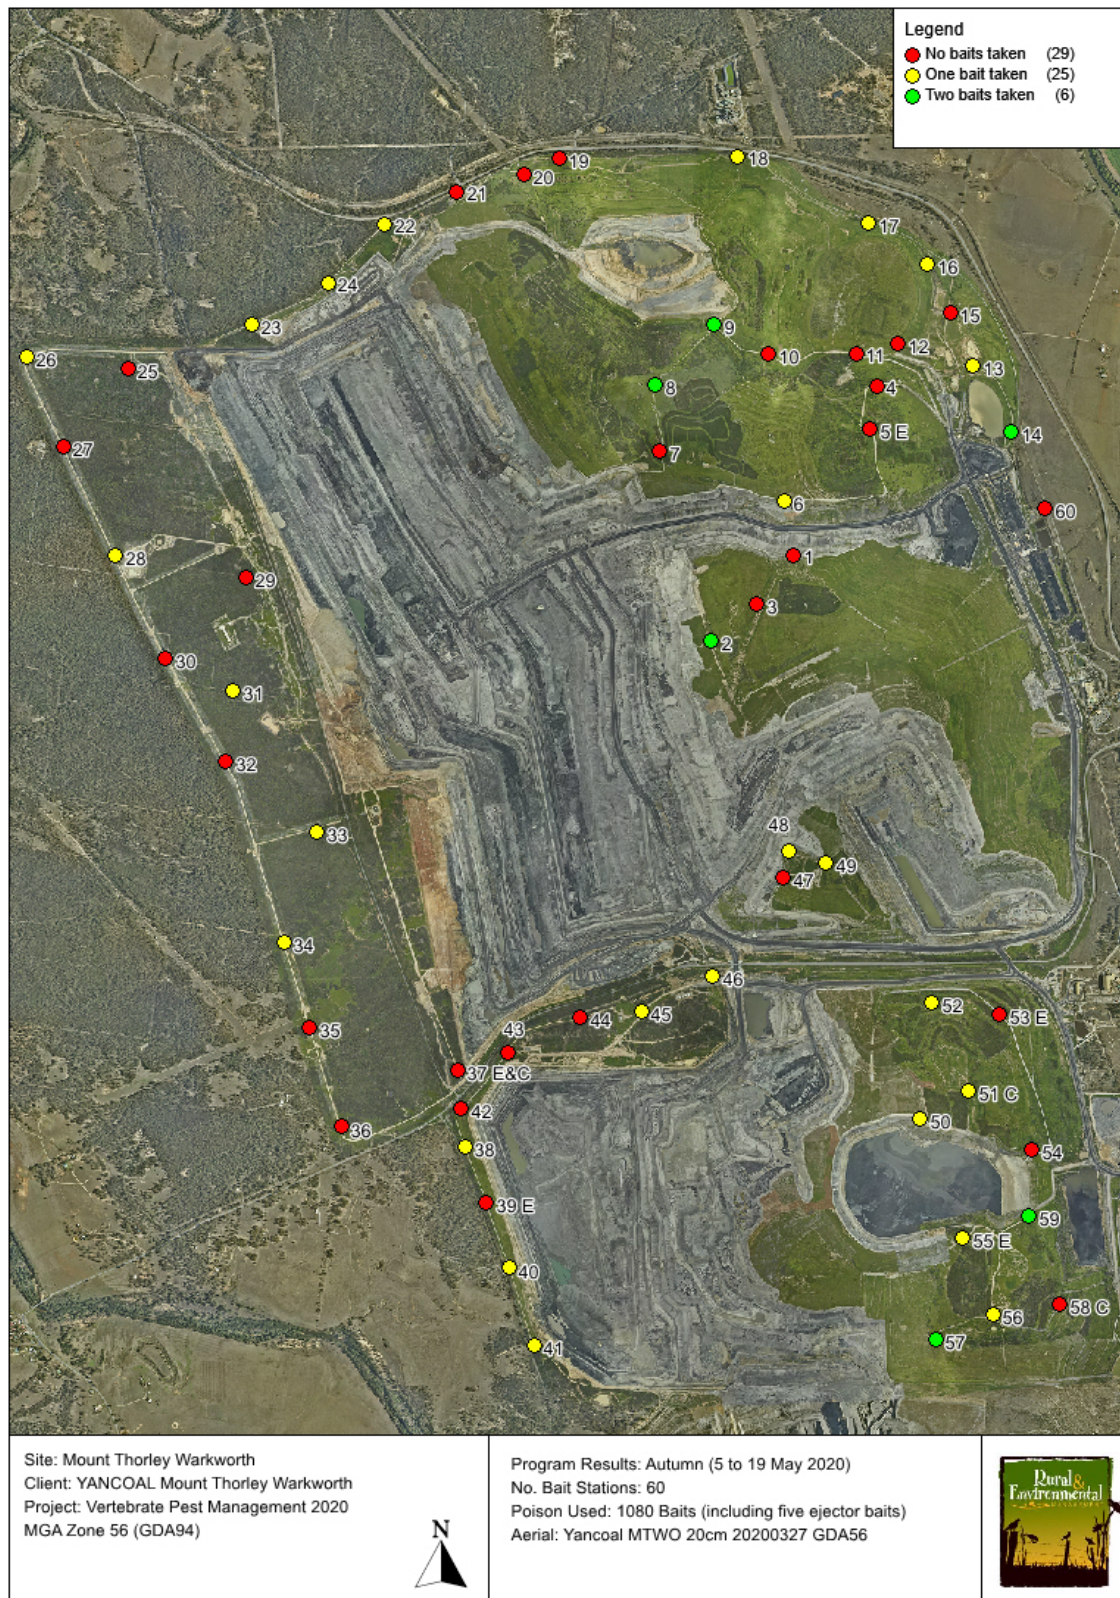
FIGURE 81: BAITING STATION LOCATIONS AND RESULTS AT MTW DURING AUTUMN 2020 VERTEBRATE PEST MANAGEMENT PROGRAMME

Table 7.6 summarises the results from the programmes carried out at MTW during 2020 with baiting locations and results for the programmes are illustrated in **Figure 81** and **82**.

- Feral pig 1080 baiting programme carried out across MTW in winter resulted in 13 feral pigs poisoned. Rabbit 1080 baiting programme carried out at the same time resulted in 400g of poisoned carrots consumed.
- Opportunistic shooting of vertebrate pests; two hare and one deer.

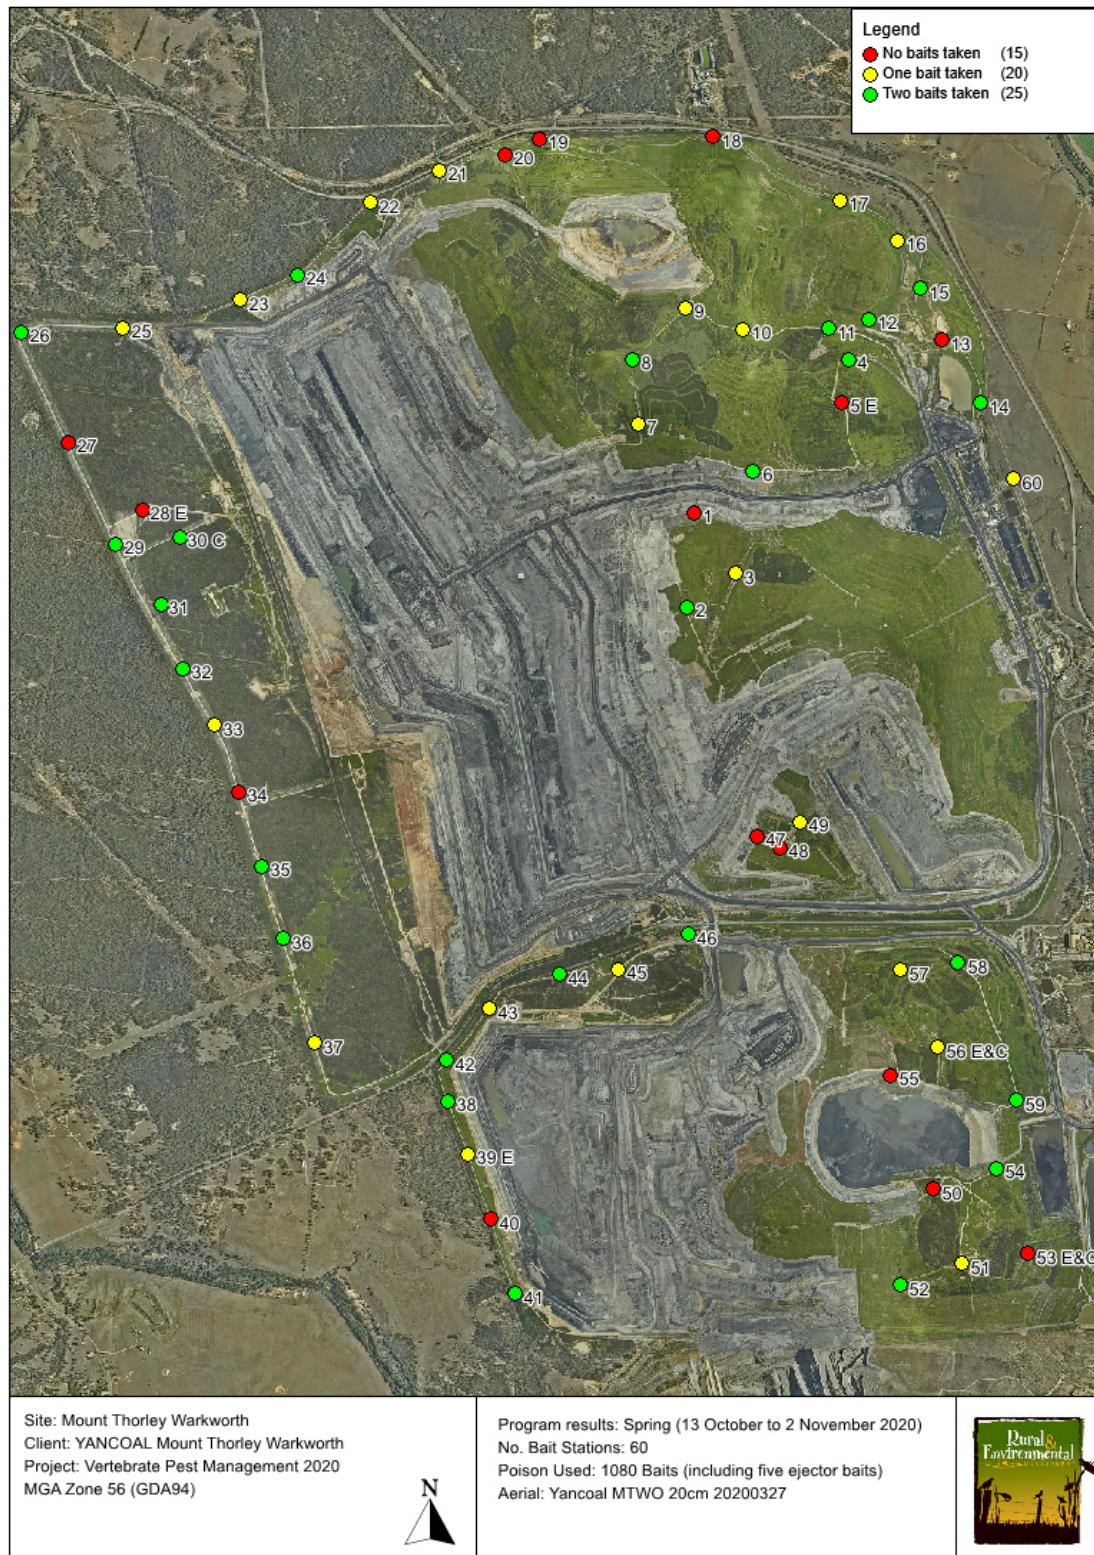
FIGURE 82: BAITING STATION LOCATIONS AND RESULTS AT MTW DURING SPRING 2020 VERTEBRATE PEST MANAGEMENT PROGRAMME

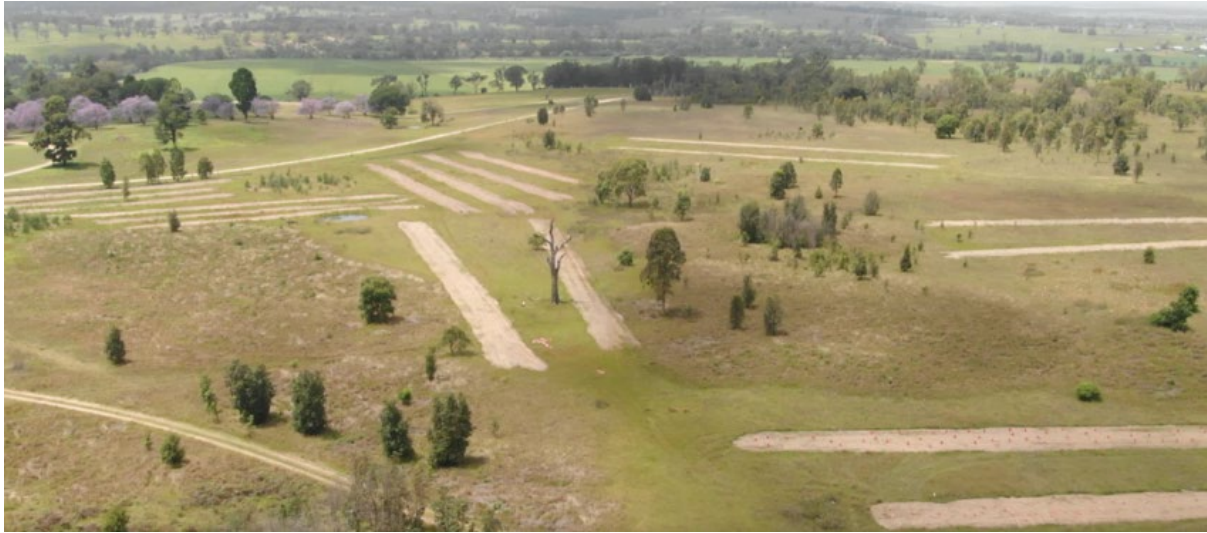
FIGURE 84: DRONE IMAGE OF NORTHERN BIODIVERSITY PLANTING AREA

The next round of planting is planned for autumn 2021 and will include 11,000 Warkworth Sands Woodland tubestock in the Northern BA and 4,400 in the Southern BA. Additional infill of the Central Hunter Grey Box – Ironbark Woodland and River Oak Forest planting areas at the Southern BA will continue as required.

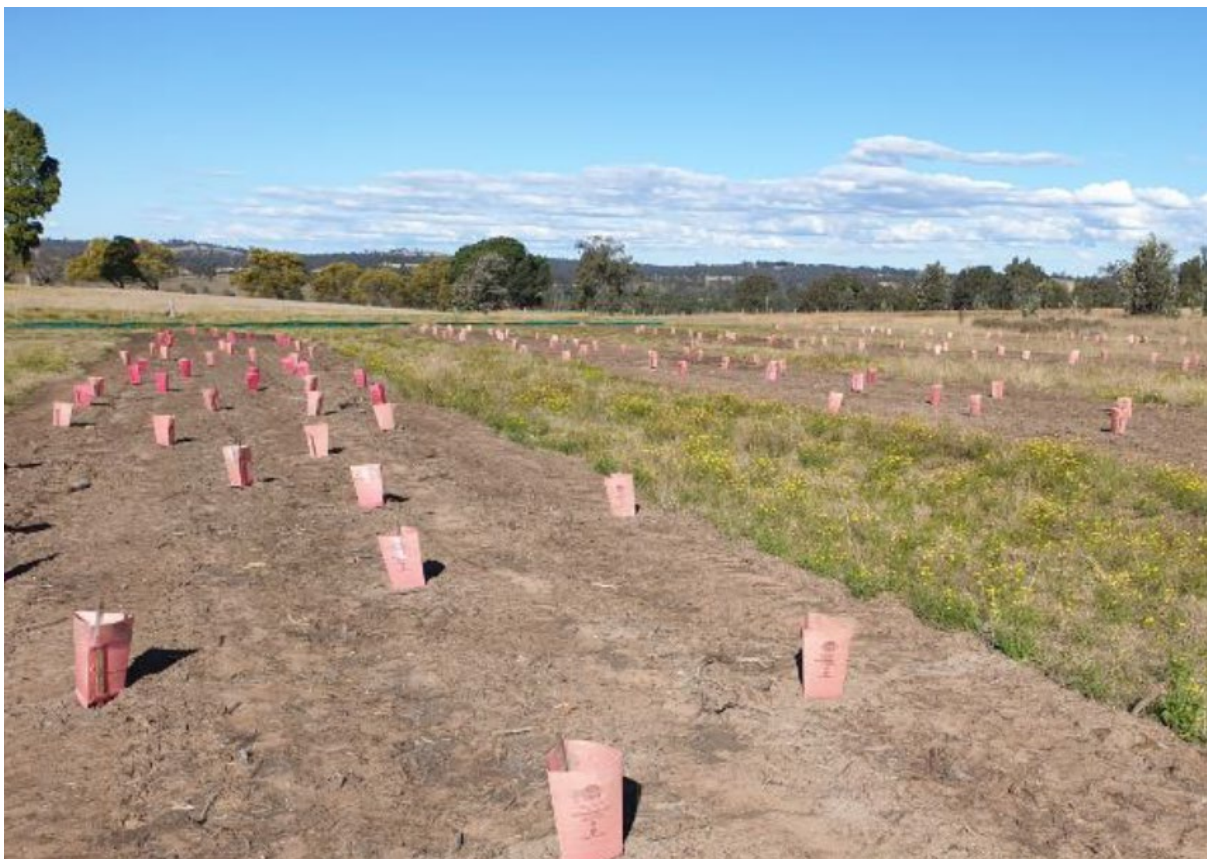
FIGURE 85: WARKWORTH SAND WOODLANDS PLANTING STRIP NORTHERN BIODIVERSITY AREA
