## MLC School Burwood

### Geotechnical Investigation - Proposed MLC School Redevelopment, Burwood, NSW 2134

GEOTLCOV25052AA-AB  
26 June 2014

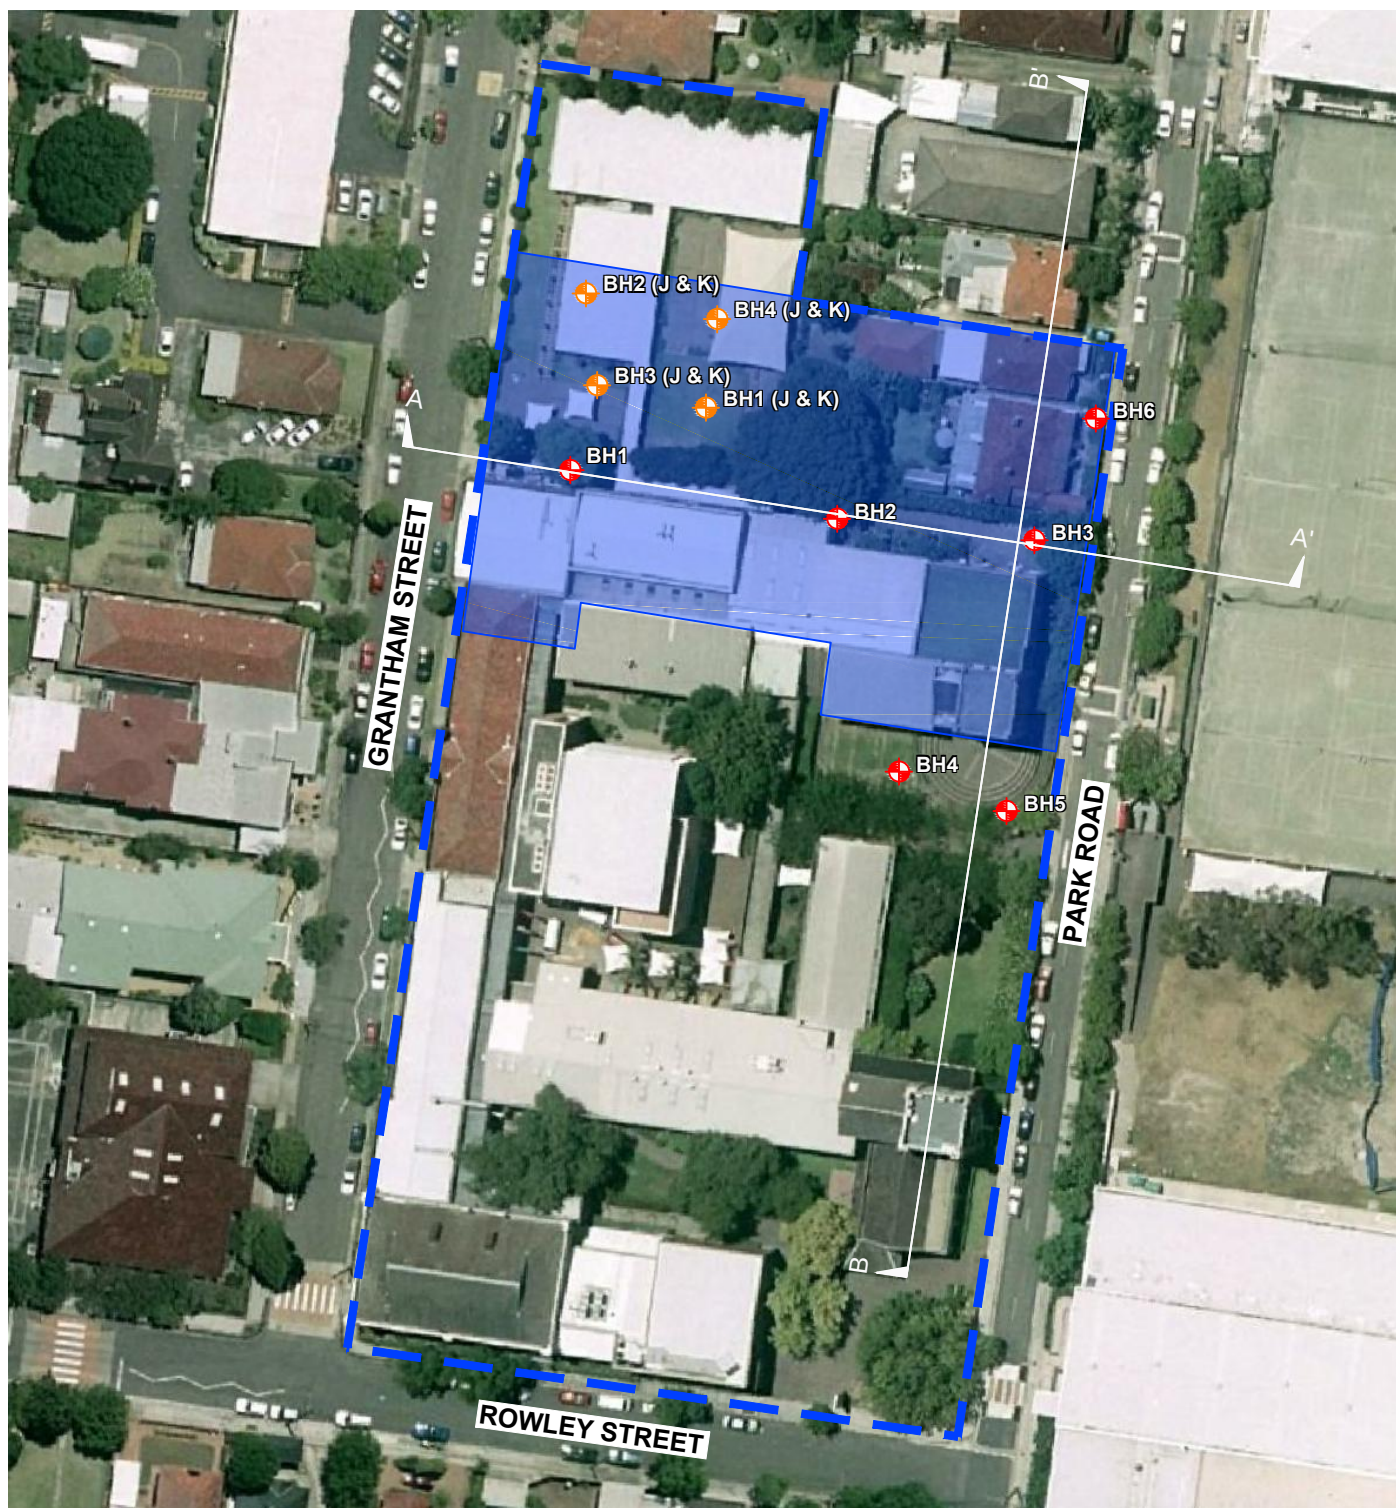
- COFFEY BOREHOLE LOCATION
- EXISTING BOREHOLE LOCATION (J & K)
- APPROXIMATE SCHOOL BOUNDARY
- PROPOSED DEVELOPMENT FOOTPRINT

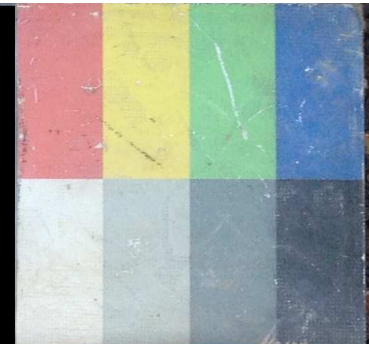
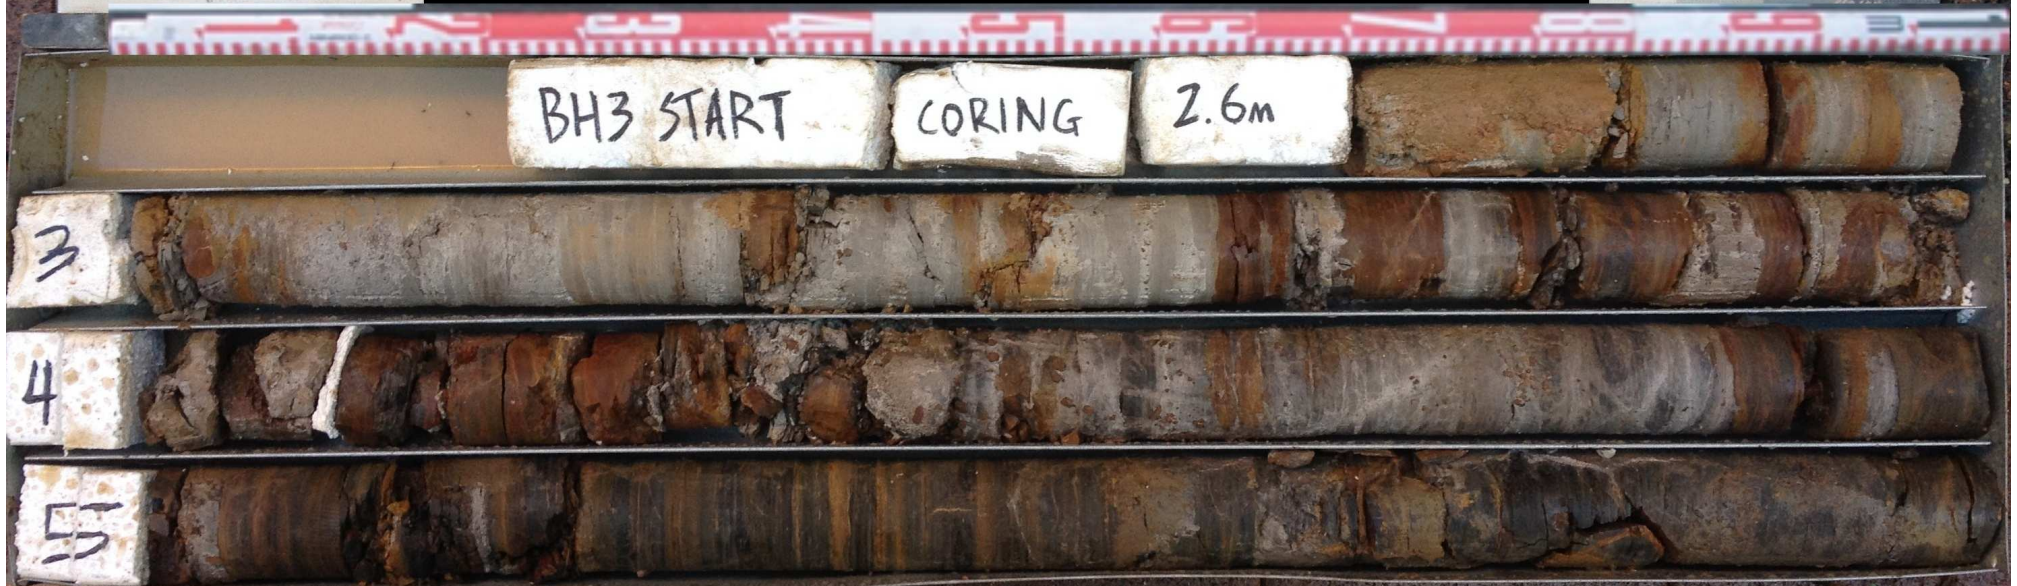
PointID : BH3 Depth Range: 2.60 - 6.00 m

| drilling information | | | | material substance | | rock mass defects | | | | | | |
|---|---|---|---|---|---|---|---|---|---|---|---|---|
| | | | 3.0 | | start coring at 2.60m<br><b>SHALE:</b> pale grey, red brown and yellow brown, indistinctly laminated at 0°, with some iron staining. | XW<br>HW | | a=0.05<br>d=0.02 | | | SM, 200 mm, extremely weathered | |
| | | | 5.0 | | <b>SHALE:</b> dark grey, with yellow brown iron staining, distinctly laminated at 0°. | HW / MW | | a=0.50<br>d=0.20 | | | SM, 30 mm, extremely weathered<br>SM, 30 mm, extremely weathered<br>SM, 20 mm, extremely weathered<br>SM, 30 mm, extremely weathered<br>SM, 60 mm, extremely weathered | |

The engineering borehole logs and photos of the material encountered are presented in Appendix A, together with Coffey soil and rock explanation sheets which describe the terms and symbols used in log preparation. The engineering borehole logs which were extracted from a geotechnical report prepared by Jeffrey & Katauskas provided to Coffey by TTW are presented as Appendix C. The subsurface conditions have been inferred from the latest geotechnical investigation carried out by Coffey and the previous investigation by Jeffrey and Katauskas.
