## **Western Sydney University- Indigenous Centre of Excellence**

Historical Archaeological Assessment

August 2025

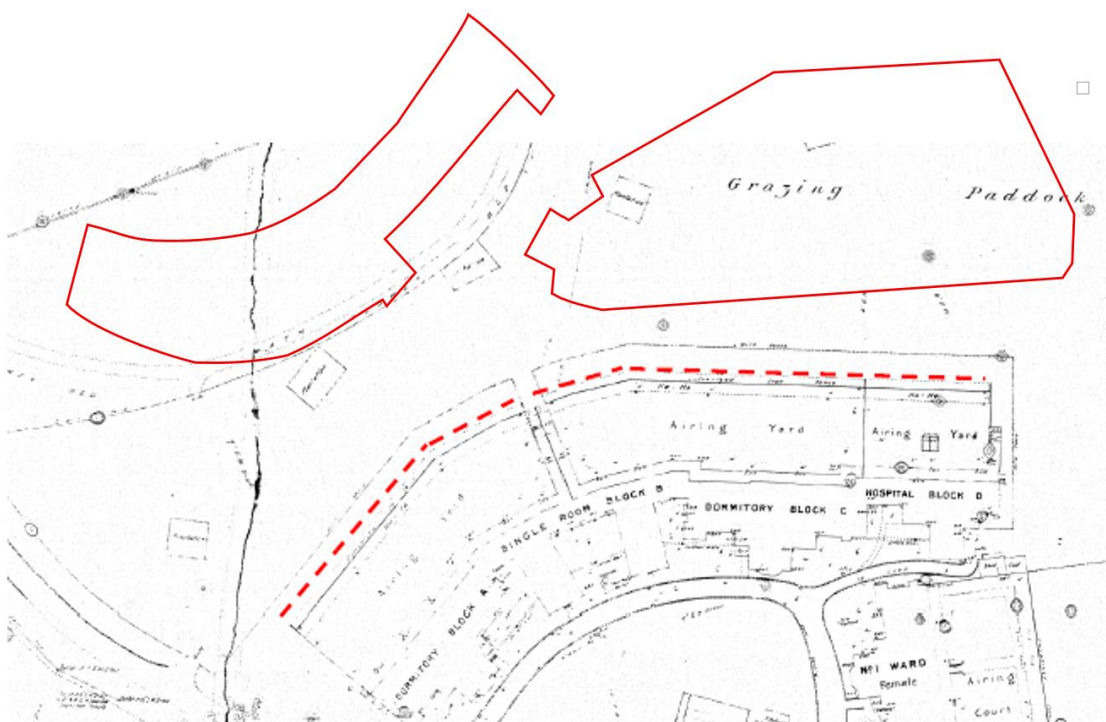
Figure 3-13: Detail from Hospital for the Insane, Rydalmere (1903). Wards 13-16 have been built and the airing yards on the north side of the buildings are defined by ha-has (dashed red). Note this plan is assumed to be made prior to the works, as the ha-has are much more angular than the curved as-built lines visible on the 1943 and 1951 aerial photography of the site. Source: WSU, formerly Rydalmere Psychiatric Hospital – General Plan – Frame 1

By the time of the 1950 aerial (Figure 3-13), the drainage ditch had been partially infilled, the tennis courts extended, a lawn bowling green installed in the north-western corner and a new rectilinear building constructed in the centre of the northern side of the study area. A 1958 photograph shows that the tennis court had been further extended to three courts, with timber posts and a likely asphalt, acrylic or concrete surface (Figure 3-14).

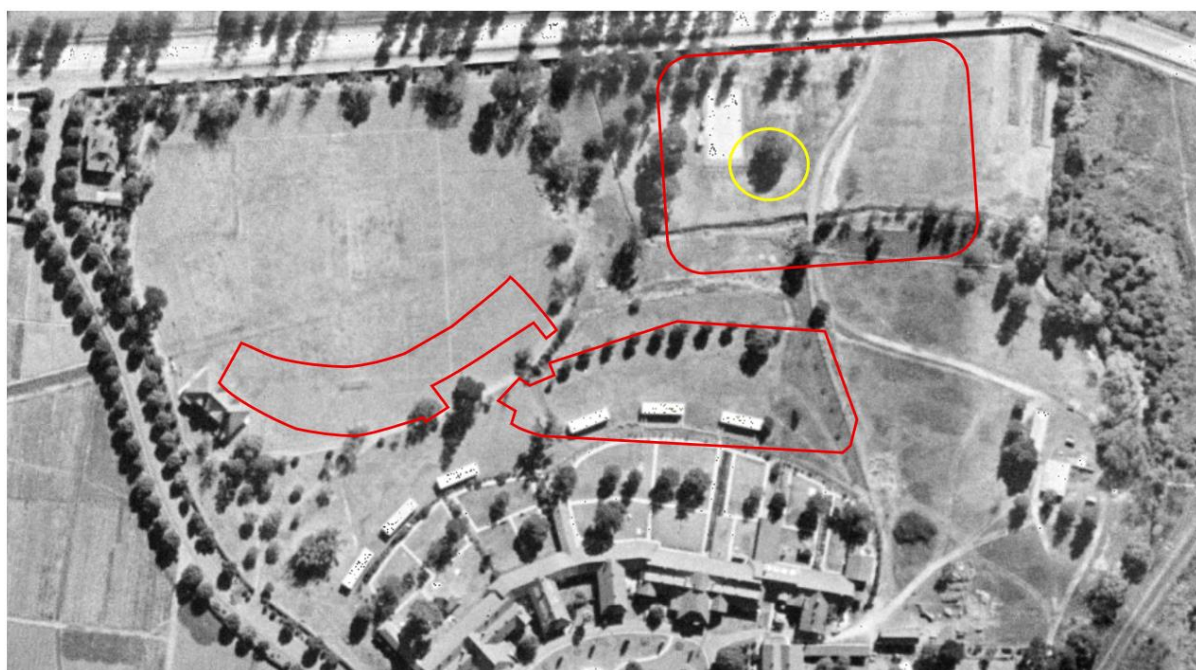
Figure 3-15: 1943 aerial photograph of study area mostly cleared, a road running roughly NE, a tennis court, a fence along the north boundary, the drainage line and trees visible. Note the retained melaleuca tree (yellow). The bright white lines within the study area are likely paved paths at the top of the ha-ha ditch, while the fainter white line is likely the ha-ha wall or an external path. The three sheds appear to be insubstantial shelter sheds. The cricket pavilion sits close to the bounds of the western car park. Source: SIX Maps

Mature trees were also present along the western boundary and the southern side of the ditch in the eastern section of the study area. The north-western section of the study area appears to have been used for agricultural purposes, as remnant lines of crops/plantings are visible. The former paling fence along the northern boundary appears to have been replaced with a more substantial, likely brick, fence by this time. The aerials indicate the continued use of the study area for recreational and agricultural purposes for the patients of the Psychiatric Hospital.

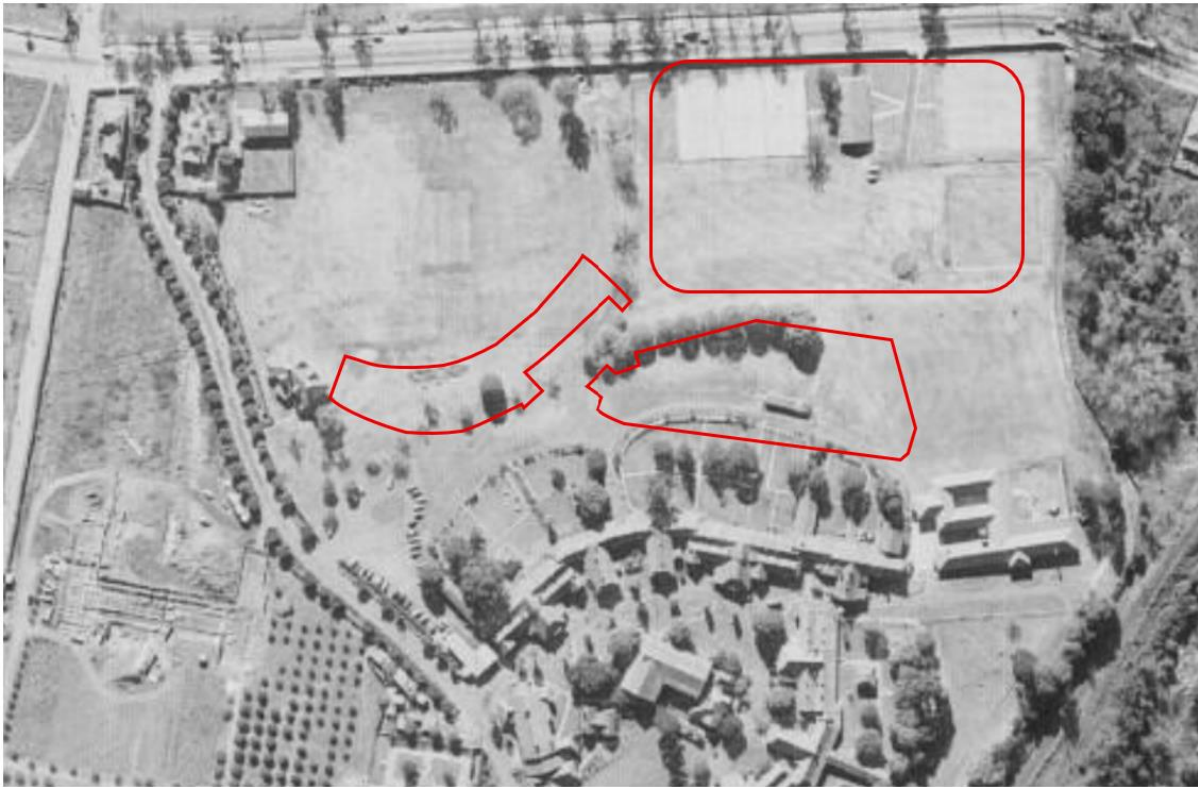
Figure 3-18: 1960 aerial photograph showing the study area to have been further cleared, the drainage line fully infilled, the tennis court extended, a paddock delineated in the south-eastern corner and the path realignment to have been completed. Little to no change to the western and eastern car parks. Source: Historical Imagery NSW

By 1960 (Figure 3-15), the remaining trees in the southern section and western side of the study area had been removed. The drainage ditch had been replaced with underground stormwater piping and the land in the southern section levelled. A playing field had been established in the south-eastern corner of the study area, while driveways had been established along the eastern and northern boundaries from Railway Street and Victoria Road respectively, leading to a parking area in the centre.

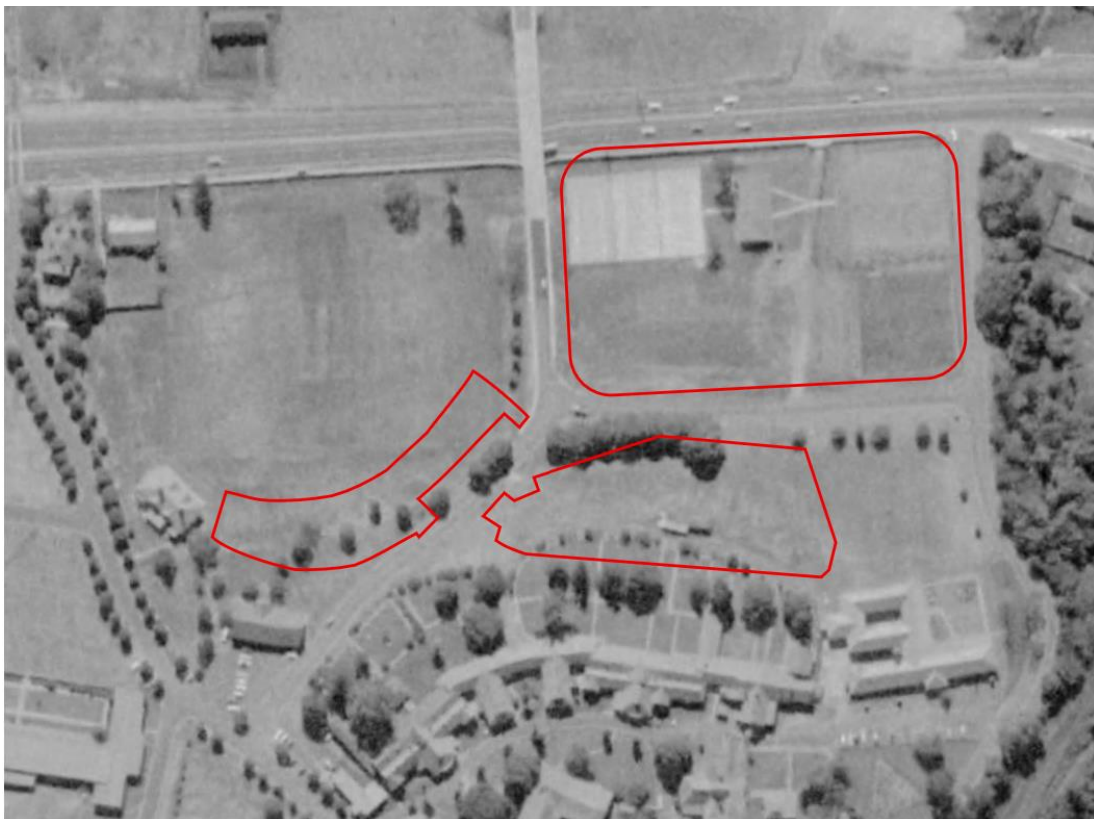
Figure 3-19: 1970 aerial photograph showing the extension of the path to the southern boundary of the study area, as well as the construction of the roads bounding the study area, including the overbridge access at the western end of the study area along Fifth Street. Source: Historical Imagery NSW

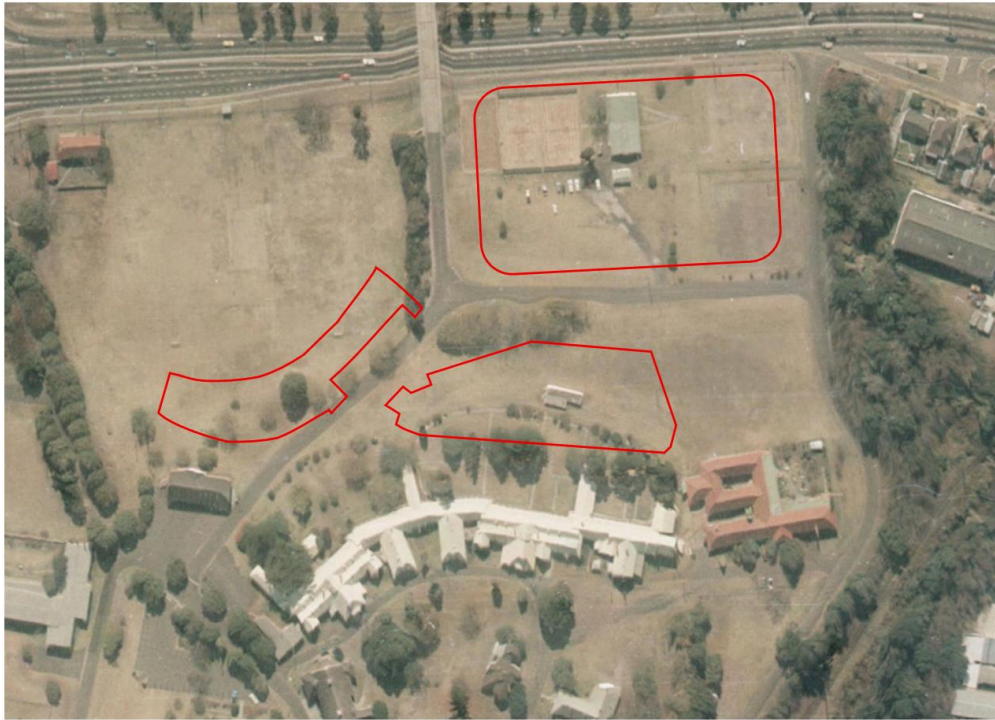
Figure 3-20: 1986 aerial photograph showing the addition of shade structures along the northern and southern sides of the tennis courts, the use of the area to the south of the courts for parking and an informal driveway between the southern boundary and the tennis courts. Source: Historical Imagery NSW

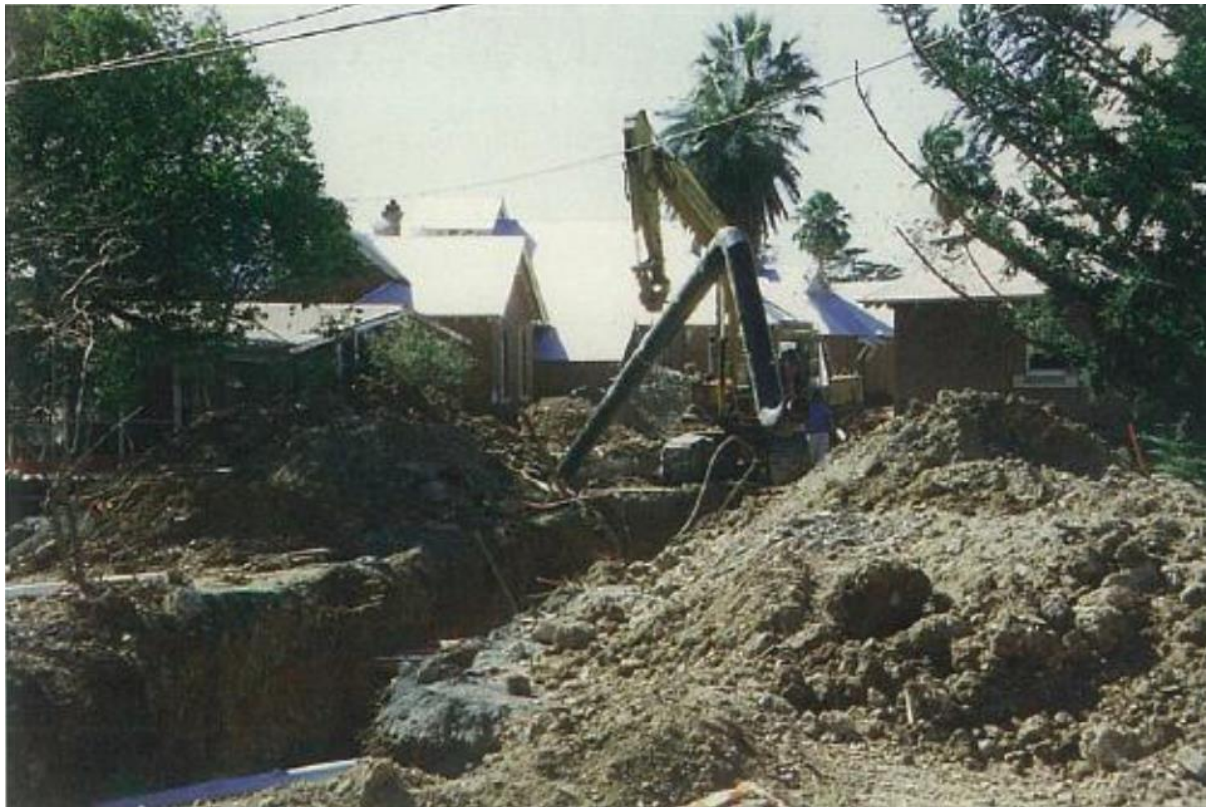
Figure 3-22: 1998 works including trenches dug for water, gas and electricity. Source: WSU 1998 pg 10 via AMBS 2024

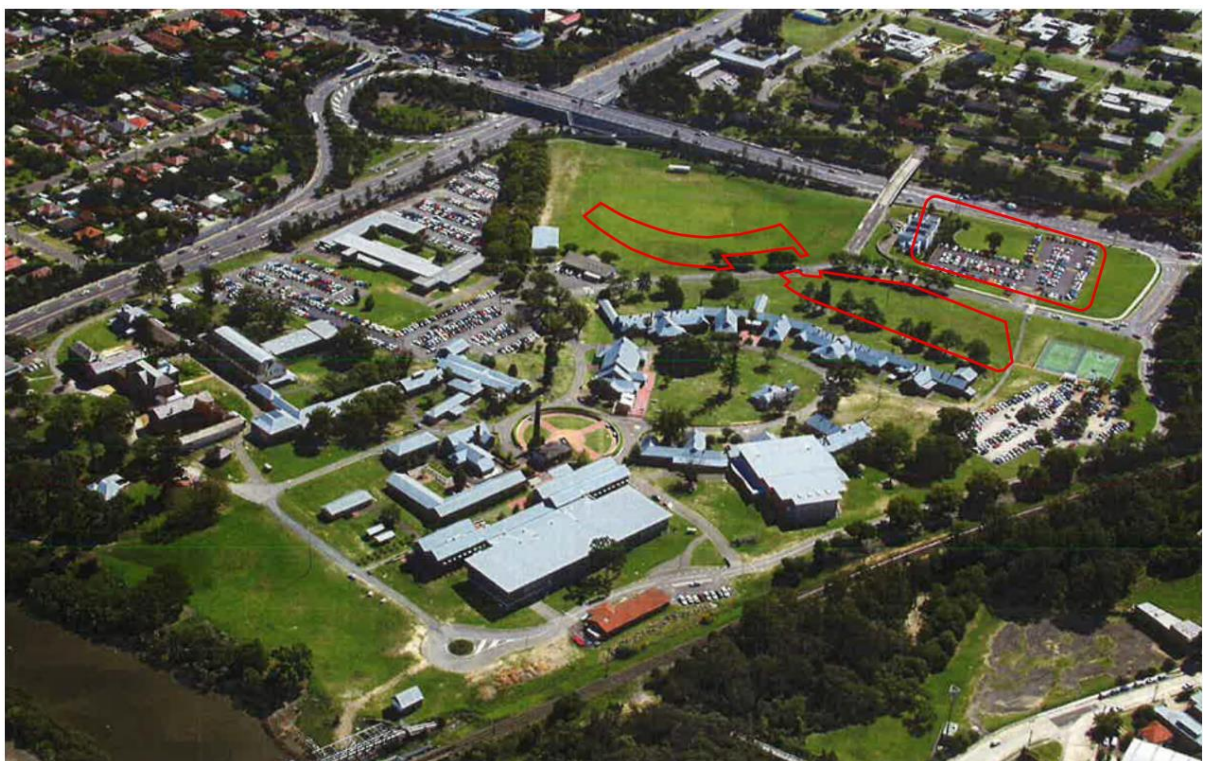
Figure 3-23: 2004 oblique aerial photograph showing the completed carpark, the Co-Generation Plant Building (Eda), grassed areas and small number of trees. The general location of the study area is shown highlighted in yellow. Source. Conybeare Morrison, 2008

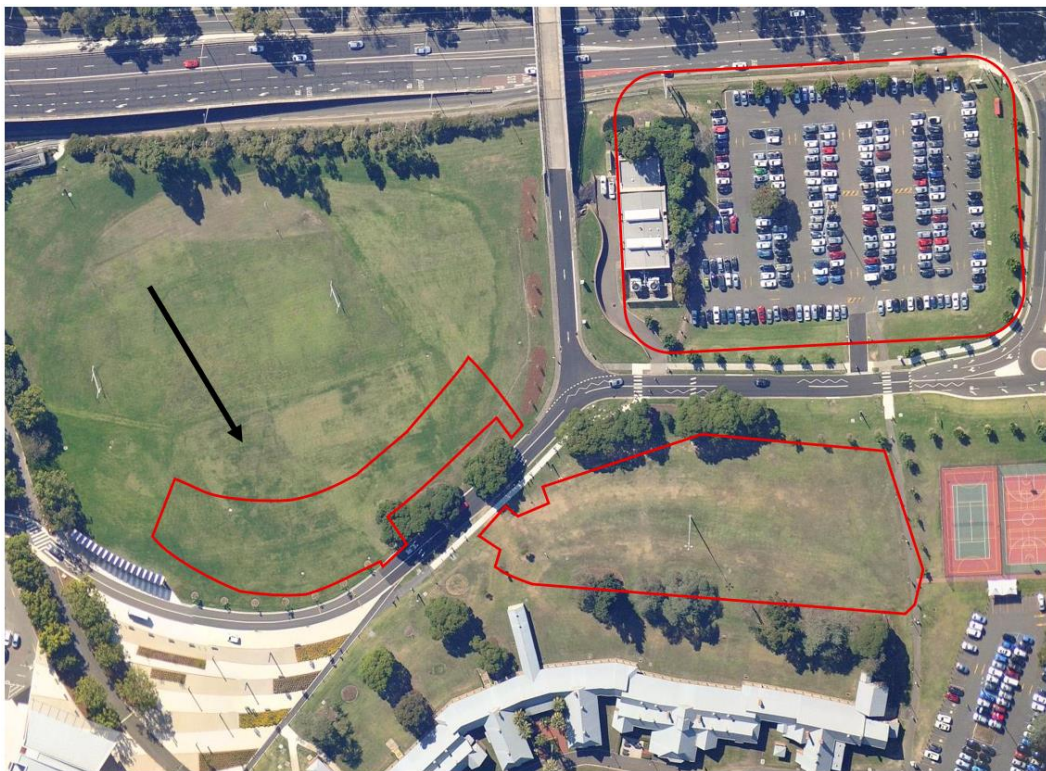
Figure 3-27: 2013 aerial after Fifth Street realignment – temporary carpark outlines still visible on the cricket oval (black arrow). Source: Nearmaps

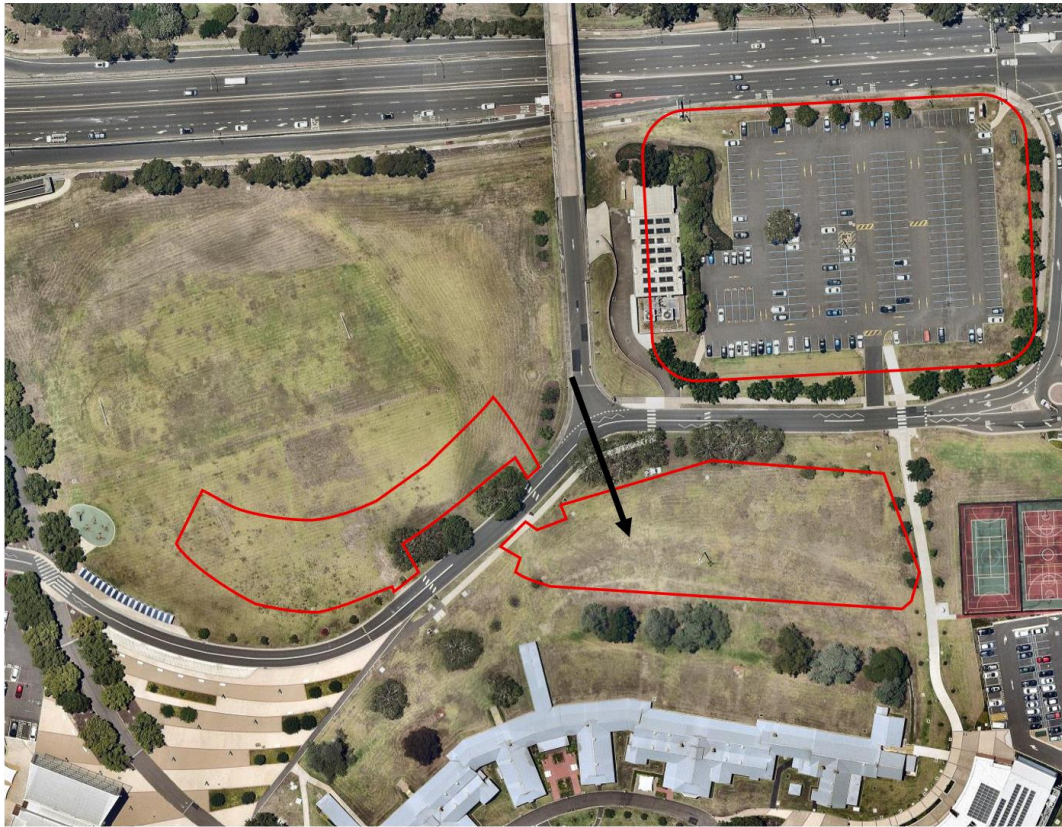
Figure 3-28: 2017 aerial (December) with dried out grass – remnant outlines of the ha-ha walls and/or paths (black arrow).  
Source: Nearmaps

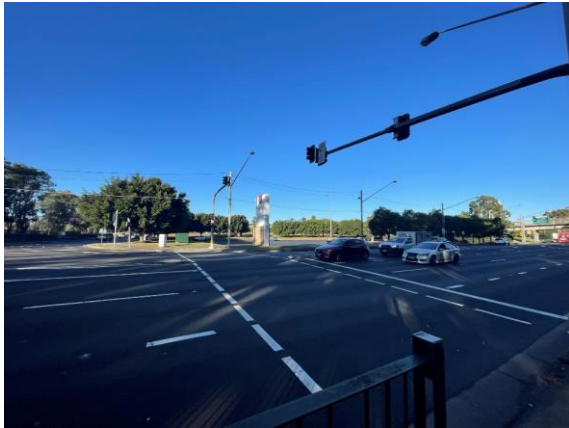
Figure 4-1: View of the north-eastern corner of the study area from the northern side of Victoria Road, looking south-west. Source: Curio Projects, 2023.

A sandstone and metal-clad Western Sydney University sign lined with river pebbles and brick paving is located in the north-eastern corner of the study area, while telegraph poles and lights line the northern boundary (Figure 4-1). Services cupboards and bins are located just to the south of the north-eastern corner of the study area (Figure 4-1).

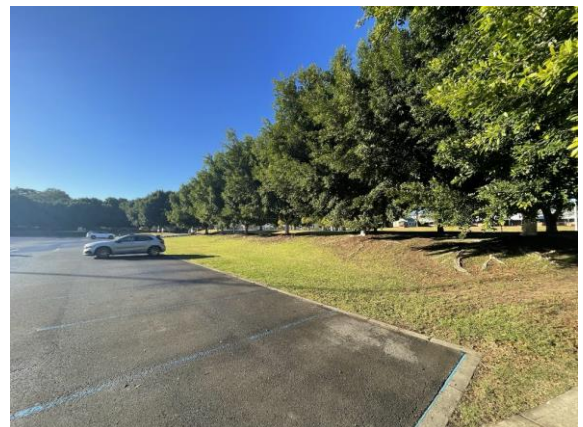
Figure 4-10: View along the southern boundary of the carpark within the study area, showing the trees lining the boundary. Source: Curio Projects, 2023.

The grassed areas lining the boundaries of the study area are slightly raised above the surface of the asphalt carpark surface, forming a levelled shallow depression in the location of the carpark (Figure 4-7 to Figure 4-12). Although the roots of the semi-mature weeping lilly pilly and hills fig trees lining the boundaries have partly contributed to the raising of the grassed areas, it is unclear as to whether the carpark area has been excavated or if the boundaries have been raised, or a combination of the two. Aside from the raised borders, the landform is generally flat and characterised by a former alluvial plain adjacent to Vineyard Creek (Figure 4-1). The western boundary appears to have been artificially raised and excavated in the vicinity of the Co-Generation Plant Building, likely in association with the cricket ground and the abutments of the Bridge Street overbridge to the west (Figure 4-2 and Figure 4-3). Where ground surfaces are exposed in the grassed areas, soils are characterised by red-brown silt (Figure 4-10).

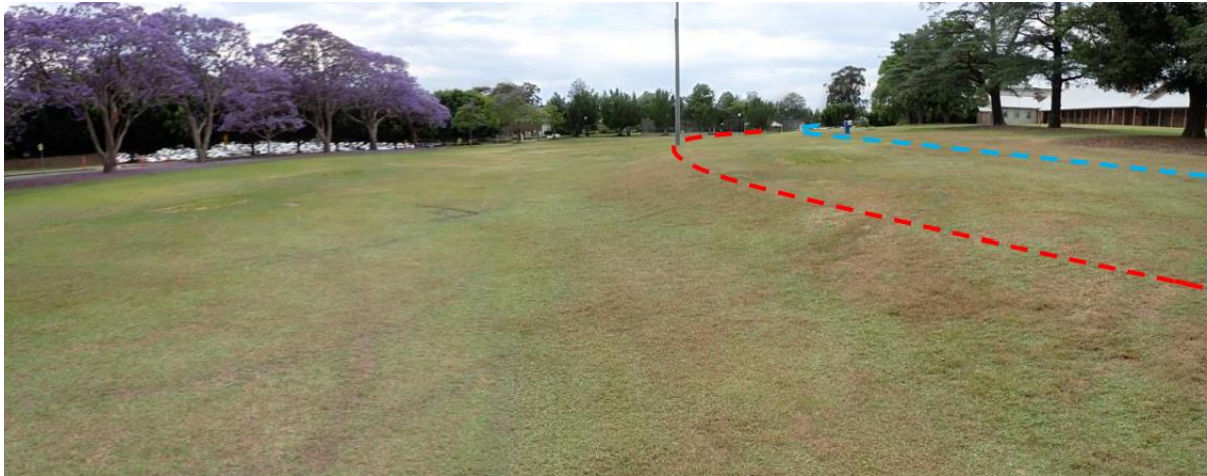
Figure 4-13: Location of eastern car park showing the crest of the steeper slope (dashed red) and crest of the gentler slope (dashed blue). There is a slight depression in the flattish area between the two slopes. Source: Adapted by Curio, from Figure 4.1 in AMBS Ecology & Heritage, 2024, Western Sydney University, Parramatta South Campus Proposed Temporary Car Park – Eastern Study Area Historical Archaeological Assessment, Impact Assessment and Research Design.

steeply rises up to near-flat plateau approximately 10m, with a second, less abrupt rise occurring southwards toward a row of mature trees which forms a second plateau.<sup>41</sup> These terraces form a raised semicircular mound along the north side of the Building EB/Vernon Building (Figure 4-13), which radiates outwards from the central sleep-out building and then dissipating to be roughly in line with the toilet block at northeast corner of the building.<sup>42</sup> Running parallel to the curve of the first rise on the first plateau is a slight linear depression and grass that shows patchy linear areas of browning and less grass growth along the crest of the first plateau (Figure 4-14 and Figure 4-15).<sup>43</sup> The mound size and volume indicate that these were the result of machine excavations during the c.1998 works across the campus.<sup>44</sup>

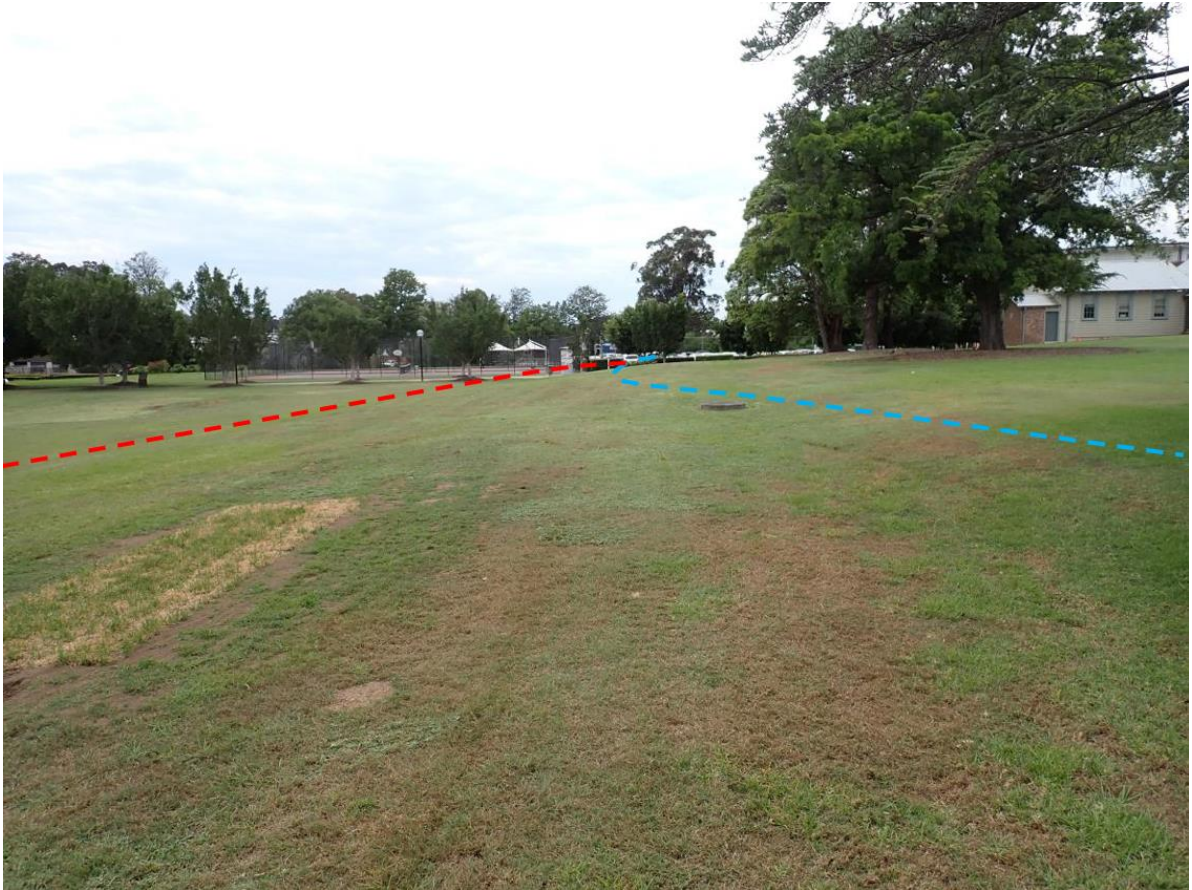
Figure 4-14: Looking east along the top of the first terrace. Geotechnical test pit TP15 is visible on the left. Source: Adapted by Curio from Figure 4.2 in AMBS Ecology & Heritage, 2024, Western Sydney University, Parramatta South Campus Proposed Temporary Car Park – Eastern Study Area Historical Archaeological Assessment, Impact Assessment and Research Design.

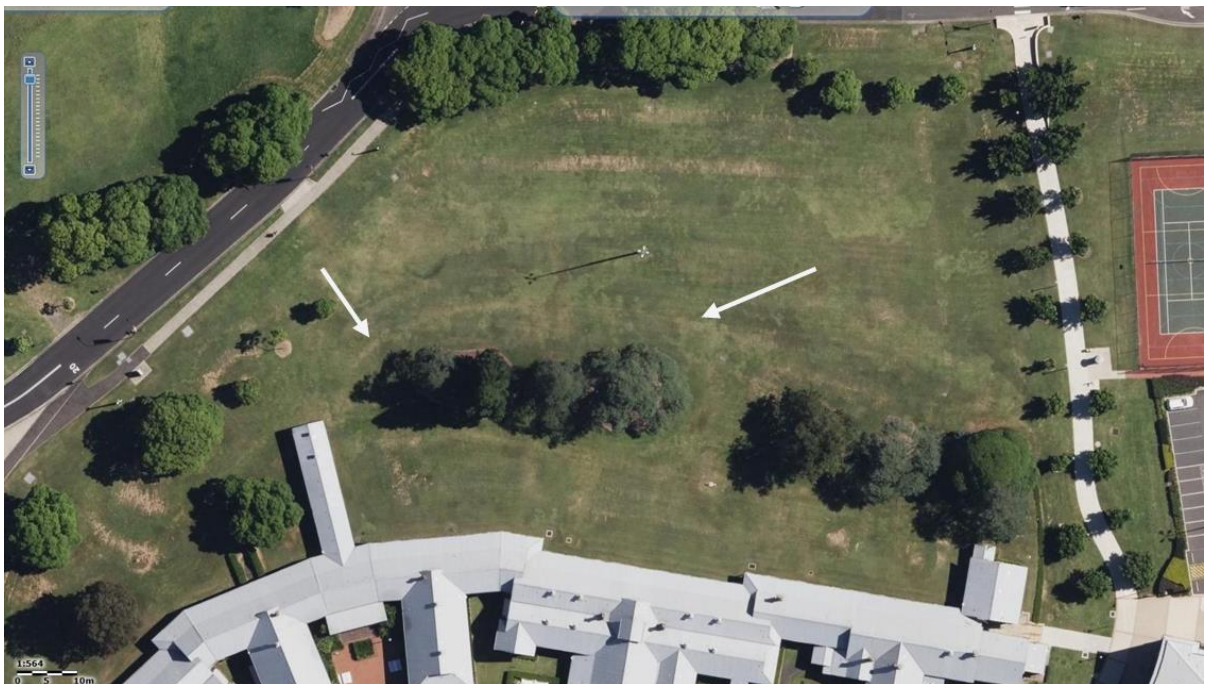
Figure 4-15: Modern satellite image showing semi-circular lines of brown grass (arrowed) that appear to match the alignment of the ha-ha from SIX Maps. Source: Adapted by Curio from Figure 4.3 in AMBS Ecology & Heritage, 2024, Western Sydney University, Parramatta South Campus Proposed Temporary Car Park – Eastern Study Area Historical Archaeological Assessment, Impact Assessment and Research Design

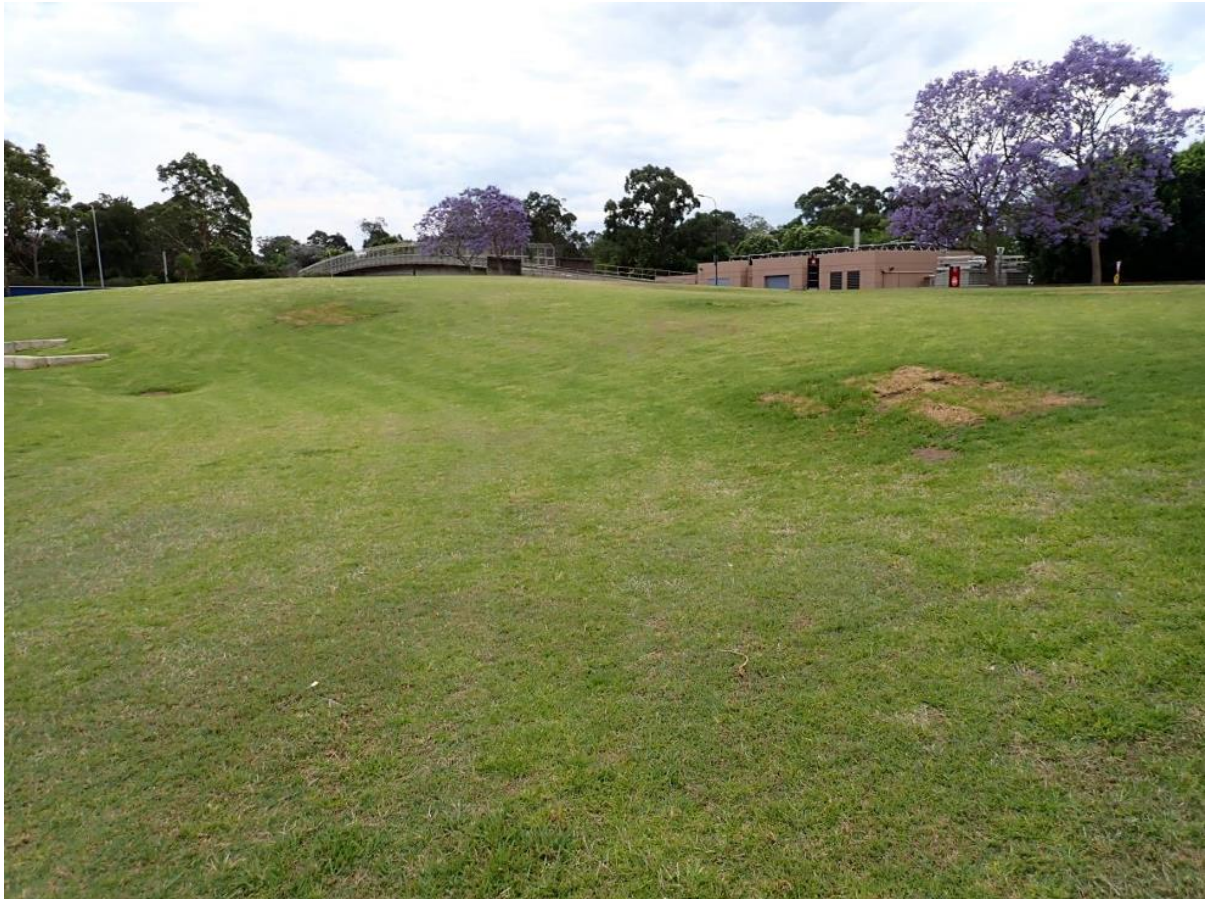
Figure 4-16: The southern section of the prominent mound where the western car park will be located. Geotechnical test pits TP9 and TP7 are visible in the background and middle right respectively. Source: Adapted from Figure 4.1 in AMBS Ecology & Heritage, 2024, Western Sydney University, Parramatta South Campus Proposed Temporary Car Park – Western Study Area Historical Archaeological Assessment, Impact Assessment and Research Design.

The proposed western car park location is located in the southeast quadrant of the oval, with the northern end of the location having a salient mound (Figure 4-16) that was most likely a result of the previous earthworks debris from the establishment of the existing P1 Car Park, Victoria Road widening and the creation of the Bridge St overpass.<sup>45</sup> There are sandstone block walls that function to retain the ground and provide informal seating in parts of the northern side of the mound, with the ground flattening out to the south and west of the mound moving towards the bus shelter.<sup>46</sup> The mound has a salient slope down towards the oval; the oval is raised up approximately 0.5m (Figure 4-17).<sup>47</sup> Mature trees are present along Fifth Street from Bridge Street to the southwest, with younger trees planted between the mature trees and the bus shelter.<sup>48</sup>

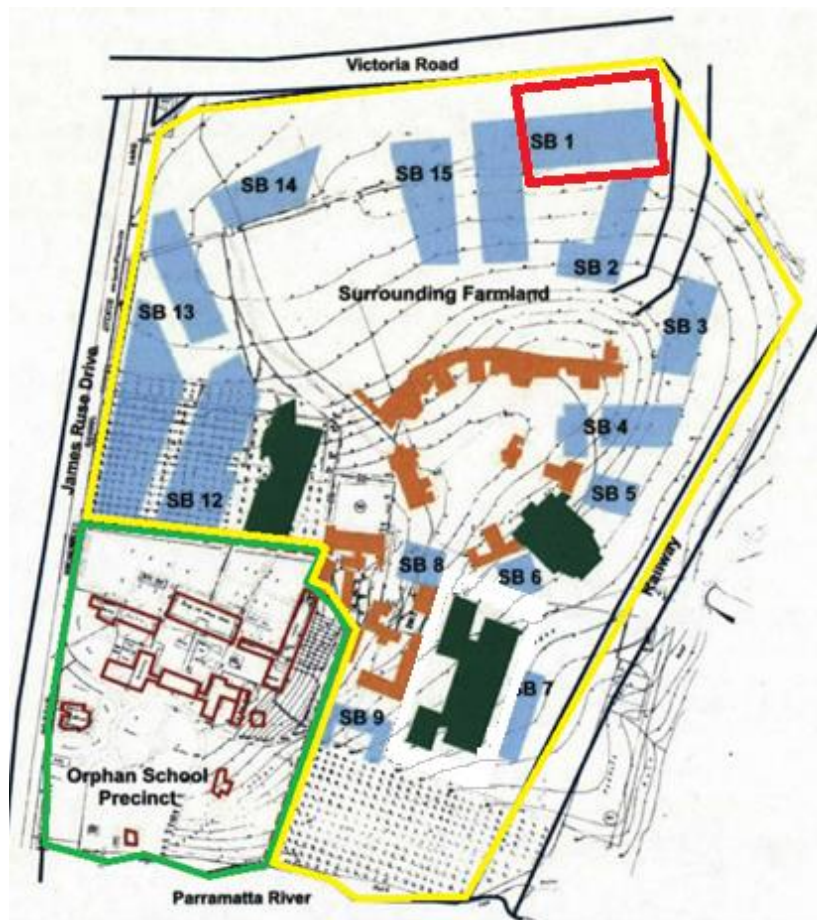
Figure 5-1: Detail of archaeological precinct map from Casey & Lowe 2007, p12, with Curio markup. Green indicated Orphan School Precinct, Yellow indicates Surrounding Farmland Precinct and ICoE study area shown in red.

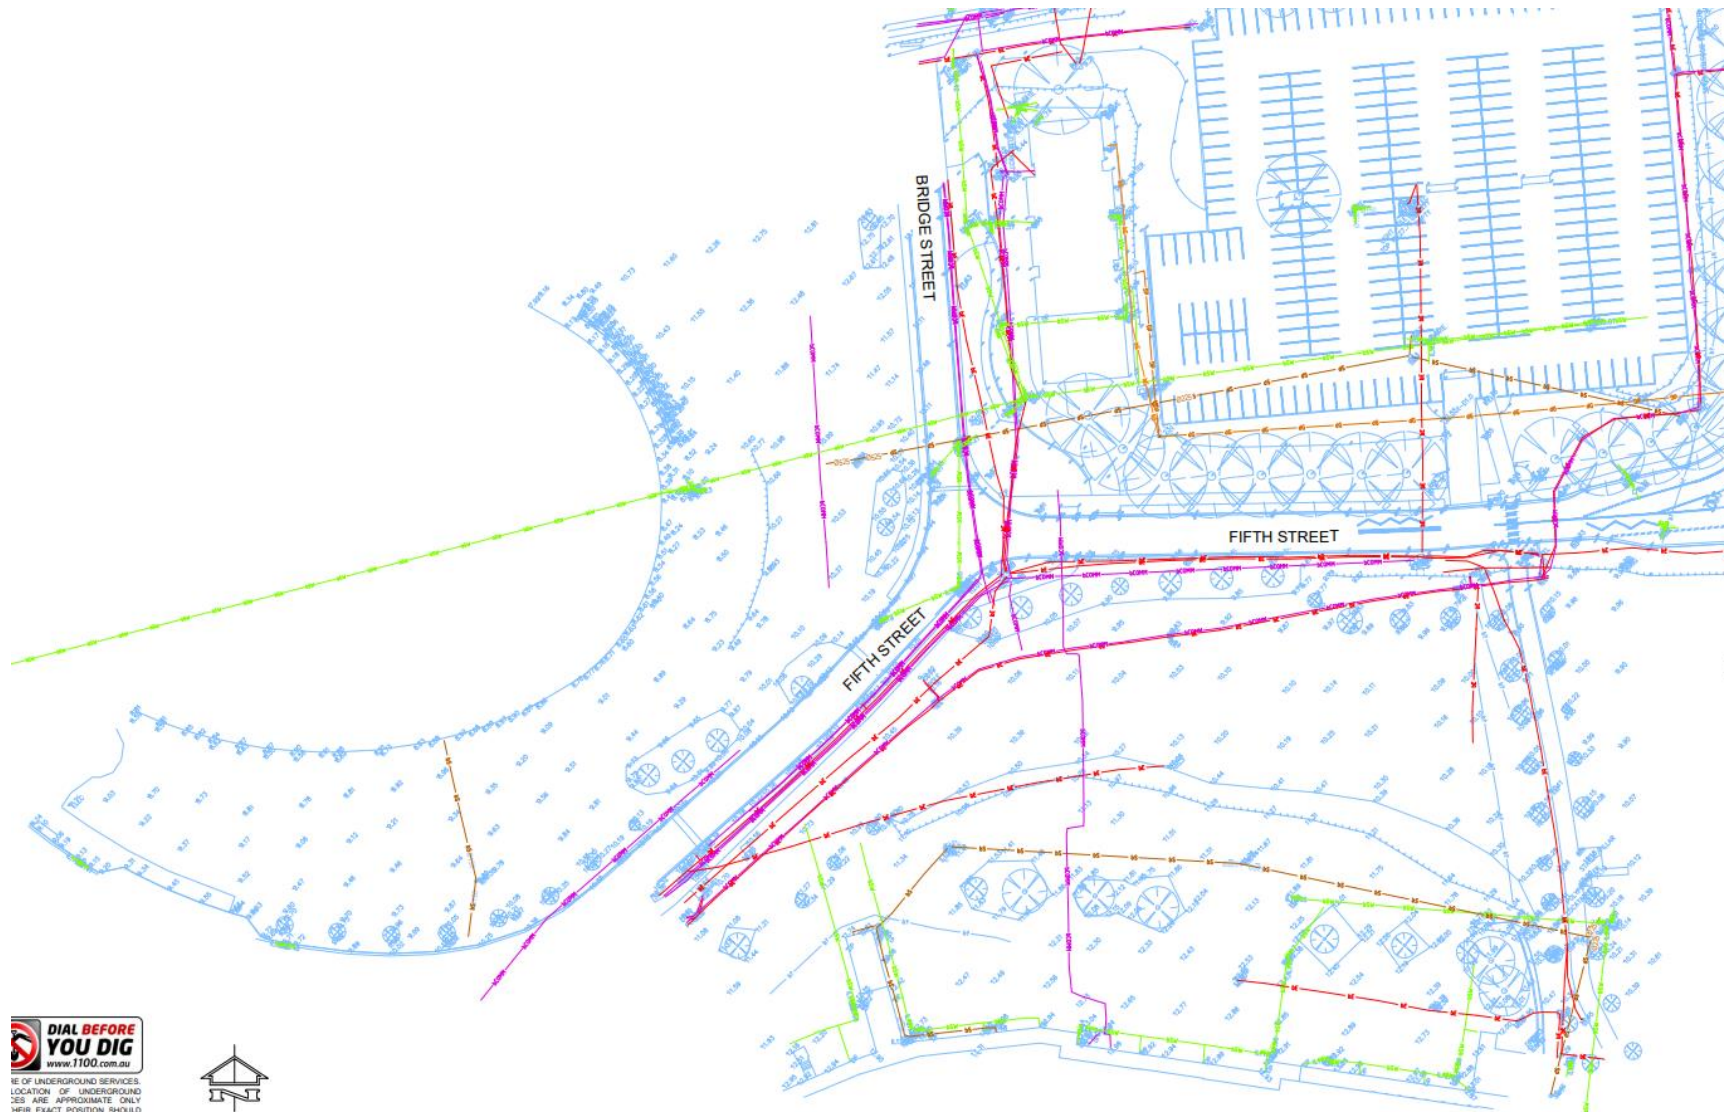
Figure 6-1: General Survey and Services Plan. Source: TTW 2025

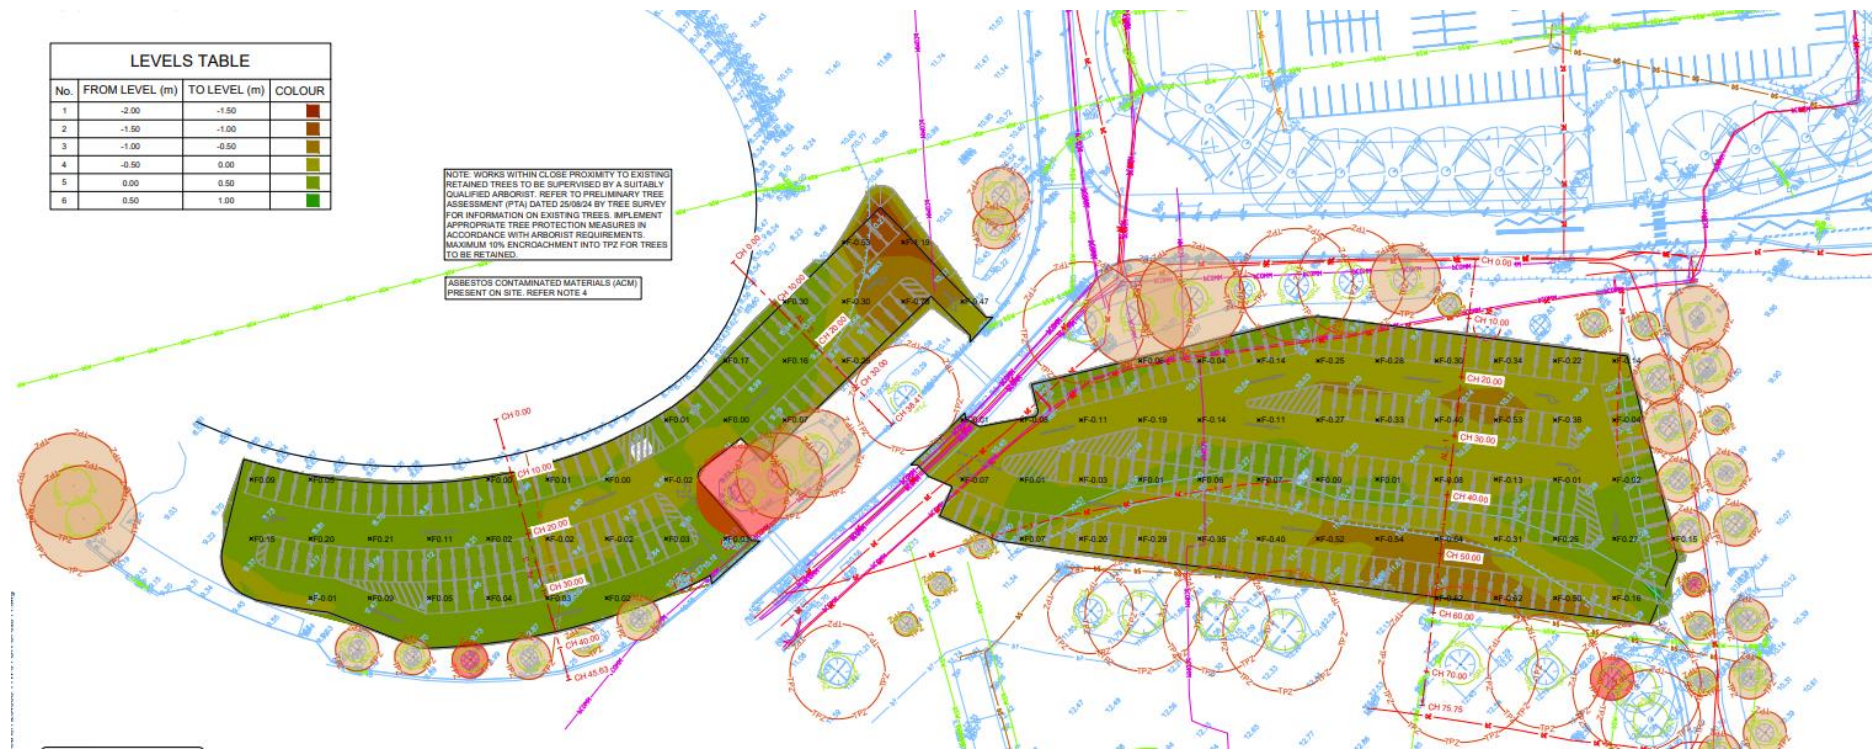
Figure 6-4: Bulk Earthworks Cut and Fill Estimates. Source: TTW 2025.

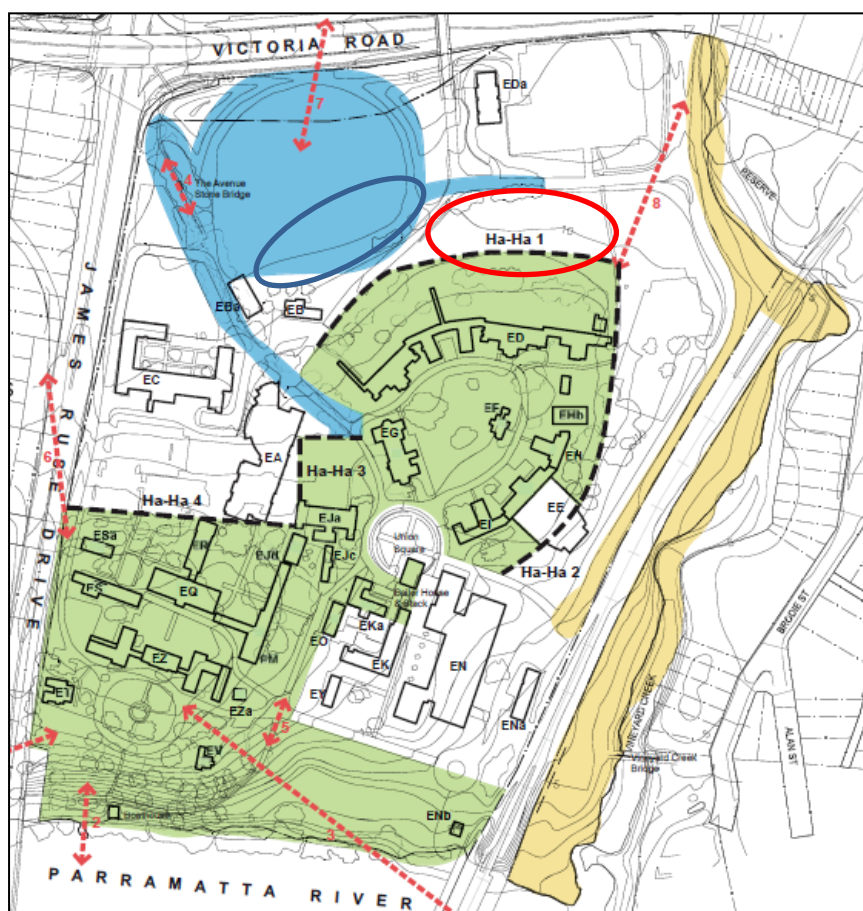
**Figure 2.4** Conservation Areas of the UWS Parramatta Campus, showing the two areas of car park. The western car park (circled blue) is within the 'Cricket Grounds and Venues Conservation Area 2' (shaded blue), while the eastern car park (circled red) is adjacent to Ha-Ha 1 on the northern boundary of the 'Institutional Complex Conservation Area 1' (shaded green). (Source: Conybeare Morrison International, 2008: 18, Figure 3.1). Historic context

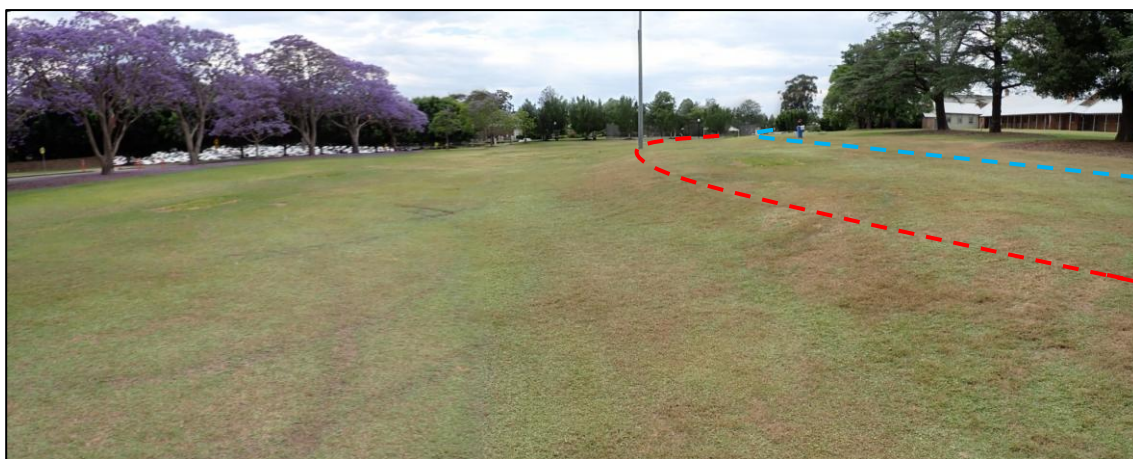
**Figure 4.1** Location of eastern car park showing the crest of the steeper slope (dashed red) and crest of the more gentle slope (dashed blue). There is a slight depression in the flatish area between the two slopes.

The proposed temporary eastern car park will be located in the mostly flat, grassed ground of the area between Fifth Street and Building EB/Vernon Building. The southernmost third of the area rises up steeply to a flatish plateau approximately 10m wide; a second gentle rise continues south up to a row of mature trees, with a second slightly higher plateau or terrace behind the trees (outside the study area). These terraces form a raised semicircular mound along the north side of Building EB/Vernon Building (Figure 4.1), starting at the central 'sleep-out' and ending roughly in line with the toilet block at the northeast corner of the building. A slight linear depression runs parallel to the curve of the first steeper bank on the first plateau. The grass shows patchy linear areas of browning and less vigorous growth along the crest of the first plateau (Figure 4.2) which are also clearly visible in satellite imagery of the site (Figure 4.3).

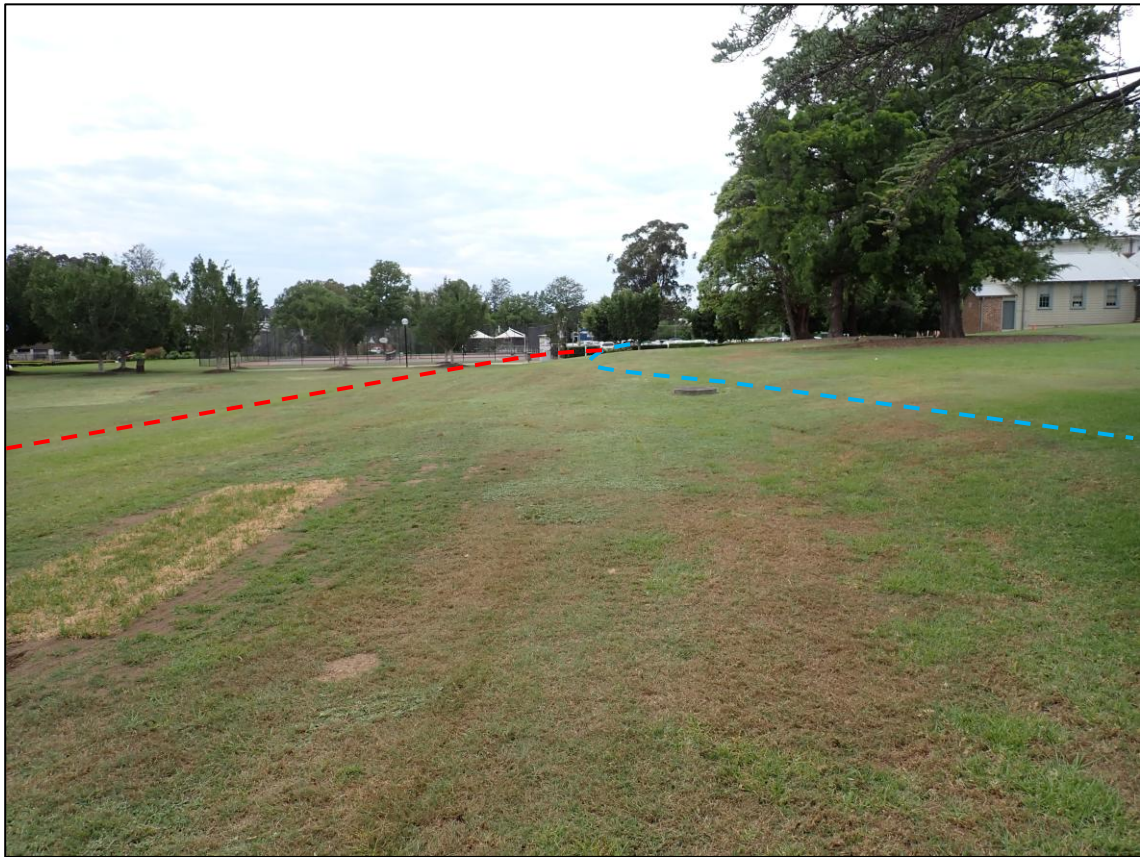
Figure 4.2 Looking east along the top of the first terrace. Geotechnical test pit TP15 is visible on the left.

The size and volume of earth forming these mounds is indicative that they were created by machine excavations during the c.1998 works across the campus.

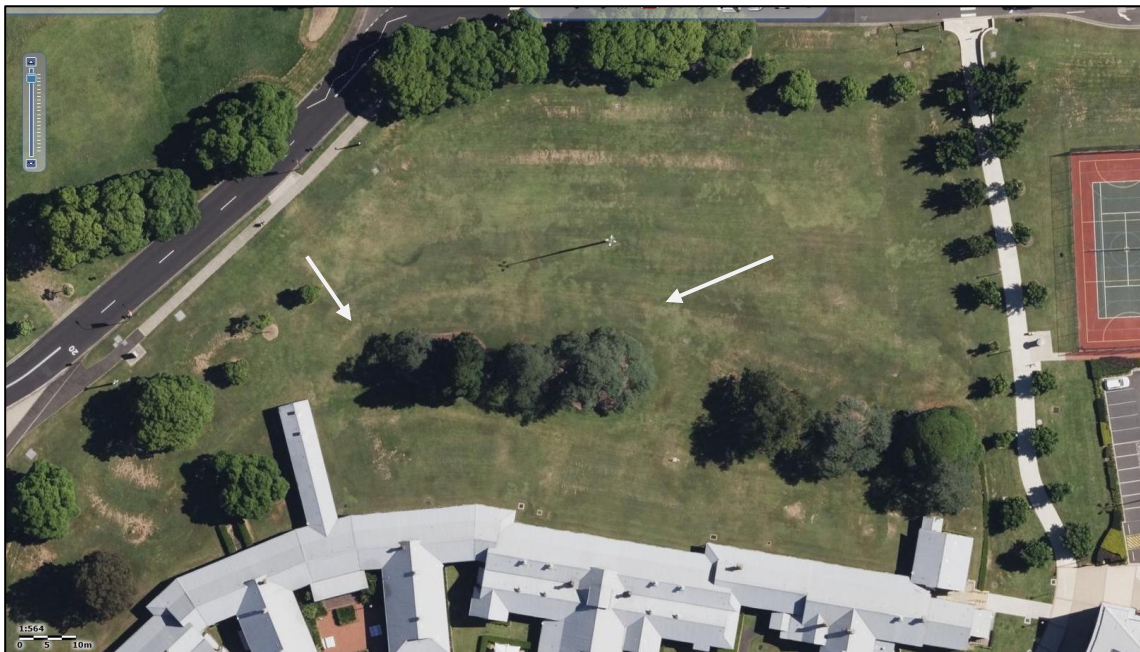
Figure 4.3 Modern satellite image showing semi-circular lines of brown grass (arrowed) that appear to match the alignment of the ha-ha (Source: SIX Maps).

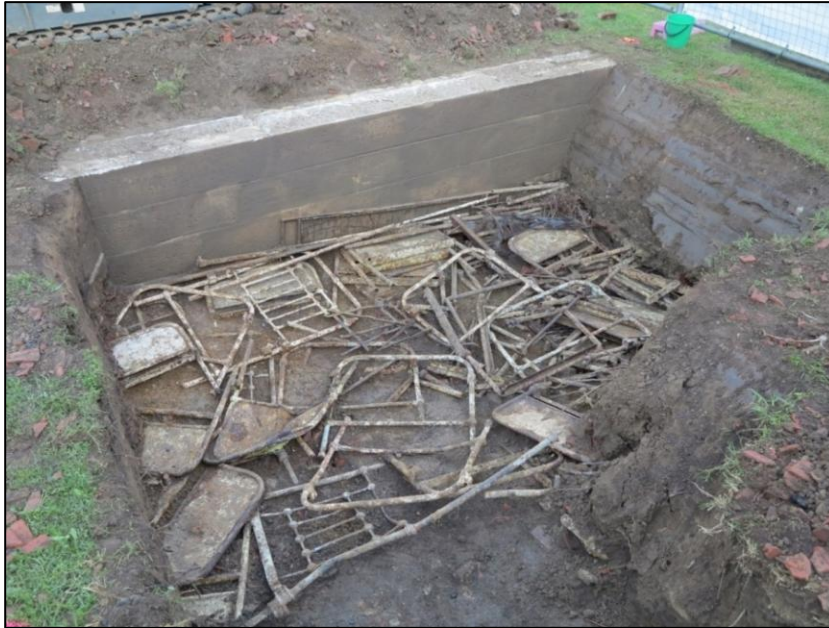
**Figure 5.4** Sandstone wall of northern ha-ha surviving in TA24/1; the ha-ha was backfilled with iron bedframes. Note the top of the ha-ha wall was uncovered just below the existing ground level (top right). Casey & Lowe 2018: 312.

In 2016-2017 Casey & Lowe undertook testing to confirm the potential and significance of the archaeological resource at the Parramatta North Precinct (Cumberland Hospital), including testing for the two now-demolished ha-ha structures added to the Parramatta Lunatic Asylum/Hospital gardens in the mid-1880s (Figure 5.3). The northern ha-ha was found to survive intact (Casey & Lowe 2018:308-311), with the exception of the uppermost one or two courses that may have protruded above the extant ground level, and had been backfilled with a large volume of cast iron bed frames disposed of by the hospital in the 1960s (Figure 5.4). Only the slope of the earthen bank of the southern ha-ha and a bitumen footpath at the base of the ditch had survived (Casey & Lowe 2018: 314-315) and the wall structure had been completely removed (Figure 5.5).
