## **Western Sydney University- Indigenous Centre of Excellence**

Historical Archaeological Assessment

August 2025

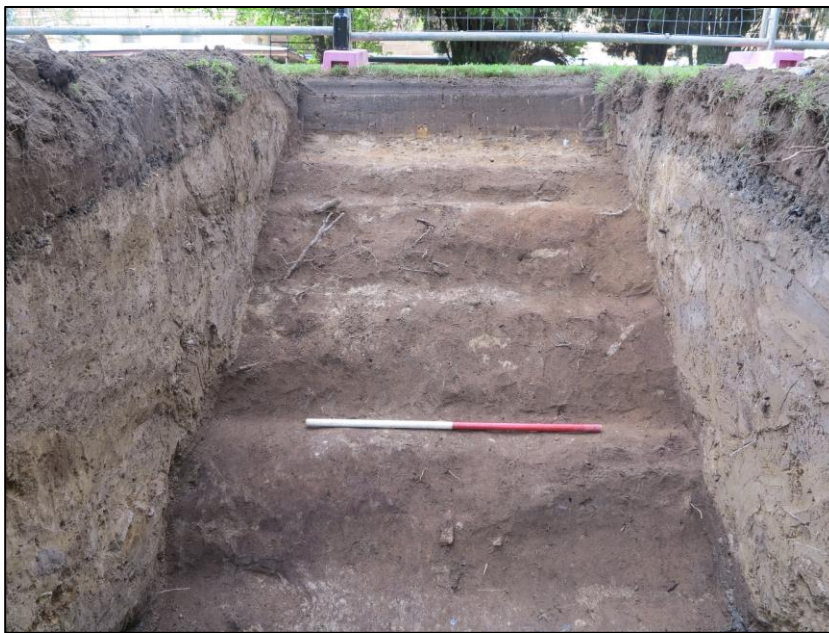
**Figure 5.5** Only the slope of the earthen bank of the southern ha-ha was visible during the investigations, with evidence of being terraced for plantings. Casey & Lowe 2018: 315.

In 2016-2017 Casey & Lowe undertook testing to confirm the potential and significance of the archaeological resource at the Parramatta North Precinct (Cumberland Hospital), including testing for the two now-demolished ha-ha structures added to the Parramatta Lunatic Asylum/Hospital gardens in the mid-1880s (Figure 5.3). The northern ha-ha was found to survive intact (Casey & Lowe 2018:308-311), with the exception of the uppermost one or two courses that may have protruded above the extant ground level, and had been backfilled with a large volume of cast iron bed frames disposed of by the hospital in the 1960s (Figure 5.4). Only the slope of the earthen bank of the southern ha-ha and a bitumen footpath at the base of the ditch had survived (Casey & Lowe 2018: 314-315) and the wall structure had been completely removed (Figure 5.5).

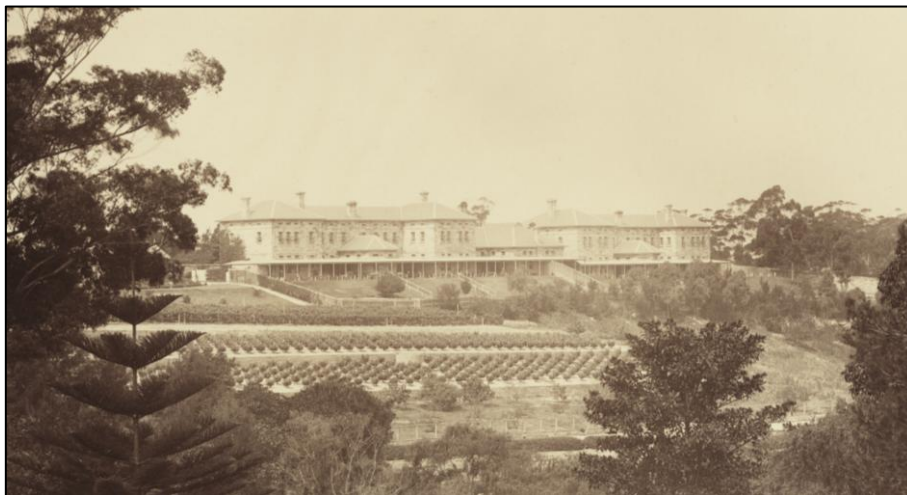
**Figure 5.7** Ha-has around the 'Hill Group' buildings at Gladesville Hospital, built c.1885. Detail from Government Printing Office photo dated 1879-c.1891. Source: SL NSW DL PXX 63.

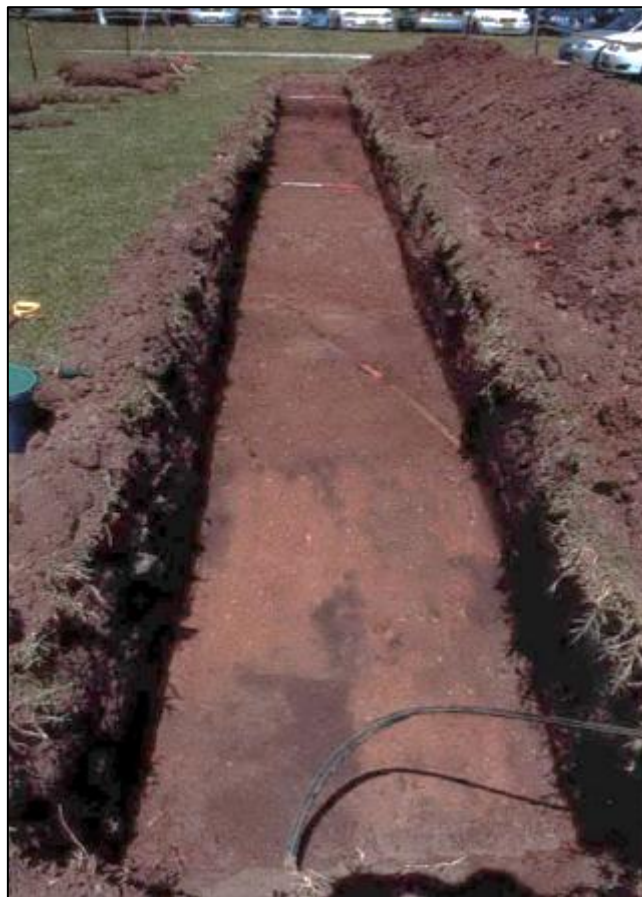
Figure 6.2 View south of test trench showing cut feature in foreground, earthenware pipe in middle ground and linear feature in cultivated soil in the background (Casey & Lowe, 2008: 8).

A number of archaeological features were found within the trench within the cultivated soil and the natural clay (Figure 6.2). The cultivated soil was exposed below the modern fills at approximately 500mm deep; the natural clay was uncovered at a depth of 840mm (Casey & Lowe, 2008: 5). A narrow earthenware pipe was located within the cultivated soil in the northern part of the trench; it was suggested that the pipe was probably related to the irrigation system of the historic vineyard or orchard. A linear feature was also uncovered within the cultivated soil that measured 220-250mm in width and 200mm in depth. The fill was different to the surrounding soil, and it was suggested that it may have been intended to be an open field drain, and related to historic agricultural activities. Two insubstantial cut features into the natural soil were also revealed; one was roughly circular, and the other roughly rectangular. Both features were filled with a soil similar to the deposit between the cultivated soil and natural clay; it was stated that the features related to the historic agricultural phase of the site, however, their specific nature was unclear (Casey & Lowe, 2008: 7).

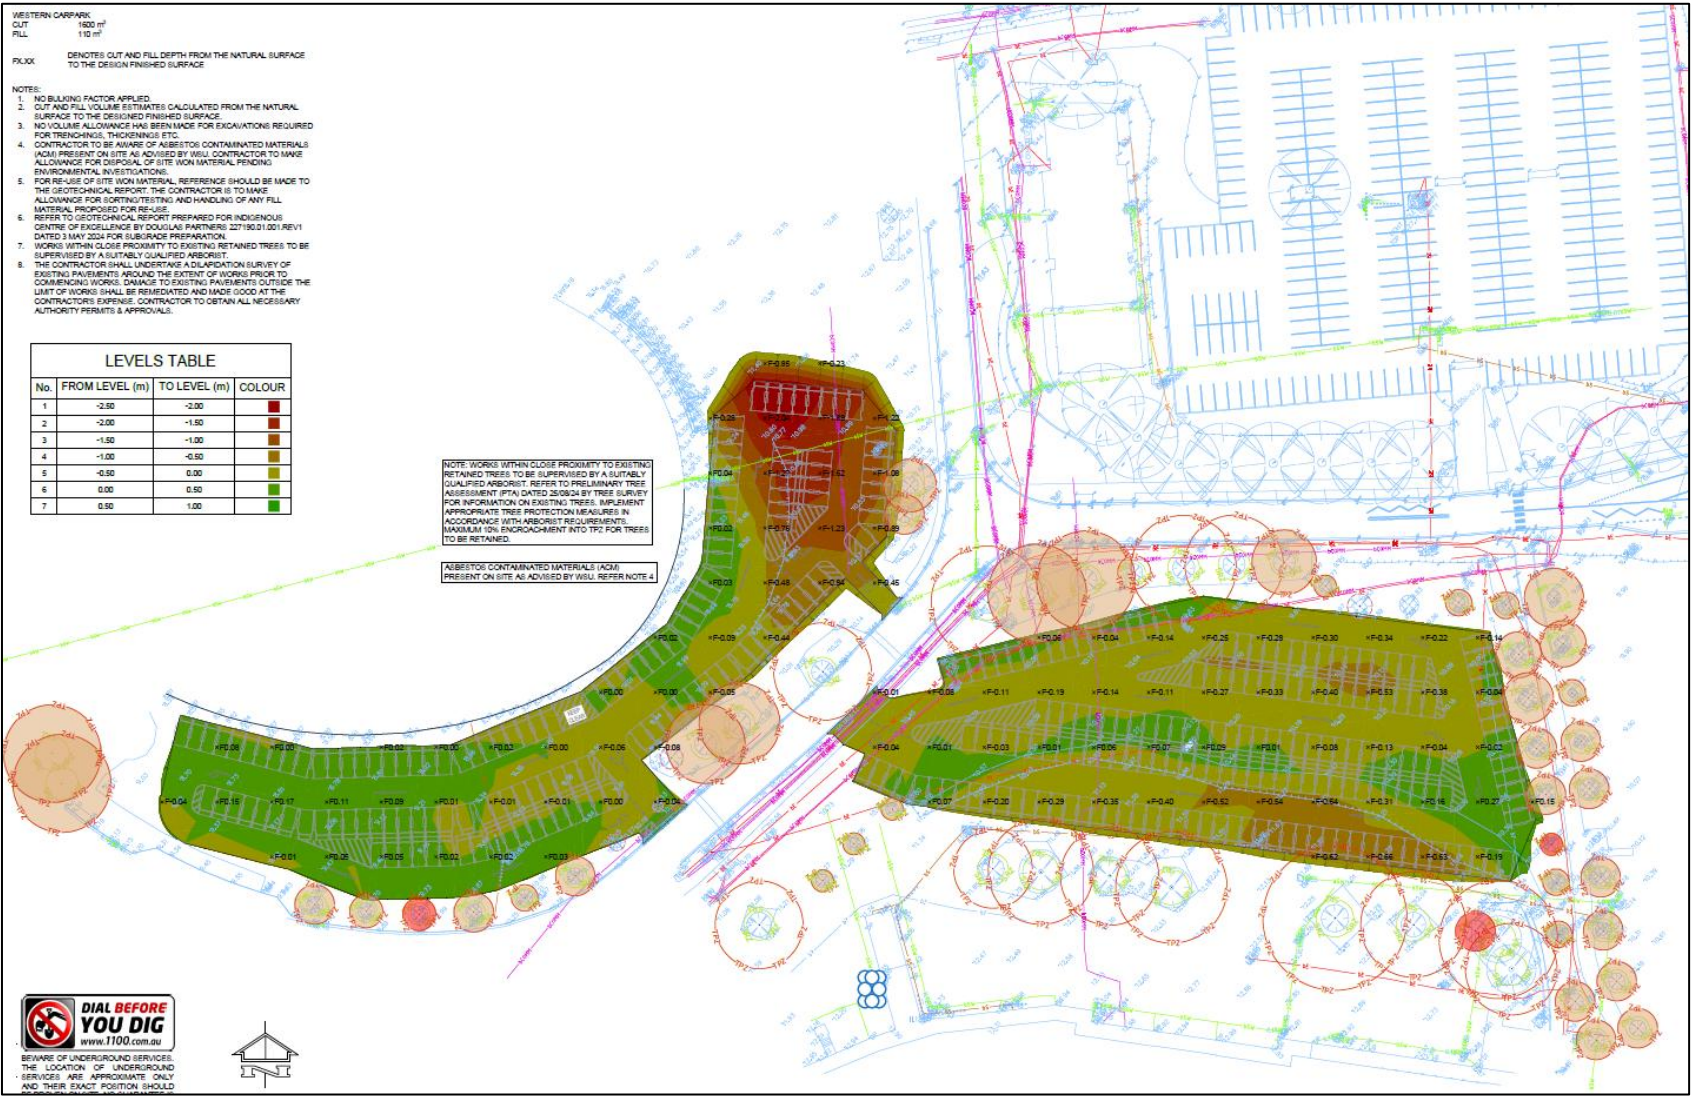
Figure 8.1 Map indicating the required level of soils to be removed for the proposed carparks (Source TTW).

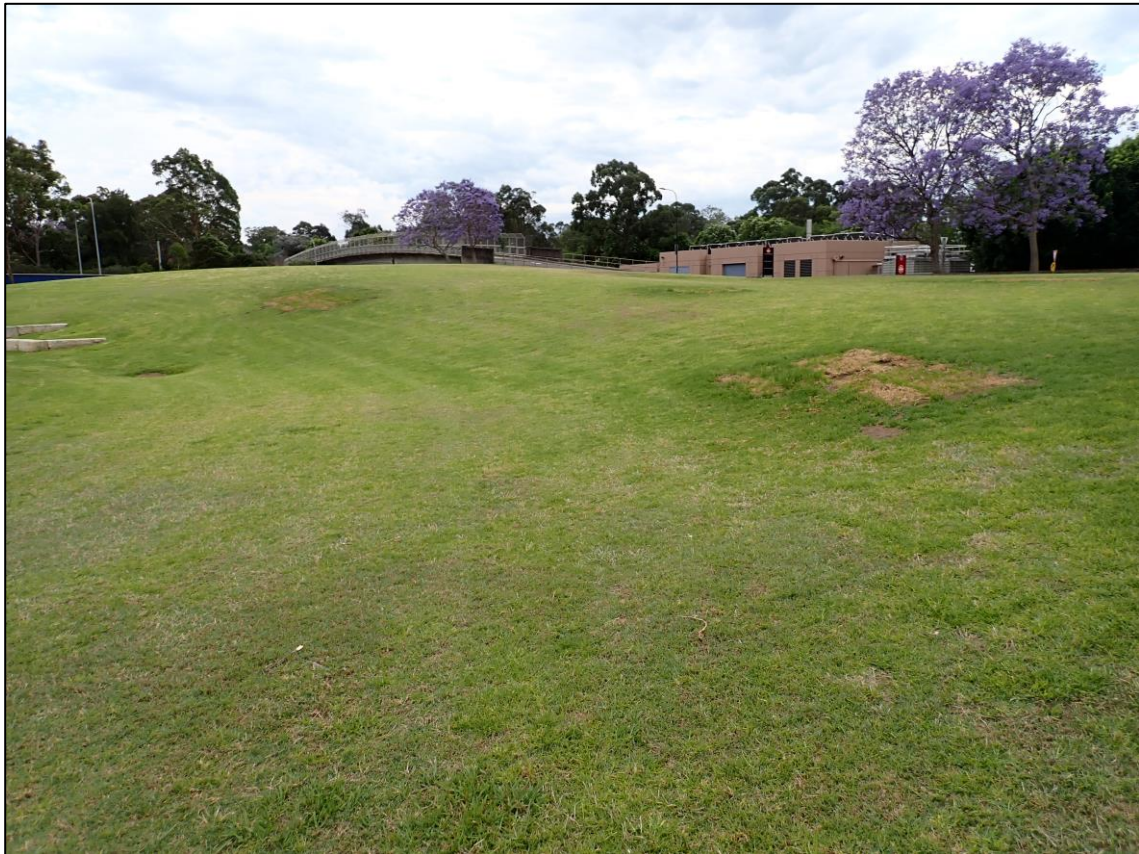
**Figure 4.1** The southern section of the prominent mound where the western car park will be located. Geotechnical test pits TP9 and TP7 are visible in the background and middle right respectively.

The western car park will be located in the southeast quadrant of the oval. The northern end of the location has a prominent mound (Figure 4.1), assumed to be deliberately created using debris from previous earthworks in the area, particularly the creation of the existing P1 Car Park, widening of Victoria Road and creation of the Bridge St overpass. Parts of the northern side of the mound have sandstone block walls to retain the ground and provide informal seating. The ground flattens out to the south and west of the mound towards the bus shelter, but has a pronounced slope down towards the oval, although the oval itself is raised up approximately 0.5m (Figure 4.2). A row of mature trees (approximate length of 75m) are growing along Fifth Street from Bridge Street to the southwest; younger trees have been planted between the mature trees and the bus shelter.

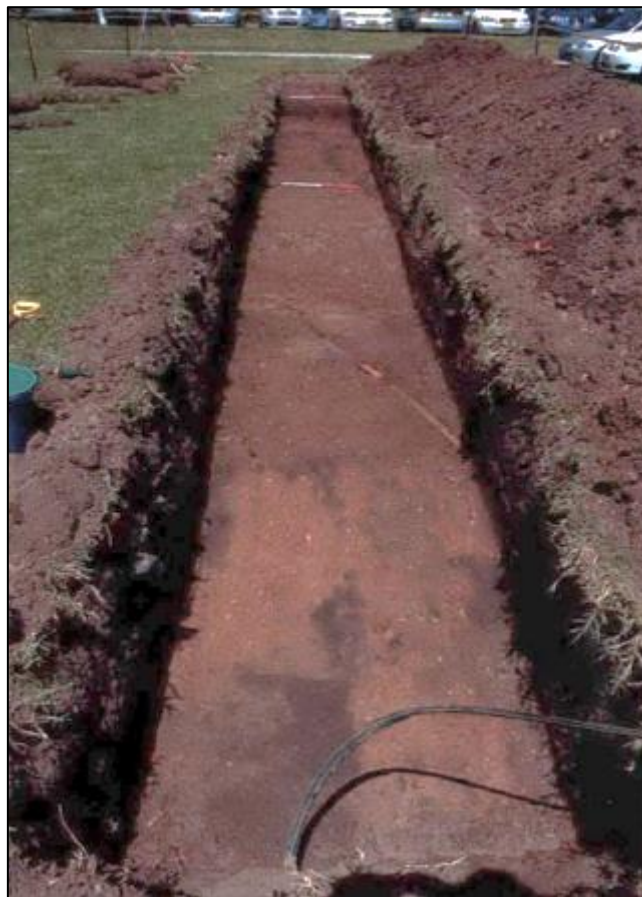
Figure 5.2 View south of test trench showing cut feature in foreground, earthenware pipe in middle ground and linear feature in cultivated soil in the background (Casey & Lowe, 2008: 8).

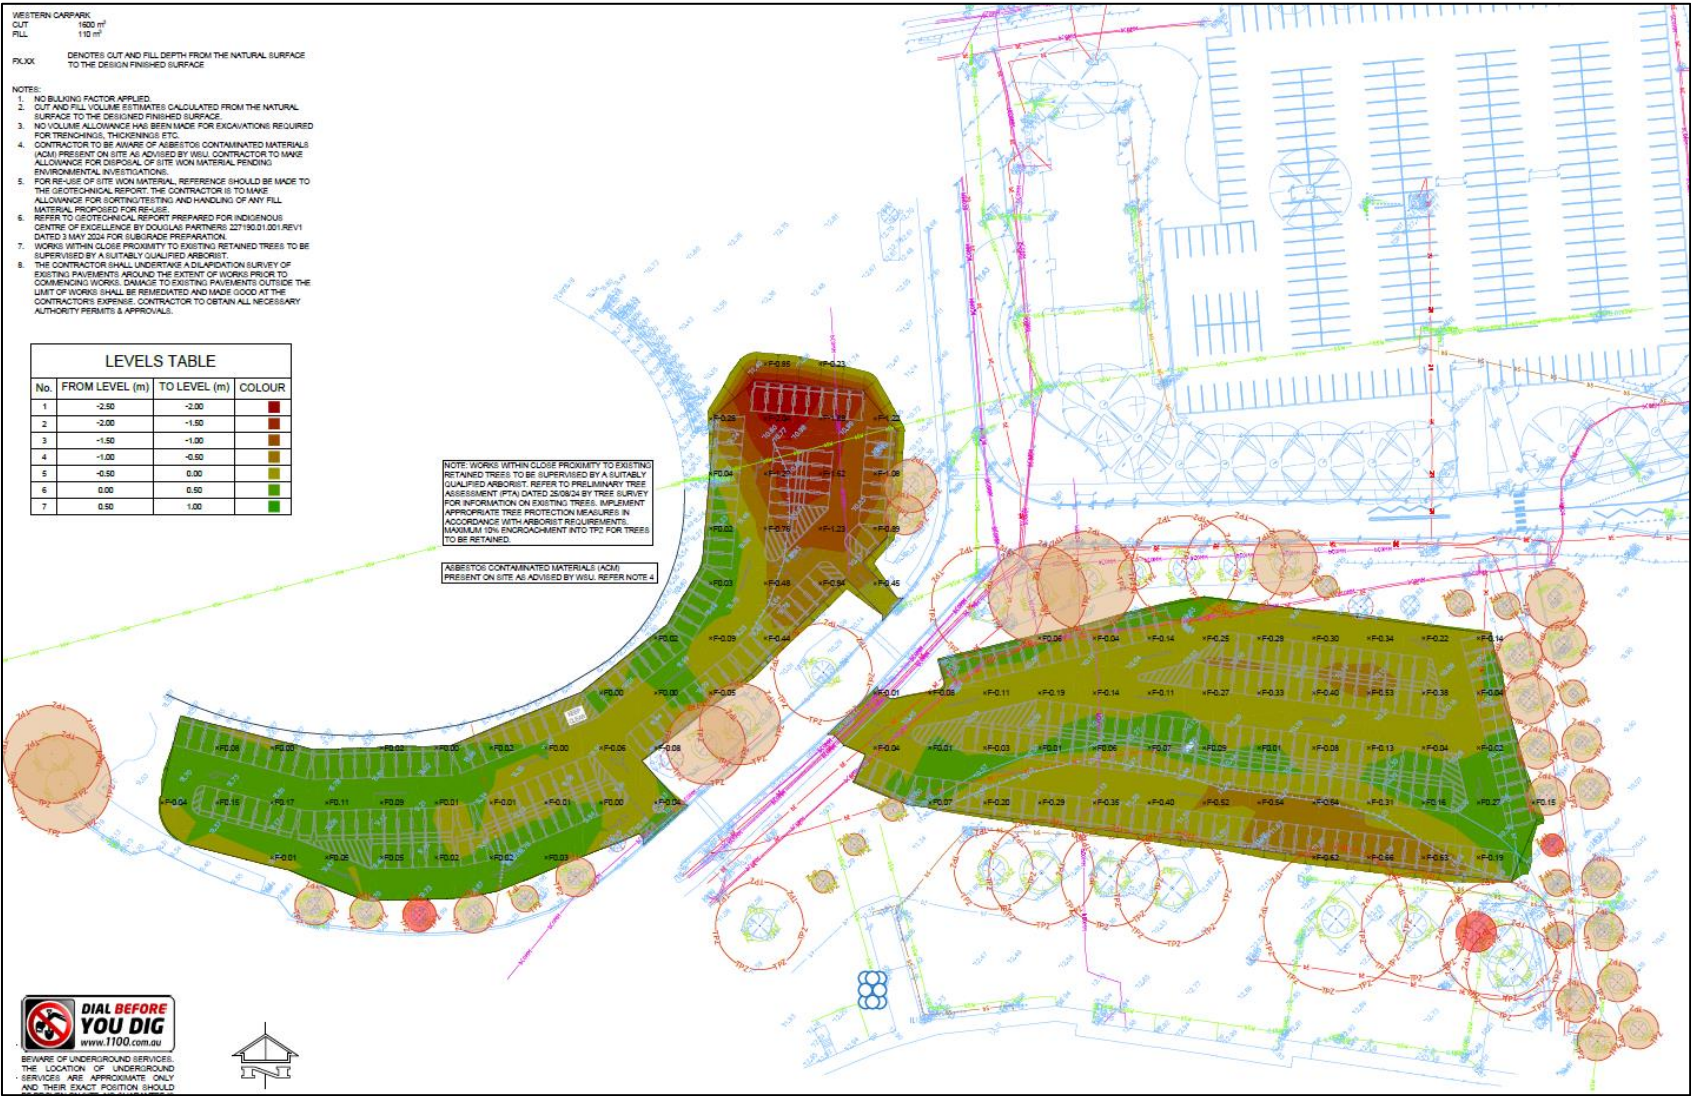
Figure 7.1 Map indicating the required level of soils to be removed for the proposed car parks (Source TTW).
