Investigation Summary Report

Client	Western Sydney University	Project No.	227191.00
Project	P1 Carpark Relocation	Date	15 November 2024
Address	Western Sydney University, 171 Victoria Road, Parramatta NSW	Reference	R.001.Rev0

1. Proposed development

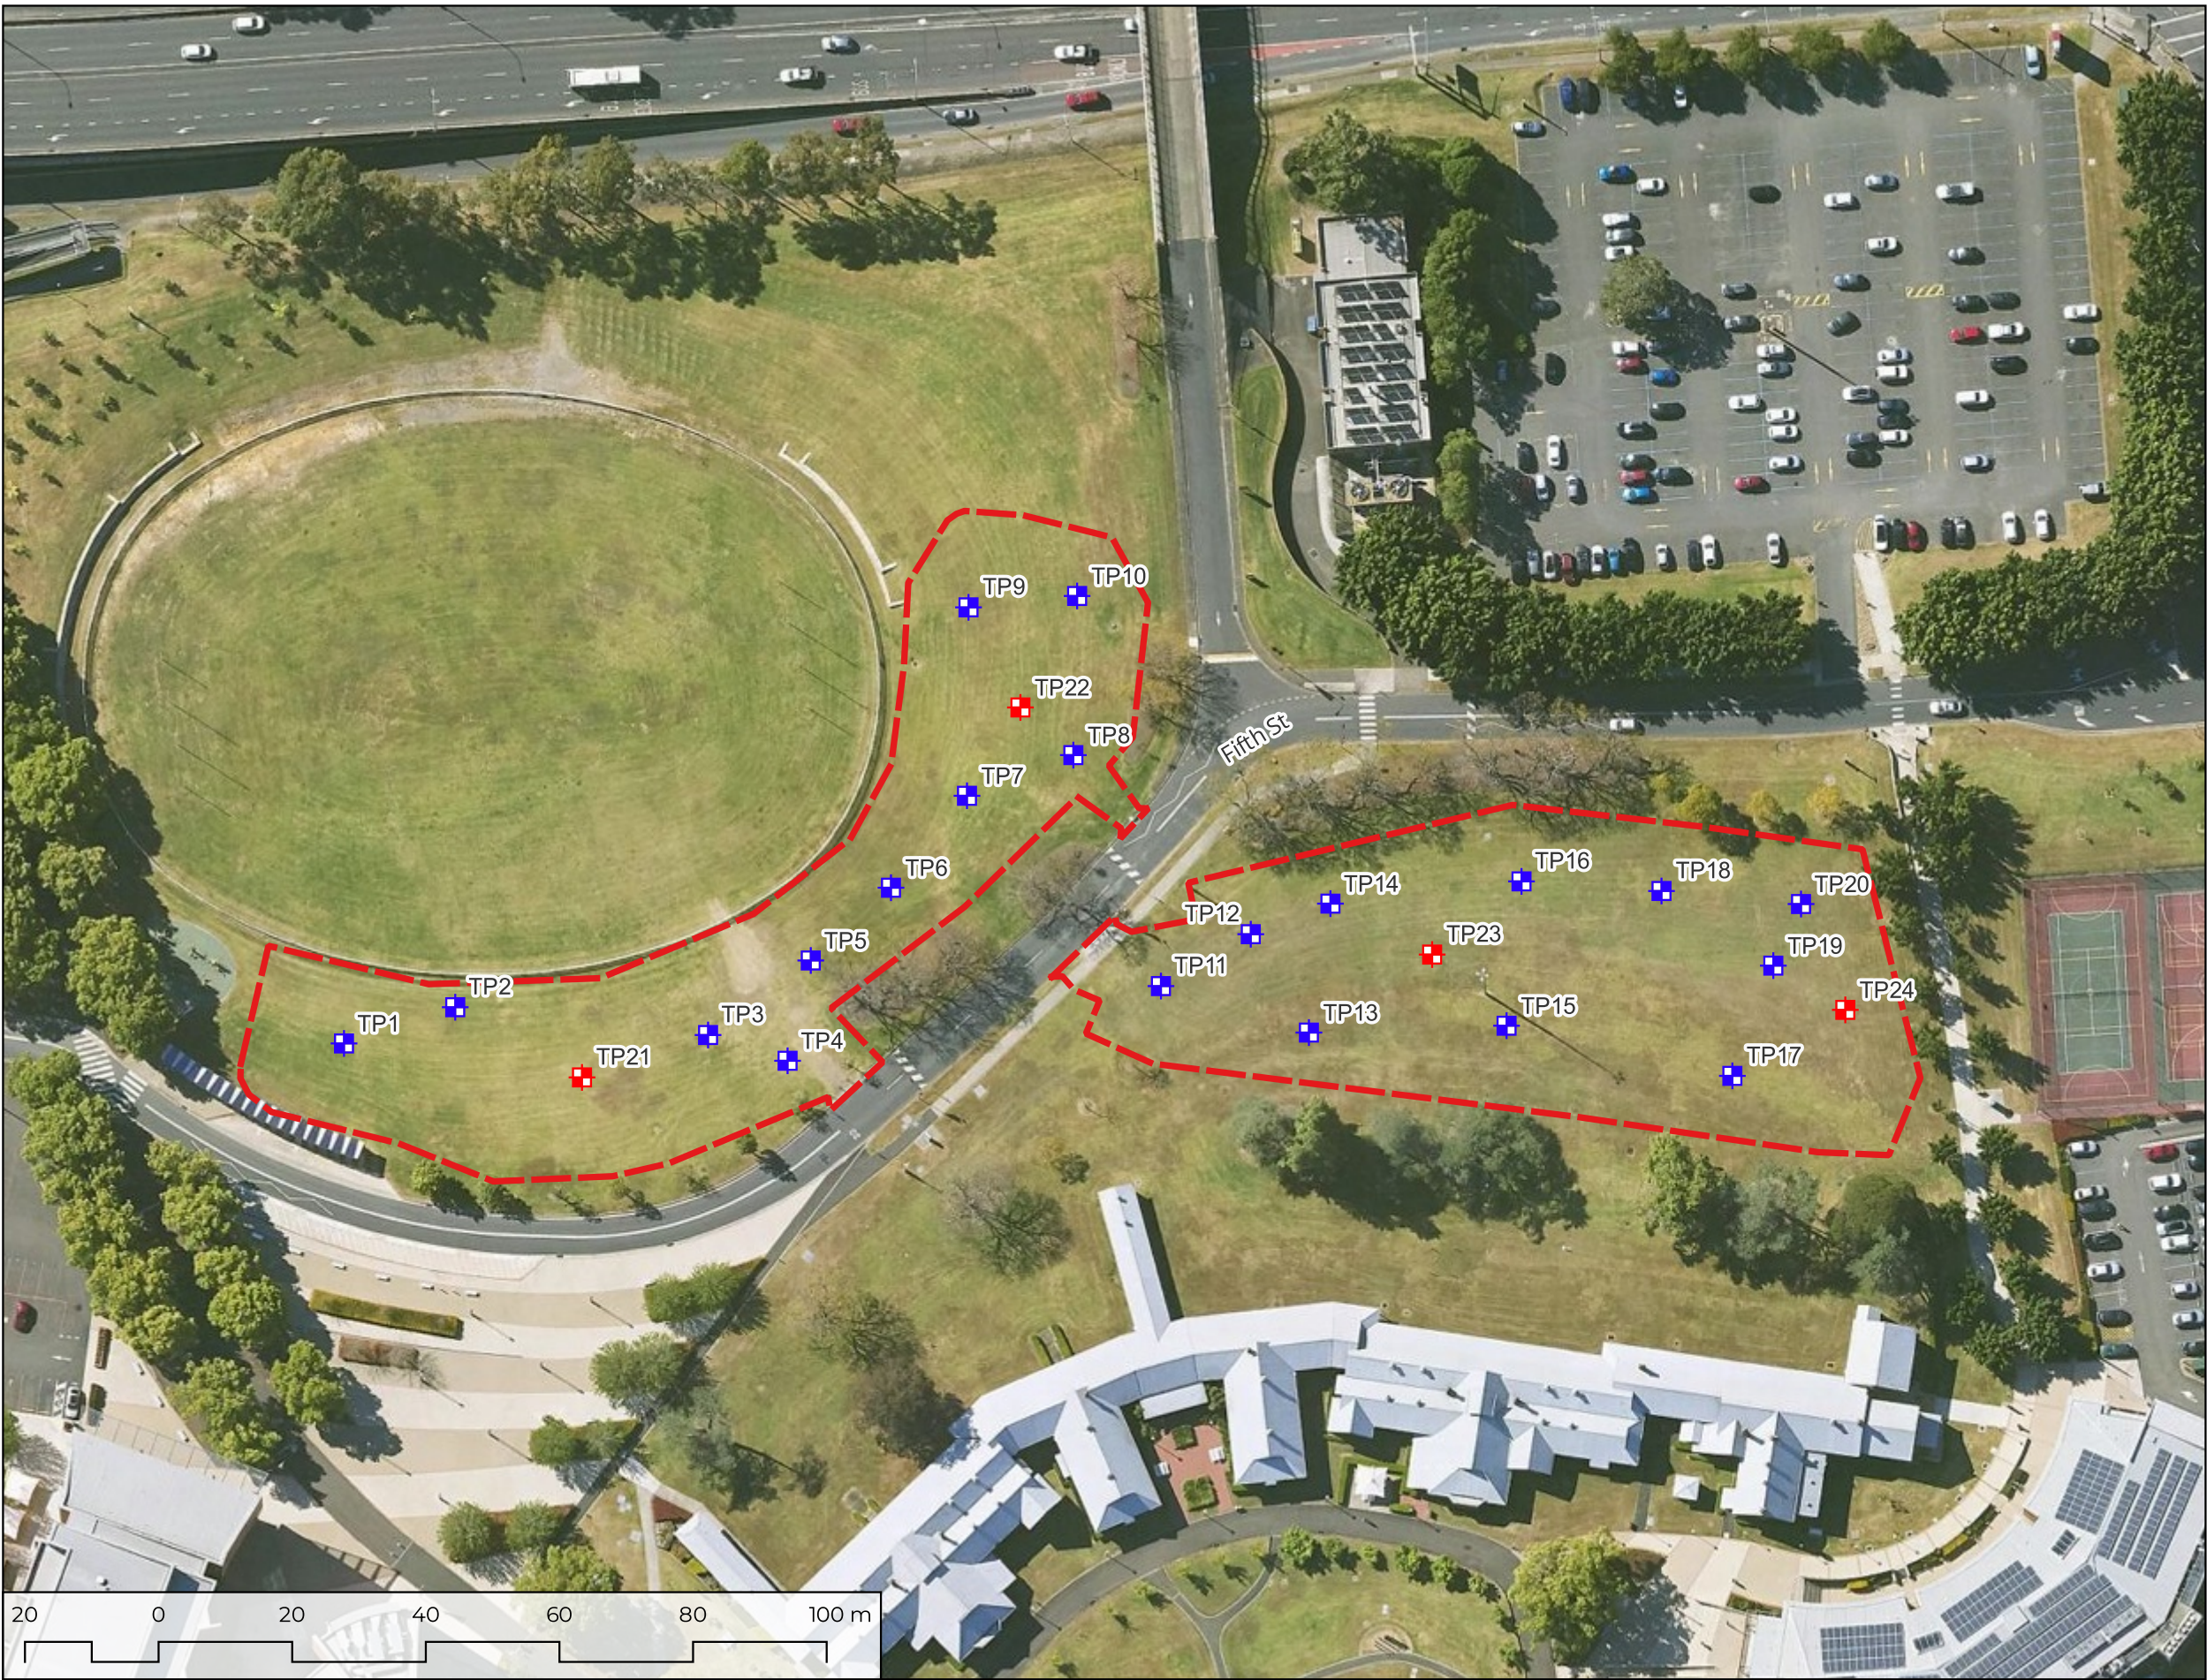
The P1 Carpark is to be temporarily relocated to the south and south-west, requiring the construction of two temporary carparks identified as the Western and Eastern carparks, as shown on Drawing 1, attached. The Western and Eastern carparks will contain 142 and 178 parking spaces, respectively.

NOTE:
1. Drawing projection in GDA2020 / MGA zone 56, adapted from aerial imagery from "Metromap" dated 23/07/2024,
2. Features shown are approximate only.

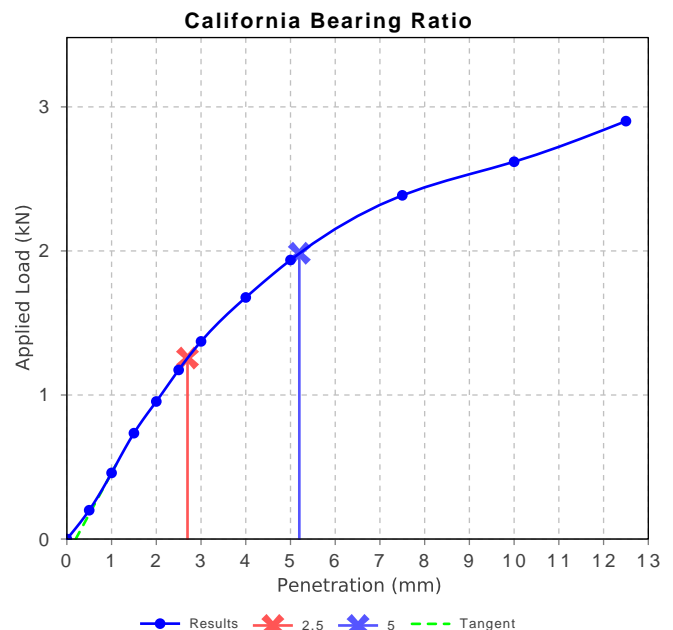
California Bearing Ratio (AS 1289 6.1.1 & 2.1.1)		Min	Max
CBR taken at	5 mm		
CBR %	10		
Method of Compactive Effort	Standard		
Method used to Determine MDD	AS 1289 5.1.1 & 2.1.1		
Method used to Determine Plasticity	Visual Assessment		
Maximum Dry Density (t/m ³)	1.78		
Optimum Moisture Content (%)	16.5		
Laboratory Density Ratio (%)	100.0		
Laboratory Moisture Ratio (%)	100.5		
Dry Density after Soaking (t/m ³)	1.80		
Field Moisture Content (%)	13.6		
Moisture Content at Placement (%)	16.7		
Moisture Content Top 30mm (%)	19.3		
Moisture Content Rest of Sample (%)	18.1		
Mass Surcharge (kg)	4.5		
Soaking Period (days)	4		
Curing Hours (h)	96.2		
Swell (%)	-1.5		
Oversize Material (mm)	19		
Oversize Material Included	Excluded		
Oversize Material (%)	8.2

Atterberg Limit (AS1289 3.1.2 & 3.2.1 & 3.3.1)		Min	Max
Sample History	Oven Dried		
Preparation Method	Dry Sieve		
Liquid Limit (%)	40		
Plastic Limit (%)	20		
Plasticity Index (%)	20
