# Preliminary Site Investigation

## Orica Tocumwal Magazine Compound Upgrade

Orica Australia Pty Ltd

13 September 2024

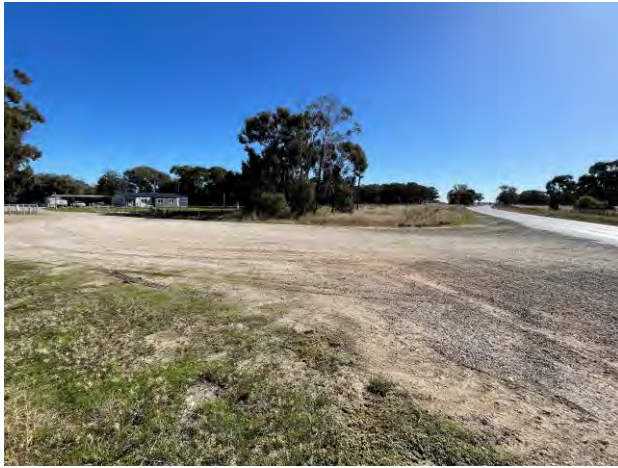
**Photograph 1 - Southeast corner site access from Newell Highway.**

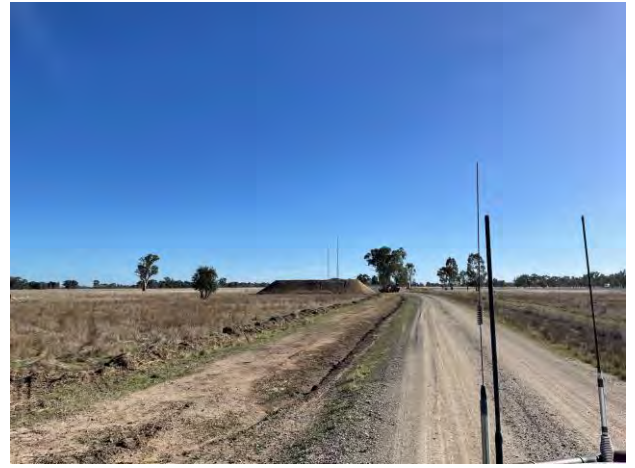
**Photograph 2 - Internal gravel access looped track within the site.**

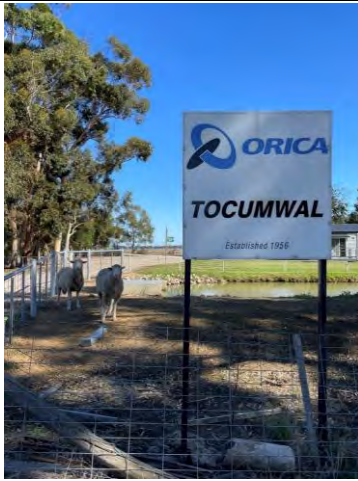
**Photograph 3 - Portions of the site are used for grazing.**

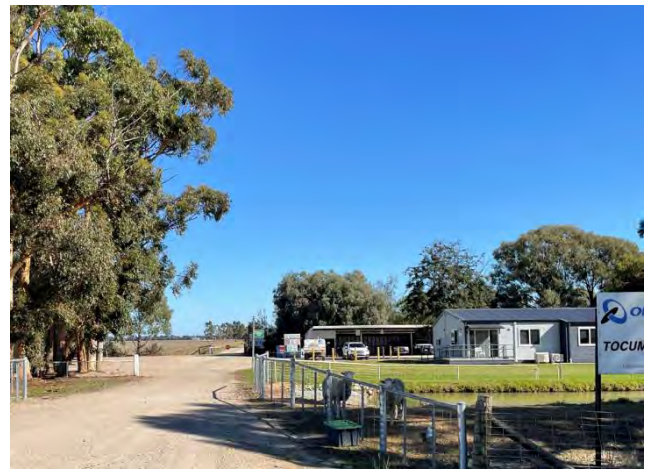
**Photograph 4 - Site office and other amenities (constructed in 2020).**

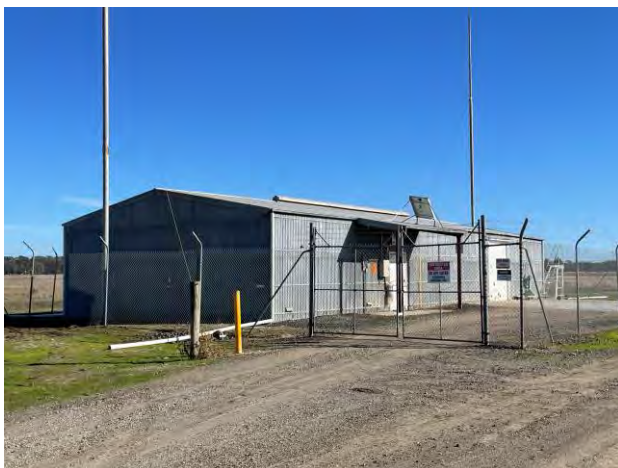
**Photograph 5 - Existing magazines surrounded by security fencing.**

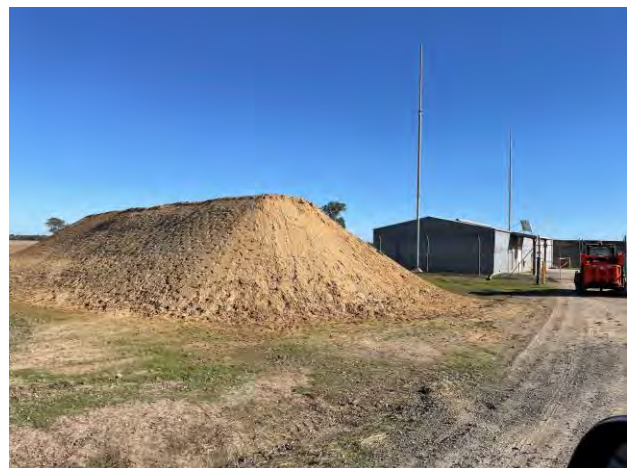
| Source | Rationale/detail | Potential contaminants | Potential for contamination within the project area |
|---|---|---|---|
| Potential contamination associated with materials sourced from the former sand mine | Use of materials from the former sand mine in the earthen blast mounds | Asbestos, heavy metals, TRH, BTEX, PAHs, OCPs, OPPs, PCBs | Low<br>No visible contamination was noted in the earthen blast mounds located in the project area. |

**Photograph 6 - Earthen blast mounds located in the vicinity of Magazine 6.**

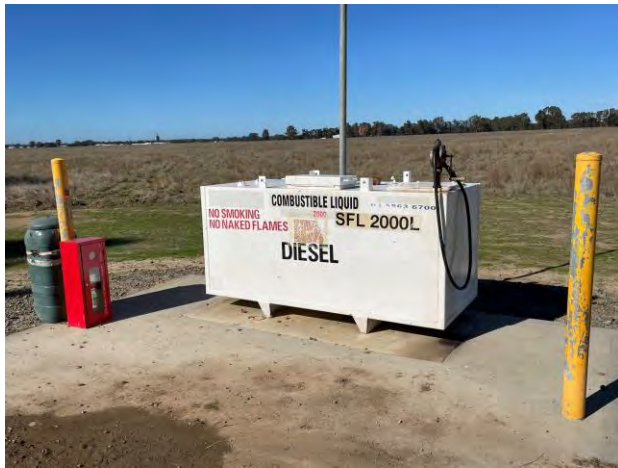
**Photograph 7 - Onsite self-bunded 2000 L diesel above ground storage tank (AST).**

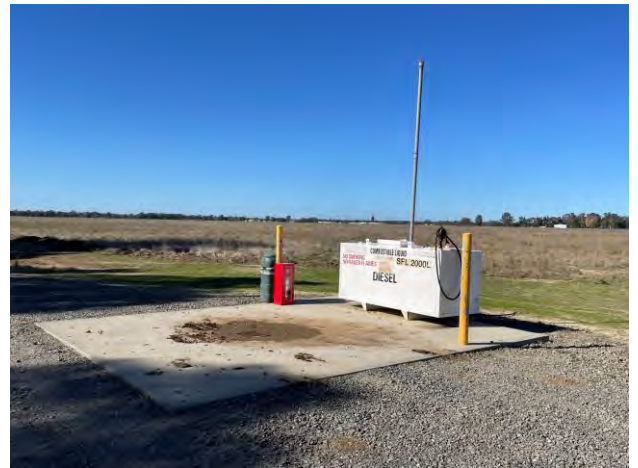
| Source | Rationale/detail | Potential contaminants | Potential for contamination within the project area |
|---|---|---|---|
| Storage, spillage or leakage of fuels / oils | Use of diesel AST and vehicles onsite | TRH, BTEXN, PAHs, heavy metals | Moderate<br>Some staining on the concrete pad was observed during the inspection in the vicinity of the diesel AST.<br><br>In addition, historical records noted a spill in the diesel area in 2010, which indicates that such incident could potentially occur onsite. It is noted that the contaminated soil was reported to had been removed and disposed offsite. |

**Photograph 8 - Onsite diesel AST with some staining on the concrete pad.**

- The soil in the vicinity of the diesel AST be further assessed if it is to be disturbed.
- The CEMP for the project includes an 'unexpected finds protocol', to manage any potential impacts associated with the disturbance of potentially contaminated soils (if encountered) during works of the project. The CEMP is to include actions to cease work on discovery, test suspected contaminated material, and safely store, treat, and dispose of the material as relevant.

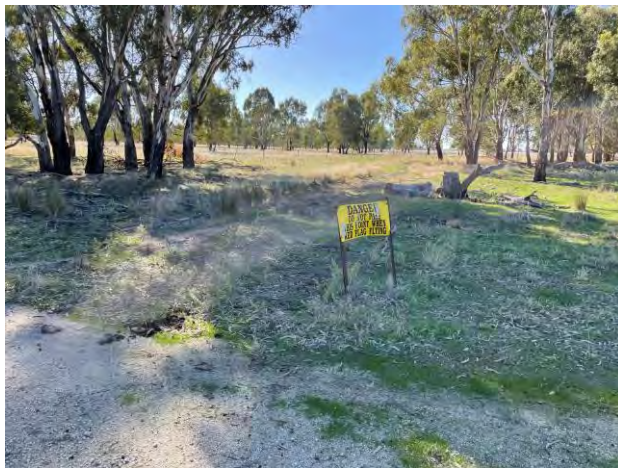
| Source | Rationale/detail | Potential contaminants | Potential for contamination within the project area |
|---|---|---|---|
| Historical incineration of detonators | Contamination in soil associated with the incineration of explosives | Explosives, heavy metals, ammonia, nitrate | Low<br>The burn areas are not located within the project area with the closest Magazine located 400 m south. Access to the burn areas (containment cell area) is restricted with fencing. |

**Photograph 9 - Location of containment cell with buried wastes which was also used as a burning ground.**

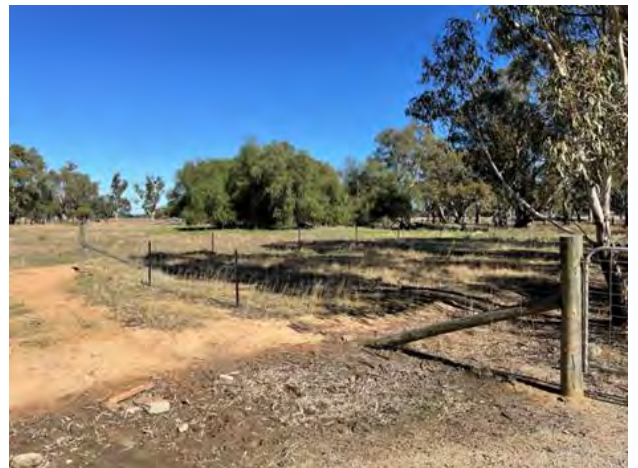
JBS&G, 2016 reported that the containment cell was clay lined and a 0.5 m layer of 'clean soil' was placed on top of the material once the cell was filled. Ten tonnes of lime was added to the soil that was placed in the cell to aid in the degradation of contaminants associated with the detonators such as lead azide and pentaerythritol tetranitrate (PETN). It was also reported that the area around the containment cell was historically used as a burning ground to dispose of explosives from a former offsite manufacturing facility. The location of the containment cell was fenced and vegetated with trees and grasses.

**Photograph 10 – The fenced containment cell, vegetated with trees and grasses.**

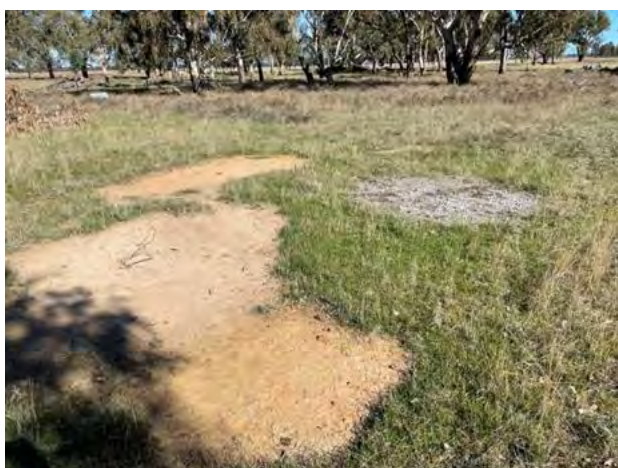
**Photograph 11 - Bare patches of land within the containment cell location.**

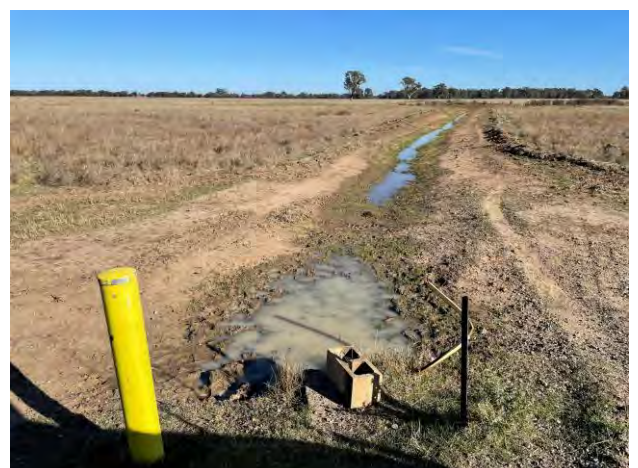
| Item | Site conditions |
|---|---|
| Ground surface and site drainage | <p>The site is generally flat and unsealed with drainage from east to the west across the site. Localised water logging in one of the site drainage lines was observed (Photograph 12). Surface water flows on the site are controlled by small changes in relief and the irrigation channel (Lalaly Drainage Channel) that traverses the southern portion of the site. The irrigation channel is connected to the nearby farm dams and directs small surface flows to these dams.</p> |

**Photograph 12 - Localised surface water ponding was noted in some areas.**

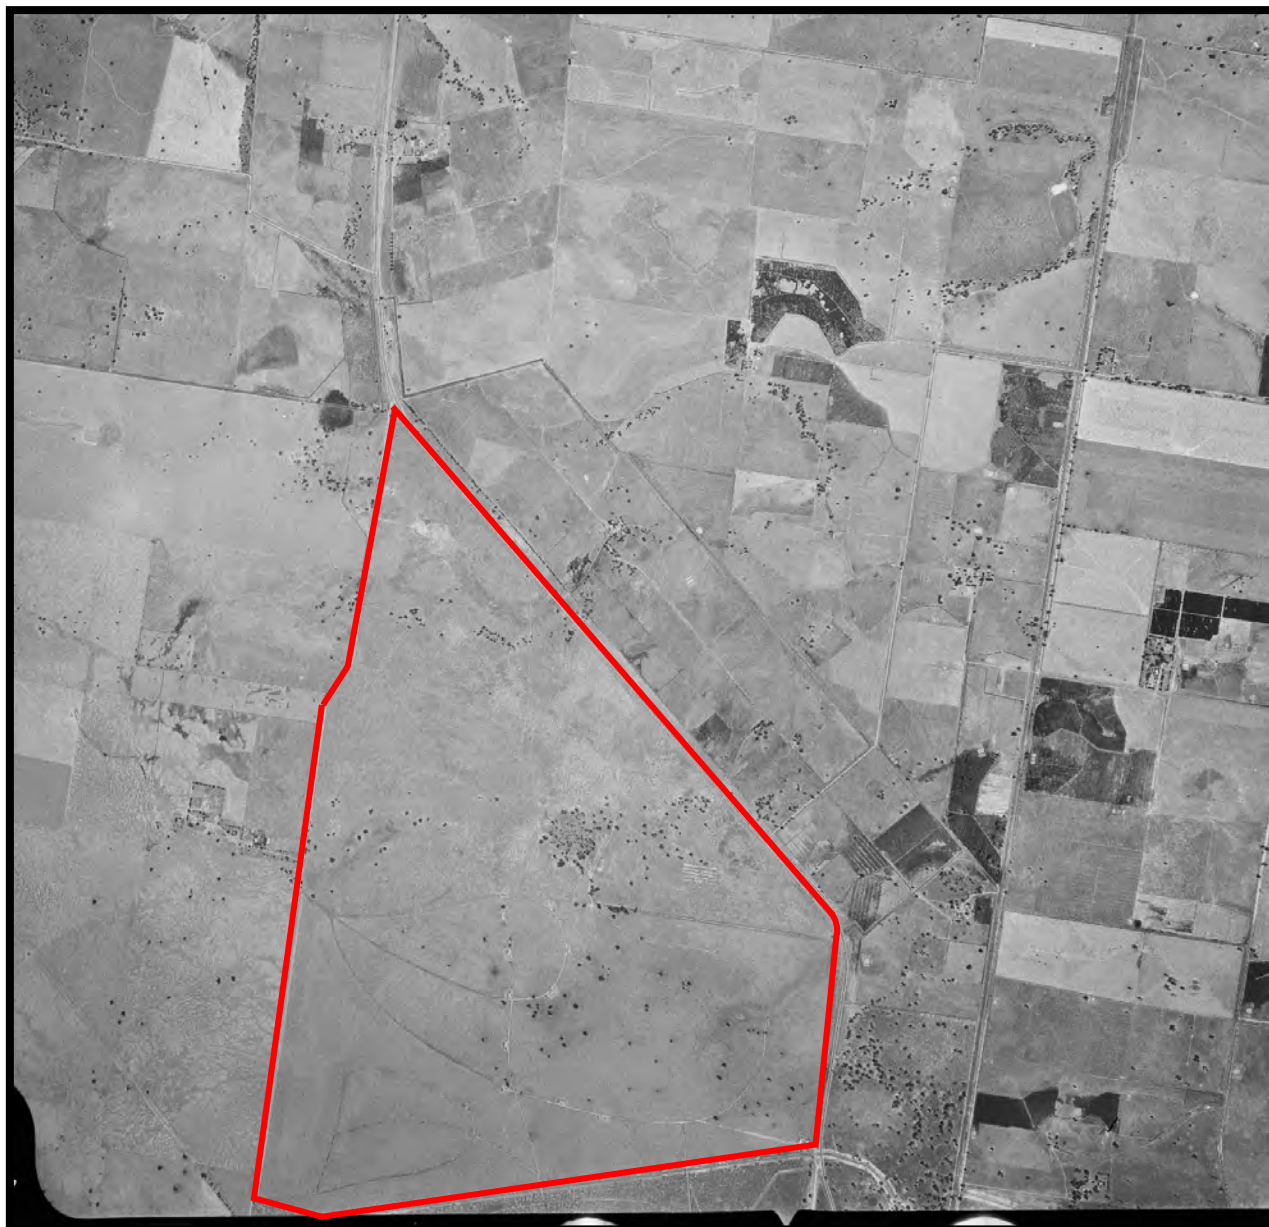
1967 - Source: NSW Historical Imagery

| Photograph | Site observations |
|---|---|
| 1967<br>Black and white | <p>The site office and Magazines 1 to 10 are already visible. Two of the three main farm dams which includes Dam 1 (east of Magazine 10) and Dam 2 (between Magazines 5 and 6) are also observed. Two other smaller farm dams which include Dam 4 (north of Magazine 8) and Dam 5 (in the western portion of the site) are also visible. A cleared area of land is evident in the northeast portion of the site which corresponds to the location of the former sand mine.</p> <p>Internal access tracks connecting the magazines are evident including an access track located at the southwest portion of the site. A structure similar to the existing magazines is located southwest of Magazine 3 and may be one of former brick magazines. Scattered vegetation within the site can be observed.</p> <p>The Newell Highway is located directly east of the site and Tocumwal No. 6 Canal Drain is located on the southeast boundary. Chinaman's Lane is located adjacent to the west and Lalaly Channel located adjacent to the site to the south. The rural/residential properties to the west and north east of the site are also visible.</p> |

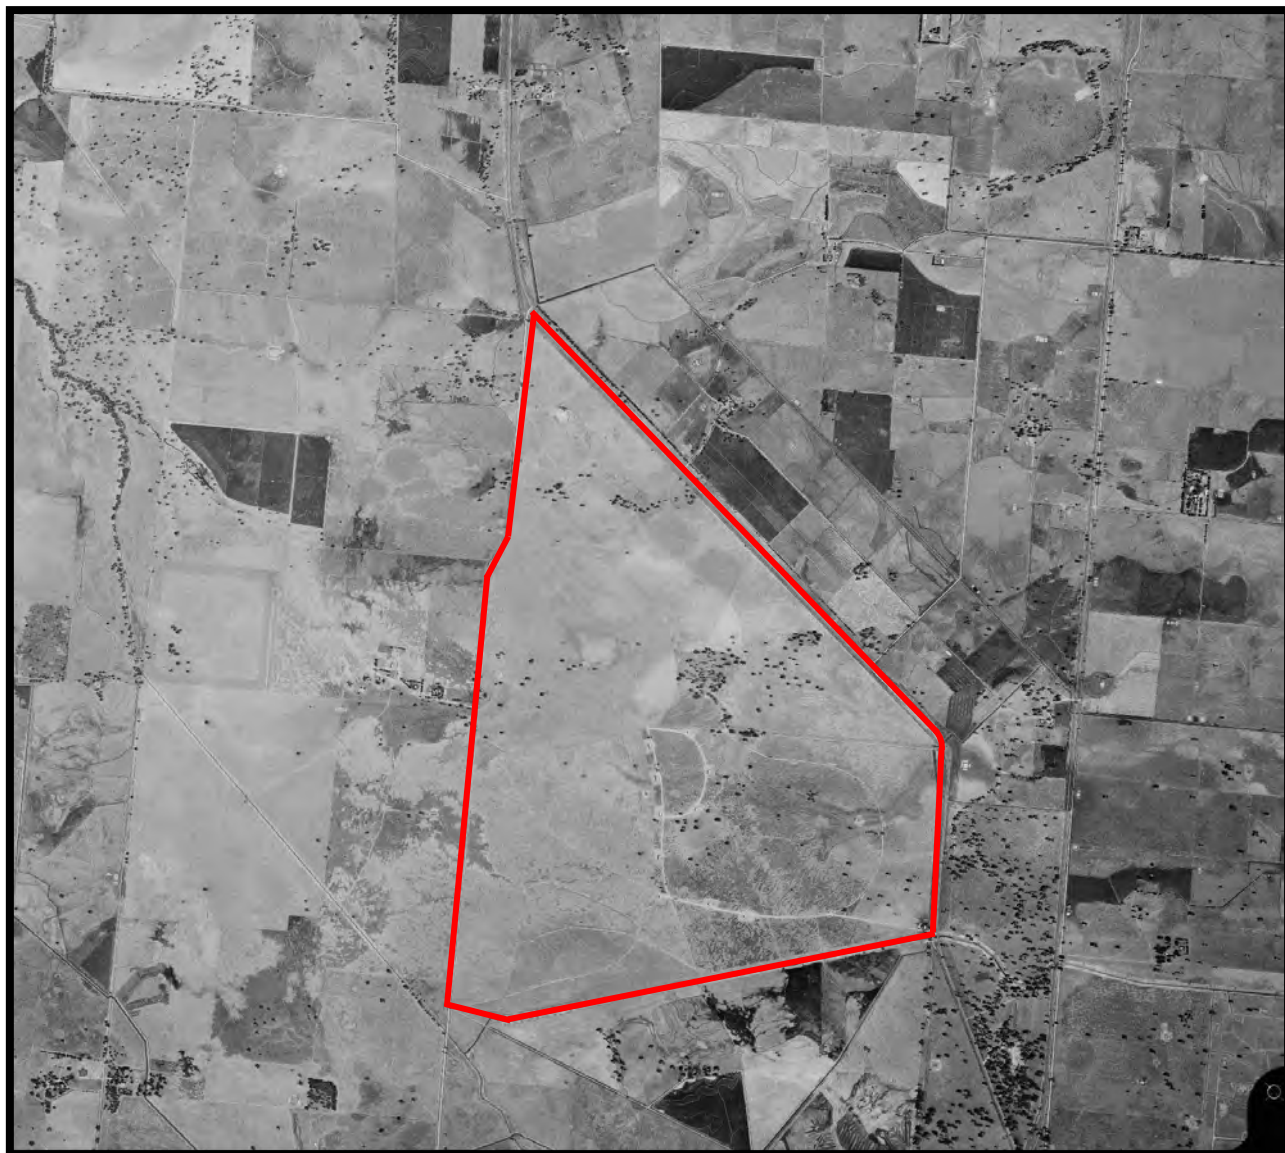
1975 - Source: NSW Historical Imagery

| Photograph | Site observations |
|---|---|
| 1975<br>Black and white | <p>There are no significant changes in the existing infrastructure with the site and its surroundings from the previous aerial photograph with the exception of the demolition/removal of the structure which appeared to be similar to the existing magazines that was located southwest of Magazine 3.</p> <p>Some rectangular patches of ground are observed across the access track in the southern portion of the site which may be the locations of the previous brick magazines that were present onsite prior to the construction of the now existing Magazines 1 to 10. The rural residential property to the south of the site is also visible.</p> |

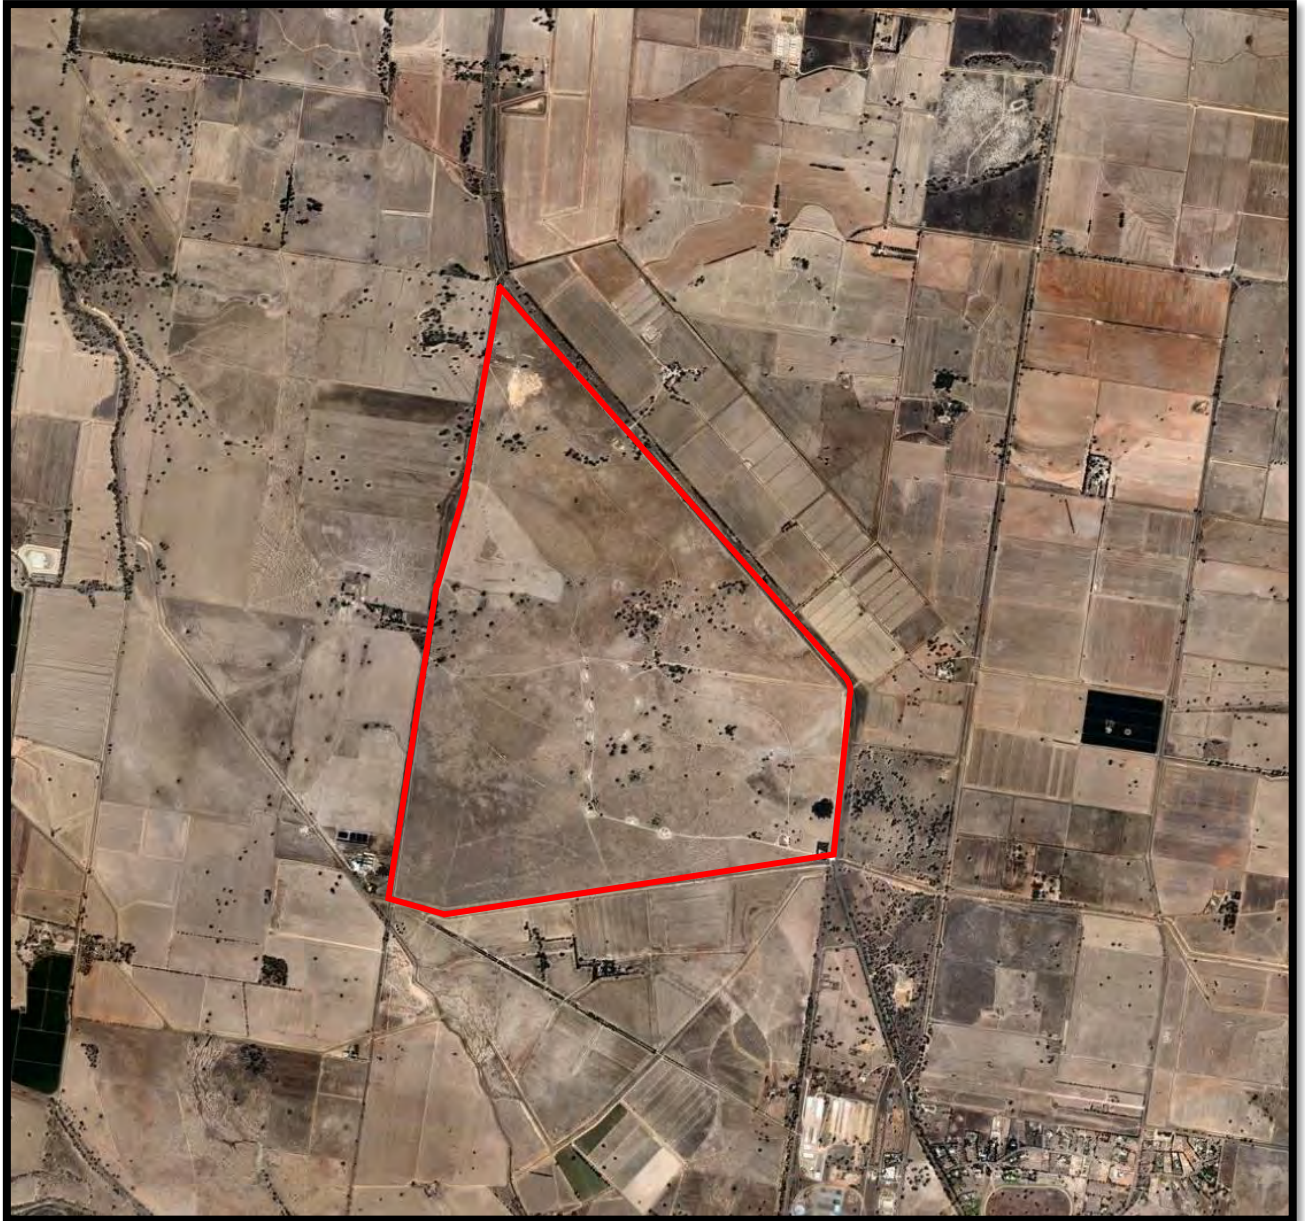
2010 - Source: Nearmaps

| Photograph | Site observations |
|---|---|
| 2010<br>Colour | <p>The site access tracks appear more visible in this photograph. Rectangular patches of ground are also evident across the access roads. These patches were noted in the 1975 aerial.</p> <p>The fenced area of the containment cell located north of Magazine 8 is now visible which correlates with the date of construction (2001-2008). The diesel AST located east of Magazine 3 is apparent.</p> |
