# Geotechnical Investigation Hunter Indoor Sports Centre State Significant Development (SSD-65595459)

2 Monash Road and 24 Wallarah Road, New Lambton, NSW  
24002155.001A

2 May 2024

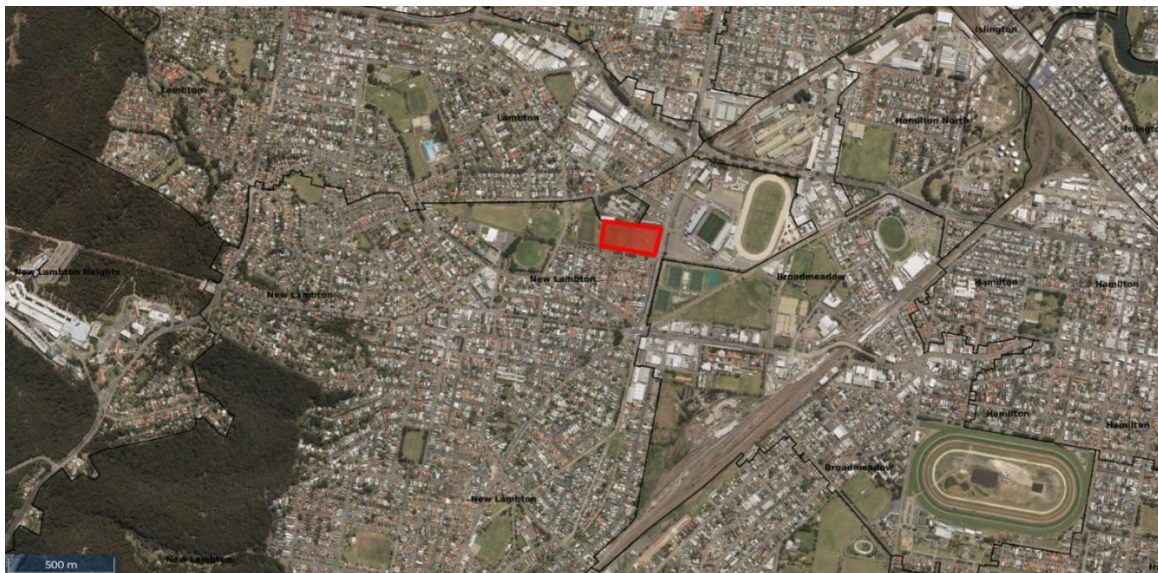
**Figure 1-1: Site Location**

The Site is bounded by Lambton High School and residential units to the north, Turton Road to the east, a shared cycleway, Lambton Ker-rai Creek and Monash Road to the south (in consecutive order), and Arthur Edden Oval to the west. The Site is outlined in a regional context in **Figure 1-1**.

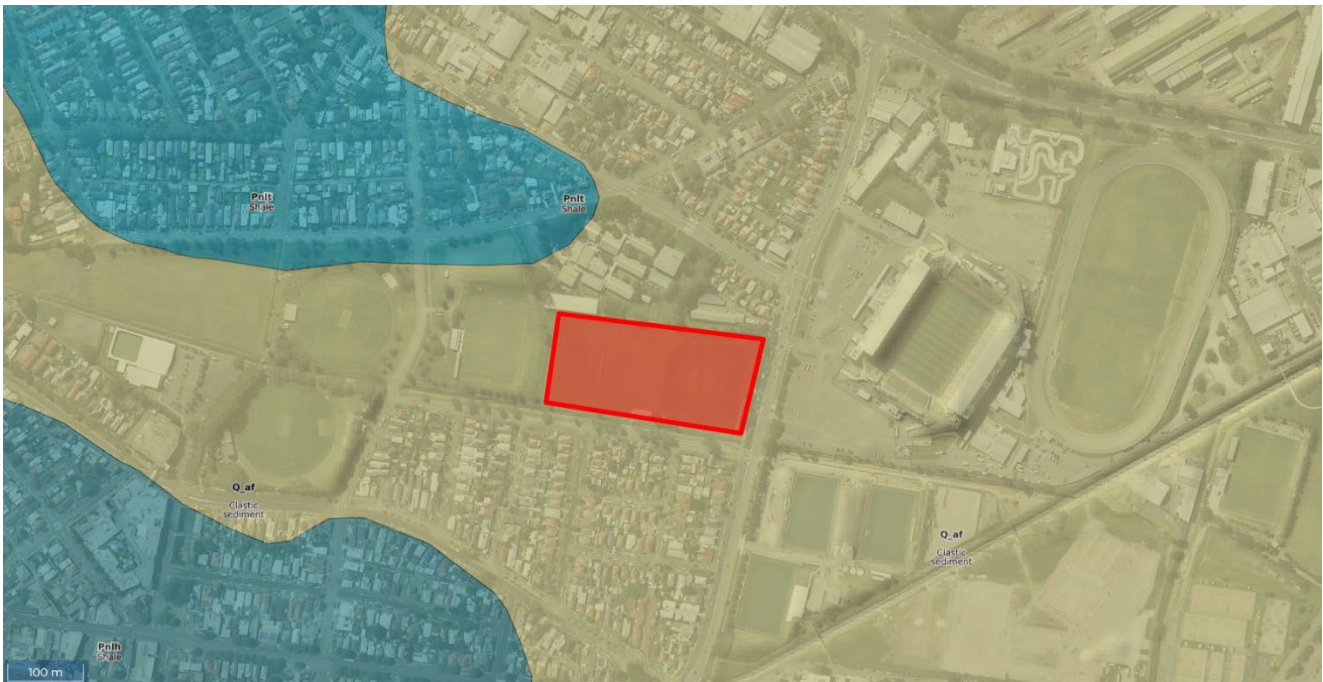
**Figure 1-2: Surface Geology**

Based on the geological map published by NSW Resources Regulator ([www.minview.geoscience.nsw.gov.au](http://www.minview.geoscience.nsw.gov.au)), the site is indicated to be underlain by Quaternary-aged, alluvial floodplain deposits of silt, very fine- to medium-grained lithic- to quartz-rich sand, and clay, shown as “Q\_af” in **Figure 1-2** below.

The observed ground conditions during the geotechnical investigation undertaken by Kleinfelder found conditions consistent with weathered units of the regional geology of the area.

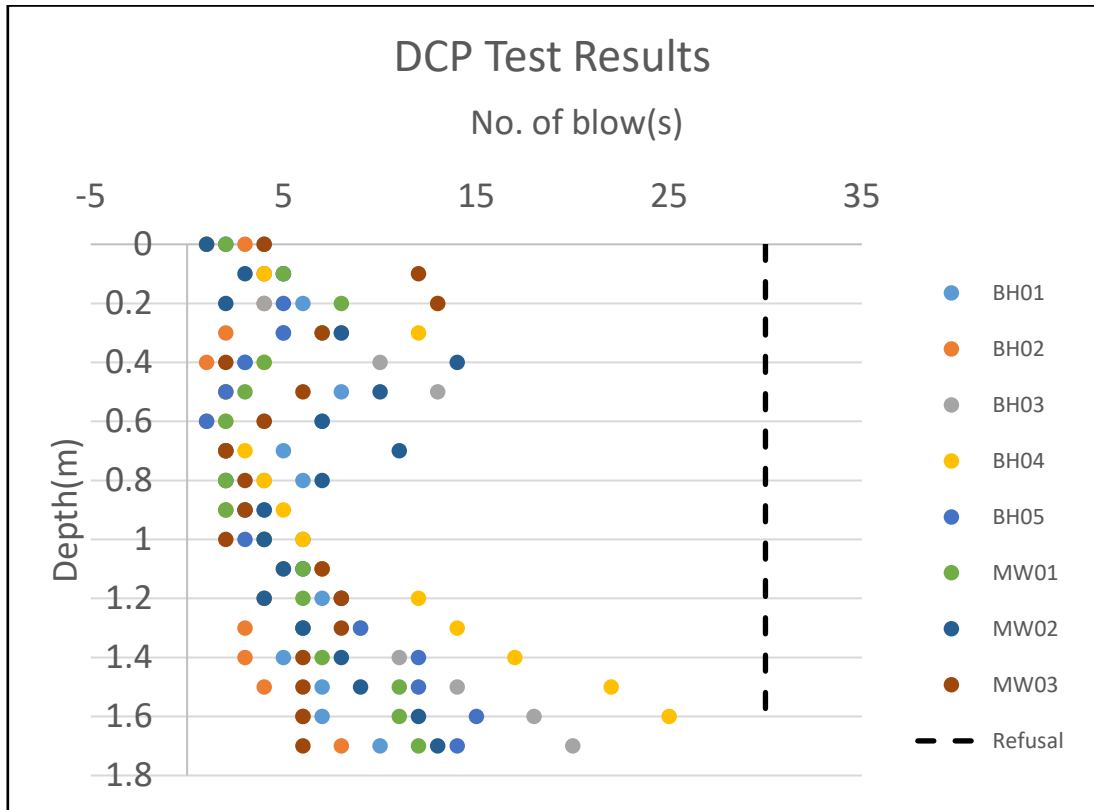
Figure 2-1: DCP Results

In-situ strength tests included DCP tests and SPTs. Eight DCP tests were performed by hand to a maximum depth of 1.8m bgl or refusal, exactly at corresponding borehole locations. The DCP/borehole locations are shown in **Appendix A** and DCP results are presented in **Appendix D**. A summary of the DCP and SPT field test results are presented below in **Figure 2-1** and **Figure 2-2**.

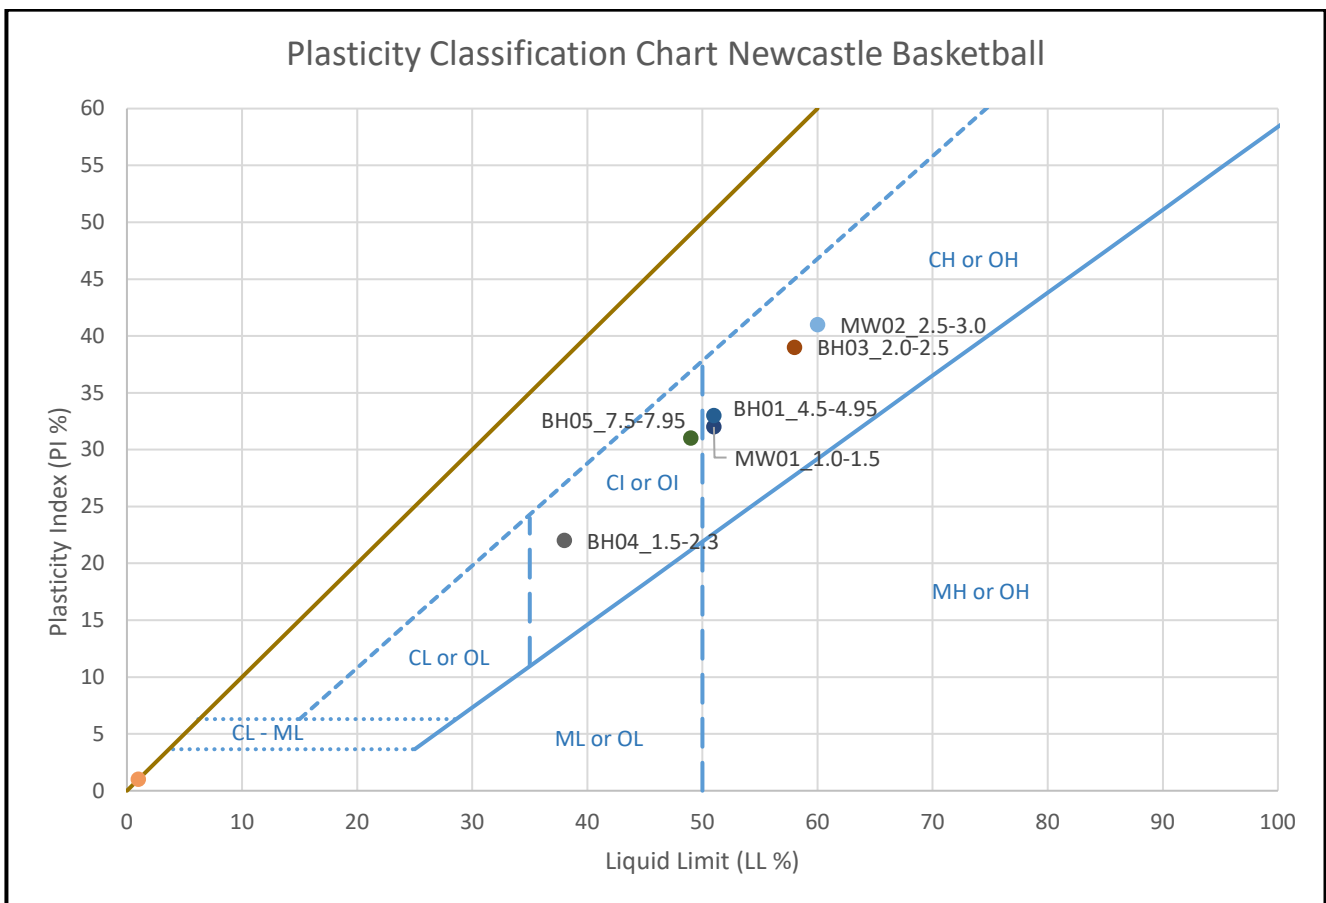
Figure 3-1: Casagrande Chart Showing Atterberg Results

Figure 3-1 below shows the results of the seven Atterberg limits tests plotted on the Casagrande chart, showing that all results were medium- or high- plasticity clays with the exception of MW03\_6.5-7.5, which was found to be non-plastic.

Where C=Clay, M=Silt, O=Organic, H=High, I=Medium, L=Low

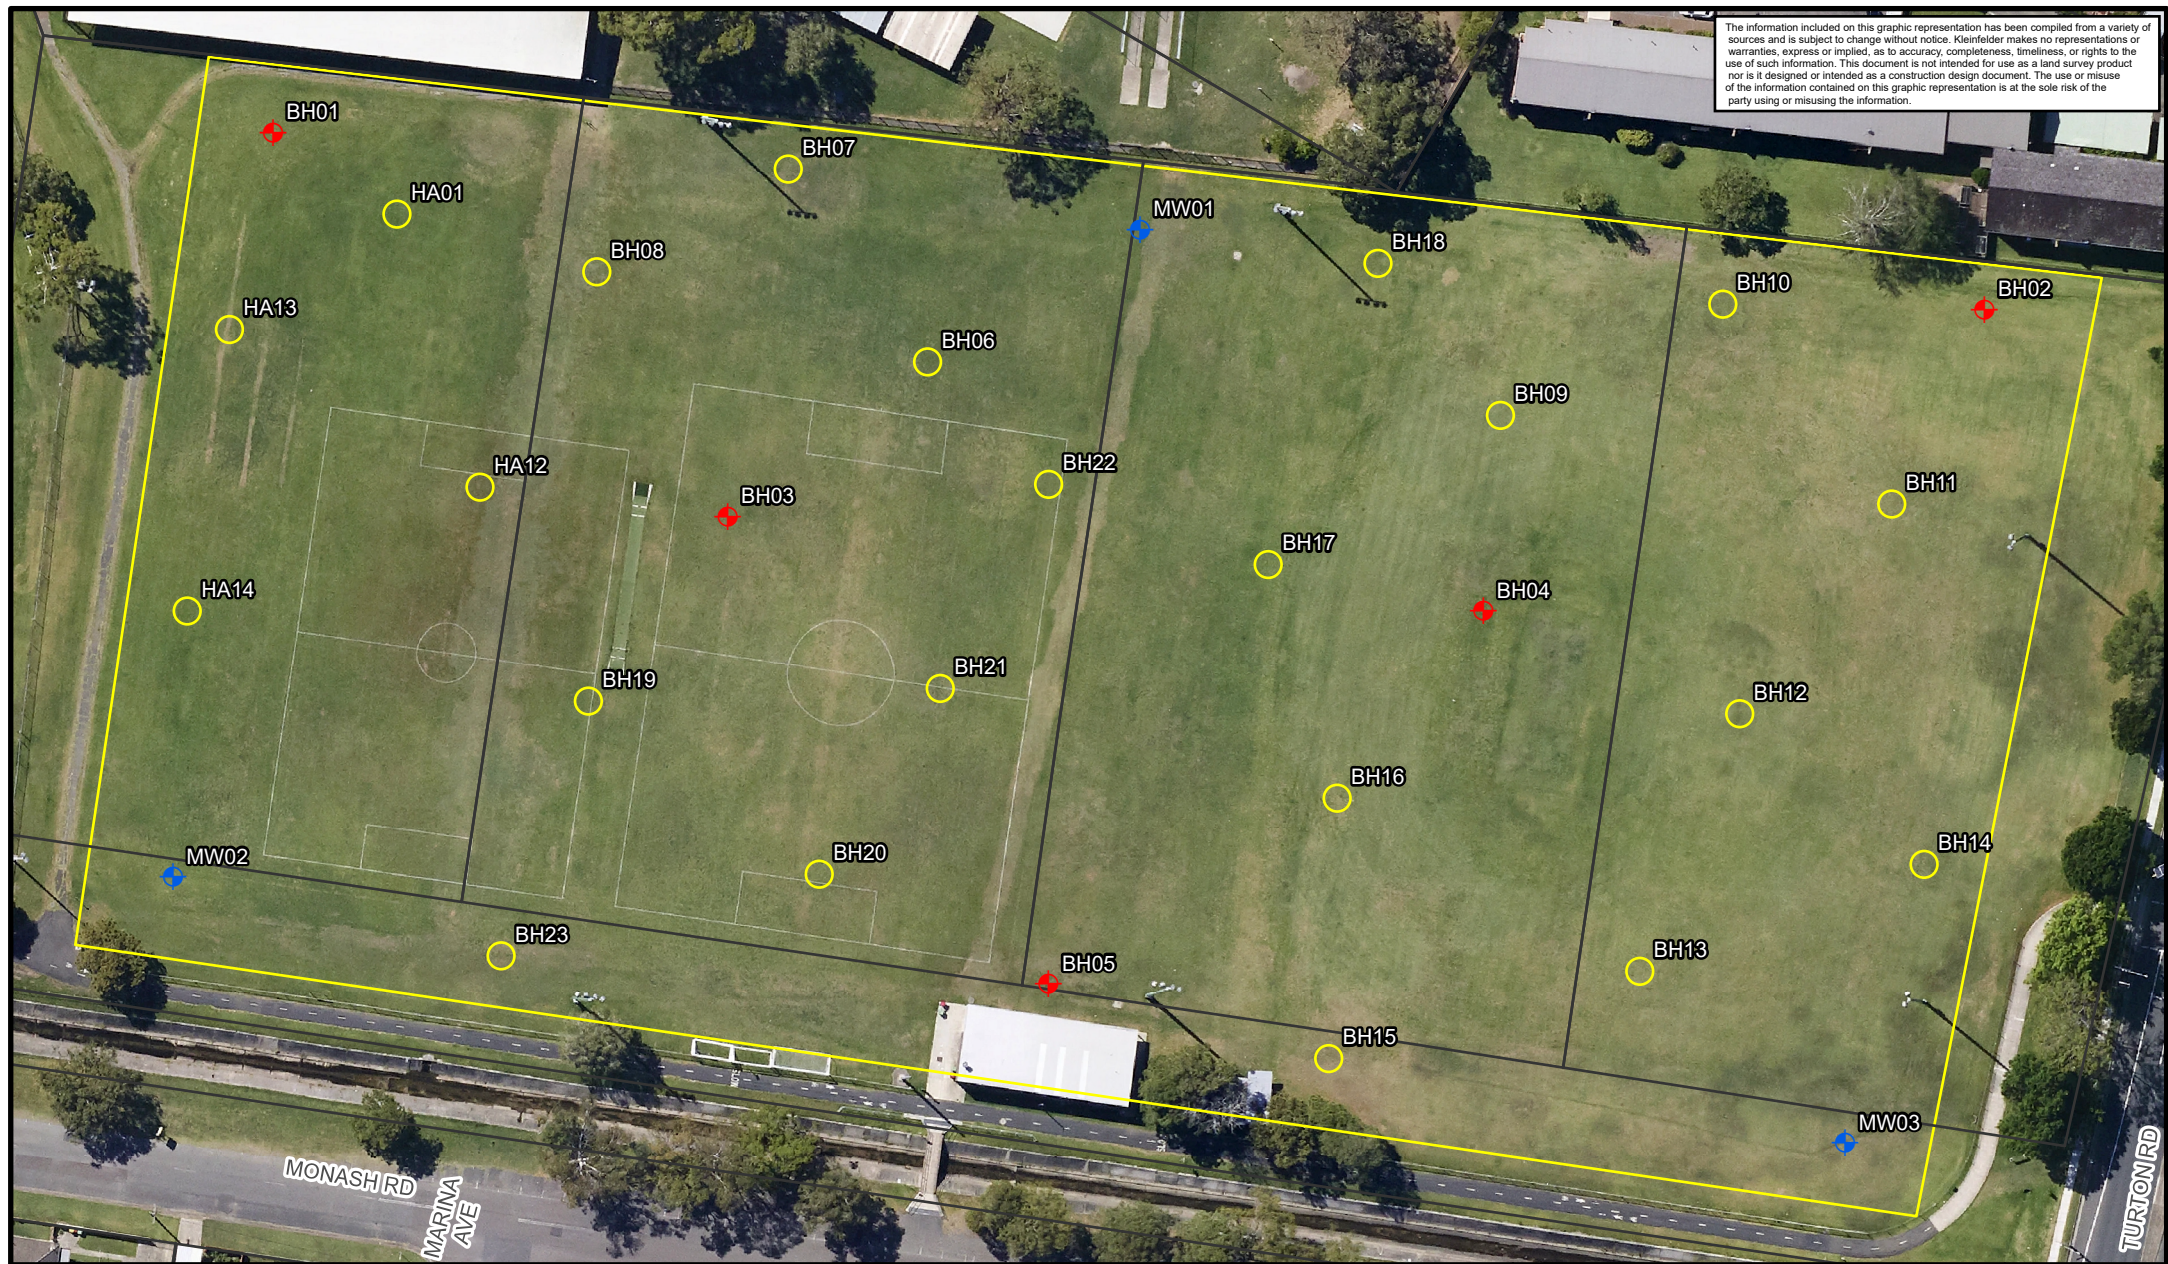
- Legend**
- Subject Area
  - ◆ Borehole
  - Hand Auger
  - ◆ Monitoring Well

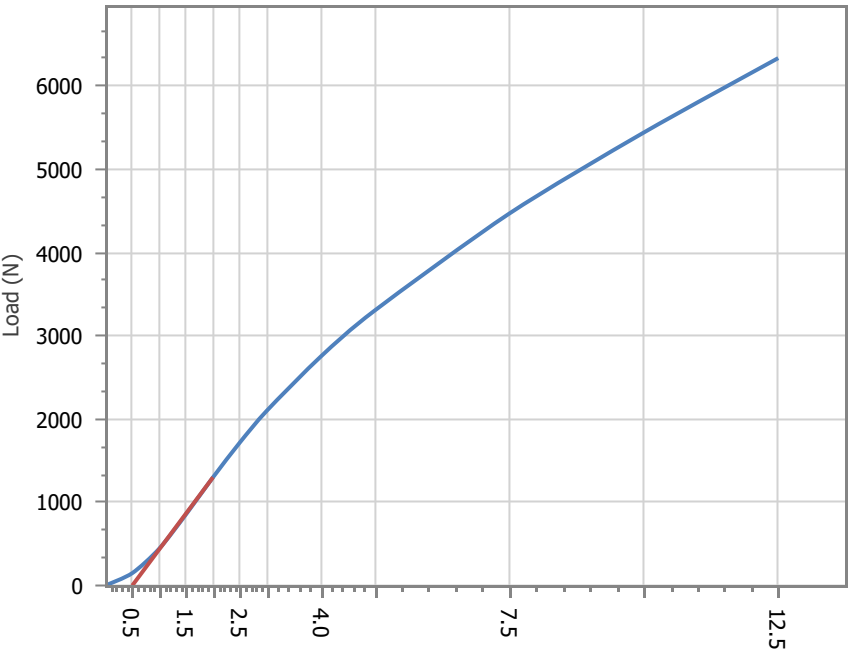
Maximum Dry Density (t/m <sup>3</sup> ):	1.82	Optimum Moisture Content (%):	12.0	Field Moisture Content (%):	8.9	Sample Percent Oversize (%):	15.0	Oversize Included / Excluded	Excluded	Target Density Ratio (%):	100	Target Moisture Ratio (%):	100	Placement Dry Density (t/m <sup>3</sup> ):	1.82	Placement Dry Density Ratio (%):	100.0	Placement Moisture Content (%):	12.1	Placement Moisture Ratio (%):	101.5	Test Condition / Soaking Period:	Soaked / 4 Days	CBR Surcharge (kg)	4.5	Dry Density After Soak (t/m <sup>3</sup> ):	1.81	Total Curing Time (hrs)	90	Liquid Limit Method	Estimation	Moisture (top 30mm) After Soak (%)	12.9	Moisture (remainder) After Soak (%)	12.0	CBR Swell (%):	0.5	Minimum CBR Specification (%):	-	<b>CBR Value @ 5.0mm (%):</b>	<b>18</b>	<div style="text-align: center;"> <h3>CBR PENETRATION PLOT</h3>

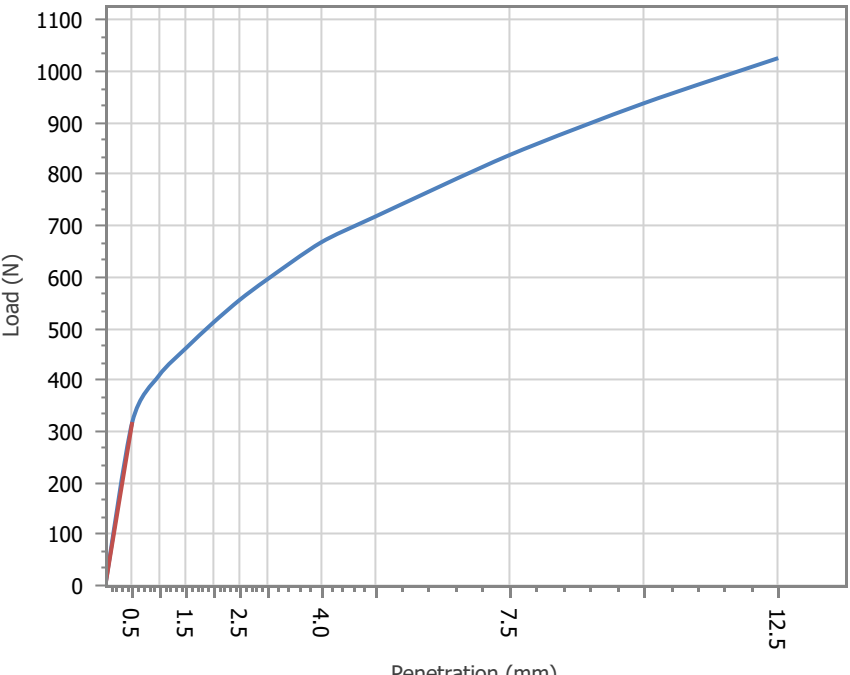
<table style="width: 100%; border-collapse: collapse;"> <tr><td>Maximum Dry Density (t/m<sup>3</sup>):</td><td style="text-align: right;">1.48</td></tr> <tr><td>Optimum Moisture Content (%):</td><td style="text-align: right;">26.5</td></tr> <tr><td>Field Moisture Content (%):</td><td style="text-align: right;">24.2</td></tr> <tr><td>Sample Percent Oversize (%):</td><td style="text-align: right;">0.0</td></tr> <tr><td>Oversize Included / Excluded</td><td style="text-align: right;">Excluded</td></tr> <tr><td>Target Density Ratio (%):</td><td style="text-align: right;">100</td></tr> <tr><td>Target Moisture Ratio (%):</td><td style="text-align: right;">100</td></tr> <tr><td>Placement Dry Density (t/m<sup>3</sup>):</td><td style="text-align: right;">1.48</td></tr> <tr><td>Placement Dry Density Ratio (%):</td><td style="text-align: right;">99.5</td></tr> <tr><td>Placement Moisture Content (%):</td><td style="text-align: right;">27.0</td></tr> <tr><td>Placement Moisture Ratio (%):</td><td style="text-align: right;">101.5</td></tr> <tr><td>Test Condition / Soaking Period:</td><td style="text-align: right;">Soaked / 4 Days</td></tr> <tr><td>CBR Surcharge (kg)</td><td style="text-align: right;">4.5</td></tr> <tr><td>Dry Density After Soak (t/m<sup>3</sup>):</td><td style="text-align: right;">1.45</td></tr> <tr><td>Total Curing Time (hrs)</td><td style="text-align: right;">91</td></tr> <tr><td>Liquid Limit Method</td><td style="text-align: right;">Estimation</td></tr> <tr><td>Moisture (top 30mm) After Soak (%)</td><td style="text-align: right;">27.5</td></tr> <tr><td>Moisture (remainder) After Soak (%)</td><td style="text-align: right;">26.6</td></tr> <tr><td>CBR Swell (%):</td><td style="text-align: right;">2.0</td></tr> <tr><td>Minimum CBR Specification (%):</td><td style="text-align: right;">-</td></tr> <tr><td><b>CBR Value @ 2.5mm (%):</b></td><td style="text-align: right;"><b>4.0</b></td></tr> </table>	Maximum Dry Density (t/m <sup>3</sup> ):	1.48	Optimum Moisture Content (%):	26.5	Field Moisture Content (%):	24.2	Sample Percent Oversize (%):	0.0	Oversize Included / Excluded	Excluded	Target Density Ratio (%):	100	Target Moisture Ratio (%):	100	Placement Dry Density (t/m <sup>3</sup> ):	1.48	Placement Dry Density Ratio (%):	99.5	Placement Moisture Content (%):	27.0	Placement Moisture Ratio (%):	101.5	Test Condition / Soaking Period:	Soaked / 4 Days	CBR Surcharge (kg)	4.5	Dry Density After Soak (t/m <sup>3</sup> ):	1.45	Total Curing Time (hrs)	91	Liquid Limit Method	Estimation	Moisture (top 30mm) After Soak (%)	27.5	Moisture (remainder) After Soak (%)	26.6	CBR Swell (%):	2.0	Minimum CBR Specification (%):	-	<b>CBR Value @ 2.5mm (%):</b>	<b>4.0</b>	<div style="text-align: center;"> <b>CBR PENETRATION PLOT</b> </div>

<table style="width: 100%; border-collapse: collapse; margin-top: 10px;"> <caption>Approximate Data Points from CBR Penetration Plot</caption> <thead> <tr> <th>Penetration (mm)</th> <th>Load (N)</th> </tr> </thead> <tbody> <tr><td>0.5</td><td>0</td></tr> <tr><td>1.5</td><td>400</td></tr> <tr><td>2.5</td><td>550</td></tr> <tr><td>4.0</td><td>680</td></tr> <tr><td>7.5</td><td>850</td></tr> <tr><td>12.5</td><td>1050</td></tr> </tbody> </table>	Penetration (mm)	Load (N)	0.5	0	1.5	400	2.5	550	4.0	680	7.5	850	12.5	1050

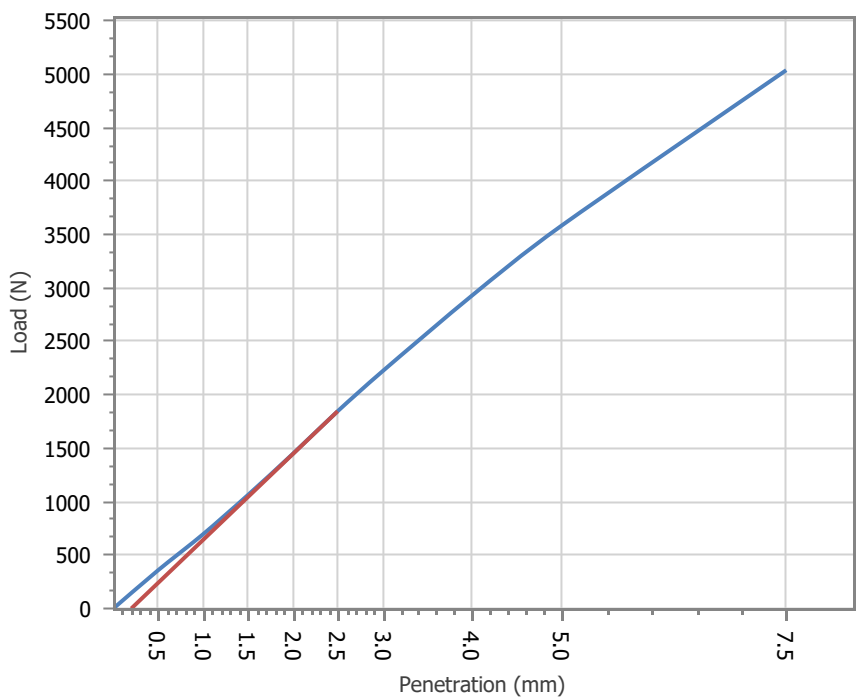
Maximum Dry Density (t/m <sup>3</sup> ):	1.94	Optimum Moisture Content (%):	12.0	Field Moisture Content (%):	9.8	Sample Percent Oversize (%):	5.0	Oversize Included / Excluded	Excluded	Target Density Ratio (%):	100	Target Moisture Ratio (%):	100	Placement Dry Density (t/m <sup>3</sup> ):	1.94	Placement Dry Density Ratio (%):	100.0	Placement Moisture Content (%):	11.8	Placement Moisture Ratio (%):	99.0	Test Condition / Soaking Period:	Soaked / 4 Days	CBR Surcharge (kg)	4.5	Dry Density After Soak (t/m <sup>3</sup> ):	1.93	Total Curing Time (hrs)	89	Liquid Limit Method	Estimation	Moisture (top 30mm) After Soak (%)	12.5	Moisture (remainder) After Soak (%)	11.9	CBR Swell (%):	0.5	Minimum CBR Specification (%):	-	<b>CBR Value @ 5.0mm (%):</b>	<b>19</b>	<div style="text-align: center;"> <b>CBR PENETRATION PLOT</b> </div>

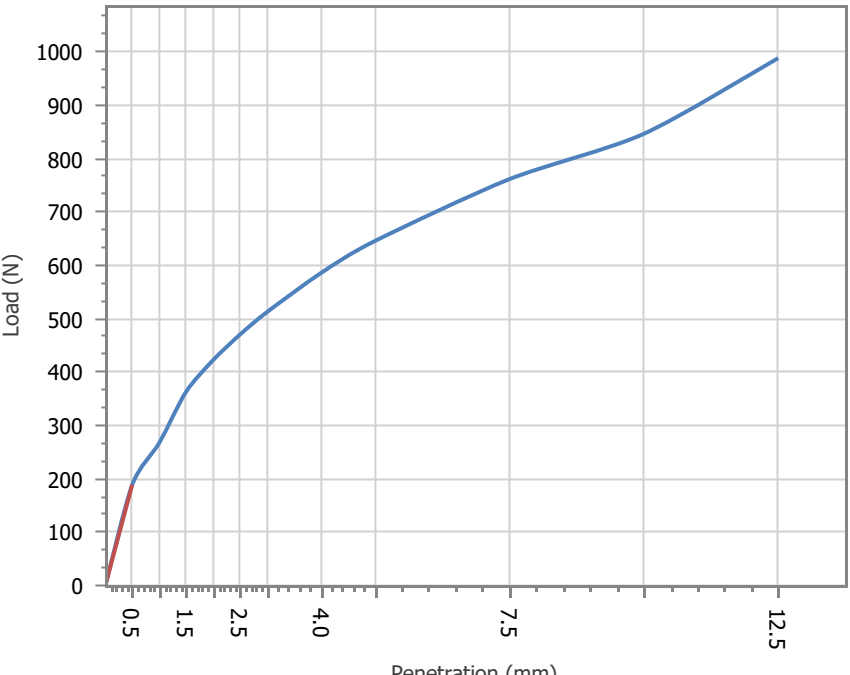
<table style="width: 100%; border-collapse: collapse;"> <tr><td>Maximum Dry Density (t/m<sup>3</sup>):</td><td style="text-align: right;">1.50</td></tr> <tr><td>Optimum Moisture Content (%):</td><td style="text-align: right;">25.5</td></tr> <tr><td>Field Moisture Content (%):</td><td style="text-align: right;">27.6</td></tr> <tr><td>Sample Percent Oversize (%):</td><td style="text-align: right;">0.0</td></tr> <tr><td>Oversize Included / Excluded</td><td style="text-align: right;">Excluded</td></tr> <tr><td>Target Density Ratio (%):</td><td style="text-align: right;">100</td></tr> <tr><td>Target Moisture Ratio (%):</td><td style="text-align: right;">100</td></tr> <tr><td>Placement Dry Density (t/m<sup>3</sup>):</td><td style="text-align: right;">1.49</td></tr> <tr><td>Placement Dry Density Ratio (%):</td><td style="text-align: right;">99.5</td></tr> <tr><td>Placement Moisture Content (%):</td><td style="text-align: right;">25.8</td></tr> <tr><td>Placement Moisture Ratio (%):</td><td style="text-align: right;">102.0</td></tr> <tr><td>Test Condition / Soaking Period:</td><td style="text-align: right;">Soaked / 4 Days</td></tr> <tr><td>CBR Surcharge (kg)</td><td style="text-align: right;">4.5</td></tr> <tr><td>Dry Density After Soak (t/m<sup>3</sup>):</td><td style="text-align: right;">1.46</td></tr> <tr><td>Total Curing Time (hrs)</td><td style="text-align: right;">96</td></tr> <tr><td>Liquid Limit Method</td><td style="text-align: right;">Estimation</td></tr> <tr><td>Moisture (top 30mm) After Soak (%)</td><td style="text-align: right;">26.2</td></tr> <tr><td>Moisture (remainder) After Soak (%)</td><td style="text-align: right;">25.6</td></tr> <tr><td>CBR Swell (%):</td><td style="text-align: right;">2.5</td></tr> <tr><td>Minimum CBR Specification (%):</td><td style="text-align: right;">-</td></tr> <tr><td><b>CBR Value @ 2.5mm (%):</b></td><td style="text-align: right;"><b>3.5</b></td></tr> </table>	Maximum Dry Density (t/m <sup>3</sup> ):	1.50	Optimum Moisture Content (%):	25.5	Field Moisture Content (%):	27.6	Sample Percent Oversize (%):	0.0	Oversize Included / Excluded	Excluded	Target Density Ratio (%):	100	Target Moisture Ratio (%):	100	Placement Dry Density (t/m <sup>3</sup> ):	1.49	Placement Dry Density Ratio (%):	99.5	Placement Moisture Content (%):	25.8	Placement Moisture Ratio (%):	102.0	Test Condition / Soaking Period:	Soaked / 4 Days	CBR Surcharge (kg)	4.5	Dry Density After Soak (t/m <sup>3</sup> ):	1.46	Total Curing Time (hrs)	96	Liquid Limit Method	Estimation	Moisture (top 30mm) After Soak (%)	26.2	Moisture (remainder) After Soak (%)	25.6	CBR Swell (%):	2.5	Minimum CBR Specification (%):	-	<b>CBR Value @ 2.5mm (%):</b>	<b>3.5</b>	<h3>CBR PENETRATION PLOT</h3>

<table border="1" style="width: 100%; border-collapse: collapse; margin-top: 10px;"> <caption>Approximate Data Points from CBR Penetration Plot</caption> <thead> <tr> <th>Penetration (mm)</th> <th>Load (N)</th> </tr> </thead> <tbody> <tr><td>0.5</td><td>200</td></tr> <tr><td>1.5</td><td>350</td></tr> <tr><td>2.5</td><td>450</td></tr> <tr><td>4.0</td><td>580</td></tr> <tr><td>7.5</td><td>750</td></tr> <tr><td>12.5</td><td>1000</td></tr> </tbody> </table>	Penetration (mm)	Load (N)	0.5	200	1.5	350	2.5	450	4.0	580	7.5	750	12.5	1000

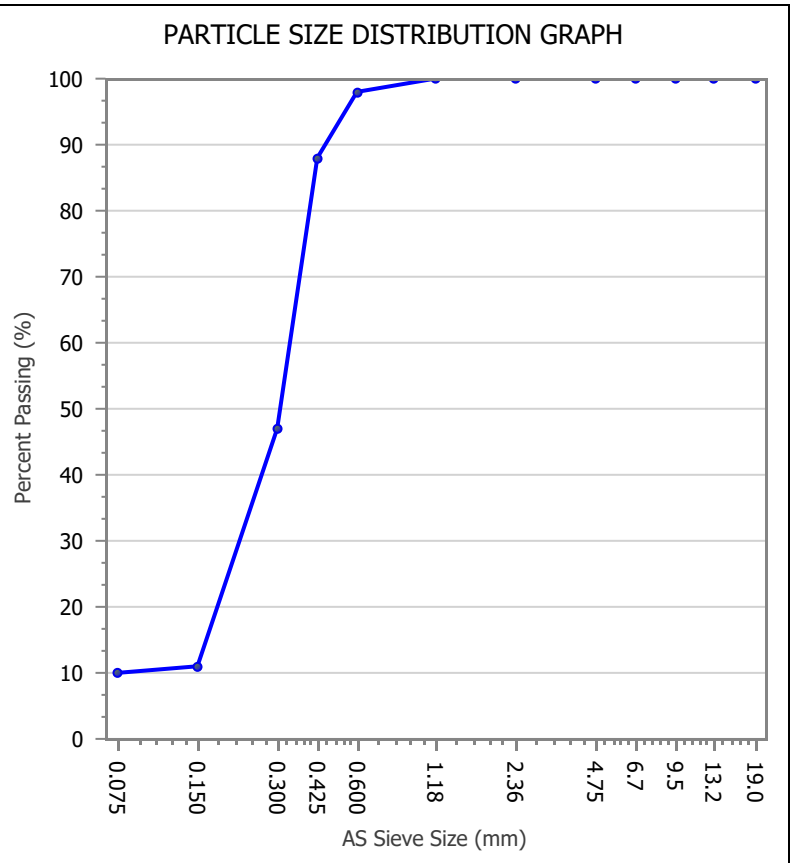
AS Sieve (mm)	Specification Minimum (%)	Percent Passing (%)	Specification Maximum (%)
19.0		100	
13.2		100	
9.5		100	
6.7		100	
4.75		100	
2.36		100	
1.18		100	
0.600		98	
0.425		88	
0.300		47	
0.150		11	
0.075		10

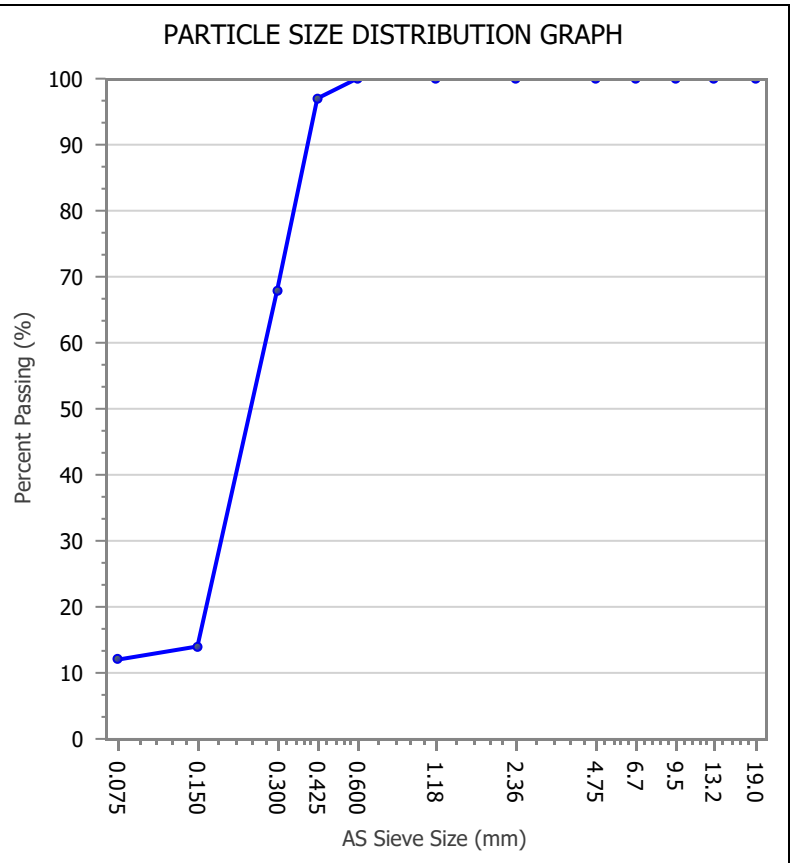
AS Sieve (mm)	Specification Minimum (%)	Percent Passing (%)	Specification Maximum (%)
19.0		100	
13.2		100	
9.5		100	
6.7		100	
4.75		100	
2.36		100	
1.18		100	
0.600		100	
0.425		97	
0.300		68	
0.150		14	
0.075		12

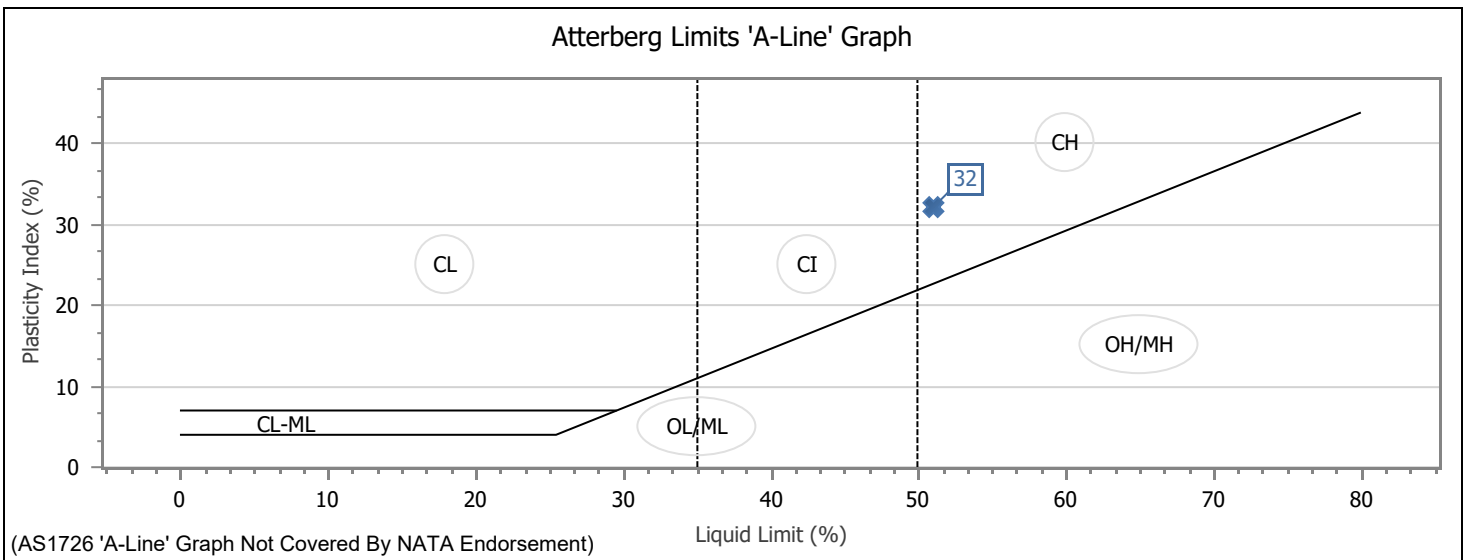
Atterberg Limit	Specification Minimum	Test Result	Specification Maximum
Liquid Limit (%)		<b>51</b>	
Plastic Limit (%)		<b>19</b>	
Plasticity Index (%)		<b>32</b>	
Linear Shrinkage (%)		<b>15.0</b>	
Linear Shrinkage Mould Length / Defects:	Mould Length: 250.6mm / None

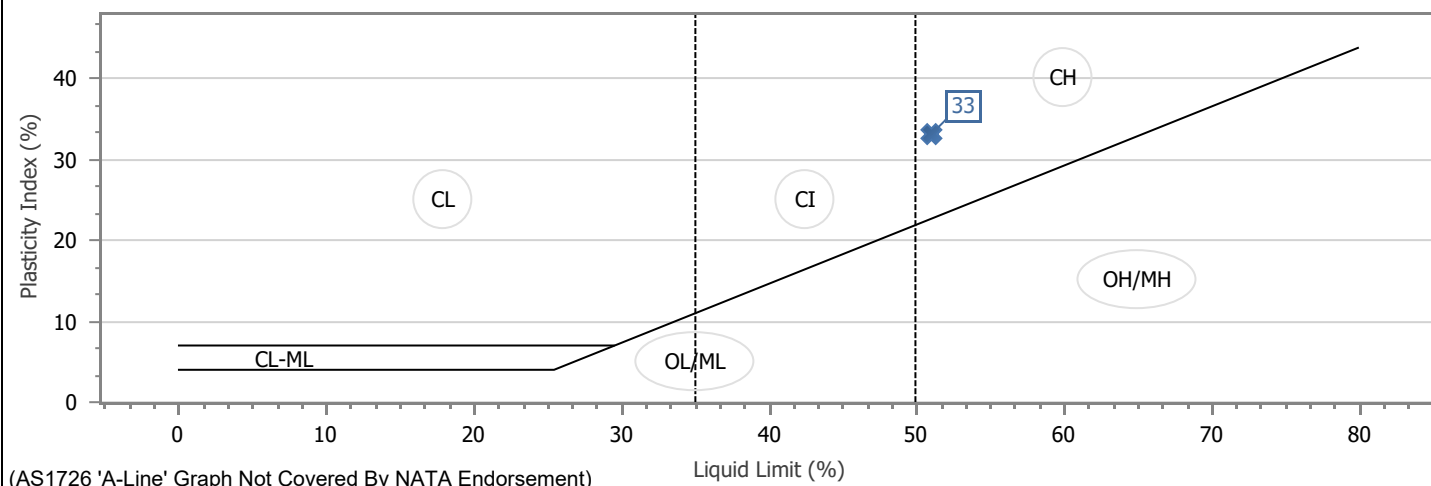
Atterberg Limits 'A-Line' Graph

Atterberg Limit	Specification Minimum	Test Result	Specification Maximum
Liquid Limit (%)		<b>51</b>	
Plastic Limit (%)		<b>18</b>	
Plasticity Index (%)		<b>33</b>	
Linear Shrinkage (%)		<b>13.5</b>	
Linear Shrinkage Mould Length / Defects:	Mould Length: 250.4mm / Cracking

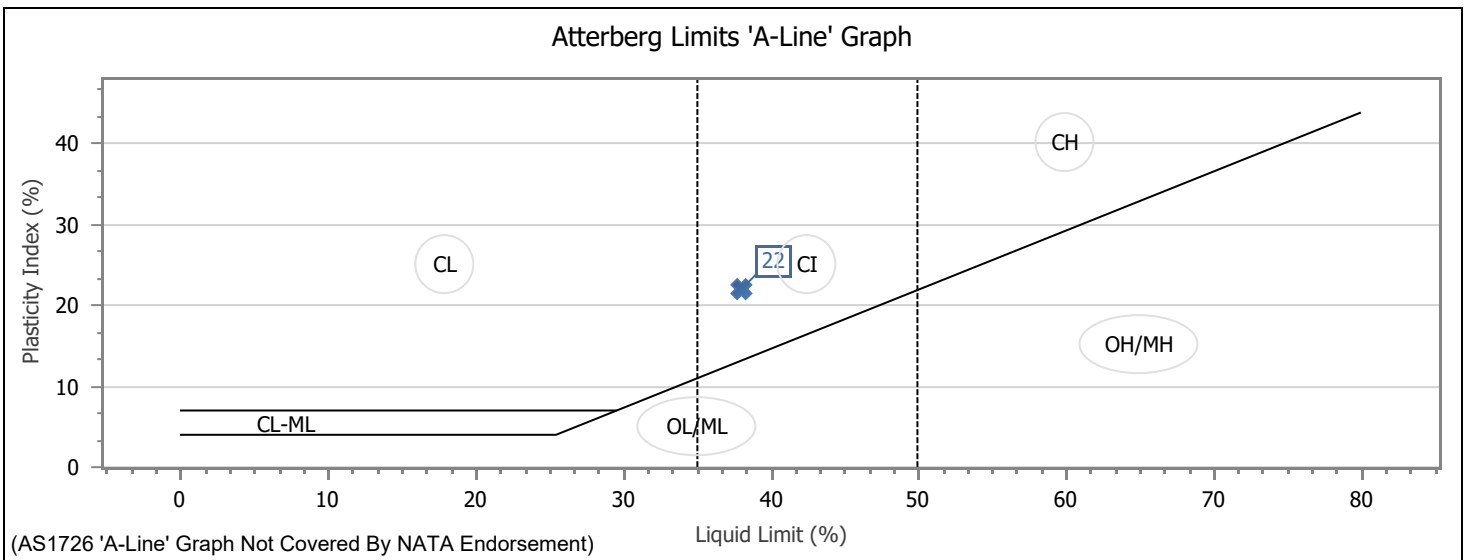
Atterberg Limit	Specification Minimum	Test Result	Specification Maximum
Liquid Limit (%)		<b>38</b>	
Plastic Limit (%)		<b>16</b>	
Plasticity Index (%)		<b>22</b>	
Linear Shrinkage (%)		<b>4.0</b>	
Linear Shrinkage Mould Length / Defects:	Mould Length: 251.1mm / None
