Remediation Action Plan Hunter Indoor Sports Centre State Significant Development (SSD-66595459)

2 Monash Road and 24 Wallarah Road, New Lambton, NSW

26000852.001A

Kleinfelder Document: **NCA25R182734**

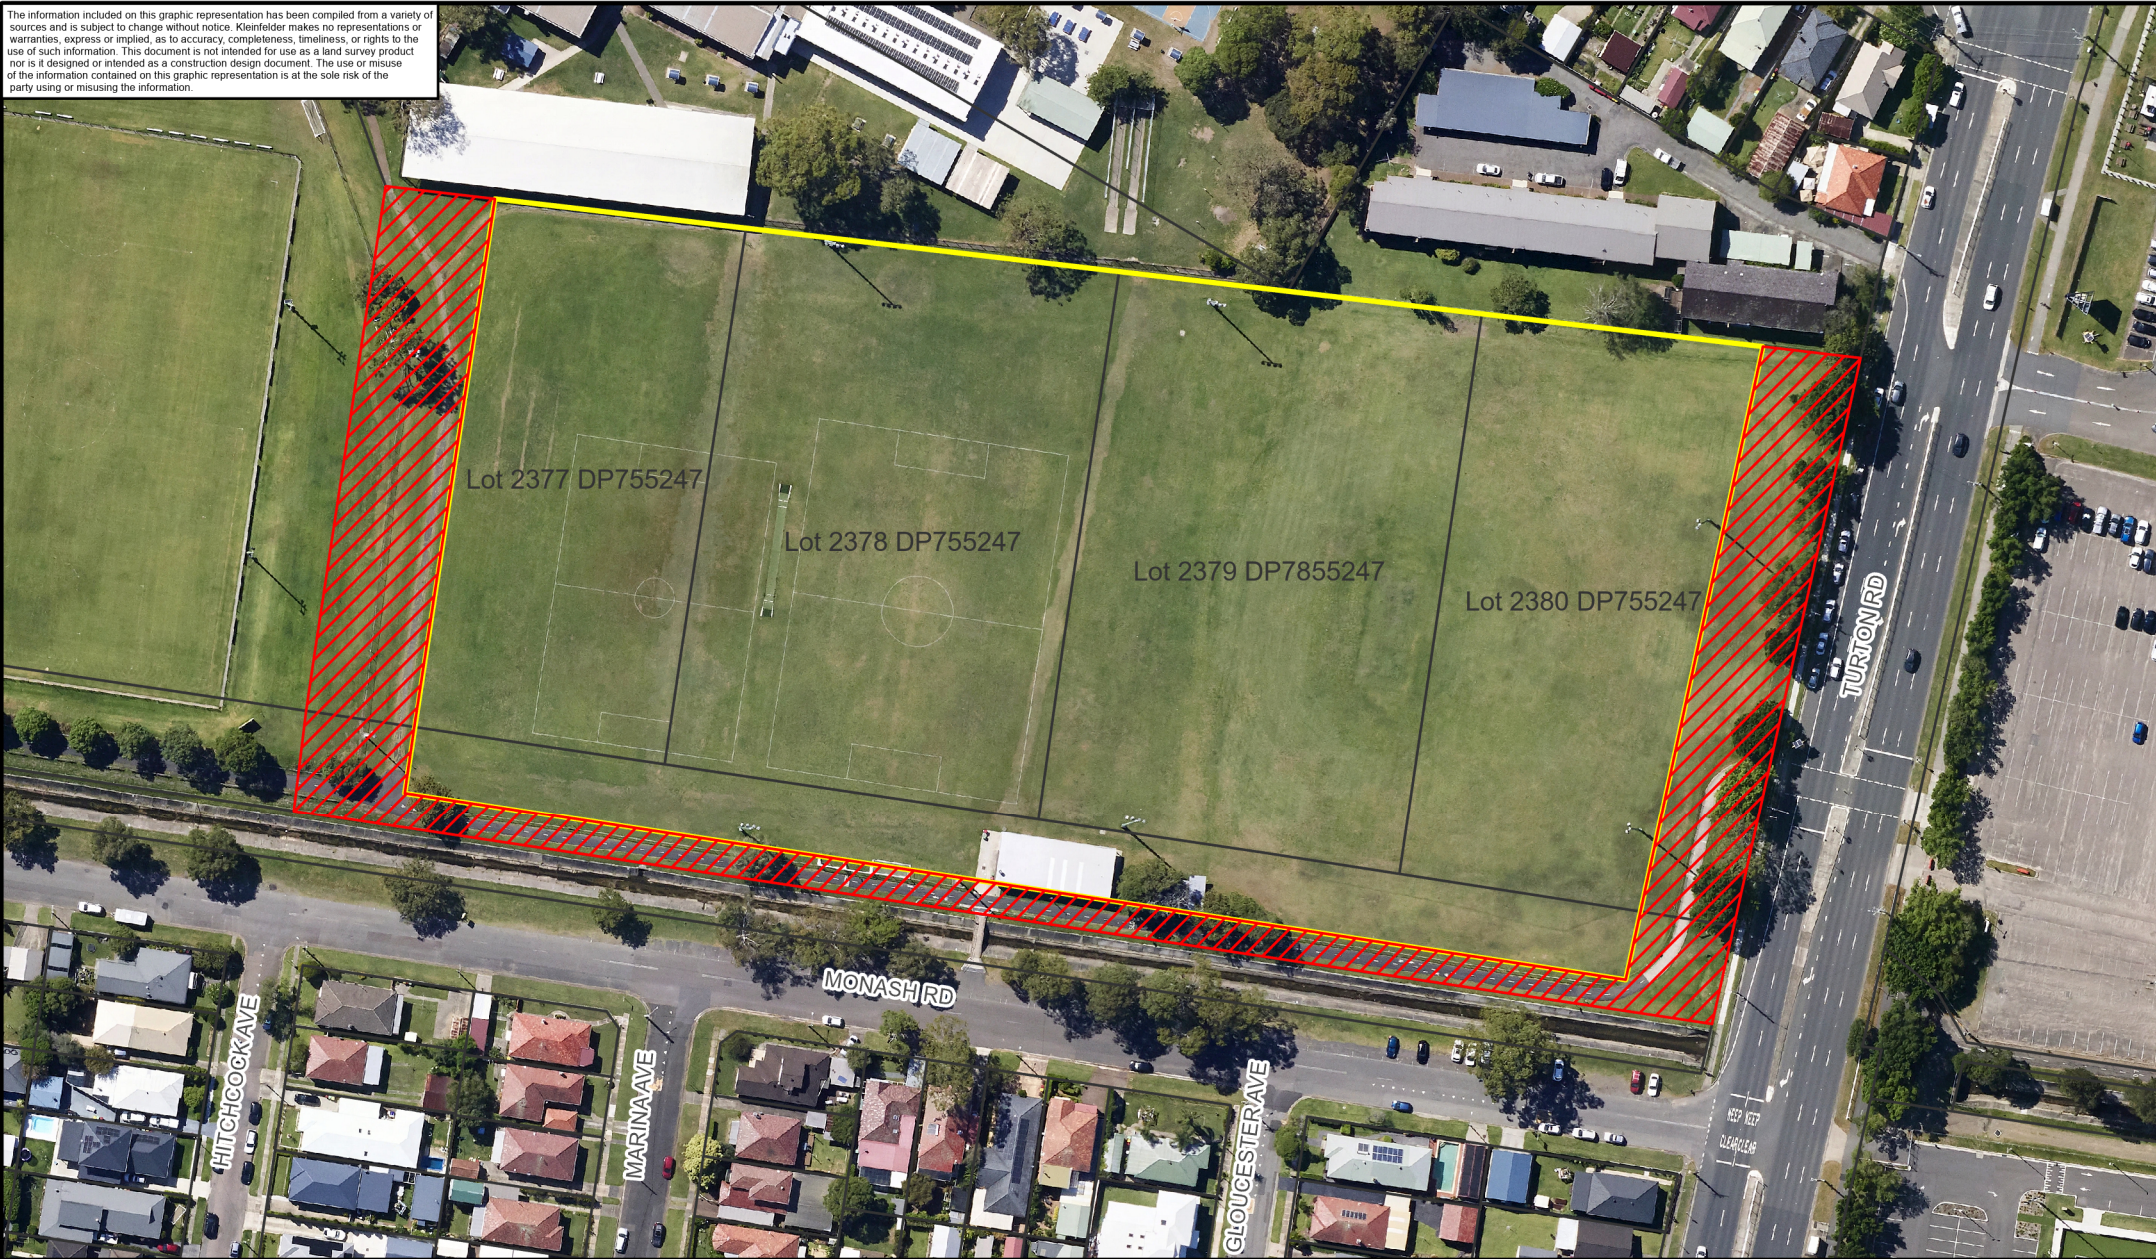
It is noted that previous investigations summarised below did not include an investigation of areas within the red hatched area, as depicted in **Figure 1**. These areas were included as part of the overall site design following the completion of previously completed investigations undertaken by Kleinfelder. As such, the findings of previous investigations may not be reflective of conditions within this area.

Given the proximity to previous investigation areas (as depicted in **Figure 1**), it is considered likely that the soil profile within the expanded site area would be comparable to that which has previously been defined. However, it is recommended that this is confirmed via additional intrusive investigations within the expanded site area prior to the commencement of site development, in accordance with the NSW EPA, 2022. *Sampling Design Part 1 – Application, Contaminated Land Guidelines*, to confirm that the nature and extent of contamination in the expanded site area is consistent with the findings of the Kleinfelder (2024a) and Kleinfelder (2024b) investigations.

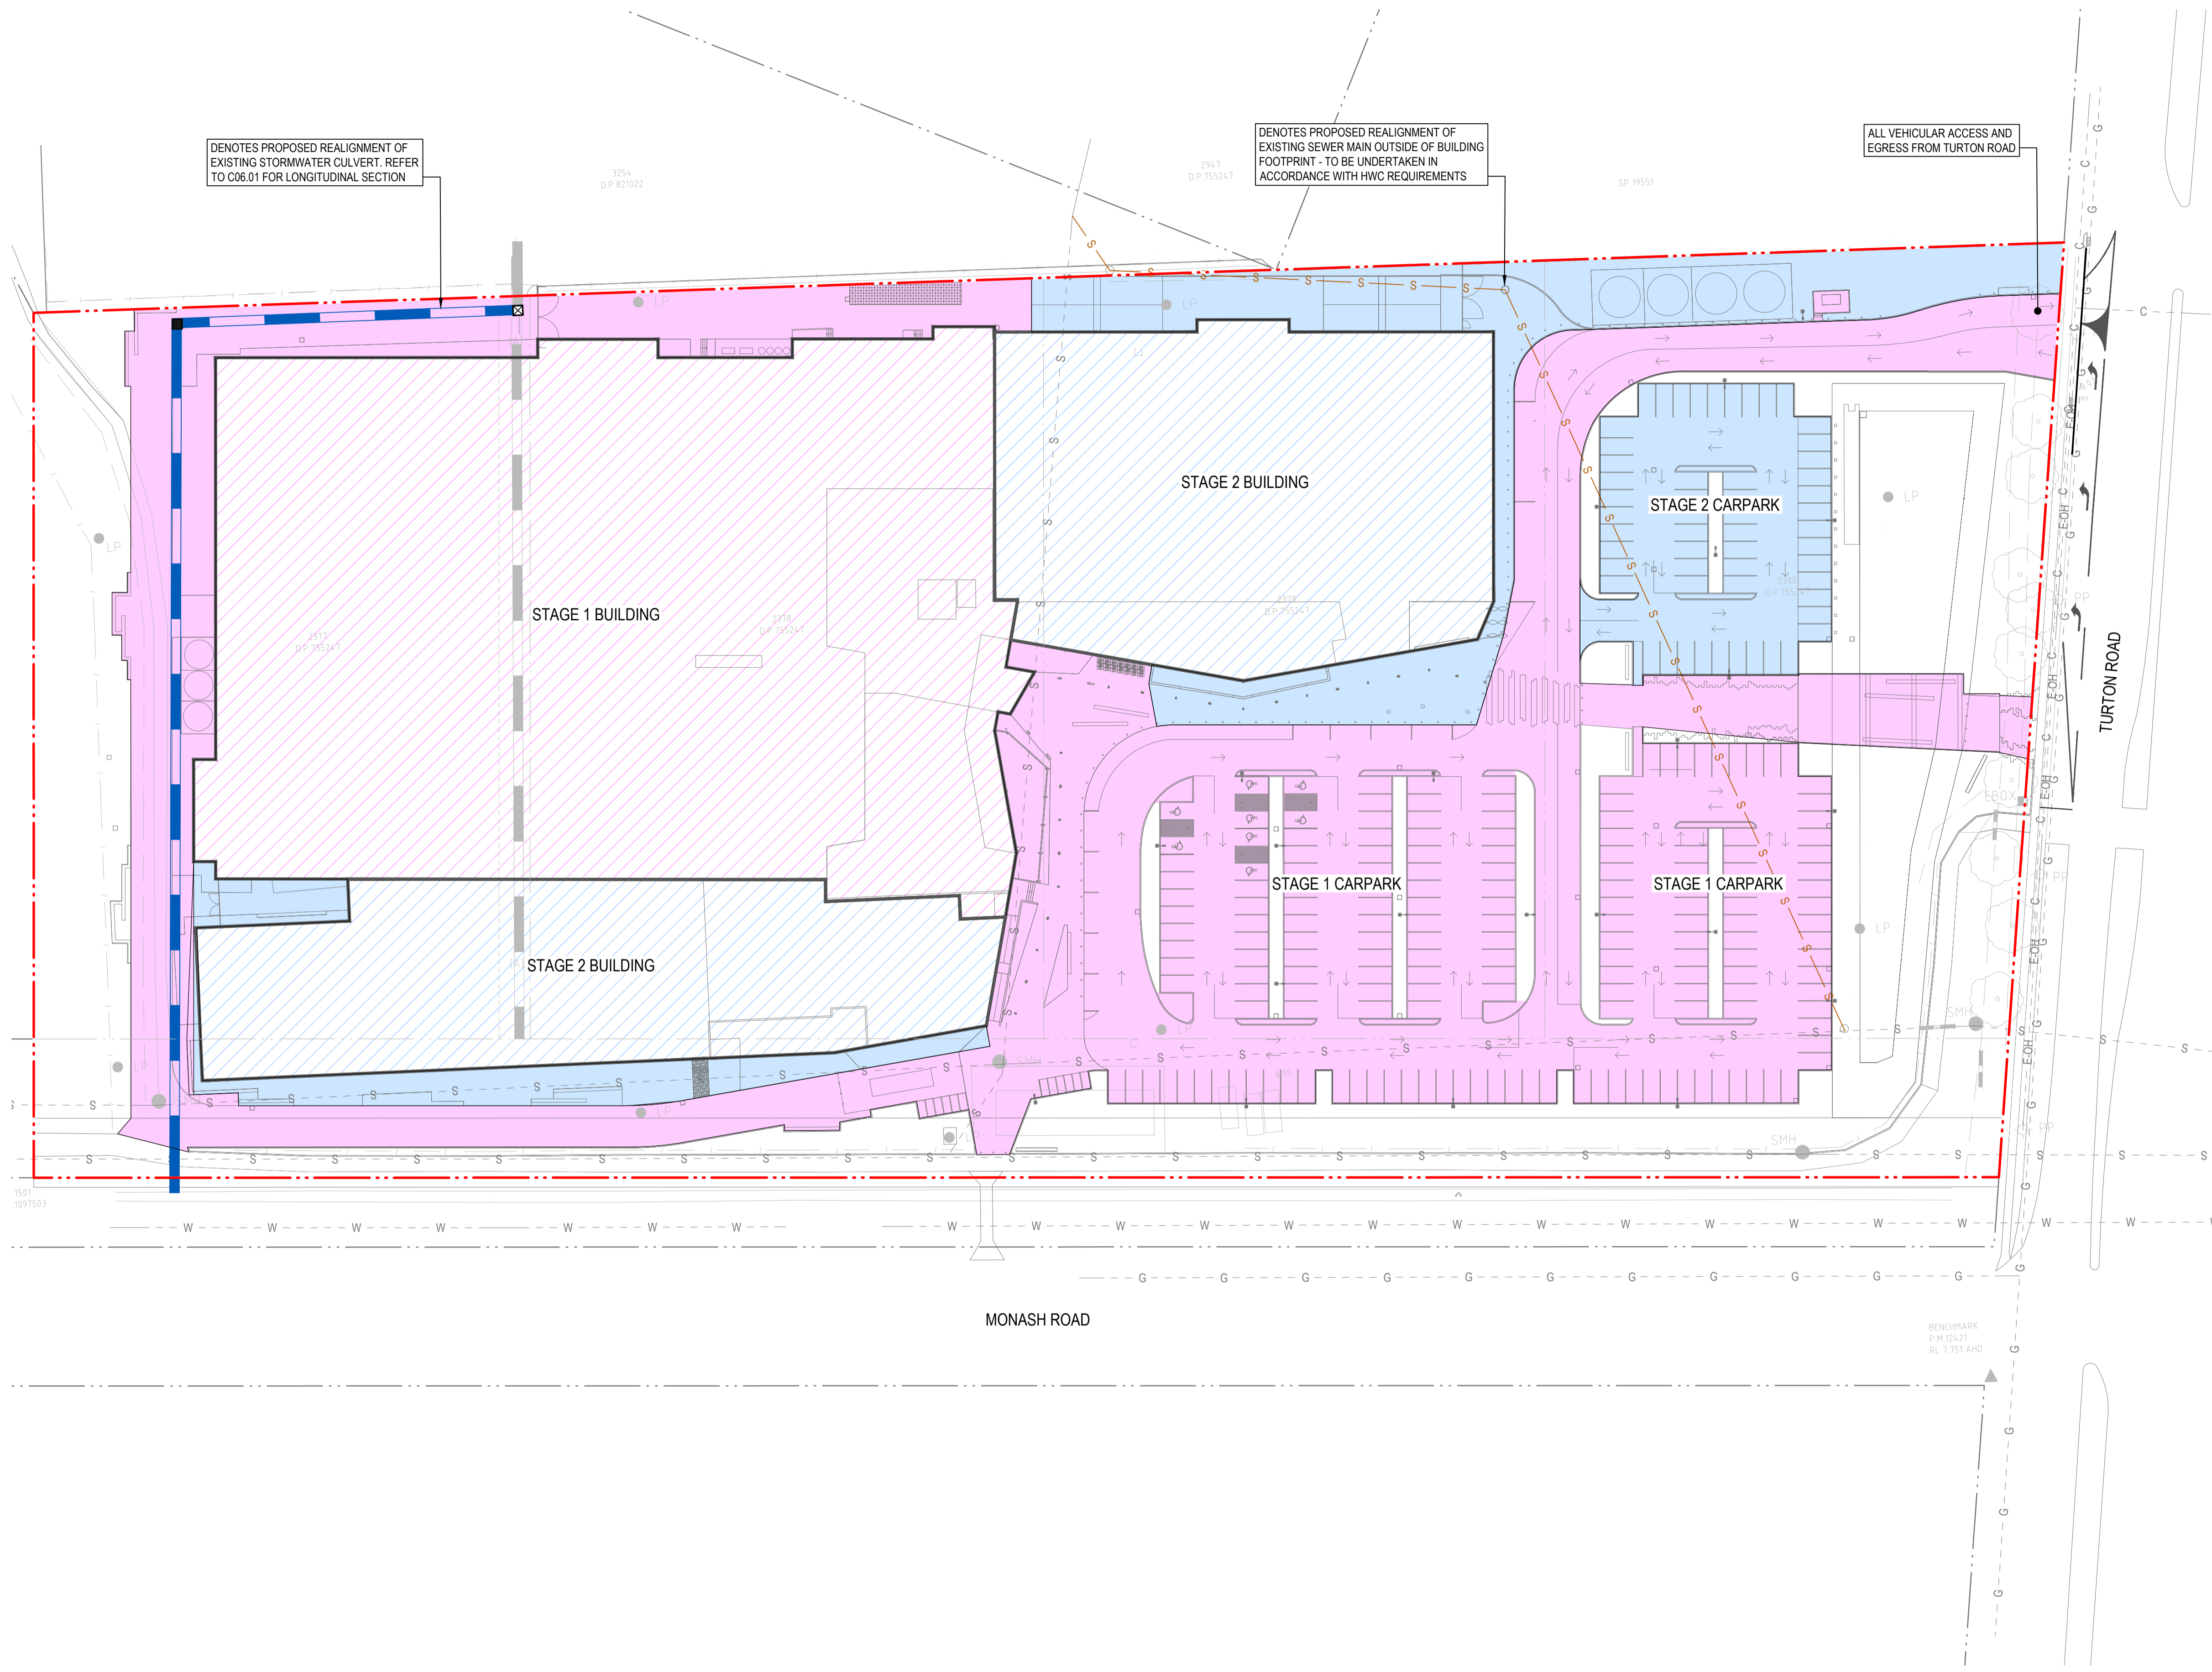
PROJECT - SET - DRAWING - SHEET
250106-DA-030-01

DENOTES PROPOSED REALIGNMENT OF EXISTING STORMWATER CULVERT. REFER TO C06.01 FOR LONGITUDINAL SECTION

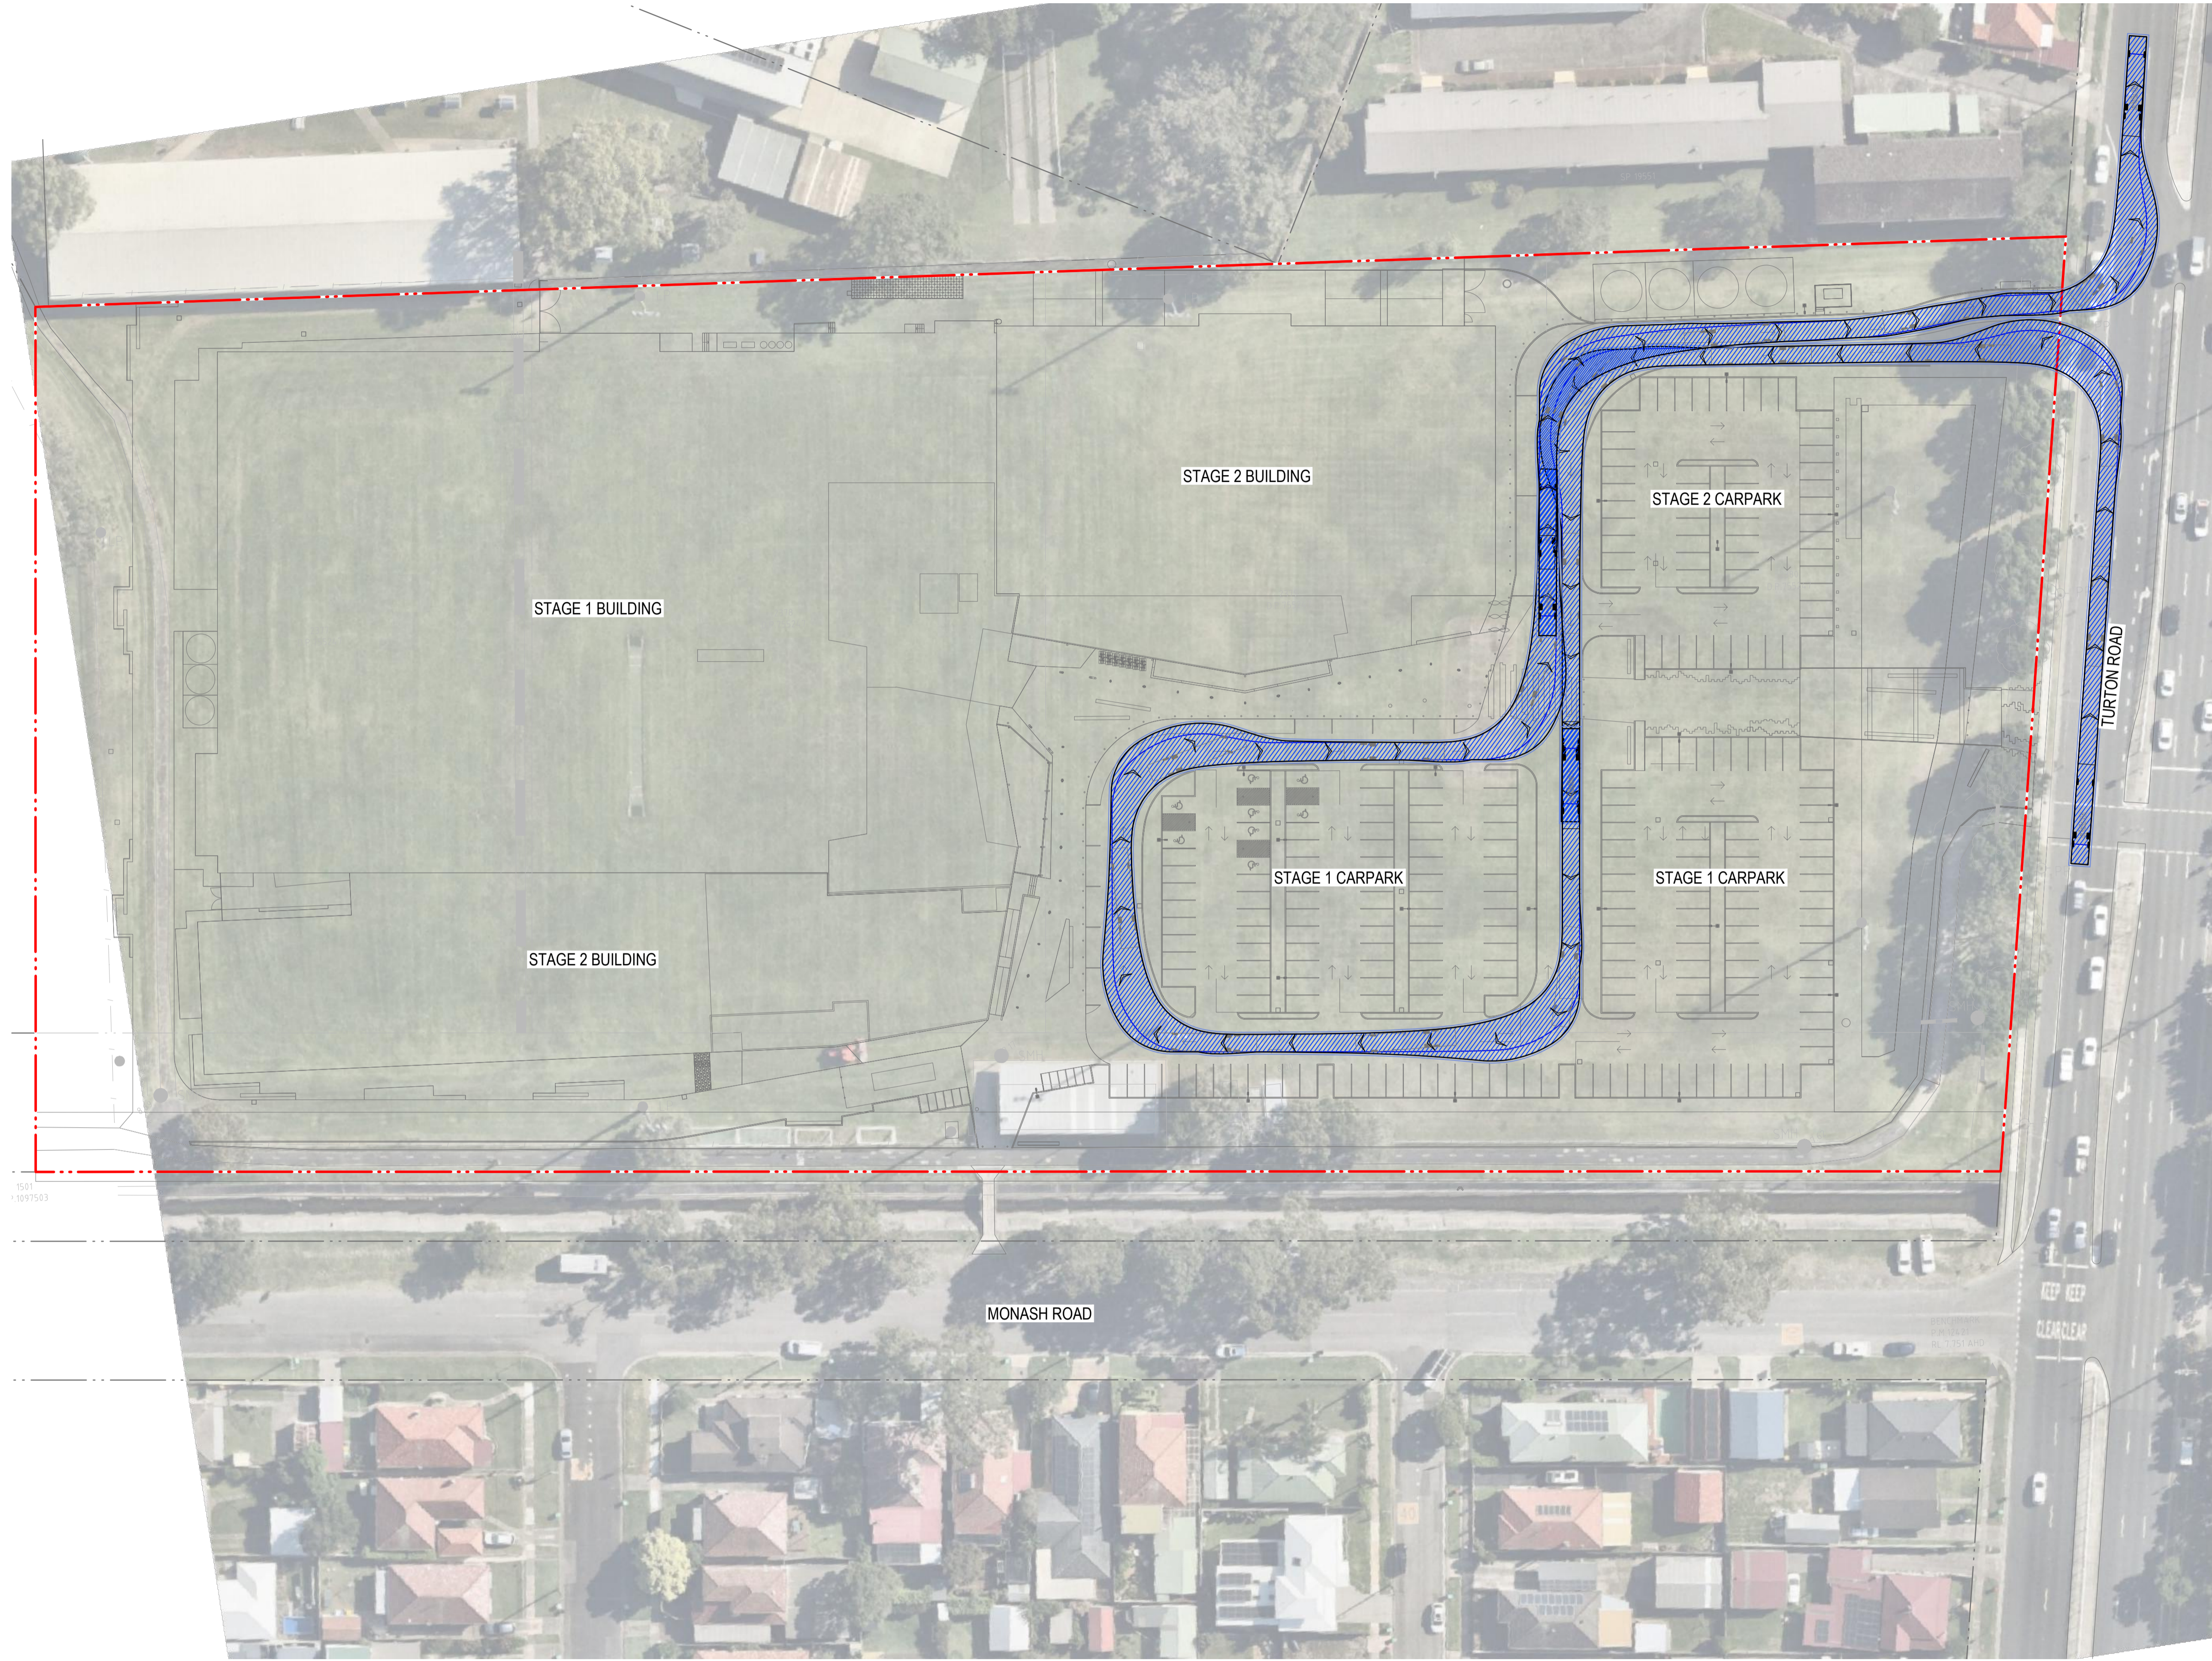
DRAWING TITLE
SWEEP PATH PLAN - 14.5m BUS

THE VEHICLE SWEEP PATHS / TEMPLATES PROVIDED HAVE BEEN PRODUCED USING SIMULATION SOFTWARE AND ARE TO BE USED AS A GUIDE ONLY. THESE SIMULATIONS MAY NOT REFLECT ACTUAL DRIVER BEHAVIOUR AND / OR EXPERIENCE UNDER ACTUAL DRIVING CONDITIONS.
