Preliminary Geotechnical Investigation Report

**40 The Retreat
Bradfield NSW 2556**

205892-PRJ1073940-GEO-REP-01

21/05/2024

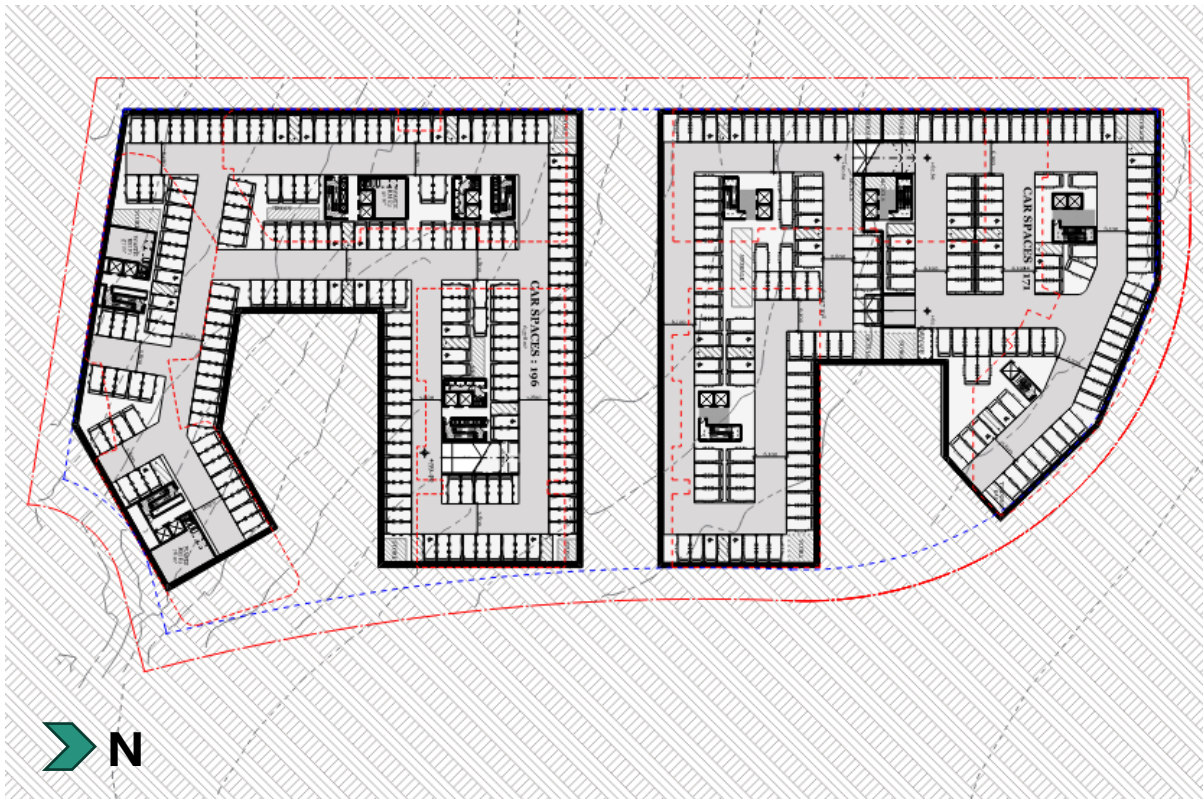
Figure 1-1: Draft concept basement floor plan (DKO Architecture, 13317, 25/10/2023)

A draft preliminary basement layout sketch was provided to Intrax to provide a general development layout (Figure 1-1).

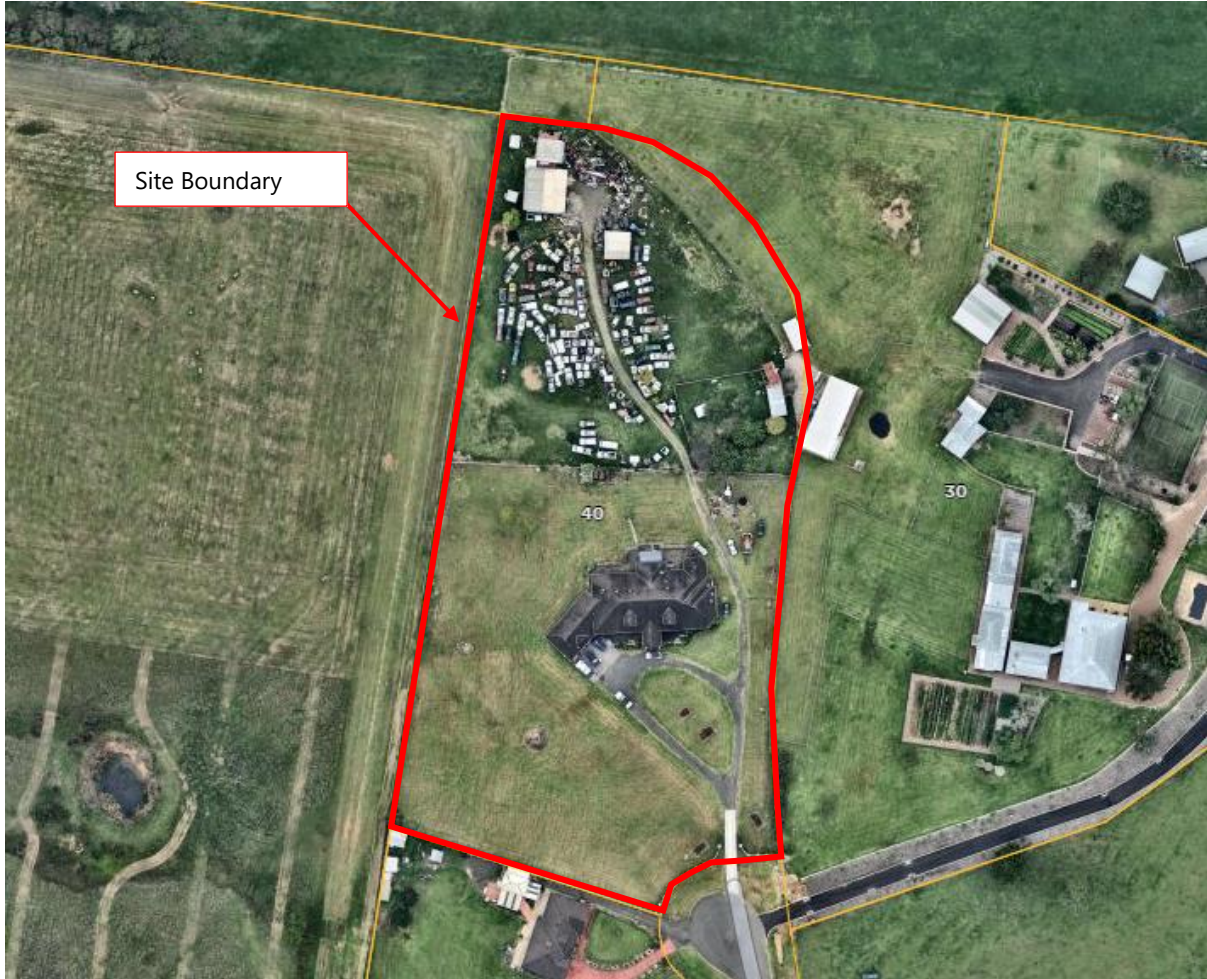
Figure 3-2: Aerial image of site – 25 January 2024 (Nearmap.com)

Pertinent site features are visible in current aerial imagery (Figure 3-2) and site plans in Appendix A. Site conditions on the date of inspection are visible in the attached photographs in Appendix C.

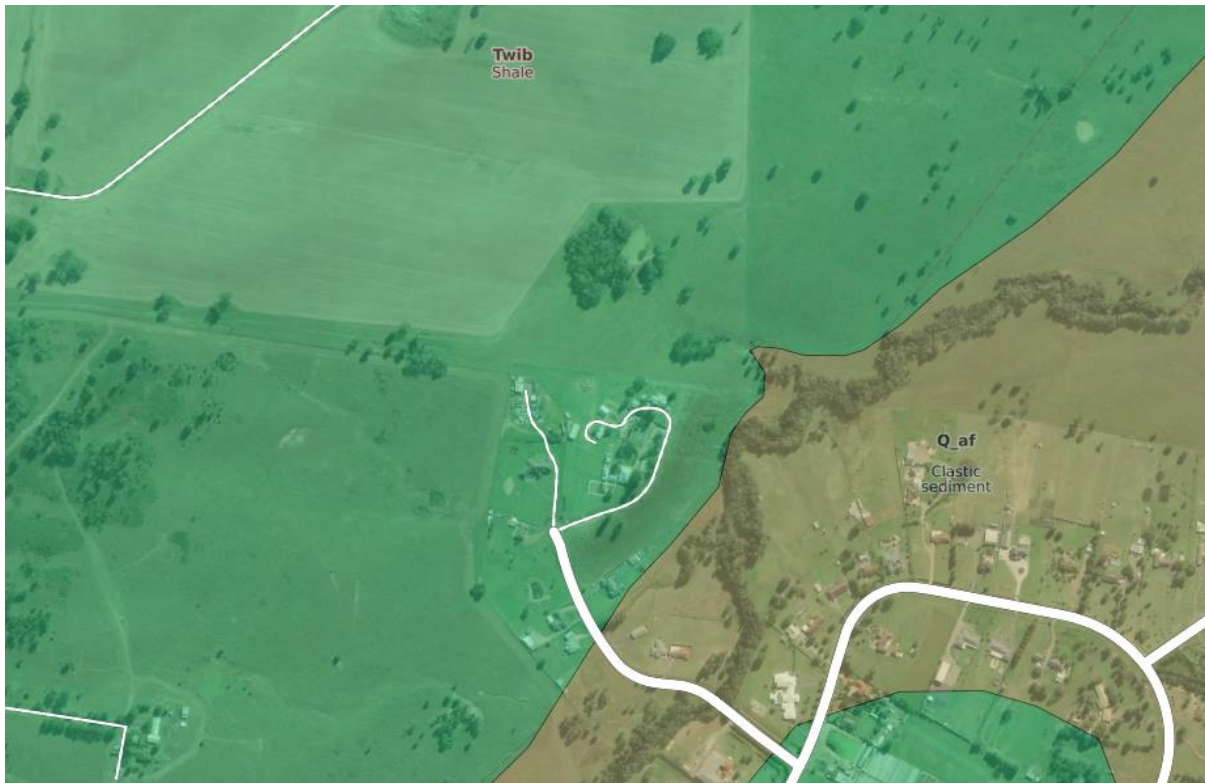
Figure 3-3: Extract of local geology, Geological Survey of New South Wales (MinView, minview.geoscience.nsw.gov.au)

The surface geology underlying the site has been mapped by the New South Wales. The digital seamless geological map for the area indicates that the surface geology is Triassic aged Bringelly Shale. The Bringelly Shale is a member of the Wianamatta Group, typically comprising shale claystone, sandstone, laminate and less commonly coal. The dominate shale unit comprises grey claystone to dark carbonaceous claystone, with next most common unit comprising light grey medium to fine grained sandstone. It is anticipated that the geological unit shall comprise a residual clay unit overlying a weathered shale profile, which typically improves with depth. An extract of the local geological map is provided below.

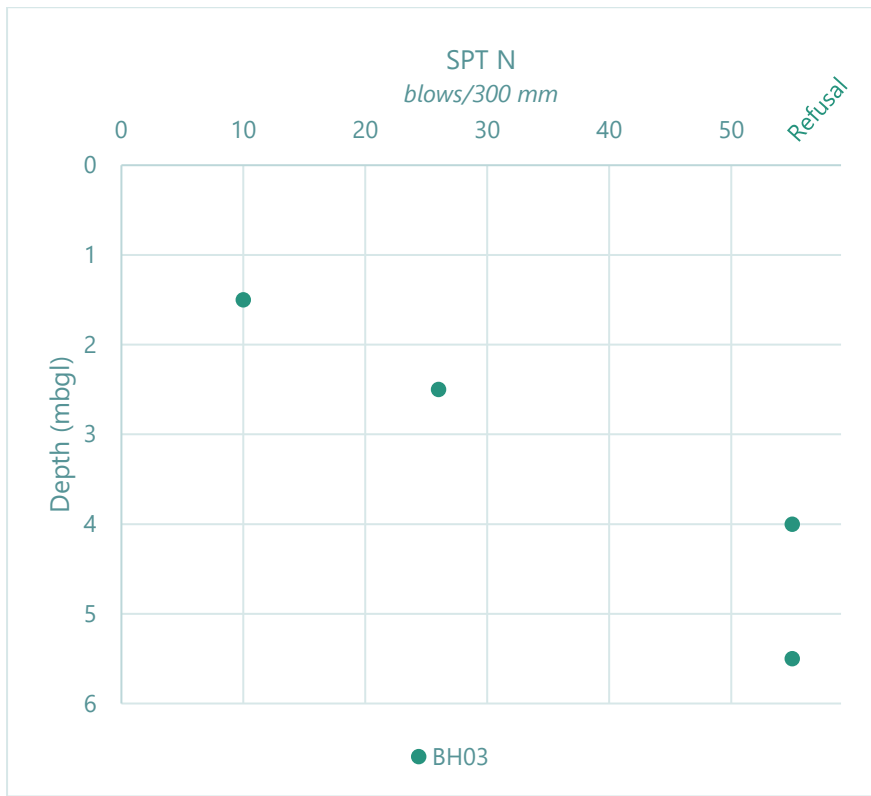
Figure 3-4: SPT N – depth profile plot

Standard Penetration Tests (SPT) were conducted at regular intervals in the soil profile, given the shallow rock head SPTs were only conducted within BH03 which had a significantly deeper soil profile. A plot of SPT results with depth is provided in figure below. The SPT results for BH03 demonstrate the material increases in

consistency from stiff at 1.5 m to very stiff at 3.0 m and hard or greater in the 4.5m and 5.5 m tests. Details of the DCP test results and SPT results are provided on the borehole logs in Appendix B.

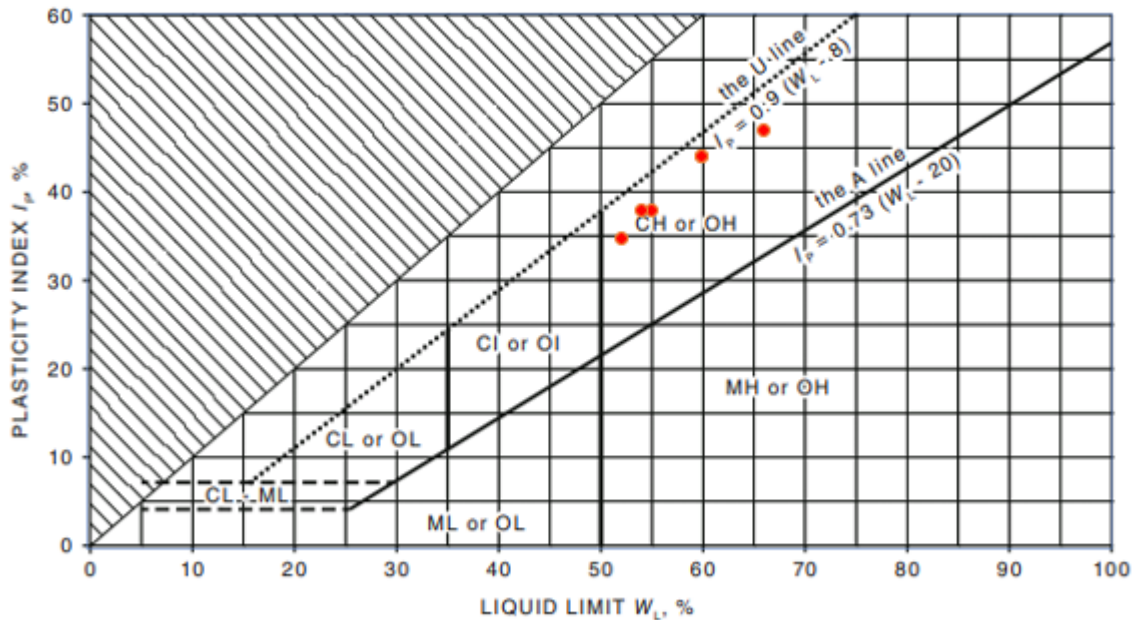
Figure 3-5: Casagrande chart plot of test results

Soil samples were obtained for classification testing, comprising moisture content, Atterberg limits, linear shrinkage, and particle size distribution. Test results are summarised in the table below. These results indicate that all residual soils are high plasticity clays with variable sand content and generally minor gravel content. The residual soils are of moderate reactivity to changes in moisture content, and insitu moisture content was below or near the plastic limit.

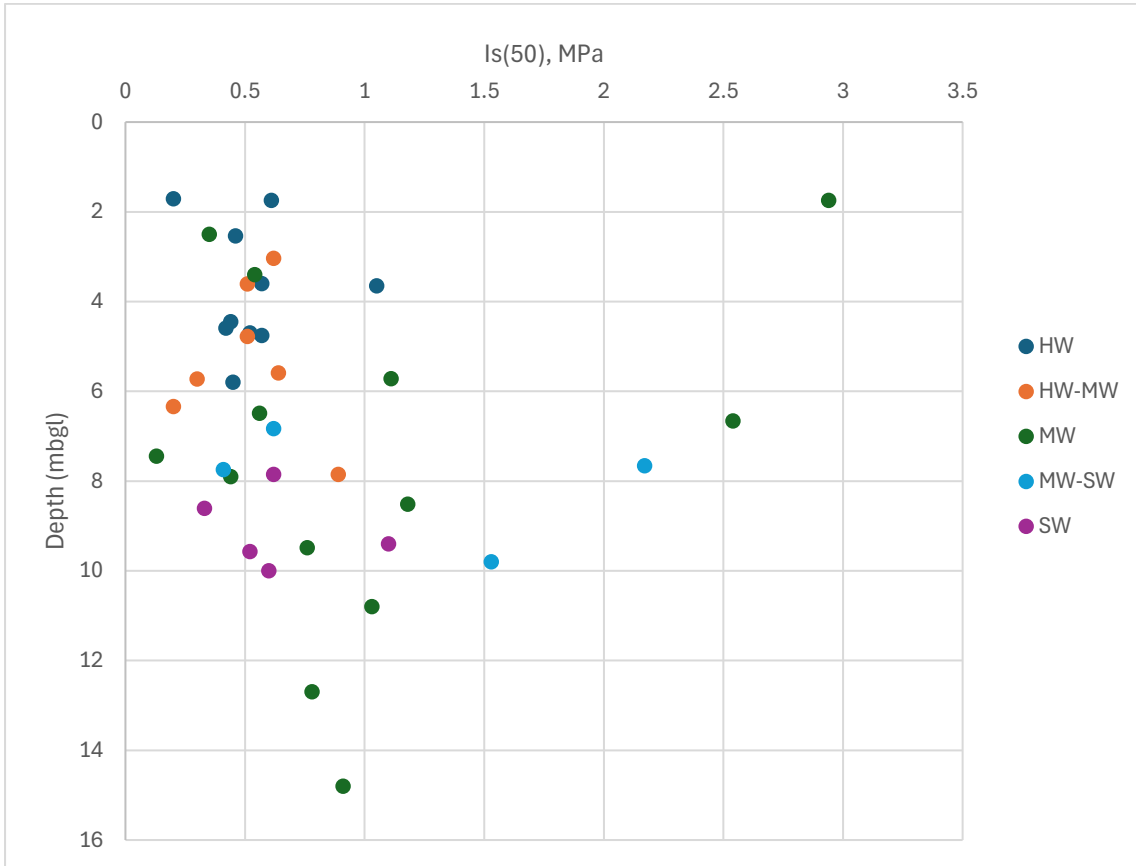
Figure 3-6: Point Load Strength Index plot

These results indicate that there is minor correlation between weathering grades and rock strength, however that the rock strength broadly increases with depth accounting for variability within the rock mass. No uniaxial

compressive strength testing was completed to establish a site specific relationship with point load index; however, based on previous testing data in the Sydney basin on other projects Intrax have assumed a relationship of $UCS = 16 \times Is(50)$ for classification of rock strength in accordance with AS1726-2017.

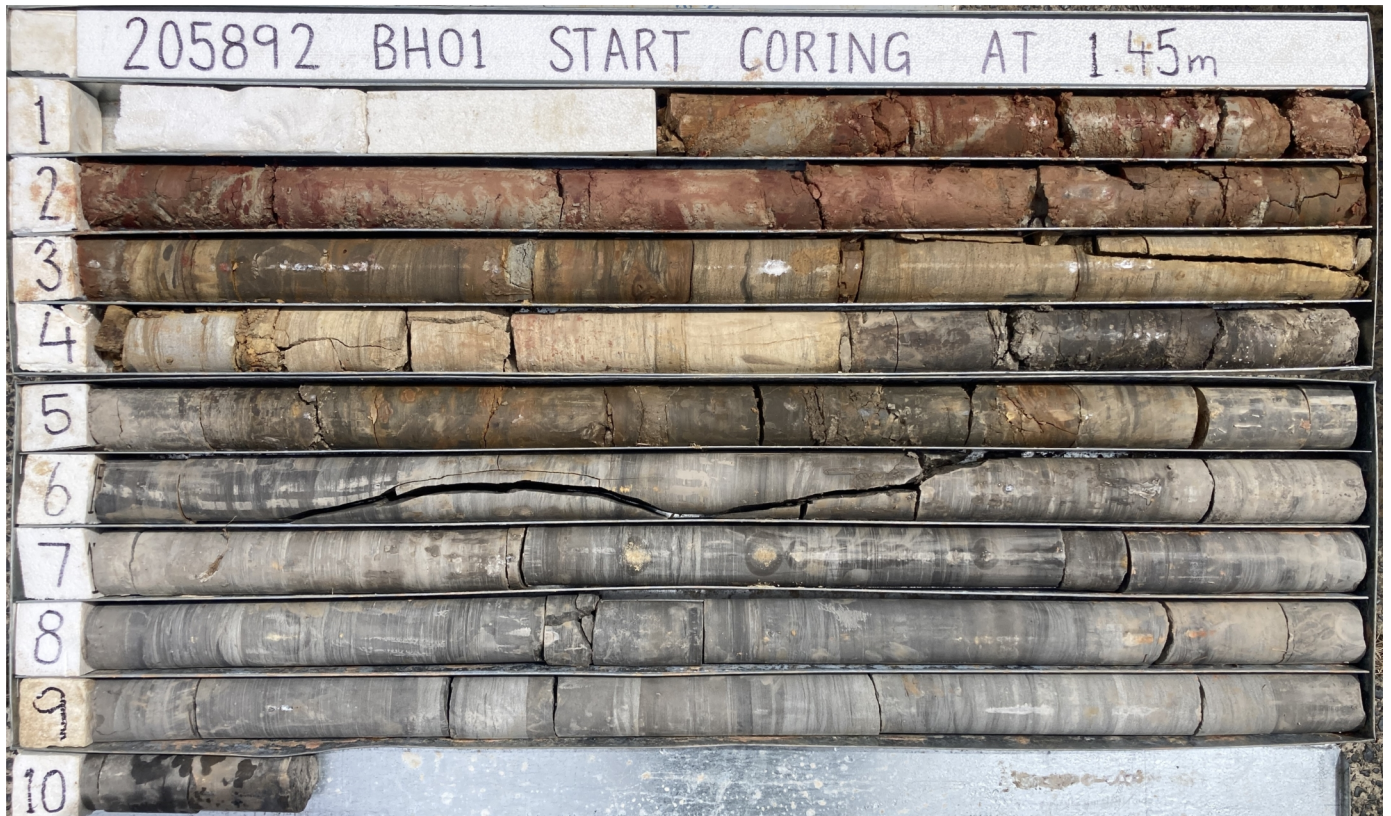
1.45-10.16m

Drilling				Material				Defect & Observation					
Progress		TCR (%)	RQD (%)	Samples & Tests	RL (m)	Depth (m)	Graphic Log	Material Description colour, grain characteristics, structure, minor components, formation	Weathering	Strength I _{s50} ● Axial ○ Diametral	Defect Spacing (mm)	Visual	Discontinuities & other observations
Drilling & Casing	Water												
		100	70	I _{Sp} A=062MPa	63	7		[CONT] SILTSTONE: grey and light grey	EL -40.03 VI -40.1 L -40.3 M -1 H -3 VH -10 EH			6.15-6.43m, JT, 85°, UN, RF, CN, Open 6.50-6.70m, JT, 70°, PR, RF, CN, Open	
				I _{Sp} A=041MPa	62	8							
		100	100	I _{Sp} A=153MPa	61	9							
					60	10							
					58.46		End Of Hole: 10.16m - Target depth - Monitoring well installed						
					59	11							
					58

Project: 40 The Retreat
 Location: 40 The Retreat, Bringelly
 Position: E: 291309.1, N: 6244430
 Project No.: 205892
 Client: Sathio Group

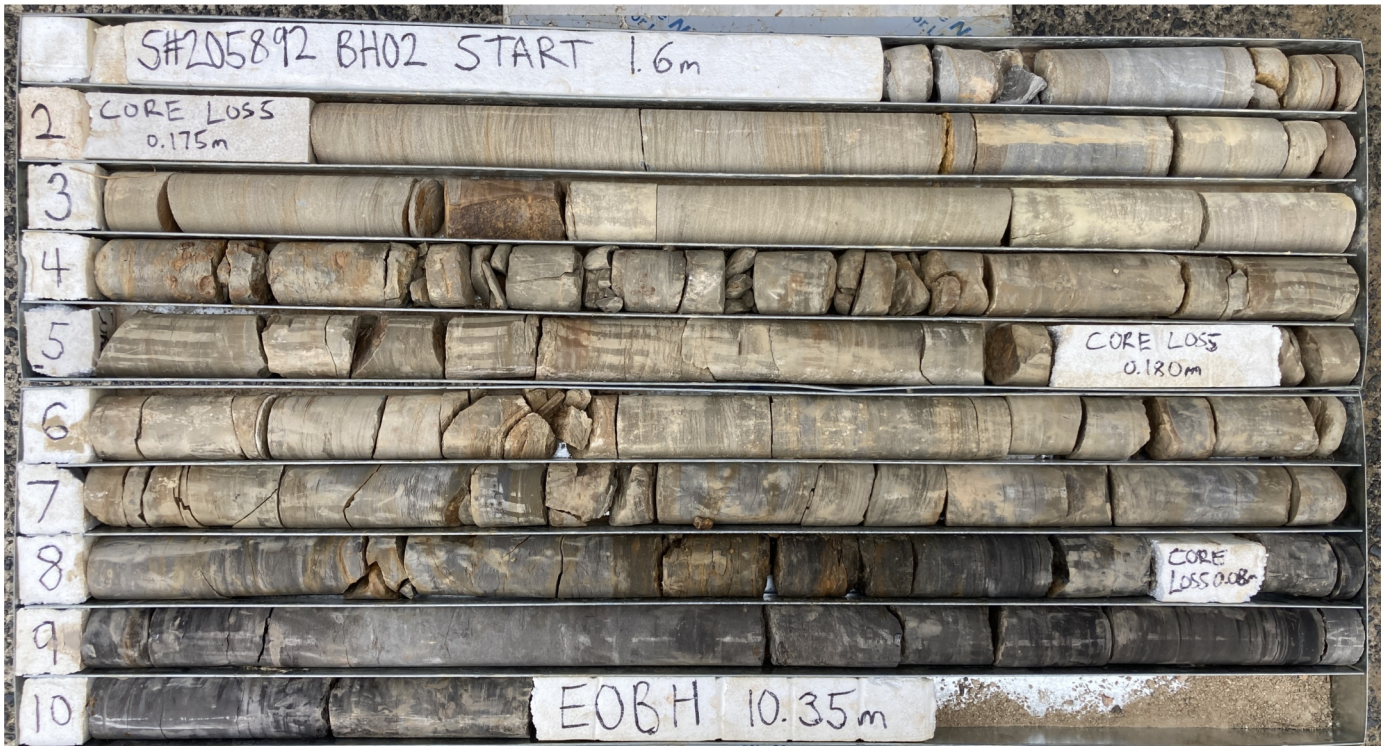
1.60-10.35m

10.35	10.35		End Of Hole: 10.35m - Target depth - Backfilled with spoil					
					56	11

Project: 40 The Retreat
 Location: 40 The Retreat, Bringelly
 Position: E: 291304.6, N: 6244344
 Project No.: 205892
 Client: Sathio Group

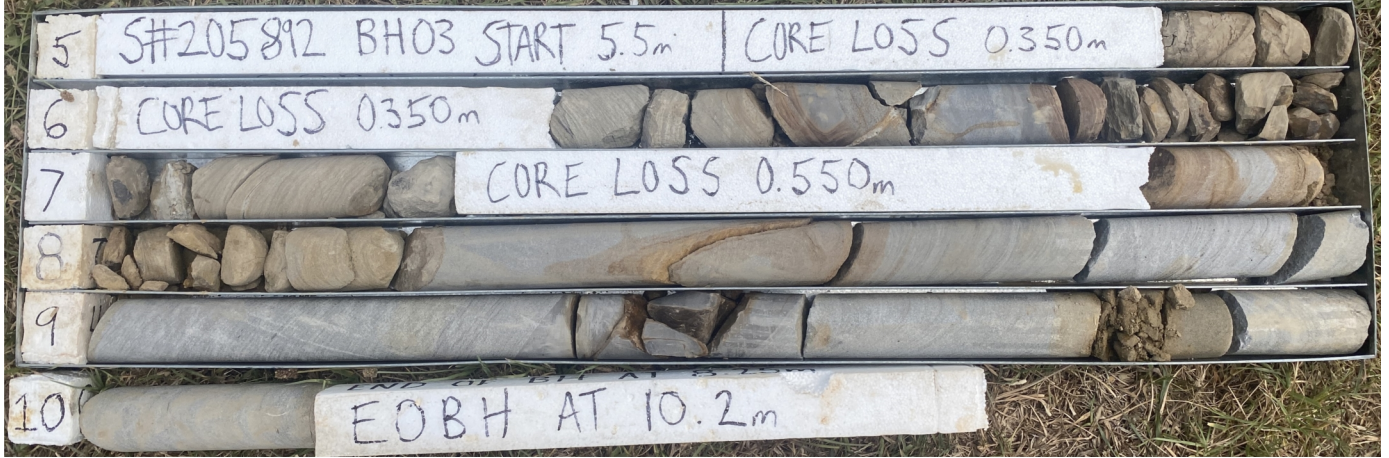
5.50-10.20m

7.30	CORE LOSS						7.04-7.07m, EW, 5°, Clay 7.11m, JT, 10°, CU, S, CN, Closed
			63	33	I _{s50} : A=062MPa	56	7.85	SILTSTONE: grey orange brown, fine grained, bedded at 40 to 50 deg, bed thickness between 2mm to 20mm, iron staining at joints.					7.30-7.85m, ?, Core Loss 7.98-8.00m, EW, sandy gravel 8.00-8.16m, FZ 8.20m, JT, 30°, CU, RF, CN, Closed 8.46-8.58m, JT, 70°, PR, RF, Open 8.61m, P, 5°, UN, RF, CN, Closed
					55	9			SW				8.95m, JT, 10°, PR, S, CN, Open
		100	78	I _{s50} : A=052MPa	54	10							9.43m, JT, 30°, CU, RF, SN, Open 9.43-9.52m, FZ 9.52m, JT, 20°, UN, RF, SN, Open
				I _{s50} : A=0.6MPa	53	10.20	End Of Hole: 10.20m - Target depth - Monitoring well installed						9.79-9.84m, EW, 5°

Project: 40 The Retreat
 Location: 40 The Retreat, Bringelly
 Position: E: 291394.3, N: 6244337
 Project No.: 205892
 Client: Sathio Group

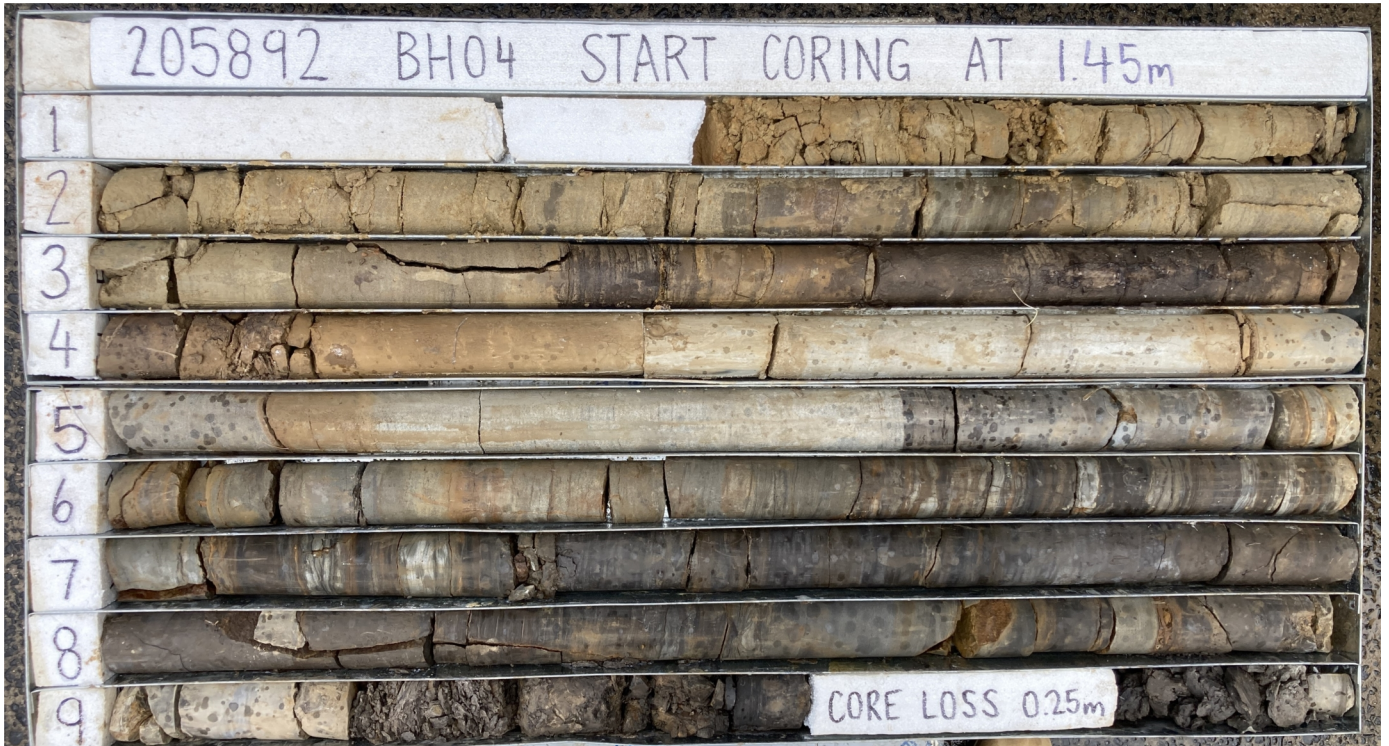
1.45-10.00m

58	9.18		SILTSTONE: dark grey, fine grained, bedded at 0 to 5 deg, bed thickness between 2mm to 20mm.	HW				8.47-8.49m, JT, 70°, PR, RF, SN, Open
					58	9.55		CORE LOSS 0.25m					8.63-8.69m, JT, 60°, UN, RF, SN, Open
					58	9.80		SILTSTONE: dark grey, fine grained, bedded at 0 to 5 deg, bed thickness between 2mm to 20mm.	HW				8.80m, P, 5°, PR, RF 8.87-8.90m, JT, 30°, PR, RF, SN, Open
					57	10		End Of Hole: 10.00m - Target depth - Backfilled with spoil					
					56	11

Project: 40 The Retreat
 Location: 40 The Retreat, Bringly
 Position: E: 291403.7, N: 6244426
 Project No.: 205892
 Client: Sathio Group

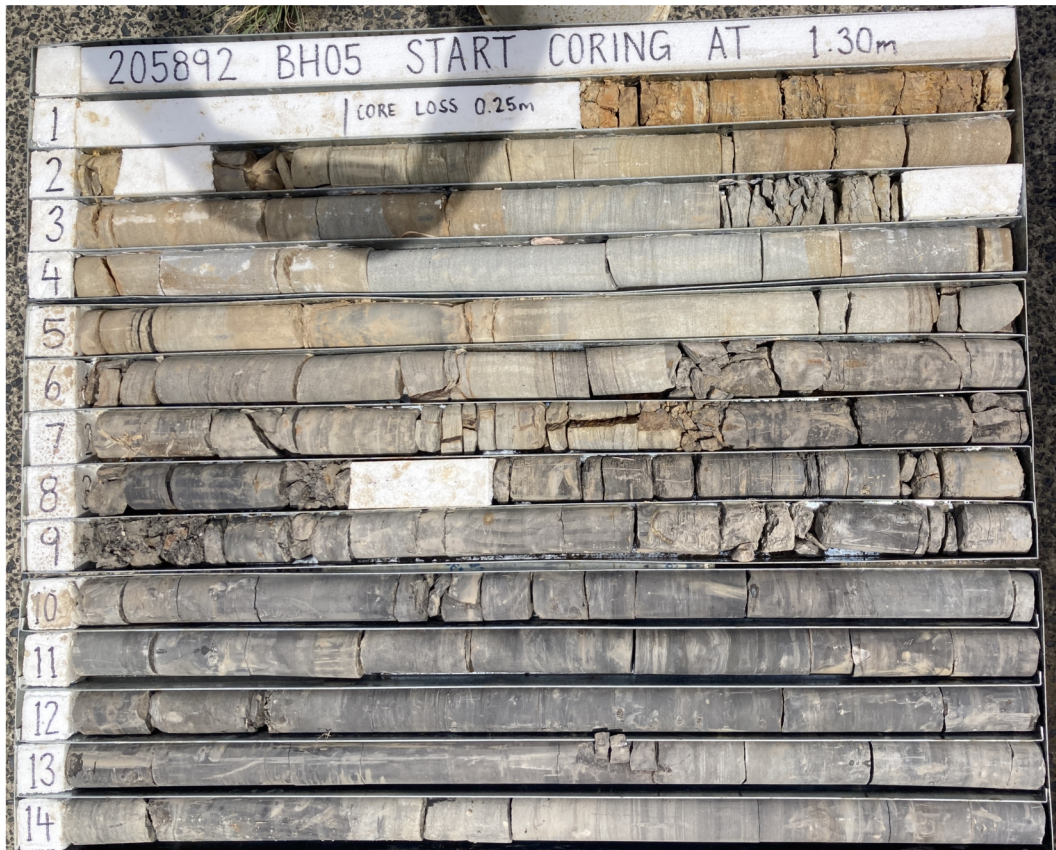
1.30-15.00m

Drilling				Material				Defect & Observation					
Drilling & Casing	Water	TCR (%)	RQD (%)	Samples & Tests	RL (m)	Depth (m)	Graphic Log	Material Description colour, grain characteristics, structure, minor components, formation	Weathering	Strength I _{s50} ● Axial ○ Diametral	Defect Spacing (mm)	Visual	Discontinuities & other observations
		100	94	I _{s50} A=078MPa	57			[CONT] As above - SILTSTONE: dark grey and grey, fine grained.	MW	●			12. 19-12.21m, EW, 20mm
		100	100	I _{s50} A=091MPa	56								13. 55-13.60m, JT, 80°, PR, RF
					15			End Of Hole: 15.00m - Target depth - Backfilled with spoil					
					54								
					16								
					53								
					17								
					52

Project: 40 The Retreat
 Location: 40 The Retreat, Bringelly
 Position: E: 291372.1, N: 6244500
 Project No.: 205892
 Client: Sathio Group

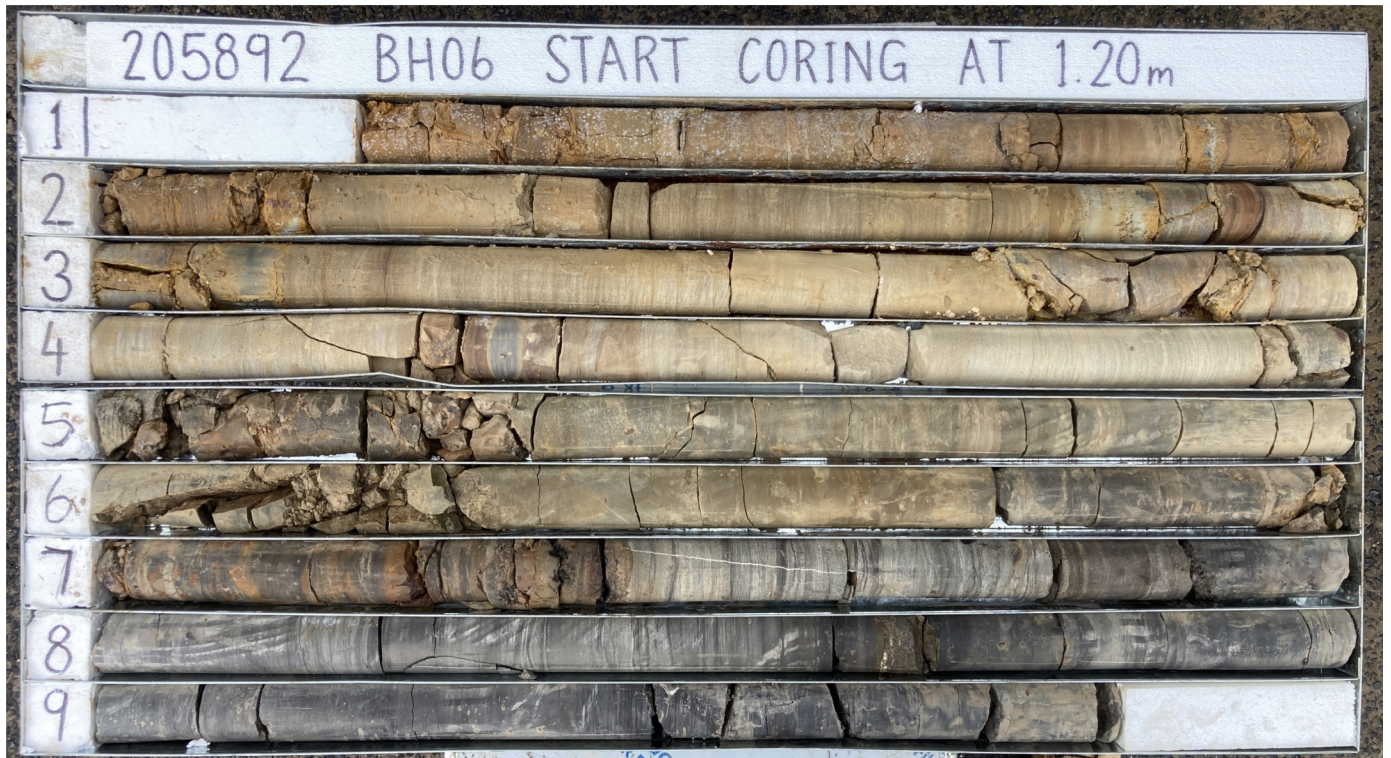
1.30-9.82m

100	81		61	9		SW					8.62-8.66m, EW, 40mm
					60								9.50-9.52m, EW, 20mm
					59	9.82	End Of Hole: 9.82m - Target depth - Monitoring well installed						
					58	11
