**Daracon Group Pty Limited**

**Martins Creek Andesite  
Quarry  
Geology and Blast Vibration  
Assessment  
August 2014**

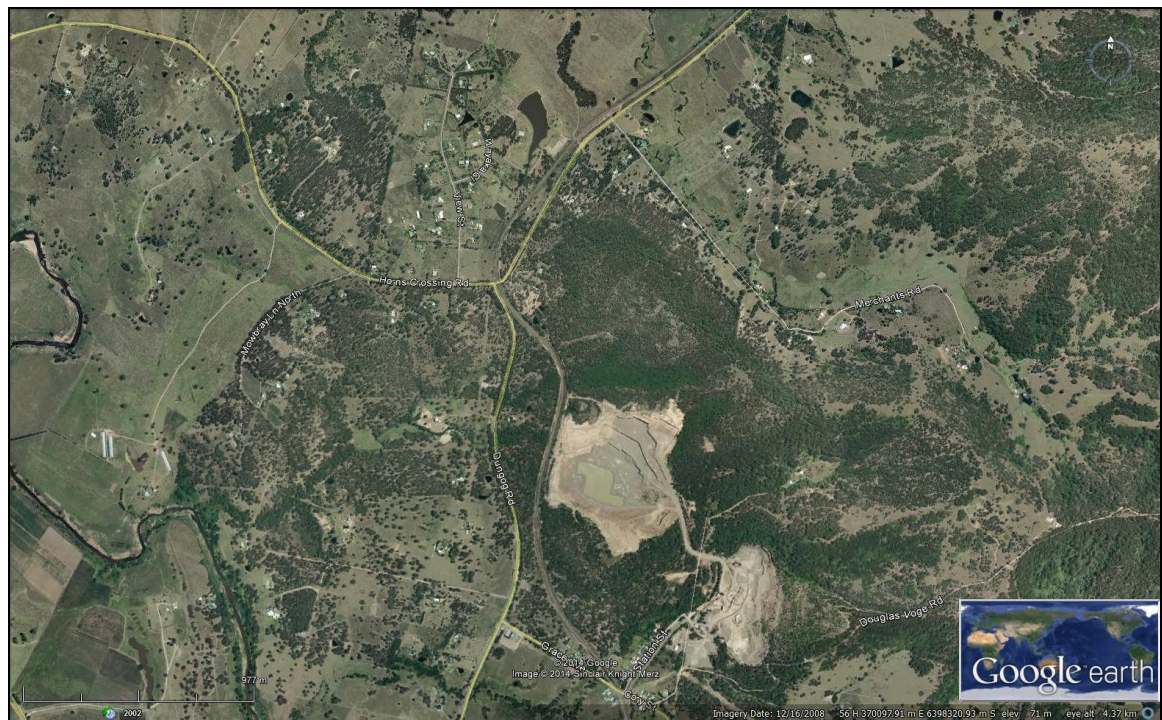
**Figure 1 – Neighbours and Quarry**

VGT Pty Limited was engaged by Daracon to evaluate the regional geology of the Martins Creek Quarry, and adjoining neighbours, in particular those found in View and Wayaka Streets (see *Figure One*). This is in response to a number of complaints regarding blast vibration.

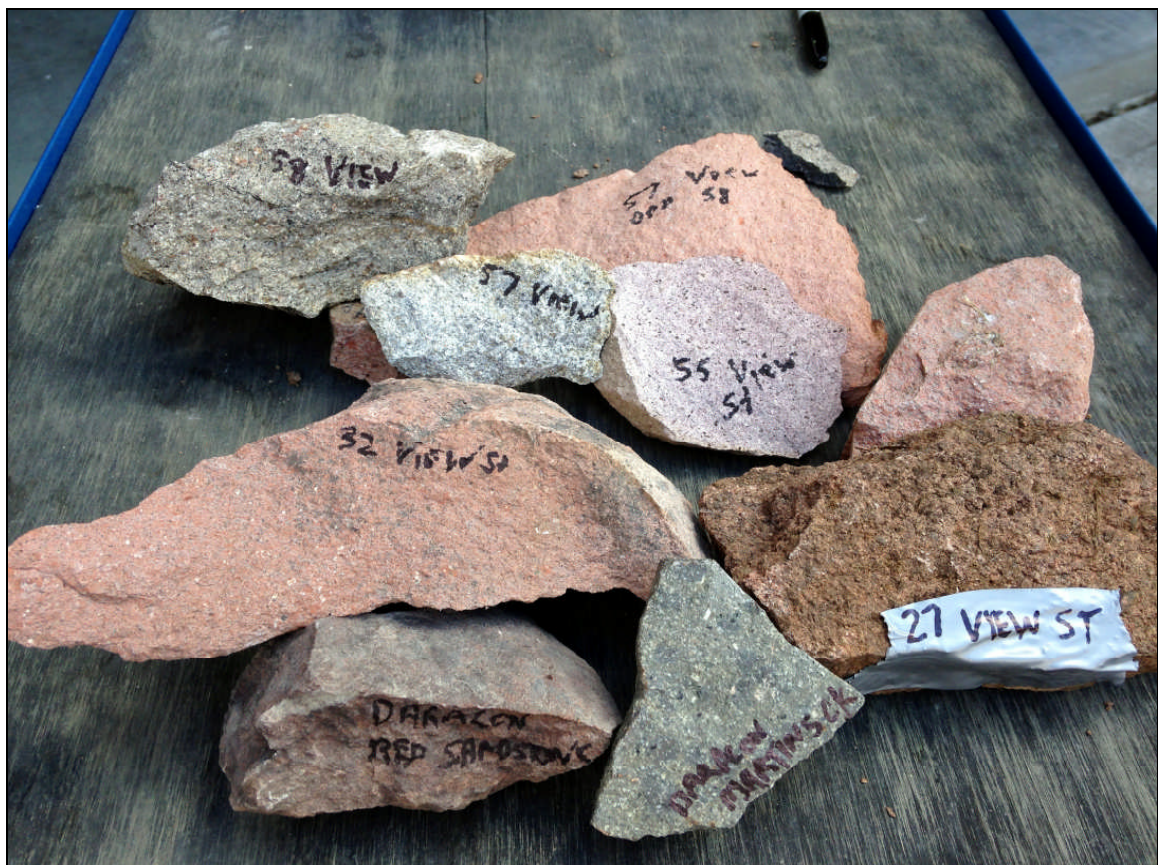
**Figure 4 – Samples collected from Daracon Quarry and View Street**

Samples below have been taken from the Daracon Quarry and View Street; the sample from 7 Wayaka Street was too small to be shown here.

The samples found in View Street are of a volcanic nature, but are visually different to that found in quarry as seen in the hand specimens and under the microscope.

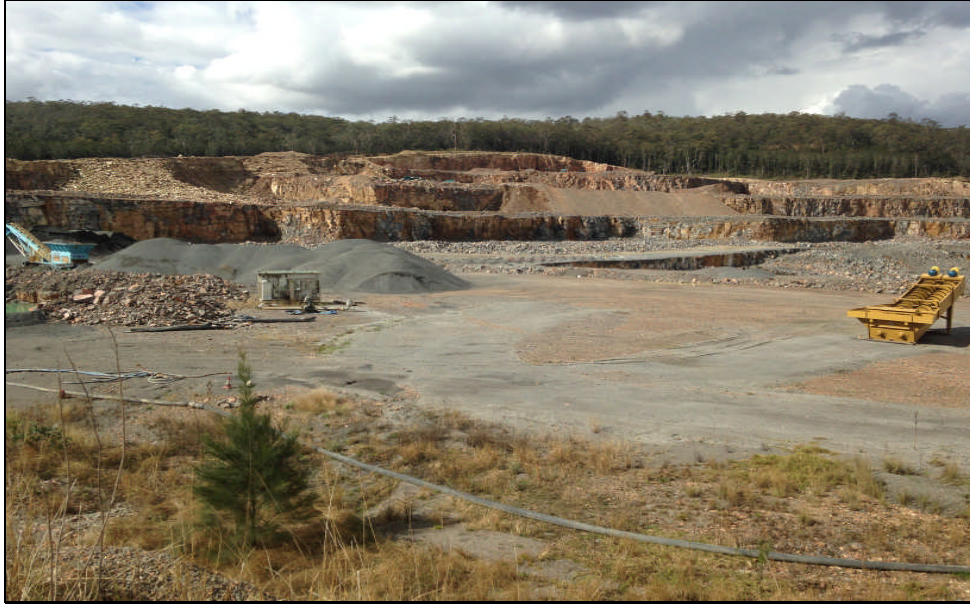
**Figure 5 – View of Daracon Quarry Floor and Faces**

The quarry faces and floor is dominated by andesite rock. There are some exposures of underlying red sandstone and clay in parts of the quarry floor. This underlying sequence is most likely to be CII the Wallaringar Formation.

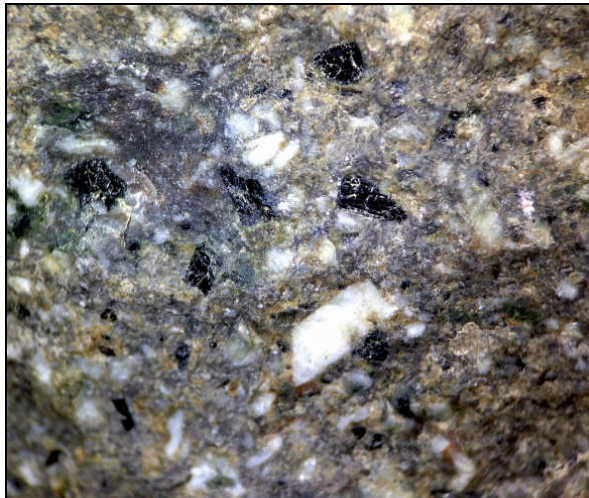
**Figure 6 – Microscopic view of Latite Tuff**

The petrological assessment of this rock has identified this as a Latite Tuff (see below sample). The large white rhombohedra crystal (plagioclase) is 3mm in length.

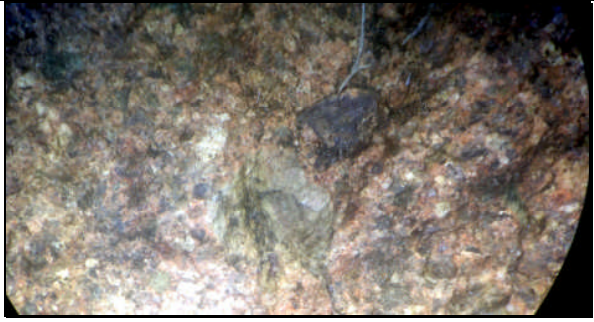
Address	Rock type (visual VGT)	Rock description (visual VGT)
27 View Street	Altered Andesitic Ignimbrite?	Brown, coarse interlocking grains, brittle in hand

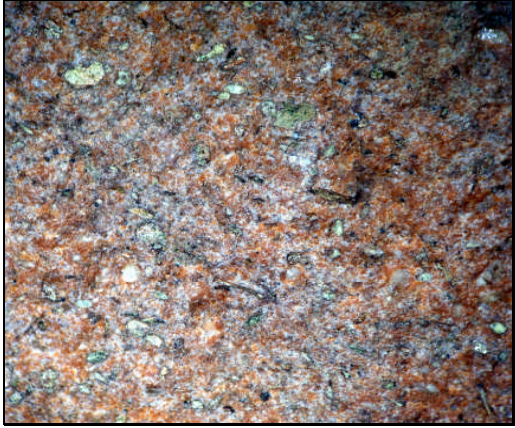
32 View Street	Pink volcanic porphyry	Pink ground mass with plagioclase crystals, hard.

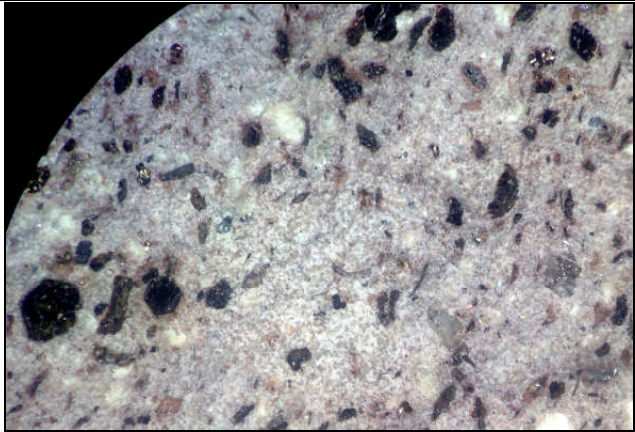
55 View Street	Micaceous Ignimbrite?	Pink Grey Volcanic, with 10% sub-rounded mica clasts, hard.

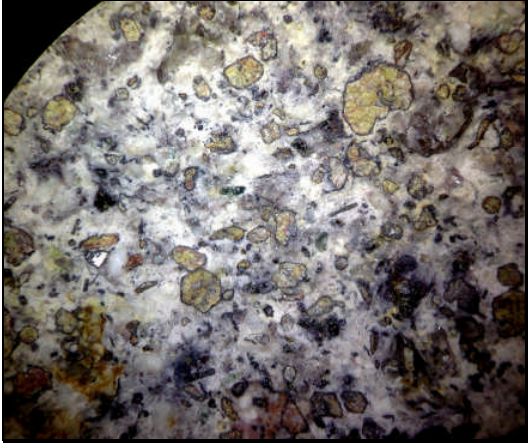
Address	Rock type (visual VGT)	Rock description (visual VGT)
57 View Street (grey)	Grey volcanic Porphyry	White cream groundmass with altered inclusions, plagioclase and micaceous crystals, hard.

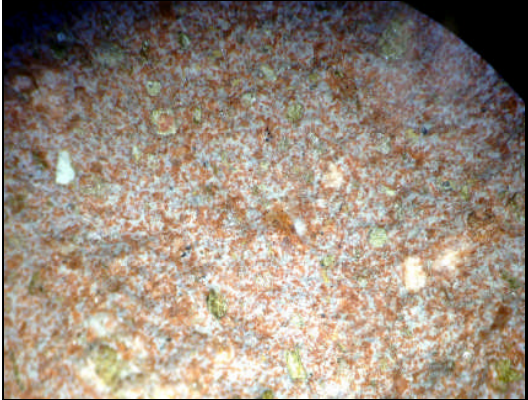
57 View Street (pink)	Pink volcanic porphyry, Rhyodacite?	Pink and cream groundmass, with quartz and plagioclase crystals

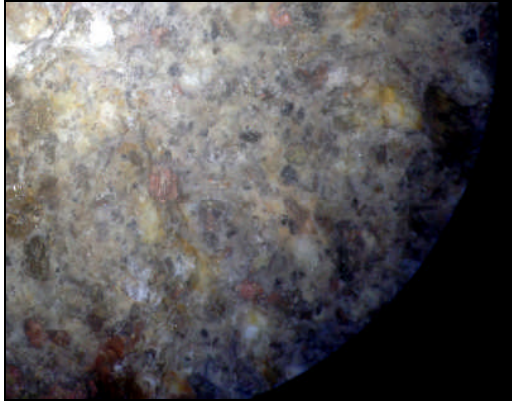
Address	Rock type (visual VGT)	Rock description (visual VGT)
58 View Street	Grey Volcanic Porphyry	Grey ground mass with plagioclase and quartz crystals

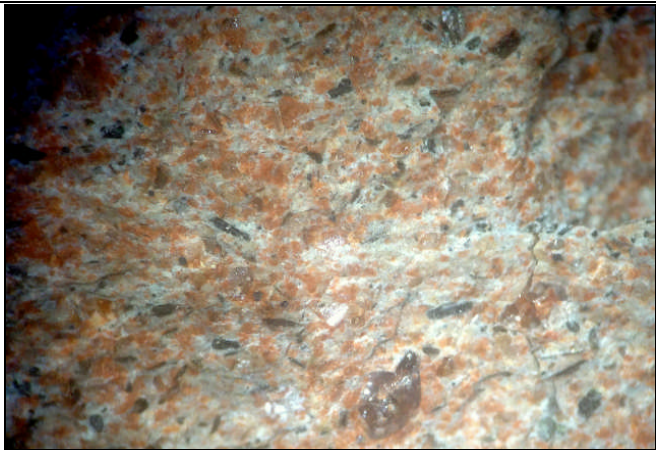
7 Wayaka Street	Pink Volcanic Porphyry	Pink cream ground mass with quartz and plagioclase crystals

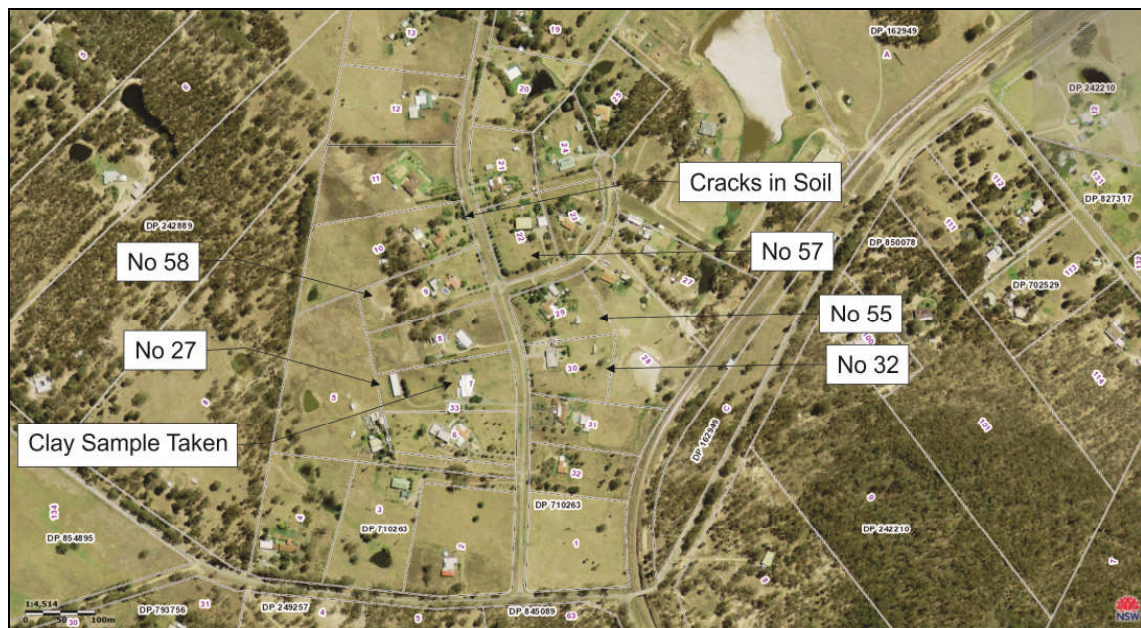
**Figure 7 – Sampling Locations**

A clay sample was taken by VGT from the back yard of 27 View Street, see *Figure 7*, and this was tested at Qualtest Laboratories for shrink / swell to determine if the sub surface strata could cause cracking in the ground and potentially in the houses.

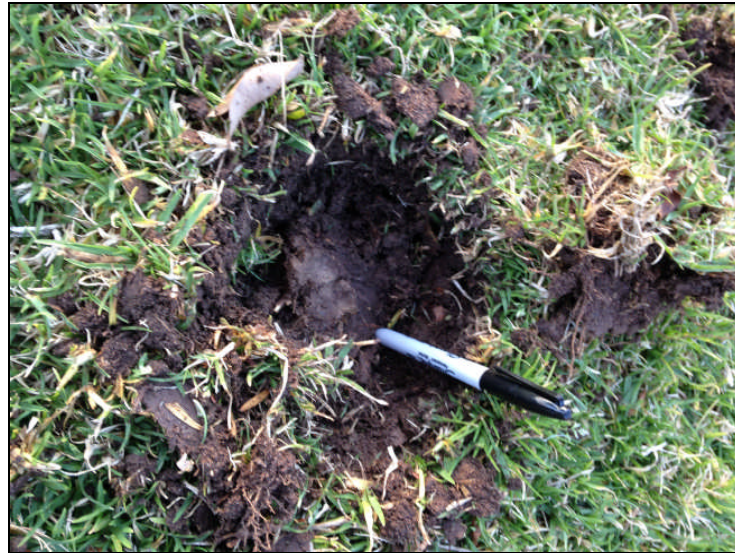
**Figure 8 – Clay Sample Hole**

The results of the test are found in Appendix A, shows that the clay has a moderate potential to crack during shrinkage, with a shrink swell index of 3.4. Discussion with Qualtest's Principal Alan Cullen, he noted that the result shows that the clay has a moderate to high potential to cracking when dry.

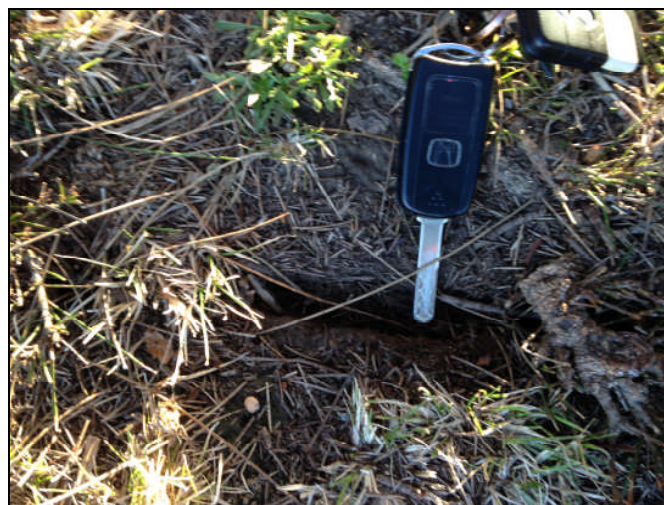
**Figure 9 – Clay Surface Cracking**

Surface cracking was found at the side of the road as seen by Peter Bellairs and Greg Thomson, at the location seen in *Figure 7* and *Figure 9* shows the typical cracks found at this location.

The clay assessment of the area showed that there was surface cracking along View Street and the shrink swell test showed a moderate level of cracking during shrinkage.
