# Aboriginal Archaeological and Cultural Heritage Assessment and Heritage Impact Statement

## Barangaroo Central SSD 6617-2014 Remediation Hickson Road Development Application

Report to Casey & Lowe Pty Ltd  
on behalf of Lend Lease Millers Point

August 2015

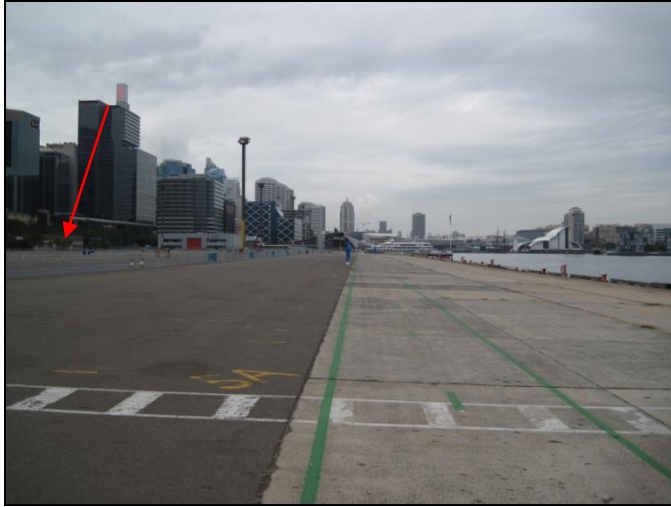
**Photograph 1:**

Facing south looking across the area designated for Stage 1 of development. The approximate area of the original shoreline is indicated by the red arrow.

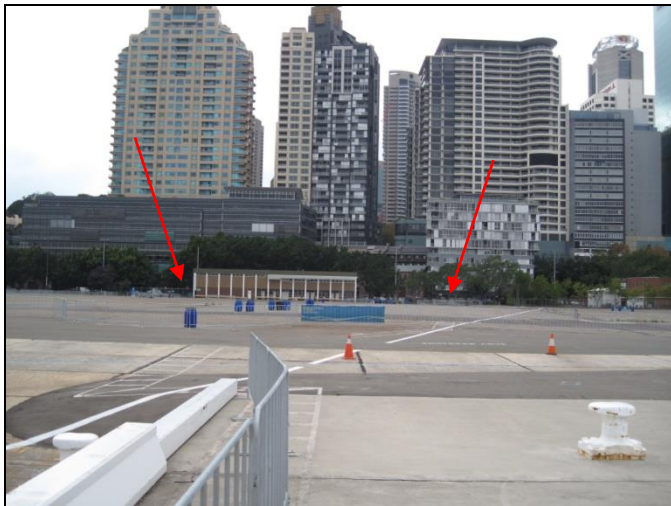
**Photograph 2:**

Facing east looking across Barangaroo towards Hickson Road. The approximate area of the original shoreline is indicated by the red arrows.

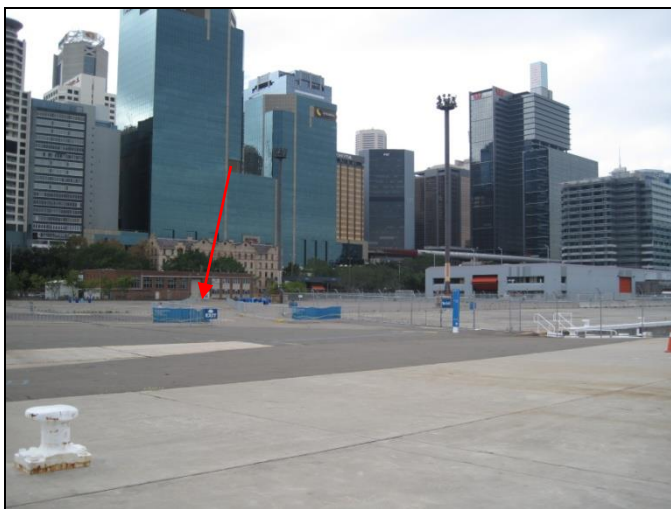
**Photograph 3:**

Looking south east across Barangaroo towards Hickson Road and the CBD. The area where the original shoreline was is indicated by the arrow.

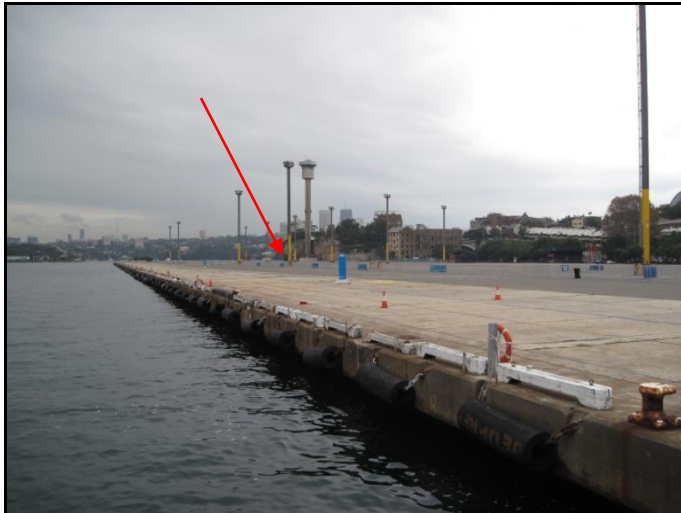
**Photograph 4:**

Looking north east across Barangaroo. The location of the area within the original shoreline is indicated by the red arrow.
