## **SSD 6624 - Slys Quarry expansion proposal Response to submissions**

Attachment: Response to agency comments  
Geological Resource Assessment – Supplementary Report (GHD, October 2015)  
Rehabilitation Plan

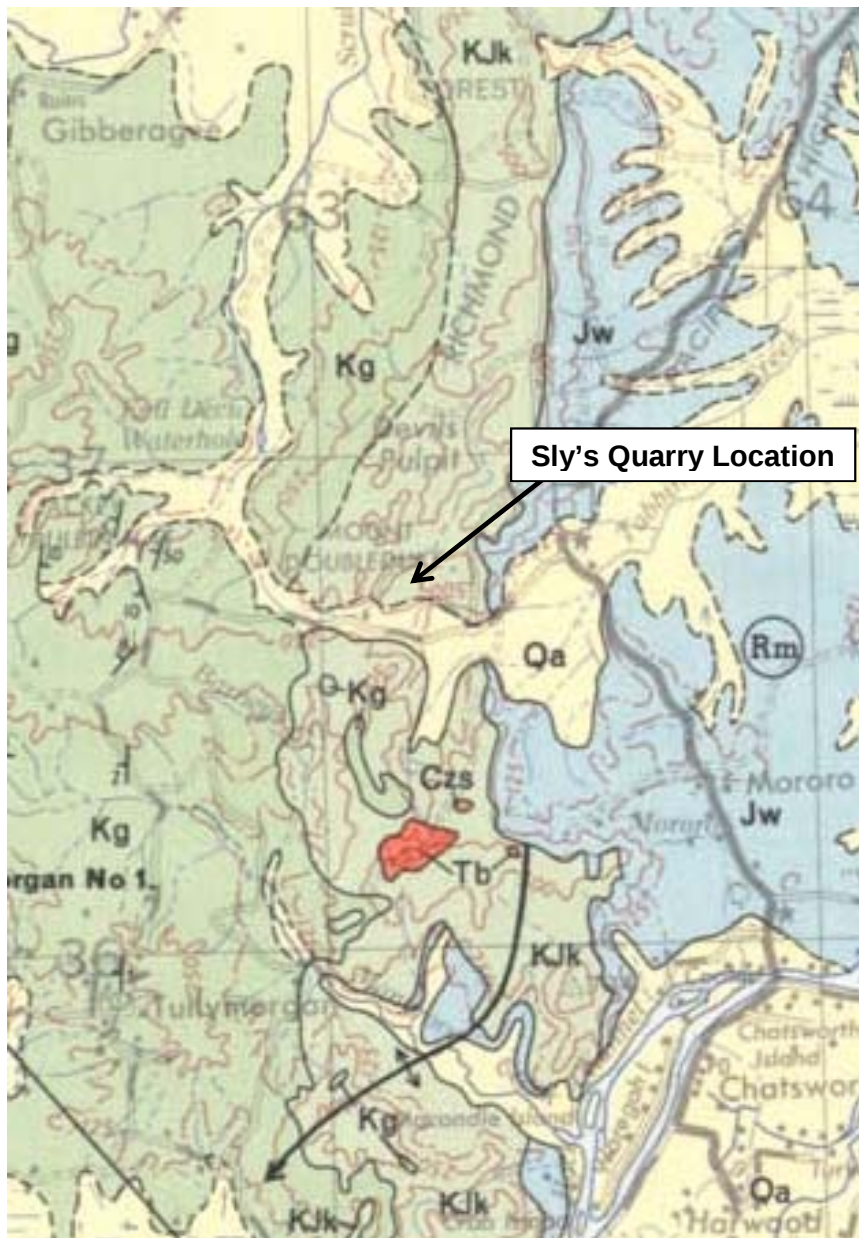
**Figure 1:** Extract from Maclean Geology Map - 1:250,000 Geological Series Sheet SH56-7, first edition 1970, compiled by the Geological Survey of NSW. The location of the quarry is noted.

The geology mapped at the site is Kjk unit, described as the Cretaceous – Jurassic aged Kangaroo Creek Sandstone – Quartz sandstone with some conglomerate.

Based on the geology we have prepared a geology map and interpreted geological sections as Figures 1 and 2 respectively.

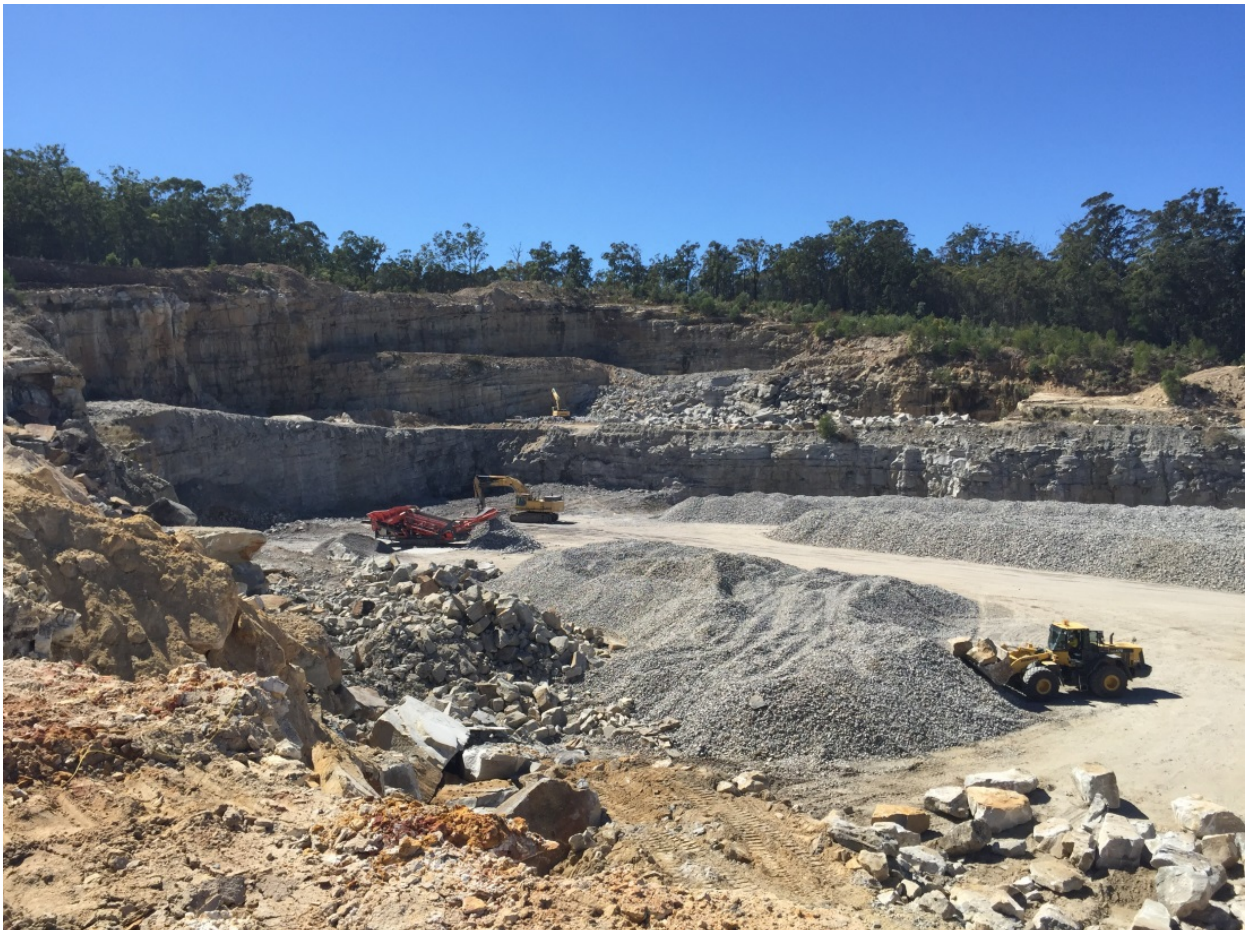
**Photo 1:** View of the quarry from the western cut face. Benches are spaced at around 10 m in height and the base of the quarry at around 44 m AHD. The dip of the sandstone beds to the north west, the left of the image is clearly visible.

Generally the sandstone beds present as several metres thick, with distinct cross bedding. A weak fining up sequence is generally present in the beds. The lower intervals of some beds are defined by pebbly lenses, with the upper contacts defined by carbonaceous inter-beds and coaly lenses. The amount of carbonaceous material is greatest in the south eastern corner of the quarry. This is the stratigraphically lowest level. Photo 1 shows a view of the quarry.

The sandstone generally presents as a pale grey sandstone which dips  $8^{\circ}$  to  $10^{\circ}$  to the north-west. The upper units exposed in the quarry face appear to be oxidised to pale yellow brown, possibly from the oxidation of disseminated sulphides within the rock mass.

Two dominant joint sets define fracturing in the quarry, and these sets are generally orthogonal to each other, with one set around  $010^{\circ}$  and a secondary set oriented around  $270^{\circ}$  to  $300^{\circ}$ .

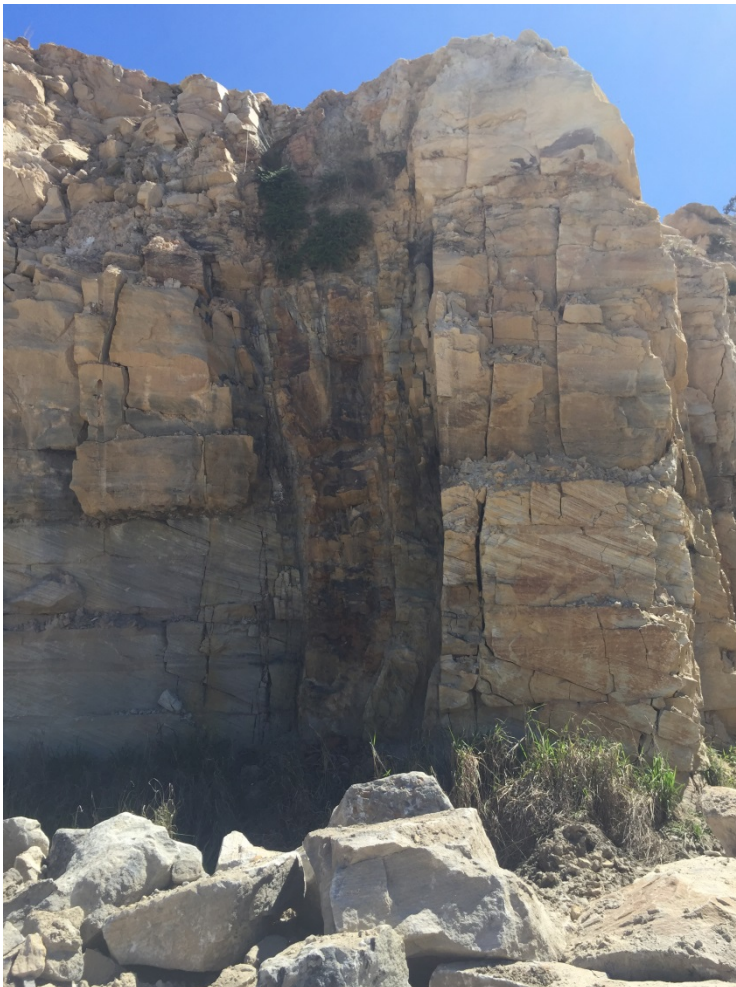
**Photo 2:** Weathered basaltic dyke in the northern wall of the quarry. The dyke is around 1 to 2 m wide and deeply weathered. No vertical displacement of the sandstone appears to have occurred across the dyke. Cross bedding within the sandstone beds is clearly visible.

A weathered basaltic dyke transects the quarry and is visible in both pit walls. The dyke ranges in thickness from around 1 m to 2 m, and has been distinctly weathered. Observation of a gravel marker bed either side of the dyke indicates that little to no vertical displacement of the sedimentary rocks has occurred across the dyke.

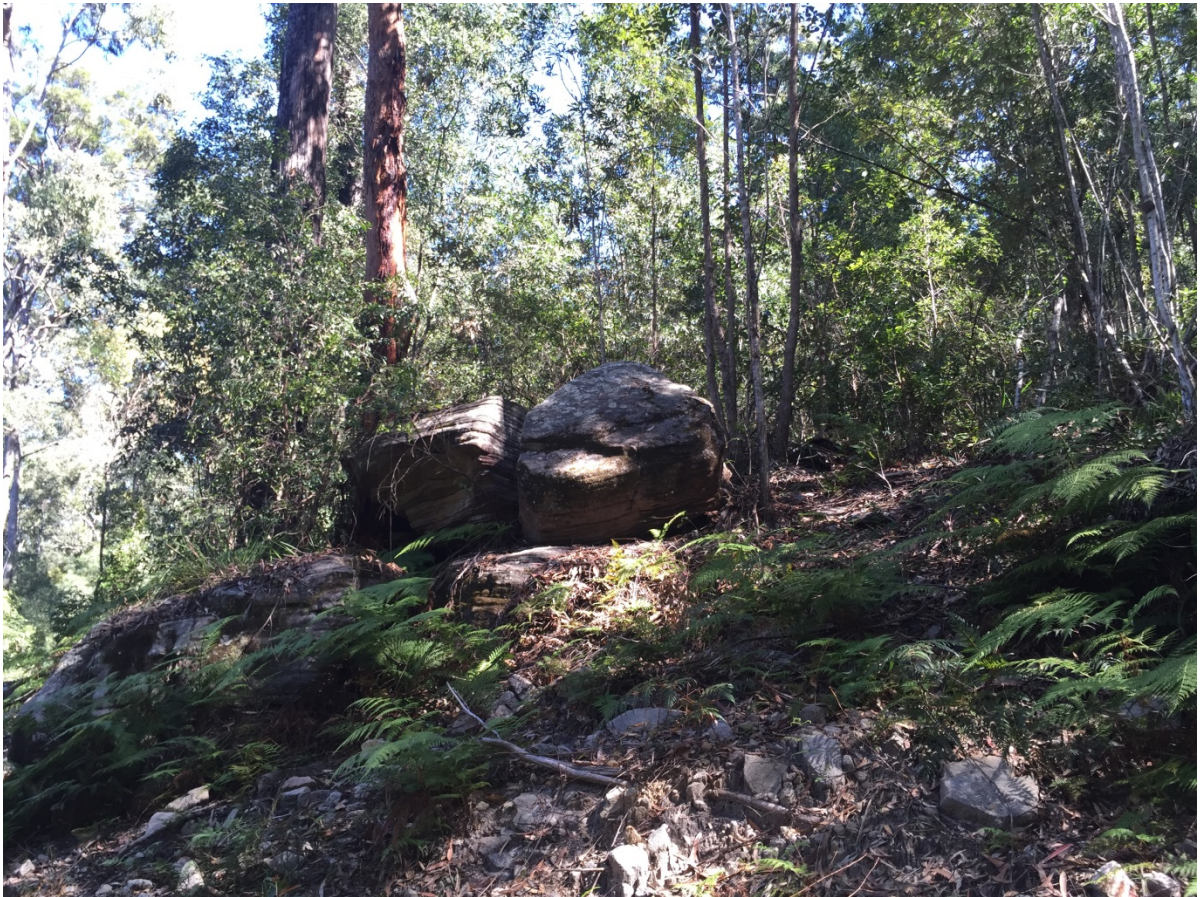
**Photo 3:** A sandstone outcrop within the expansion area north of the existing quarry. The sandstone was interpreted to be Kangaroo Creek Sandstone.

Distant from the quarry face, regular sandstone outcrops are observed within the bushland. Photograph 3 shows one such outcrop. The outcrops are numerous and indicate that the Kangaroo Creek Sandstone can be reasonably expected to underlie the whole of the proposed expansion area. Photo 3 shows one observed outcrop.

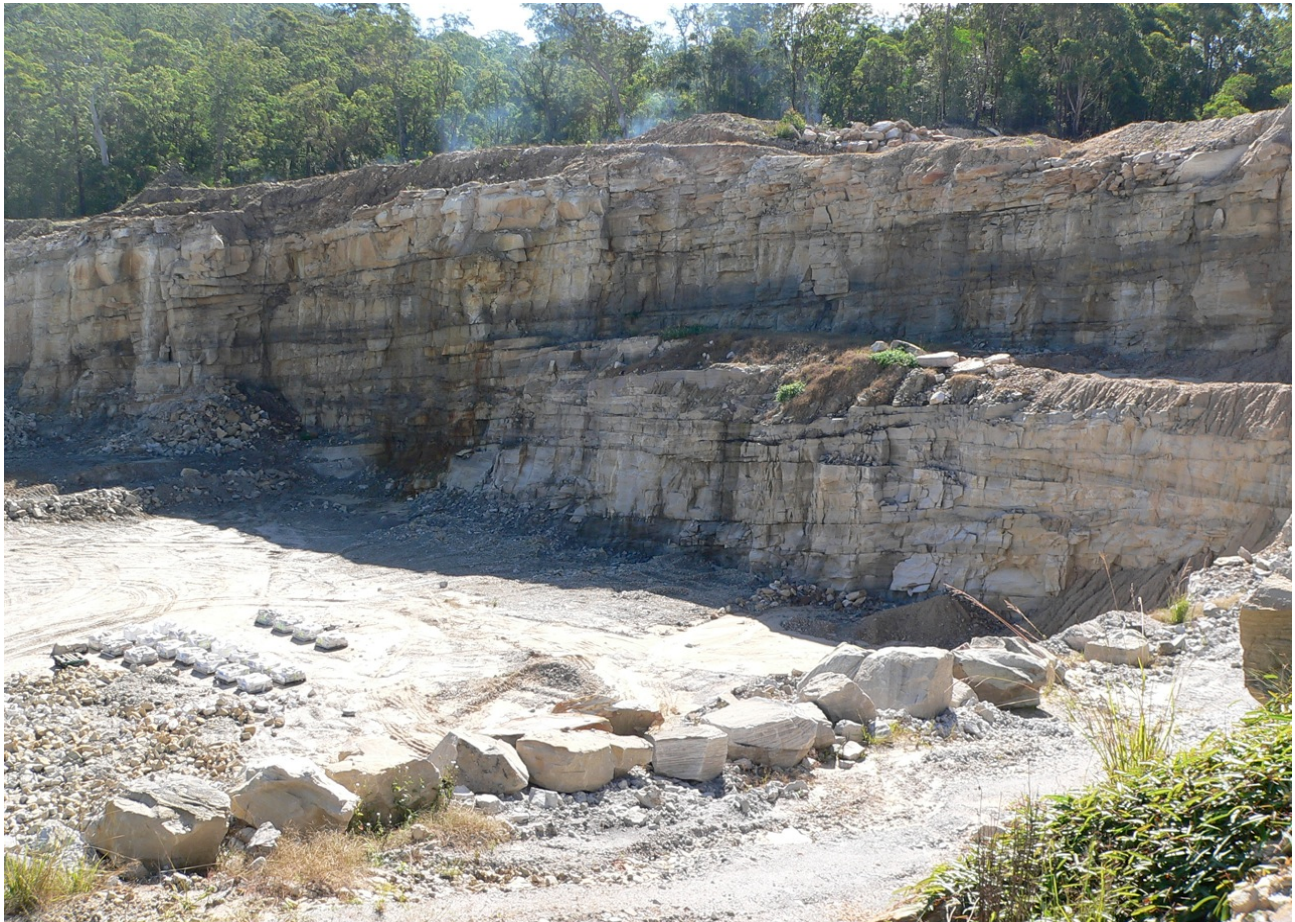
Rear (northern) wall of Newman's sandstone quarry. The wooded area behind is part of the proposed extension.

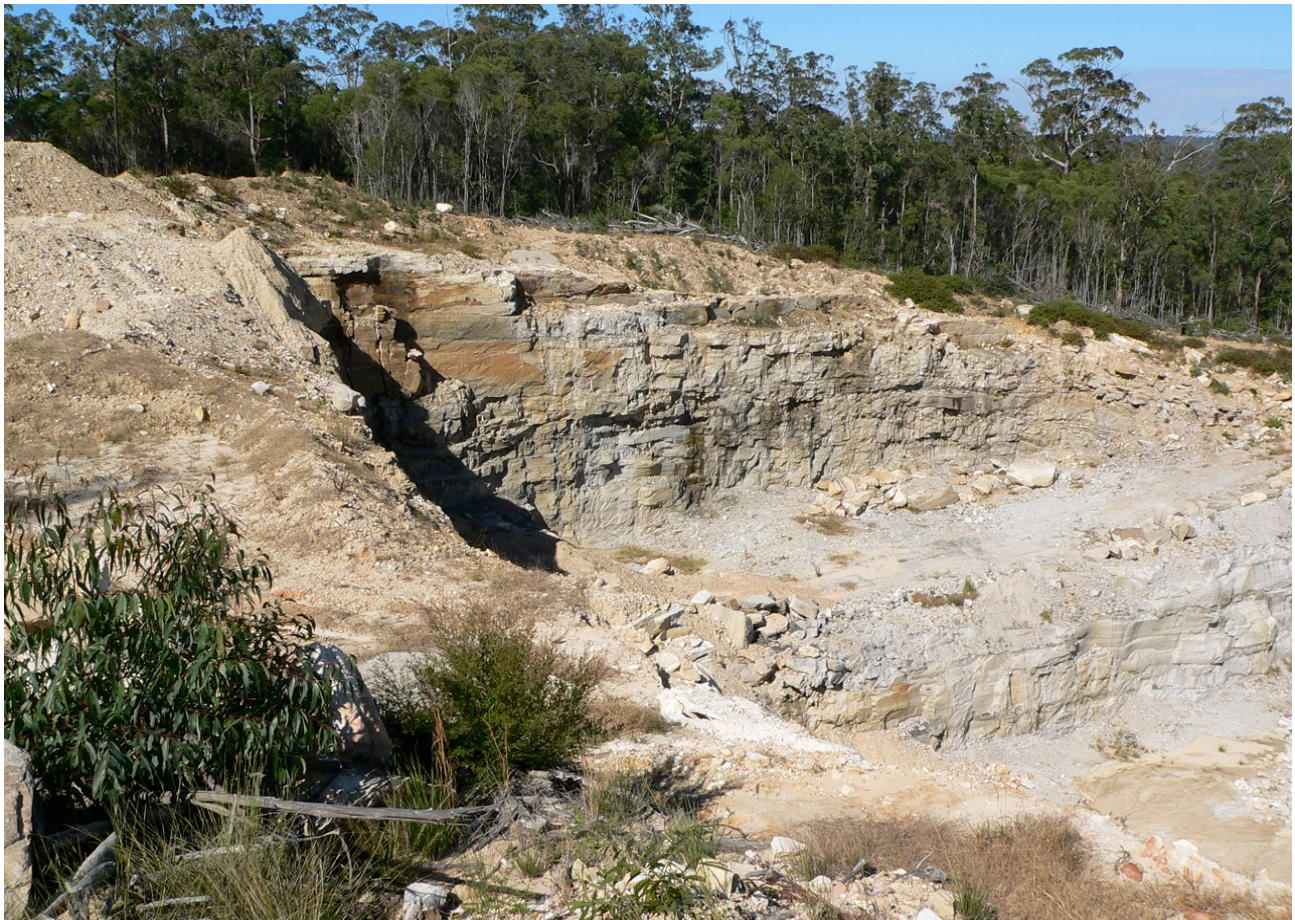
Eastern wall of Newman's sandstone quarry. The wooded regrowth area behind is part of the proposed extension.

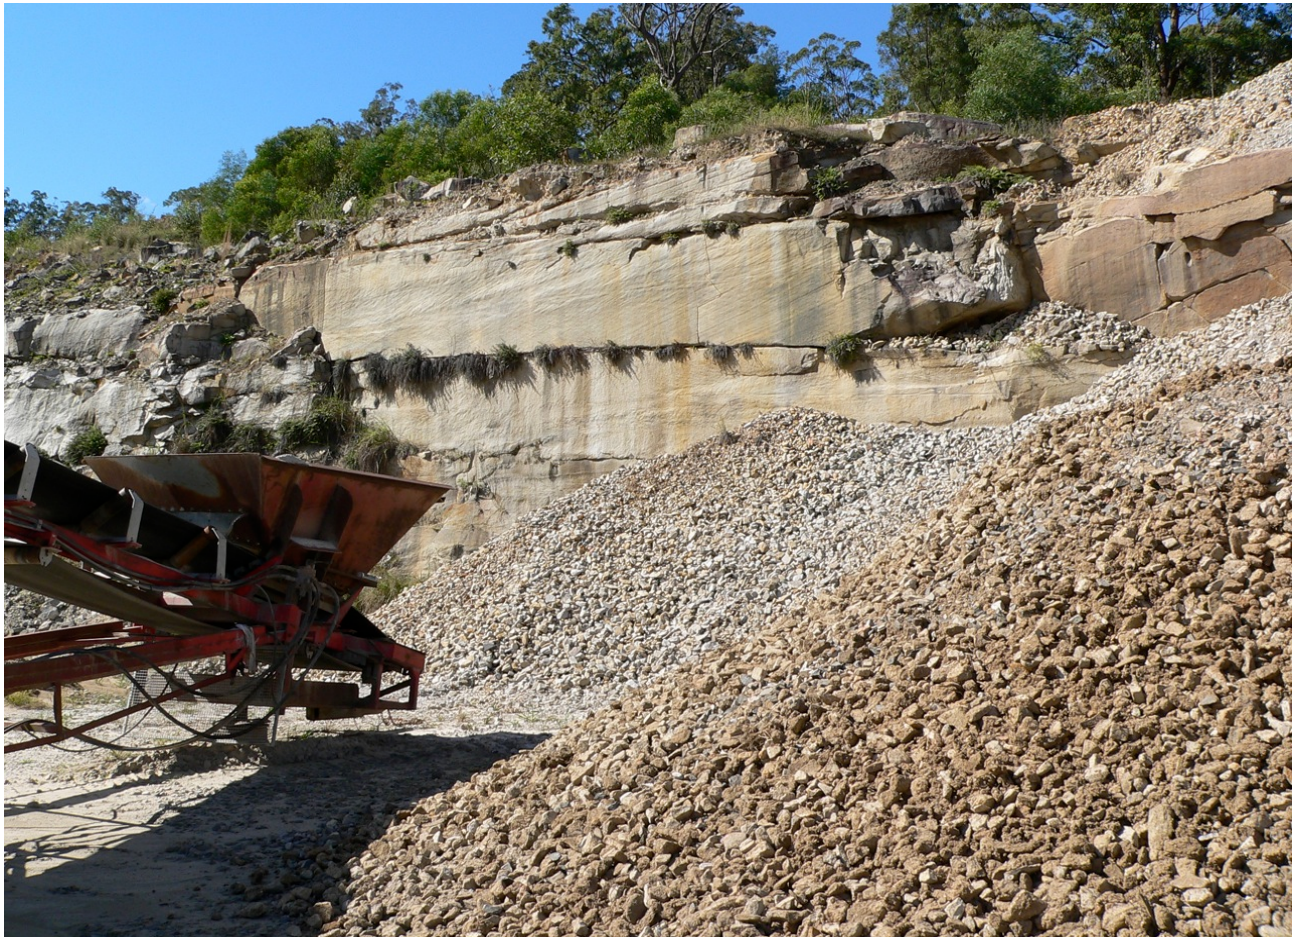
Several thick beds of coarse-grained sandstone on the eastern quarry face

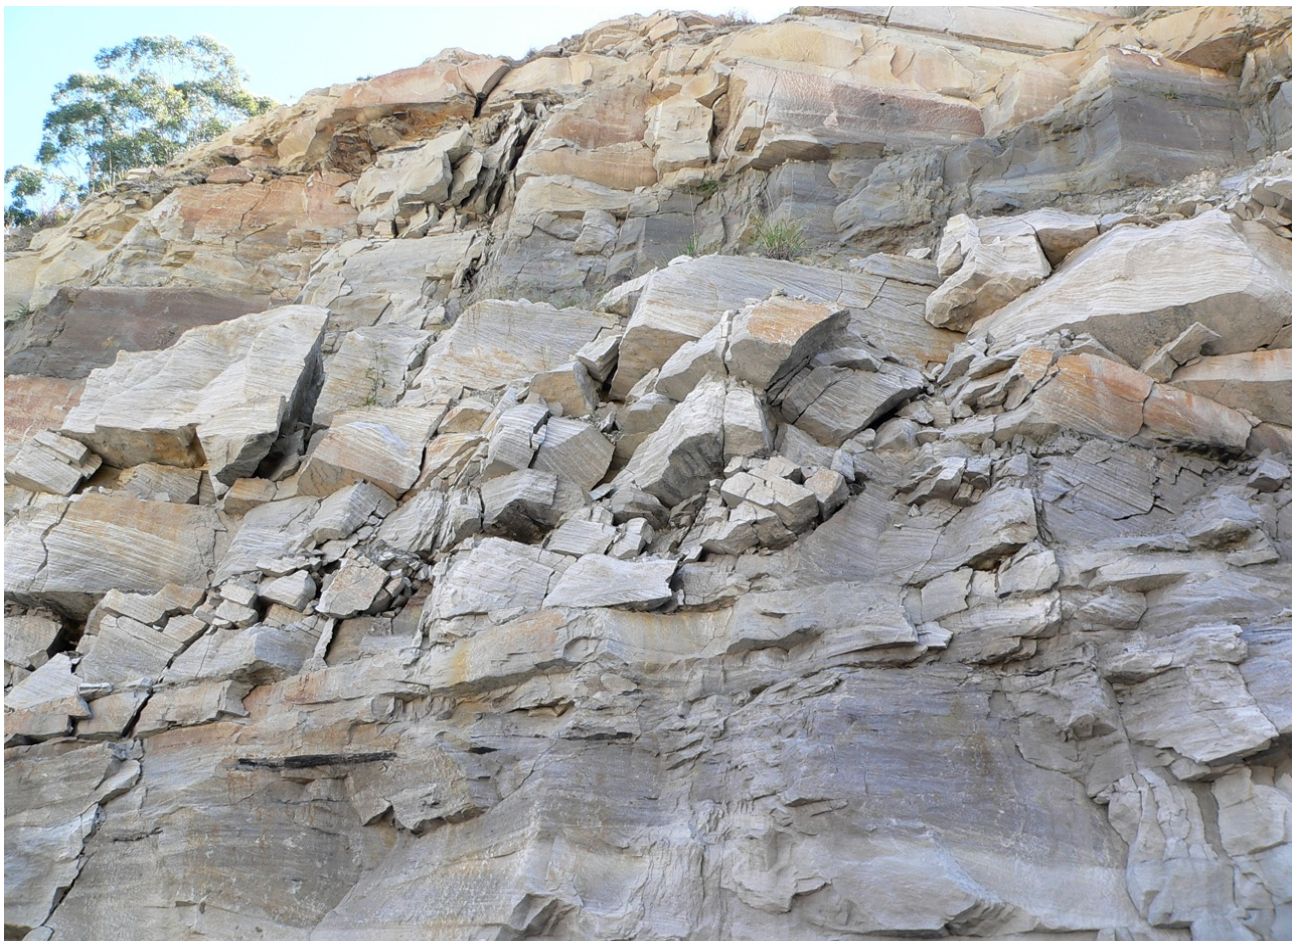
Western wall of Newman's sandstone quarry showing the typical bedding style including the prominent cross-bedding

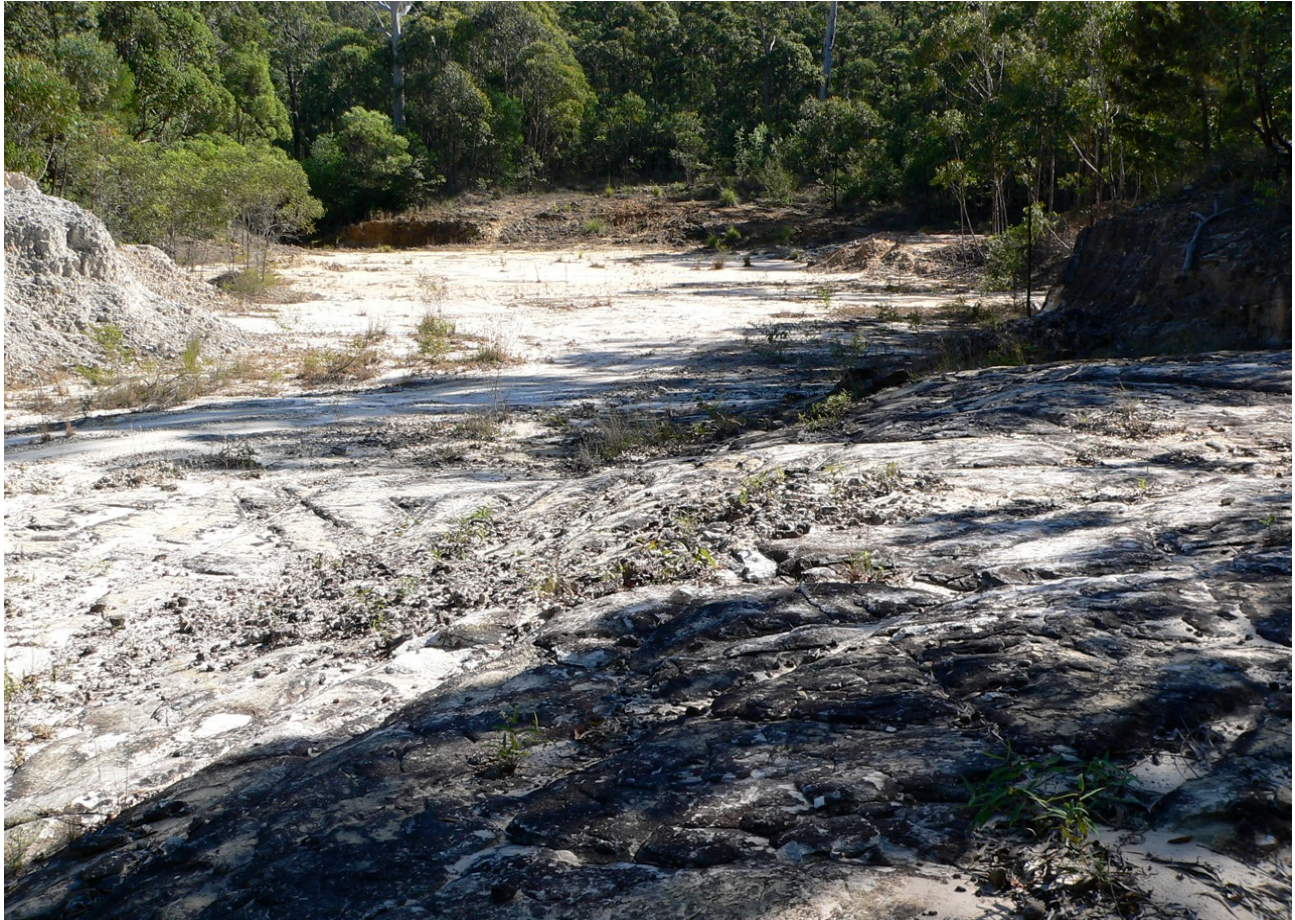
Track from northern quarry face to an original sandstone quarry/pit to show the northern limit of the proposed extension. Note the almost continuous exposure of sandstone

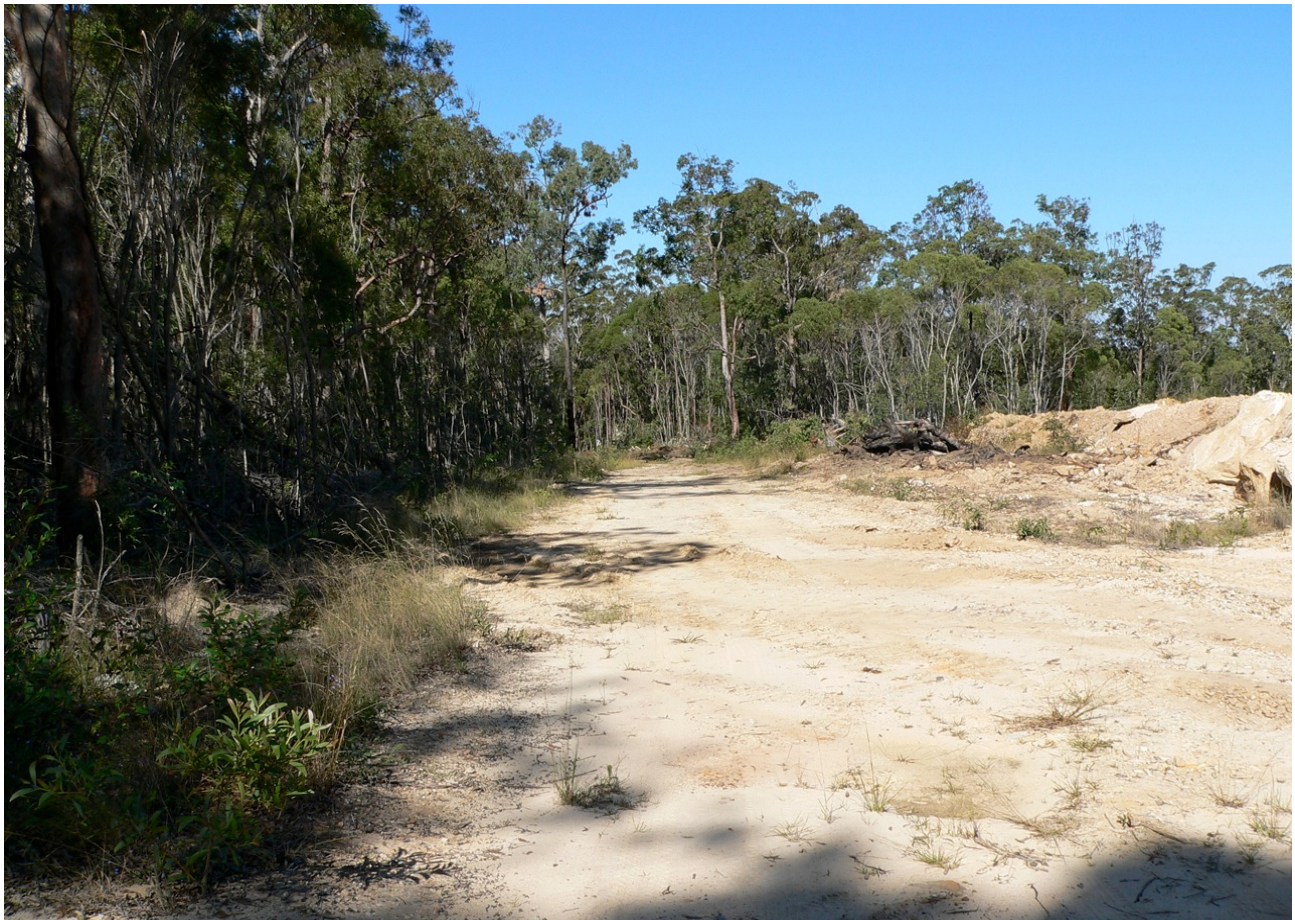
Looking east along the track above the existing quarry marking the eastern portion of the proposed extension
