**Darling Square - South East Plot**

Geotechnical assessment for SSDA 9

South East Plot  
Geotechnical Investigation Report

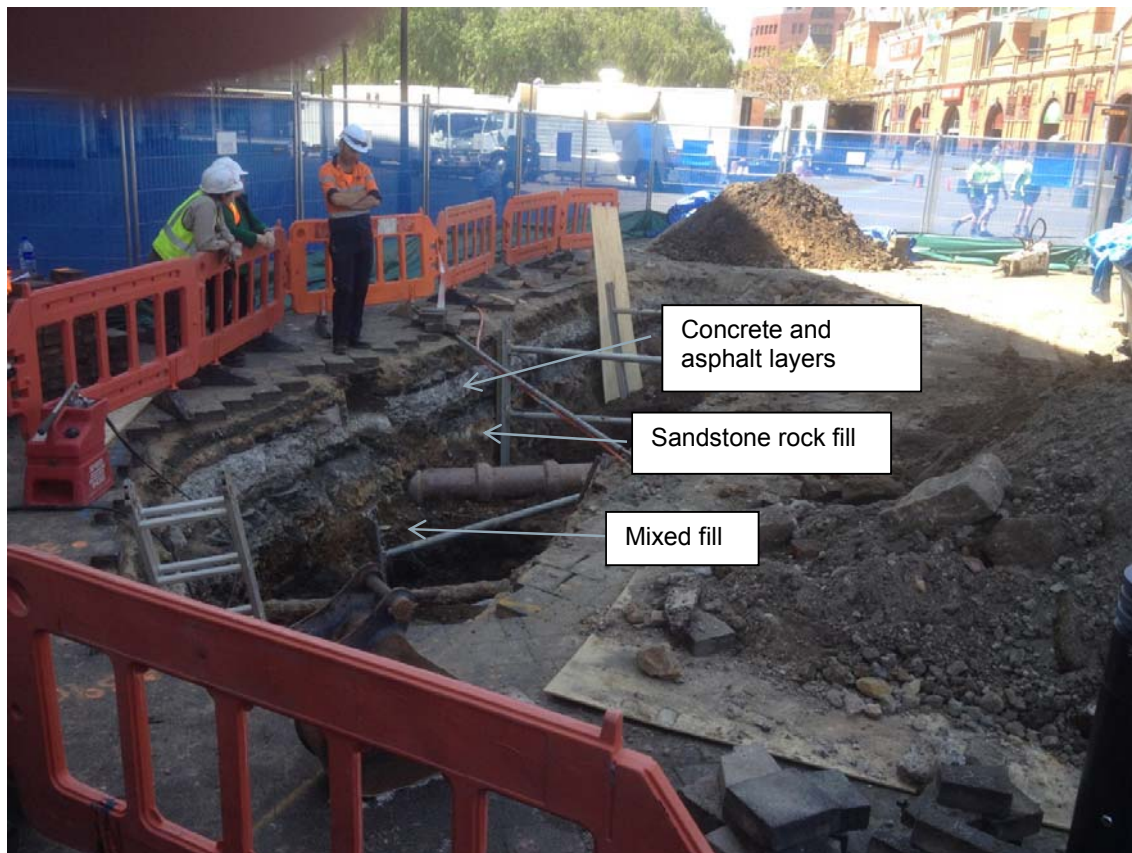
**Photograph 1: Archaeological Excavation at approximate R2-5 location**

Additional to the borehole logs, Photo 1 shows some of the fill profile in an archaeological excavation on the south side of the QCUA near R2-5 borehole location. The excavation was not logged.
