Report on  
Preliminary Site Investigation with Limited Sampling

Biological Sciences Project  
UNSW Gate 11, Botany Street, Kensington

Prepared for  
The University of New South Wales

Project 73492.03 - Rev 4  
February 2014

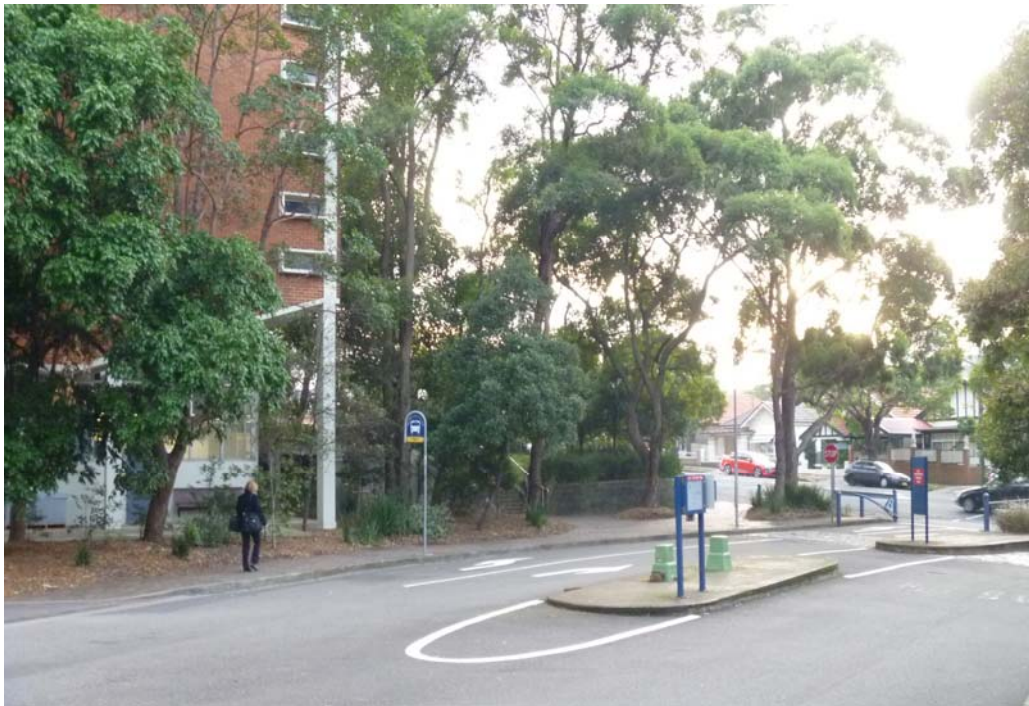
Photo 1 – Site access via Gate 11, Botany Street, Kensington

- Access was made available via Gate 11, located in the south-eastern portion of the site (Photo 1, Appendix B).
- The ground level of the Biomedical Theatres building was used as a science laboratory workshop (Photo 2).

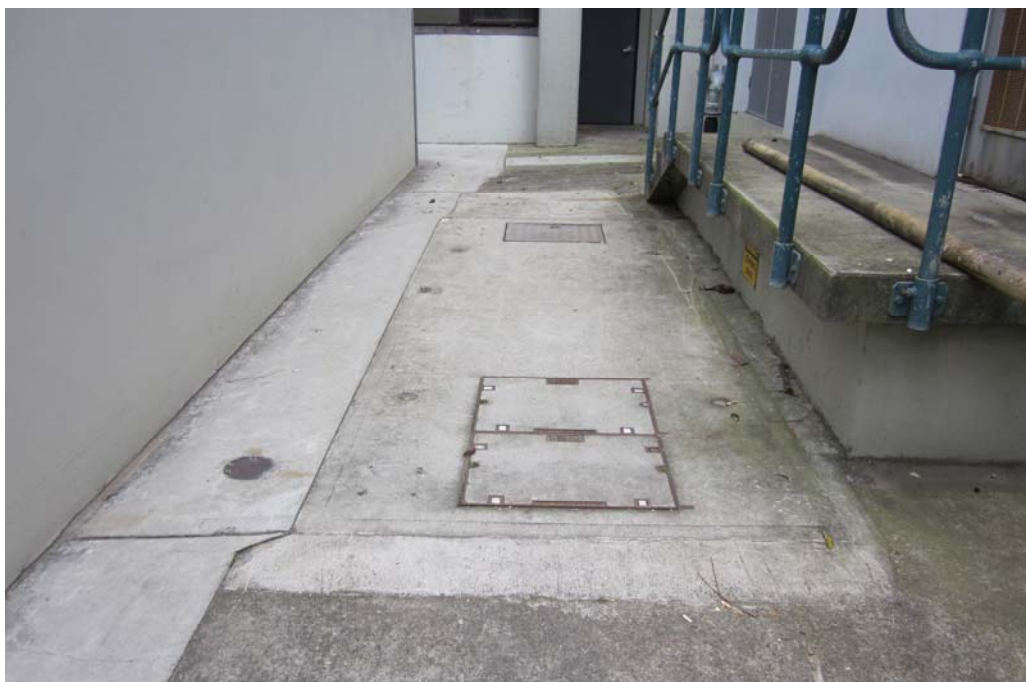
| Potential AEC | Description of Potential Contaminating Activity | Chemicals of Concern |
|---|---|---|
| Underground trade waste tank (coded D26 – 2/69) | An underground trade waste tank was discovered during the site inspection. A soil test bore was drilled in the vicinity of the tank to possibly determine the condition of the tank i.e. any potential for leakage. | No information is available on the tank contents except that it is used for “dilution” purposes. Assumed to contain wastes with an acid pH. |

Photo 4 – Liquid trade waste tank observed between the BEES Work Area and Substation No. 6.

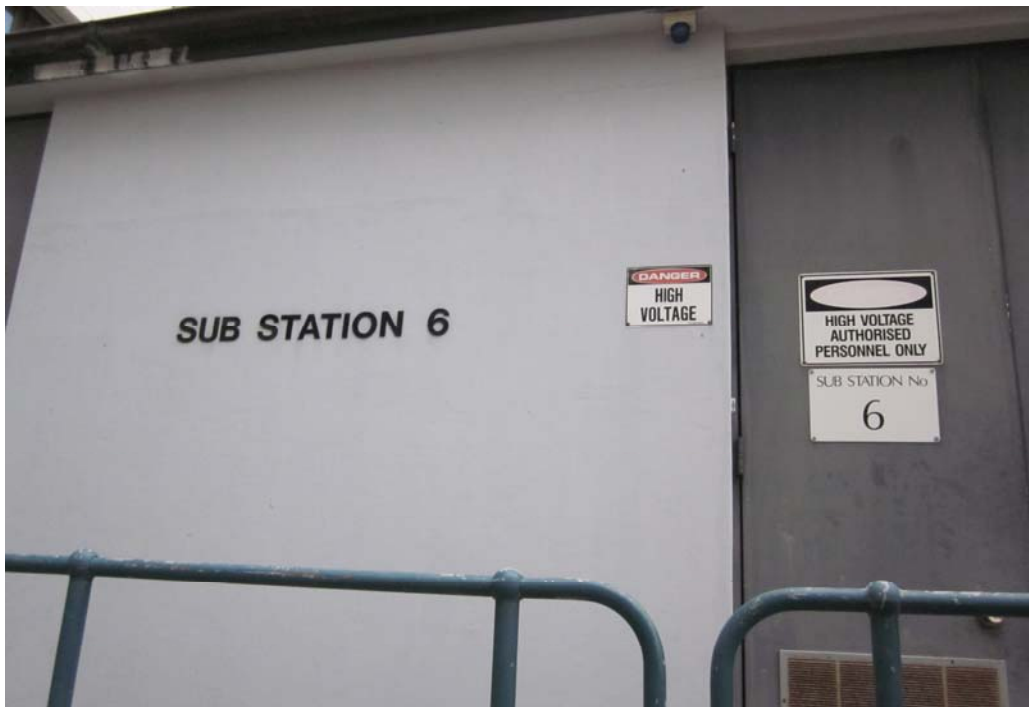
- A substation (No. 6) was observed to the west of the Biomedical Theatres (Photo 5).
- A biological hazard waste (biowaste), chemical waste and general waste storage areas are located at rear of the Biomedical Theatres, adjacent to the loading dock zone (Photo 6).

Photo 5 – Substation No. 6

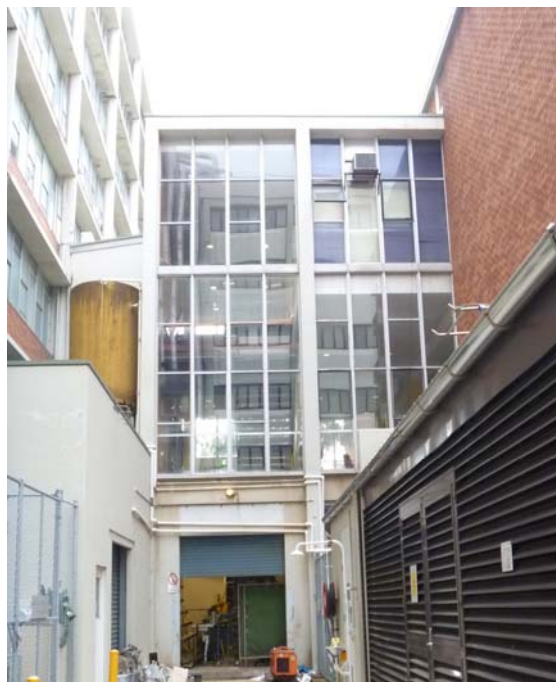
| Potential AEC | Description of Potential Contaminating Activity | Chemicals of Concern |
|---|---|---|
| Chemical waste and general waste storage area. | Given that the waste storage areas were observed to be generally well maintained and isolated with hardstand below, the potential for soil and groundwater contamination is considered to be low or limited with the exception of accidental spillage. | Heavy metals, TPH/BTEX, PAH and phenols. |

Photo 6 – Biological hazard waste, chemical waste and general waste storage area located at the rear of the Biomedical Theatres.

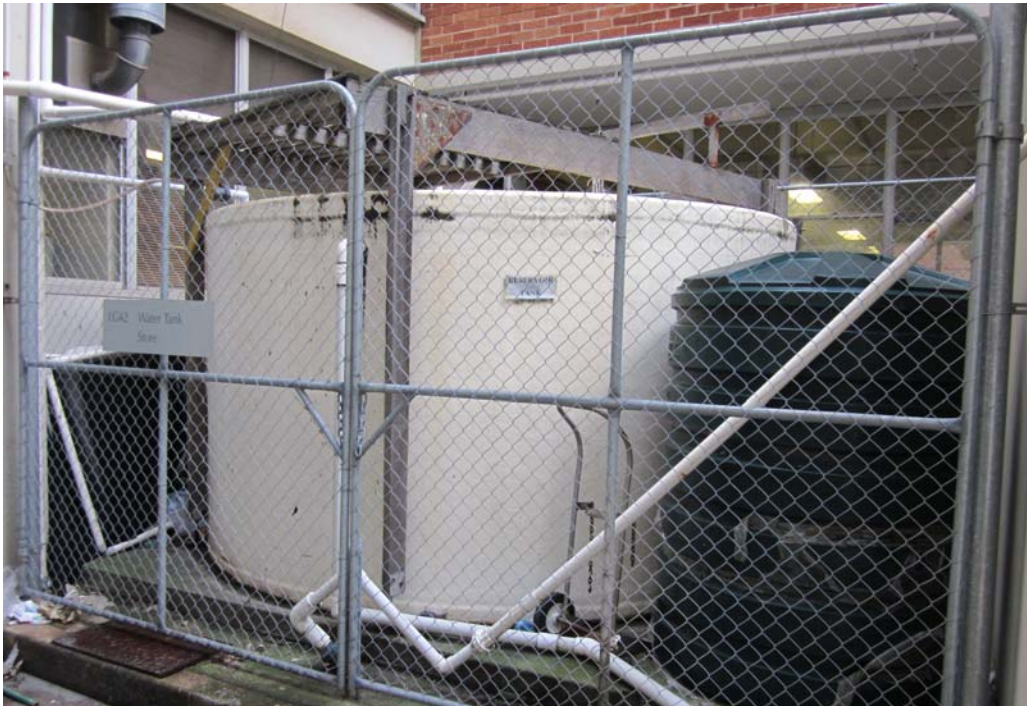
- An aboveground reservoir tank was observed adjacent to the chemical waste storage area (Photo 7).
- A landscaped garden area with above-ground and underground services, concrete paths and stairs to the east (Photo 8).

Photo 7 – Aboveground reservoir tank

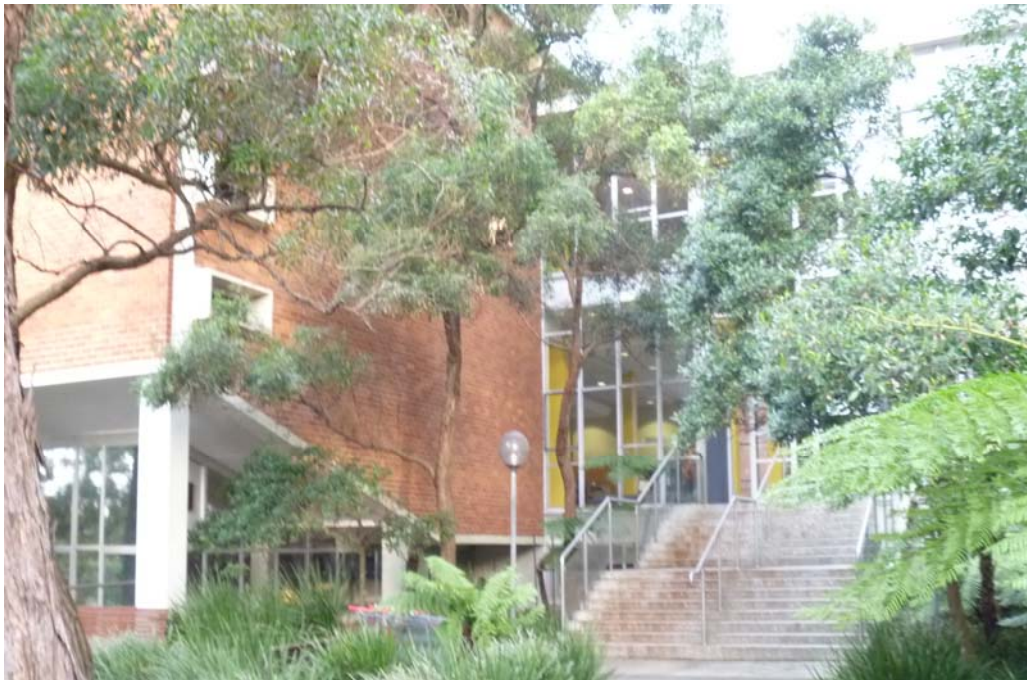
Photo 8 – A landscaped garden area with above and underground services, concrete paths and stairs to the east.

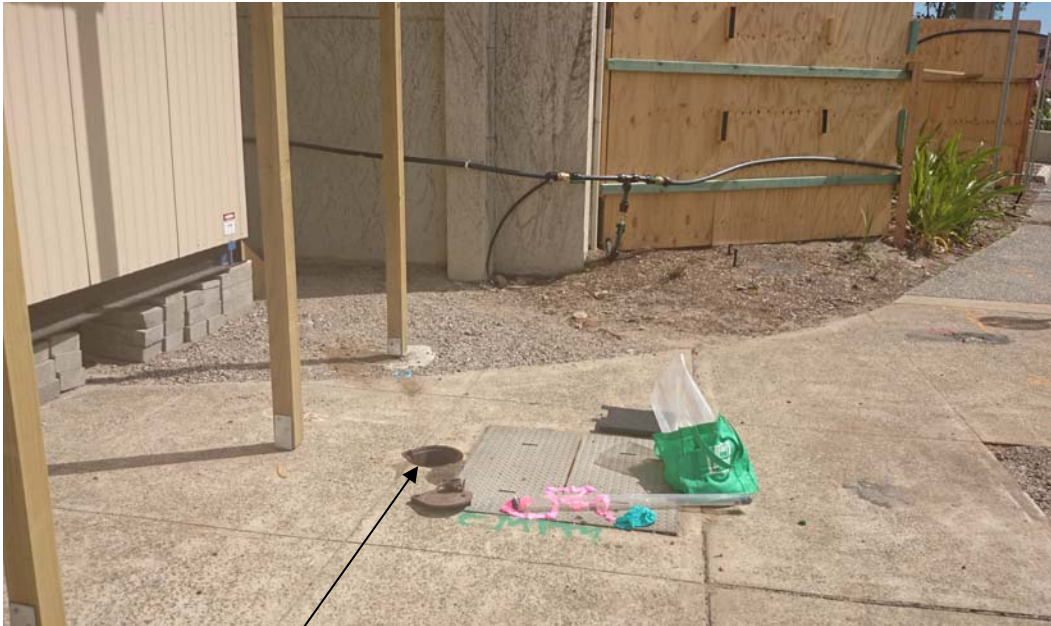
Fill Point

The UPSS comprises one underground storage tank (UST), with no bowser observed. The locations of the pipework and outlet point for the UST are not known. The UST location has been identified

Photo 9 – Fill point for UPSS to the east of Building E27
