Our Ref: PSM4669-017L

3 May 2024

**RE: LANCELEY PLACE DATA CENTRE, ARTARMON - PROJECT EOS - PRELIMINARY  
GROUNDWATER IMPACT ASSESSMENT**

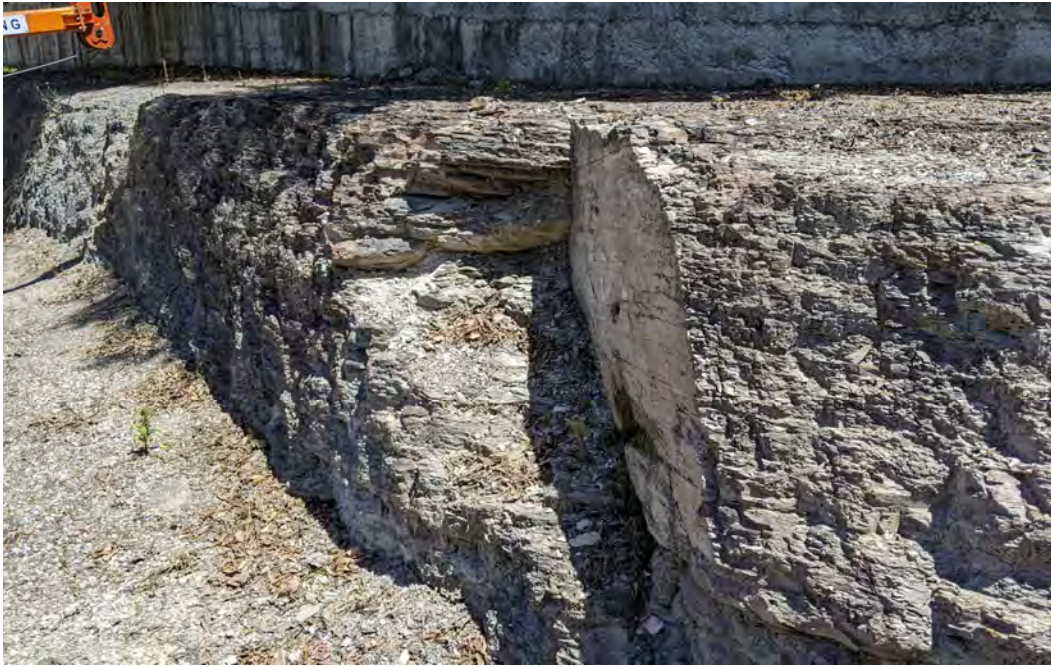
Photo 5 - Joint observed in rock cutting along south-west boundary of the site

Jointing observed in the rock cutting exposed along the southwest boundary of the Site were consistent with those described above. Photo 5 in Figure 4 contains a photo of one such joint.

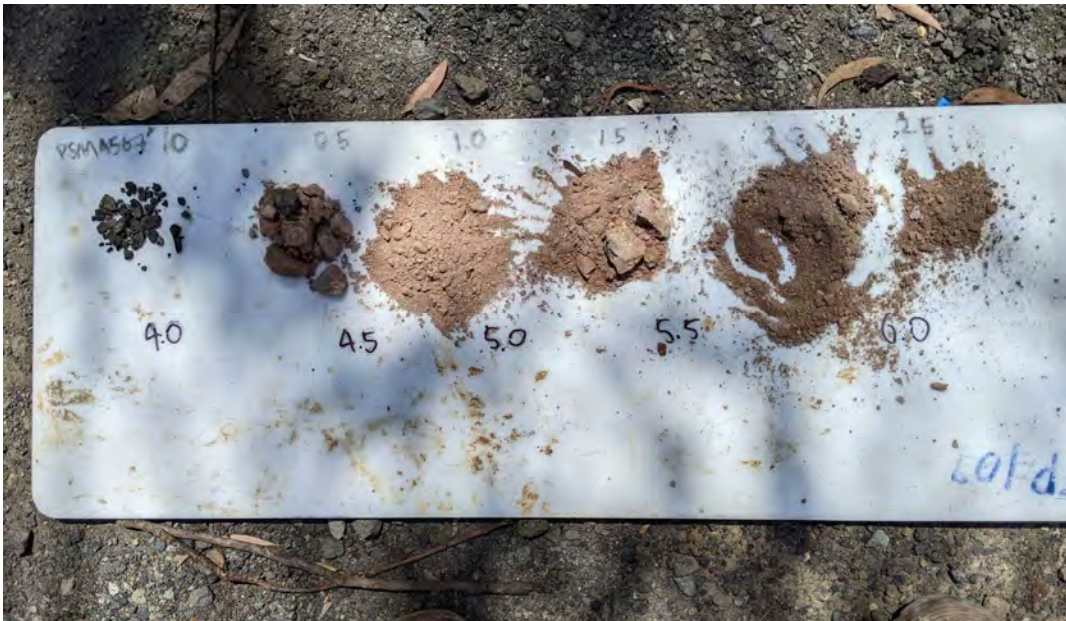
Photo 6 - Soil profile at BH04

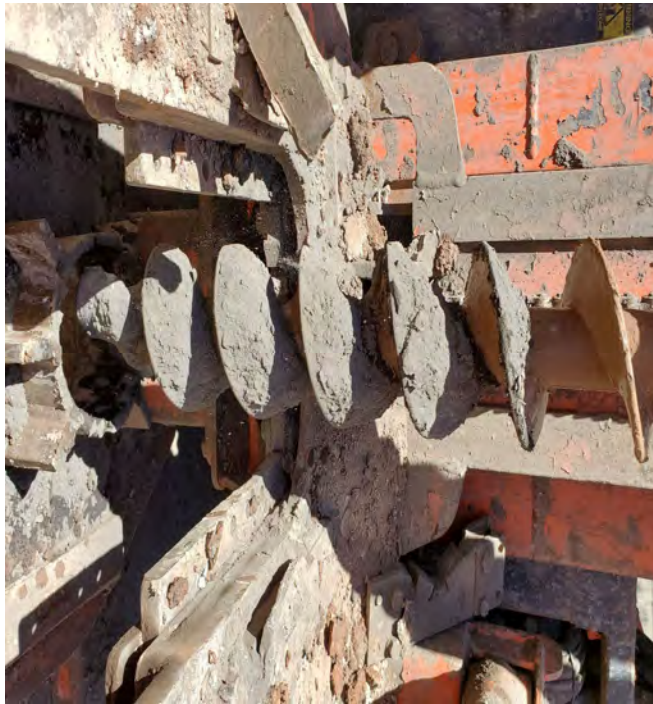
Photo 7 - SILTSTONE encountered near surface at BH05

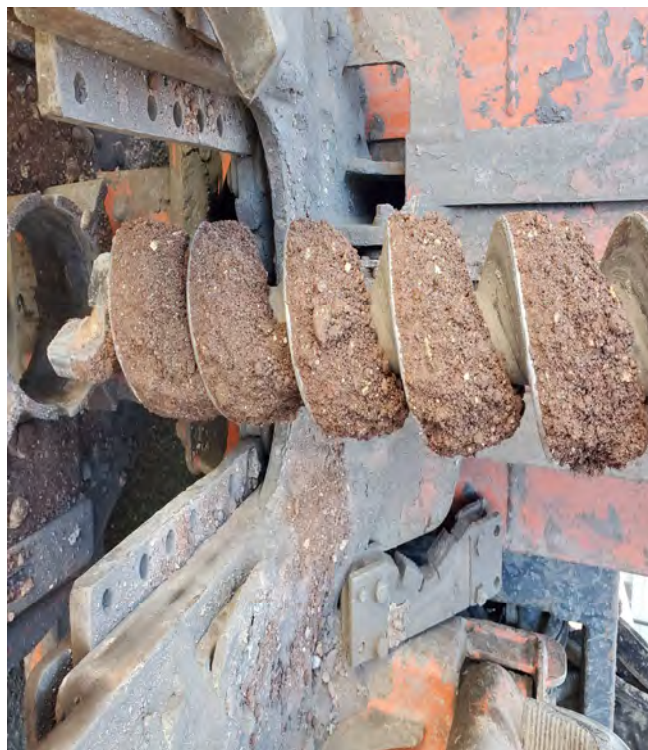
Photo 8 - Sandy GRAVEL with Clay (FILL) observed in BH06

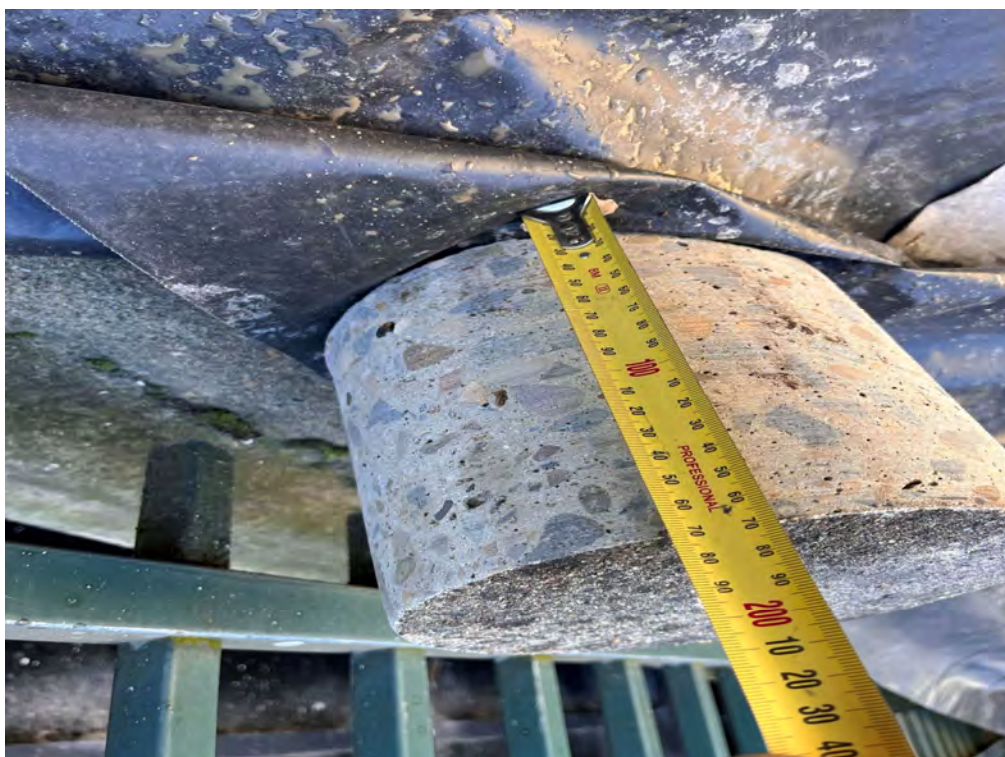
Photo 14 - Measurement of the Depth of Concrete Core at BH10

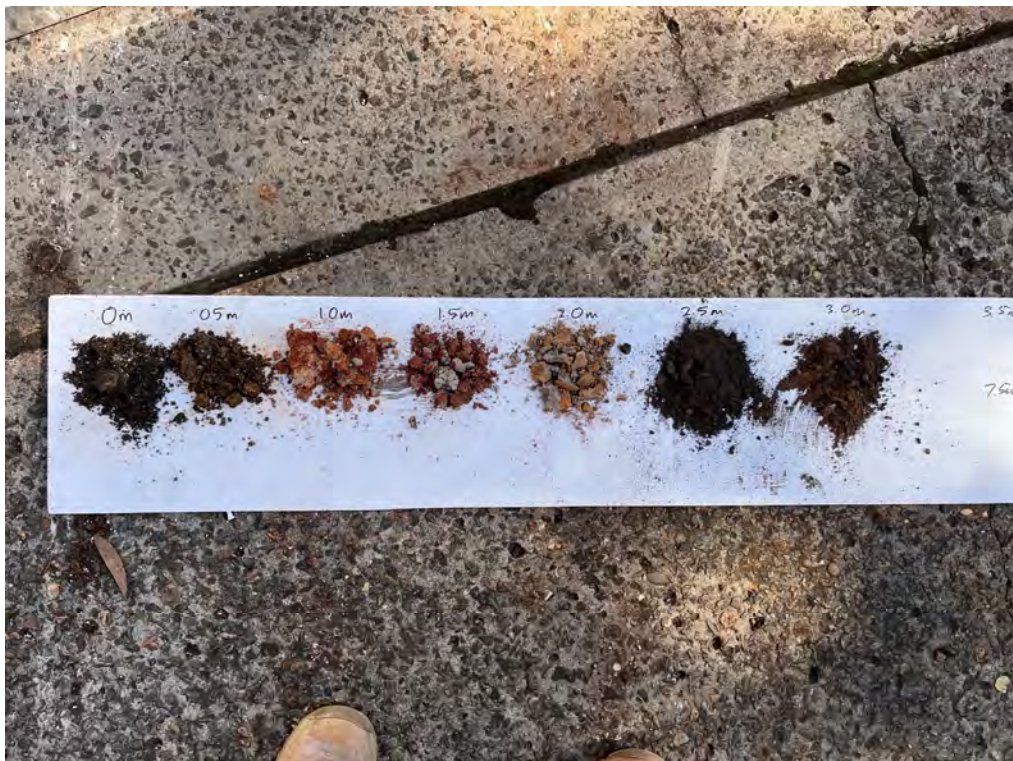
Photo 15 - Soil Profile at BH11

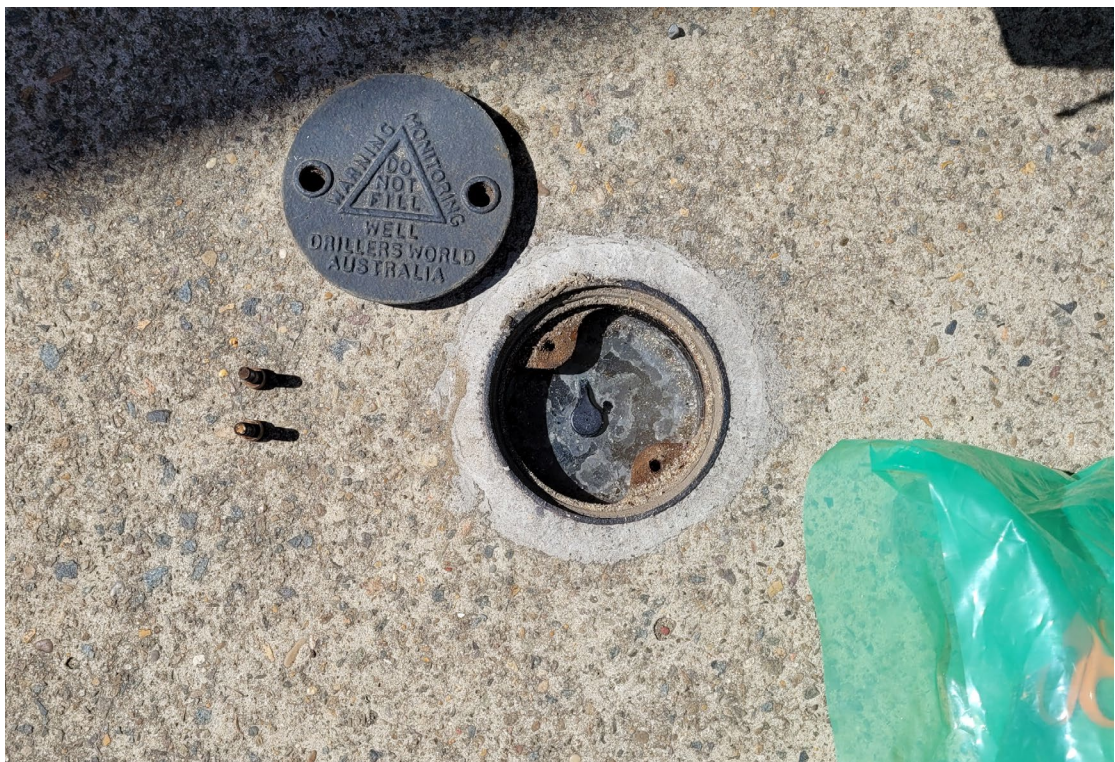
Photo 1 - Water observed outside well casing of BH1 on 18 November 2022

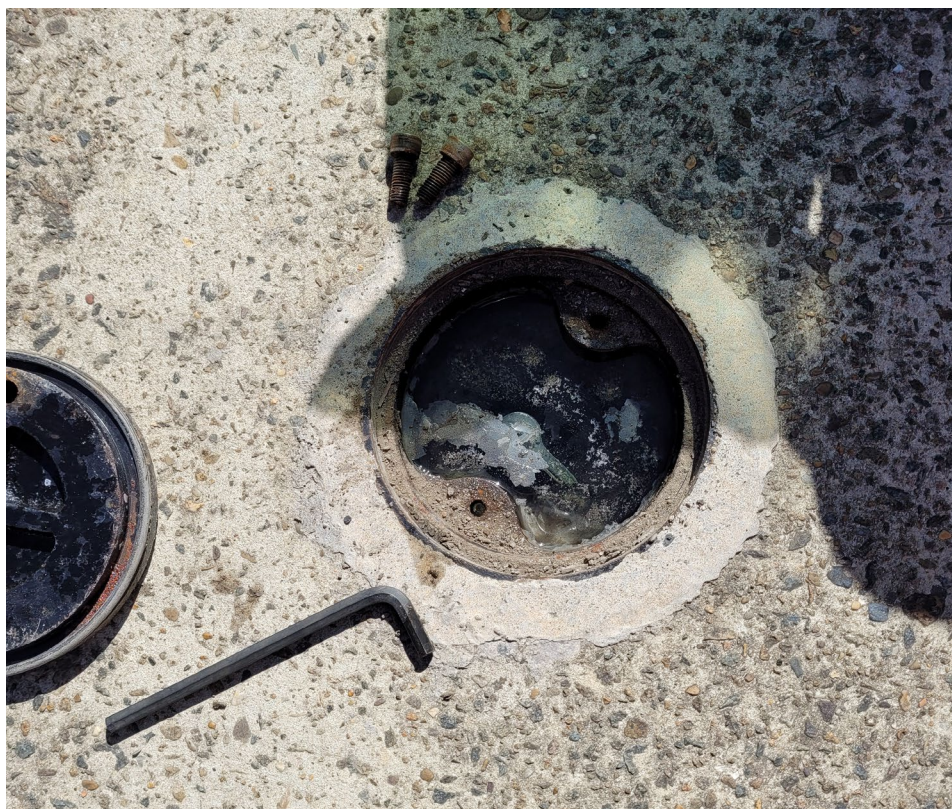
Photo 2 - Condition of BH12 on 18 November 2022

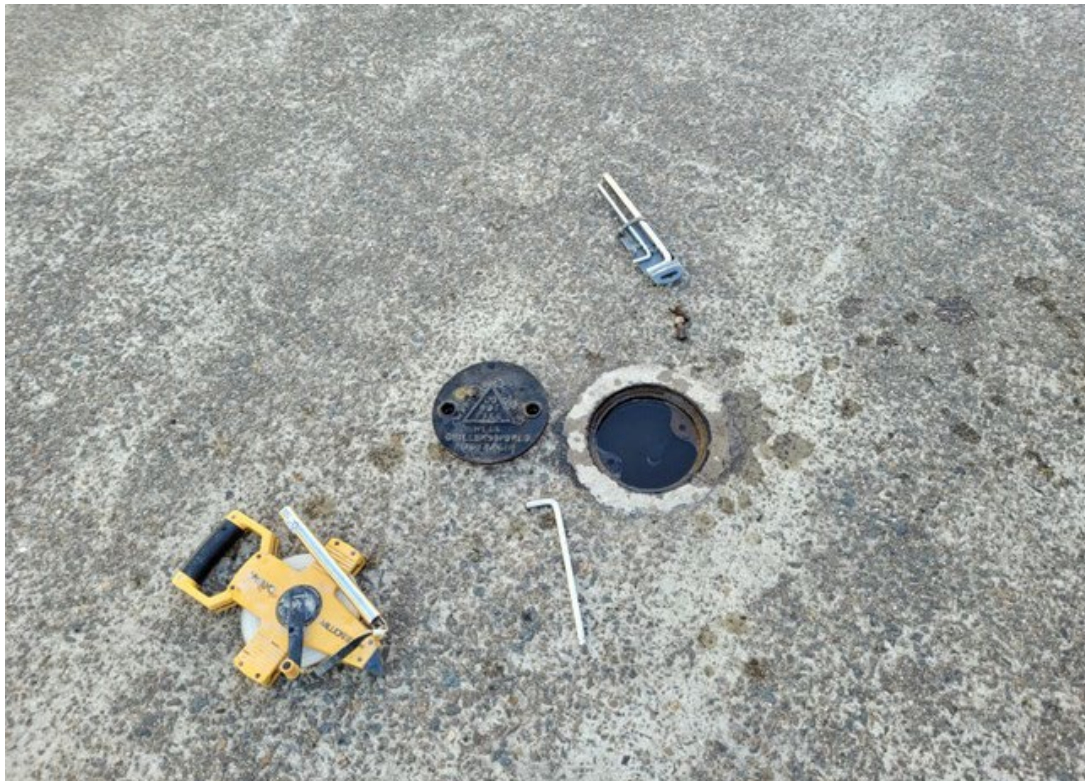
Photo 3 - Water observed outside of well casing at BH12 prior to removal of PVC cap (26 July 2023)

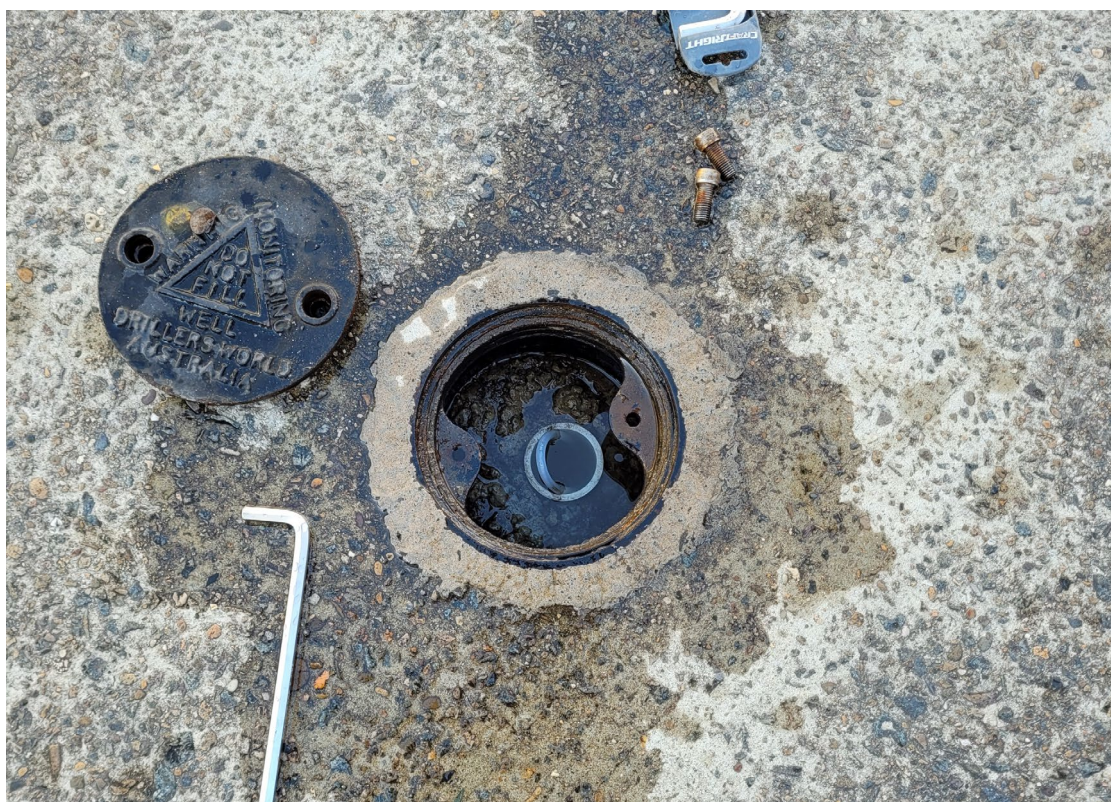
Photo 4 - Condition of BH12 on 26 July 2023 following removal of PVC Cap
