# **ABORIGINAL OBJECTS DUE DILIGENCE ASSESSMENT**

Fiveways  
391-423 Pacific Hwy,  
3-15 Falcon St & 8 Alexander St  
Crows Nest NSW  
Cammeraygal Land

Prepared for  
**DEICORP PROJECT CROWS NEST PTY LTD**  
14 March 2023

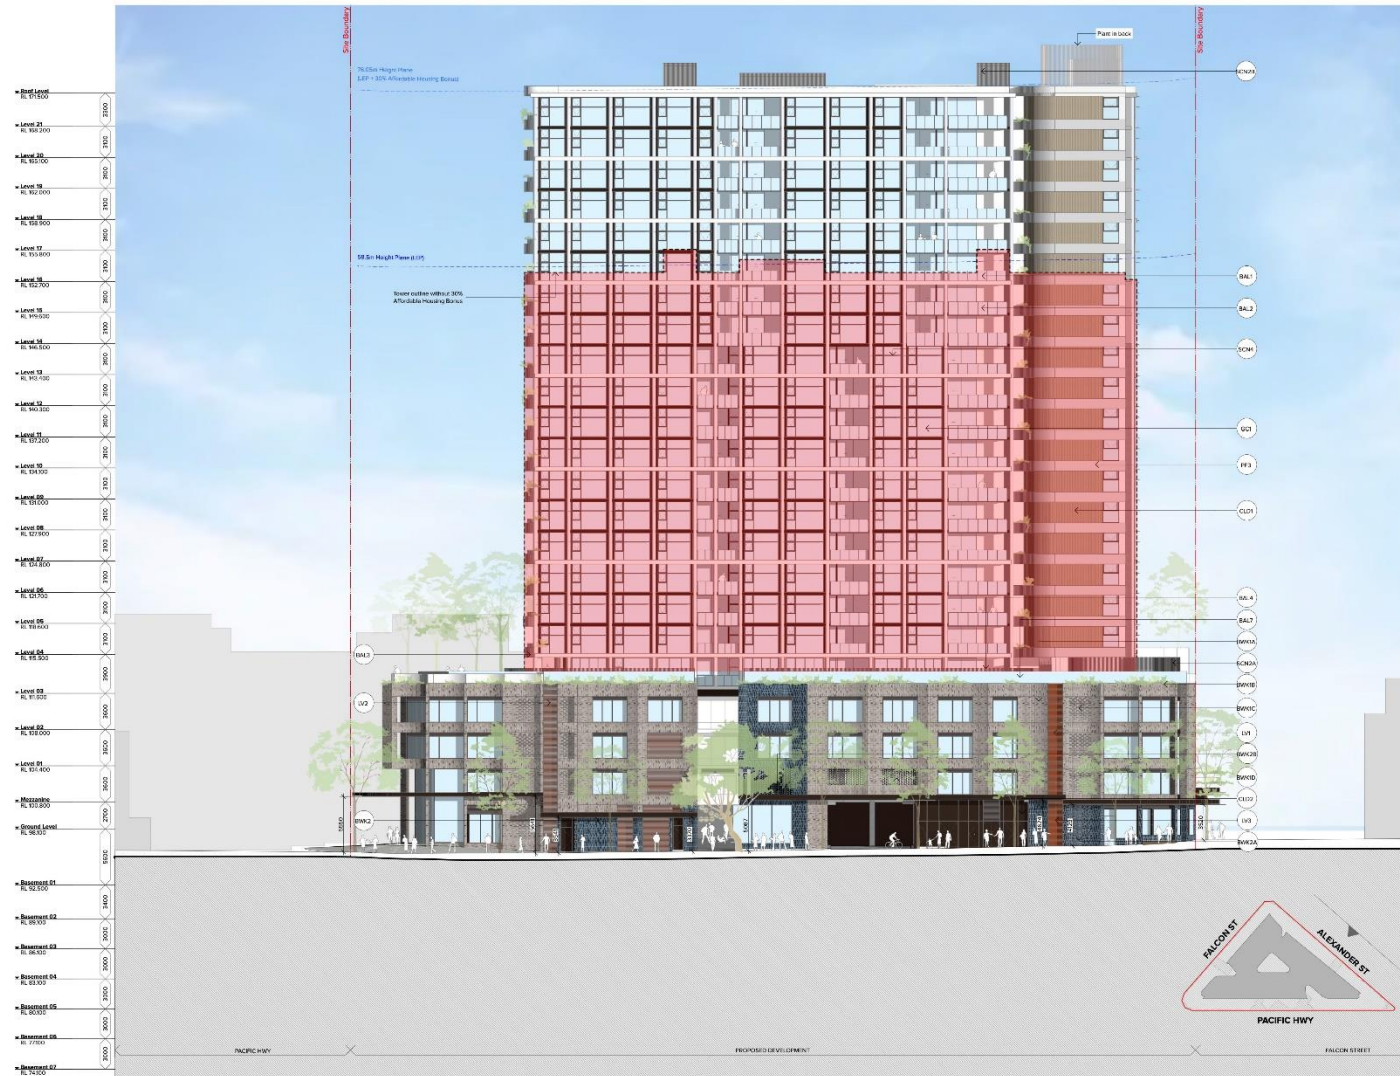
Figure 5 – GA Elevations, East Elevation – Alexander Street

Source: Turner, 07.03.24, Drawing no. DA-220-201, Rev. H

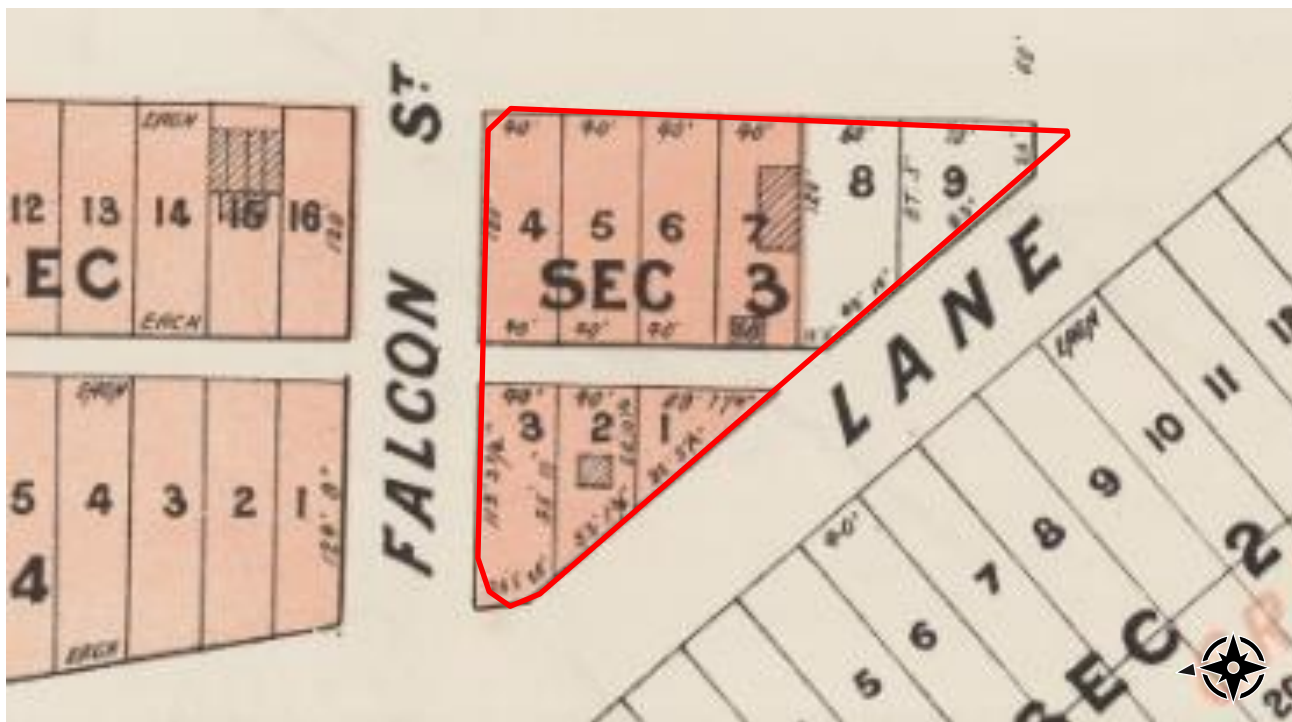
Figure 11 – Historical subdivision plan showing the subject site from c.1885. Note the presence of buildings in Lot 2 and Lot 9.

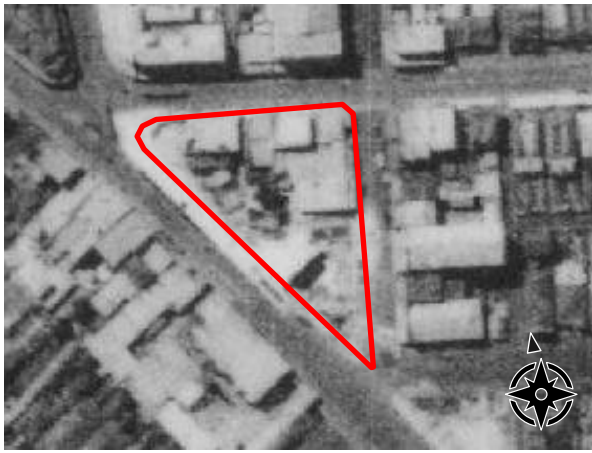
Figure 12 – Historic aerial photo of the subject area from 1930.

Altogether, historical activities within the subject area, including the clearance of vegetation, construction and demolition of buildings and earthworks, have caused ground disturbance that remains clear and observable throughout the entire subject area. The extent of these impacts has been demonstrated by the geotechnical assessment of the site which has indicated the entire removal of the A-Horizon soils (See Section 2.2.1).

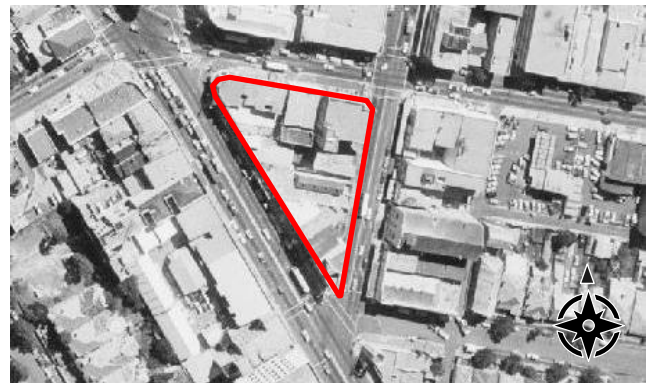
Figure 15 – Historic aerial photo of the subject area from 1973.

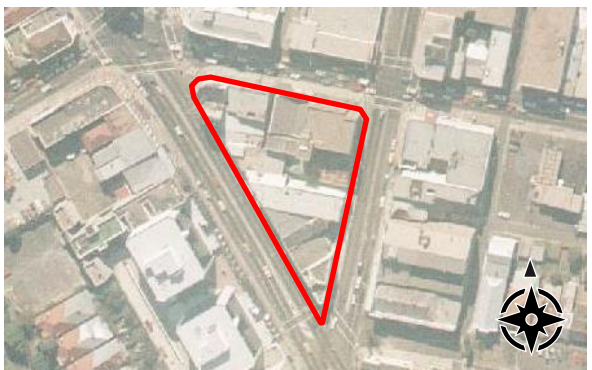
Figure 16 – Historic aerial photo of the subject area from 1983.

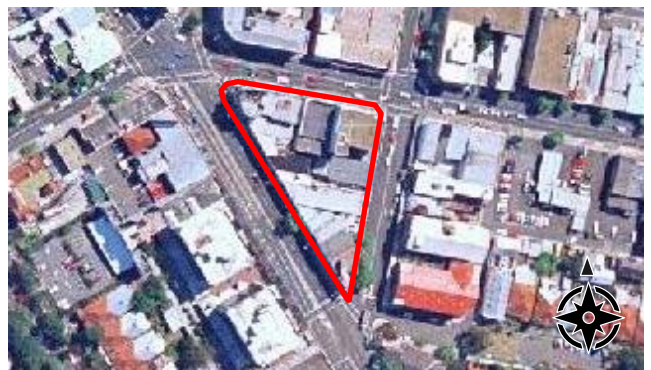
Figure 17 – Historic aerial photo of the subject area from 1994.
