### **G.7.3 Ecology Due Diligence Assessment – Indicative OSOM Haulage Route**

## Briefing Note

**To:** Matt Stafford  
**cc:** Allison Riley, Bill Wallach  
**From:** Philippa Fagan  
**Date:** 09 December 2021  
**Subject:** Ecological Due Diligence for OSOM Haulage Route

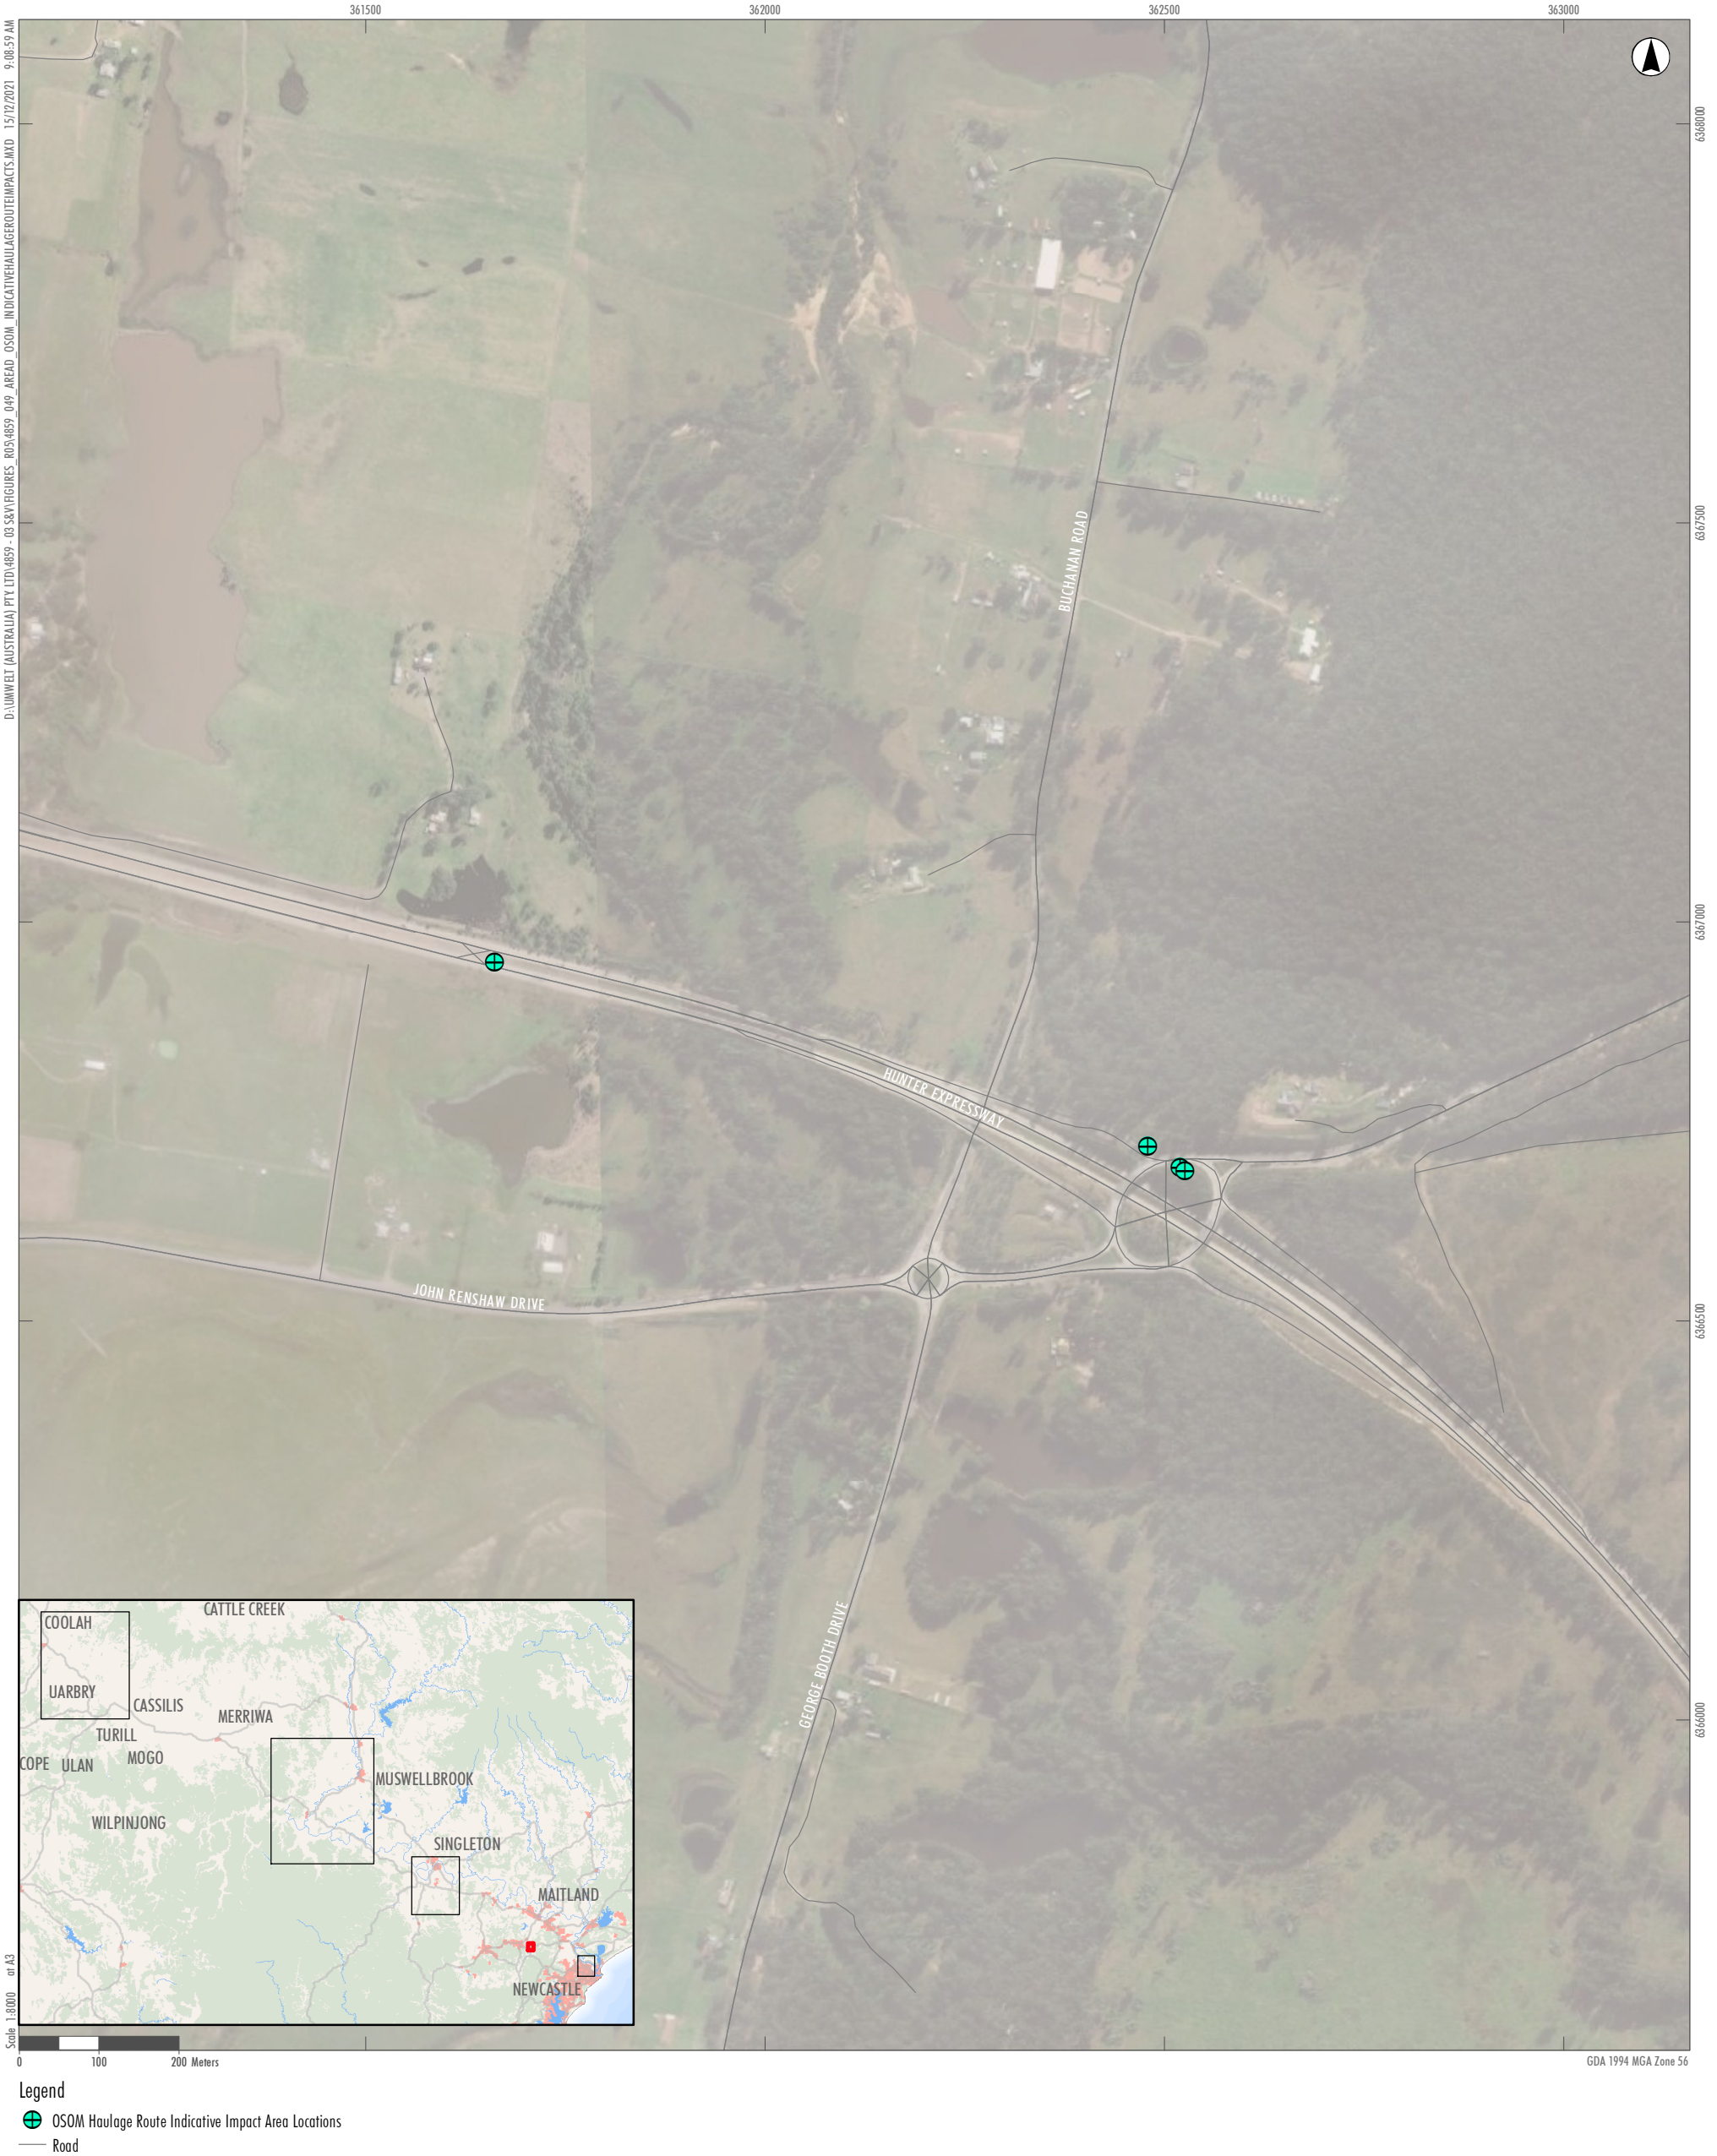
FIGURE 1.5

OSOM Haulage Route  
Investigation Area (Area D)

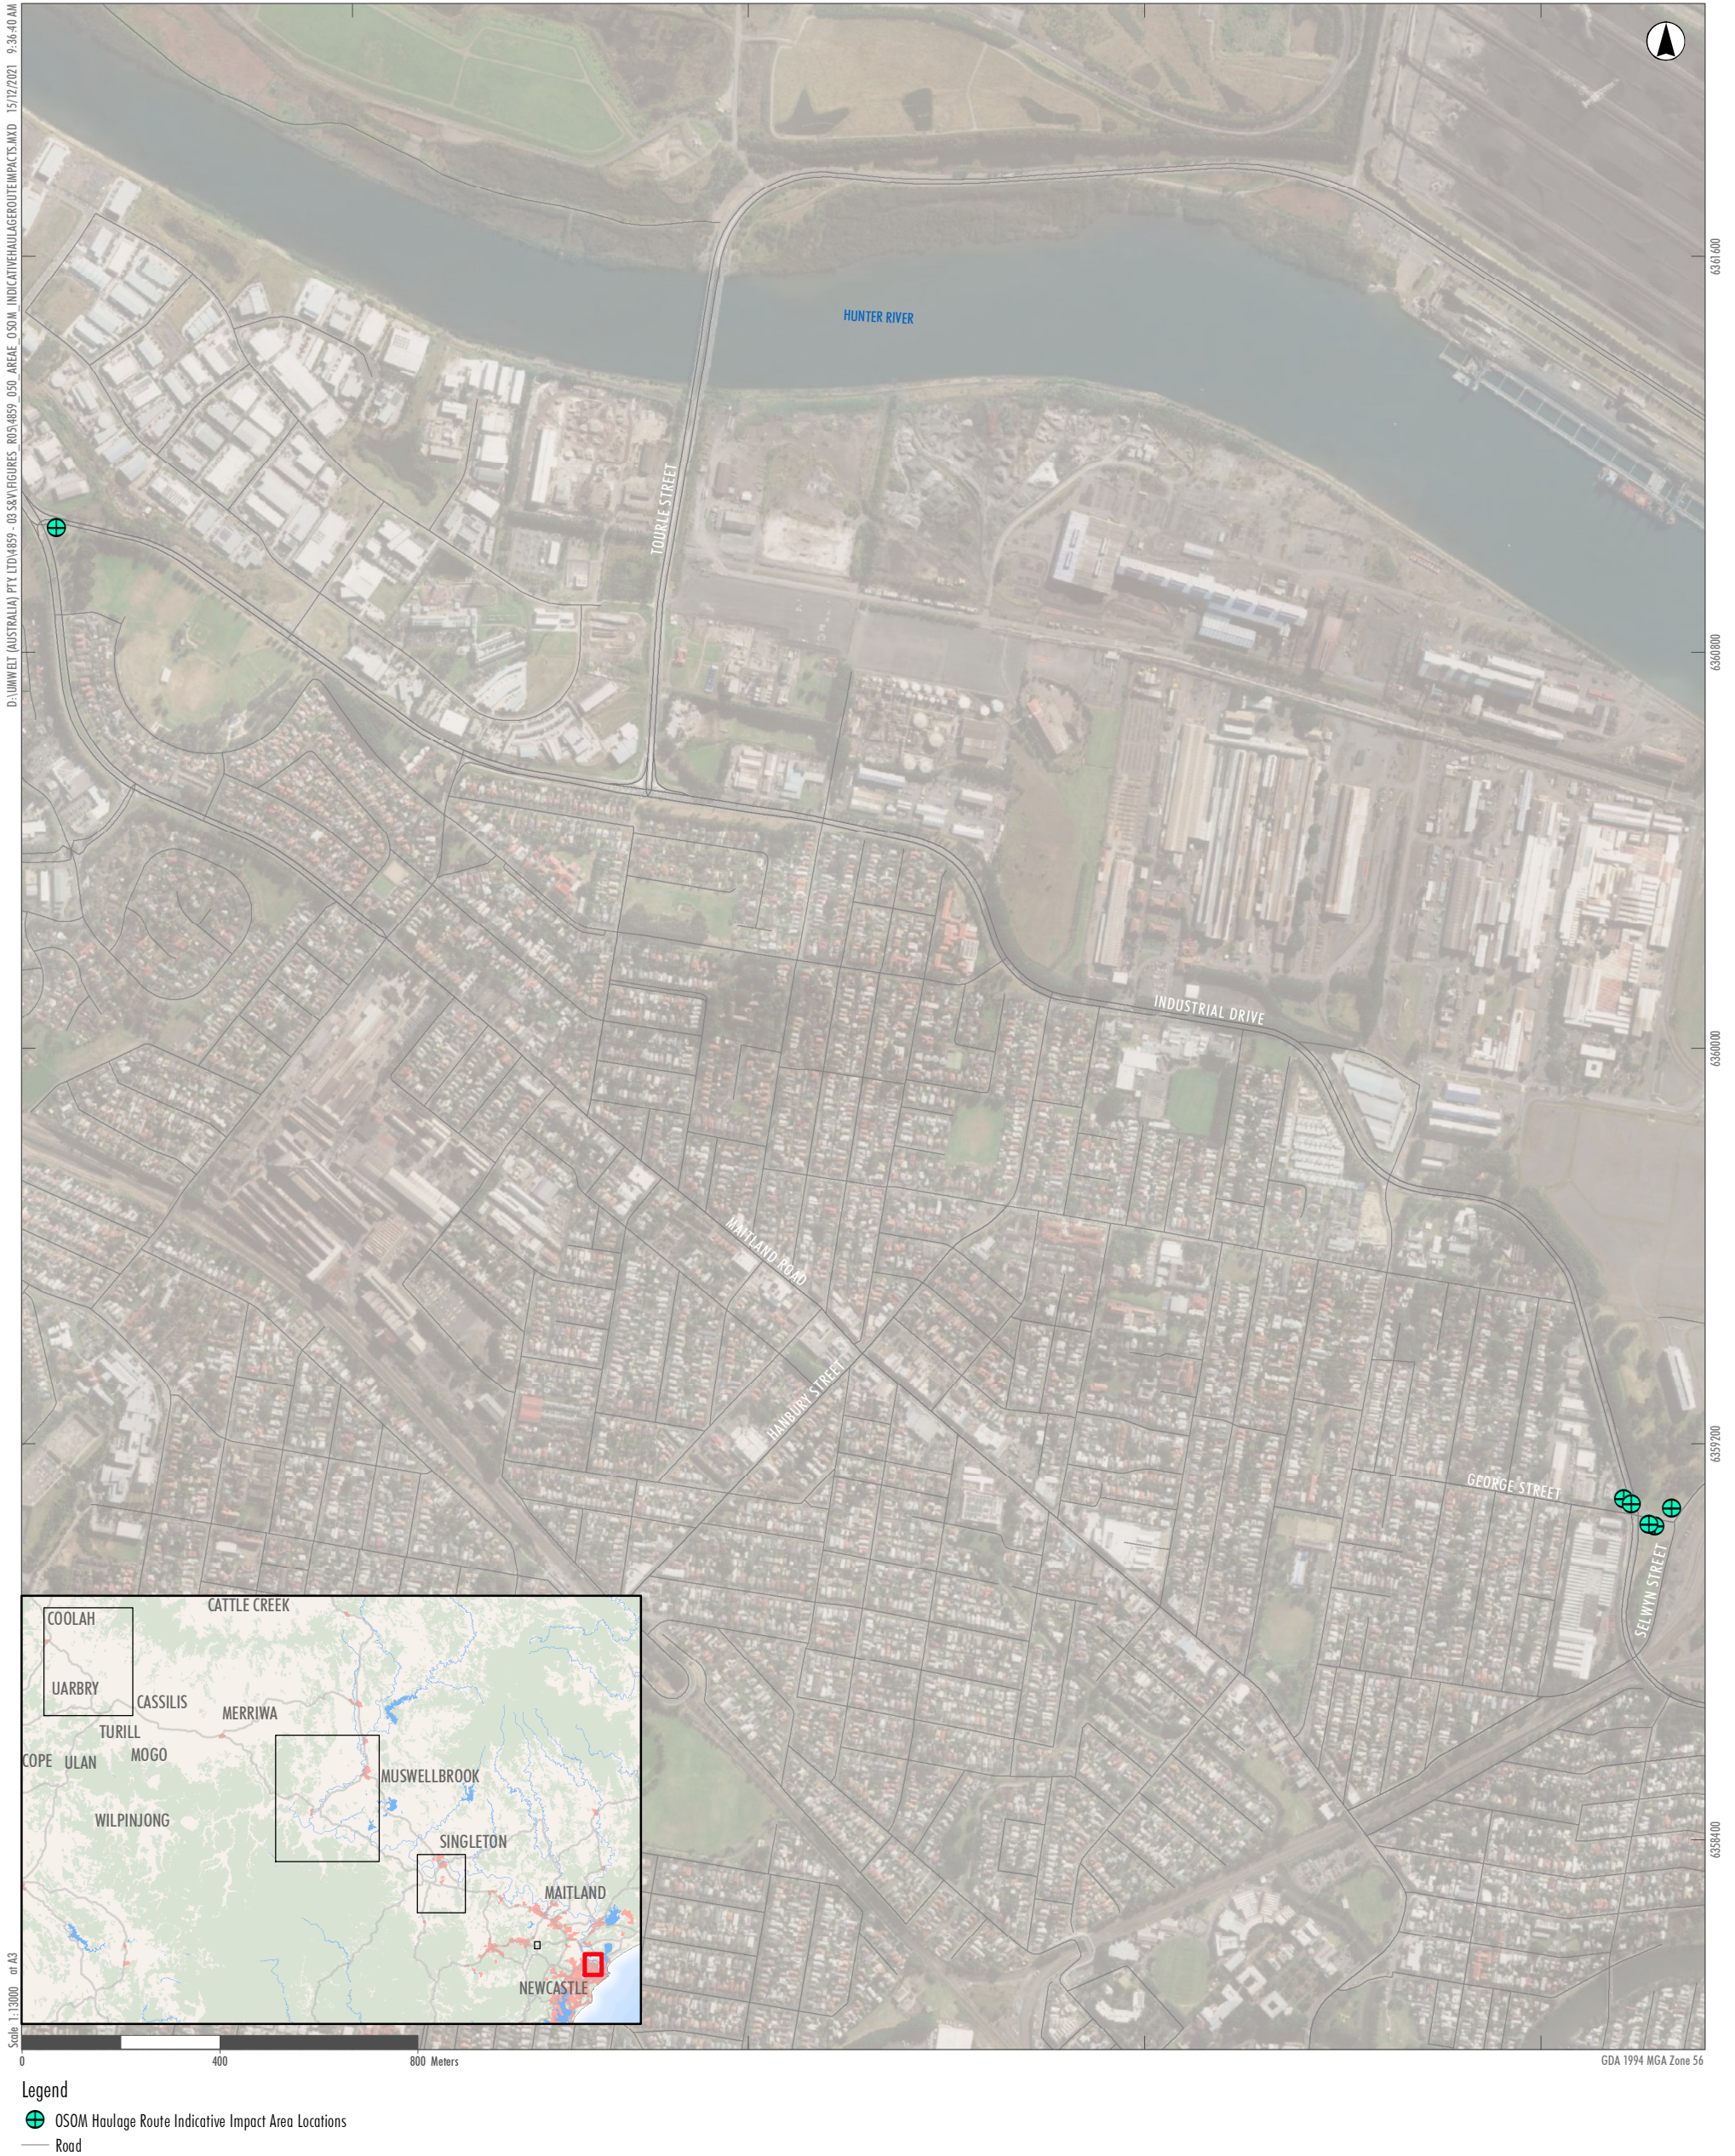
FIGURE 1.6

OSOM Haulage Route  
Investigation Area (Area E)

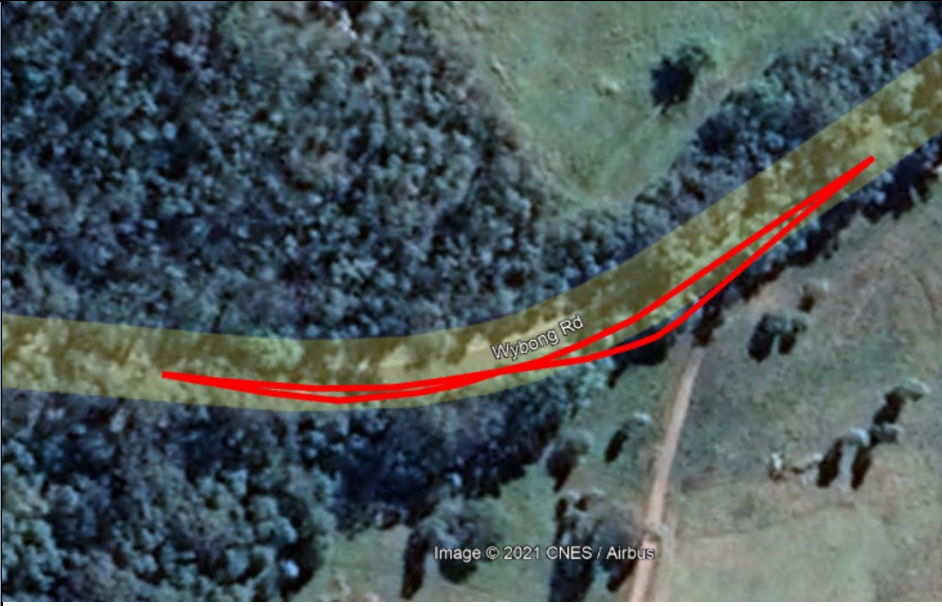
Location, Coordinates and Disturbance Type	
<p>Wybong Road, Muswellbrook LGA. Tree removal.</p> <p>(840327.36, 6418130.19).</p> <p><i>Eucalyptus blakelyi</i>/ <i>Eucalyptus crebra</i>/ <i>Angophora floribunda</i> shrubby woodland of the upper Hunter.</p>

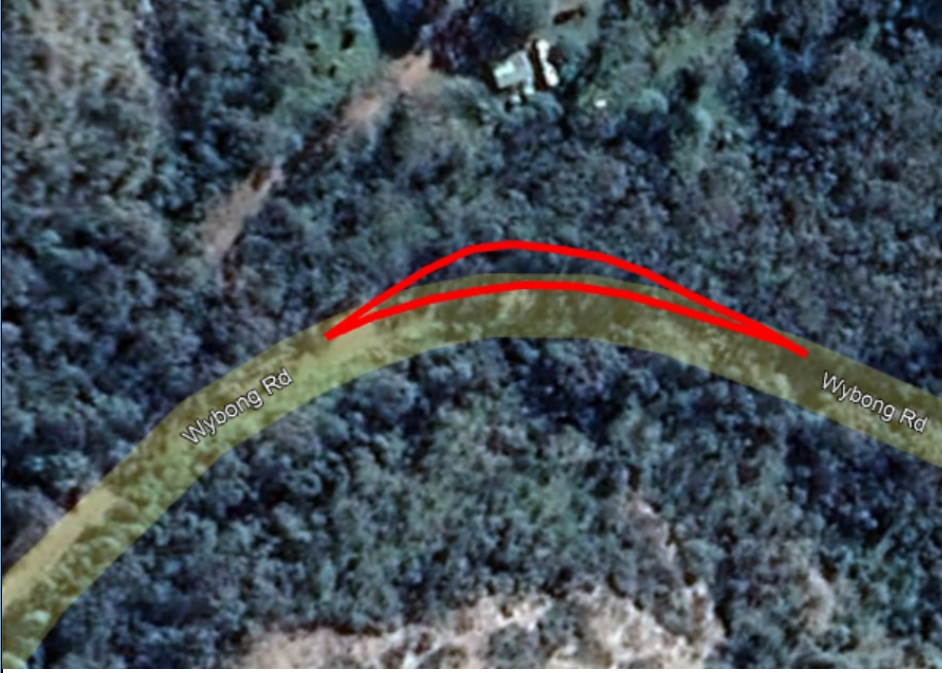
<p>Image © 2021 CNES / Airbus</p>
<p>Wybong Road, Muswellbrook LGA. Tree removal.</p> <p>(839927.65, 6418227.61).</p> <p><i>Eucalyptus blakelyi</i>/ <i>Eucalyptus crebra</i>/ <i>Angophora floribunda</i> shrubby woodland of the upper Hunter.</p>

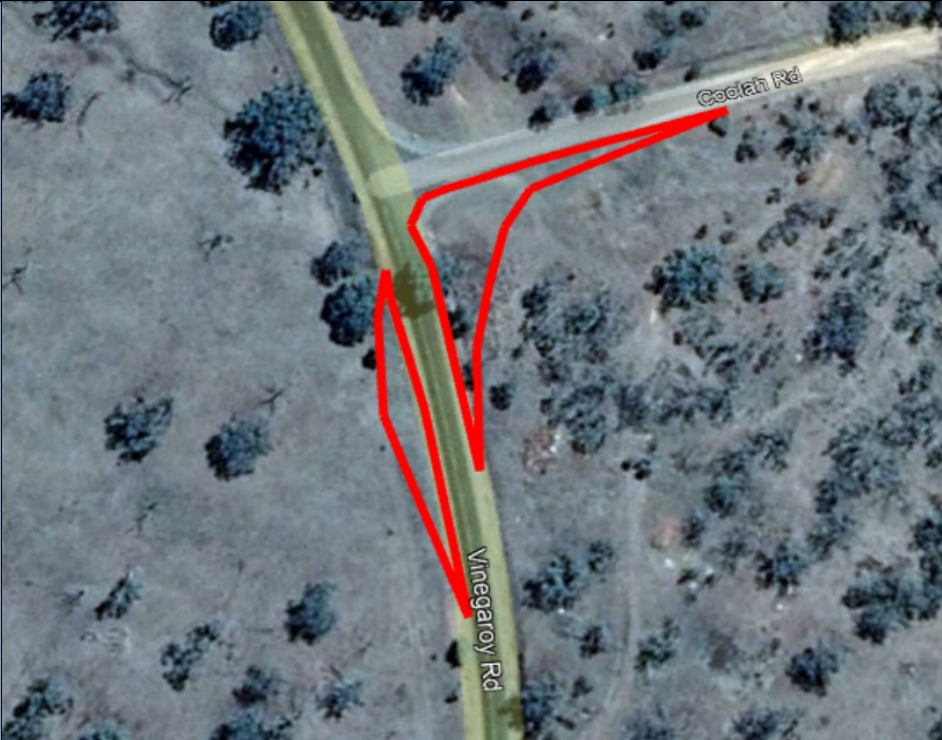
Location, Coordinates and Disturbance Type	
<p>Coolah Road/Vinegaroy Road, Upper Hunter LGA. Tree Removal.</p> <p>(773003.93, 6457484.80).</p> <p><i>Austrostipa aristiglumis/ Aristida ramosa/ Austrodanthonia bipartita</i> grassland on basalt soils of the Merriwa plateau and removal of Box-Gum Woodland CEEC.</p>

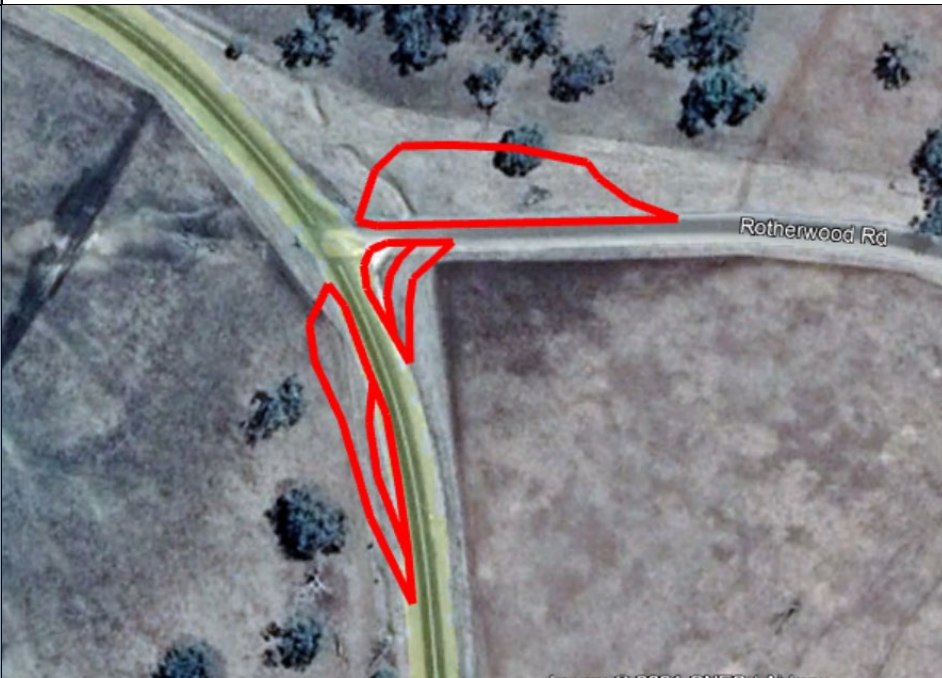
<p>Rotherwood Road/Vinegaroy Road, Warrumbungle LGA. Tree Removal.</p> <p>(768390.72, 6465804.10).</p> <p><i>Austrostipa aristiglumis/ Aristida ramosa/ Austrodanthonia bipartita</i> grassland on basalt soils of the Merriwa plateau. Potential removal of Box-Gum Woodland CEEC.</p>
