RE: INTERIM AUDIT ADVICE LETTER NO. 1 - REMEDIATION ACTION PLAN, PROPOSED EILEEN O'CONNOR CATHOLIC SCHOOL, 84 GAVENLOCK ROAD, MARDI NSW

Ref: 318002087

Audit Number: LW-063

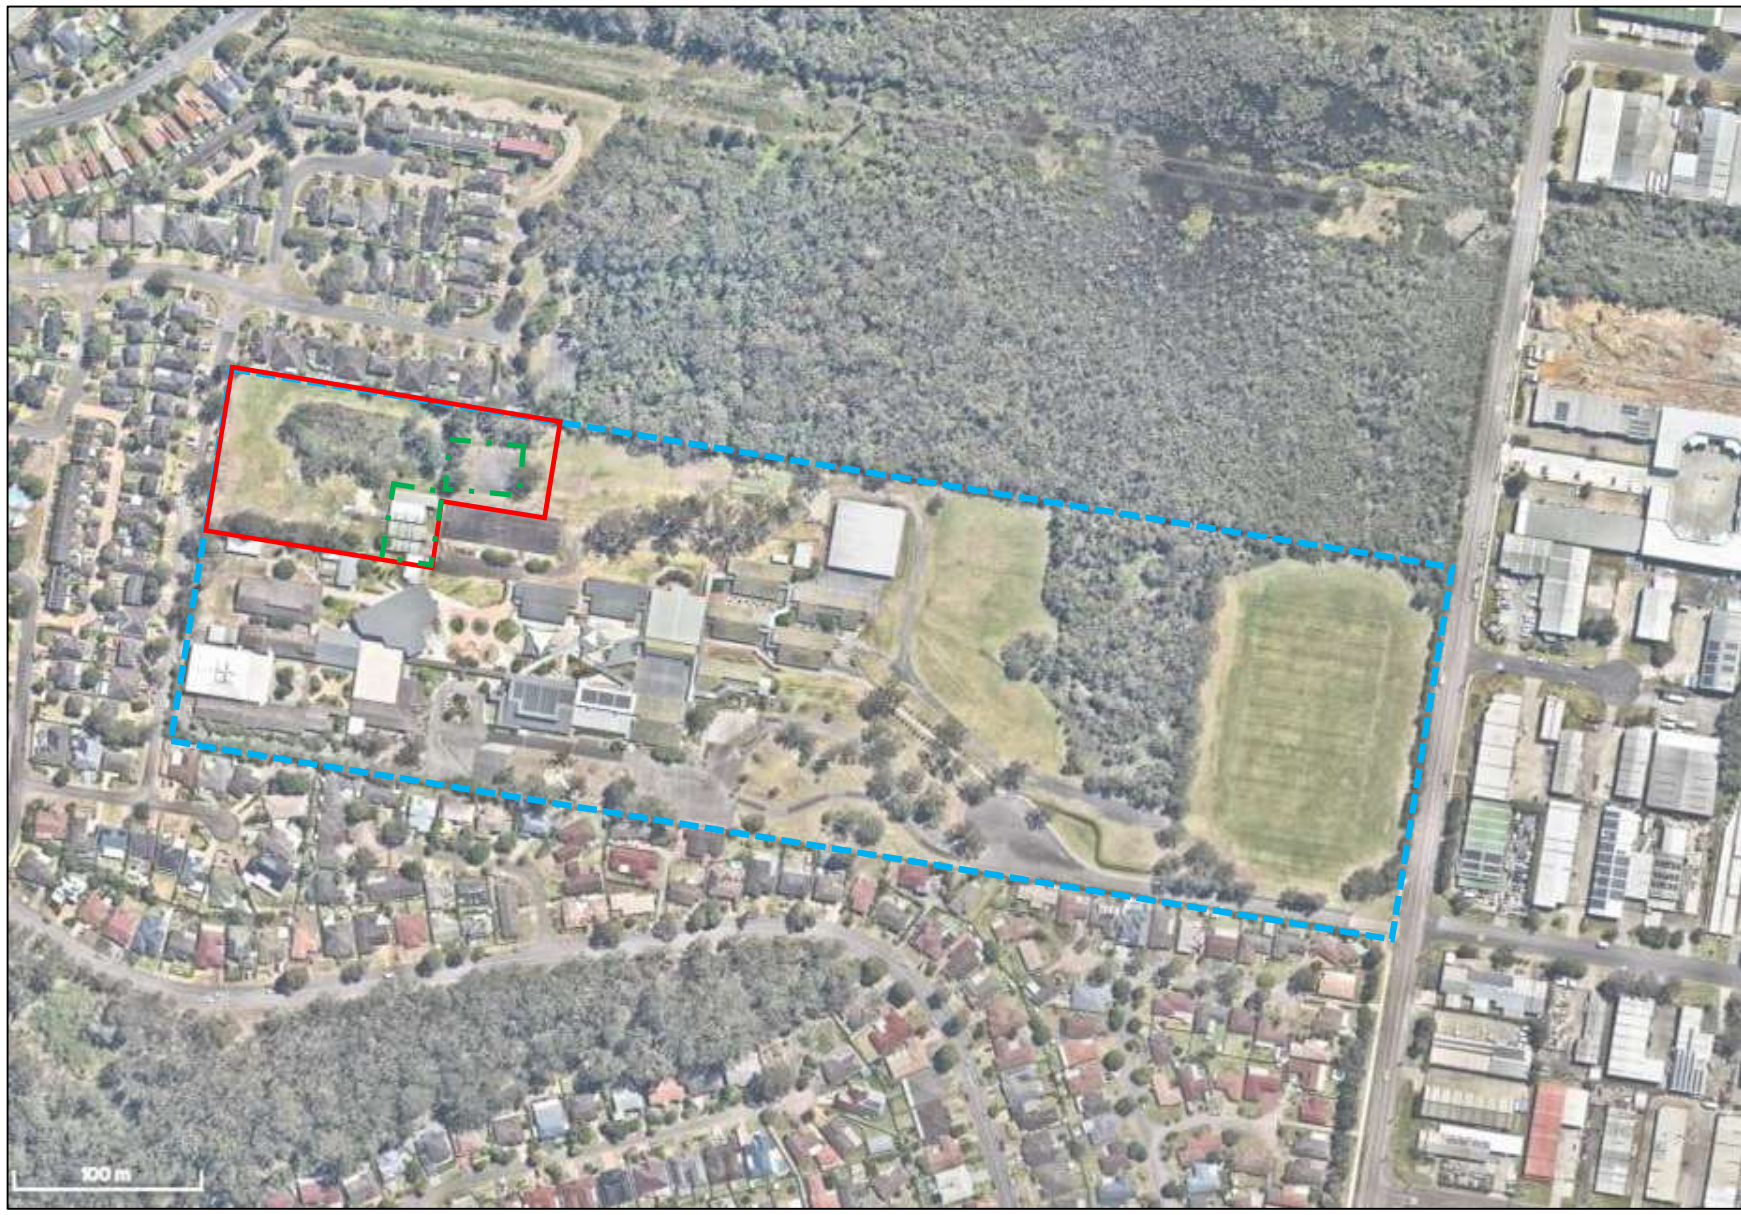
Figure 2:
Site Layout Plan

Data Gap
Investigation Area

As noted in **Section 8**, based on the results of the DSI, REE did not identify contamination requiring remediation. However, due to access constraints, two areas of the site (a fill platform and playing court area, shown on **Attachments 1 and 3**) were identified that were not able to be assessed during the DSI. Further assessment of the soil conditions below existing buildings and structures and hardstand areas in the data gap areas is proposed in the RAP following demolition of site structures and removal of hardstand surfaces. The RAP requires the DGI to comprise a combined total of 16 sample locations (8 per area) as illustrated in **Attachment 3**.
