# Preliminary Site Investigation

Eileen O'Connor Catholic School  
84 Gavenlock Road, Mardi  
NSW, 2259

March 2024

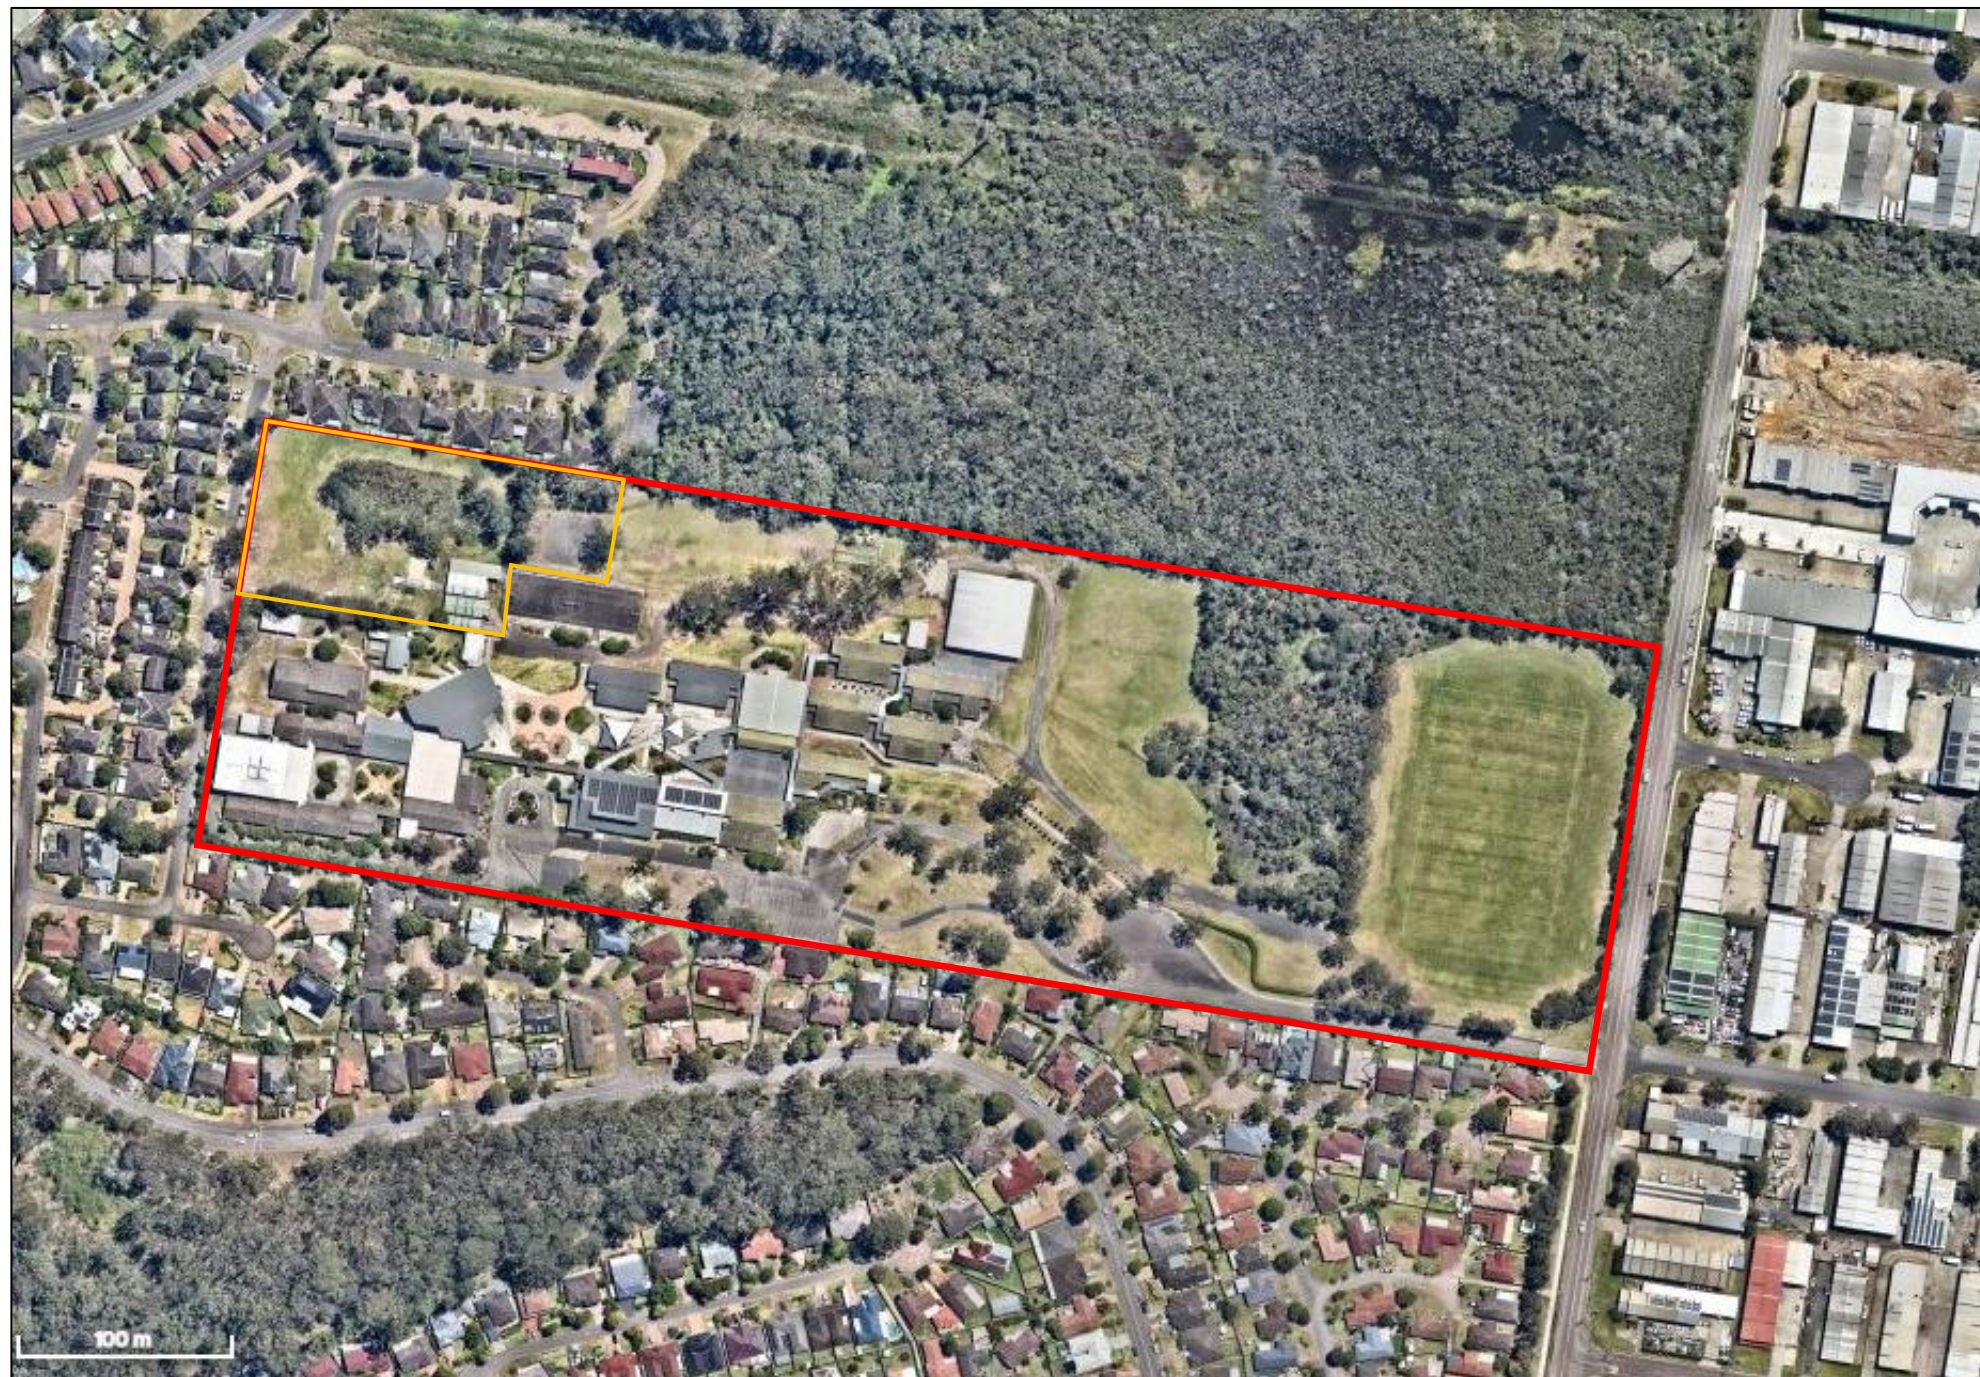
**Figure 2:**  
Site Layout Plan

A site location plan is shown in Figure 1, with a site layout plan shown in Figure 2, **Appendix A**. A summary of the Site Details is shown below in **Table 1**.

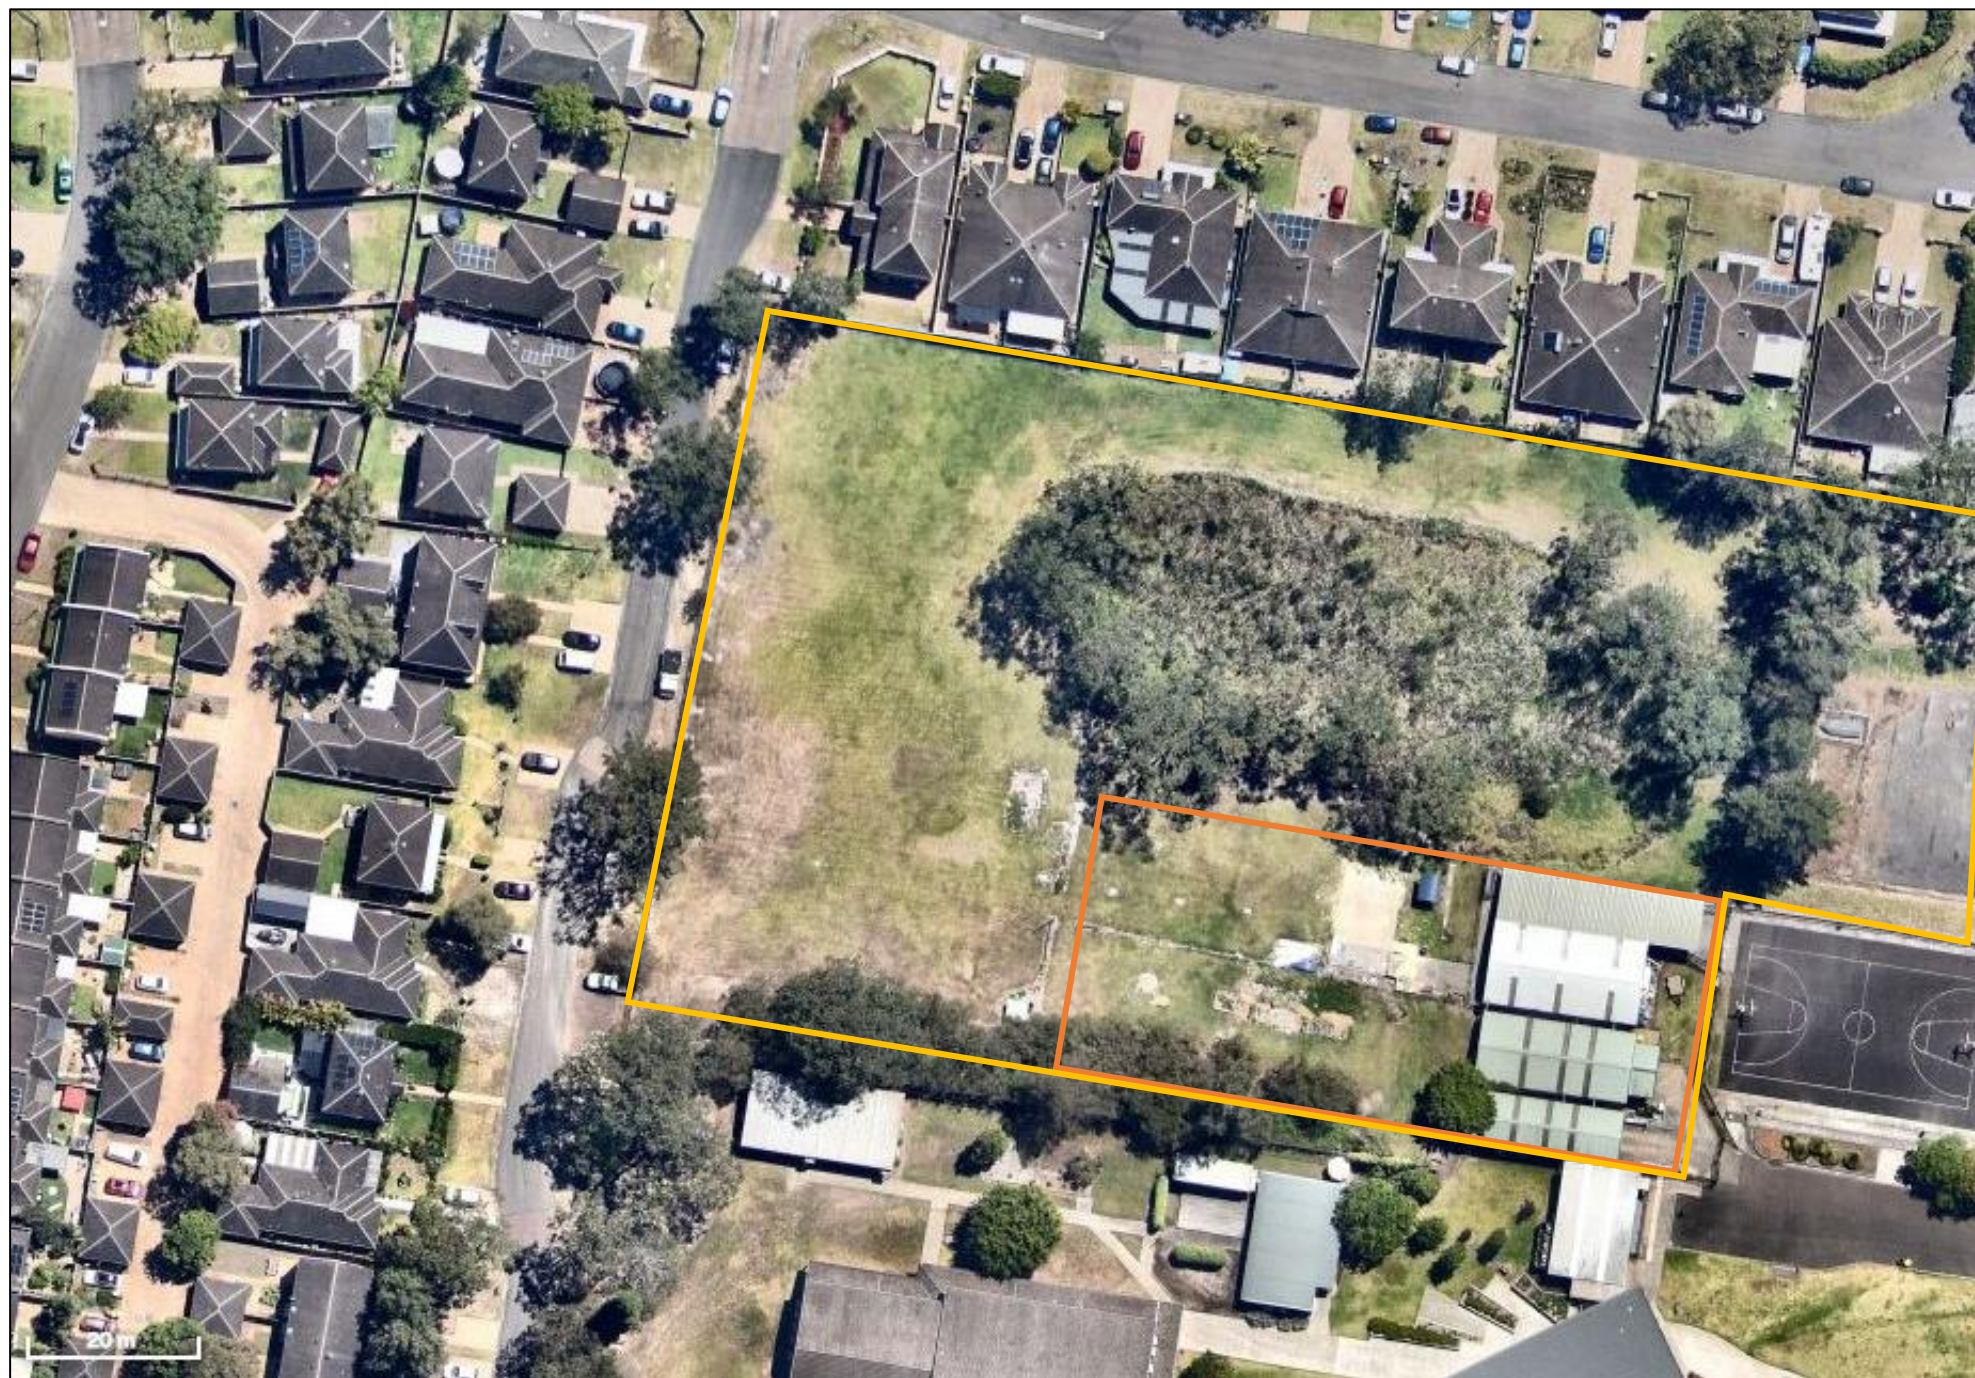
**Figure 3:**  
Areas of Environmental  
Concern Plan

- AEC1 – Potential uncontrolled fill material situated across site beneath the concrete building slab.

Based on the preliminary CSM, the potential exposure of CoPC at the site is considered **low-moderate** given the presence of one (1) AECs identified across the site, as shown in Figure 3, **Appendix A**.

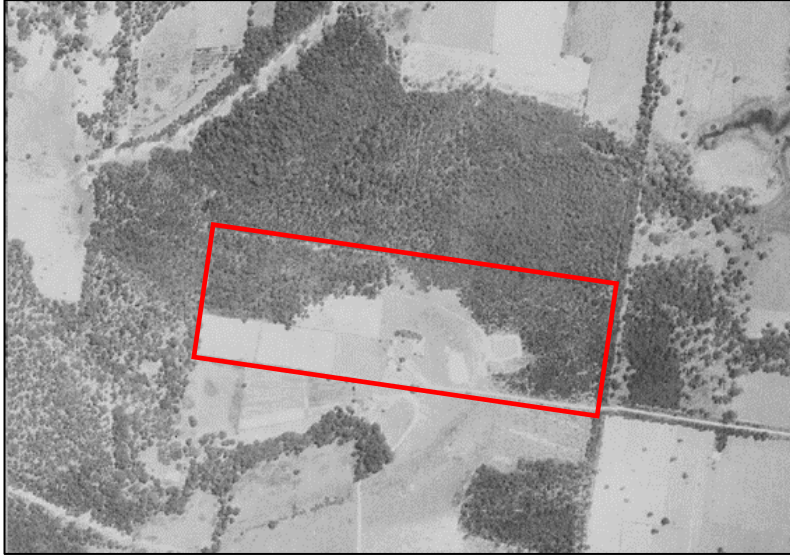
| <i>Table 5: Summary of Historical Aerial Review</i> | | |
|---|---|---|
| 1965 | The site seems to be a farm, partially covered by dense vegetation, mainly in the northern portion of site. There is a farmhouse in the centre portion of site. | The surrounding is undeveloped as the site. Dense vegetation can be seen along north and west directions. Deforested area to south. |

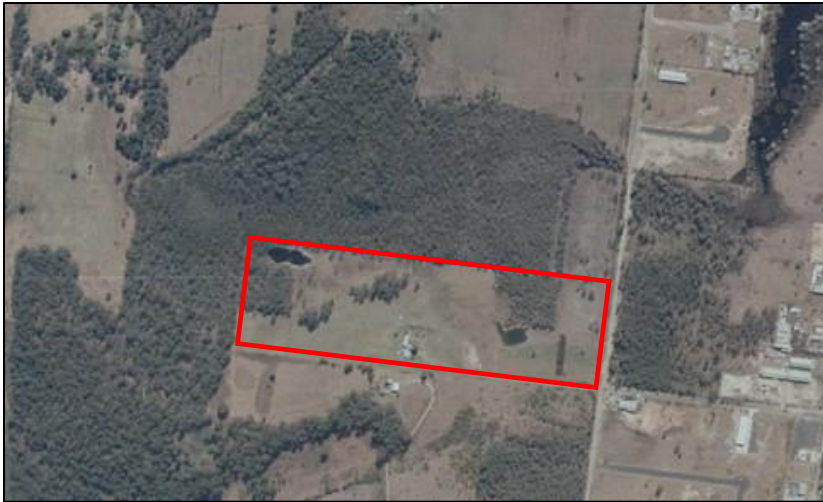
| <i>Table 5: Summary of Historical Aerial Review</i> | | |
|---|---|---|
| 1975 | Part of the site area has been deforested. Two patches of vegetation left, one in the north-eastern portion and another in the western portion of site. It is possible to see a surface water body in the north-western portion of site. | Vegetation surrounding the site seem to be denser. Some builds can be seen in the eastern and north-eastern directions, suggesting signs of development in the surrounding area. |

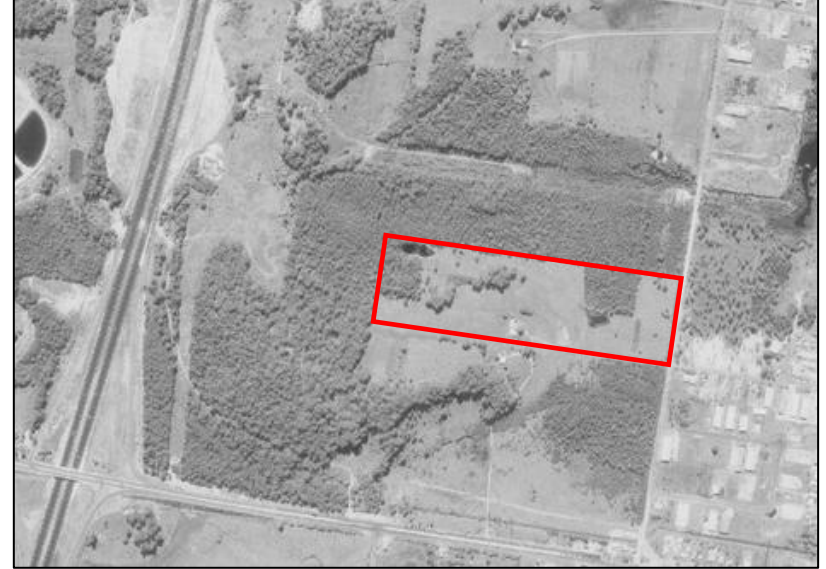
| <i>Table 5: Summary of Historical Aerial Review</i> | | |
|---|---|---|
| 1983 | The site is relatively unchanged. | Development started in the eastern direction across Gavenlock Road with visible buildings. |

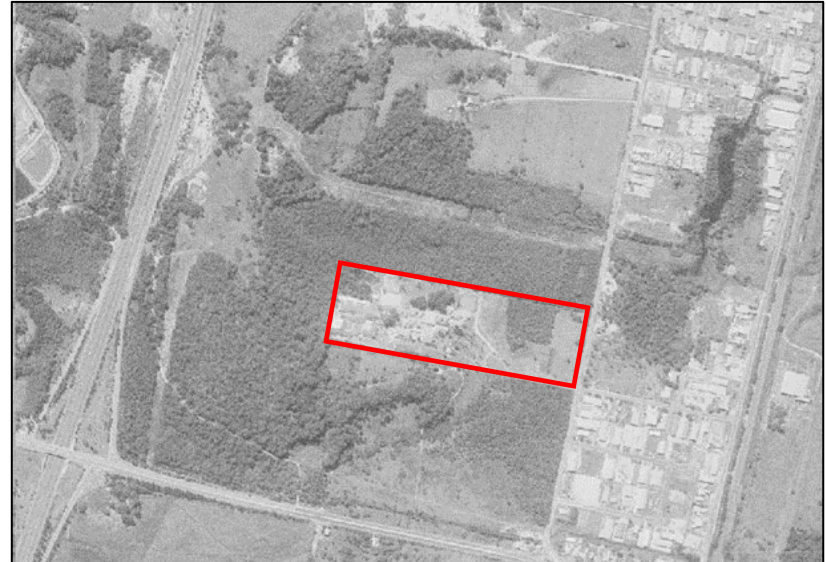
| <i>Table 5: Summary of Historical Aerial Review</i> | | |
|---|---|---|
| 1989 | The site has been developed. Several buildings can be seen as well as roads, mainly in the centre and western portion of site. | The building density has increased mainly in the eastern, north-eastern, and south-eastern directions. Deforestation can be noted to the south of site. |

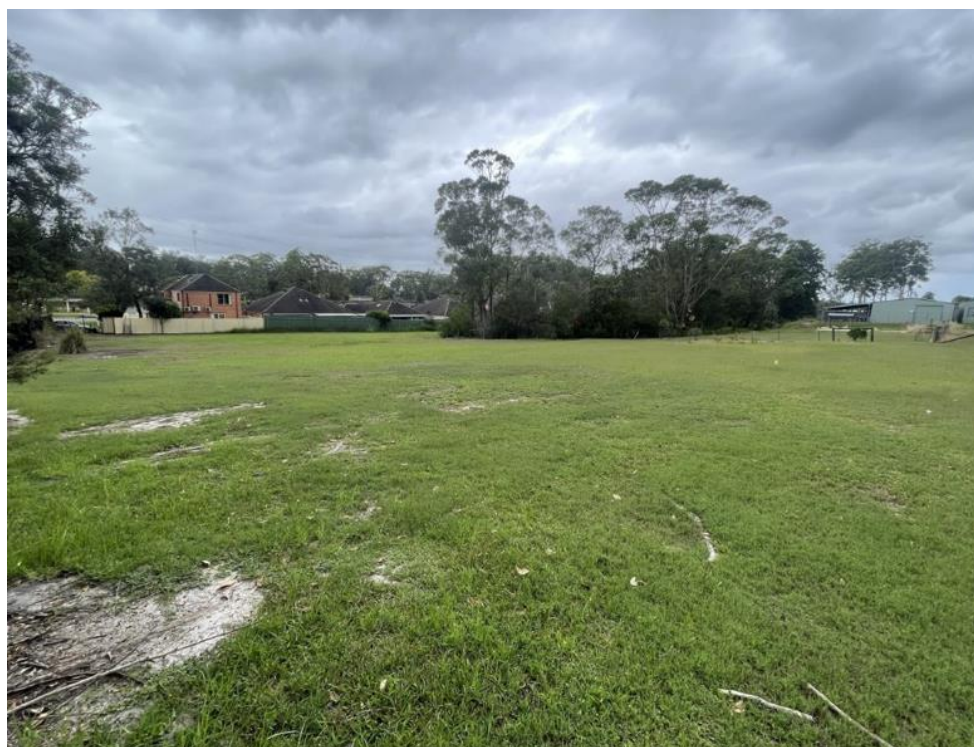
Photo 1: Overview of the investigation area, looking north-east. Vegetation surrounding the surface water body and sheds in the background.

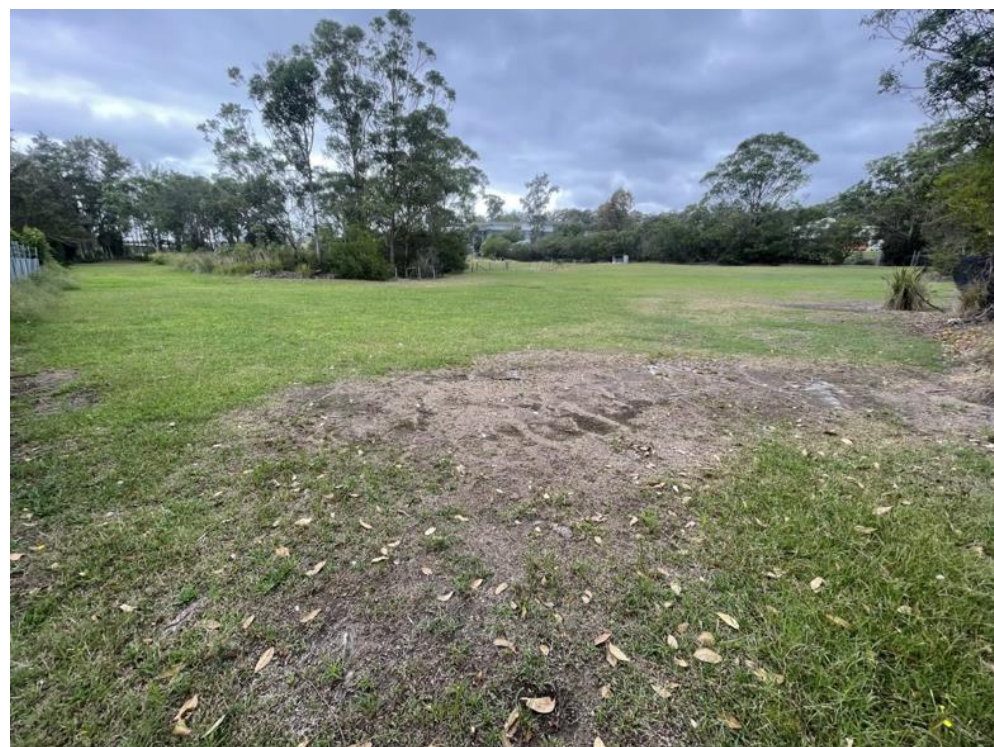
Photo 2: Overview of the investigation area, looking east.

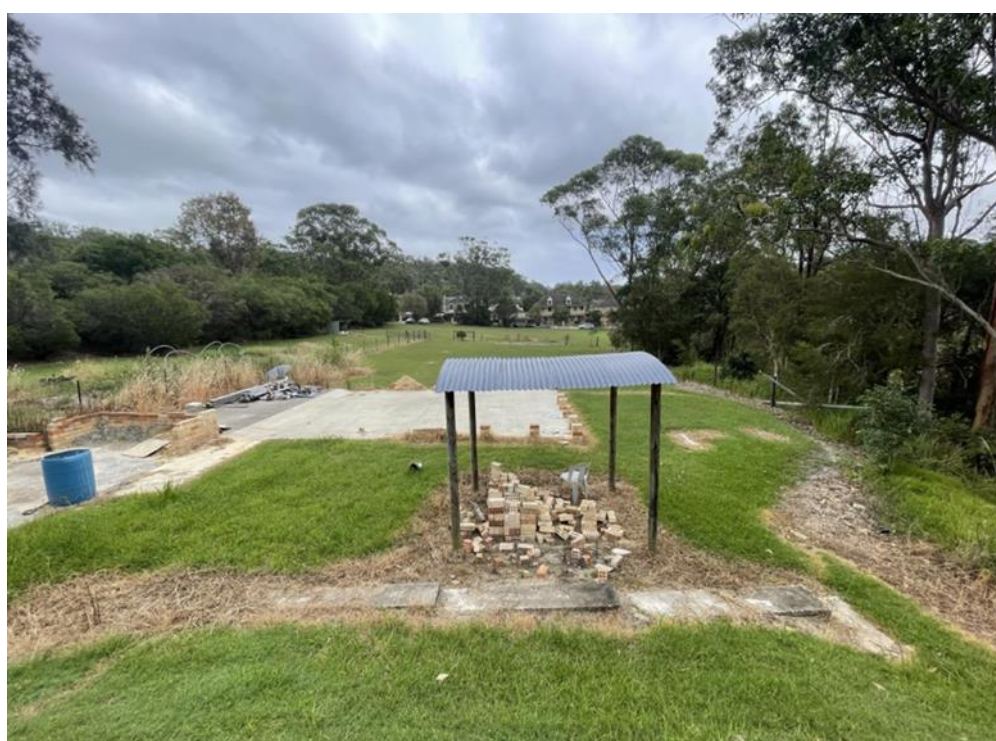
Photo 3: Overview of the site, looking west. Detail for concrete structure in front and surface water body on the right.

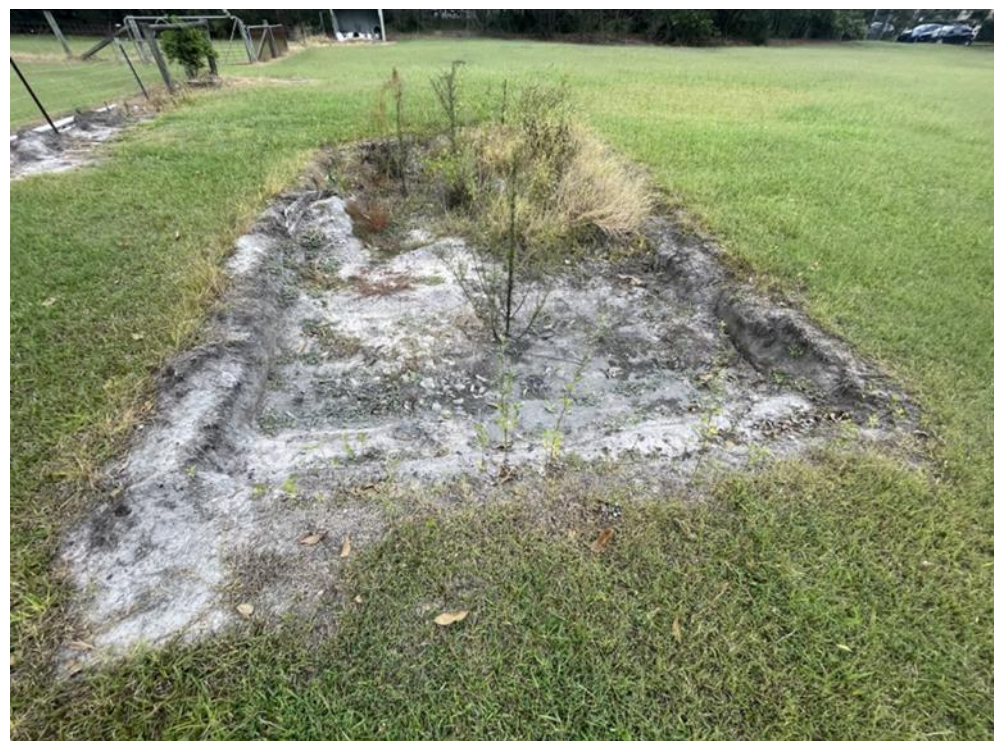
Photo 4: Sand pit found within 50m west from the sheds.

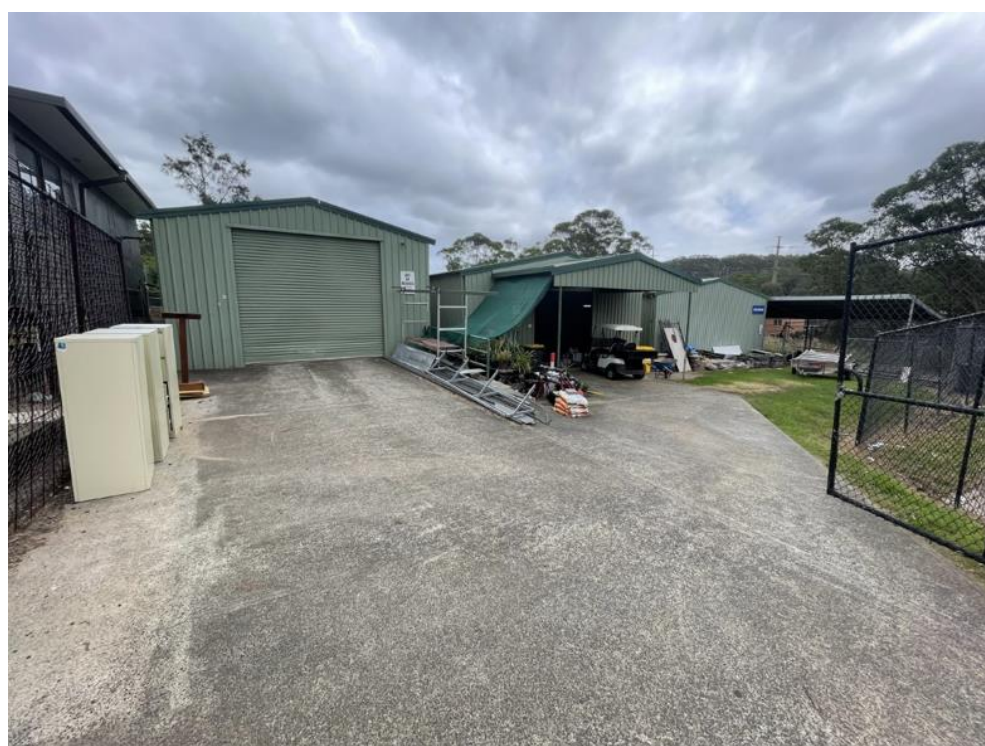
| <b>Table 2: Site Layout and Current Use</b> | |
|---|---|
| <b>Building construction</b> | There are 3 single-storey buildings (sheds) built on concrete slab, with steel frame structure and corrugated metal walls and roofing. There is also a joined veranda along one of the sheds. |

Photo 5: Picture showing the sheds present on site. Looking north-west.

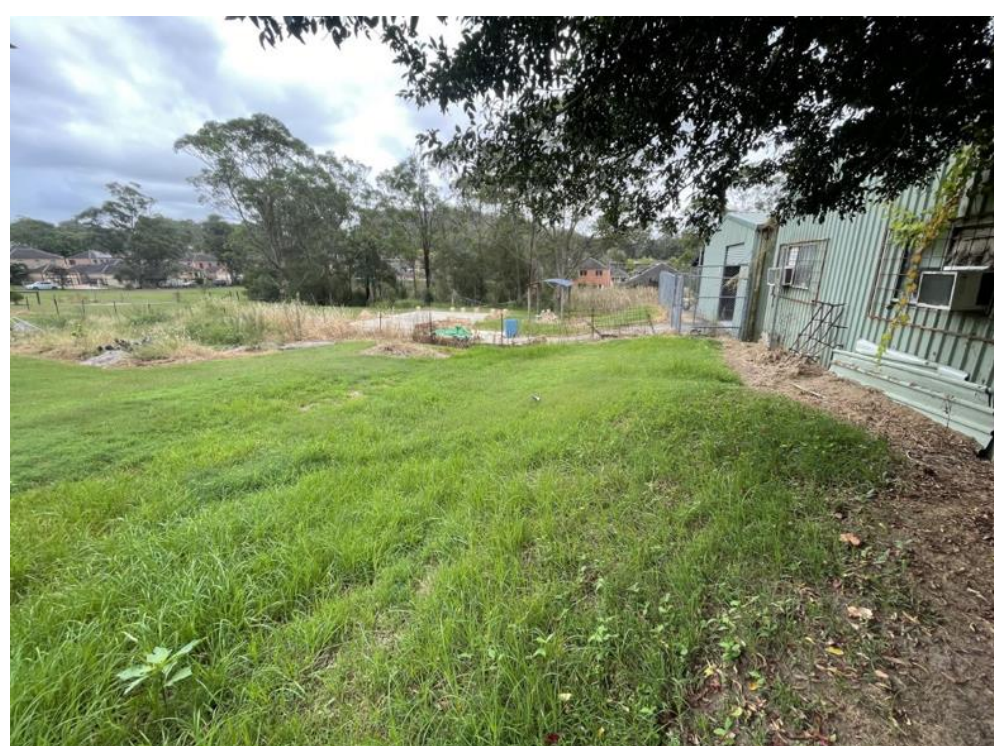
Photo 6: Picture showing the slope down from the rear of the sheds towards the investigation area.
