Surface and Groundwater Impact Assessment

Eileen O'Connor Catholic School
84 Gavenlock Road, Mardi
NSW, 2259

March 2025

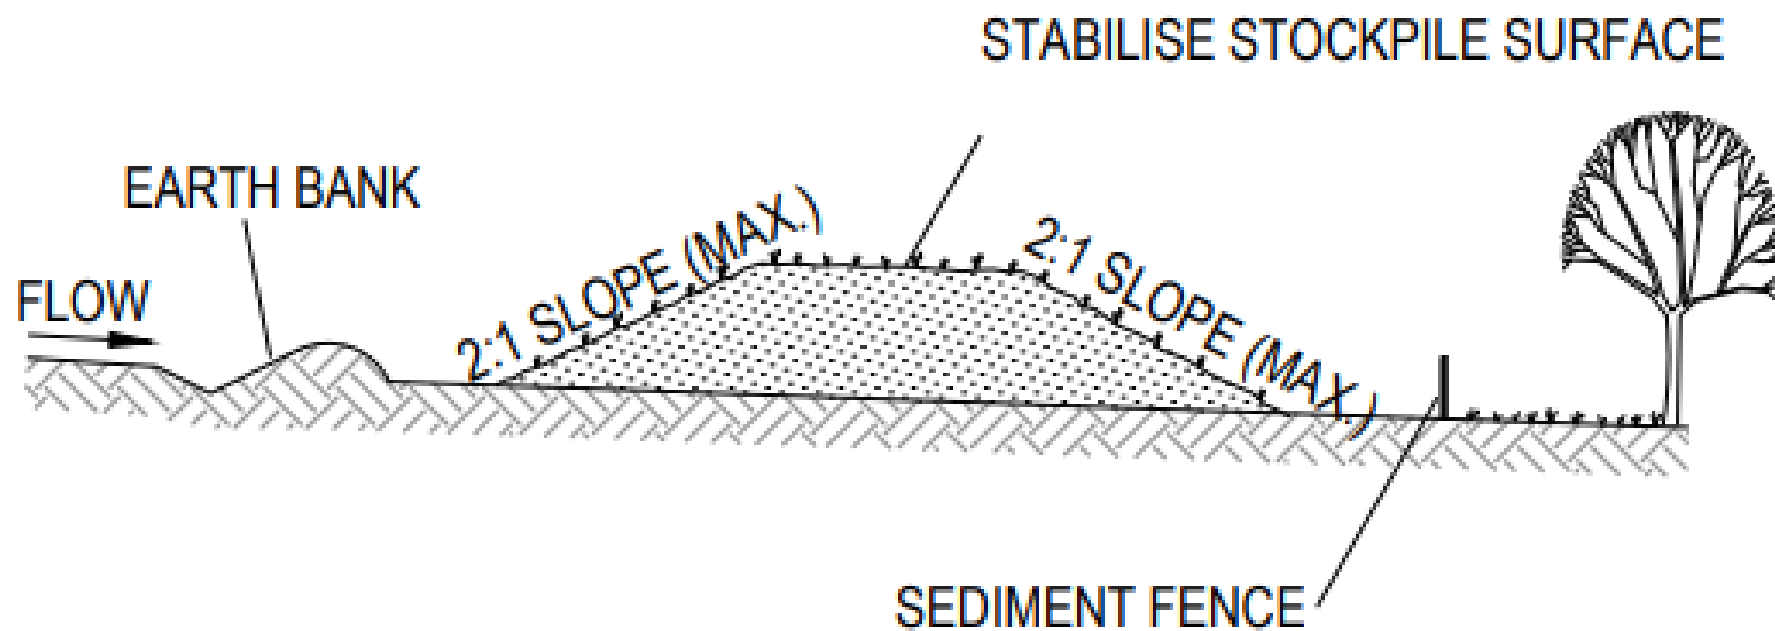
Figure 9:
Diagram of onsite stockpile
establishment

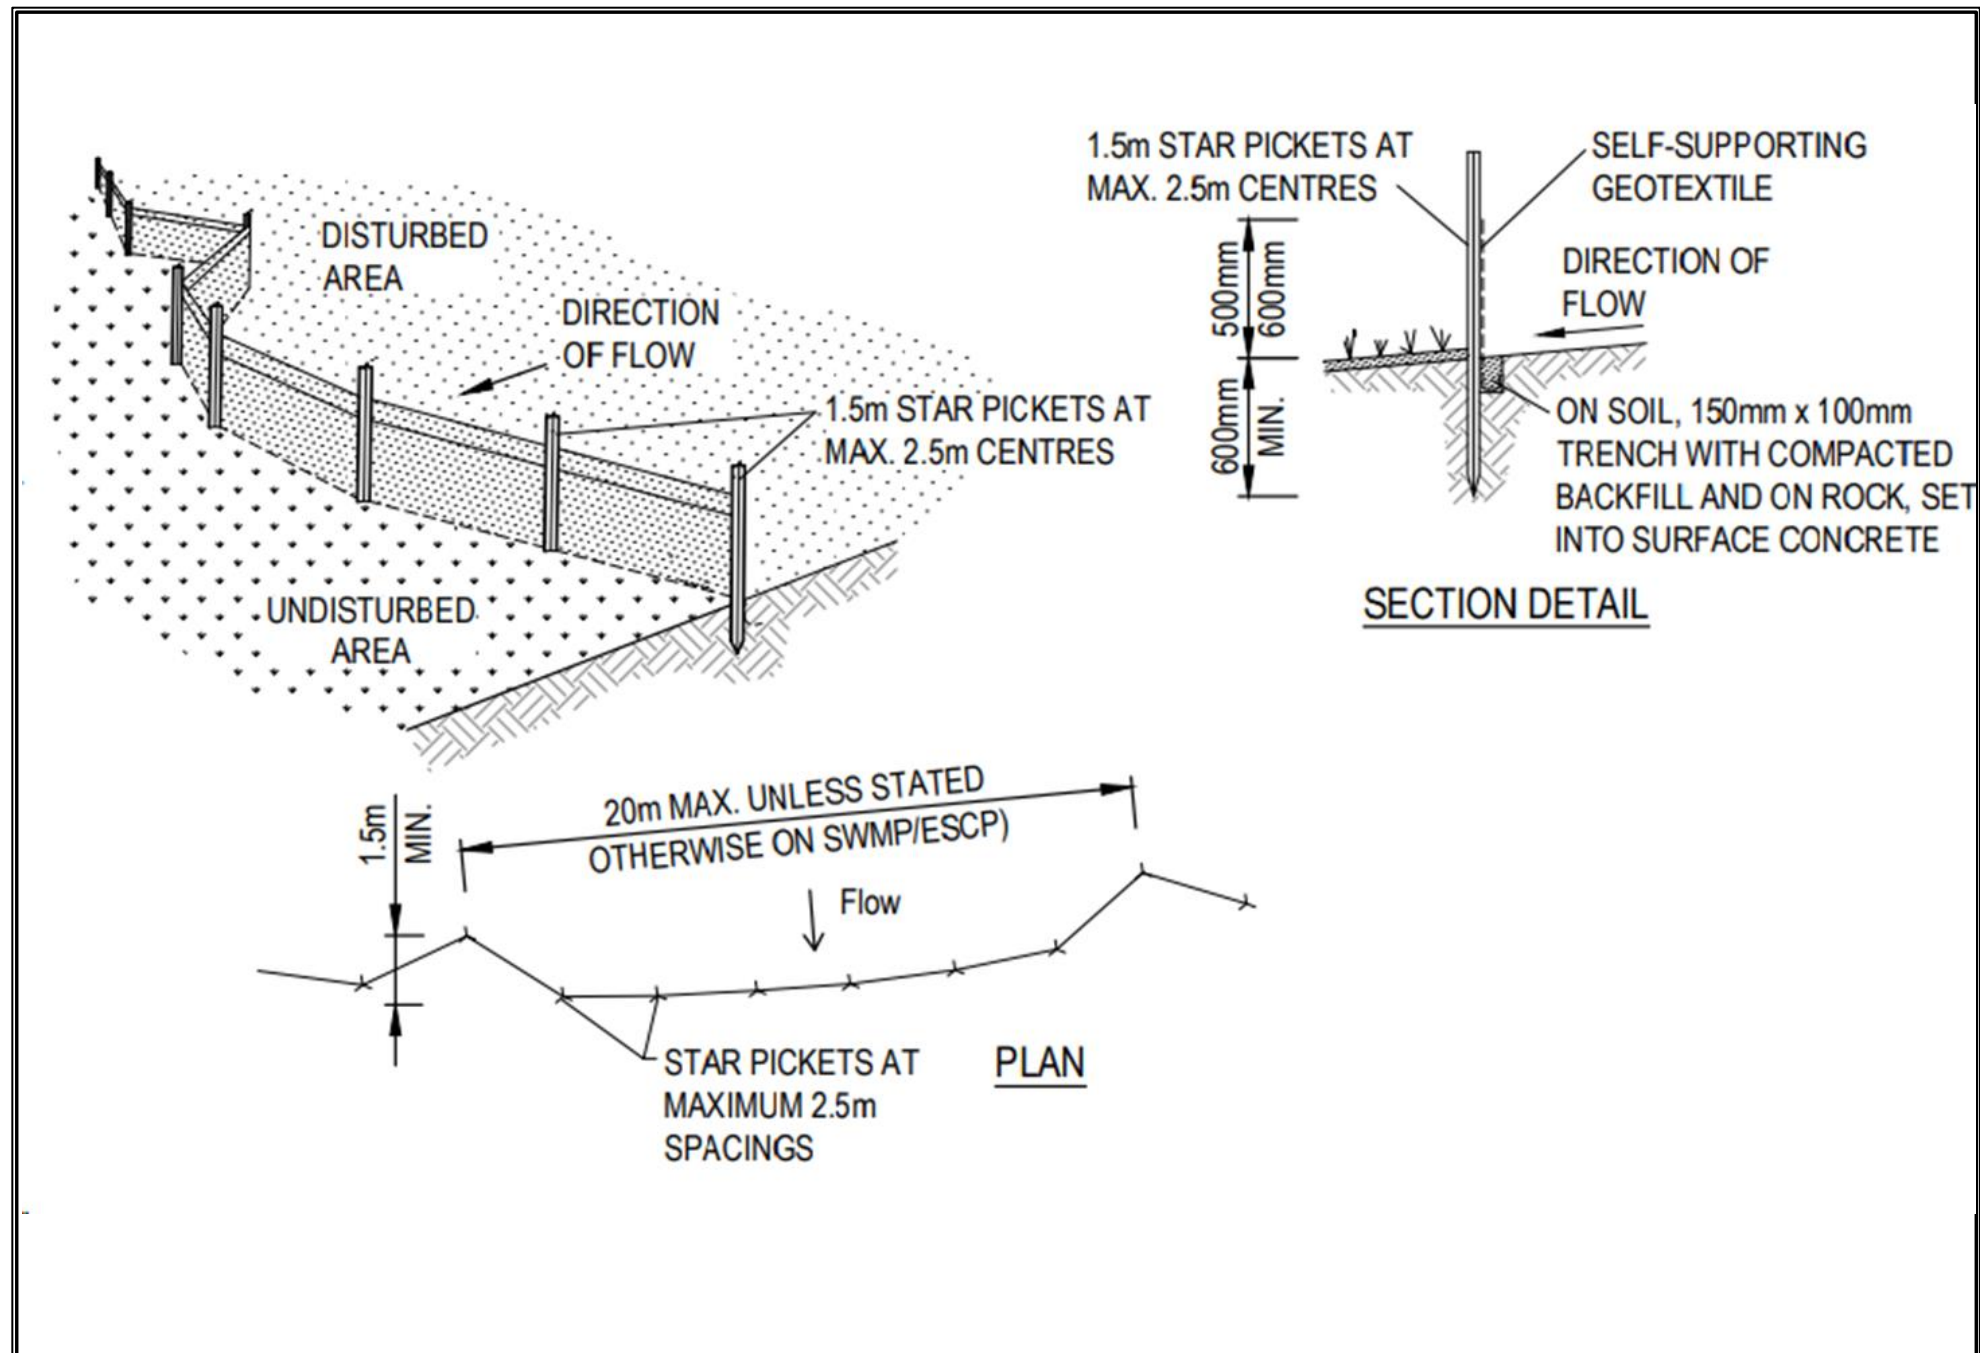
Figure 10:
Diagram of appropriate
sediment fencing
