Acid Sulfate Management Plan

Eileen O'Connor Catholic School

84 Gavenlock Road Mardi, NSW, 2259

October 2023

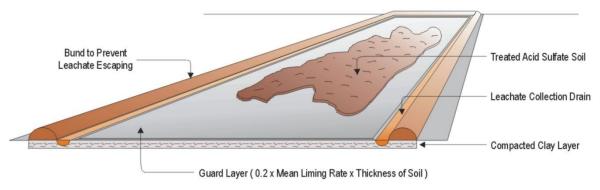
Figure 1: Treatment Pad Design

The liming pad should be constructed so the base of the pad is composed of compacted fine-grained material, so as to produce as impermeable foundation as possible. Ideally a clay liner, no less than 300 mm thick, should be placed on the base of the pad. The base of the pad should slope gently (2 – 5%) so as to allow water/leachate to drain to a designated collection point. A leachate collection system, as described above, should be constructed.

Guard layer $(kg/m^2) = 0.2 \times thickness$ of layer to be treated (m) x average liming rate (kg/tonne).

• The aglime for the guard layer should be spread using an aglime/fertilizer spreader (tractortowed) to ensure the base of the pad is evenly covered, prior to the placement of the material requiring treatment.

Prior to commencement of excavation, the treatment area must be appropriately constructed to intercept any material that may cause environmental harm to the surrounding environments (e.g. acid leachate collection systems and sediment traps around the treatment pad). Multiple treatment areas may be required for different portions of the excavation to allow for effective onsite treatment and validation before removal. Refer to Section 10.8 for the Option 3, Ex Situ Treatment pad design.

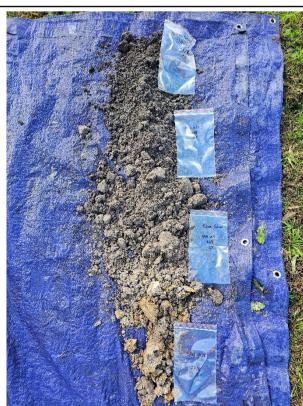
Photo 5: Representative shallow soils encountered in HA01, predominantly sand

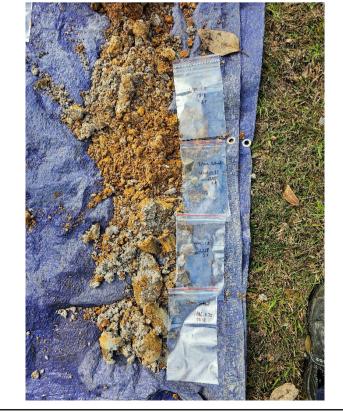
Photo 6: Representative deeper soils encountered in HA01, predominantly clay

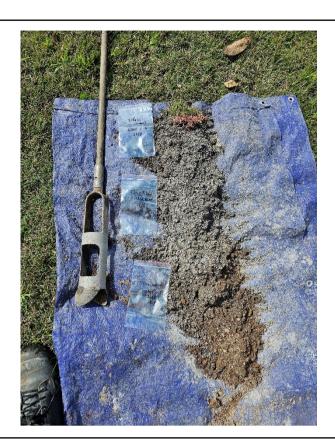
Photo 7: Representative shallow soils encountered in HA02, predominantly sand

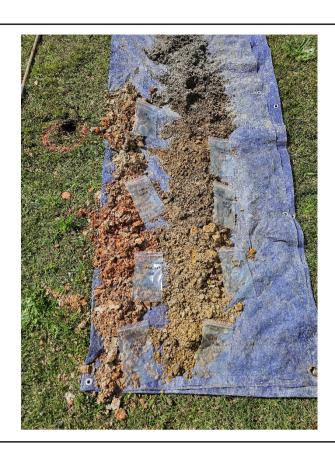
Photo 8: Representative deeper soils encountered in HA01, predominantly clay

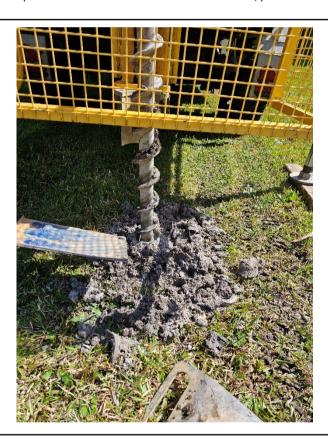
Photo 9: Drilling process of HA04

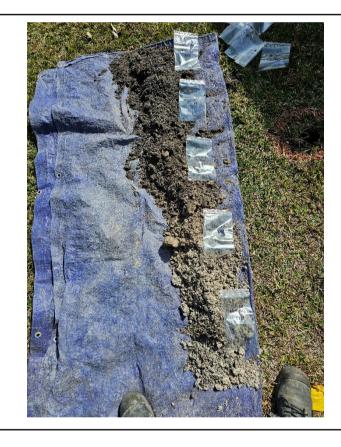
Photo 10: Representative shallow soils encountered in HA04, predominantly sand

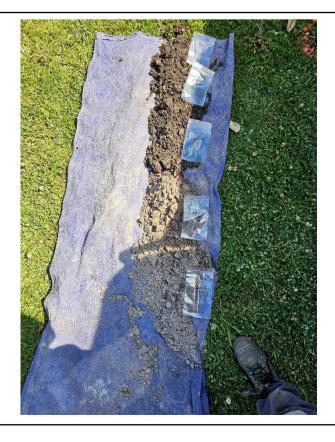
Photo 11: Representative shallow soils encountered in HA05, predominantly sand

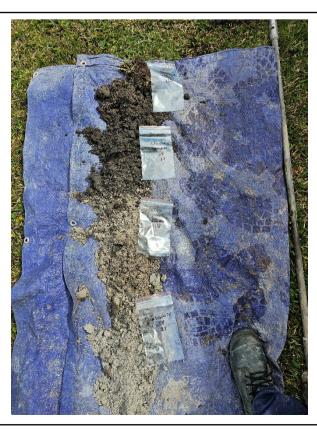
Photo 12: Representative shallow soils encountered in HA06, predominantly sand
