**REPORT  
on  
REMEDIAL ACTION PLAN**

**UTS BLACKFRIARS CAMPUS  
CHIPPENDALE**

***Prepared for  
University of Technology, Sydney***

***Project 45996.02 Rev 2  
January 2015***

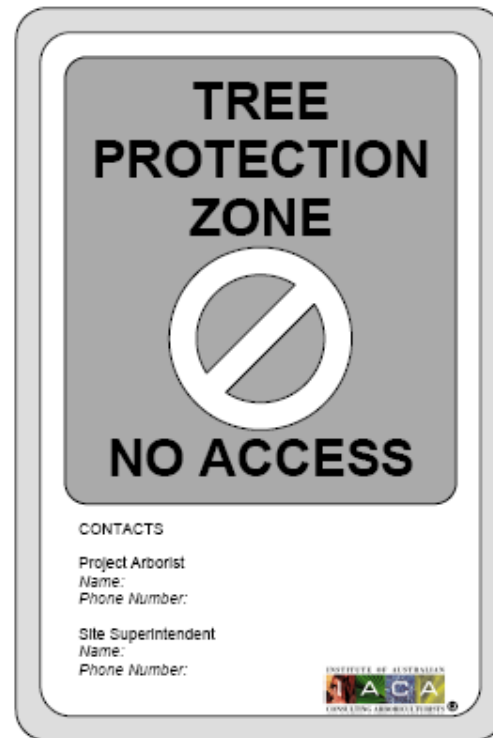
Example of Tree Protection Zone (TPZ) Signage
