# University of Technology Sydney Blackfriars Campus 4-12 Buckland St, Chippendale Conservation Management Plan

Prepared for  
University of Technology Sydney

November 2015

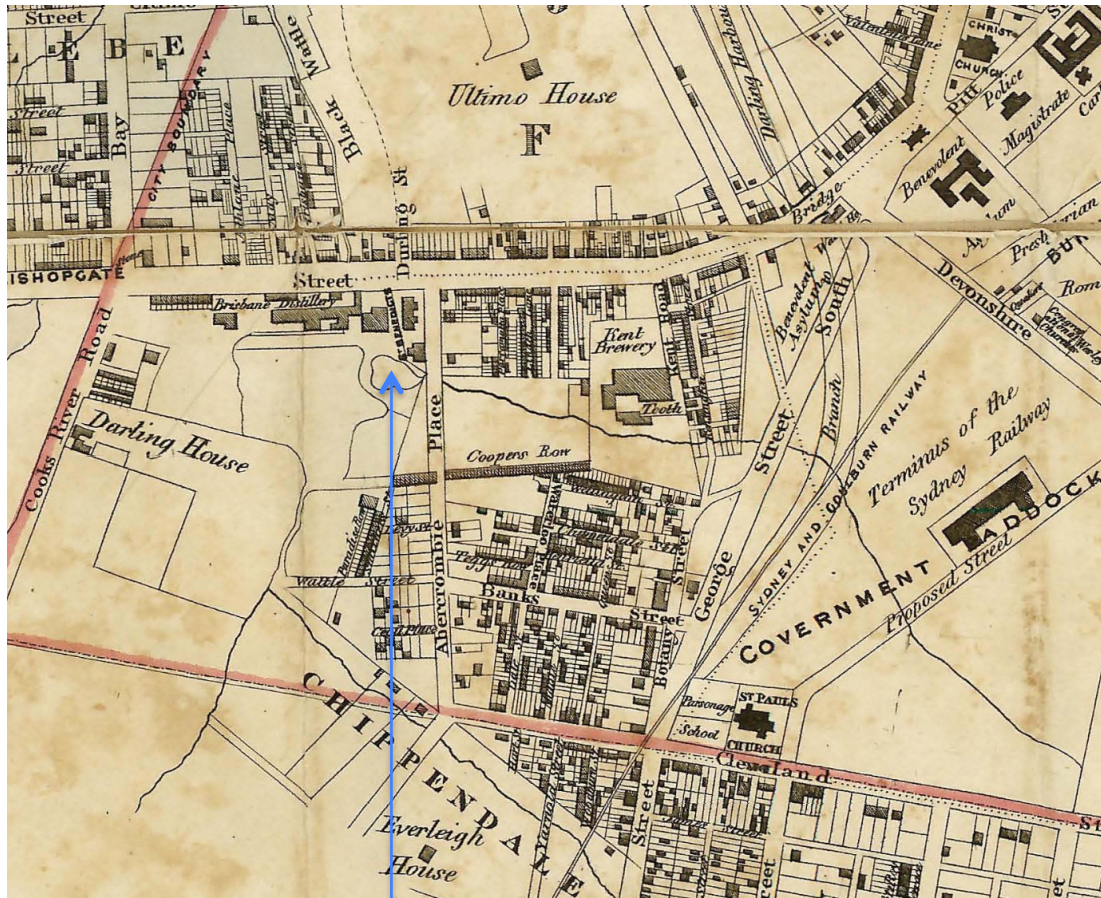
Figure 31: Extract of Woolcott & Clarke's Map of Sydney 1854, showing the location of the Brisbane Distillery on Parramatta Road. A dam is located approximately where the Blackfriars campus is located today (arrowed). Note "Cooks River Road" marked at left is today City Road. Source: City of Sydney Archives Historical Maps collection

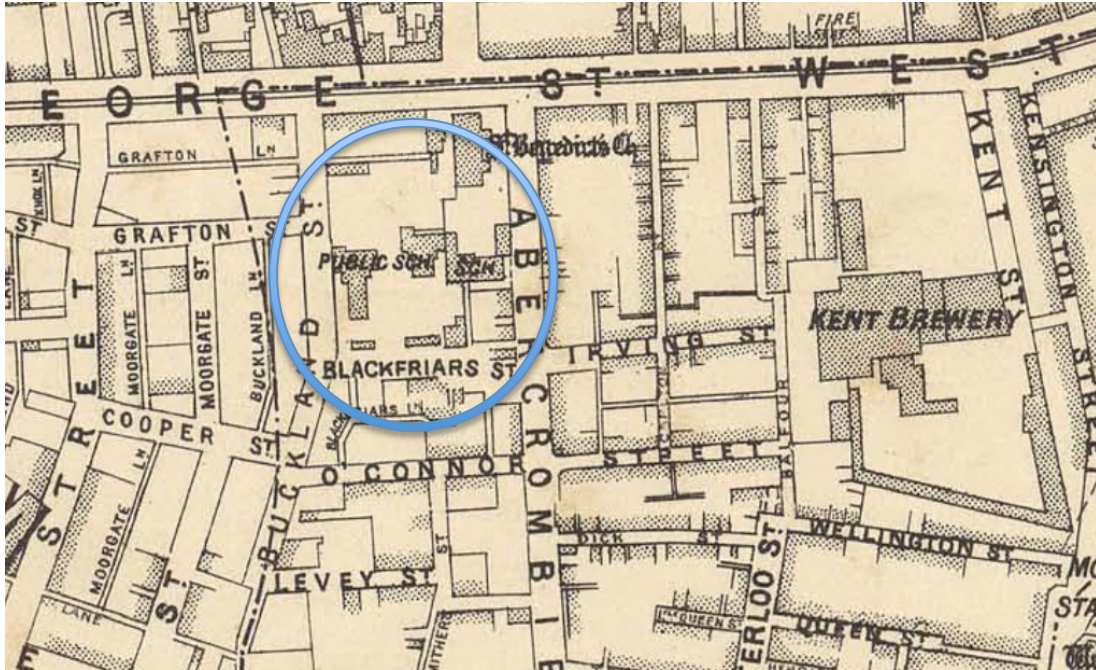
Figure 35: Extract of a 1903 City of Sydney map showing the Blackfriars school site (circled). Source: City of Sydney Archives Historical Atlas of Sydney

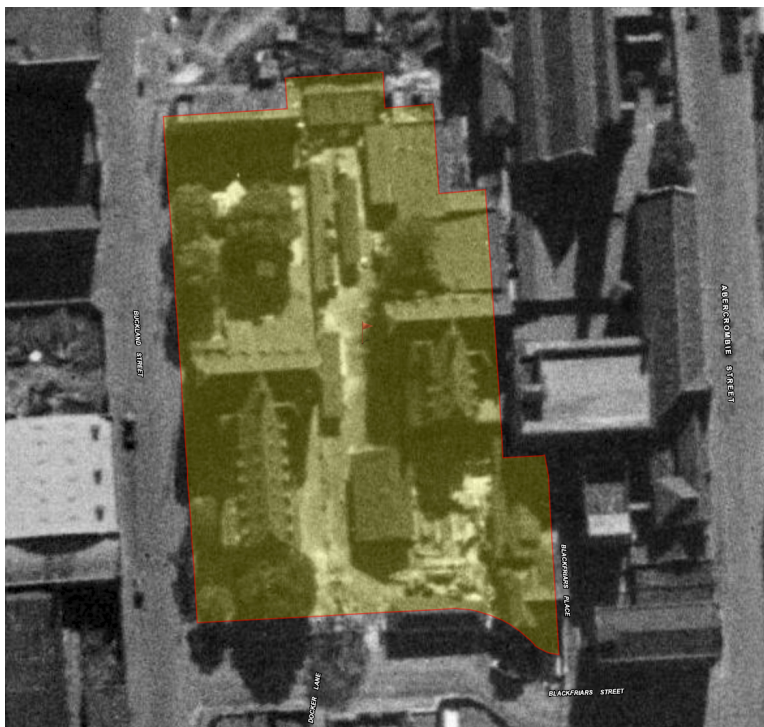
Figure 36: 1943 aerial photo showing the Blackfriars site with numerous small buildings around the three original 1885 buildings Source: NSW Land & Property Information Six Maps.

Comparison of the two 1940s aerial photos with modern satellite photo of the site establishes that there are more trees and grassed areas on the site today than in the past. Prior to the 1943 aerial photo it appears that the site contained little landscaping.

The site was quite cluttered with utilitarian buildings and accretions to existing buildings, both brick and weatherboard, prior to 1990 and was extensively asphalted. The site today contains grassed areas and substantial trees (some of these trees evident in the 1943 and 1949 aerial photo above).

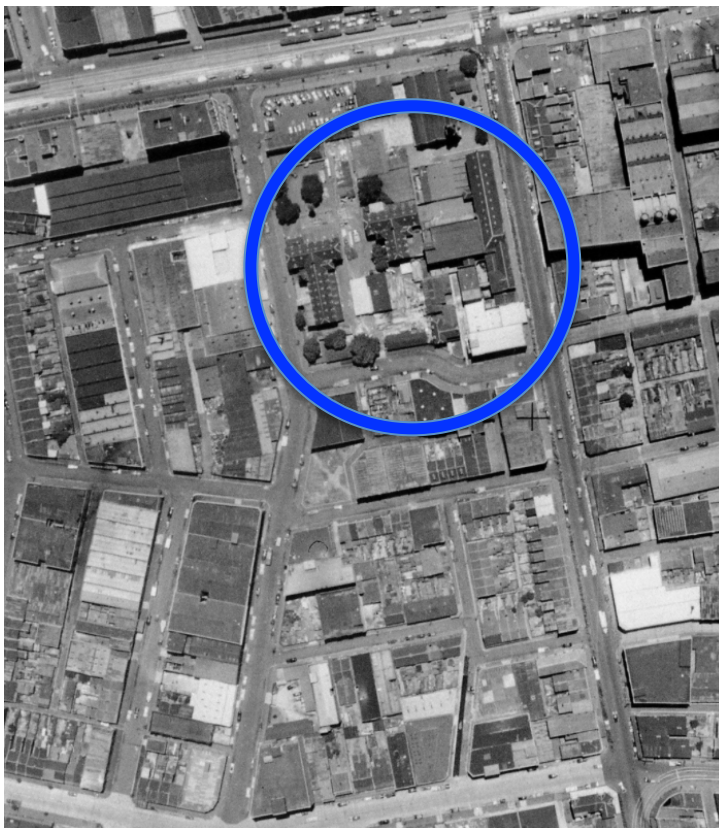
Figure 38: 1949 aerial photo with the site circled. By this time the site was less cluttered. Source: City of Sydney Archives Historical Atlas of Sydney
