# **ARBORICULTURAL IMPACT ASSESSMENT REPORT**

## **PROPOSED RESEARCH FACILITY UTS BLACKFRIARS 4-12 BUCKLAND STREET, CHIPPENDALE**

**May 2018**

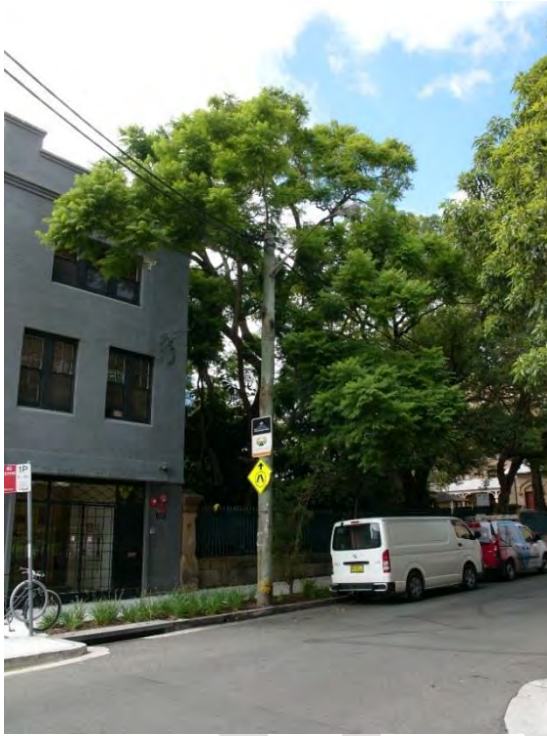
**Plate 1** – Tree 33 – Jacaranda

- 9.1.3 The proposed development will necessitate the removal of five (5) of high retention value, being T33 (Jacaranda), T34 (Camphor Laurel), T35 (River Oak), T45 (Chinese Tallow) and T50 (Brushbox). These trees do not have any special ecological or heritage significance, but they are all in good health and condition and make a positive contribution to the amenity of the site and the streetscape. In order to retain these trees, significantly greater setbacks between the trees and built structures would be required to limit encroachments to the TPZ (including that to facilitate construction) and canopy (including the impact of temporary scaffold) to no greater than 15%. Consideration has been given to the retention of these trees, but it is not considered feasible given the proximity of the proposed building and the extent of site development proposed.

- 9.1.4 In order to compensate for loss of amenity resulting from the removal of T33, T34 & T35 to accommodate the proposed development, replacement planting with two new trees is proposed to be undertaken within the front setback area using advanced plant stock. The available soil volume at each location is limited to approximately 40-50 cubic metres. This will be sufficient to support one medium sized tree (at each location) of approximately 10 metres in height and eight metres crown spread.

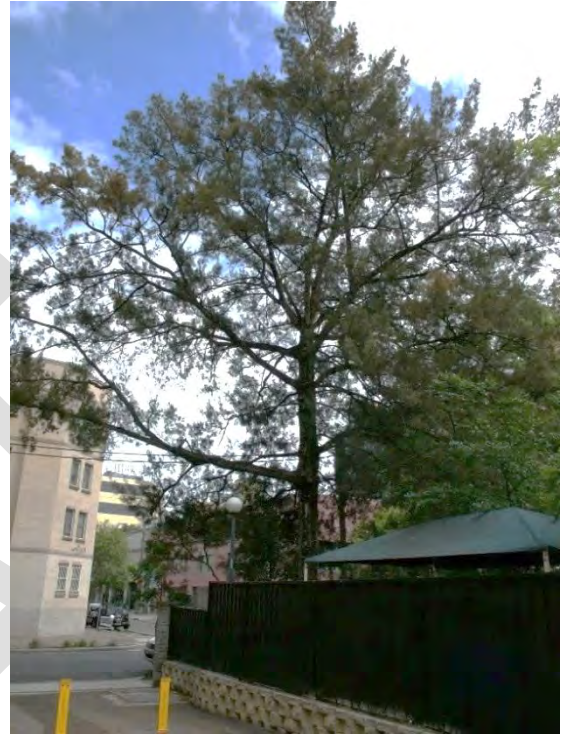
**Plate 2** – Tree 35 – River Oak

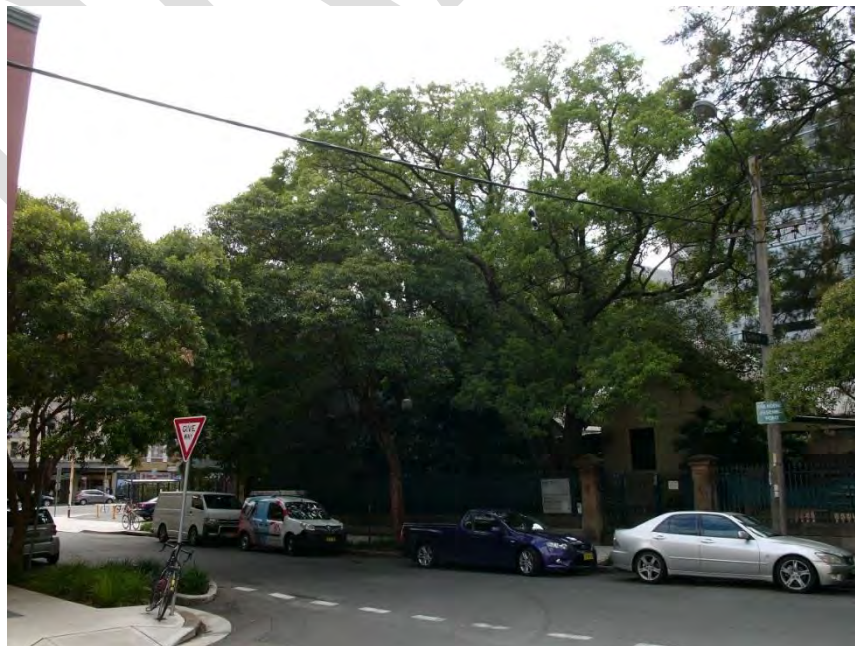
**Plate 3** – Tree 34 – Camphor Laurel.

| Tree Identification No. | Species | Height (m) | Spread (m) | Trunk Diameter (mm) at 1.4 metres | Live Crown Size (m <sup>2</sup> ) | Maturity Class | Condition | Previous Pruning | Health | | Remaining Safe Useful Life Expectancy (SULE) | Landscape Significance Rating | Retention Value | Location |
|---|---|---|---|---|---|---|---|---|---|---|---|---|---|---|
| 34 | <i>Cinnamomum camphora</i> (Camphor Laurel) | 13 | 16 | 520 + 650 | 176 | M | Appears stable with fair branching structure. Exhibits a moderate partly occluded wound and cavity/decay at 1.8 metres in former PL branch collar. Moderate bark inclusion at 1.5 metres at junction of PL. | Selectively pruned (large PL to east). Deadwooded. May have been previously lopped at 5 metres (crown restored). | Good | No Evidence | Long - more than 40 years | 3 | High | On-site |

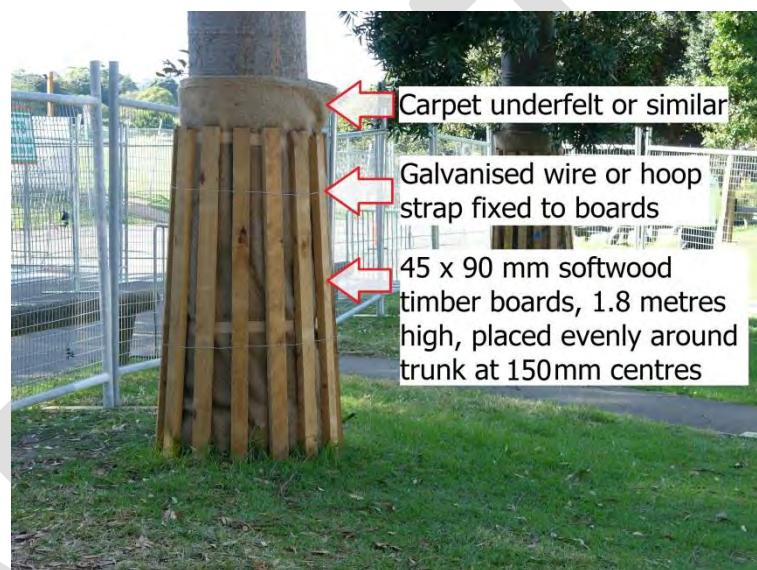
**Figure 3 – Detail of Trunk Protection**

- 10.4.1 Trunk Protection shall be erected around the trunks of Trees [T1, T23, T28, T29a, T30 & T31] to avoid accidental damage during construction, as indicated on the Tree Protection Plan (**Appendix 6**). The trunk protection shall consist of a layer of carpet underfelt (or similar) wrapped around the trunk, followed by 1.8 metre lengths of softwood timbers (90 x 45mm in section) aligned vertically and spaced evenly around the trunk at 150mm centres (i.e. with a 50mm gap) and secured together with 2mm galvanised wire or galvanised hoop strap as shown in **Figure 3**. Recycled timber (such as demolition waste) may be suitable for this purpose, subject to the approval of the Project Arborist. The timbers shall be wrapped around the trunk (over the carpet underfelt), but not fixed to the tree to avoid mechanical injury or damage to the trunk. Trunk protection should be installed prior to any site works and maintained in good condition for the duration of the construction period. Carpet underfelt (alone) is sufficient for trees with a trunk diameter of less than 200mm. This shall be wrapped in double thickness and held in place (prevented from unravelling) with durable adhesive tape.

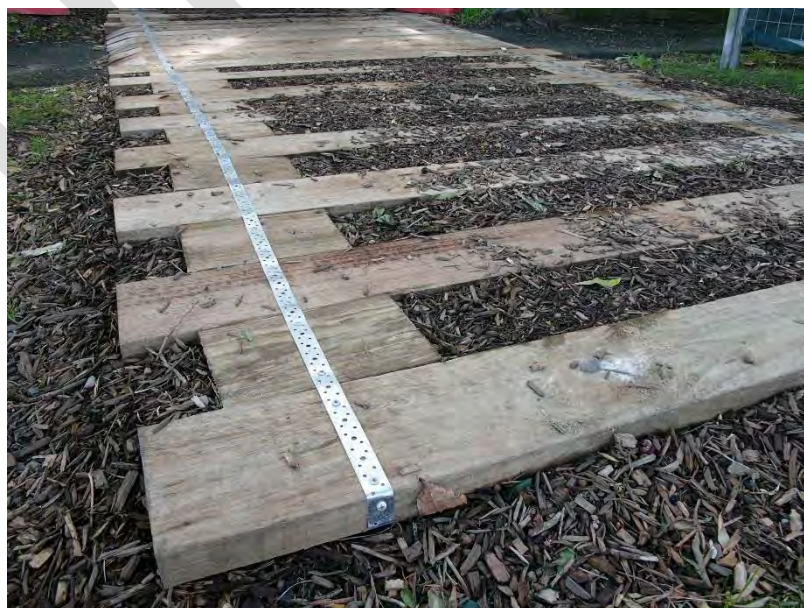
- 10.13.2 To minimise displacement of woodchip/sand in highly trafficked areas, 20mm thick marine ply sheets, truck mats (such as Envirex Versadeck® access mats) or rumble boards should be placed over the top of the woodchip/sand. Rumble boards can be constructed with timber sleepers or similar spaced with no more than 200mm gaps between boards and held together with galvanised hoop strap or similar (refer **Figure 3**).

**Figure 3** – Showing typical detail for rumble boards.

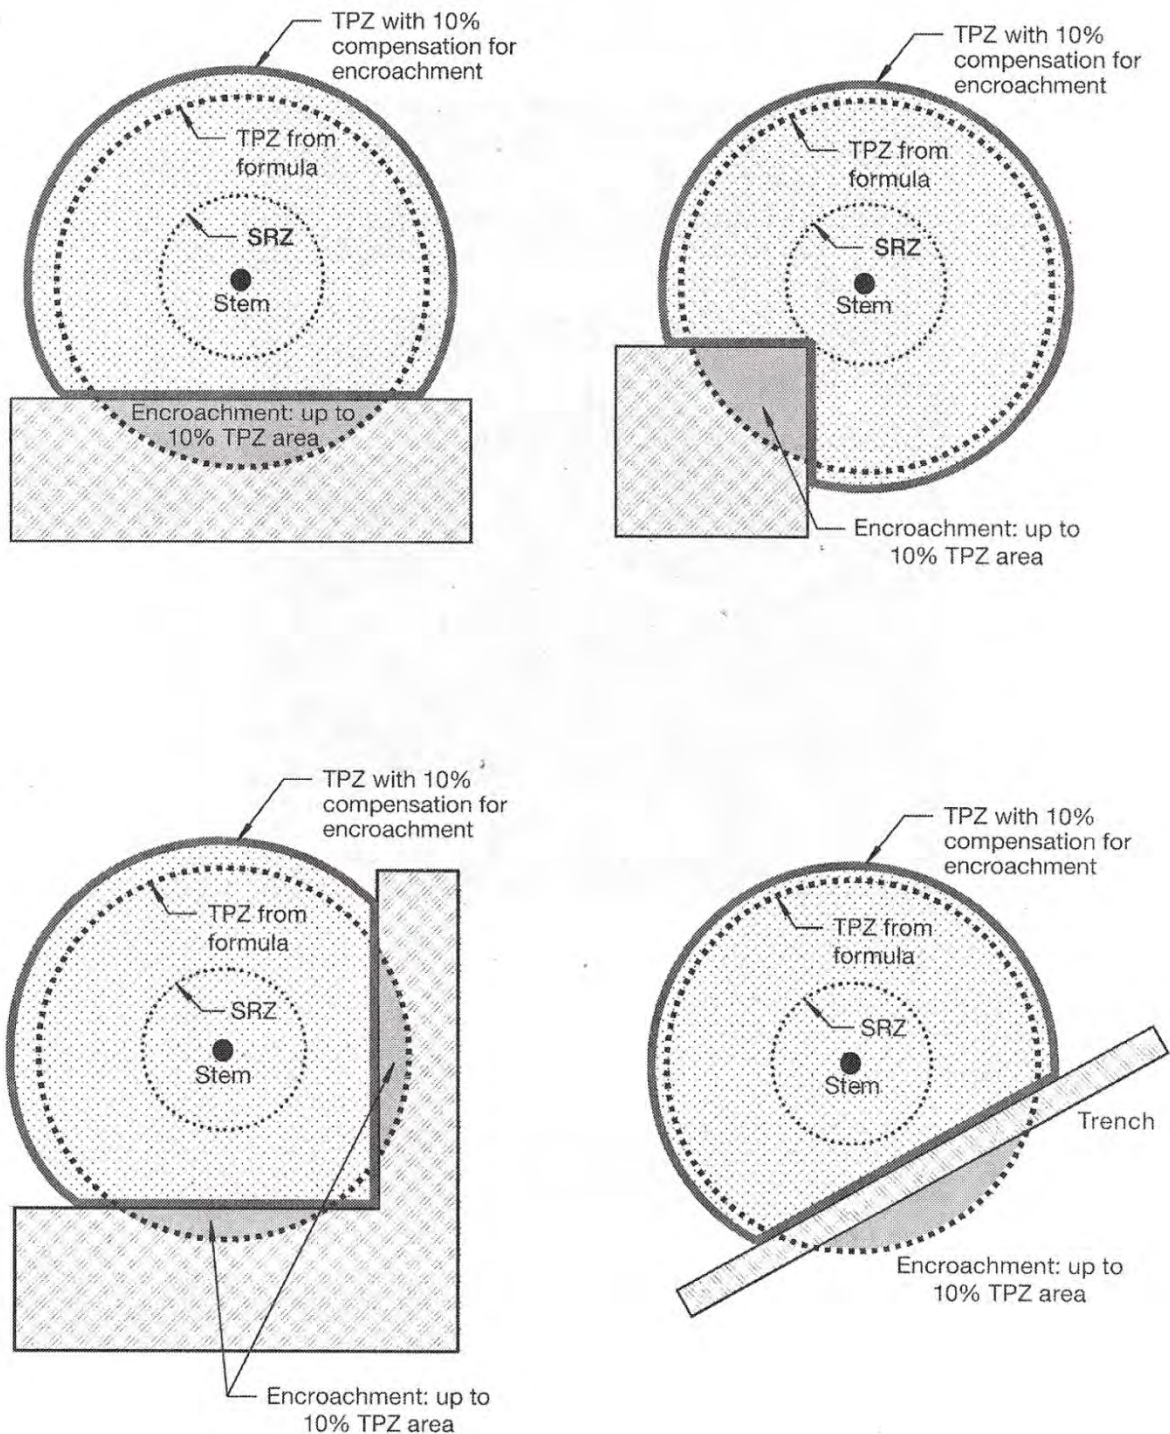
## APPENDIX 2 – ACCEPTABLE INCURSIONS TO THE TREE PROTECTION ZONE (TPZ)

NOTE: Less than 10% TPZ area and outside SRZ. Any loss of TPZ compensated for elsewhere.

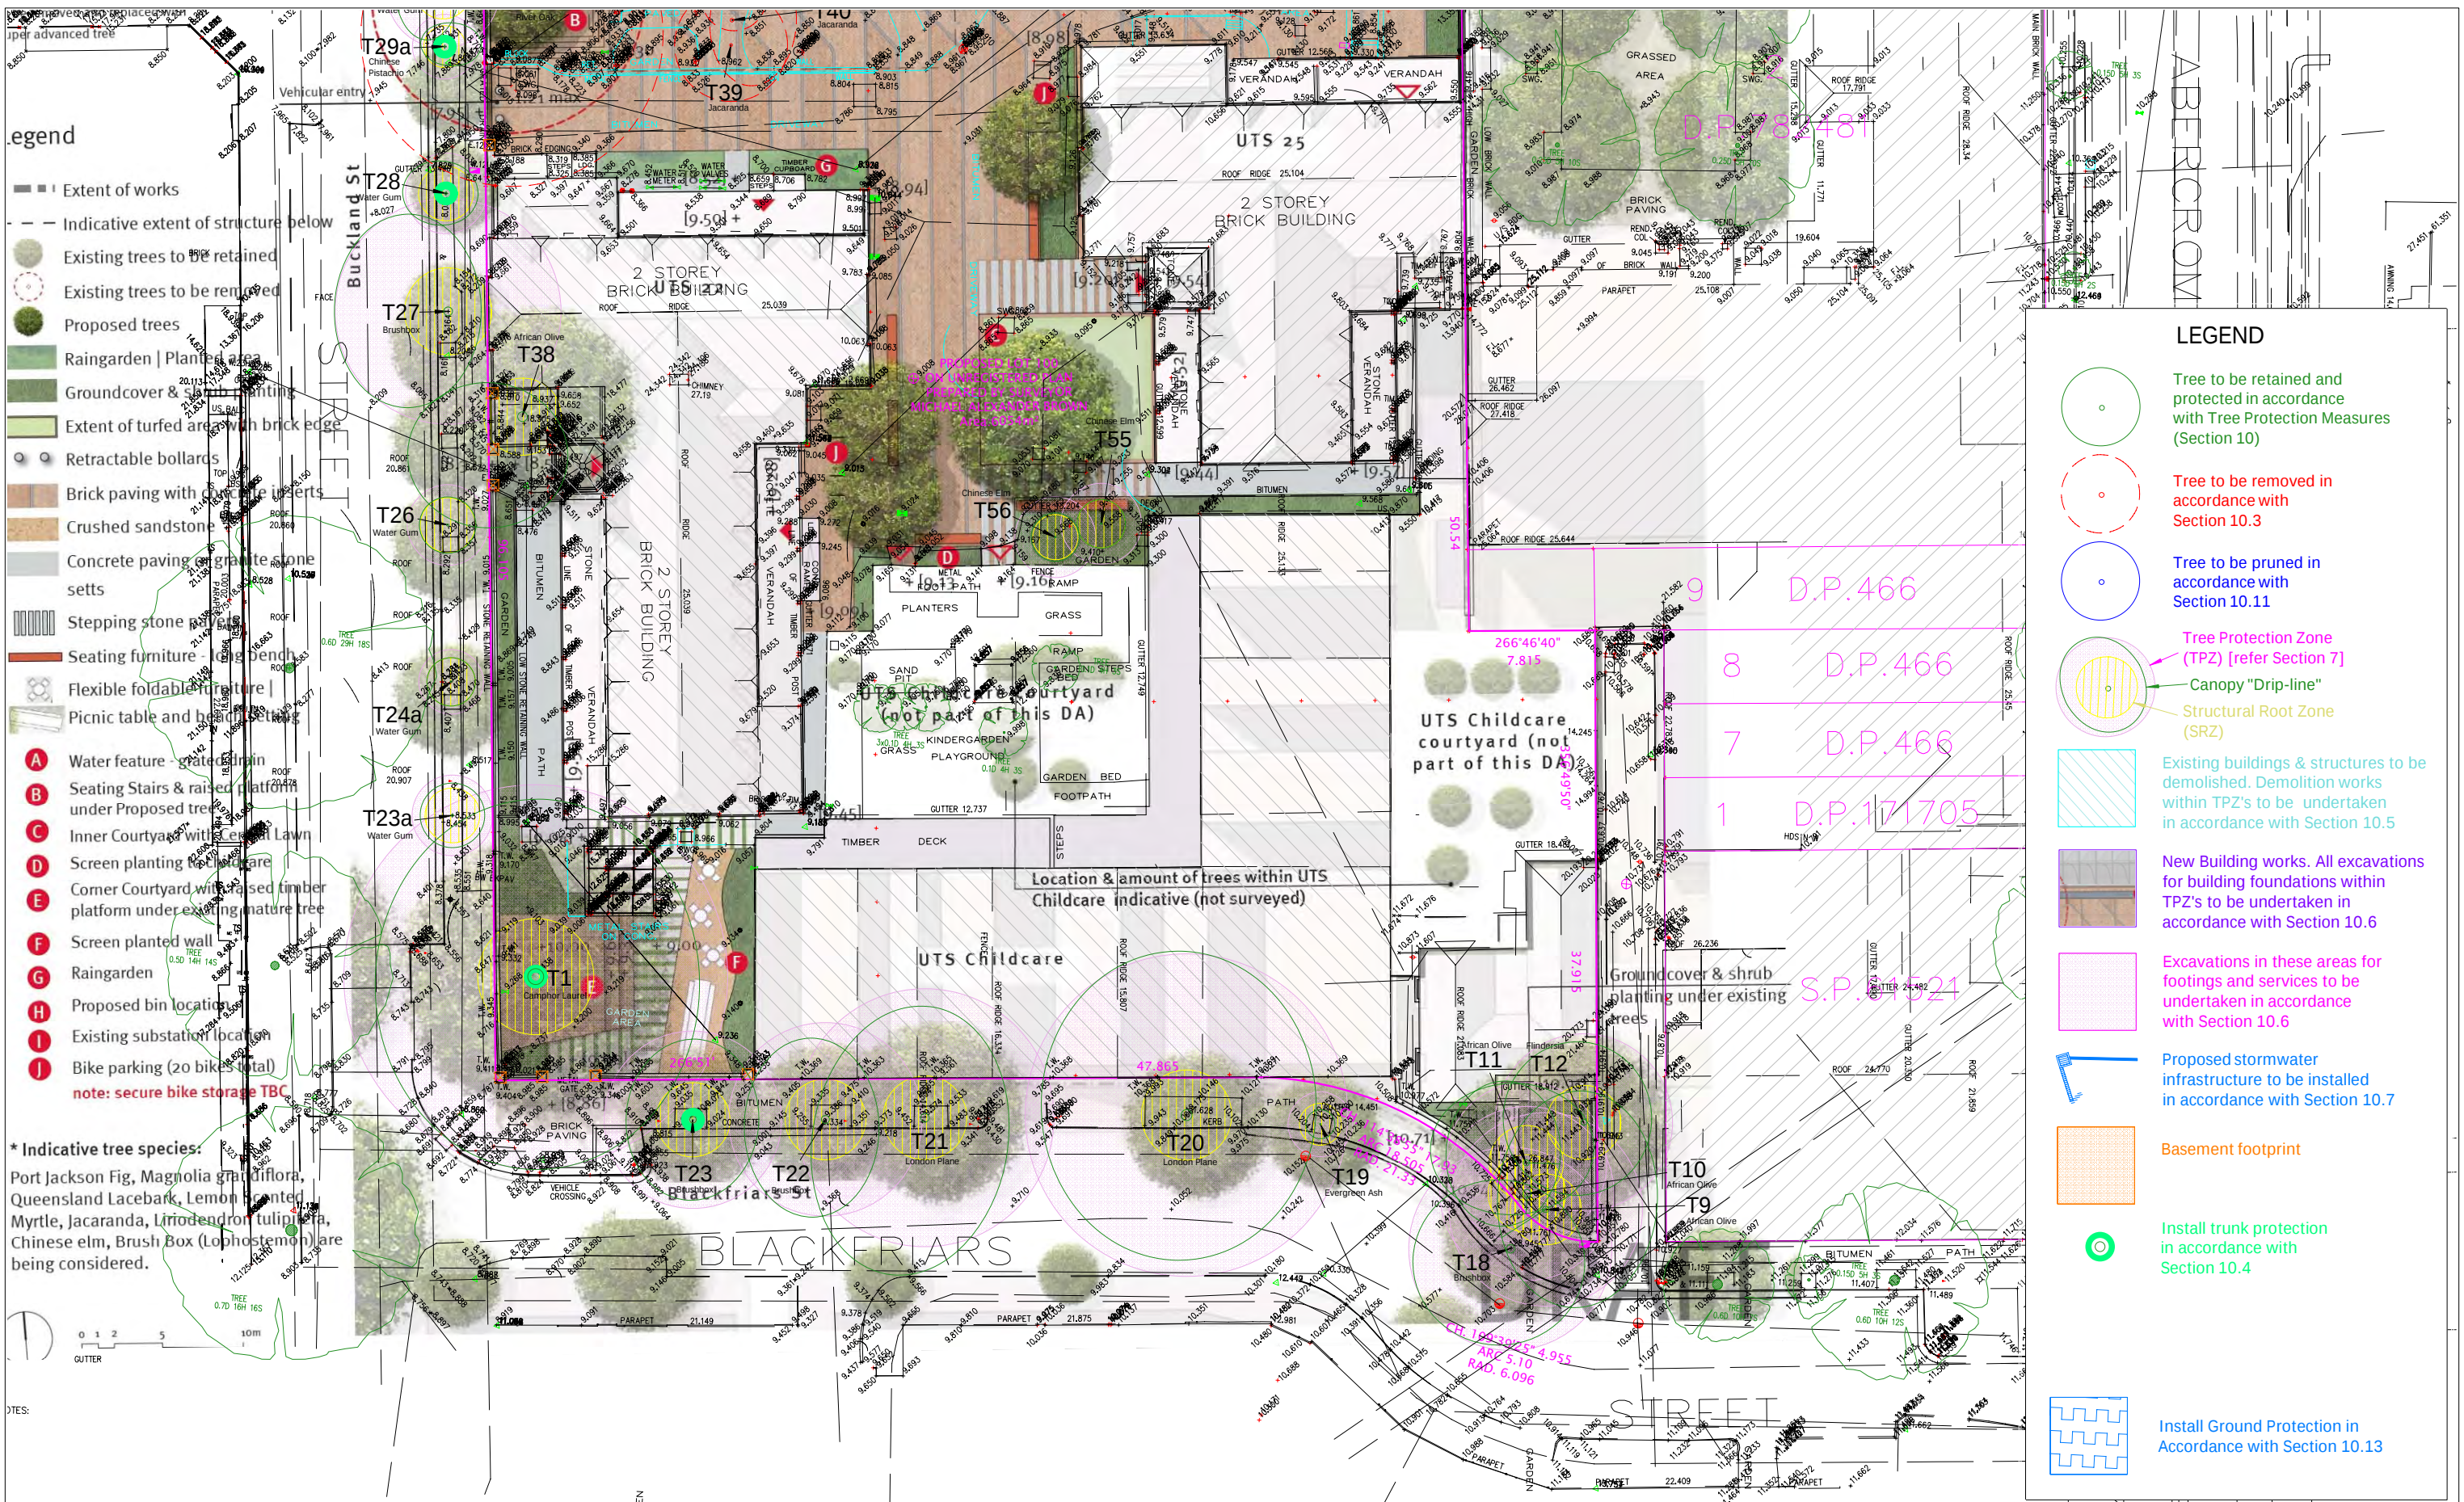
## APPENDIX 6 TREE PROTECTION PLAN

10.1.1 The following Tree Protection Measures should be read in accordance with the Tree Protection Plan (**Appendix 6**). The Tree Protection Plan (TPP) indicates the position of tree protection devices and other recommended measures to ensure the protection of trees within the site to be retained as part of the proposed development.
