## Preliminary Hazard Analysis

120 Houghton Road, Yanco 2703

ACEnergy Pty Ltd

**Riskcon Engineering Pty Ltd**

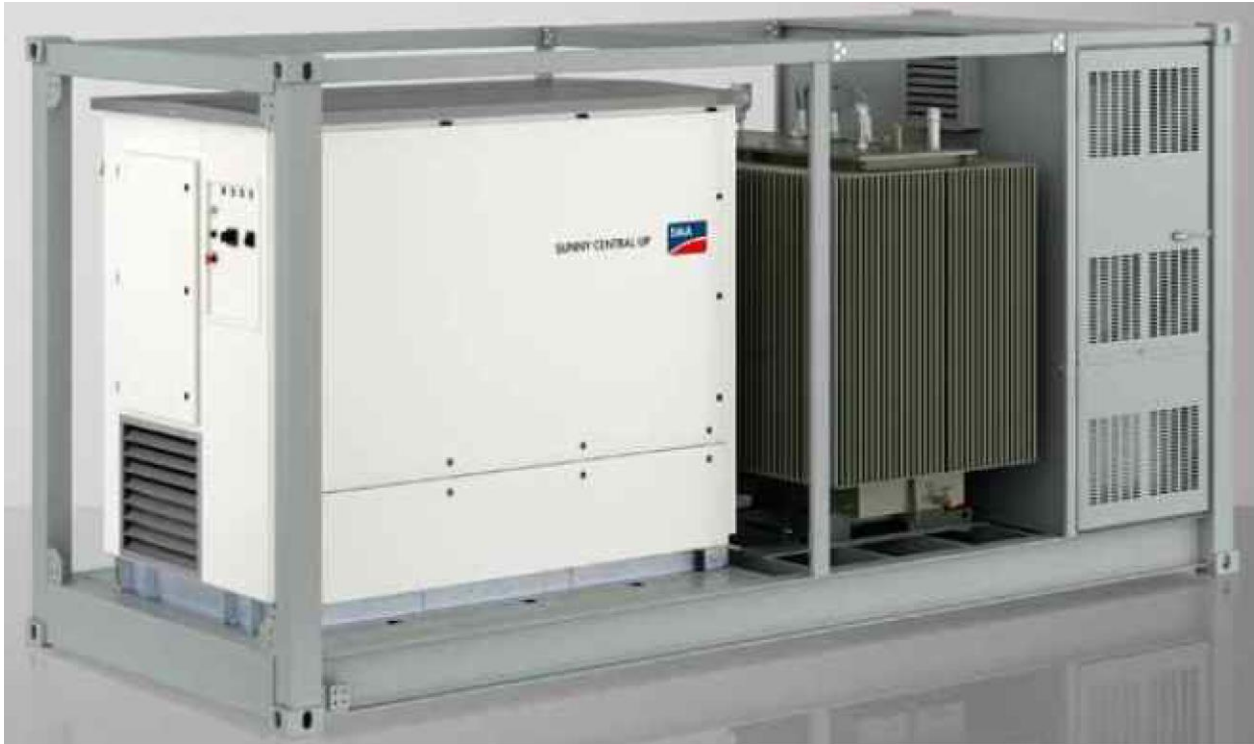
**Figure 3-3: Typical MVPS**

The inverters convert the Direct Current (DC) to Alternating Current (AC), while the transformers increase the voltage from Low Voltage to a Medium or High Voltage, as required for the electricity grid connection. MVPS are a compact, containerised product, with each unit measuring approximately 2.5 m wide by 3 m high, with a depth of 6 metres. **Figure 3-3** provides an example of a typical MVPS.

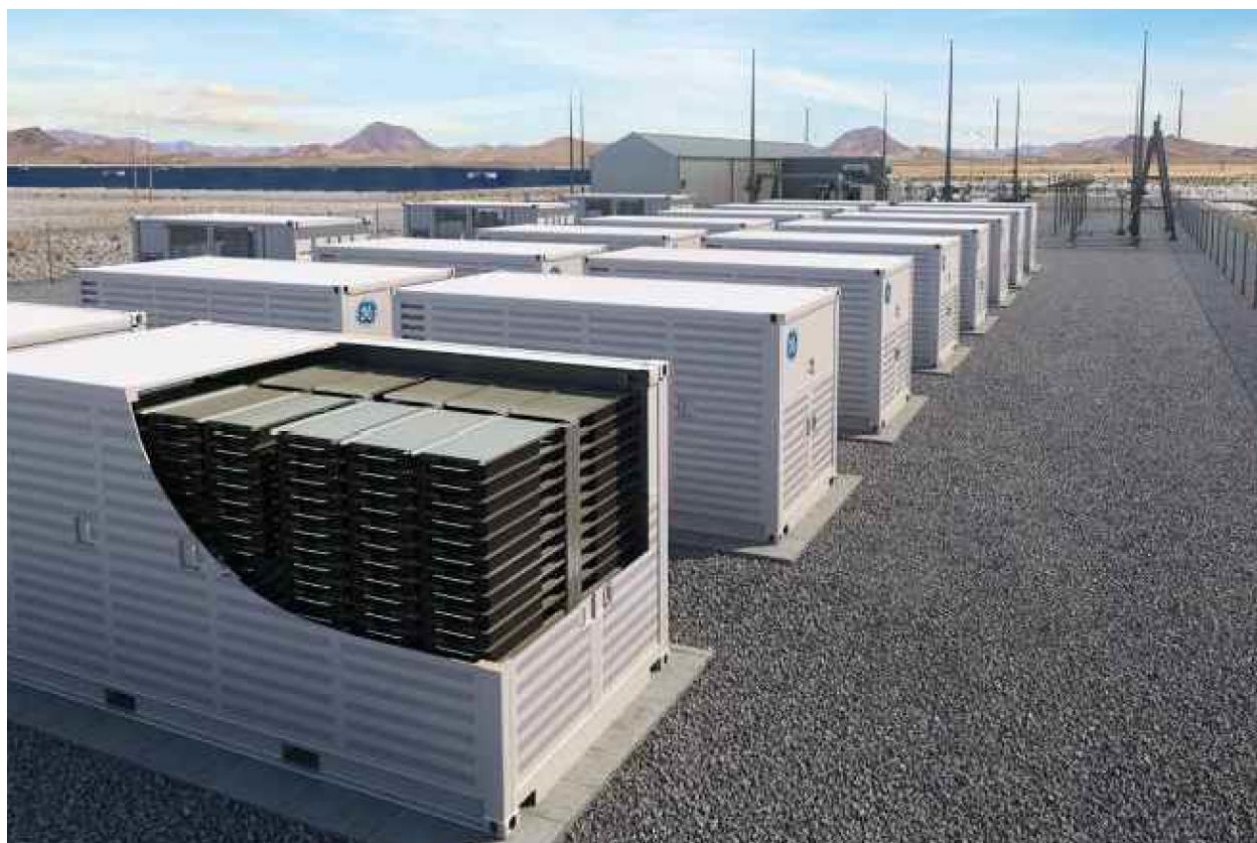
**Figure 3-4: Typical BESS Arrangement**

352 CATL BESS units will be located within the site compound, laydown and substation footprint area. The BESS converts electrical energy into chemical energy and stores the energy internally. It may also provide additional network support such as Frequency Control Ancillary Services (FCAS) assisting with transmission network grid stability. A typical BESS is shown in **Figure 3-4**.
