# Preliminary Site Investigation (PSI)

for potential contamination at

Yanco BESS

| <b>Project Name:</b> | Preliminary Site Investigation (PSI) for contamination on part of 120 Houghton Road Yanco NSW 2703 |

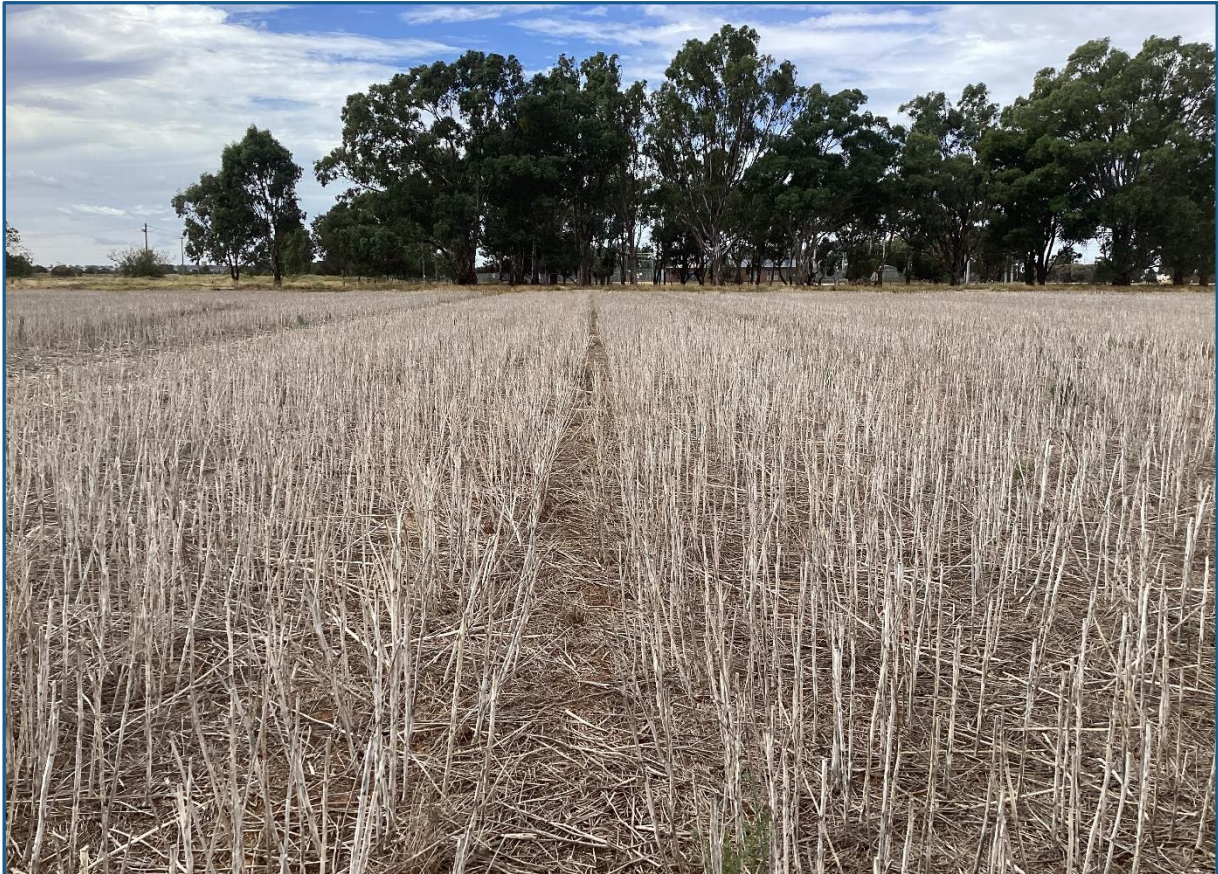
**Image 1:** Facing the eastern boundary of the site with the Yanco Substation in the background behind rows of roadside planted native trees; canola stubble pictured on the site.

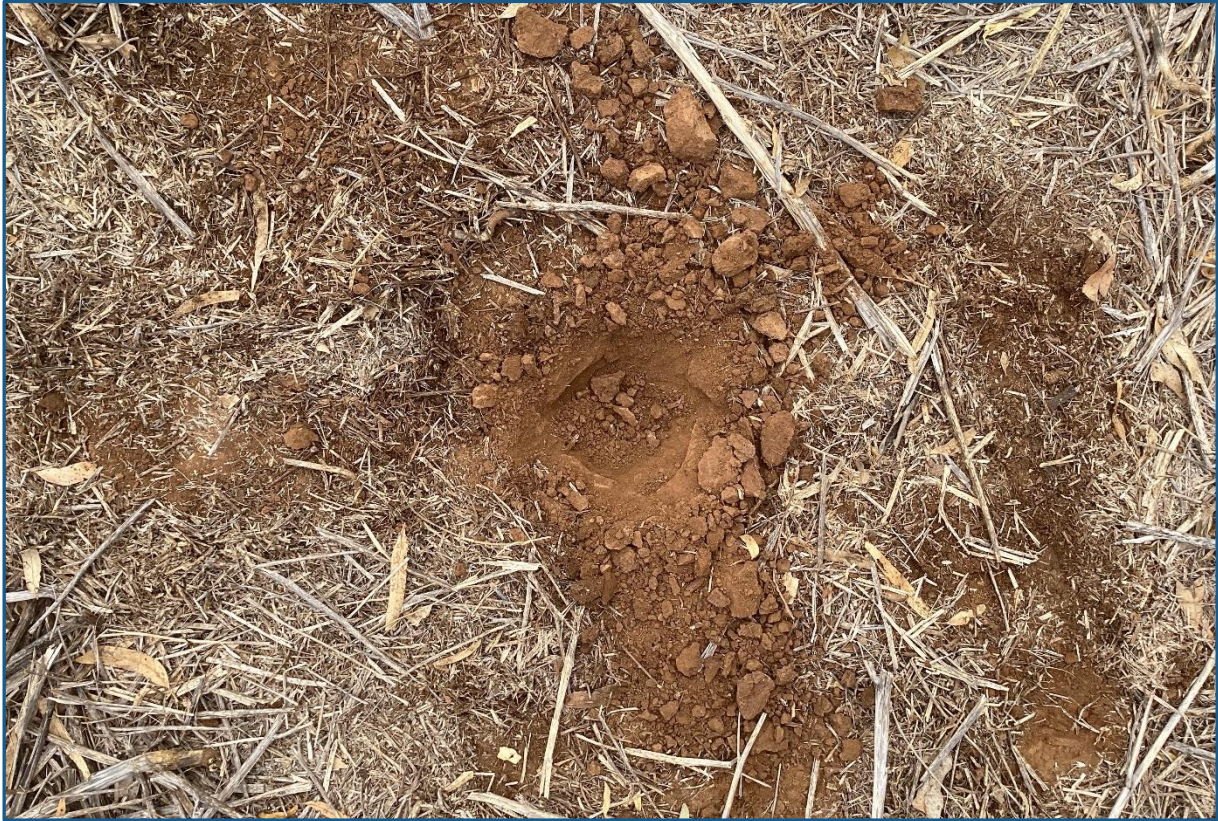
**Image 2:** A sample of surface soil was collected from the site with a decontaminated 100mm diameter hand auger.

To help assess the potential for contamination and to screen for the presence of contaminants, one soil sample was collected from the site from the upper 10 cm of the soil profile. The soil sampling location and parameters analysed were based on the potential for contamination ascertained from the desktop review and site inspection, and on the consultants' experience with on-site and adjoining land use, being long-term agriculture and substations. As detailed hereunder, one sample was collected from a potential 'hotspot' (the area in the vicinity of the water release point from the farm distribution channel flood gate adjoining the water authority irrigation channel parallel to the Yanco Substation) which was deemed to have the highest risk of contamination and this soil sample was subject to a targeted soil contaminant screen (Sample 3 (S3)). The location of the soil sample collection point S3 is depicted in the appendices (Appendix B - Site Plans) and sampling location GPS coordinates are provided in Table 1.

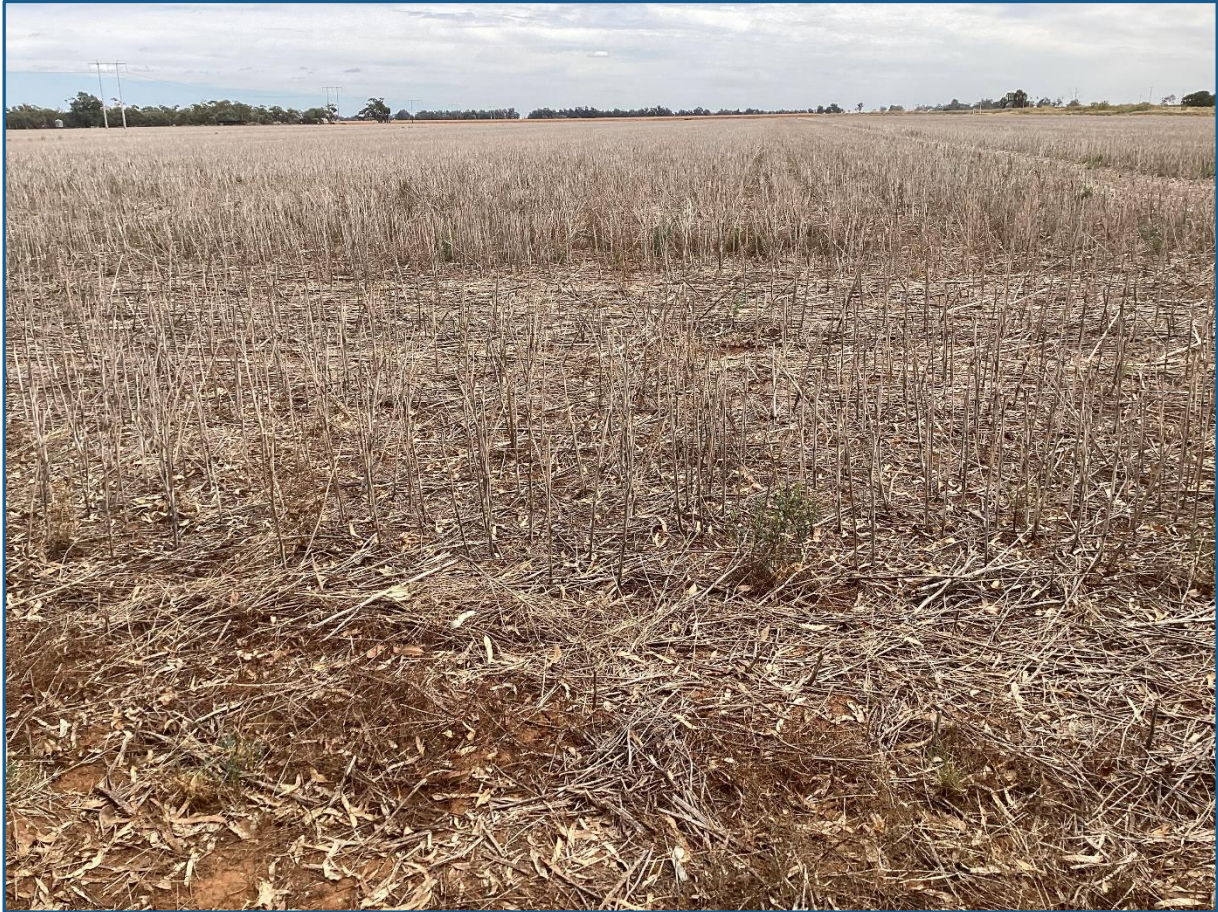
*Image 3: Facing west on the site; canola stubble.*

The site consists of open, irrigable, land formed, agricultural cropping and grazing land (*Image 3*). The landowner indicated he took ownership of the land in the mid-1970s and understood that the land was irrigated periodically for approximately 50 years prior to that time. The landowner advised that the property was historically used for sheep grazing and cropping land and may have been used for rice production in a minor way. The landowner indicated that he had used the site for irrigated summer crops and winter crops over a 30 year period; lucerne was grown for half of that time and other summer and winter crops for the other half. However, the landowner has since moved away from irrigated summer cropping on the site given difficulties with establishing summer crops due to hard setting soil, which requires more effort and subsequently lower yields. The landowner advised that he currently conducts rotational winter cropping and grazing on the site, growing predominately winter crops (wheat, barley, and canola) which are occasionally ‘shoulder’ irrigated in autumn and spring. The landowner indicated that he would continue rotational winter cropping on and in the vicinity of the site (most likely barley in winter 2024) and subsequently in the vicinity of the site during the proposed BESS construction and operation. He did not indicate any plans for other future uses of the site or land in the vicinity of the site. Based on historical aerial imagery, the Yanco Substation, adjacent to the eastern boundary of the site, appears to have been established between 1945 and to 1968. Further information on the site is provided in the appendices (*Appendix A - Locality Plan; Appendix B - Site Plans; Appendix E - Historical Aerial Imagery; Appendix F - Site Environmental Features*).

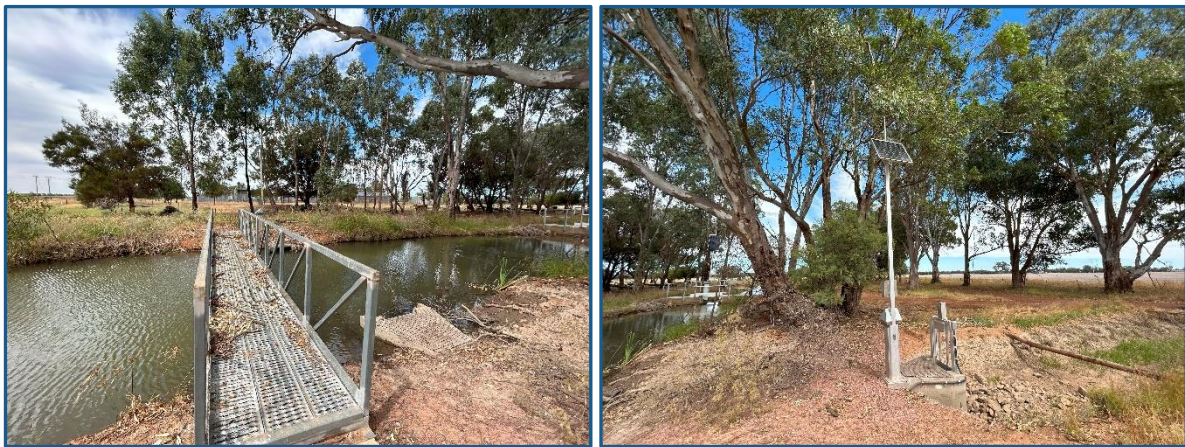
**Image 4:** Water authority irrigation channel running parallel to Yanco Substation (left); slide gate to channel that enters a pipe under Hulme Road into the farm distribution channel on the eastern boundary of the site (right).

eastern boundary of the site by way of an irrigation slide gate and pipe under Hulme Road (*Image 4*, *Image 5* and *Image 6*). Based on historical land use, the highest risk of land contamination is associated with the potential for land contamination presented by the Yanco Substation where a variety of maintenance activities would likely be undertaken, including the use of dielectric fluid. This presents a risk for land contamination by way of excess water run-off from the Yanco Substation onto the site through the irrigation system. The land closest to the first irrigation gate in the farm distribution channel on the eastern boundary of the site was deemed to present the highest risk for localised land contamination and was therefore the focus of soil sample collection (*Image 6*).

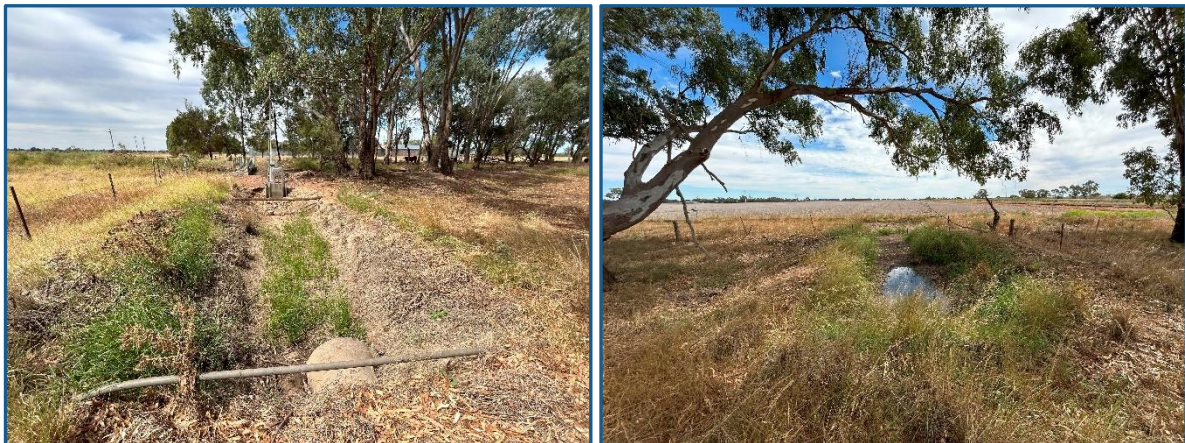
**Image 5:** Slide gate to channel and pipe under Hulme Road (left); facing west onto the site, water sitting in the channel at exit of pipe under Hulme Road to farm distribution channel on the eastern boundary of the site (right).

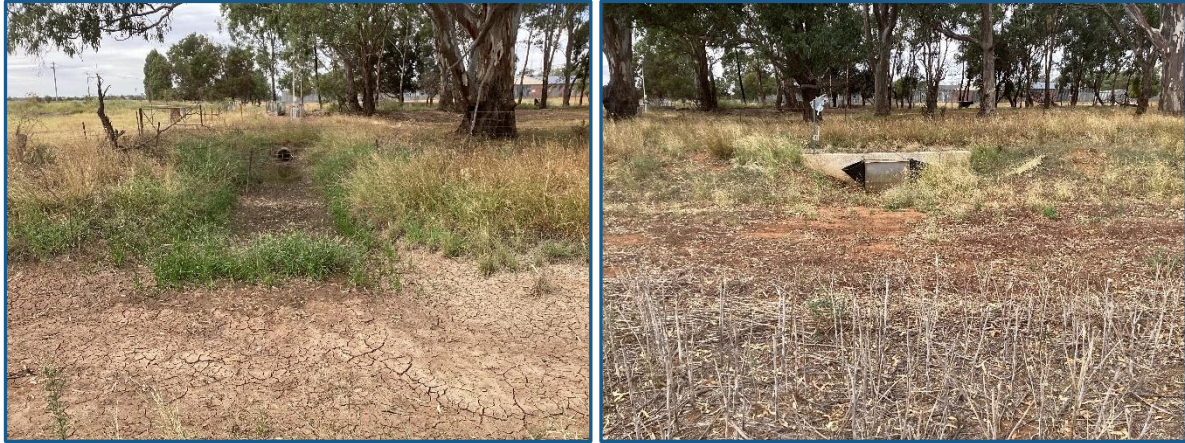
**Image 6:** Facing east from the farm distribution channel on the eastern boundary of the site, pipe under Hulme Road and Yanco Substation and water authority irrigation channel in the background (left); area where sample was taken outside of first gate on the farm distribution channel on the eastern boundary of the site where water is released onto the site (right).

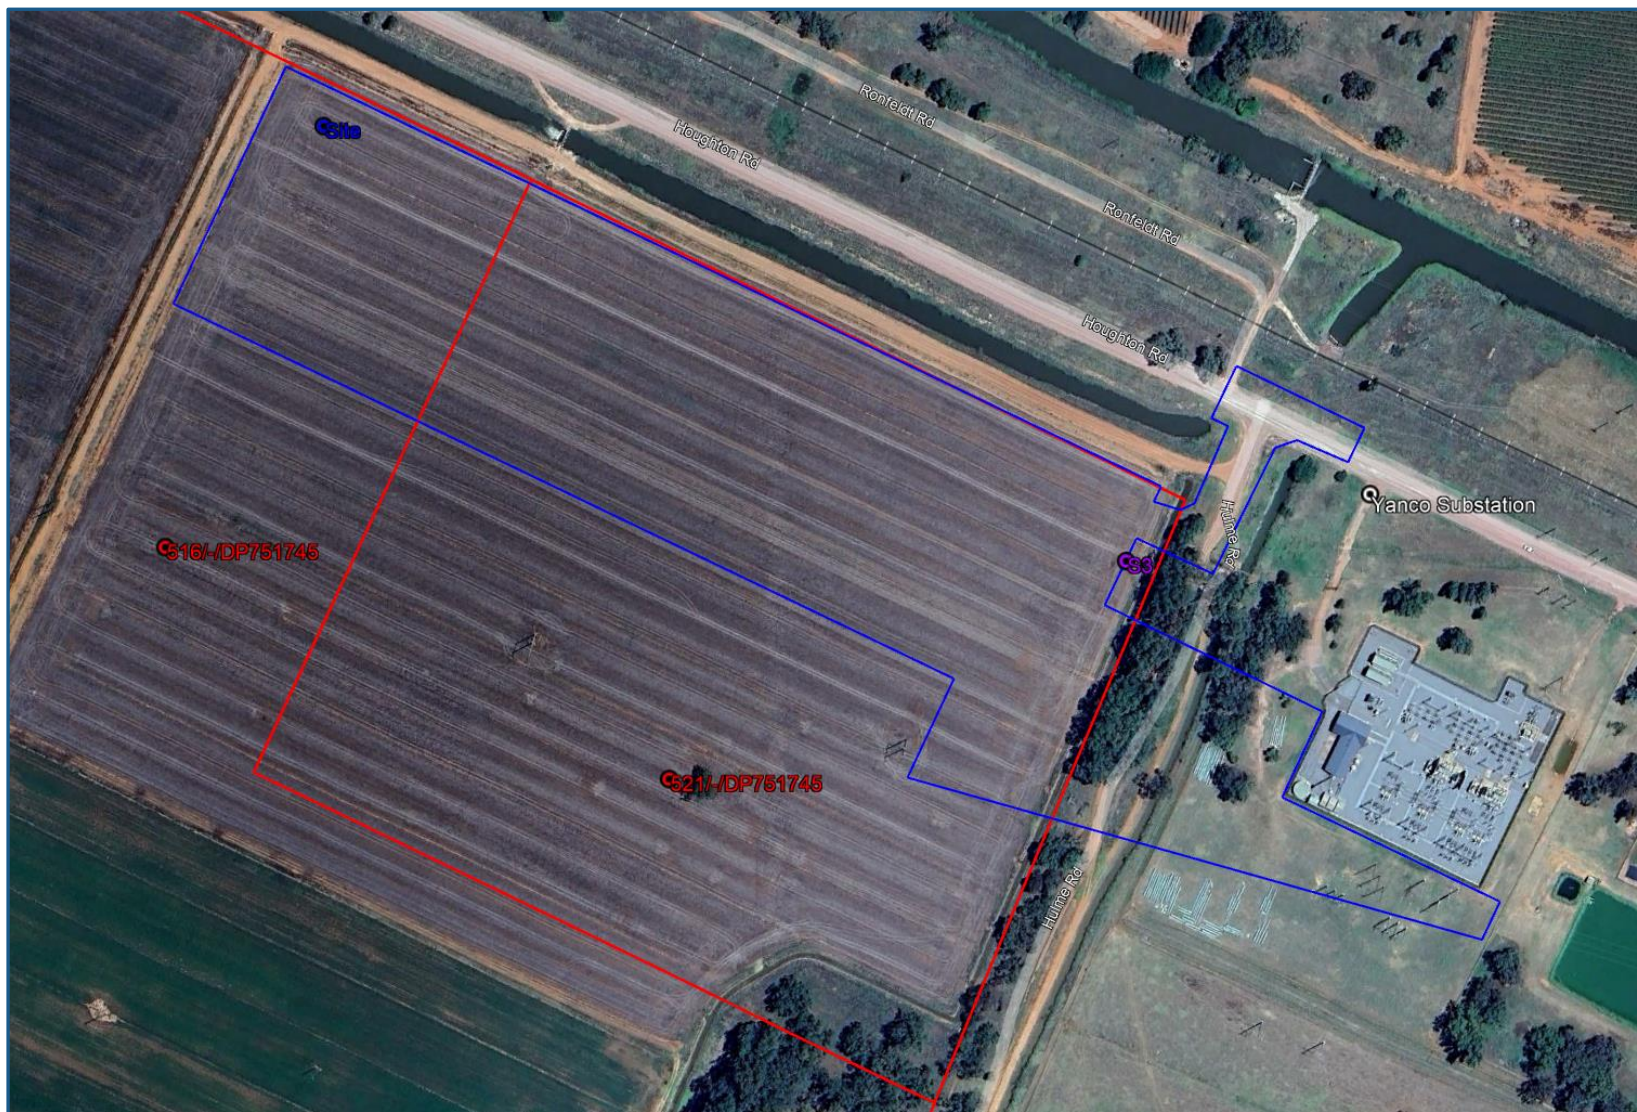
**Image B1:** Layout of the site showing the location from which the soil sample (S3) was collected - image sourced from Google Earth 2024.

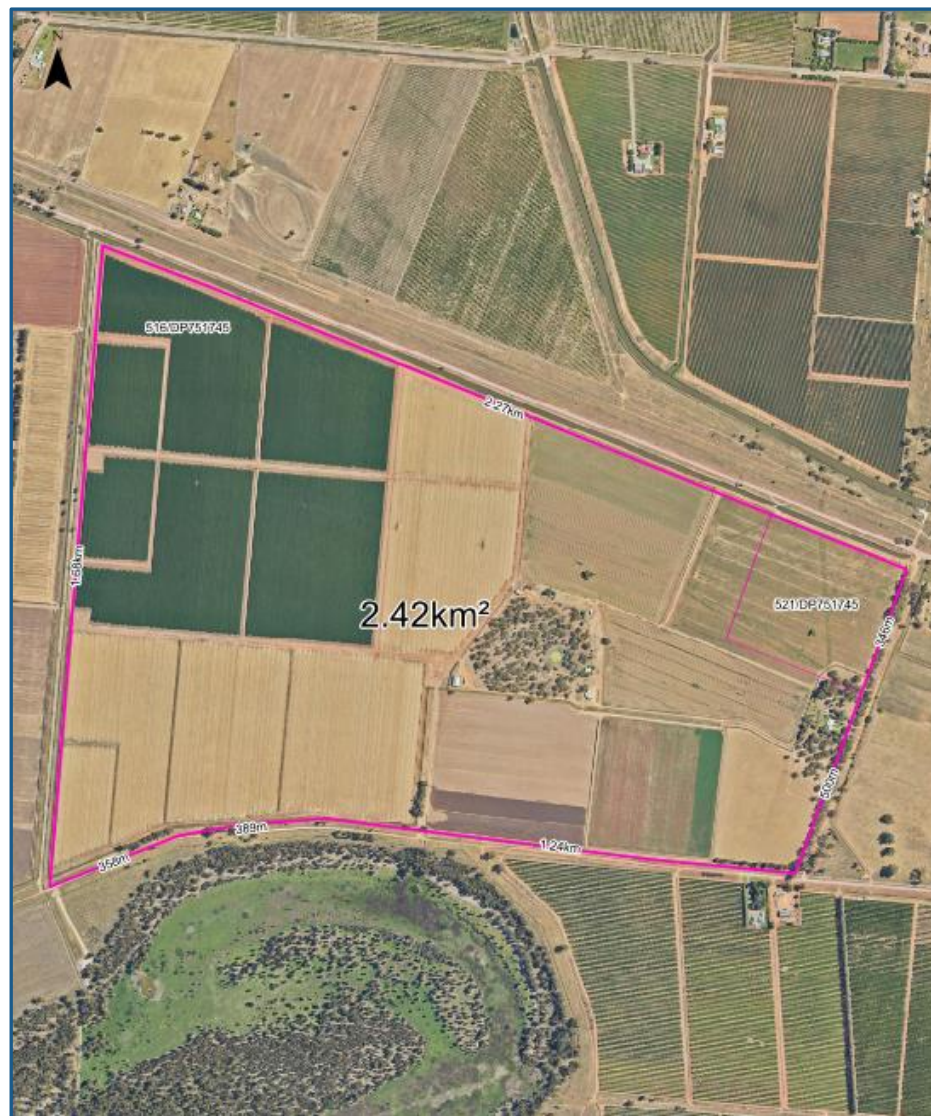
**Image B2:** The thick pink boundary line denotes the outer boundary of Lot 521 and Lot 516 at 120 Houghton Road, Yanco whilst the thin pink line denotes the internal parcel boundary between the two Lots - image sourced from Lotsearch.

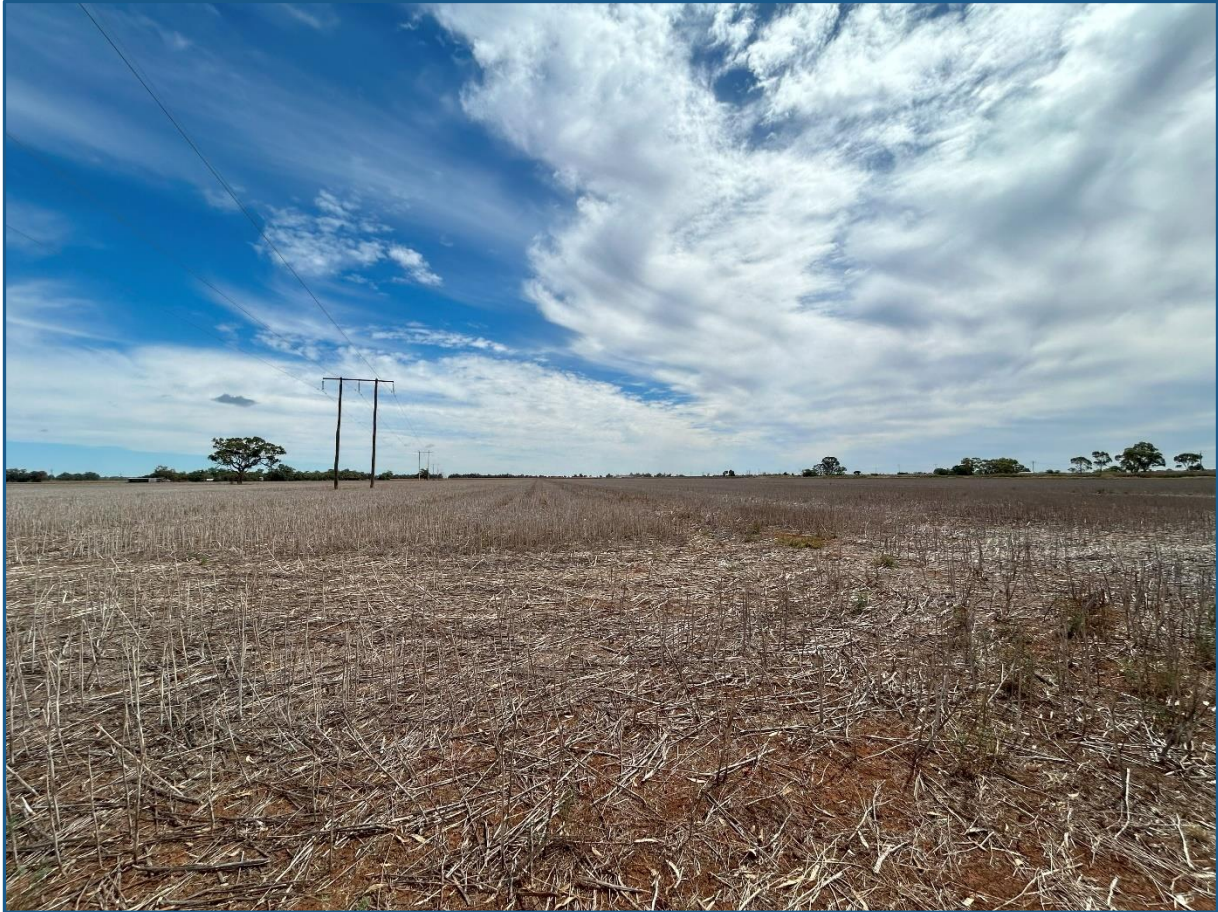
**Image F1:** The site is located in a predominantly flat landscape but has a slight surface slope created through land forming to facilitate excess surface water drainage for agricultural production.

As detailed above, the site is predominantly flat but has a slight surface slope created through land forming to facilitate excess surface water drainage for agricultural production (*Image F1*). Slightly higher elevation land occurs to the northeast of the site whilst lower elevation land occurs to the south of the site. It is not likely that excess surface water run-on would impact the site due to its location in the landscape and the existing water authority and farm irrigation water supply channels, the latter which occur adjacent to the northern and eastern boundaries of the site. Accumulations of excess surface water on the site would drain to the western boundary of the site and enter the aforementioned farm drainage system. The soil profile on the site is moderately to poorly drained however, site drainage is generally adequate as the site has adequate surface slope to facilitate acceptable surface water drainage. There was no evidence of excessive surface water pooling or water accumulation on the site.

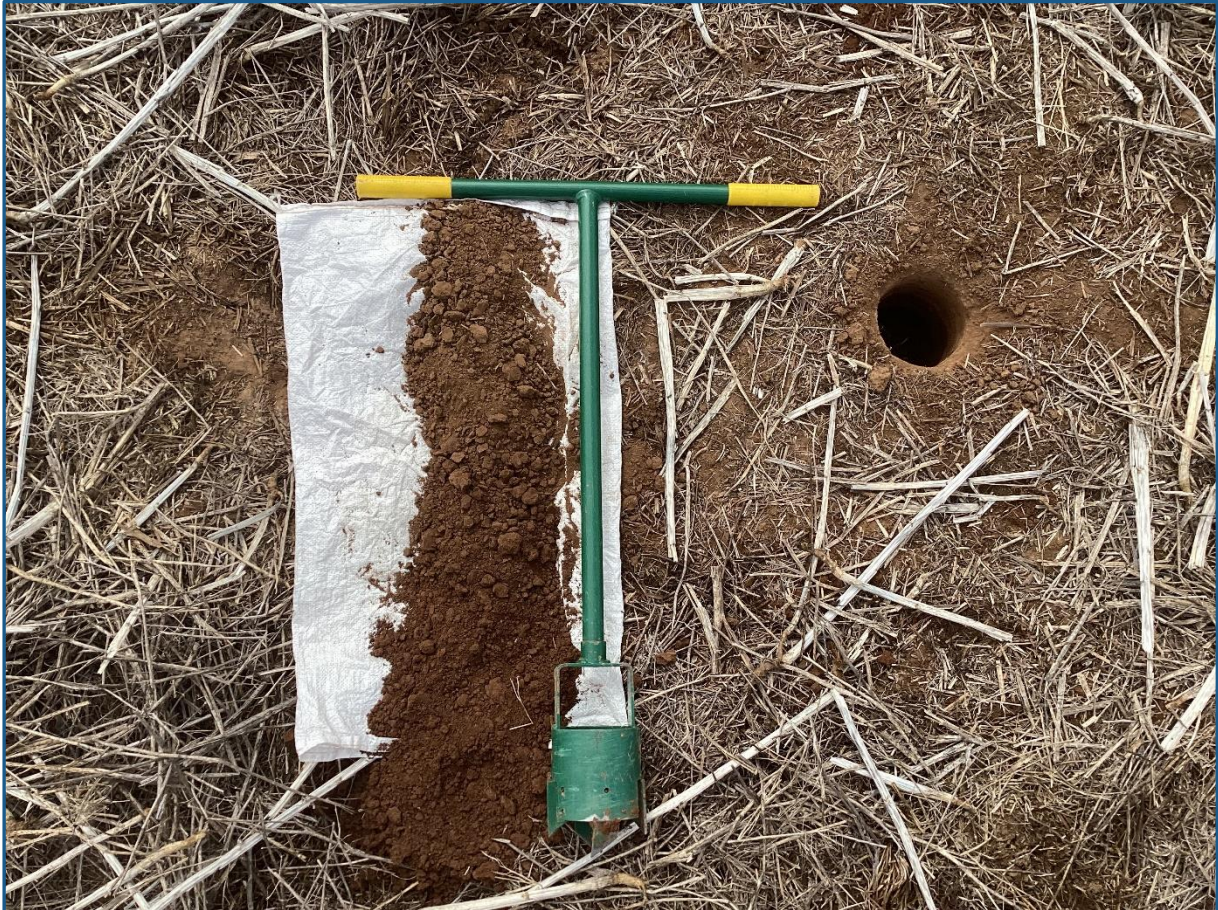
**Image F2:** The soils on the site are classified as Chromosols and Red-Brown Earths which are duplex soils with red subsoil colouring.

characteristics confirmed that the soils across the site consist of Red-Brown Earths (Great Soil Group) and are Chromosols (ASC). Chromosols and Red-Brown Earths are duplex soils with dominant red, orange or yellow colouring, particularly in the subsoils. The soils across the site consist of approximately 20 cm of light brown loam surface soil overlying dull to bright red-brown clay, medium clay subsoils (Image F2).

**Soil Physical Characteristics** - The soil profile, which is relatively uniform across the site, consists of 20 cm of a light brown loam surface soil which is poorly structured, massive, moderately friable and is susceptible to slaking and crusting. This topsoil relatively abruptly grades into the clay dominant initial subsoil layer which consists of dull to bright red-brown medium clay. This subsoil is slightly friable and is well structured typically consisting of moderate to strong subangular blocky structure. Deeper subsoil layers (> 40cm depth) grade into grey-brown, light to medium clays with fine, subangular blocky structure and traces of natural lime (calcium carbonate). Lime content gradually increases down the soil profile and cannot be discerned in the surface soil or upper subsoil, but increases to 1 to 2% in the deeper subsoil below depths of 40 cm and consists of fine powdery deposits and nodules, the latter < 5 mm in diameter. Clay content is likely to approximate 25% in the surface soils and 45% in the subsoils.

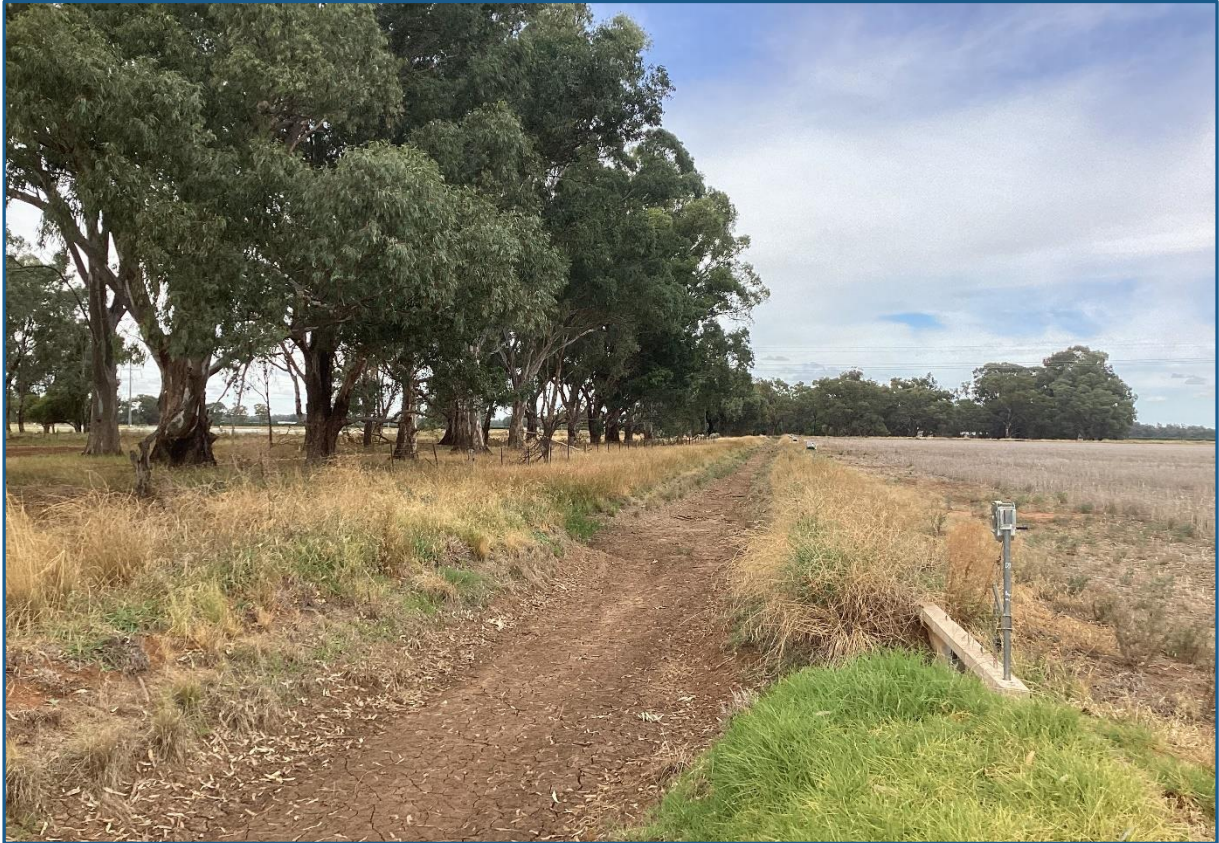
**Image F3:** Facing south from the northeast corner of the site; eastern boundary fence line and planted native trees adjacent to the Yanco Substation (left); irrigation channel with floodgates and minor weed and couch grass coverage (foreground); canola stubble (right).

There are no trees and no native or remnant vegetation on the site. Planted native trees are located parallel to the eastern fenced boundary of the site (*Image F3*). There are some weeds concentrated along the flood irrigation channel along the eastern boundary of the site. In recent times, land on the site and on irrigation areas to the west and south of the site have been utilised for rotational winter cropping and grazing. The site currently contains canola stubble and the landowner indicated he will continue a winter cropping rotation, most likely barley in winter 2024. Over a 30 year period, the landowner indicated he grew lucerne for half of that time and other summer and winter crops for the other half. The landowner also advised that historically the site may have been used for rice production in a minor way. The landscape is Older Terrace Riverine Floodplain which would have originally supported Riverine Plains Grassy Woodland which would naturally have consisted of Riverine Grassy Forest and Riverine Grassy Chenopod Woodland ecosystems, which includes Grey Box, Yellow Box and River Red Gum Forests, Black Box Woodlands, White Cypress Woodlands and Native Grasslands.
