# Aussie Skips Recycling Bellfrog St Site Upgrade

Phase 2 Detailed Site Investigation

State Significant  
Development Application

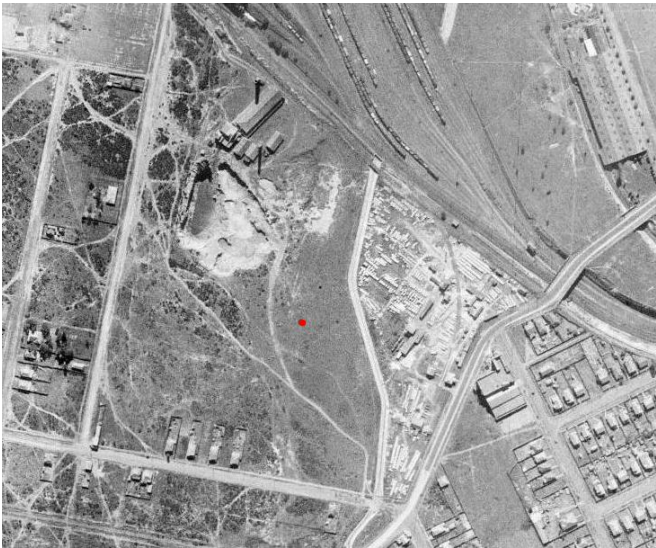
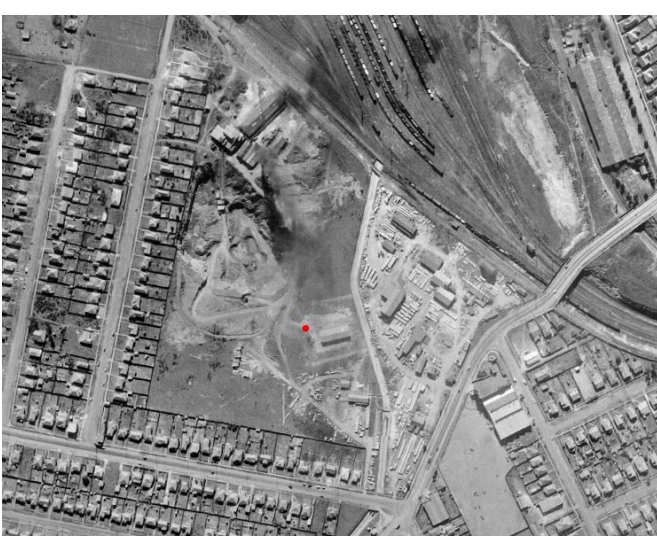
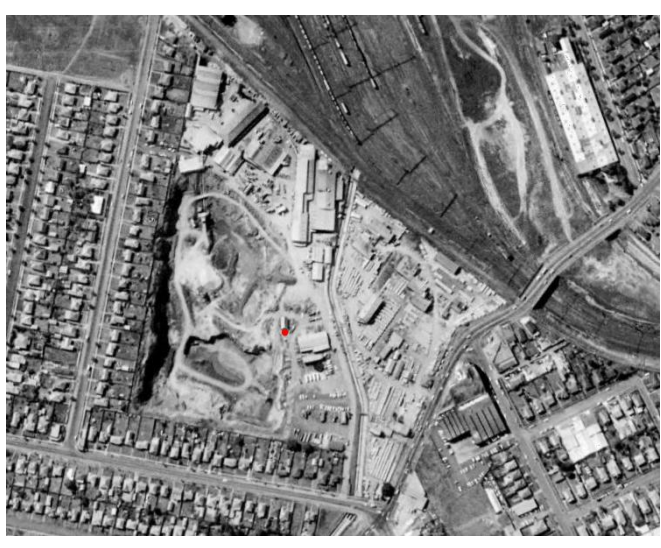
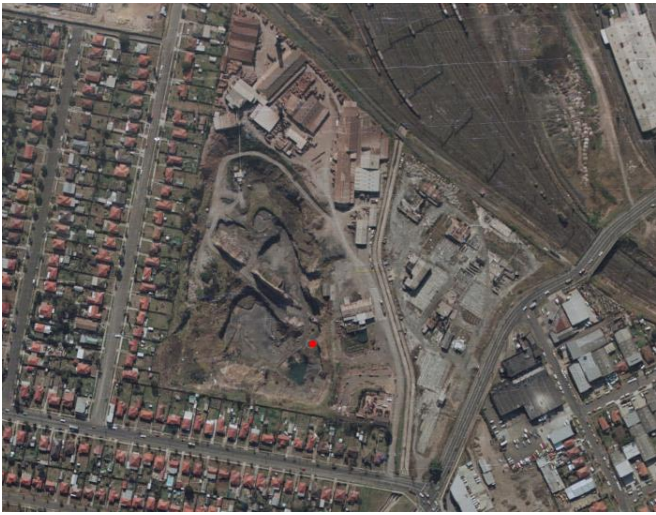
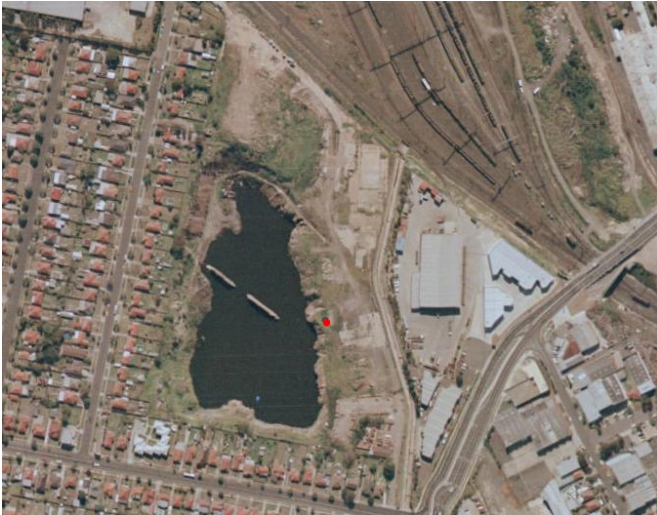
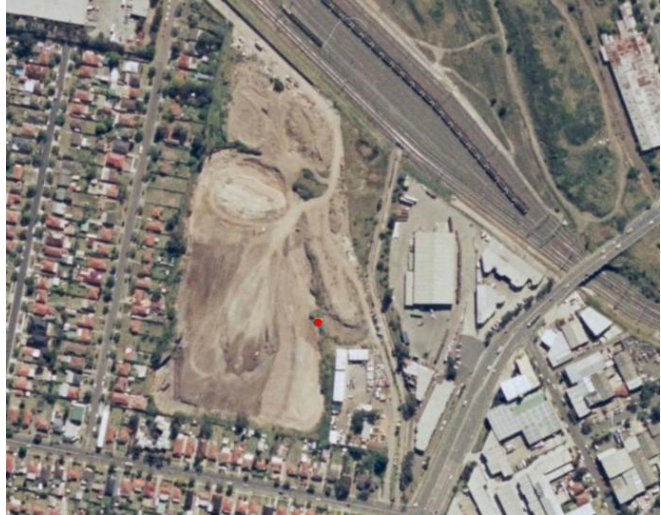
Figure 4: Historical Aerial Imagery of the Site.

The information obtained from the historical sources reviewed has been found to be in general agreement with other sources. The Site's history can reasonably be summarised as a block of land that was part of a commercial quarry in the past. The quarry had been filled sometime between 1998 and 2004, when it was developed into an industrial business park, as it stands today.

In order to develop the Conceptual Site Model (CSM) and inform the Site investigation, a review of historical information was completed. This review included freely available aerial imagery. Historical aerial photographs were sourced from NearMap and NSW Historical Imagery portal. Relevant aerial imagery can be found in Figure 4.

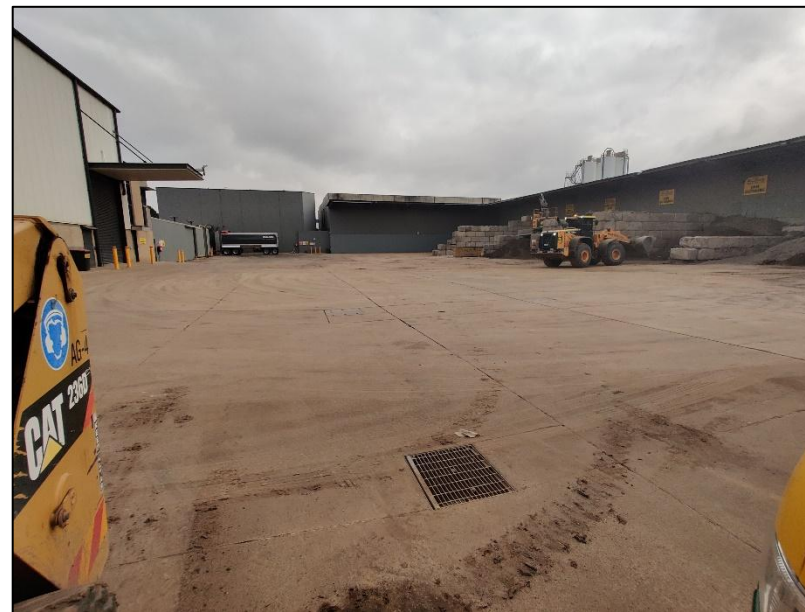
*Photograph 2: Hardstand area of the site and material bays. Facing west.*

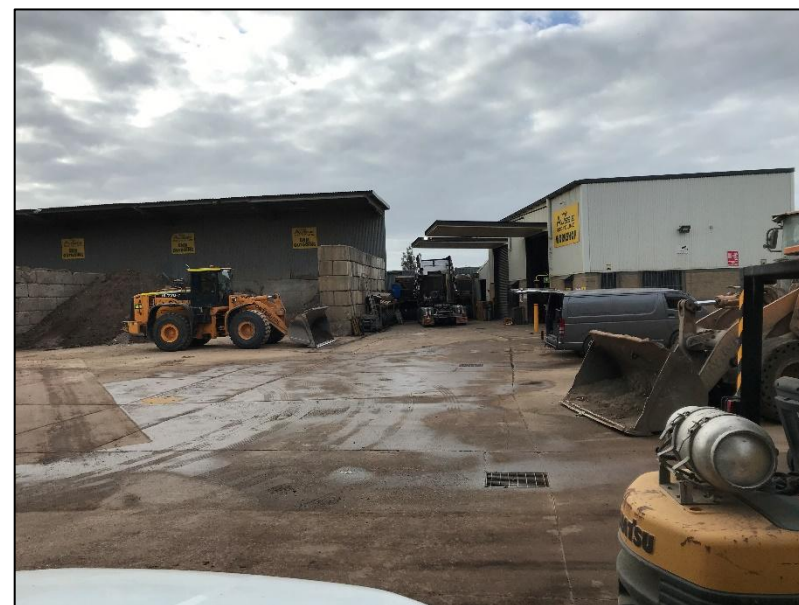
*Photograph 4: Workshop area. Facing north.*

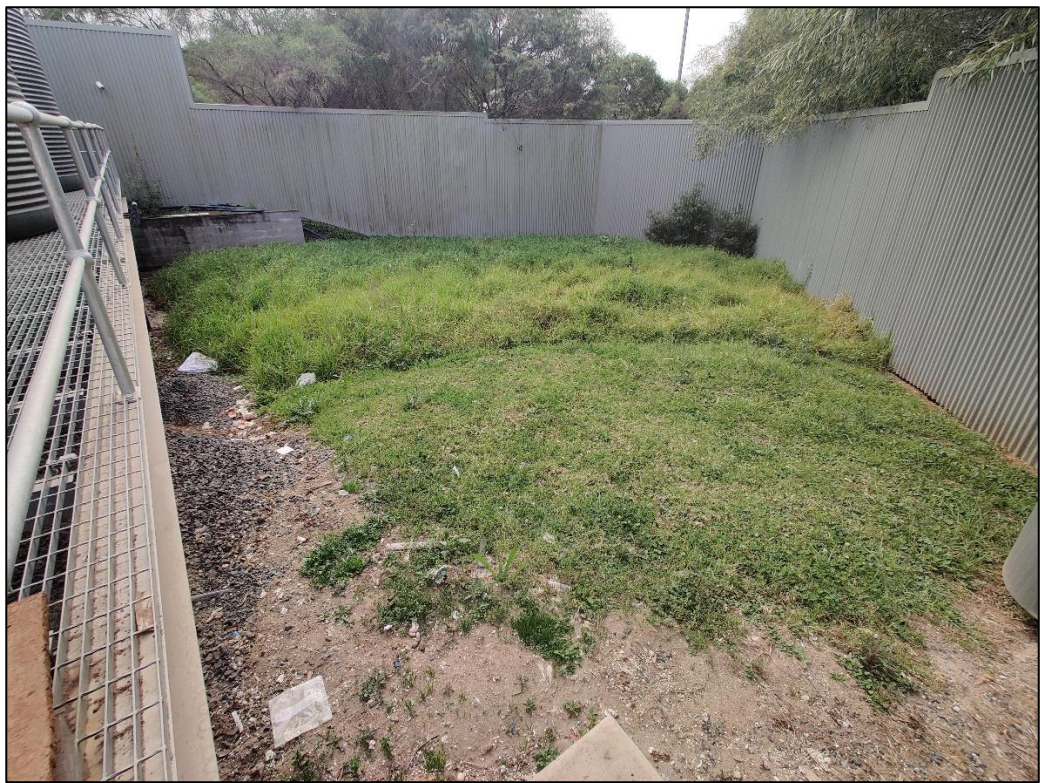
- The surface soil material in the vegetated swale was found to consist of medium-grained sandy-silty fill, of dark brown to light brown in colour. Samples were dry to moist, with medium plasticity. Minor ash was observed in both samples.

*Photograph 5: Vegetated Swale area. Facing north-east.*

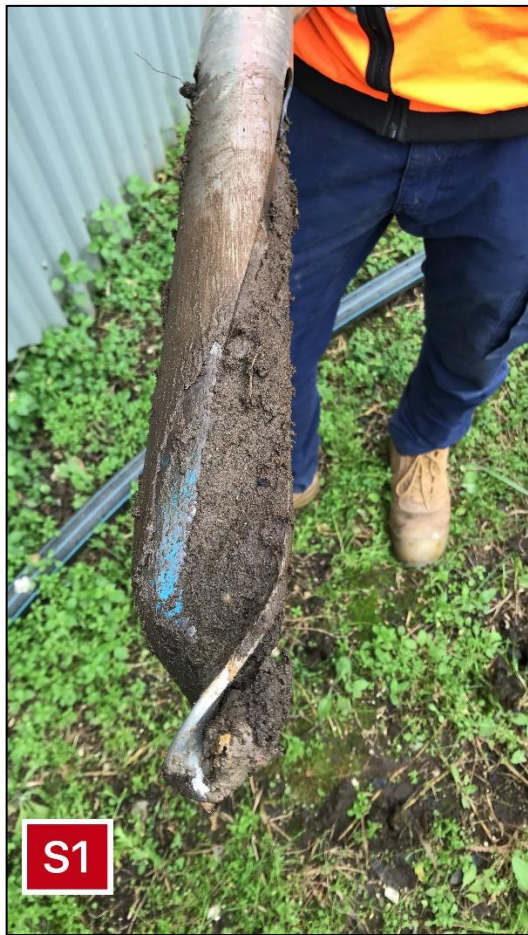
*Photograph 6: Sample S1.*

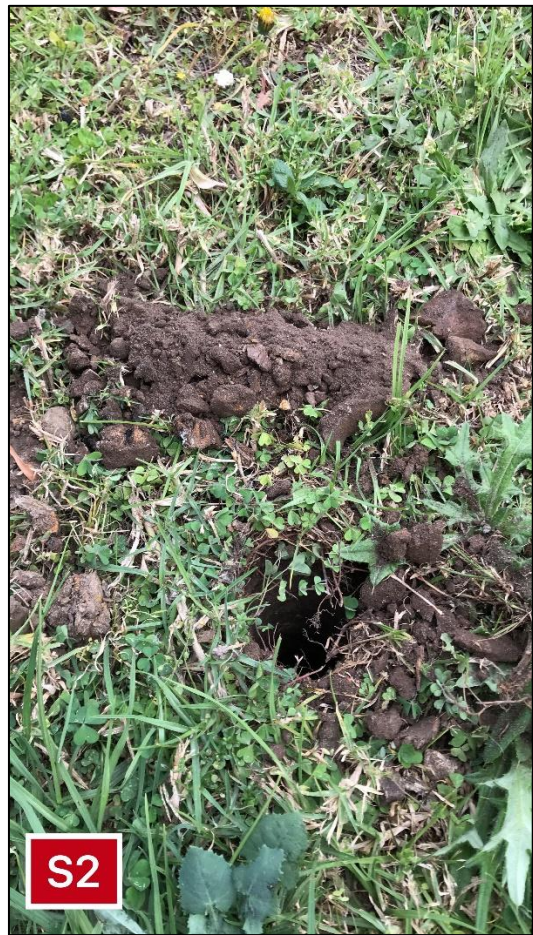
*Photograph 7: Sample S2.*

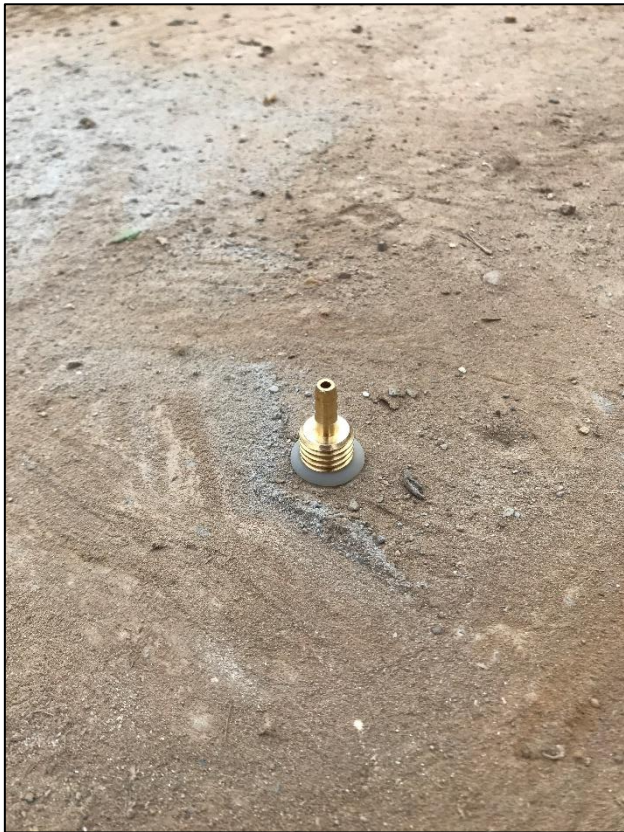
Three samples were collected using a laboratory provided 1-litre SUMMA Cannister set with a 30-minute flow restrictor. Firstly, using a hammer drill, a 16mm hole was drilled through the concrete floor slab and a further 5cm into the sub-surface material. Gloves, a P2 particulate filter mask, safety glasses and hearing protection was worn during drilling. A brass soil Vapor Pin with silicon sheathing was hammered into the hole until the base of the Vapor Pin assembly thread was flush with the slab surface. The silicon sheathing ensures an air-tight seal between the sub-slab vapour and ambient air. A Vapor Pin installation/extraction tool was used as not to damage the pin during installation and extraction.

Photograph 8: Temporary Vapor Pin and silicon sheathing

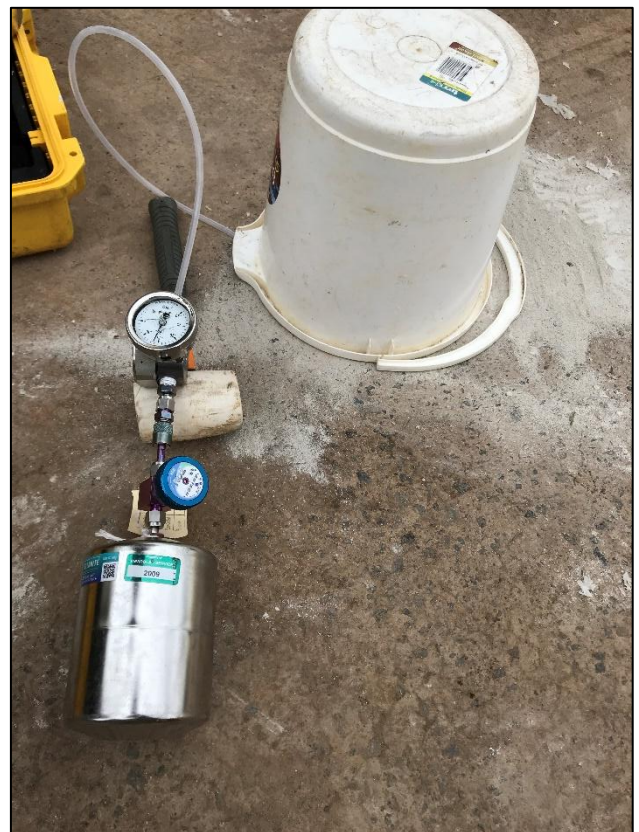
Secondly, the Summa cannister was subject to pre-extraction vacuum and leak checks by attaching the vacuum gauge to the Quickfit fitting on the top of the cannister. The valve was then opened on the cannister, and the initial vacuum reading was noted on the COC – whereby the vacuum should read -30 inches of mercury ("Hg). Leak testing was completed by attaching the flow restrictor assembly to the cannister but leaving the endcap on. The cannister valve was then opened for 1 second before being closed. The flow restrictor gauge was then observed to see whether the vacuum within the train started to fall. If the vacuum does not fall, then the sampling train is considered leak proof.

Following this, ¼ inch Teflon tubing was attached to the top of the Vapor Pin and purged by siphoning the ambient air within the tubing approximately 4 times using a 50 mL syringe. After purging, the other end of the tubing was connected to the flow restrictor sampling train via a ¼ inch Swagelok nut and ferrule. Once all components of the sampling train had been prepared, assembled and installed, a shroud containing an isopropyl alcohol (IPA) spiked rag was placed atop of the Vapour Pin sampling point, but not covering the Summa Cannister. This is done to check for leaks between the ambient air and sub-slab vapour. The Summa Cannister valve was then opened, and the time was recorded on the COC. The flow restrictor gauge was observed for approximately 30 minutes or until the vacuum reached between -10 and -5 inches of mercury ("Hg). Once this was achieved, the Summa Cannister valve was closed and time and vacuum reading noted on the COC.

Photograph 9: Summa Cannister and shroud.

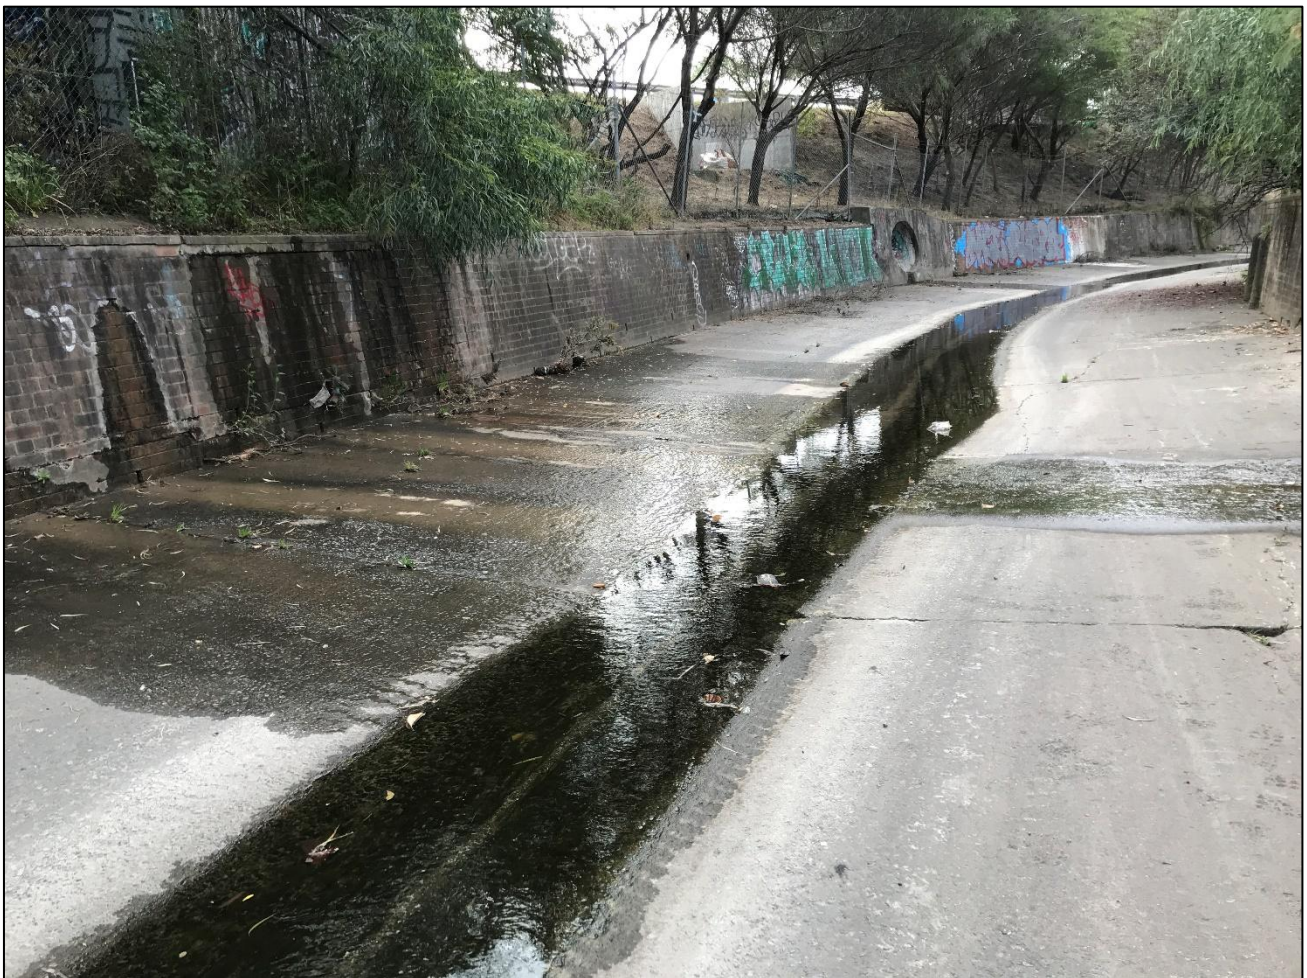
The nearest surface water body to the Site is Coxs Creek, bordering the Site to the east adjacent the vegetated swale. The channels of Coxs Creek are concrete lined, and the creek ultimately drains into the Cooks River within the Strathfield Local Government Area. Coxs Creek is part of the Upper Cooks River catchment system comprising a network of minor street drains managed by the council and trunk drainage lines controlled by Sydney Water Corporation. Culverts located under the railway crossings are the responsibility of Rail Access Corporation. Four main drainage lines are found in the sub-catchment, all of them are urban streams receiving road and stormwater runoff and are considered to be more of a stormwater drainage system than an aquatic ecosystem.

- Results of the laboratory analysed surface water samples showed concentrations of all analytes to be below the adopted site criteria, except for cadmium, copper and zinc in sample US, and copper and zinc in sample DS. No patternable increase in contaminant concentration has been observed between upstream and downstream samples, indicating that contamination is inherent to Cocks Creek and not attributable to the Site. Elevated cadmium, copper and zinc levels are not considered to be the result of on-site impact and no further assessment into groundwater or surface water at the Site is considered necessary.

Photograph 10: Surface Water sampling location (Coxs Creek). Site boundary to the left of the photo. Facing north.
