# Wilpinjong Extension Project

## Historical Heritage Assessment

Prepared for Peabody Energy Australia Pty Ltd

November 2015

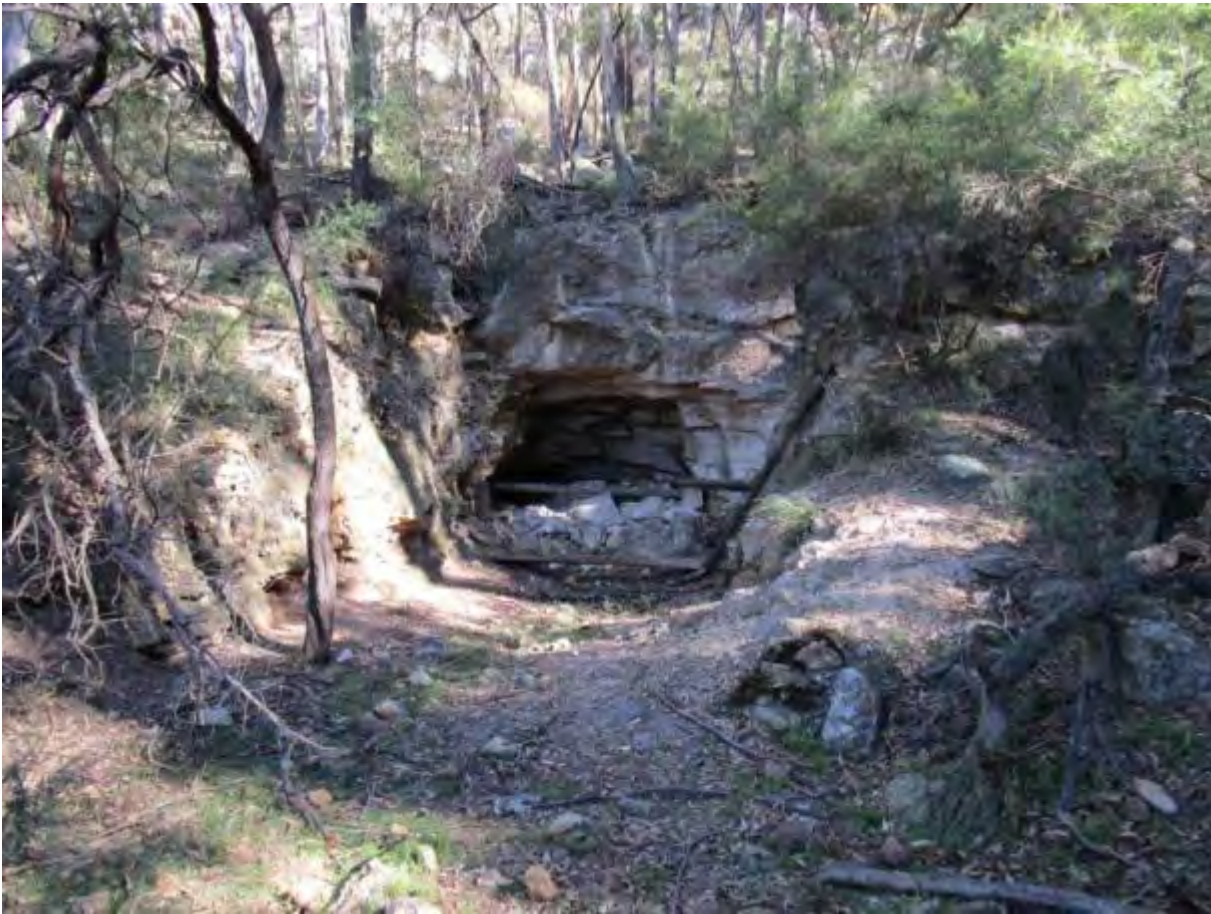
**Plate 1. Wollar Shale Oil Mine Adit**

The Shale Oil Mine and associated items are located within Slate Gully. The mine adit (Plate 1) is located at the base of the slope associated with the ridgeline that separates Slate Gully from the existing Wilpinjong Coal Mine. Remnant post and rail fencing, a cart ramp and a ventilation shaft are all located on the lower slopes of the ridgeline. The remains of the retort are located on the valley floor. A chimney from the caretaker's hut is located uphill of a flat rise within the valley. A stockpile of hardwood timber planks is located on the valley floor near the mine adit. The locations of the components of the Shale Oil Mine Complex are presented on Figure 5.

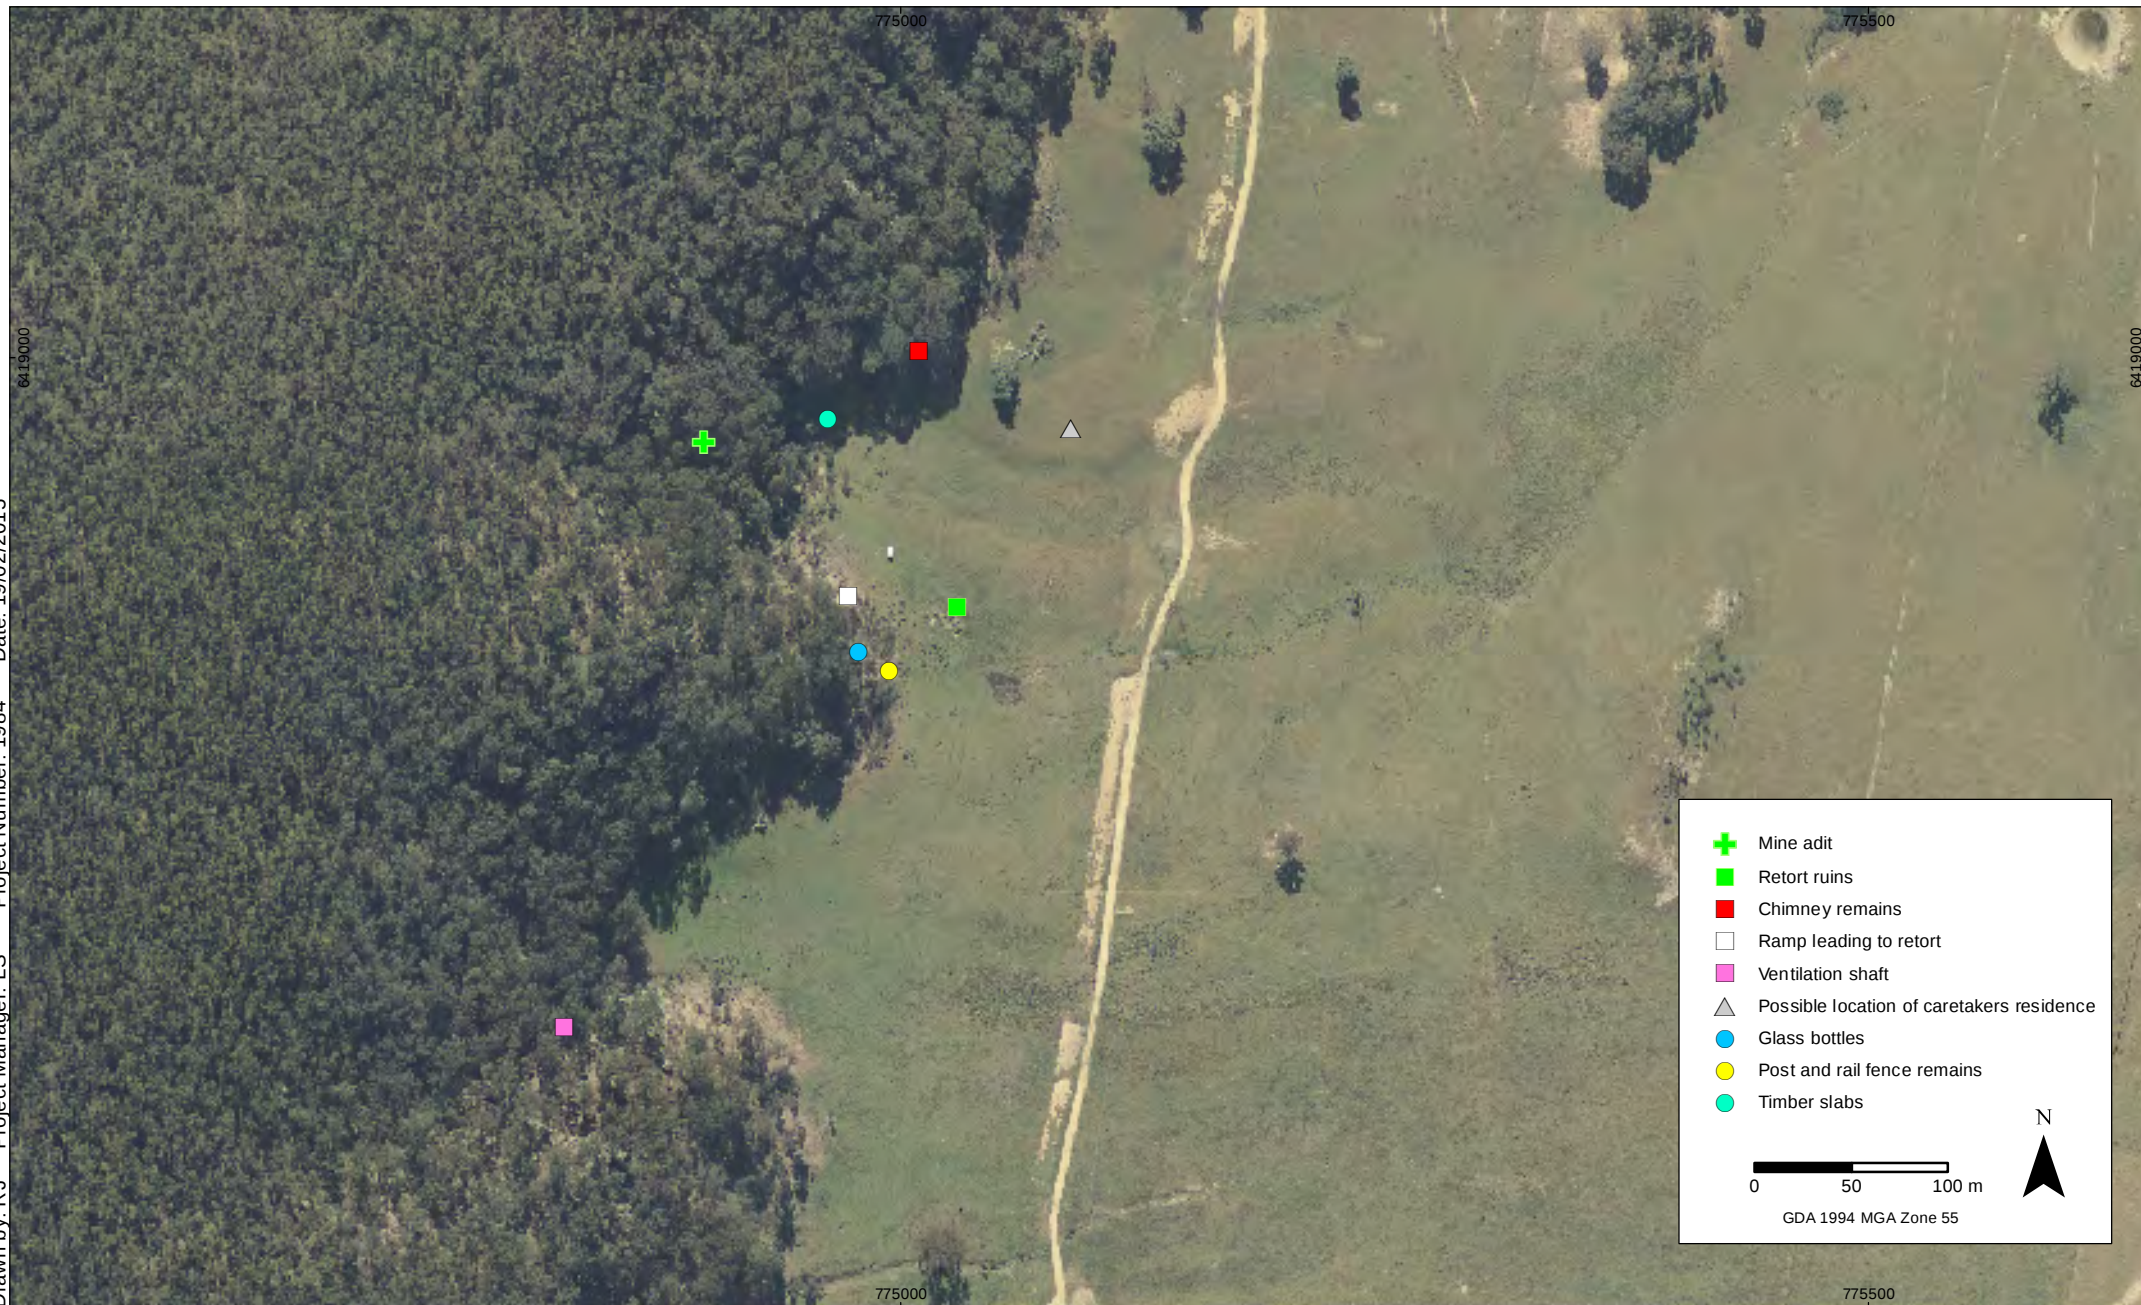
**FIGURE 5**

Overview of Shale Oil Mine Complex  
Wilpinjong Historical Heritage Assessment

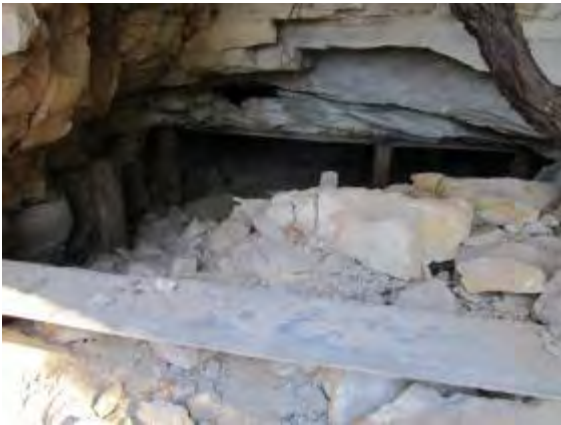
**Plate 2. The timber reinforced roof of the Mine Adit.**

The mine adit is in fair to poor condition. Large quantities of rubble from the adit overhang have collapsed into the adit face, covering approximately three quarters of the original opening. Despite this, the reinforced timber beams appear to be intact. The sandstone is cracked and flaking and a large tree root has grown across the entrance.

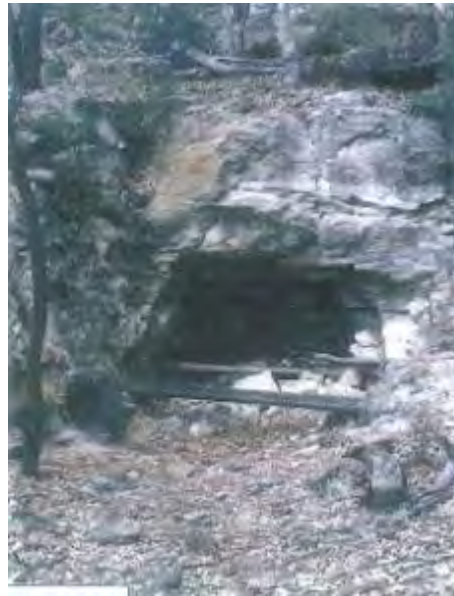
**Plate 3. Wollar Shale Oil Mine, 1997 (Source: Mr and Mrs McDermott).**

The shale oil mine adit was constructed into the sandstone at the base of the slope associated with the ridgeline that separates Slate Gully from the existing Wilpinjong Coal Mine. The opening of the adit is reinforced with timber sets to reduce the risk of collapse. Horizontal timber beams have been placed across the adit to indicate that it is closed (Plate 1 - Plate 5).

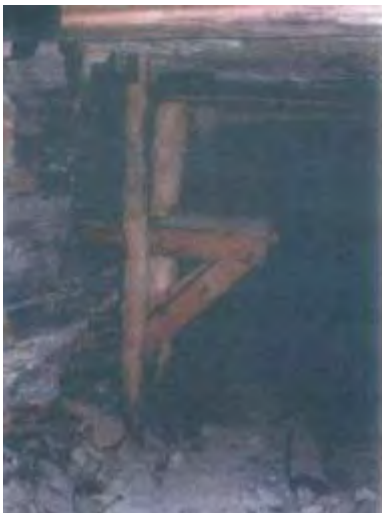
**Plate 4. Internal view of Wollar Shale Oil Mine showing shelf, 1997 (Source: Mr and Mrs McDermott).**

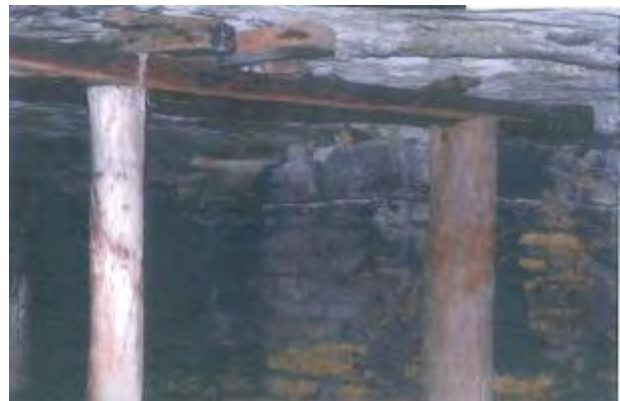
**Plate 5. Internal view of Wollar Shale Oil Mine showing support beams, 1997 (Source: Mr and Mrs McDermott).**

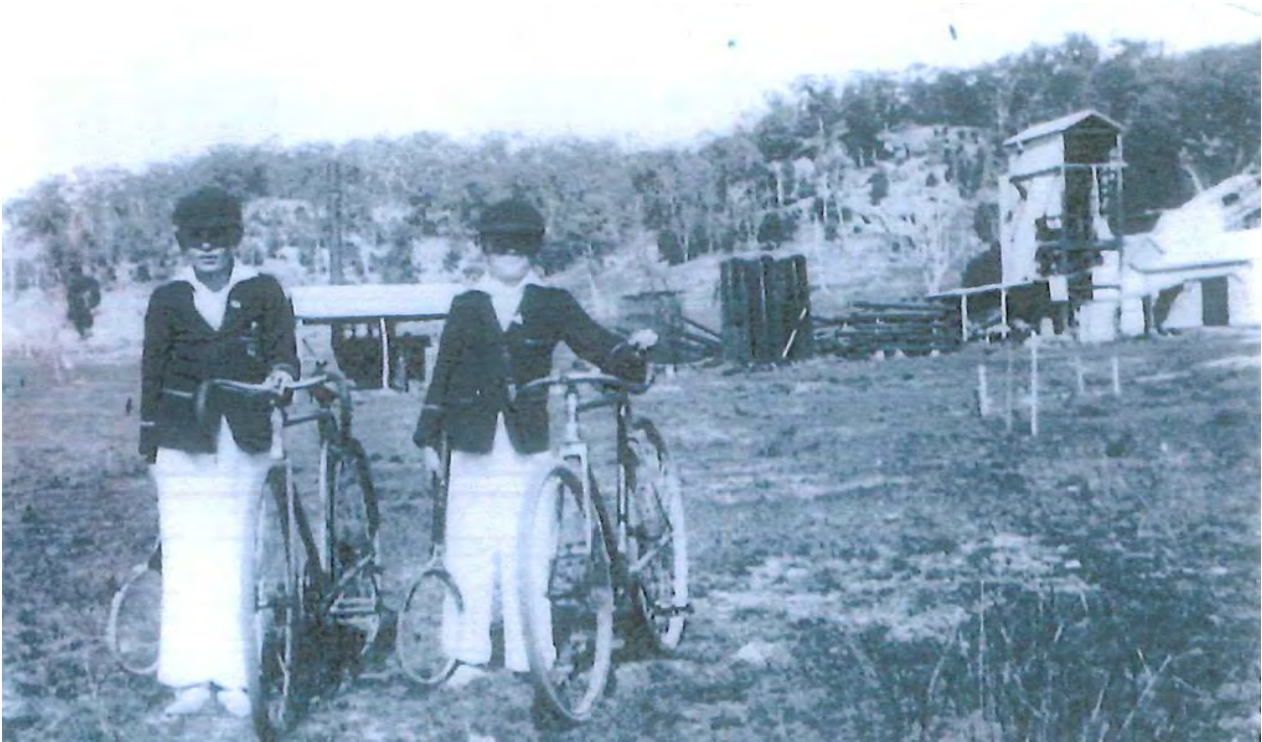
Large concrete blocks, lying next to a concrete slab are the ruins of the shale oil retort (Plate 7 and Plate 8). Remnant identifiable items include a furnace and some metal posts. Parts of the shale oil refinery works originally located alongside the retort were a crusher and gantry, boiler house, condenser, distilling columns, an engine room and a storeroom (Plate 6). No specific remains of these additional items were identified during the field survey.

**Plate 6. Undated photo of the refinery works (Source: Mr and Mrs McDermott).**

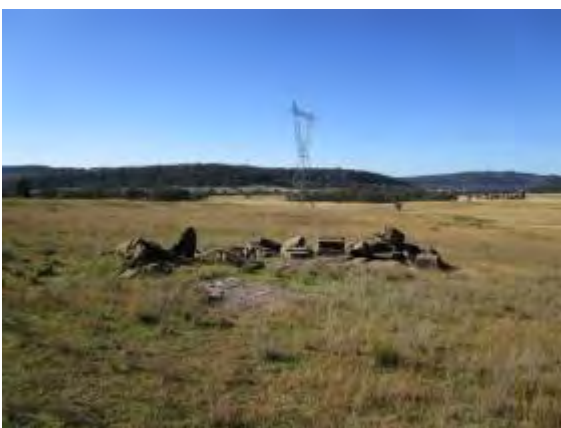
**Plate 7. View of retort ruin.**

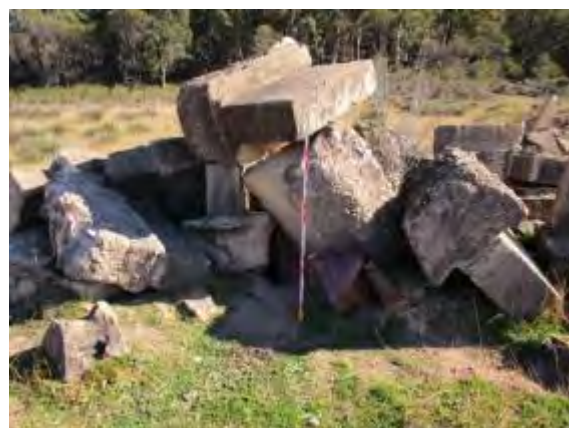
**Plate 8. Large cement blocks from retort.**

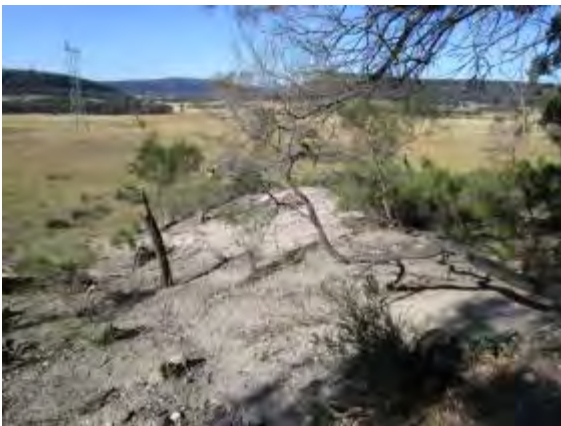
On the slopes of the ridgeline that separates Slate Gully from the existing Wilpinjong Coal Mine and above the mine adit, a gravelled ramp extends from the direction of the adit declining towards the retort ruins. The ramp extends out from the side of the slope towards the retort ruins (Plate 9). Presumably a track would have extended from the ramp to above the adit.

**Plate 9. Evidence of cart ramp leading to the shale oil refinery works.**

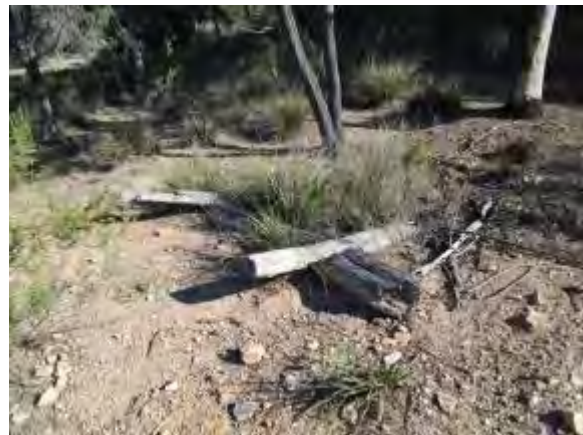
A collapsed timber post and rail fence are located on the gradual slopes associated with the ridgeline that separates Slate Gully from the existing Wilpinjong Coal Mine (Plate 10).

**Plate 10. Collapsed post and rail fence.**

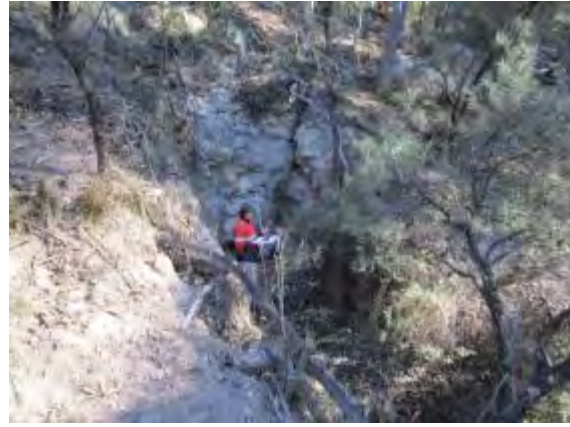
Located on the other side of a small spur off the main ridgeline is a shaft. The cavity is much smaller than the mine adit and is clearly not intended to be used for access purposes due to its small size. The vertical drop and lack of reinforcement around the shaft face indicate the shaft was likely to have been used to ventilate the mine (Plate 12).

**Plate 12. Ventilation shaft.**

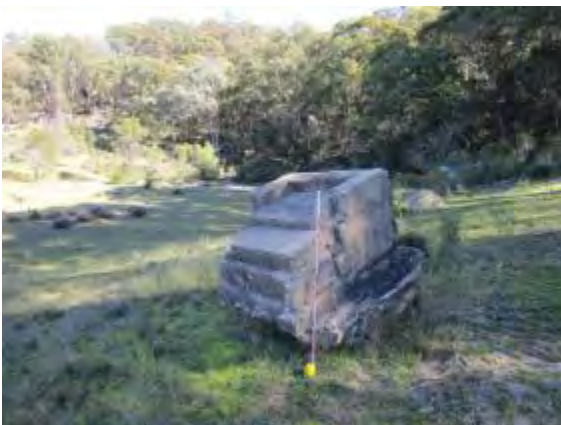
A cement and stone fireplace is the only obvious remains of the Caretaker's cottage. The fireplace is located on the slope of a rise (Plate 13).

**Plate 13. Relocated fireplace from Caretaker's Cottage.**

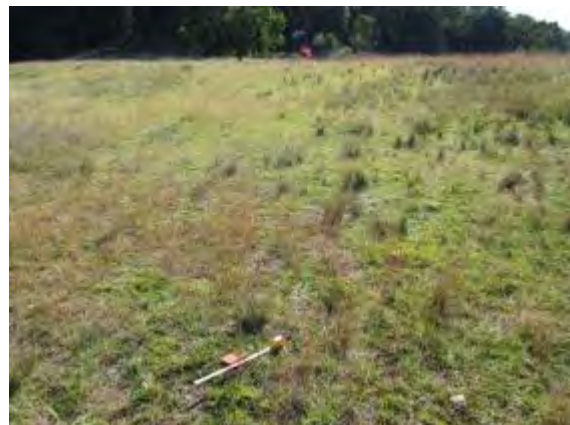
A level area of land located downhill from the fireplace on a rise above a small gully could be the possible location of the Caretaker's cottage. Some fragments of brick are located across the levelled area with increasing quantities of brick fragment down the slope of the rise. Historical aerial imagery also indicates this location may have been the position of the Caretaker's cottage as there is evidence of a remaining access track terminating at this location (refer red circled area) (Figure 6). While it is likely that this was the location of the Caretaker's cottage, no in situ structural material was identified during the field survey (Plate 14).

**Plate 14. Possible location of Caretaker's Cottage.**

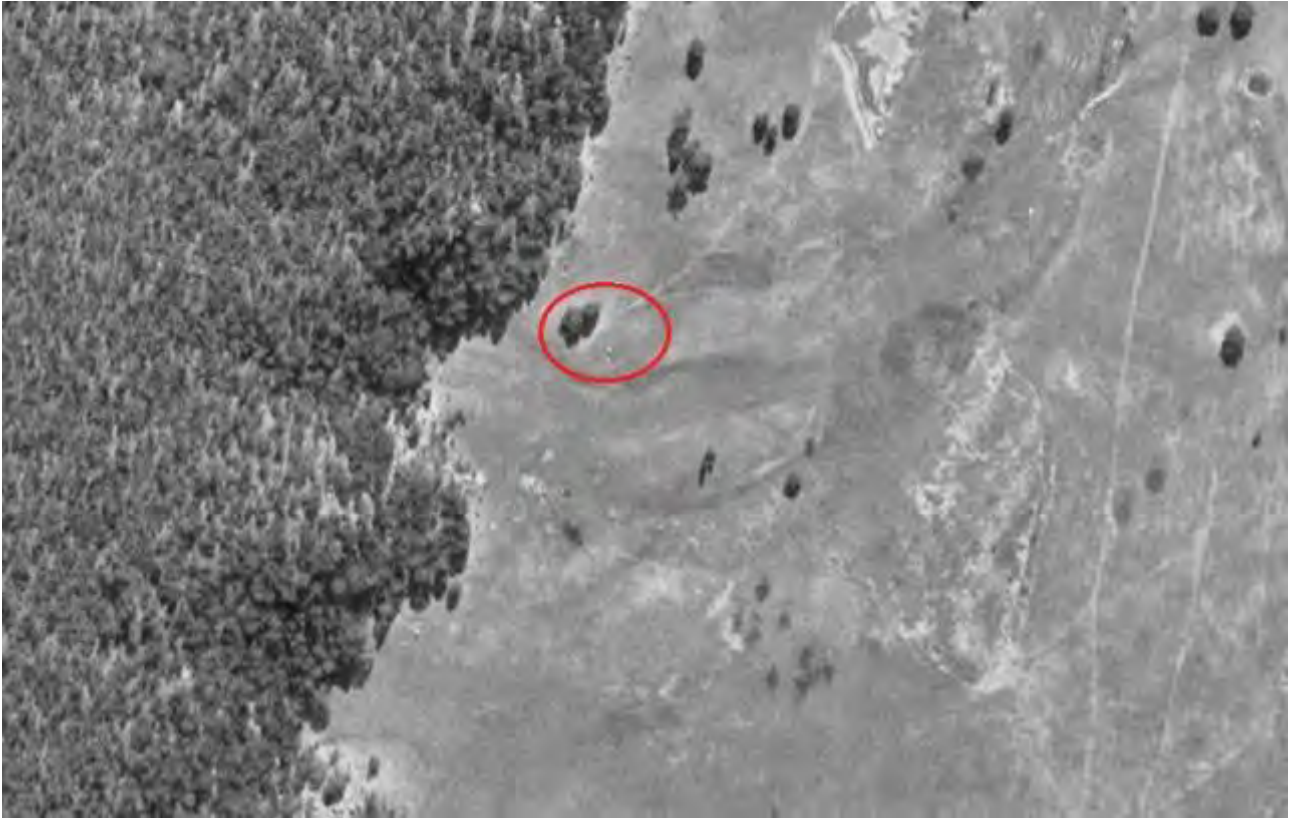
**Figure 6. 1961 aerial photograph of the probable location of the Caretakers Cottage circled in red at the Wollar Shale Oil Mine (Source: Land and Property Information 2014).**

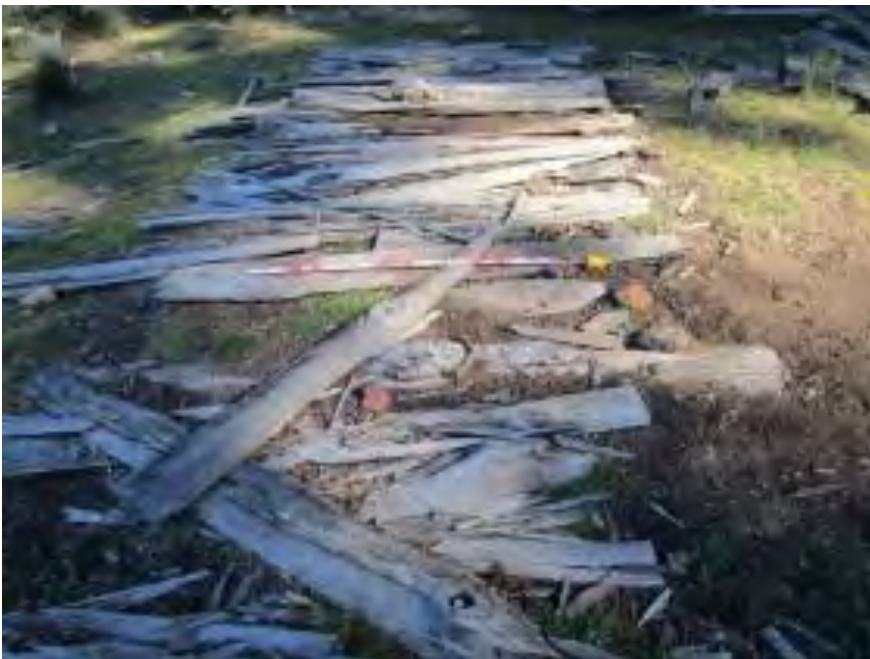
**Plate 15. Cut timber stockpile.**

A cut hardwood timber stockpile is located close to the entrance to the mine adit. The cut timber has been placed in a straight row (Plate 15).

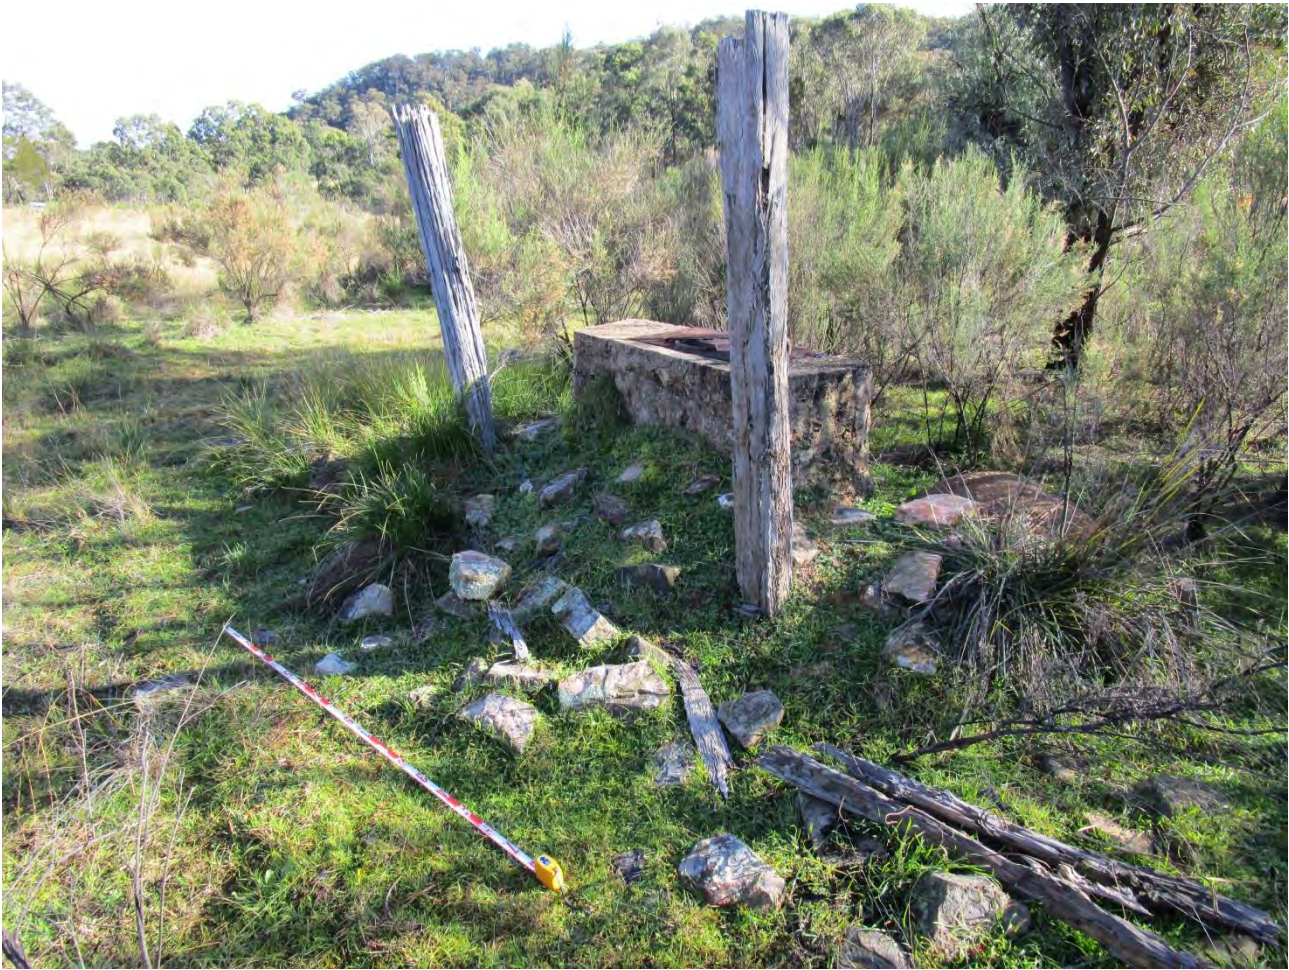
**Plate 16. Main residence of Archer's Cottage, northern elevation.**

The site of the Archer's Cottage ruins is comprised of an orchard, a stockyard and the ruins of a cottage (Plate 16). The Item is located on the Wilpinjong Creek flats to the north of the Project. The orchard is only metres from the creek and the trees from the orchard appear very old and possibly dead (Plate 17). Remnant post and rail fencing around the orchard is still evident, with some timber posts still present in situ. Other posts and rails have been piled amongst the orchard (Plate 18).

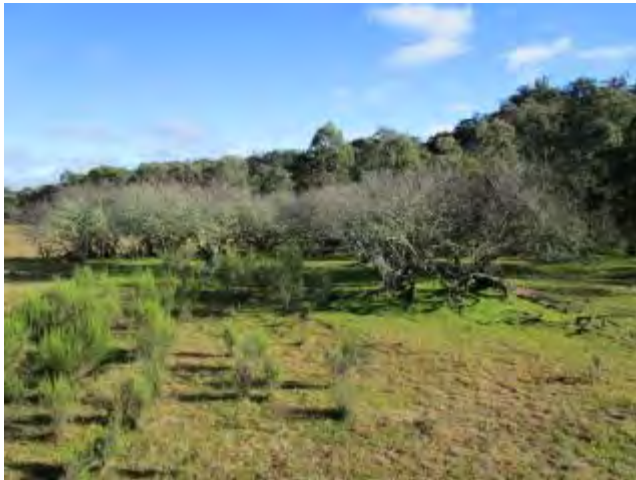
**Plate 17. View of orchard at Archer's Cottage ruins.**

The bulk of the fabric of Archer's Cottage has been removed, with the exception of the stove. The trees within the orchard appear very old and possibly dead and the fence associated with it has collapsed. The stockyards have also collapsed. Overall the item is in poor condition.

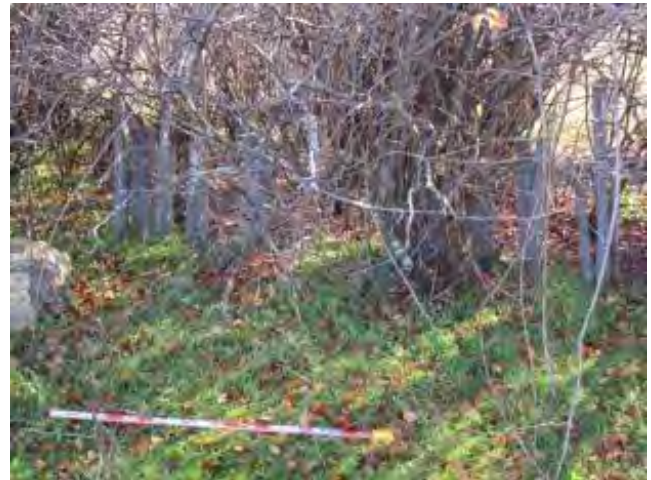
**Plate 18. Remnant post and rail fence within orchard at Archer's Cottage ruins.**

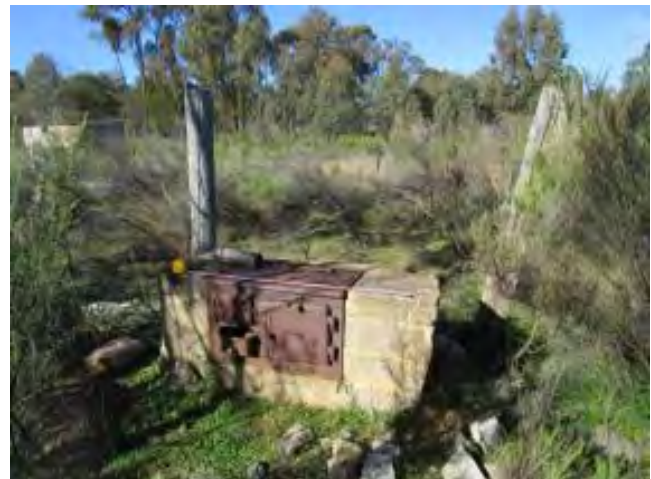
Approximately 80 m south-west of the orchard are the remains of the cottage. Located within a paddock, a parcel of land has been fenced in recent times during a family reunion of the Archer descendants. Within the fenced area shrubs have flourished. A raised grassed platform indicates the pad of the original cottage. At the south end of the pad is a cast iron stove set into solid cement aggregate. There are two timber posts at each end of the stove (Plate 20). The brand of the stove is "Auburn", "WT CARMICHAEL LTD".

**Plate 20. Stove located at Archer's Cottage ruins.**

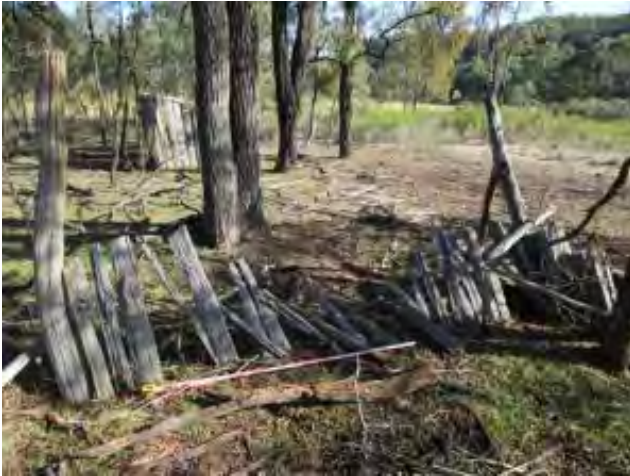
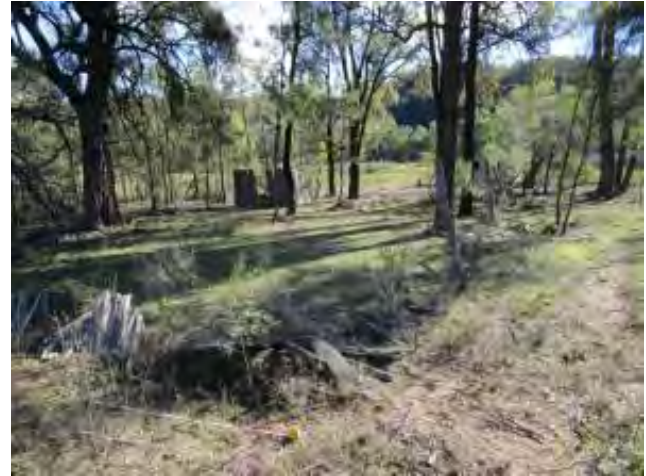
Approximately 30 m south-east of the pad is a modern cement besser block shed. Behind the shed are the remains of timber stockyards (Plate 21, Plate 22). The stockyards are comprised of vertical timber slabs which have been wired together and erected into the ground, forming a large square. Most of the fence has fallen down. Approximately 10 m north of the stockyard is a three walled slab shed, which has been filled with rubbish.

Plate 21. Remnant stockyards at Archer's Cottage ruins.

Plate 22. Remnant stockyards at Archer's Cottage ruins.

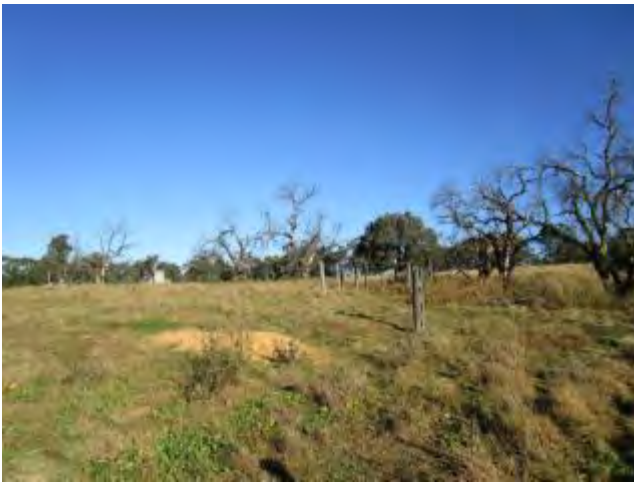
**Plate 24. Remains of timber fence and shed/holding pen.**

The Cumbo Hut has collapsed and is in poor condition. The fencing and shed/holding pen has mostly collapsed and are also in poor condition.

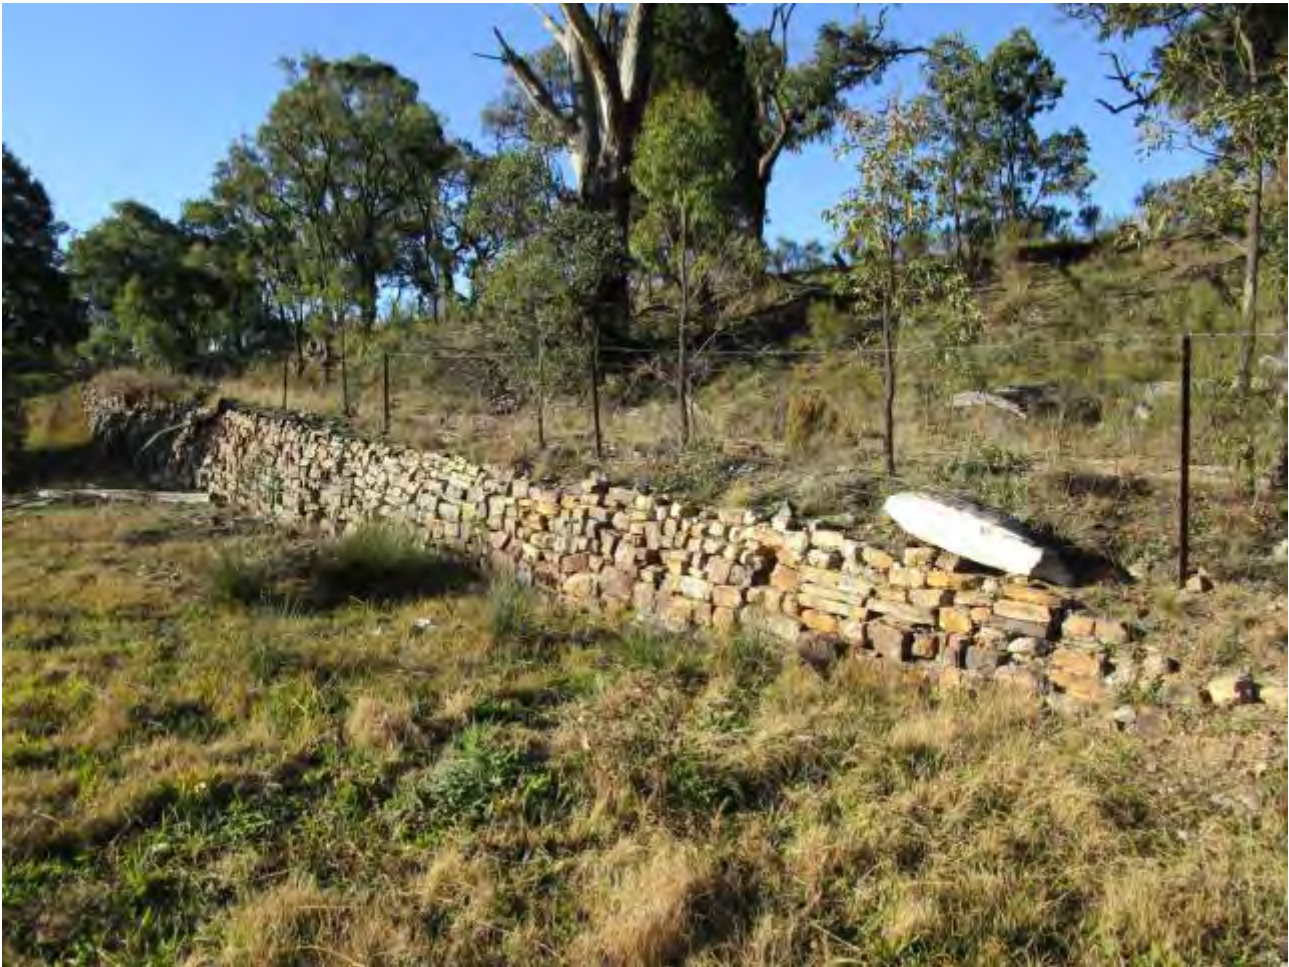
**Plate 27. Road embankment**

The Road Embankment has some bulging stones and some stones are missing, but is mostly in a stable condition. The northern end of the embankment shows more signs of movement. Overall the road embankment is in fair condition.

- Damage to the Road Embankment (Item 7.4) should be avoided by the relocation of the 330kV ETL TransGrid during the detailed design, if practical.
- Archival recording of William Carr's Hut should be undertaken by a qualified archaeologist (if not already undertaken or proposed by Moolarben Coal-the item has been identified in Moolarben reports as Farm Site, Portion 29). Indirect impacts from blasting have the potential to impact on the heritage values of William Carr's Hut. (Archival recordings of the Road Embankment [Item 7.4] and Pine Park [Item 7.5] were undertaken in 2006 by Wilpinjong Coal, presented in Wilpinjong Coal Project Non-Aboriginal Heritage Archival Record).

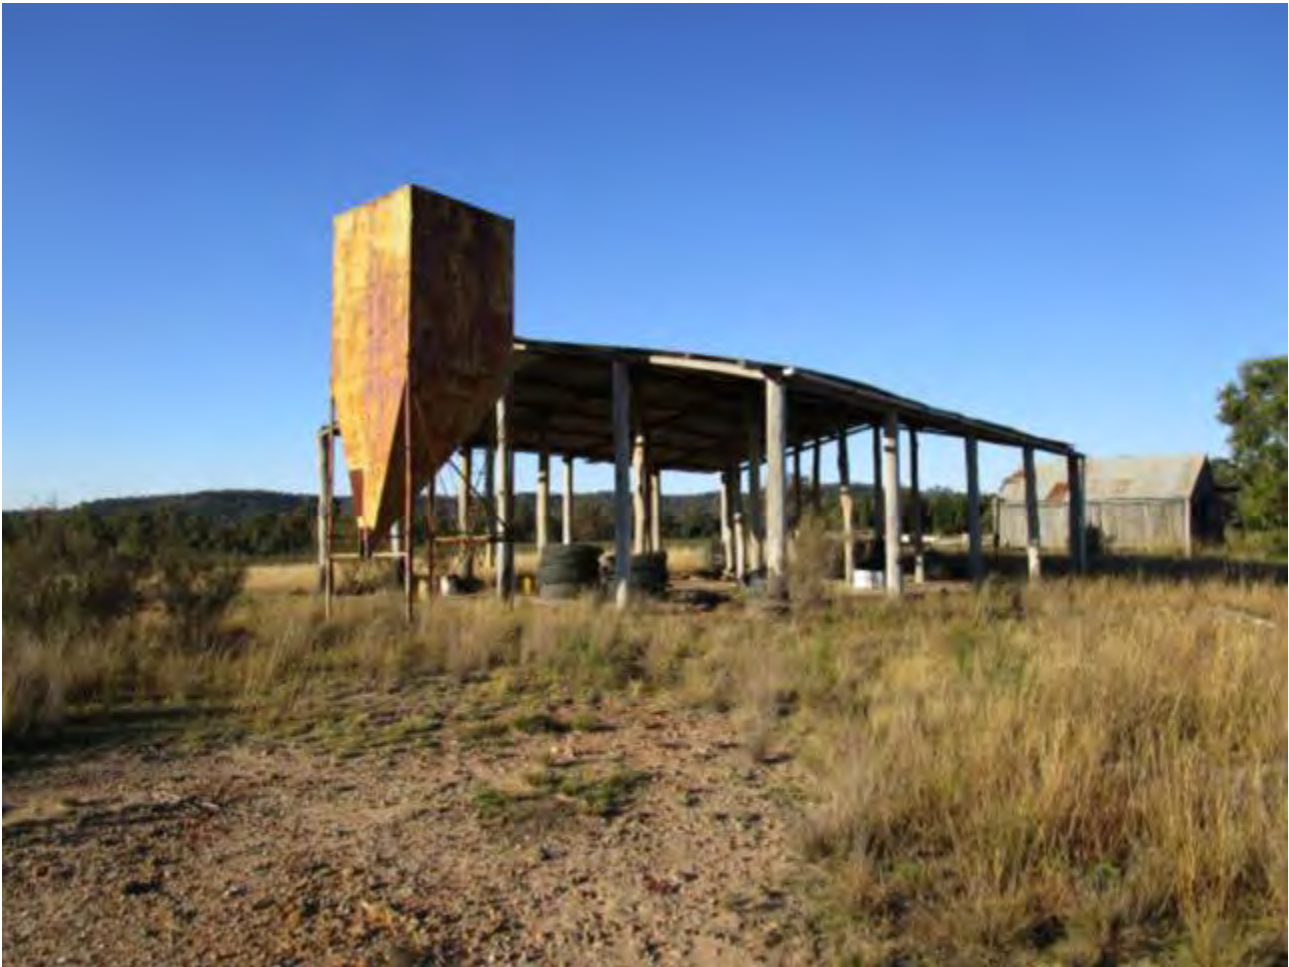
**Plate 28. Pine Park grain silo and shed with woolshed in the background**

The silo and pole shed appear to be structurally sound and are of moderate condition. The yards including the sheep run and stone trough are in poor condition. The timber of the sheep run is deteriorating, the trough have weathered and the yards, in general, are in poor condition. The woolshed itself is still structurally sound and is of moderate condition (Plate 29 and Plate 30). Overall the condition of the Item has not changed since the 2006 archival recording (WCPL 2006:41).

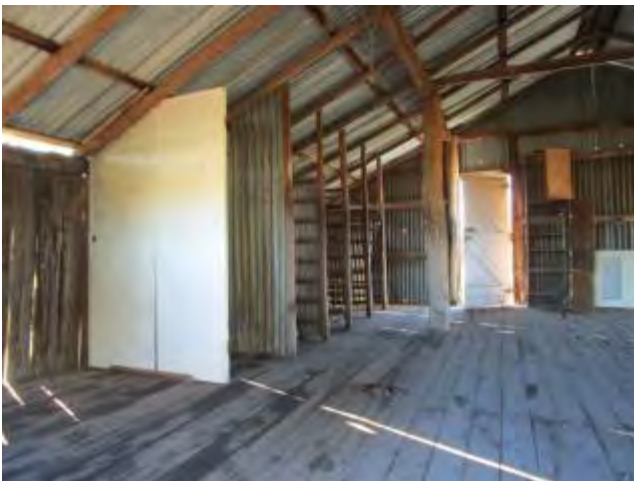
**Plate 29. Interior of woolshed.**

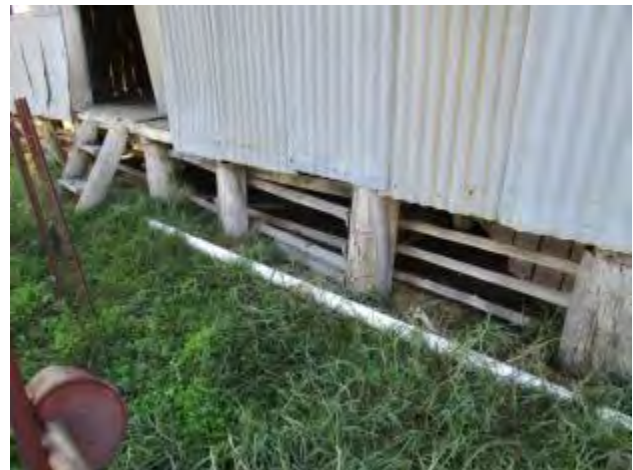
**Plate 30. Raised shearing shed with room to hold sheep underneath prior to shearing.**

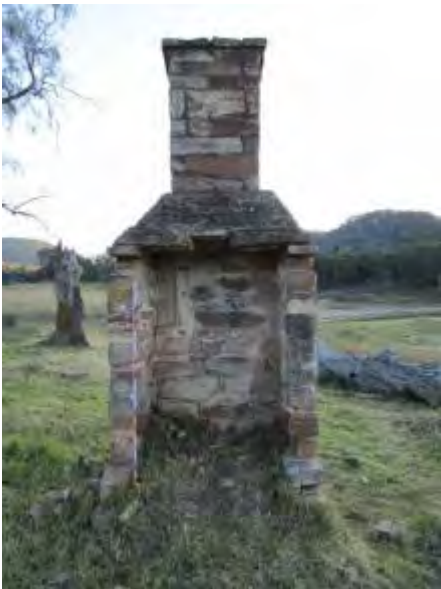
**Plate 37. View of the fireplace from the old cottage.**

Overall the Item is in poor condition.

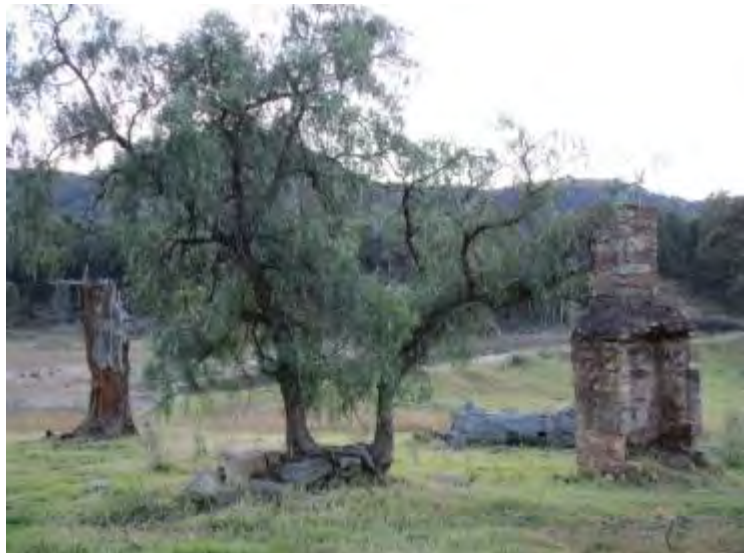
**Plate 38. View of fireplace and remnant stone wall held together by the Peppercorn tree.**

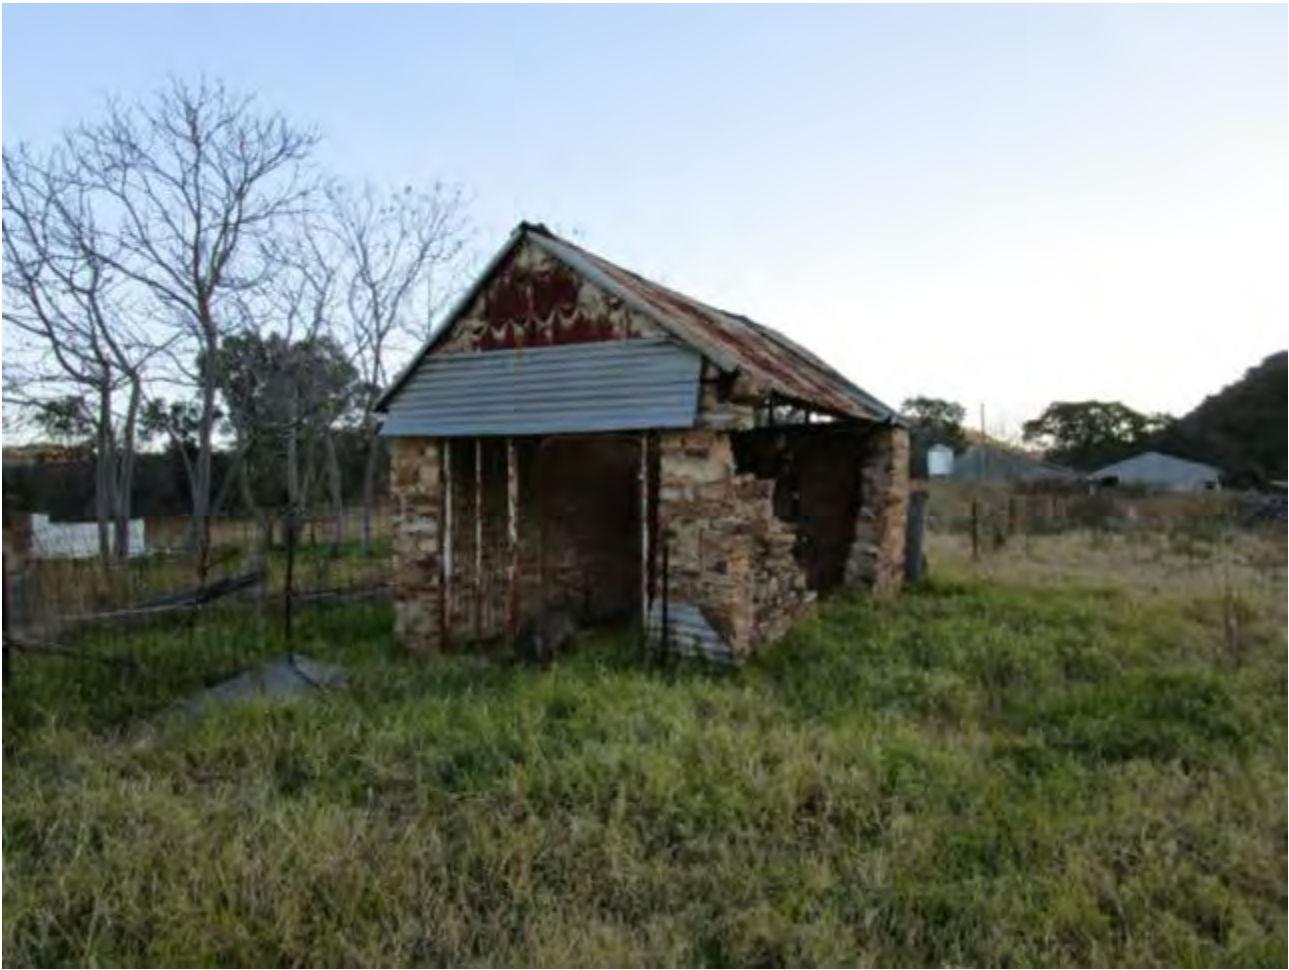
**Plate 39. Sandstone shed on Hillview Property**

The sandstone shed is in unstable condition as the rear wall features a significant crack and the side has a large gap where stones are missing (Plate 39 and Plate 40). The sandstone shed is in poor condition.

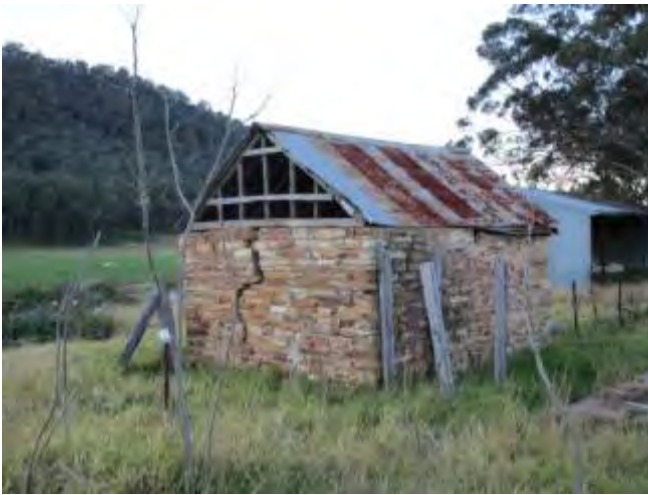
Plate 40. View of sandstone shed.

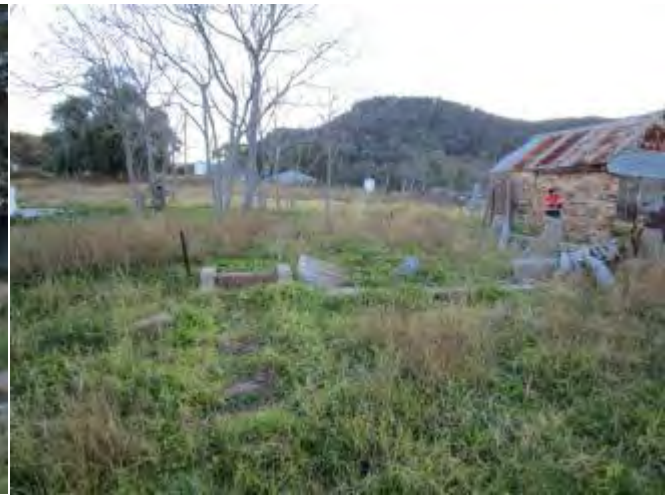
Plate 41. Cement foundations of Hillview.

The Hillview Cottage has been demolished and, therefore, is in poor condition.

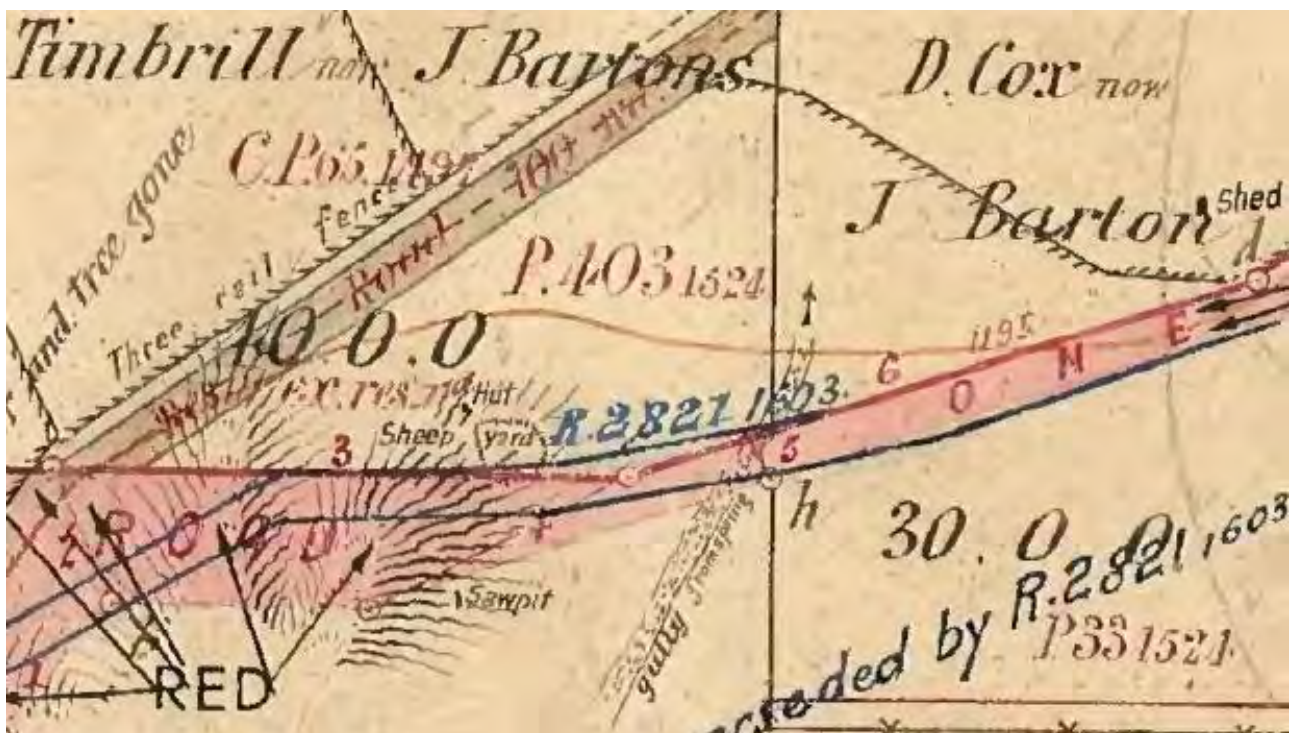
Figure 8. Extract from 1881 Crown Plan (Source: LPI 2203-1603).

The Crown Plan for this property shows the extent of the land worked by the Barton's within the Hillview property by 1881. The plan shows a hut which may have been the original rooms of Hillview. Also marked on the plan are: a sheep yard, a sawpit to the south (closer to the Barton's Cottage [Item 7.7]) and numerous fences. A shed is also marked to the north east.

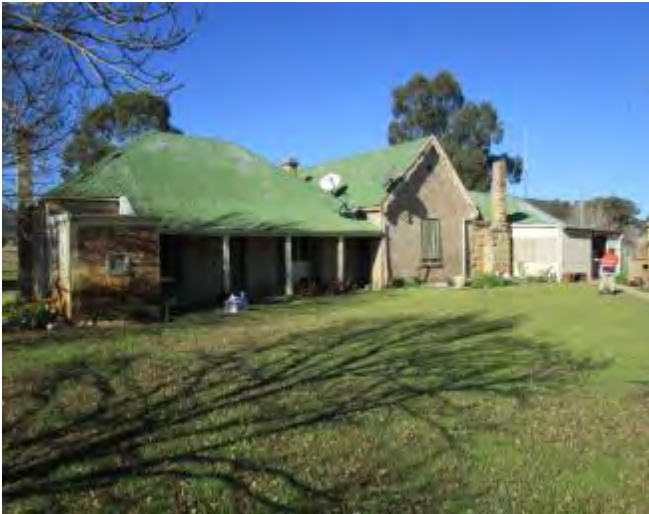
A fibro skillion roof extension has been constructed as an extension on the west side of the kitchen building. Separate gabled roof cement shed has been constructed adjacent to the fibro extension on the west. Another skillion roofed fibro room has been added to the south west corner of the original building. There is also a fibro garage situated on the west side of the homestead.

**Plate 44. Rear view of Wandoona Homestead.**

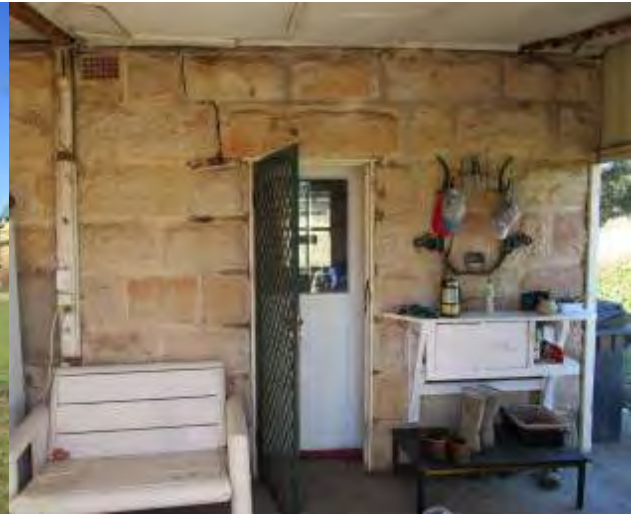
**Plate 45. Evidence of cracking in sandstone wall of kitchen.**

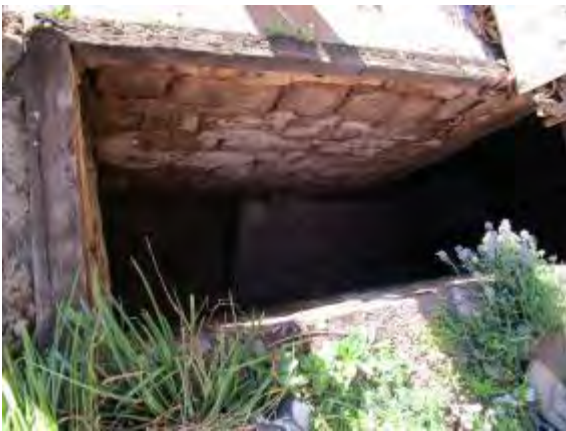
**Plate 46. Sandstone lined cellar.**
