# Wilpinjong Extension Project

## Historical Heritage Assessment

Prepared for Peabody Energy Australia Pty Ltd

November 2015

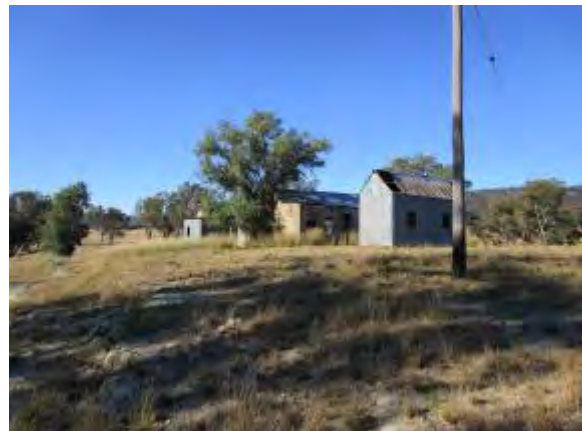
**Plate 47. Shearers quarters.**

To the east of the homestead, on the top of a rise, are the ruins of the former wool shed and shearers' quarters. The shearers quarters include two besser block buildings (Plate 47). One building is the sleeping quarters with four rooms and the other building is the cook house with an external double chimney attached. There are also two other corrugated iron and timber floor buildings with internal fibro lining. One of these buildings was a shower block with shower recess and basins in situ in a timber frame. Due to the deteriorated state of the interior of the later it is difficult to determine its original purpose.

The shearing quarters are in poor condition. Although the external walls appear in good condition, internally the floor and internal walls are missing, and buildings have old furniture and deteriorating building materials inside.

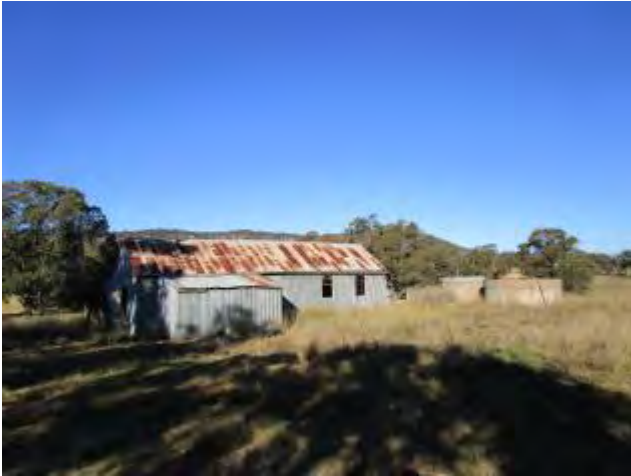
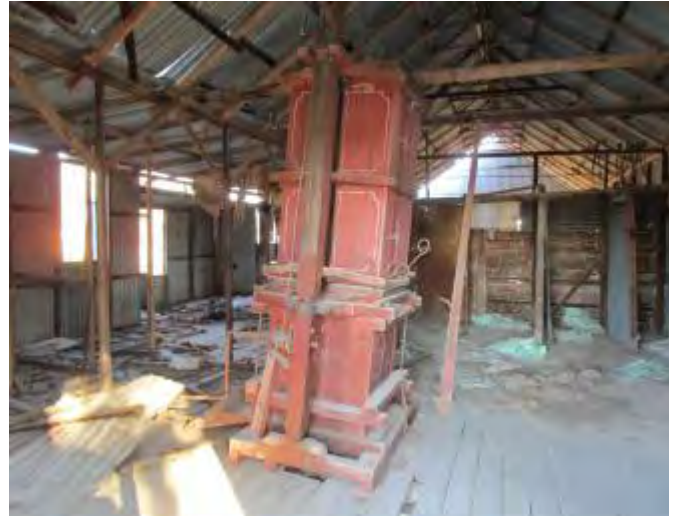
**Plate 48. View of woolshed.**

Nearby to the shearers' quarters is the larger corrugated iron woolshed with timber floor and exposed internal timber frames. A red painted timber wool press still sits in the middle of the woolshed (Plate 48 and Plate 49).

The woolshed is one large empty room with pieces of deteriorating building materials and the wool press inside. The walls are not lined internally. The woolshed is in fair condition.

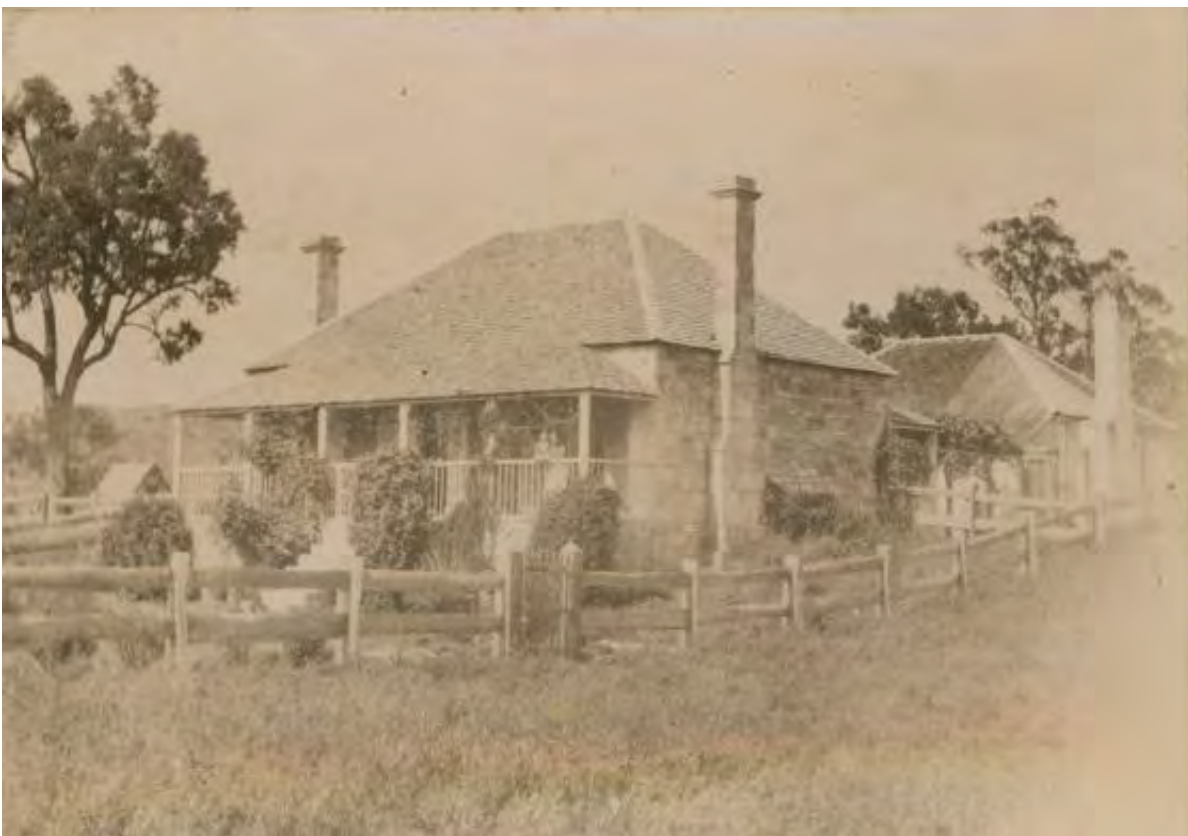
**Plate 50. C. A. Sibert. n.d Wandoona (Homestead), Wollar (Source: State Library of Victoria).**

Henry Single had the Wandoona homestead constructed for him and his family to live in. The undated photograph below of Wandoona was taken after the construction of the 1878 cottage (Plate 50). It shows that, originally, this cottage was behind a two rail wooden fence, and had a rear veranda and a slate roof. Behind the cottage is a wooden building with a slate roof and chimney. This building was probably the original four-roomed cottage mentioned in the 1872 advertisement, however, once the stone house was built the wooden cottage was likely to have been used as the kitchen rather than the living quarters. It is also likely that the 1902-3 bushfires burnt it down along with the wooden fences after which the new stone kitchen was constructed.

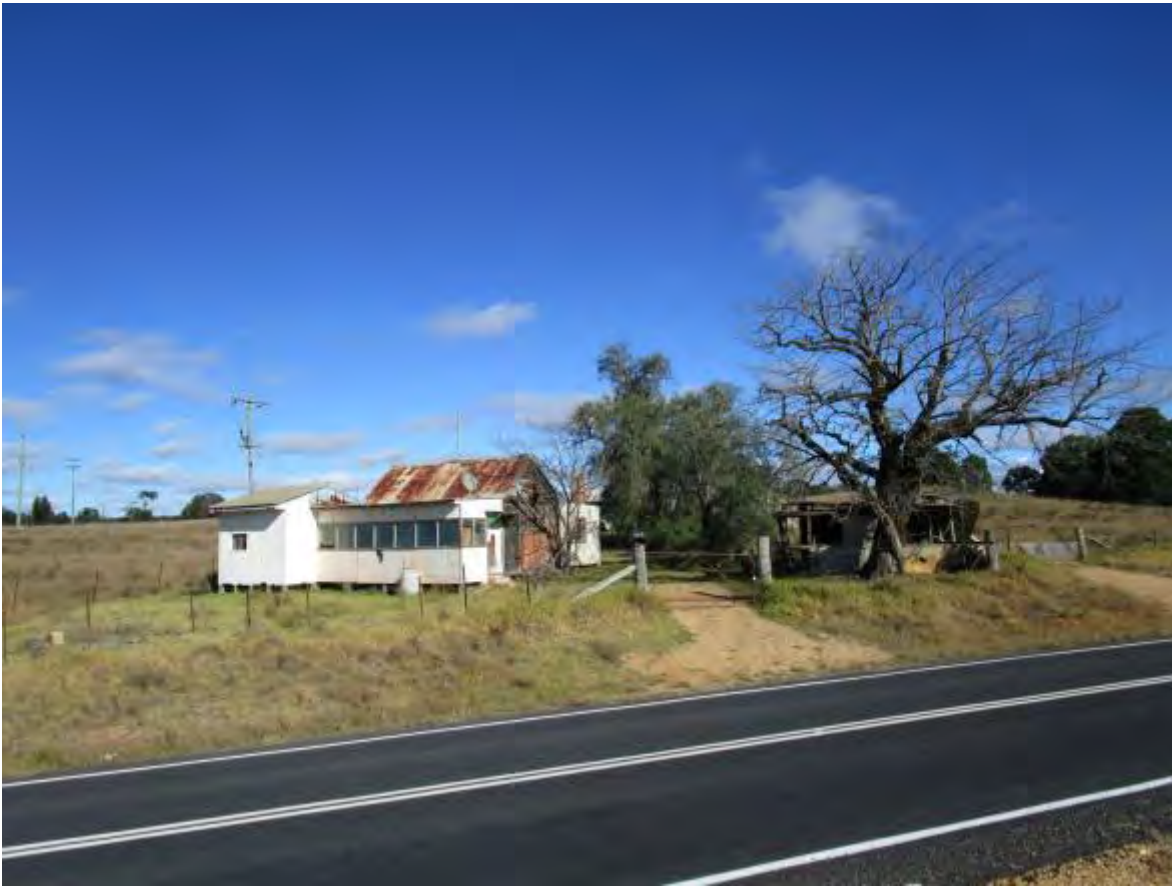
**Plate 51. View of timber slab hut clad with fibro.**

Located on Wollar Road, evidence of the original c1883 slab hut of the William Carr's Hut can still be seen. The hut has a corrugated iron gabled roof. A section of the north-western end of the slab structure has been boxed in with bricks. The slab has three fibro extensions, one skillion roofed extension to each side of the slab hut, and a third gabled roof extension to one of the extensions. Located near the house are three Peppercorn Trees. Fronting the road is a slab shed with collapsed roof and partially collapsed walls (Plate 51).

The slab hut has been heavily modified with extensions and gaps have been bricked in. The fibro extensions are deteriorating. The shed fronting the road has also deteriorated rapidly since the Heritas Architecture (2008:26) survey of the item. The photograph presented in the Moolarben Coal Project Stage 2 European Heritage Assessment shows the shed complete with roof and without collapsing walls. The condition of the item is poor to fair.

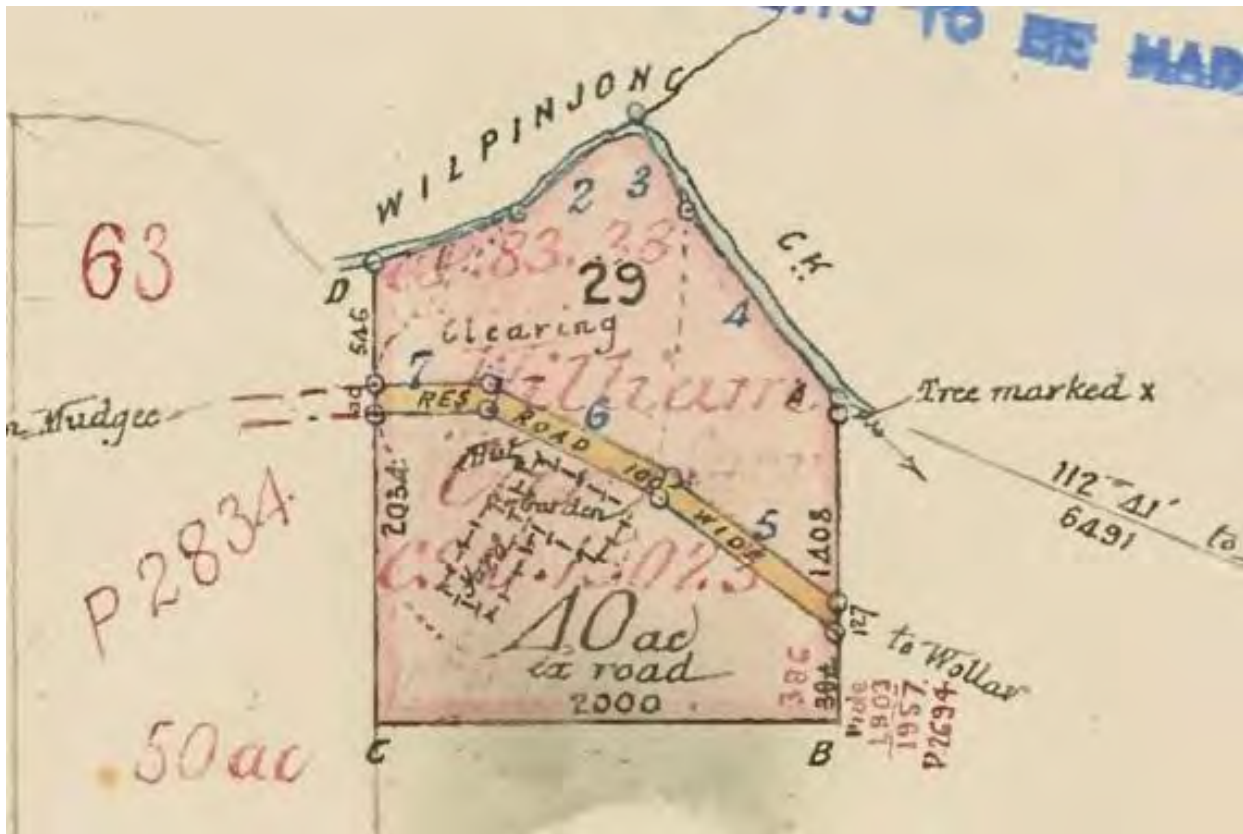
Figure 9. Extract from 1883 Crown Plan (Source: LPI 1883 1282-2125).

The Crown Plan surveyed in 1883 shows that by this stage the slab hut had already been constructed and a garden and yard had been cleared and fenced. The value of improvements at the time of the survey included: a hut valued at 7 pounds; fencing valued at 17 pounds; clearing valued at 15 pounds and a garden valued at 5 pounds (LPI 1883 CP1282-2125).

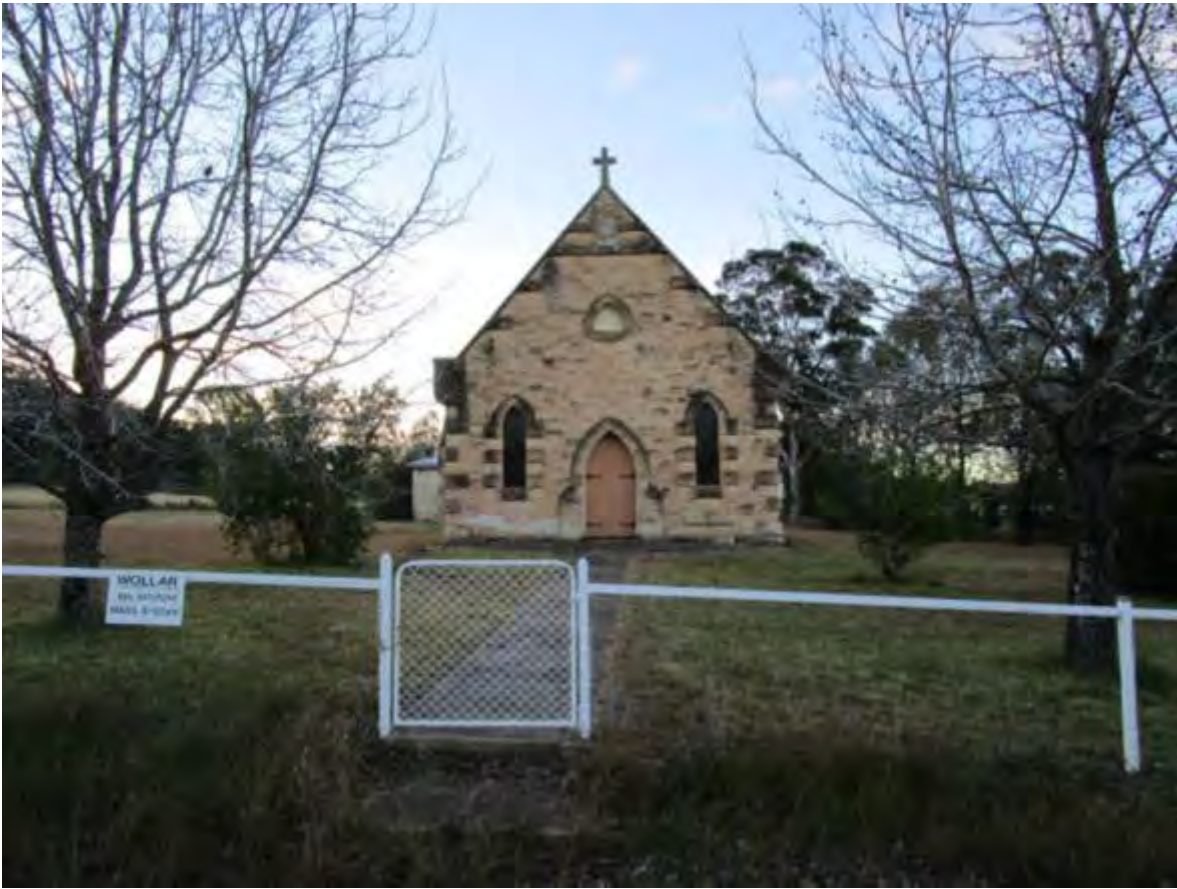
**Plate 52. View of St Laurence O'Toole Catholic Church.**

The St Laurence O'Toole Catholic Church is a Gothic style sandstone church with a gabled corrugated iron roof and three gabled roof vents on each side of the roof (Plate 52). A prominent gabled verge extends from the east side of the church which acts as the vestry and leads in to the Chancel. There are three arched windows on the east wall of the main structure and one on the vestry, as well as a door on each side of the vestry and an inscribed foundation stone that reads "This stone was blessed and laid by the Rev Father McGee on Oct the 9th 1904". There are three stone crosses with one on each gable peak, including the vestry gable. The north side of the building has a central pointed arch door at its centre and faces the road. On each side of the door is a pointed arched window and above the door in the gable pitch is an arched vent. The south side of the church consists of a singular arched window with a decorative timber frame. The west side of the church has four peaked arched windows. The windows are stained glasses in a diamond pattern. Although the church has closed it is still furnished with timber pews, Stations of the Cross, and statues of St Laurence, Mary and baby Jesus, St Patrick, Joseph and baby Jesus, Sacred Heart of Jesus and St Teresa (Plate 53).

The church is in an overall good condition. There is some minimal evidence of cracking along the joins of the sandstone and of re-mortaring. Some of the sandstone has blackened from mould due to damp conditions. This is particularly apparent near the guttering and pipe drains. The internal fittings of the church are in good condition.

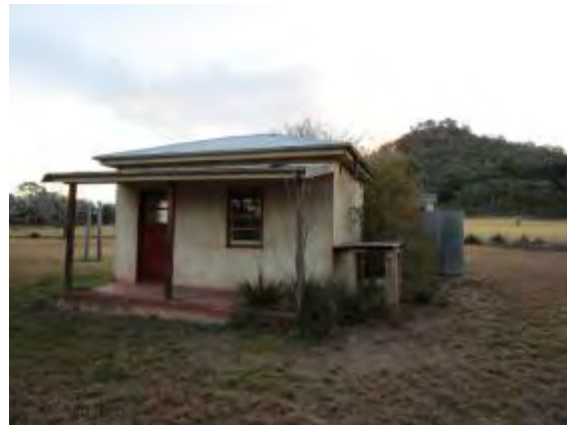
**Plate 54. Priest's accommodation.**

The “priest accommodation”, although unused, appears in good condition with minimal cracking in the cement. The tank stand is on a lean. The paint on the timber of the outhouse is well weathered, but otherwise, the outhouse appears structurally sound.

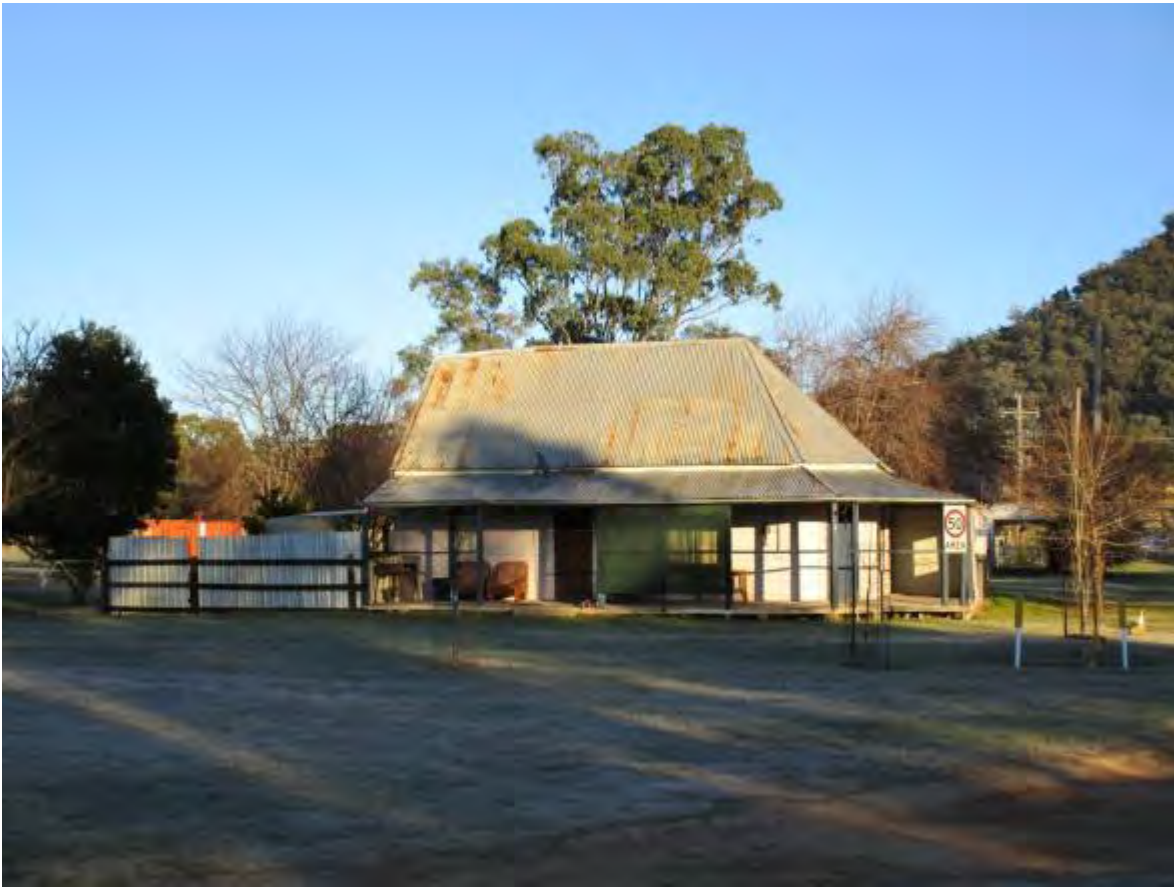
**Plate 55. Former Mason's Store**

The item is currently used as a residential house, but was originally used as a store. The building is a timber construction with a corrugated iron hipped roof and a corrugated iron awning protruding over a timber floored veranda (Plate 55). The front of the veranda and house is curved in shape. The house sits on timber stump foundations and has three single paned windows and two doors along the face of the building. There is a brick chimney at the rear of the building.

The house is in good condition.

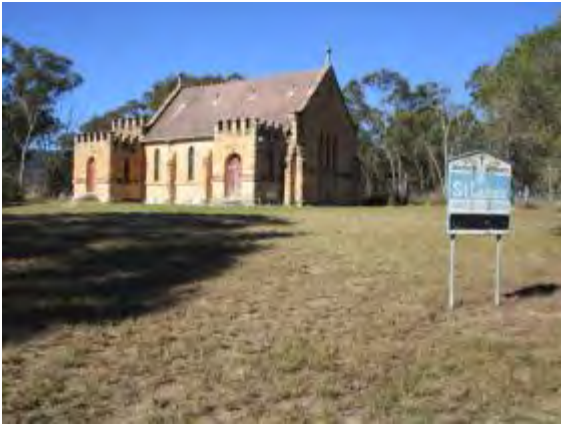
**Plate 59. View of the north and east sides of the church.**

Overall the stonework and pointing of the church is in good condition, with the exception of the lower courses which show evidence of weathering. In places mortar has deteriorated and in some places re-mortaring is evident (Plate 62). The copper guttering and piping appears to have holes in places, and a build up of black discolouration on the stone indicates they are leaking.

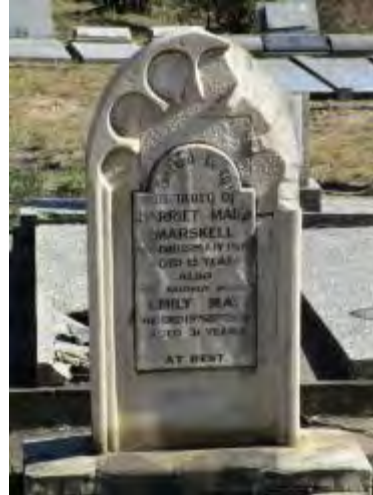
Behind the church to the east is the church cemetery. The cemetery is set in leafy surrounds and the graves are marked with sandstone headstones (Plate 60). Family names prominent in the cemetery include the Marskell and Single families. The earliest known burial is Myers in November 1874 which predates the construction of this church, and the believed construction date of the earlier timber church 1877 (Broadley 2009: 40). Many of the headstones are from around 1914. Some of the graves have cast iron fences around them, either for single graves or for more than one family grave. There are 103 known graves located within this cemetery (McDermott and Robinson 2012:45).

**Plate 60. Evidence of deterioration of grave headstones.**

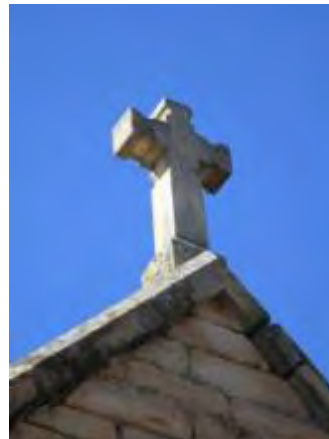
**Plate 62. Evidence of re-mortaring between the sandstone blocks.**

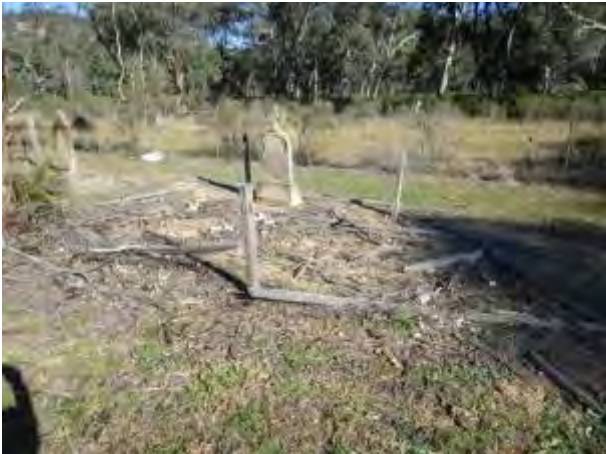
The timber fencing within the cemetery has deteriorated and only remnants of it remain.

**Plate 65. Remnant timber fencing around graves.**

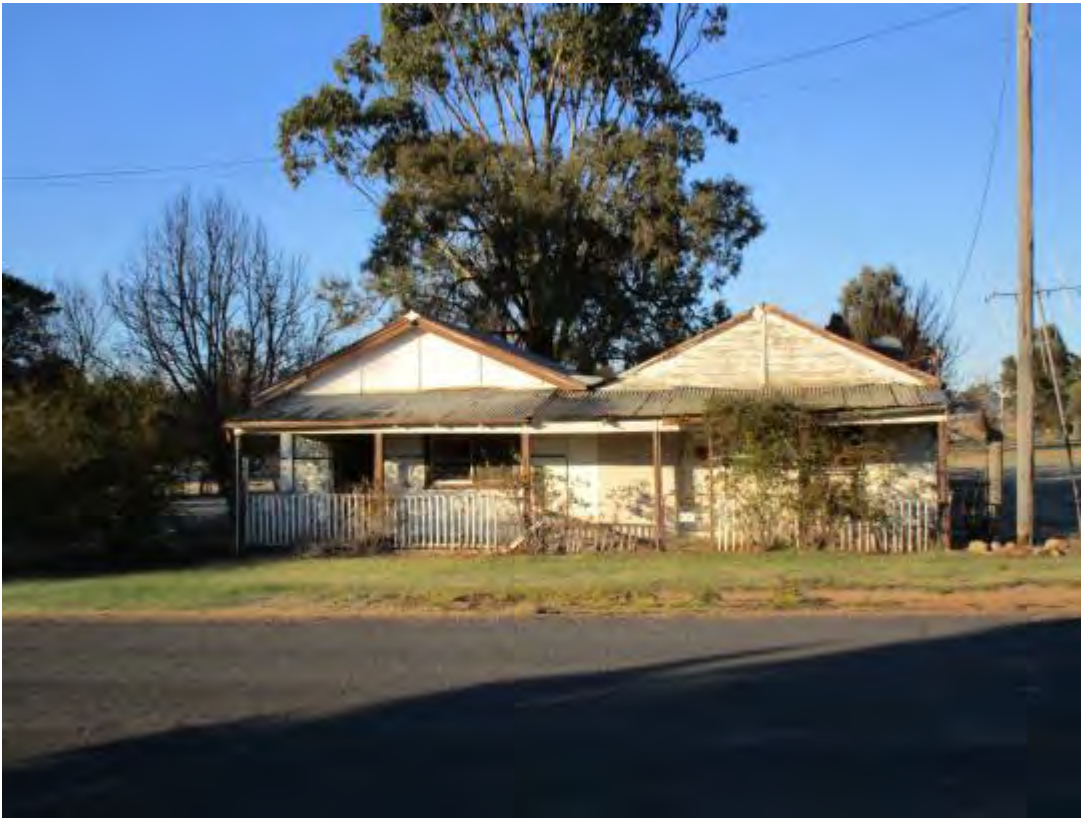
**Plate 67. Former butcher and garage.**

Located on the corner of Maitland and Barigan Streets, Wollar, are two semi detached cottages constructed of weatherboard with corrugated iron gabled roof. The first building was built in the 1930s as a garage before the second building was built as a butcher shop. The former butcher building is clad with white tiles at the front and the gable pitch has fibro cladding. A corrugated iron skillion roof veranda extends across the two cottages supported by simple timber posts. A white timber fence fronting the cottages is in a state of disrepair, particularly in front of the former garage building which still has a weatherboard gable pitch and has undergone less restoration works (Plate 67).

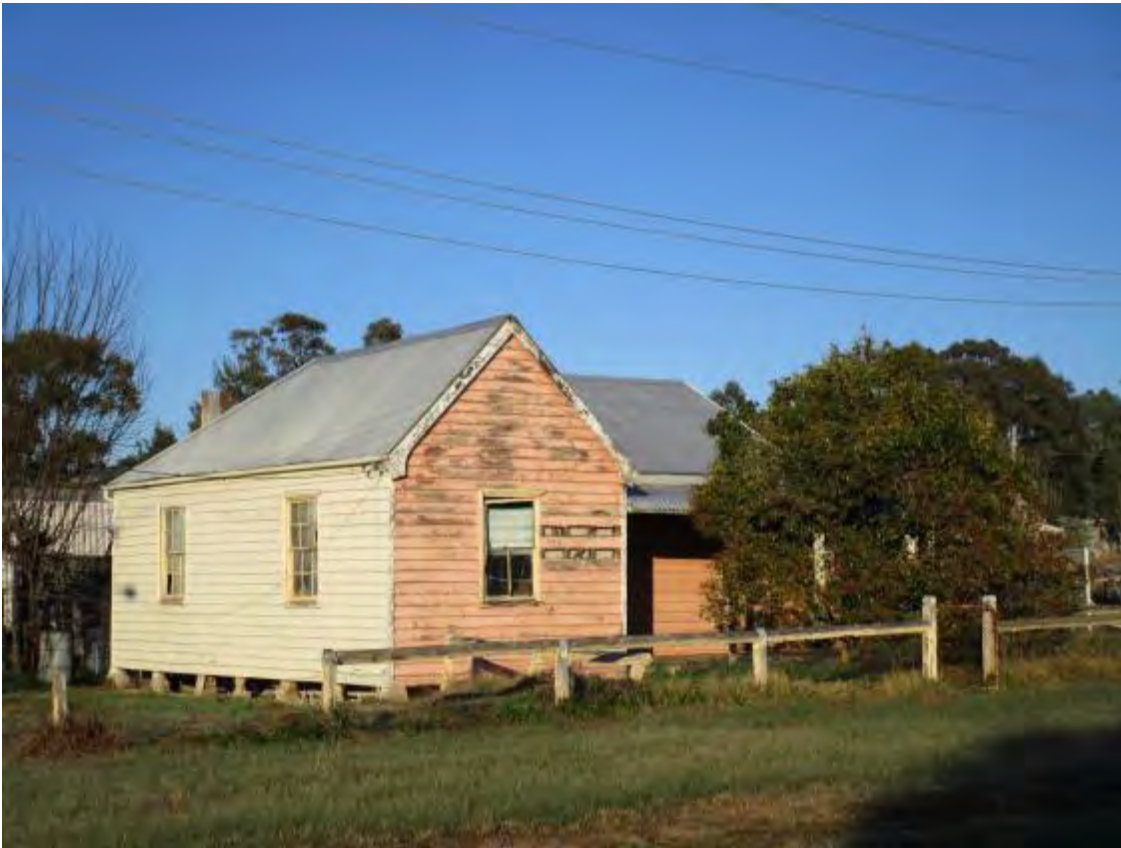
**Plate 70. Lynch's House.**

Lynch's House is a c1890-c1915 federation timber bungalow with corrugated iron gable roof and a separate veranda roof supported by simple timber posts. The side of the house has two 12 paned double hung windows and double hung sash windows at the front of the house. The entrance is via the veranda with a brick chimney at the rear of the house. An extension has been added to the rear of the house. A simple timber fence surrounds the house with a metal gate. The front of the house has been painted pink while the sides of the house are cream (Plate 70).

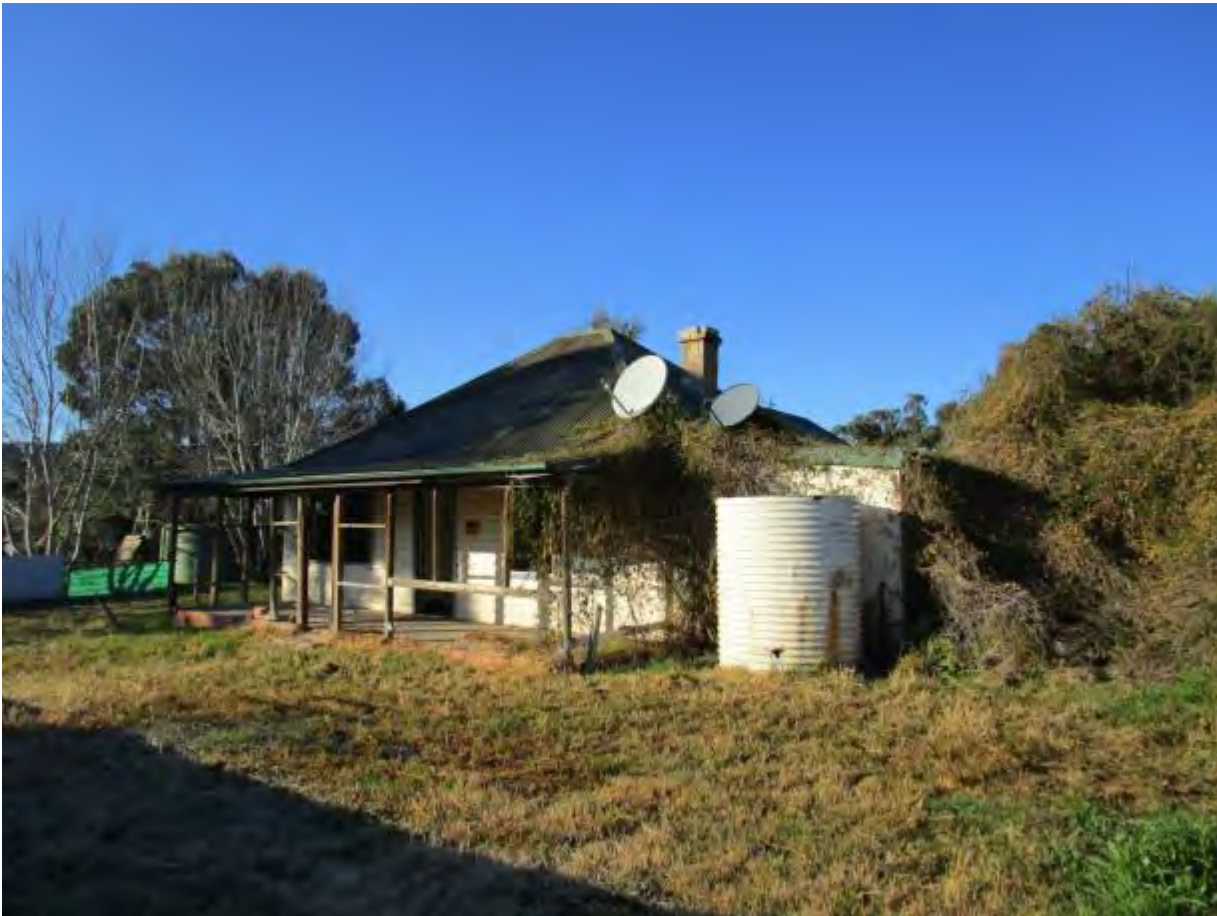
**Plate 73. King's House.**

Located on the corner of Price Street and Barigan Street in Wollar, c1890 King's House is a Victorian Georgian timber cottage with green painted corrugated iron hipped roof and a sandstone chimney. There is a door at the centre of the facade of the cottage with two symmetric windows on either side. The skillion backed veranda roof is supported by simple timber posts. The veranda floor is constructed of concrete. There is a brick chimney and fibro room extension at the side of the house with a skillion roof. In front of the extension is a corrugated iron tank (Plate 73).

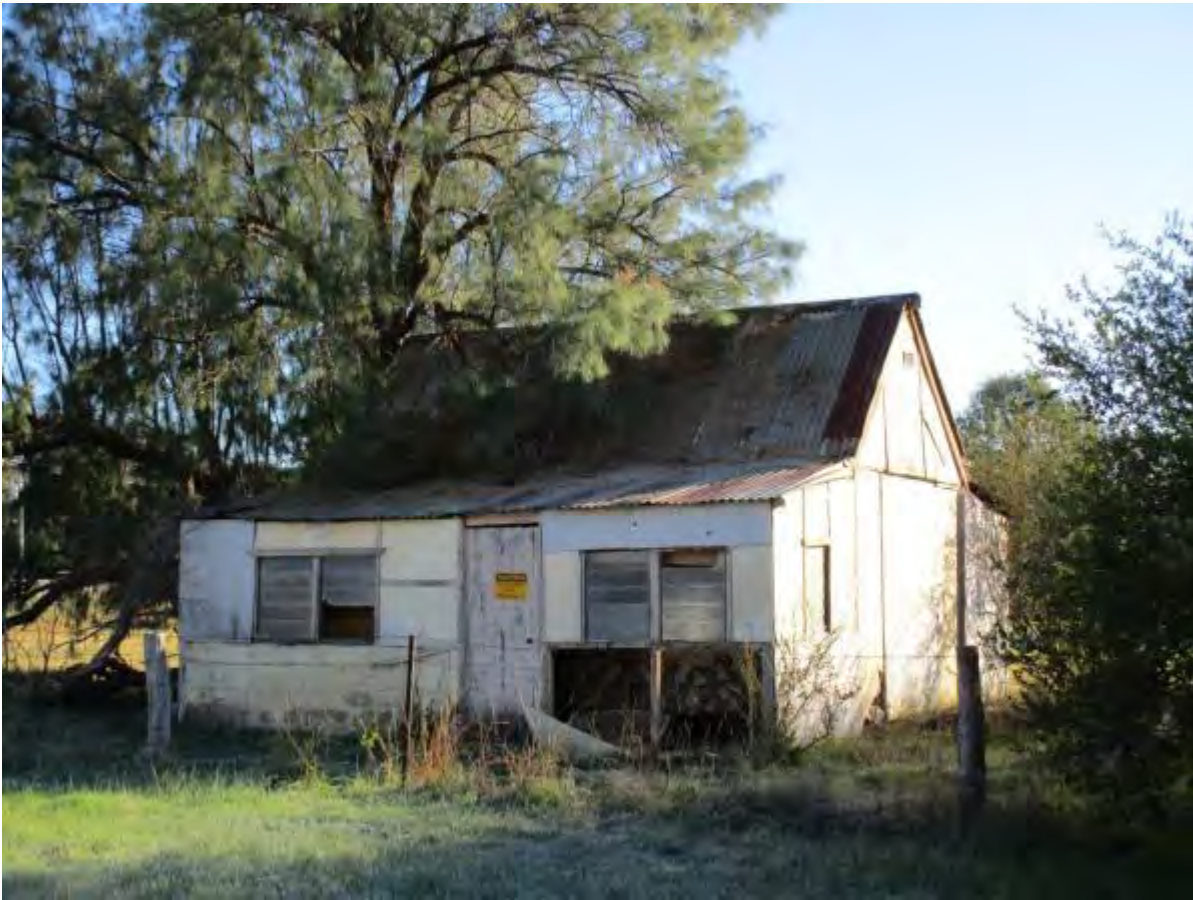
**Plate 76. Kirkland's Hut.**

Kirkland's Hut is located on the corner of Price Street and Barigan Street in Wollar and is unoccupied. This hut was originally of slab construction but was clad with fibro c1960s. The hut has a corrugated iron gable roof with broken-back skillion roof extension of two rooms on each side of the house. Both these skillion roofed rooms were probably originally constructed as front and back veranda which were later enclosed to create extra rooms. The front of the house has a timber door and two double louvered windows. A mature Peppercorn Tree grows next to the house (Plate 76).

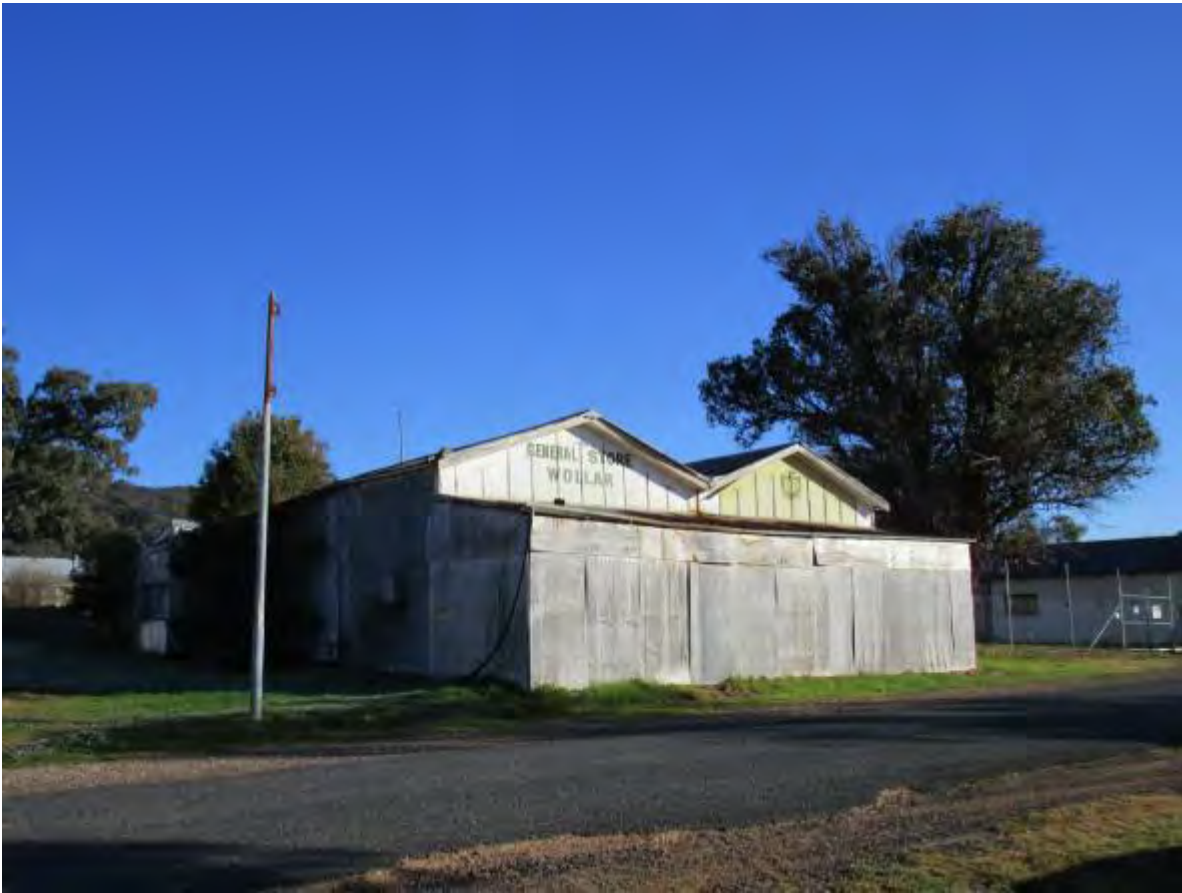
**Plate 79. Old general store.**

Located on Barnett Street in Wollar, the Old General Store comprises of two semi detached buildings originally constructed of timber, with corrugated iron gabled roof and skillion veranda awning. The veranda has been enclosed with tin sheeting and the walls have been clad with tin sheeting (Plate 79). The buildings are unoccupied and contain asbestos (pers. comm. Jamie Lees 2/7/2014).

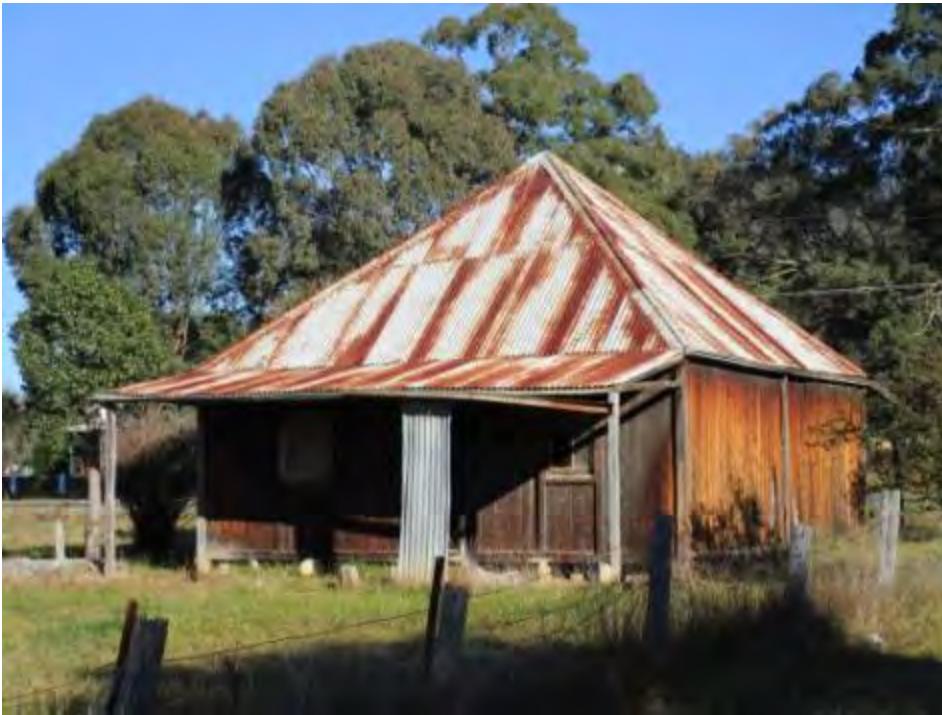
**Plate 80. Slab hut.**

The Slab Hut in Wollar is a timber slab constructed hut with a corrugated iron pyramidal roof and an extended veranda awning at front and rear supported by simple timber posts. The hut has an external sandstone block chimney. The front door has a four paned glass window on each side of the door. One window is boarded over the other is broken. There are two windows at the rear of the hut (Plate 80).

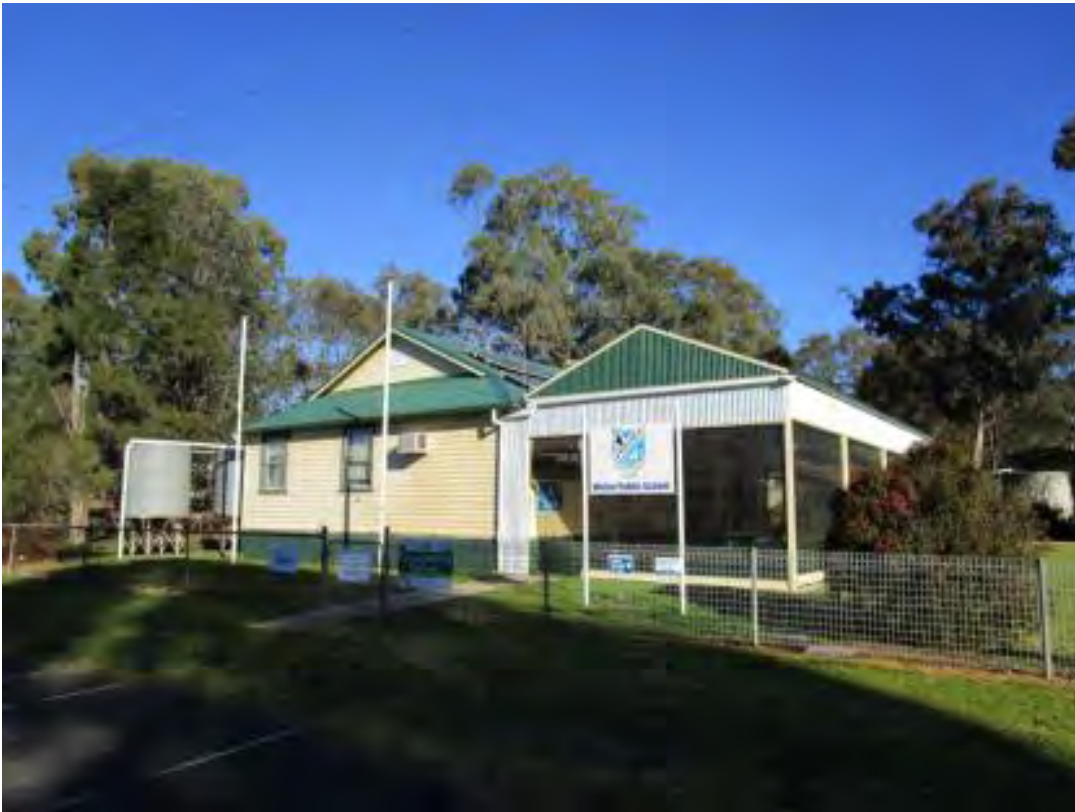
**Plate 82. Wollar School.**

The Wollar School building (1927) is of weatherboard construction with a corrugated iron gable roof. The entrance to the building is via a gabled roof plastic weather shelter. The front of the school building has a corrugated iron awning extending out from under the gable pitch of the roof and appears as though it was originally a veranda which has been enclosed. This wall has two double hung windows (Plate 82).

The school is in good condition.

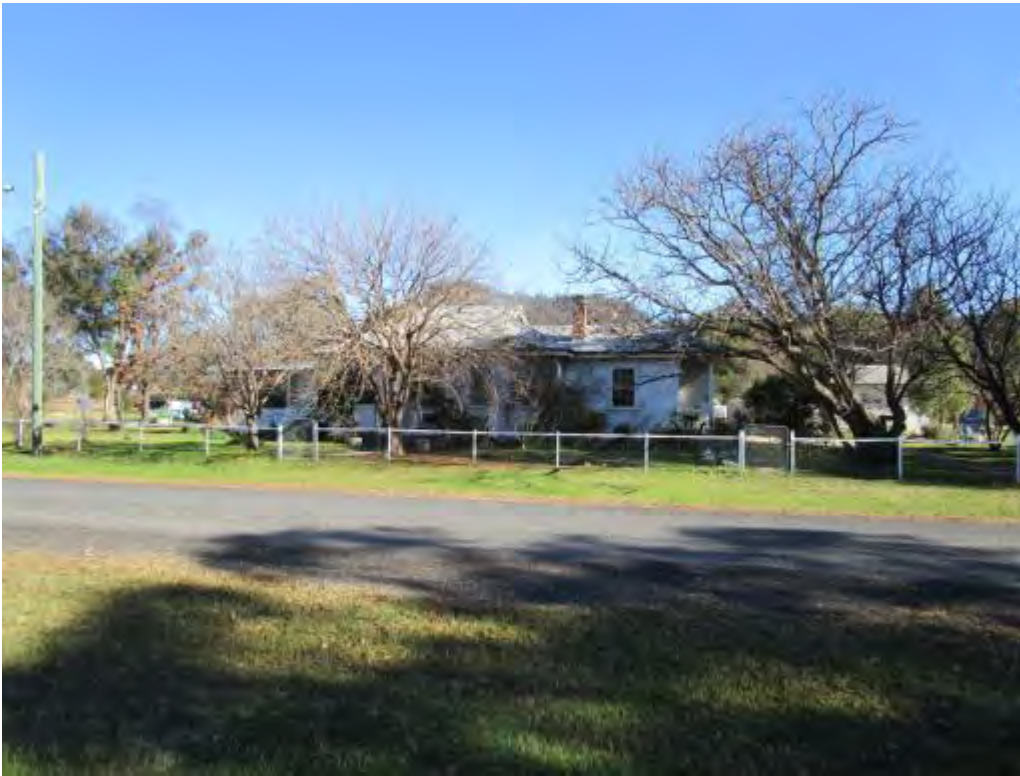
**Plate 83. View of former police station.**

The Former Police Station is a 1936 inter-war Georgian Revival weatherboard building with a corrugated iron hipped roof, boxed eaves, brick chimney, paned double hung windows of vertical proportion and a pilaster style entrance (Plate 83).

Access to this building was restricted and its condition could not be assessed.

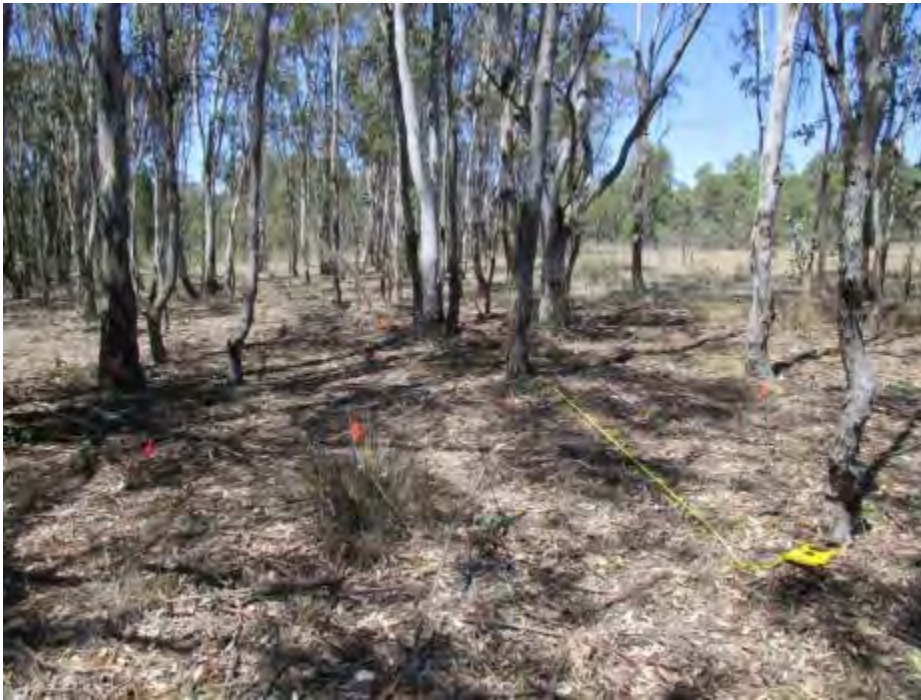
**Plate 84. Location of church site.**

The remains of the former St James Church are located in a lightly forested area of land which, until recently, was still owned by the Church. A rough dirt track leads from Ulan Wollar Road to the church site. A very old large Gum tree is situated next to the site of the former church. The tree is now dead but would have provided a shady and picturesque aspect when the church was operational (Plate 84). The remains of the church comprise of two obvious foundation posts (Plate 85 and Plate 86), and ten foundation post holes which would have, or may still contain, the structure supporting posts (Figures 12 and 13).

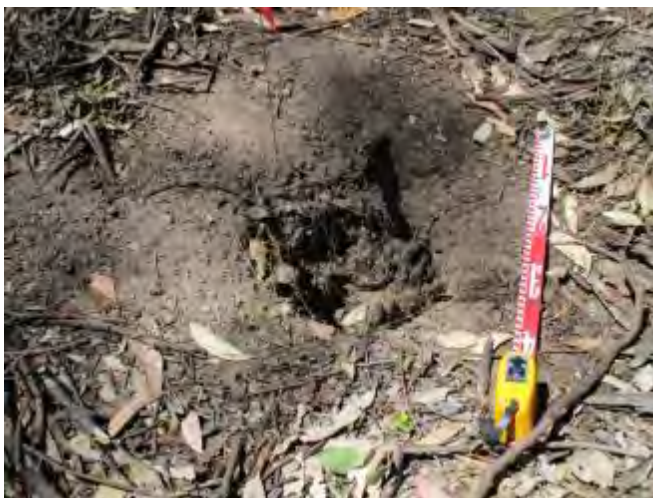
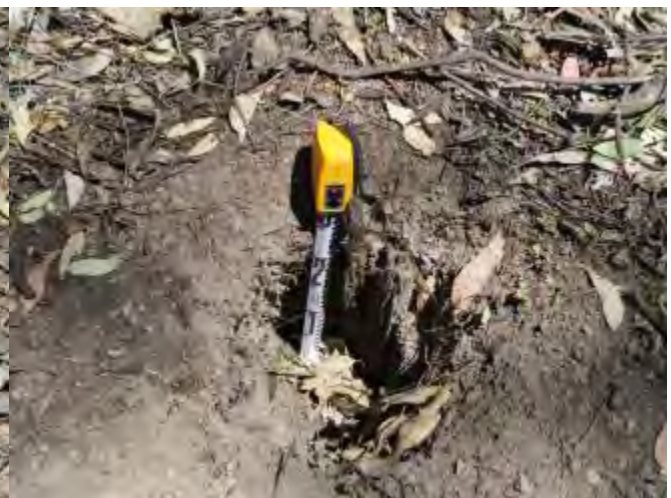
**Plate 85. Post from church foundations.**

**Plate 86. Post from church foundations.**

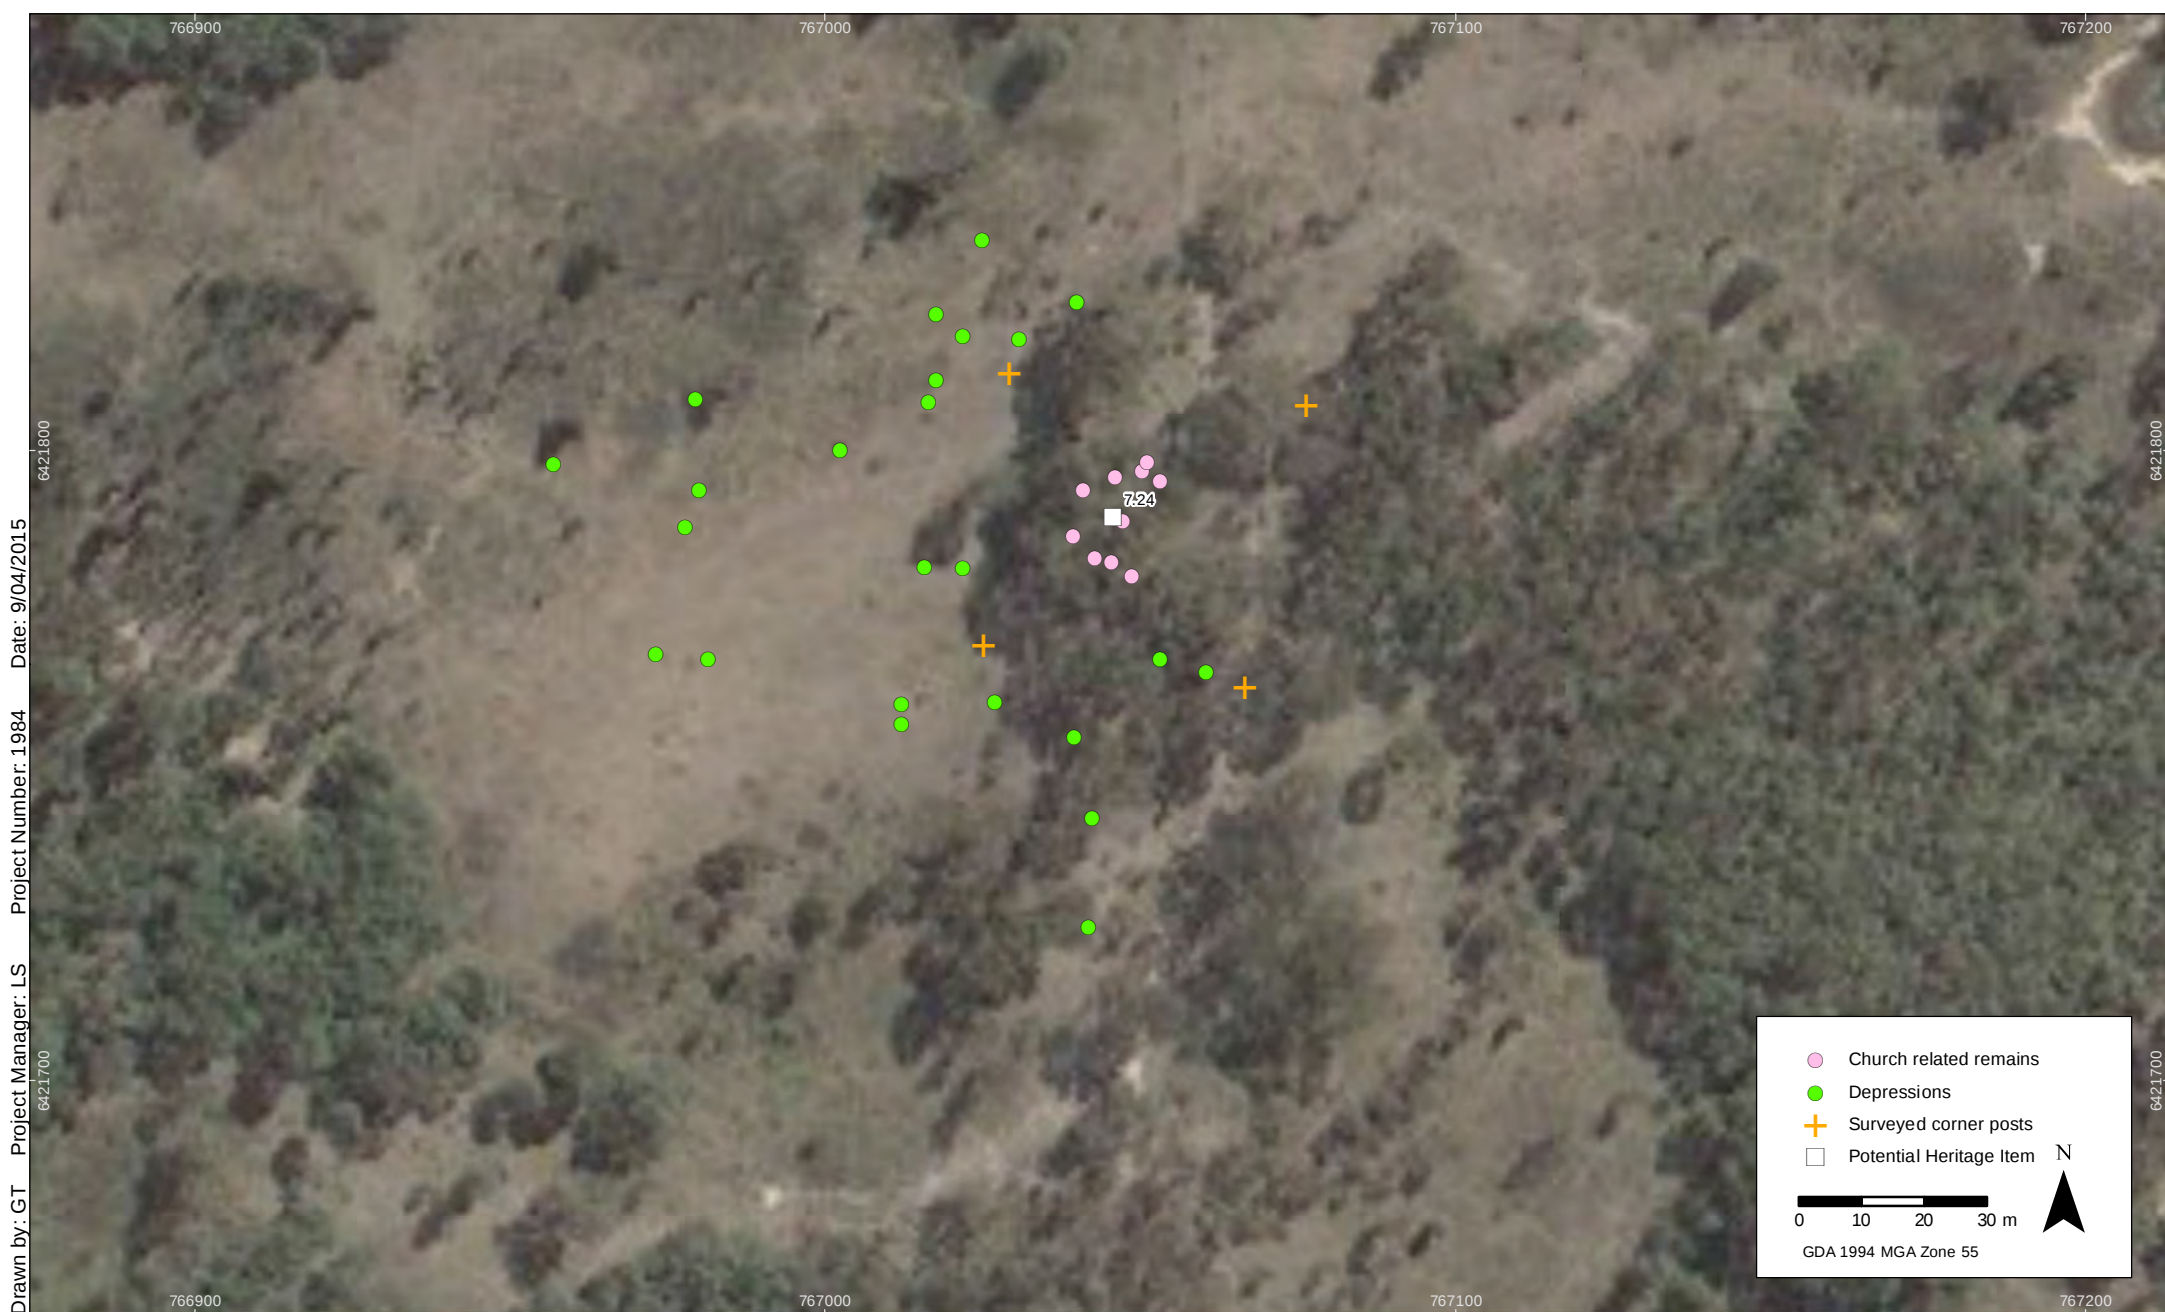
**FIGURE 13**

Plan showing former St James Church Lot, Wilpinjong  
Wilpinjong Historical Heritage Assessment

Approximately 24 depressions were located near the former church (Figure 13). The majority of the depressions were located on the land which was privately owned and is now owned by Ulan Coal Mines Limited. Compared to the church land the private land appears to have been extensively cleared and it seems likely the depressions are from the removal of tree stumps and/or large rocks.

The remaining depressions on the church land may have also been caused by early land clearance. There is, however, a chance that one or two of them could be unmarked graves associated with the church. One could also have been a well associated with the church.

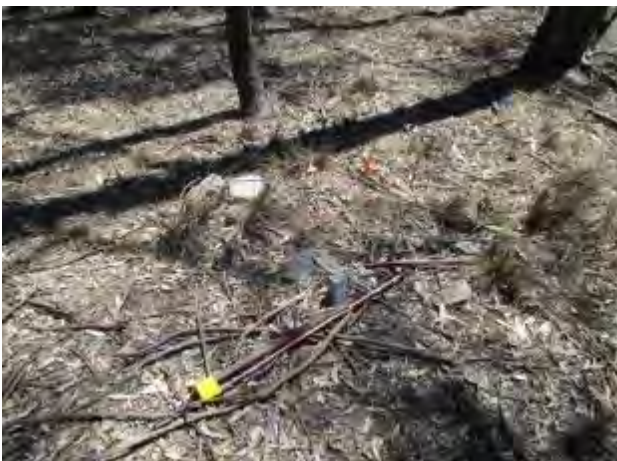
**Plate 87. Surveyed corner marker.**

The church land appears to have been relatively recently marked out and the corner survey pegs are still evident (Plate 87). Four corner pegs were located during the survey. The corner pegs were marked in two instances by excavated narrow trenches that joined to form a corner, one of which also had a post in the ground at the corner point. Another corner was marked with a post in the ground and a pile of rocks and the fourth corner was marked with a pile of rocks (Plate 87).
