# Wilpinjong Extension Project

## Historical Heritage Assessment

Prepared for Peabody Energy Australia Pty Ltd

November 2015

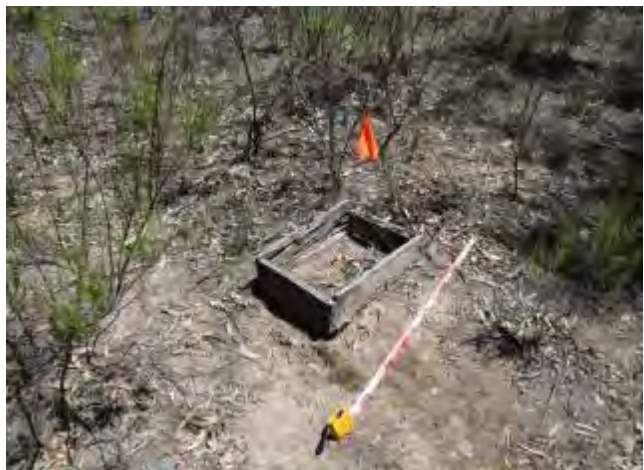
**Plate 88. Bee box.**

Near one of the corner pegs an old timber bee box was located lying on the ground. Fragments of timber that appear associated with the bee box were also identified (Plate 88).
