2019 Annual Review

Wilpinjong Coal Mine

Table 1 Annual Review Title Block

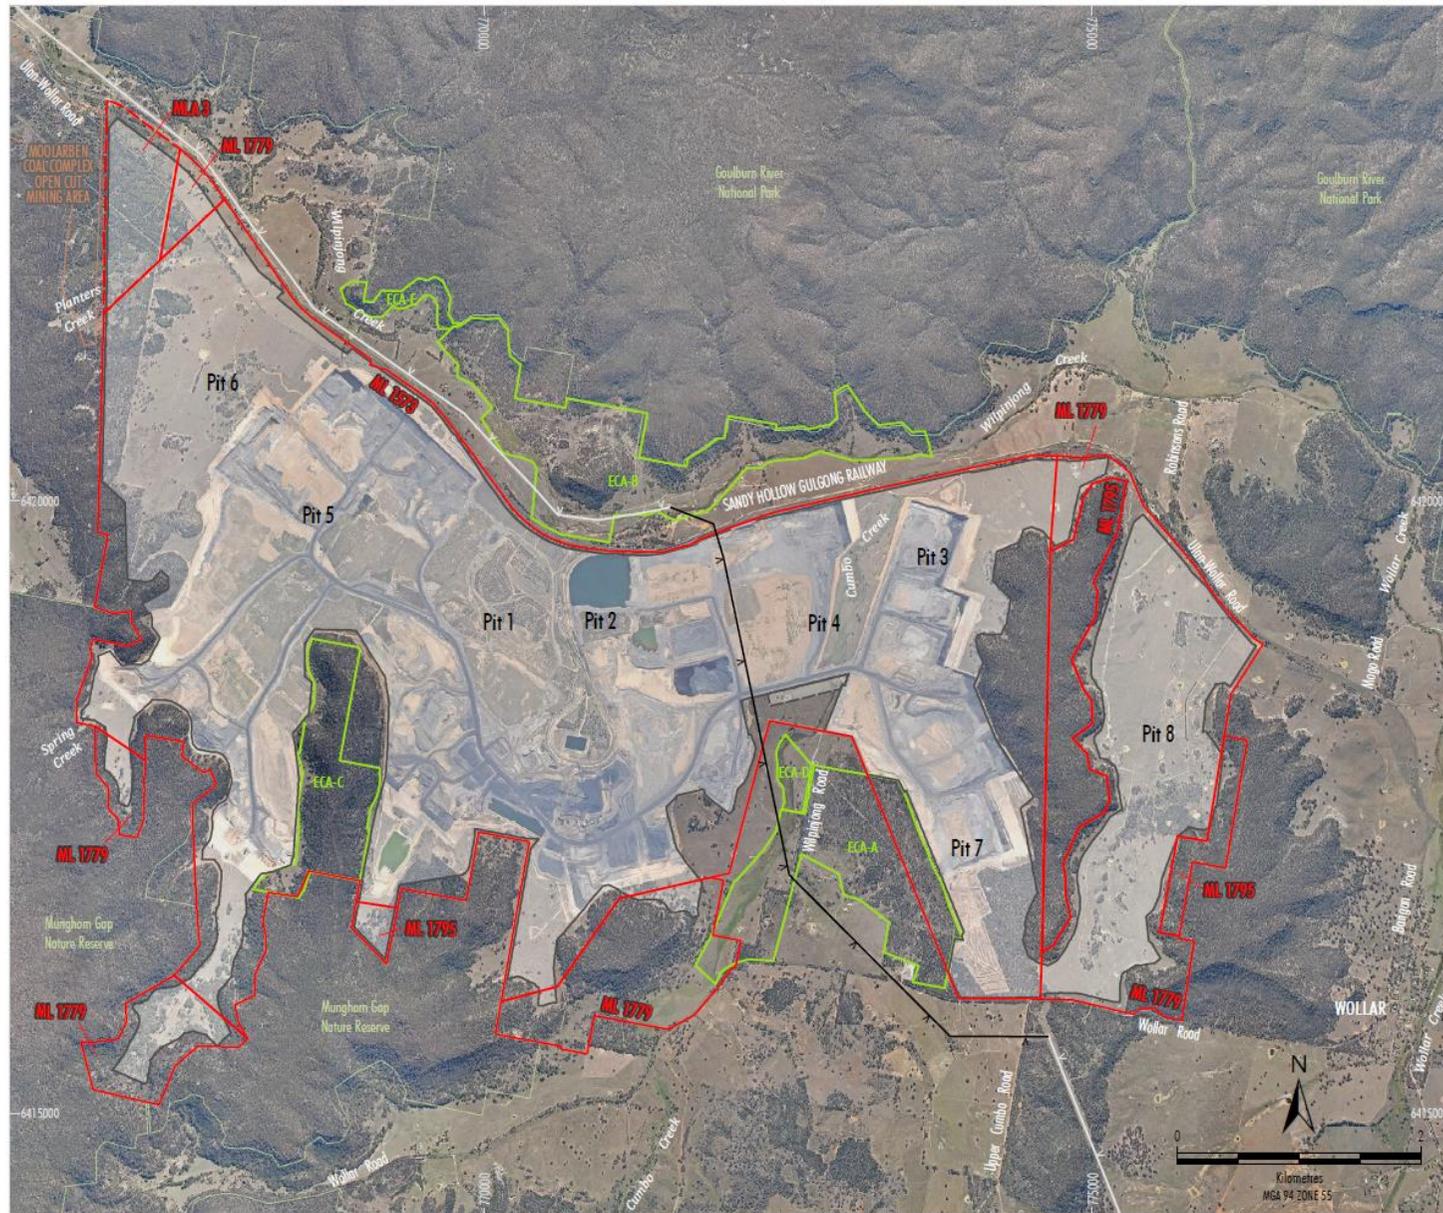
Figure 2 The Approved WEP Layout and Surrounds

* Inclusive of the agreed minor change to the area confirmed by DPIE on 23rd August 2019.

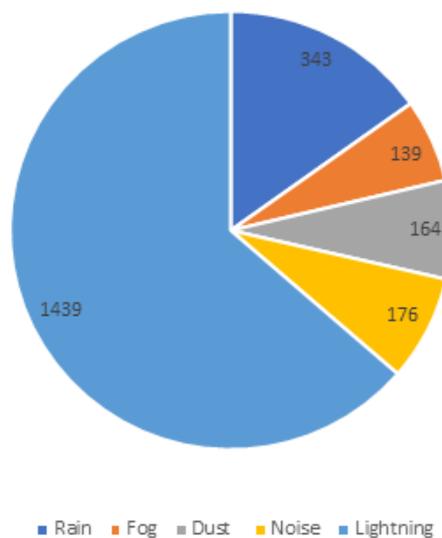
Figure 3 Breakdown of Lost Time Hours 2019 (Dust)

- Water sprays were utilised on the ROM coal bins, and recently stripped areas as required.
- In 2019, approximately 164hrs of lost time hours associated with implementation of dust management strategies (**Figure 3**).

Notes: The increase in lost hours due to lightning in 2019 is a result of implementation of a new Lightning TARP and the occurrence of more frequent electrical thunderstorms (mainly dry lightning) in 2019.

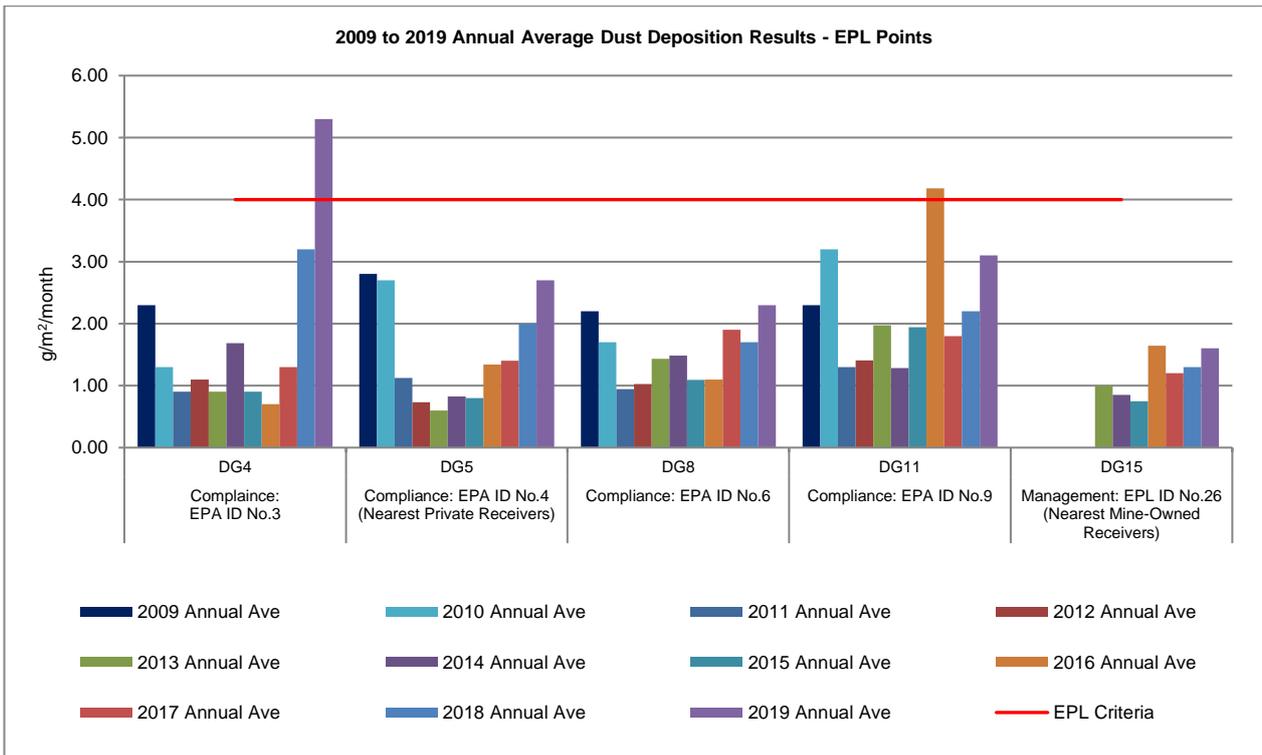
Graph 1 Compliance Annual Average Dust Deposition Results 2009 – 2019

Notes: Based on the positioning of the compliance monitors at WCM, it can be assumed that the DDG8 monitor is sufficiently away from mining activity and is generally represented of background levels for the area. On this basis, the potential incremental contribution from WCM can be estimated as the level recorded at the compliance monitors minus the level at DDG8 (Todoroki, 2019). Except for DG4 (refer to **Table 12**), the resulting incremental levels would below the relevant criterion of 2g/m²/month and indicate compliance with the criterion.

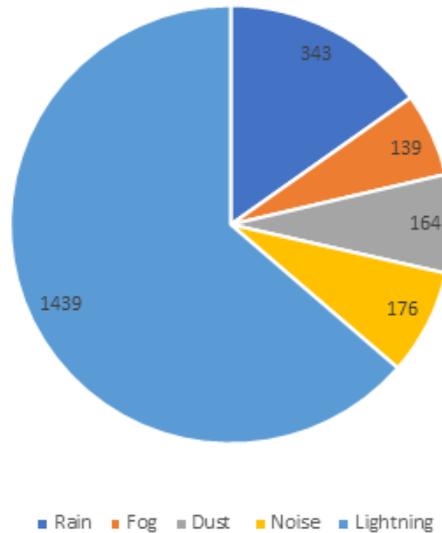
Figure 4 Breakdown of Lost Time Hours 2019 (Noise)

- There was a decrease of noise complaints in 2019. A total of 6 noise complaints were recorded in 2019, as opposed to 28 complaints in 2018.
- In 2019 there was approximately 176 hours lost time (i.e. lost time only captured for primary dig implements such as dozers, excavators and loaders) as a direct result of modifying the operations to remain compliant with relevant noise criteria (**Figure 4**).

Notes: The increase in lost hours due to lightning in 2019 is a result of implementation of a new Lightning TARP and the occurrence of more frequent electrical thunderstorms (mainly dry lightning) in 2019.

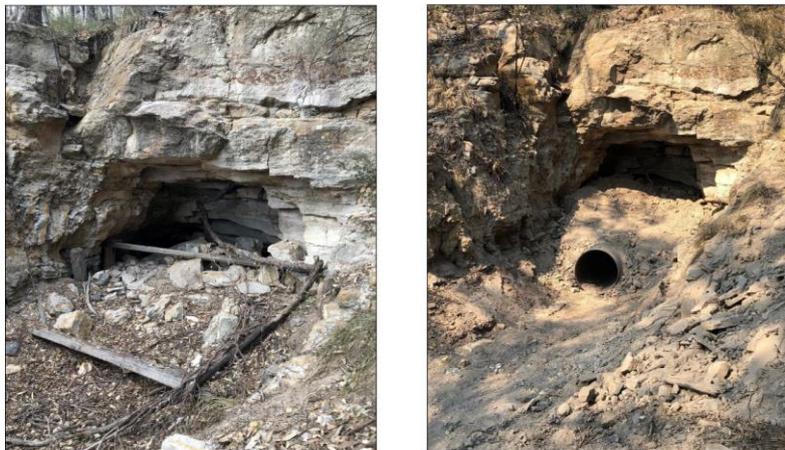
Plate 1 Culvert Support of the Oil Shale Adit 2019

In accordance with the Biodiversity Management Plan, Eastern-Bentwing Bat Management Strategies were undertaken in 2019. To mitigate the potential for future collapse of the Oil Shale Adit entrance, rock debris was removed with a section of 1000mm diameter steel pipe culvert inserted into the Adit to ensure access/egress for bats into the Adit. The area surrounding the pipe was then backfilled as to minimise the potential for rockfall to collapse the pipe (**Plate 1**). With these works completed in 2019, monitoring will continue throughout 2020 to evaluate bat activity and the effectiveness of the restructured Adit entrance.

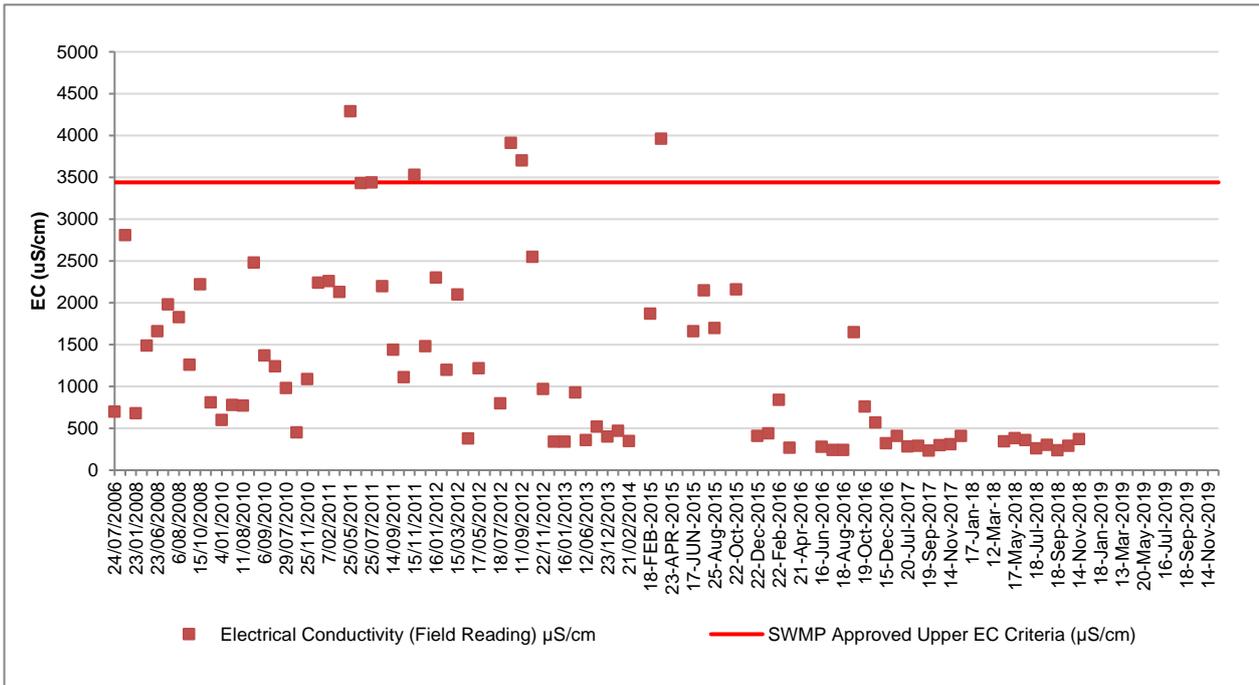
Graph 13 Long-term EC Water Quality Results at WIL_NC

Notes: No available water samples at WIL_NC during the 2019 reporting period where available for sampling due to the prolonged drought conditions, therefore no long-term EC trend analysis can be accurately displayed on graph. Overall trends for EC at WIL_NC since late 2016 have shown decreasing trends.

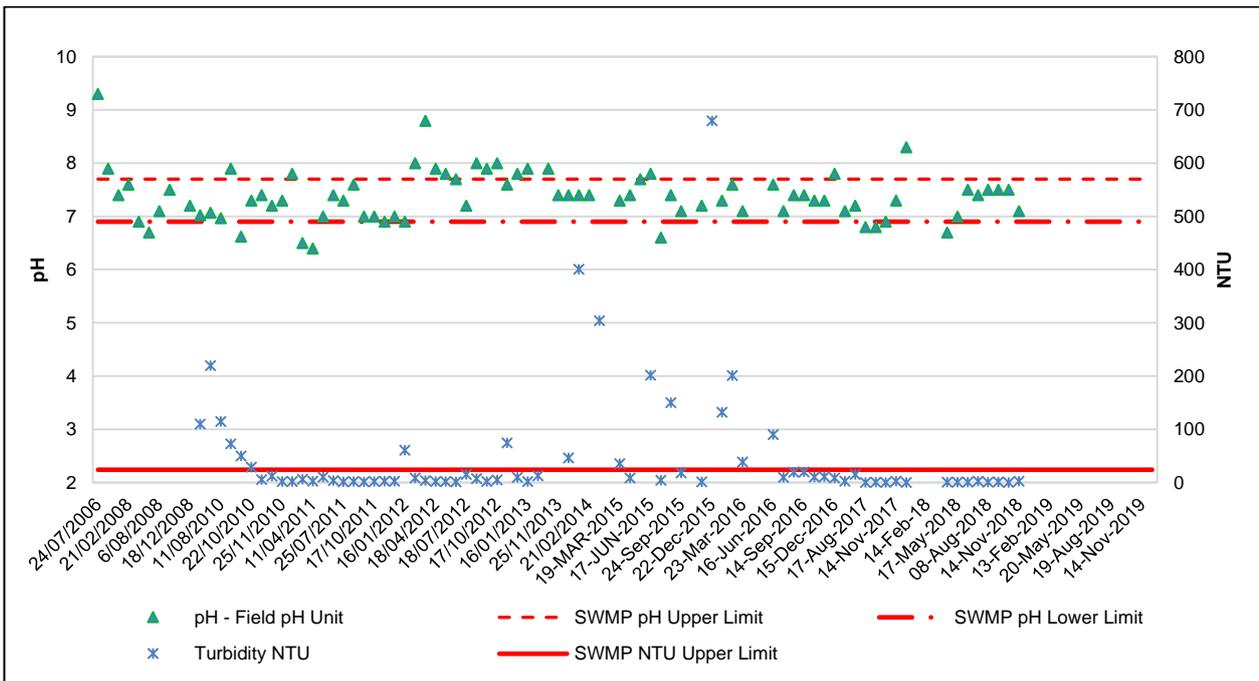
Graph 14 Long-term pH & NTU Water Quality Results at WIL_NC

Notes: No available water samples at WIL_NC during the 2019 reporting period where available for sampling due to the prolonged drought conditions, therefore no long-term pH and turbidity trend analysis can be accurately displayed on graph. Overall trends for turbidity at WIL_NC since 2016 have shown decreasing trends. Overall trends for pH at WIL_NC have generally been consistent since 2015 and mostly within criteria.

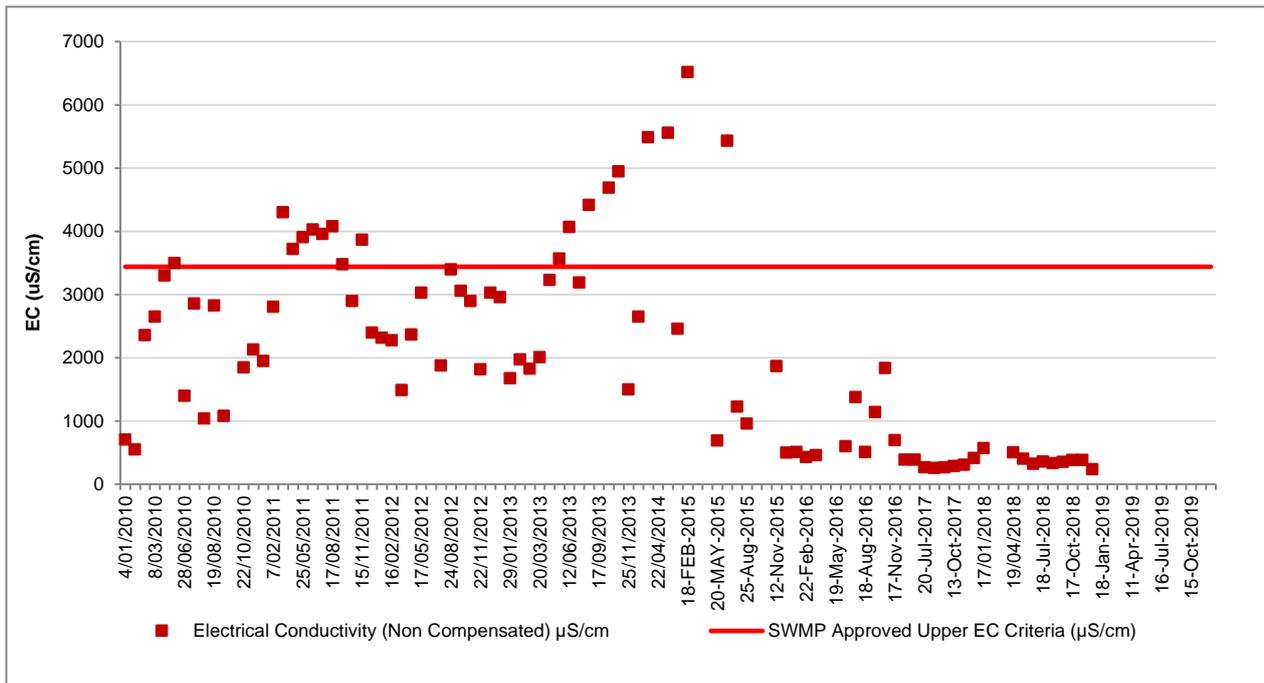
Graph 15 Long-term EC Water Quality Results at WIL_D2

Notes: No available water samples at WIL_D2 during the 2019 reporting period where available for sampling due to the prolonged drought conditions, therefore no long-term EC trend analysis can accurately be displayed on graph. Overall trends for EC at WIL_D2 since late 2016 have shown decreasing trends.

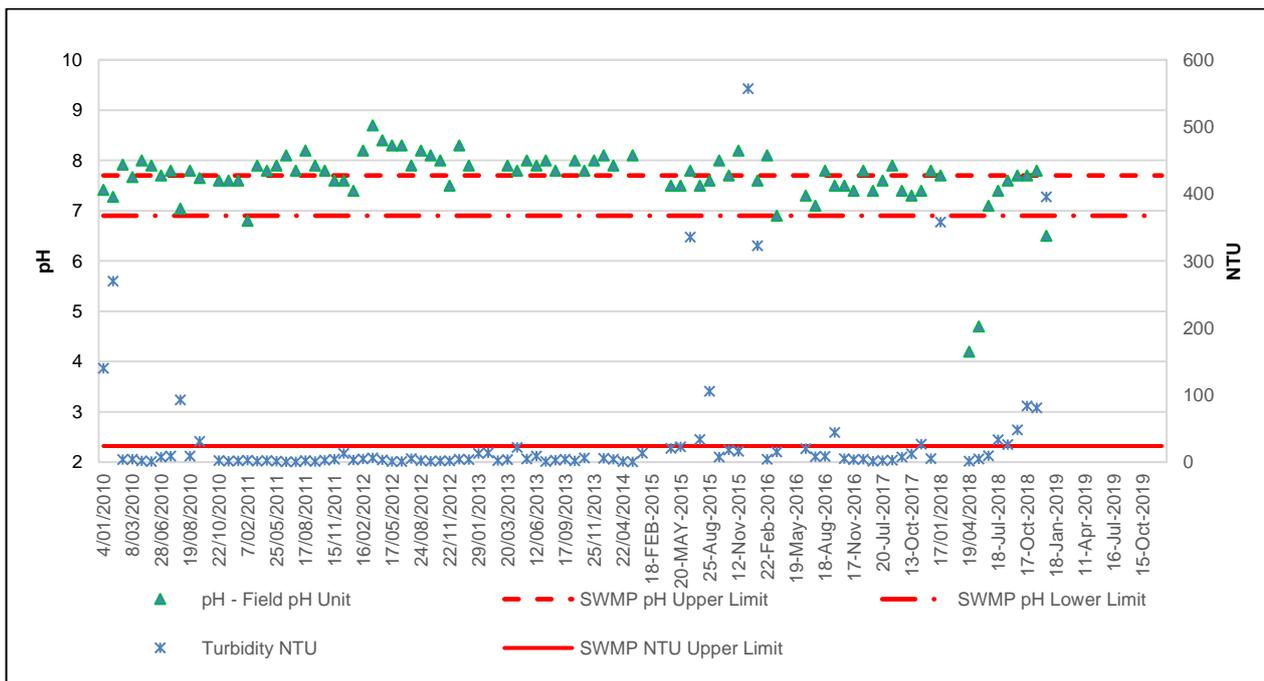
Graph 16 Long-term pH & NTU Water Quality Results at WIL_D2

Notes: No available water samples at WIL_D2 during the 2019 reporting period where available for sampling due to the prolonged drought conditions, therefore no long-term pH and turbidity trend analysis can be accurately displayed on graph. Overall trends for turbidity at WIL_D2 since 2016 have shown decreasing trends. Overall trends for pH at WIL_D2 have generally been consistent since 2016 and mostly within criteria.

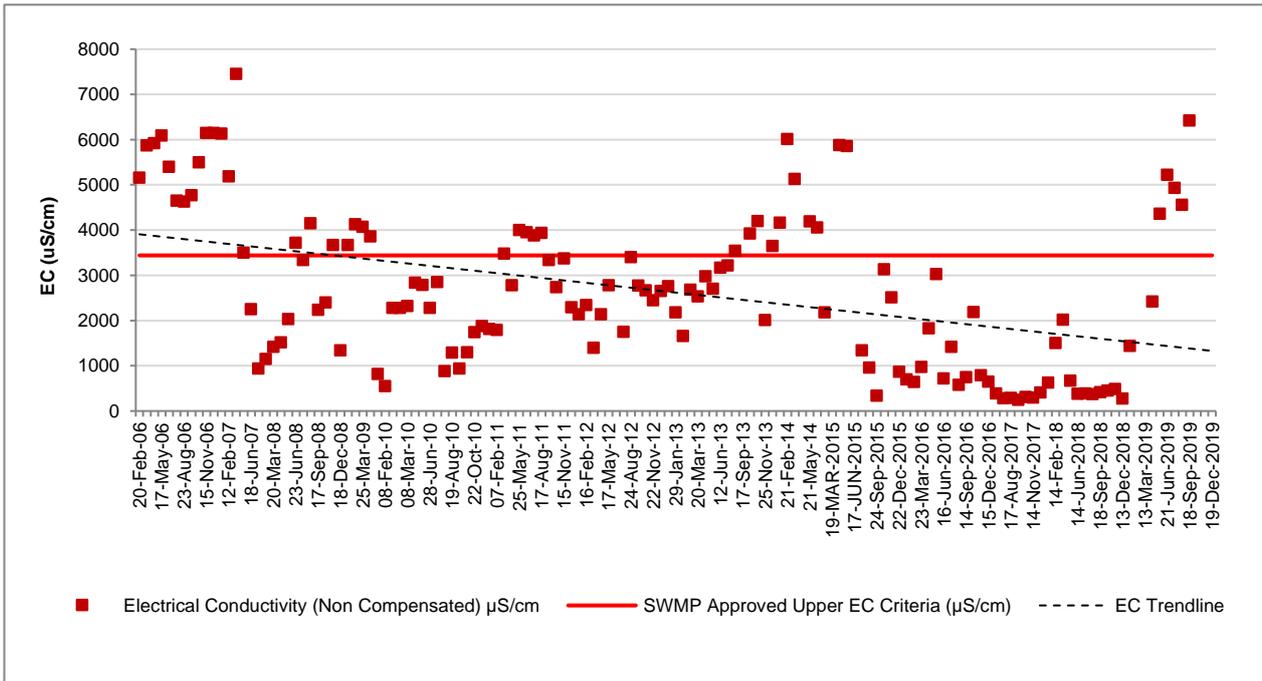
Graph 17 Long-term EC Water Quality Results at WIL_D

Notes: Overall trends for EC at WIL_D since late 2016 have shown decreasing trends. During 2019, EC observations at the upstream sites ranged from 3750-6000 µS/cm, reasonably consistent with observations at downstream sampling points, indicating the increase in EC is unlikely to be related to Wilpinjong mining activity.

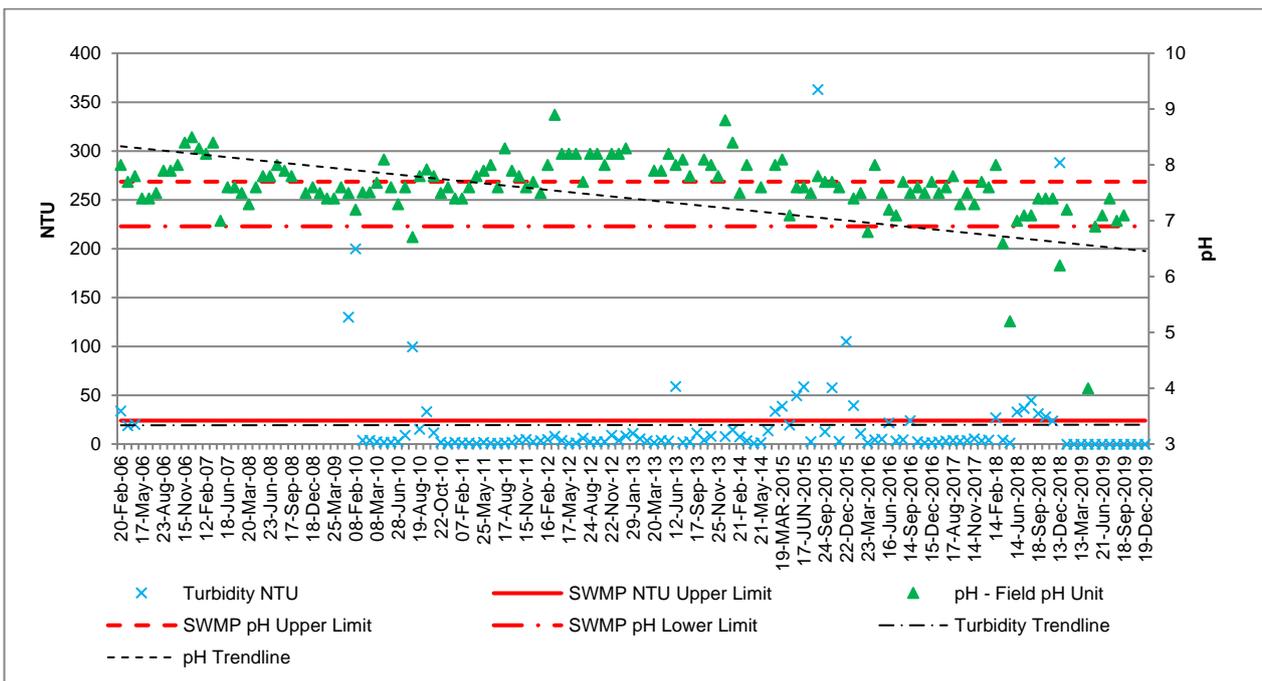
Graph 18 Long-term pH & NTU Water Quality Results at WIL_D

Notes: Overall trends for turbidity at WIL_D since 2016 have shown stable trends. Overall trends for pH at WIL_D have generally been decreasing and consistent since 2016, mostly within criteria.

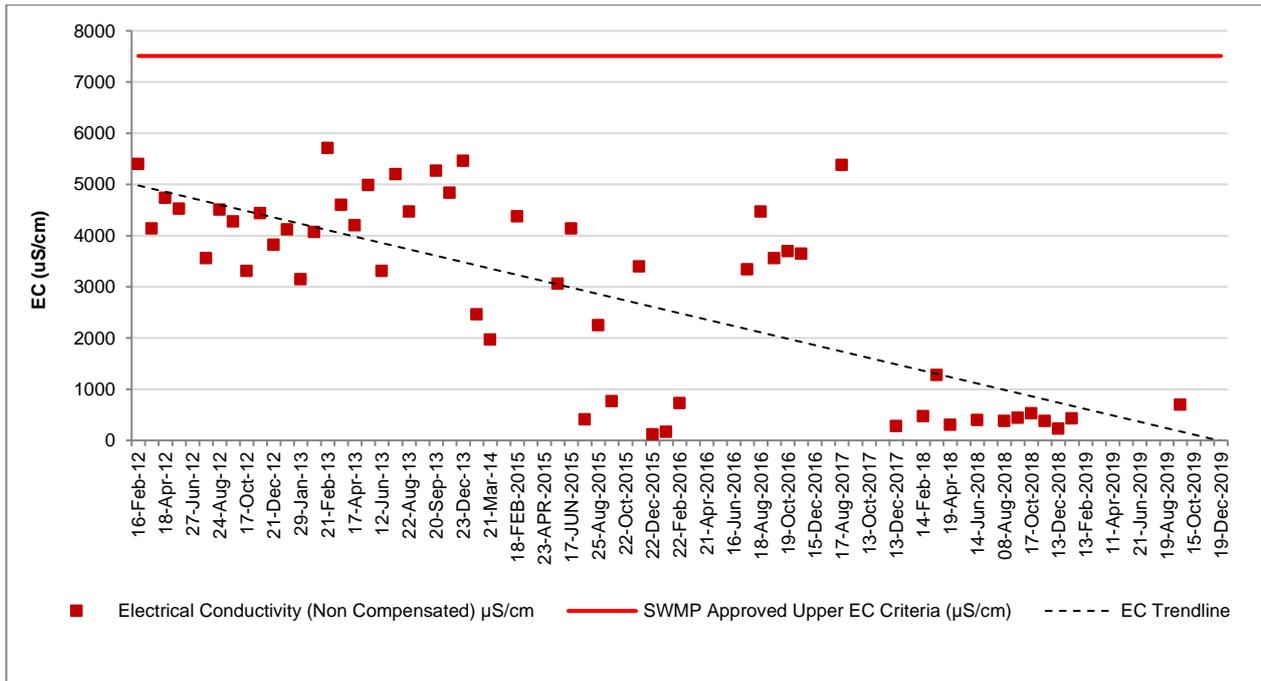
Graph 19 Long-term EC Water Quality Results at CC_1

Notes: Overall trends for EC at CC_1 since late 2017 have shown decreasing trends.

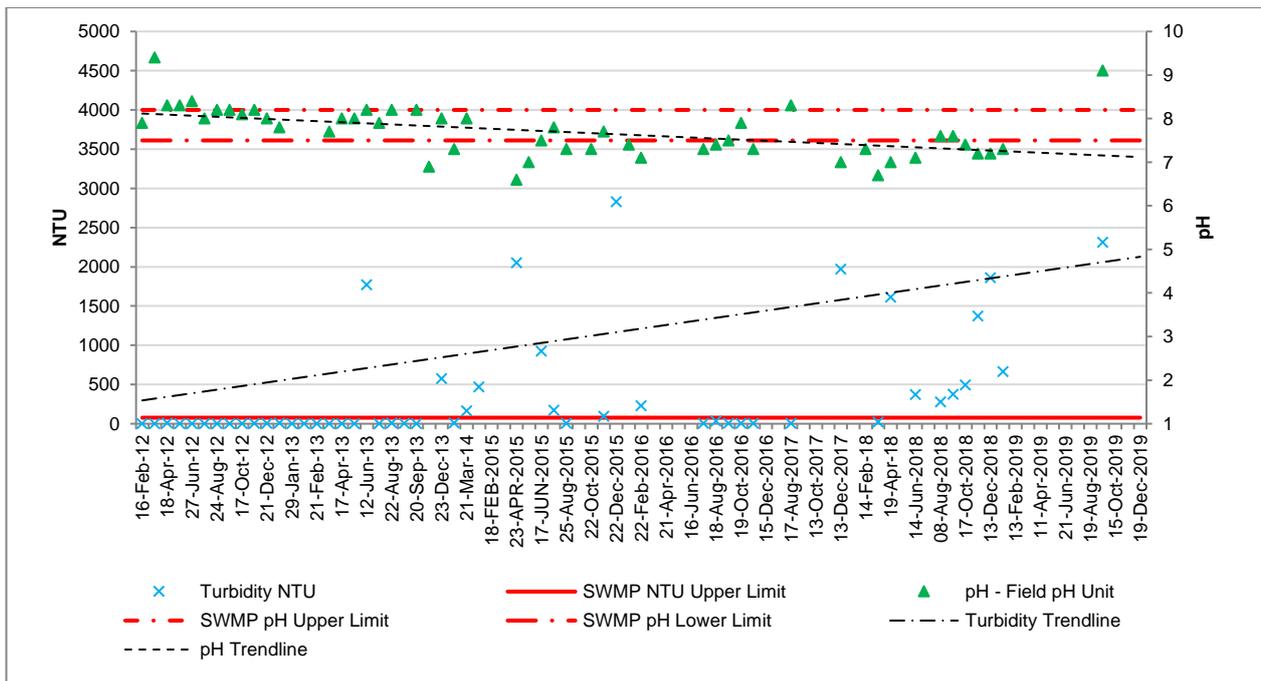
Graph 20 Long-term pH & NTU Water Quality Results at CC_1

Notes: Overall trends for turbidity at CC_1 have increased since 2016. The source of this increased turbidity at the Cumbo Creek Downstream area is likely to be a combination of low/no-flow conditions in Cumbo Creek, in conjunction with an increase of sediment to the creek, most likely from the nearby unsealed Ulan-Wollar Road. Overall trends for pH at CC_1 have generally been decreasing and consistent since 2016, mostly below criteria. While these observations constitute an exceedance of the pH trigger level, all observations are within the pH 6.5-8 range defined in the ANZECC (2000) guidelines for the protection of aquatic ecosystems and do not pose a threat to the health of the system.

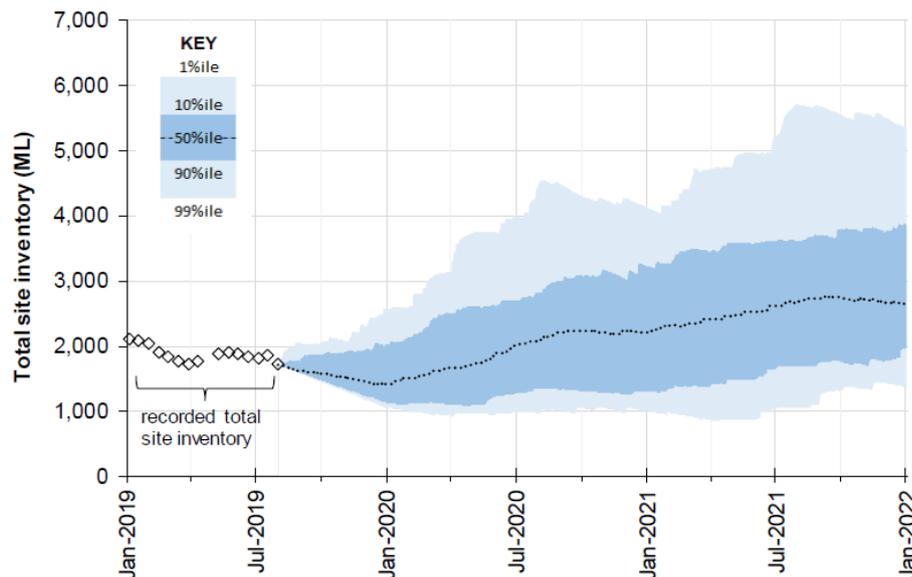
Figure 5 Forecasted total site water inventory (WTF Scenario 1)

- For the 1%ile results (very wet climatic conditions), the total site water inventory increases by 3,629 ML, to reach a volume of 5,353 ML by 31 December 2021.
- For the 50%ile results (median climatic conditions), the total site water inventory increases by 932 ML, to reach a volume of 2,657 ML by 31 December 2021.
- For the 99%ile results (very dry climatic conditions), the total site water inventory decreases by 347 ML, to reach a volume of 1,377 ML by 31 December 2021.

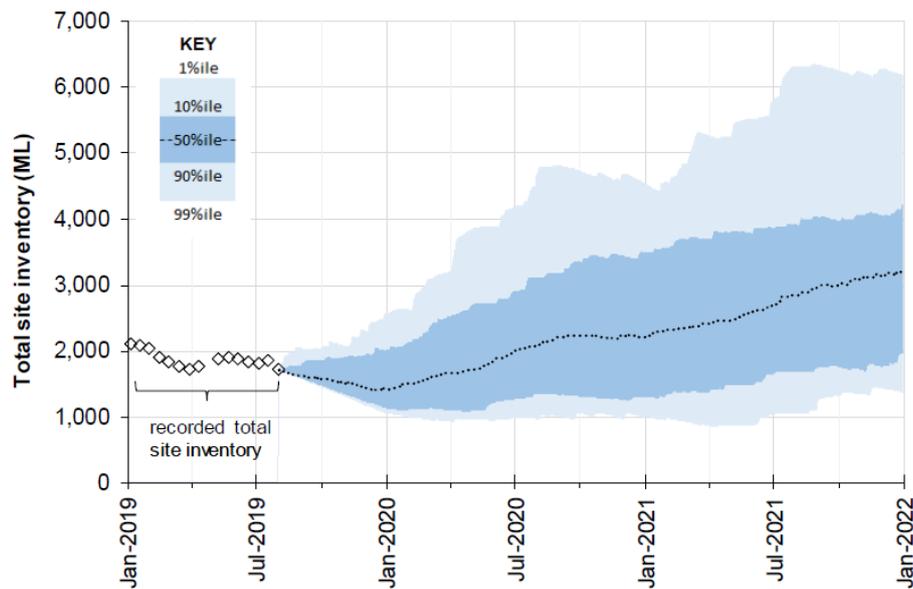
Figure 6 Forecasted total site water inventory (WTF Scenario 2)

Figure 6 shows the forecasted total site water inventory for the period between 1 August 2019 and 31 December 2021 for WTF Scenario 2. The following is of note:

- For the 1%ile results (very wet climatic conditions), the total site water inventory increases by 4,450 ML, to reach a volume of 6,175 ML by 31 December 2021.
- For the 50%ile results (median climatic conditions), the total site water inventory increases by 1,472 ML, to reach a volume of 3,197 ML by 31 December 2021.
- For the 99%ile results (very dry climatic conditions), the total site water inventory decreases by 347 ML, to reach a volume of 1,377 ML by 31 December 2021.

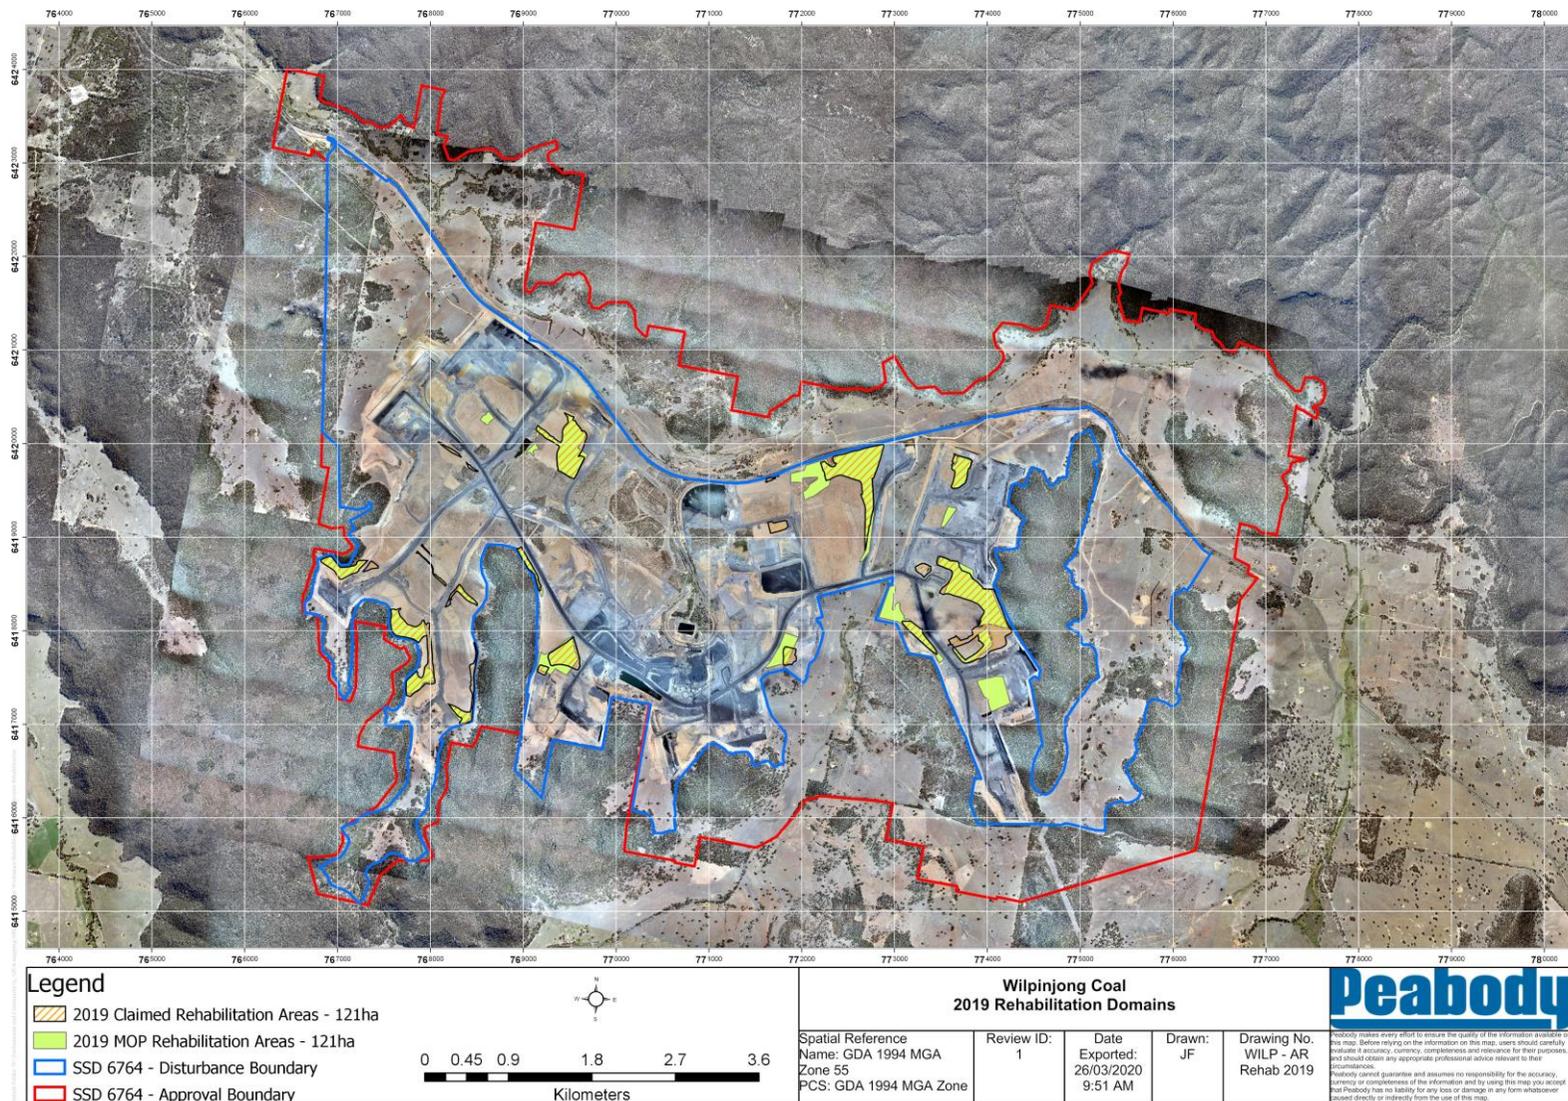
Figure 8 Rehabilitation Proposed and Completed in the MOP Term Year 1

There were only minor changes to rehabilitation areas completed in 2019, as proposed in Year 1 of the MOP. These changes relate to variances in the completed rehabilitated surface areas at several rehabilitation locations, which did not affect the total hectares completed against the hectares proposed in the MOP (**Figure 6**) and considered generally consistent with the rehabilitation scheduled and targets proposed in the MOP for Year 1. WCPL consider the approved rehabilitation program proposed in the current approved MOP has been achieved for Year 1 and rehabilitation targets will be achieved for Year 2 of the MOP in 2020 (**Table 30** and **Table 31**).

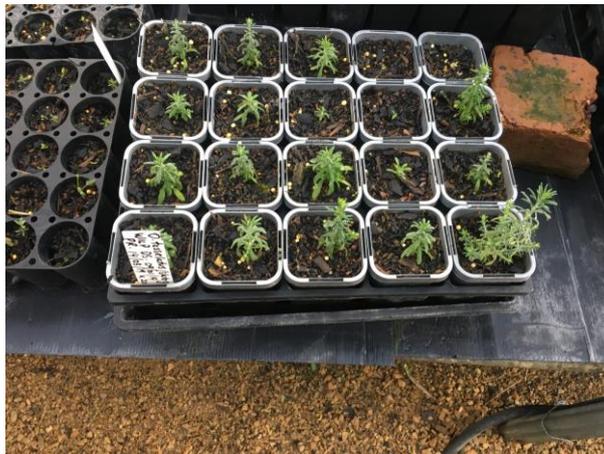
Plate 2 *Ozothamnus tessellatus* propagated seedlings 2019

- 3 grams of *Ozothamnus tessellatus* seeds were harvested in 2019;
- 1 gram of *Ozothamnus tessellatus* seeds were sown to grow seedlings in 2019 (**Plate2**);
- On 26 September 2019, 30 *Ozothamnus tessellatus* seedlings were planted in ECA_C;
- Grazing pressure from native/feral animals and the ongoing drought resulted in 100% mortality; and
- The *Ozothamnus tessellatus* propagation and planting trial will continue in 2020.

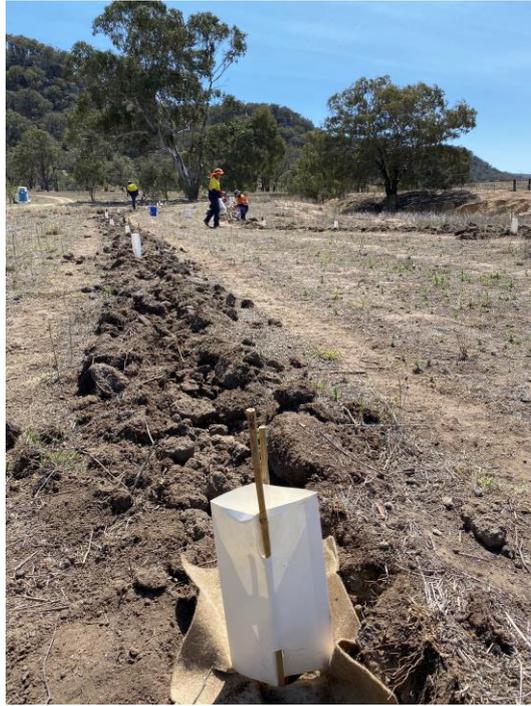
Plate 3 Wilpinjong Creek Management Strategy (Year 1)

In addition to planting 1400 trees within the *Wilpinjong Creek Management Strategy (Year 1)* area being a mix of Yellow Box, Blakey's and Rough Barked Apple communities, 65 Rough Barked Apple eucalypts were planted in ECA_C.

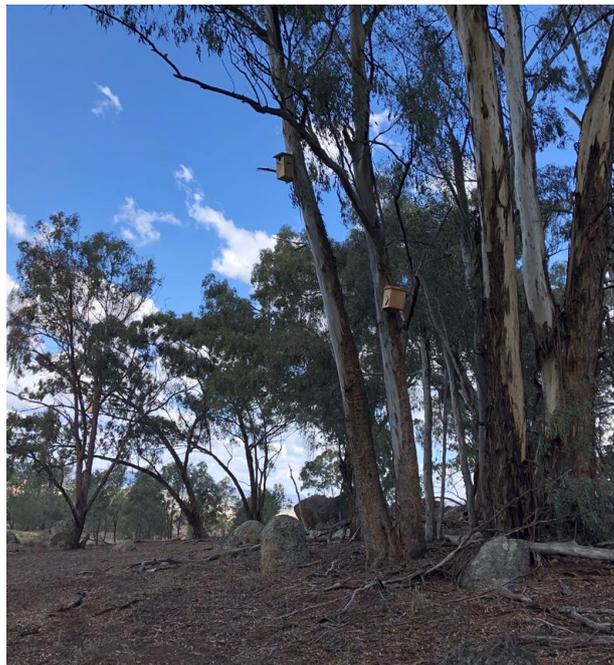
Plate 4 Nest Box Installations in 2019

To meet the requirements of the BMP, WCPL continued with the relocation of surplus trees removed from the mining footprint for mine site rehabilitation and re-establishment as log habitat and the establishment of nest boxes. During 2019 approximately 100 nest boxes were installed (**Plate 4**) (refer to figure in **Appendix 7**) in Regen Areas 5 and 9 and ECA_B.

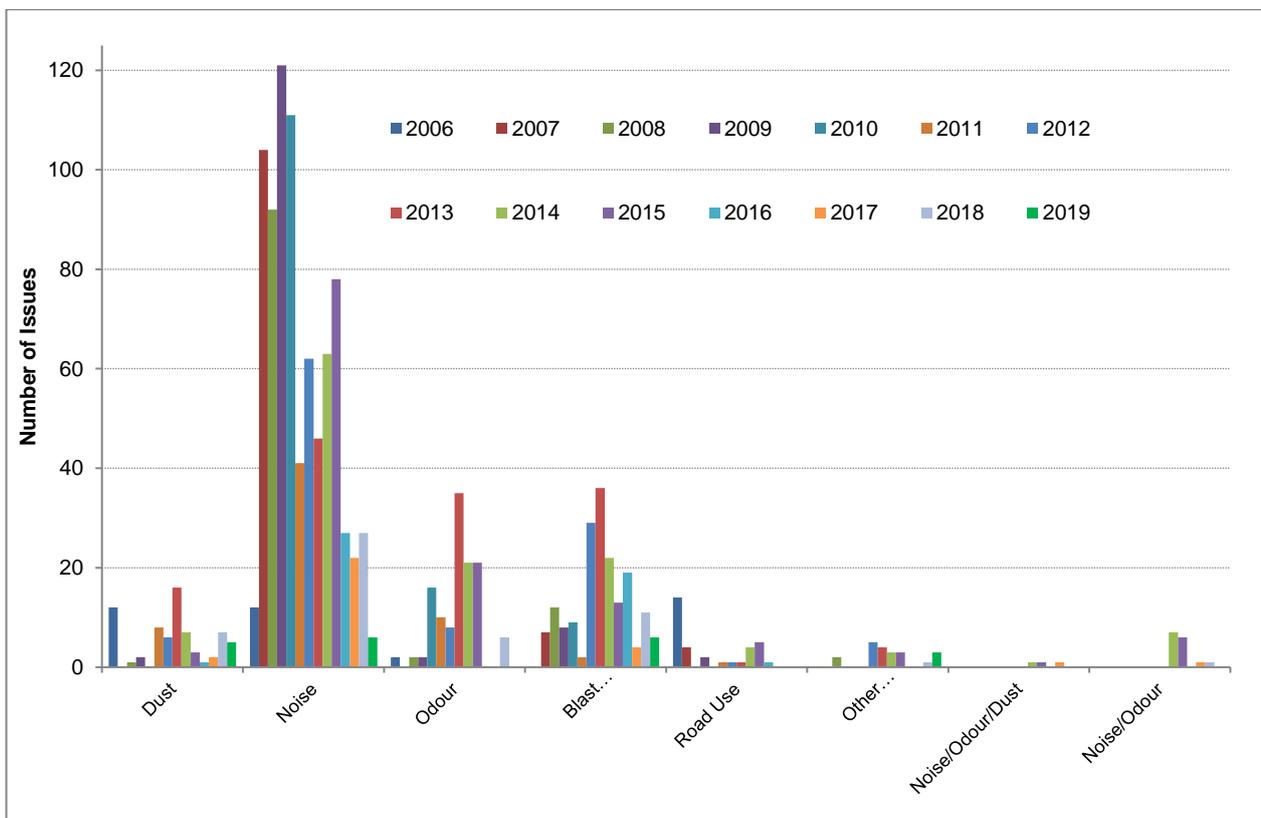
Graph 21 Summary of Community Complaints and Issues Raised by Complainants 2006 – 2019

During the 2019 review period, 20 community complaints were received by WCPL (**Appendix 6**) as opposed to 53 community complaints in 2018. **Graph 21** presents a comparison of the environmental complaints received by WCPL over the period 2006 to 2019. **Graph 22** indicates an overall declining trend in community complaints from 2006 to 2019.
