# 15 INDIGENOUS HERITAGE

# 16 NON- INDIGENOUS HERITAGE

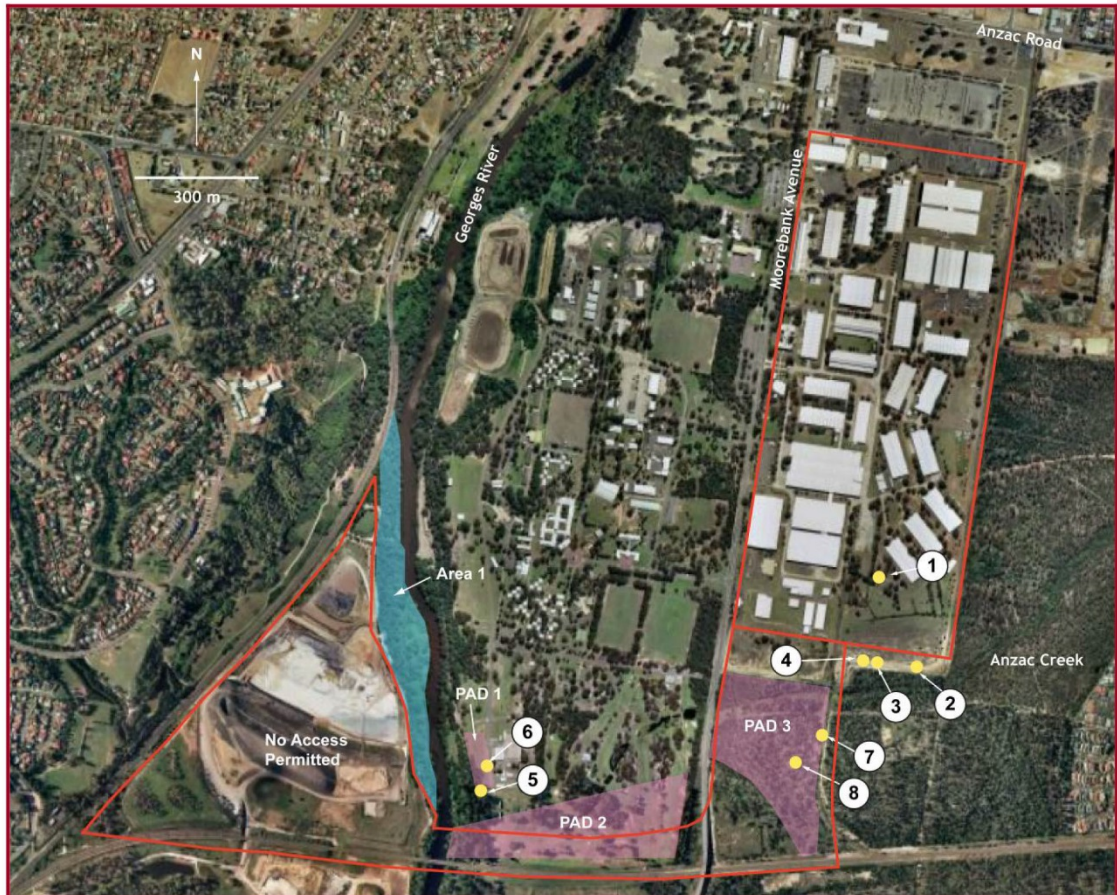
**Figure 15-1 Results of Aboriginal heritage field surveys (identified archaeological findings) (AHMS, 2012a)**

- The areas where artefacts were identified include: a river terrace on the east side of the Georges River (PAD 1), the southern-most part of the Project site (Artefact 1), between Moorebank Ave and the disused existing rail spur directly south of, and adjacent to the SIMTA Site (PAD 3) (refer to Figure 15-1). In addition to this, part of the RAE Golf Course south of Anzac Creek (within the MIC site) has been designated PAD 2.

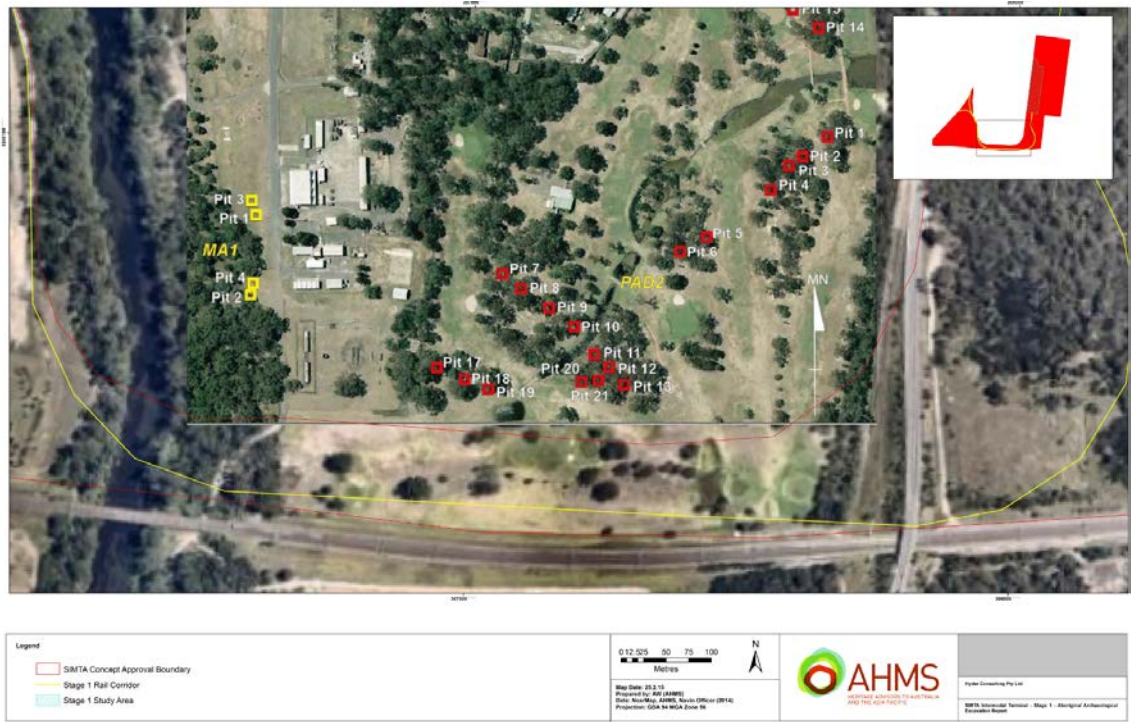
Figure 15-3 Location of subsurface investigations undertaken by Navin Officer (2014) for the MIC Proposal

A key part of the 2014 study involved undertaking subsurface investigations in parts of PAD 2, which was identified by AHMS (2012a). Figure 15-3 shows the location of these subsurface investigations. These investigations failed to recover any Aboriginal objects in the identified areas, that is, along Anzac Creek to the north of the Rail Corridor (identified in the Concept Plan Approval).

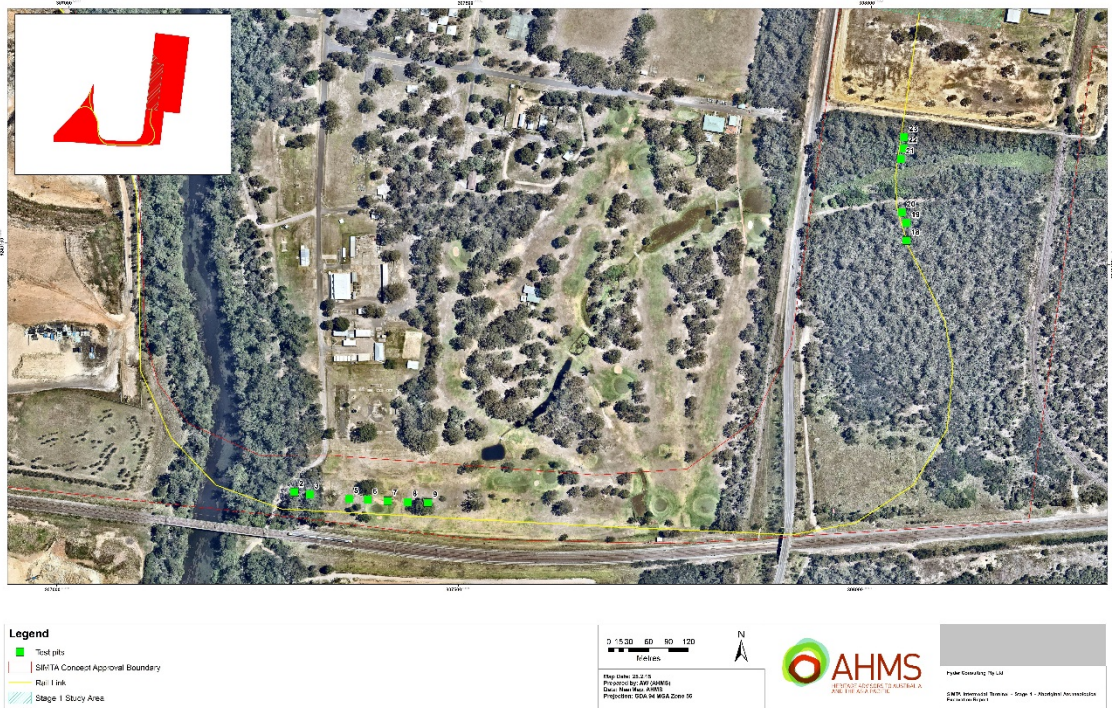
Figure 15-4 Location of subsurface investigations undertaken by AHMS (2015) for the Proposal

A total of 13 test pits (1 m<sup>2</sup>) at 20 m spacing were excavated along the Rail Corridor, focussing on the banks of the Georges River and either side of Anzac Creek (PADs 2 and 3). Seven test pits were undertaken within the RAE Golf Course (MIC site) (encompassing 250 m of the terrace overlooking the Georges River and within the curtilage of PAD 2); and six test pits (three on each side) of Anzac Creek, (within the curtilage of PAD 3). The location of these is shown in Figure 15-4.
