# SIMTA Intermodal Terminal Facility - Stage 1

## Remediation Action Plan

Remedial Action Plan  
SIMTA Intermodal Terminal Facility - Stage 1

26 May 2015  
50342-61155 (Rev 1)  
JBS&G

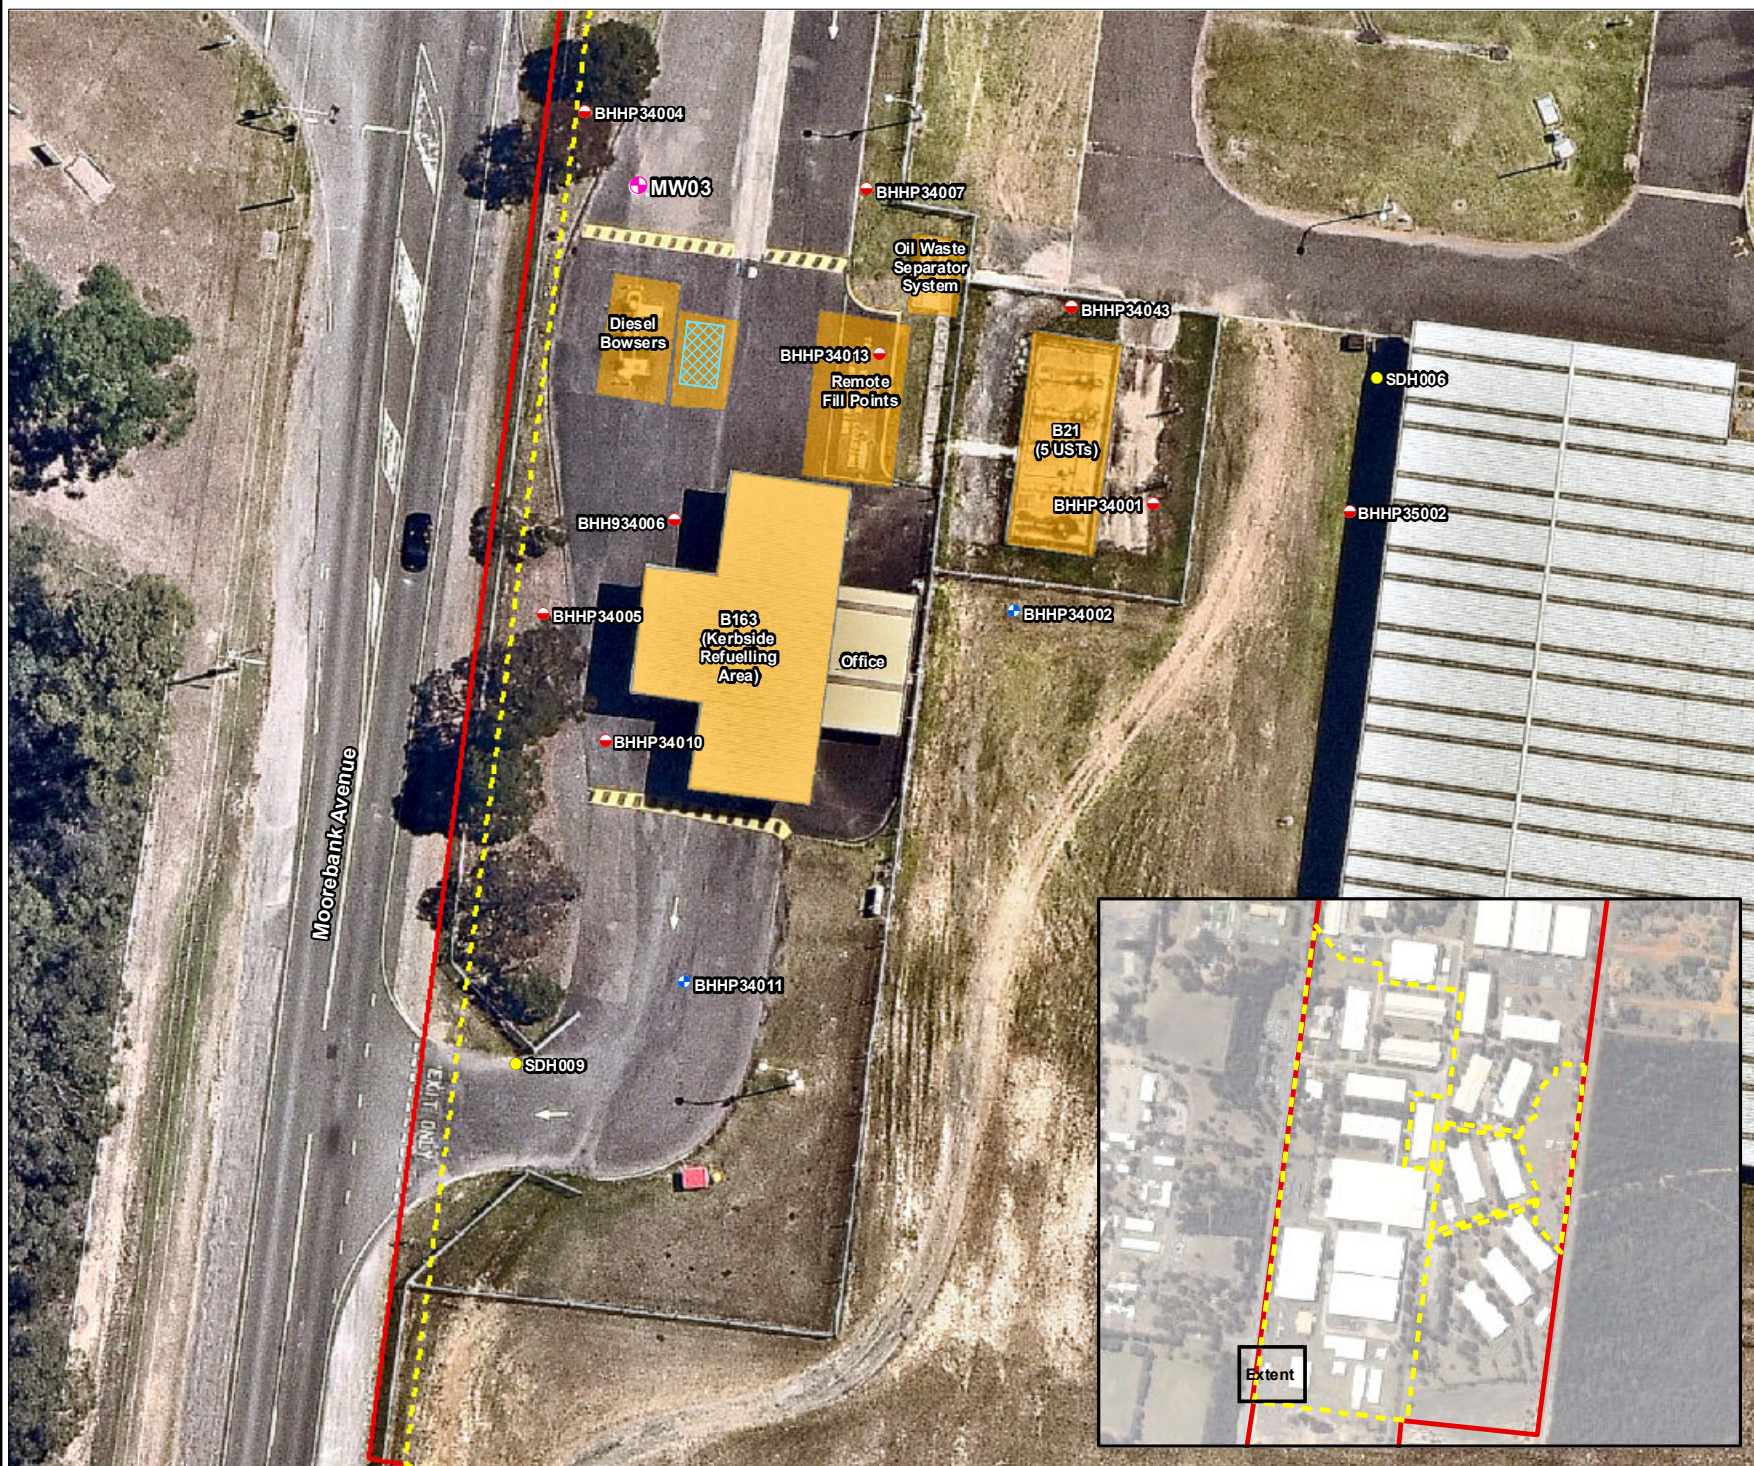
**FIGURE 15**

**REFUELLING AREA AND  
UNDERGROUND STORAGE  
TANK FARM AND APPROXIMATE  
REMEDIAL AREAS**

Historical leaks from the underground storage tanks may have resulted in the noted contamination in the form of light non-aqueous phase liquid (LNAPL) at the refuelling area within the Stage 1 site. Impacts in this area of the site may pose a potential risk to future workers at the site. It is proposed that this area be remediated to the extent practicable
