# **Ecological Assessment**

# **Ecological Assessment for the Northern Channel adjacent to Rayben and Owen Streets, Glendenning**

**April 2015**

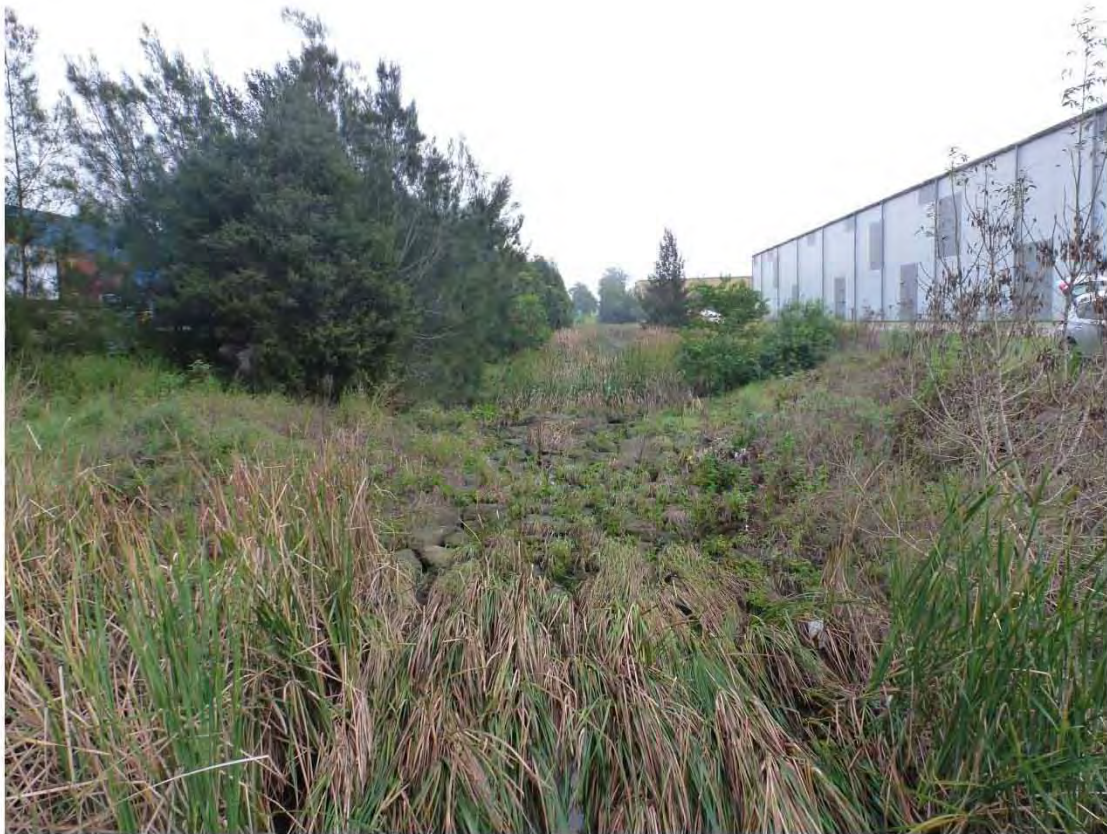
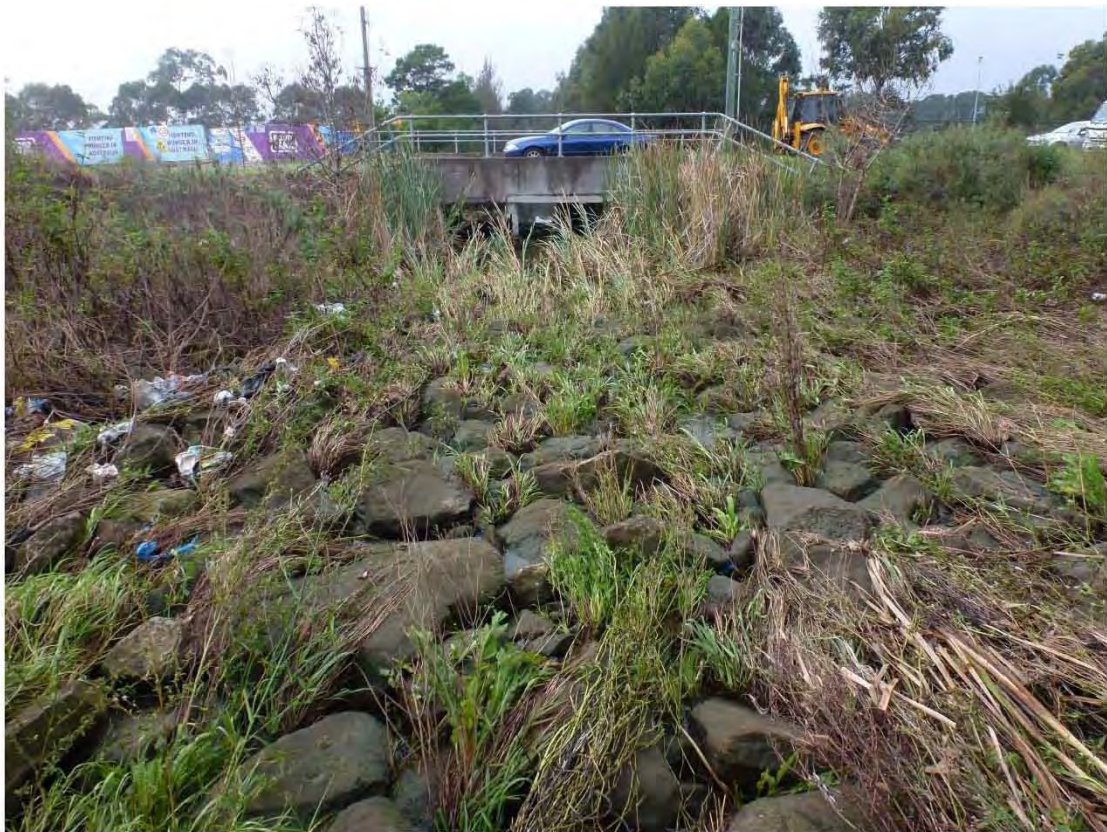
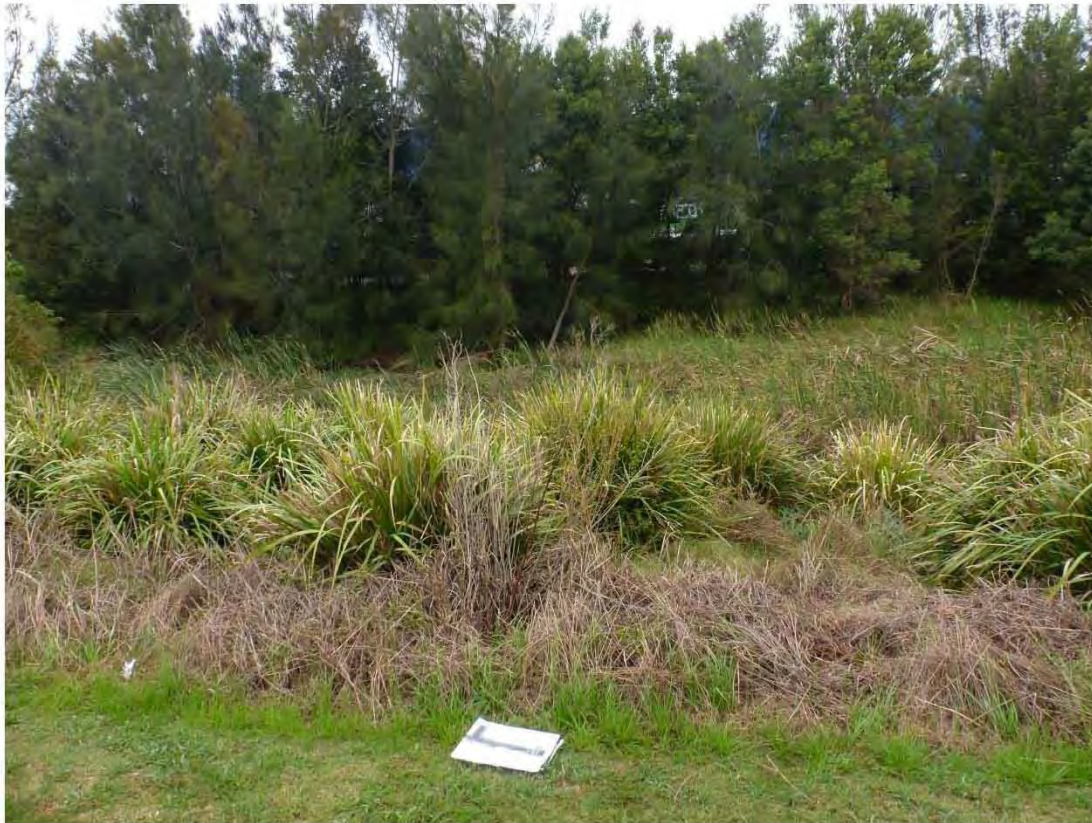
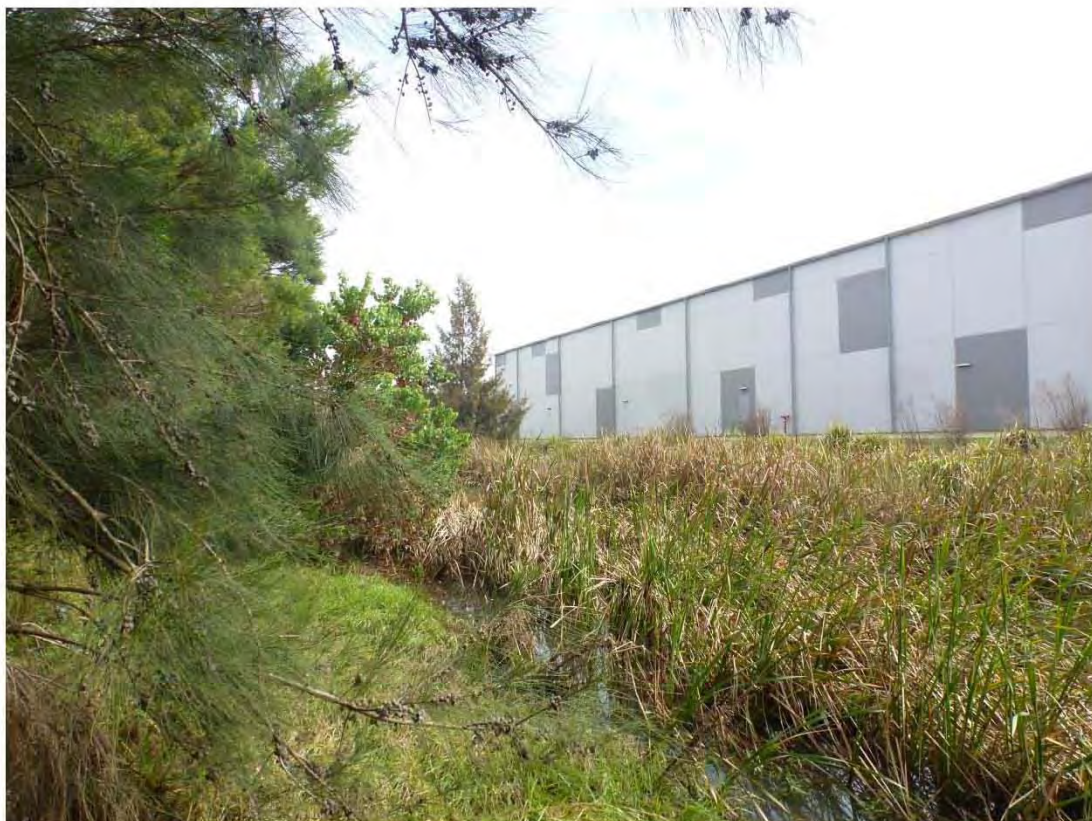
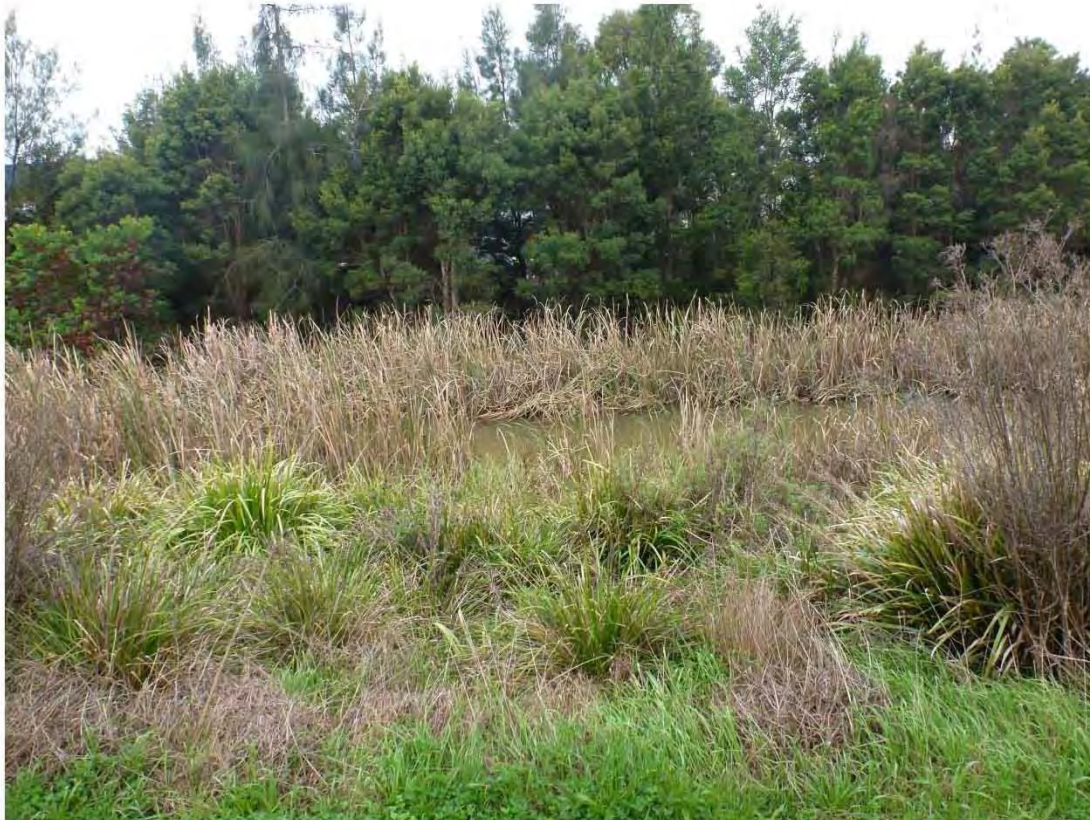
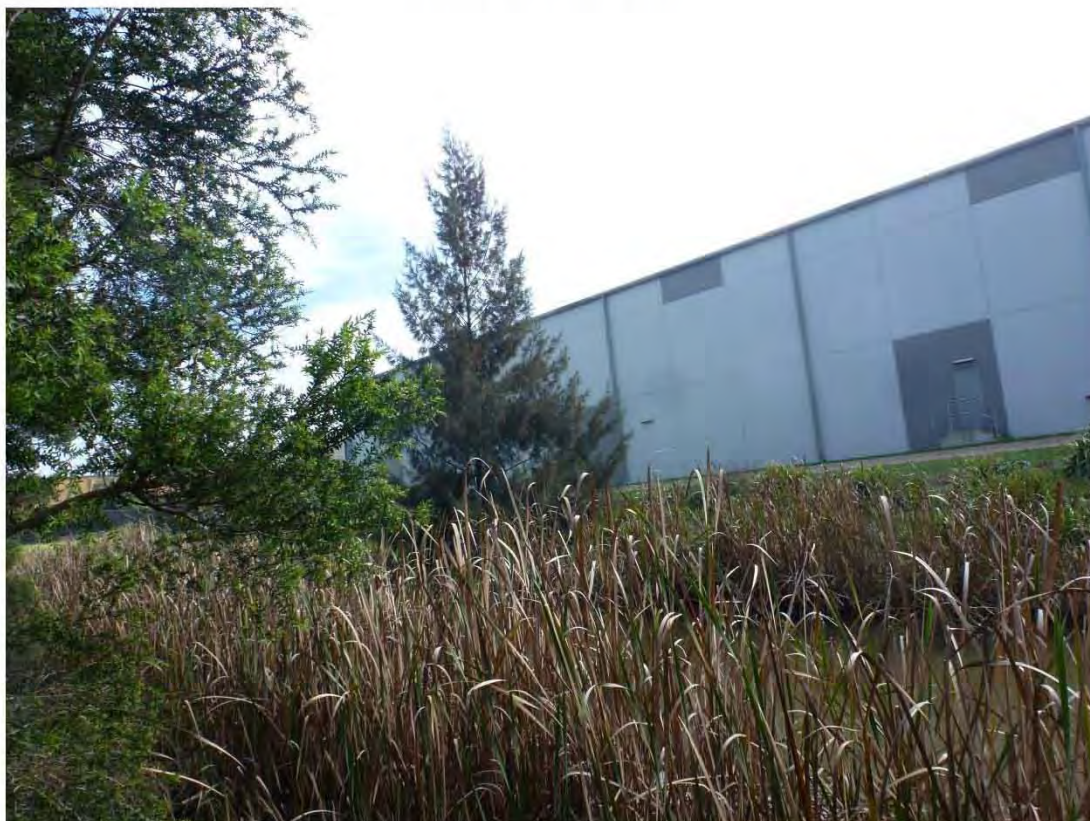
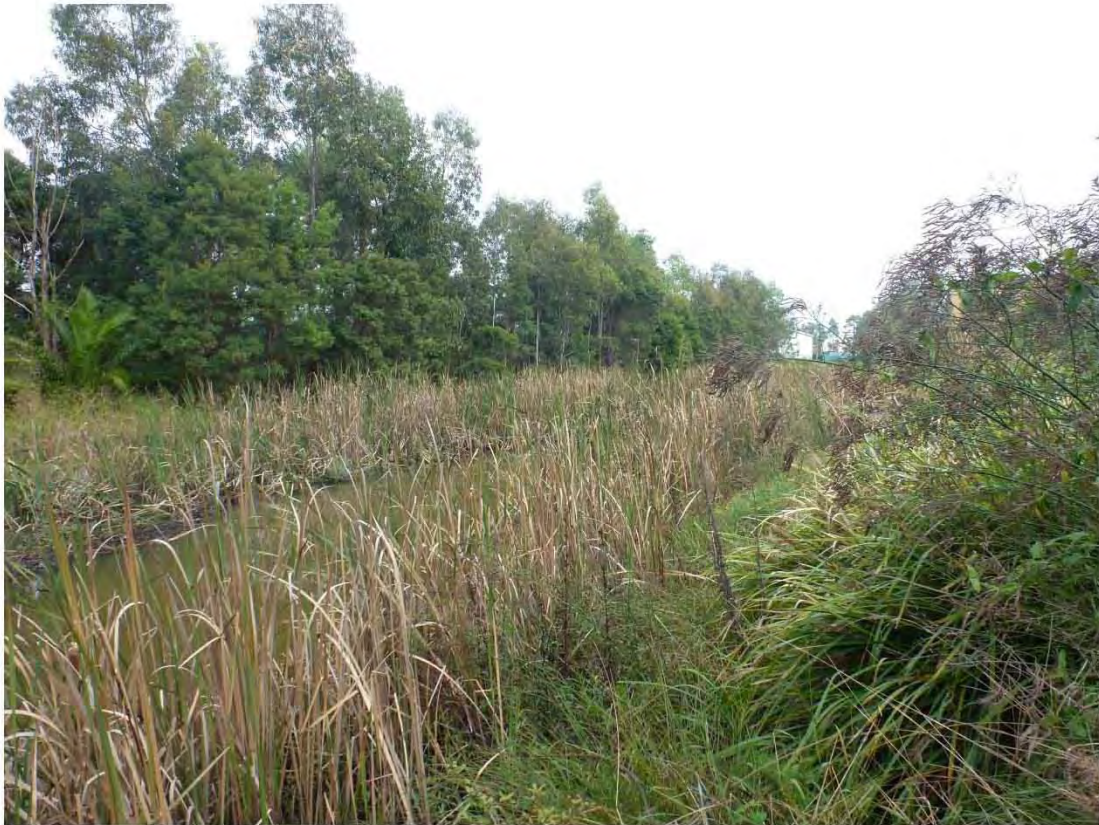
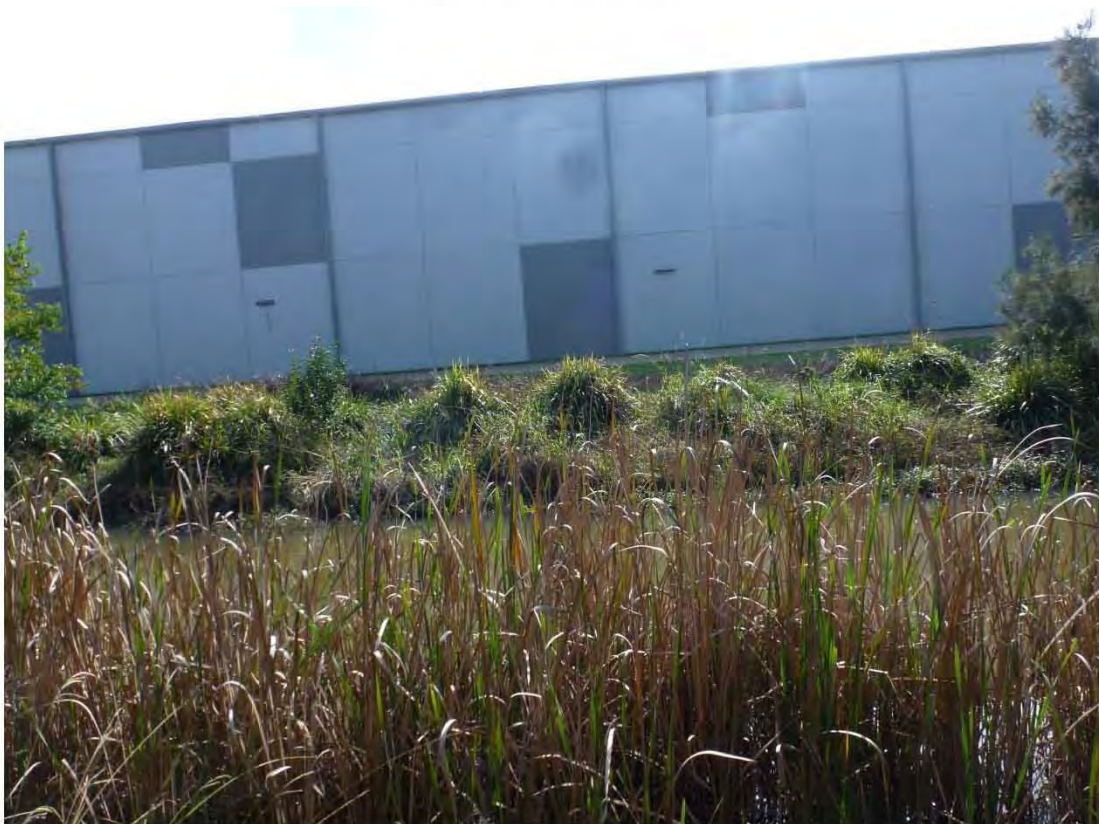
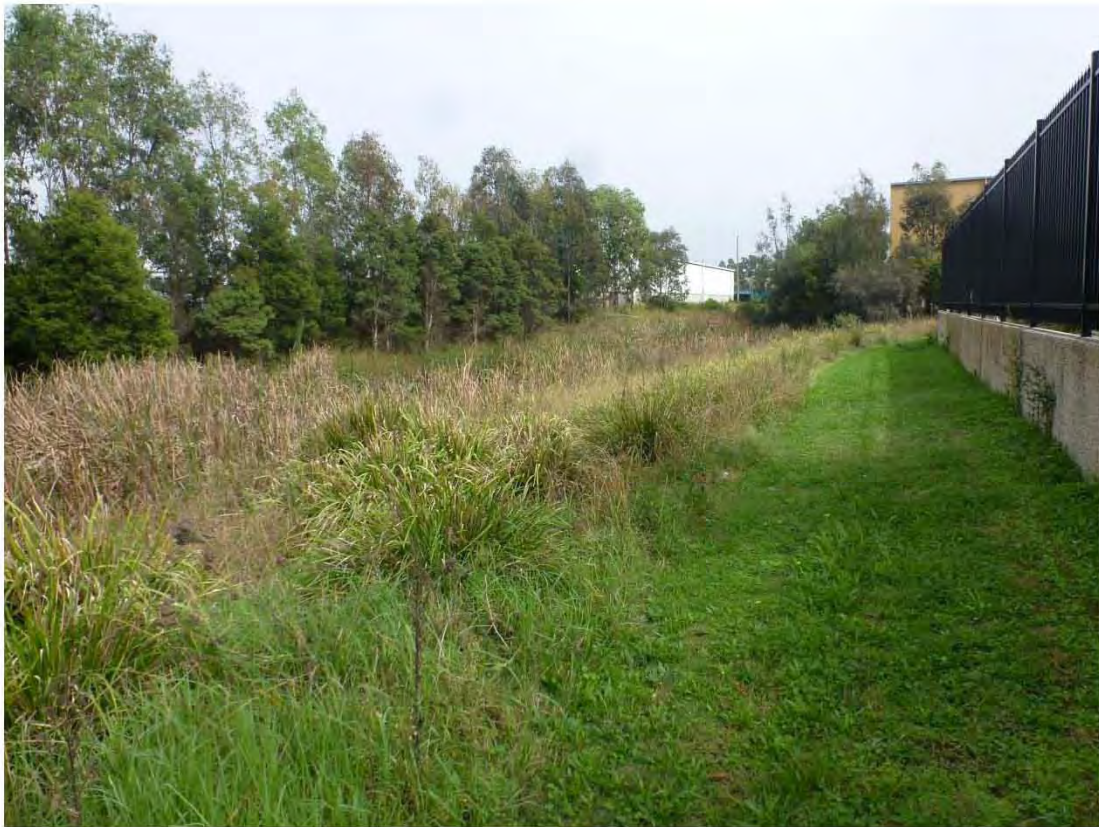
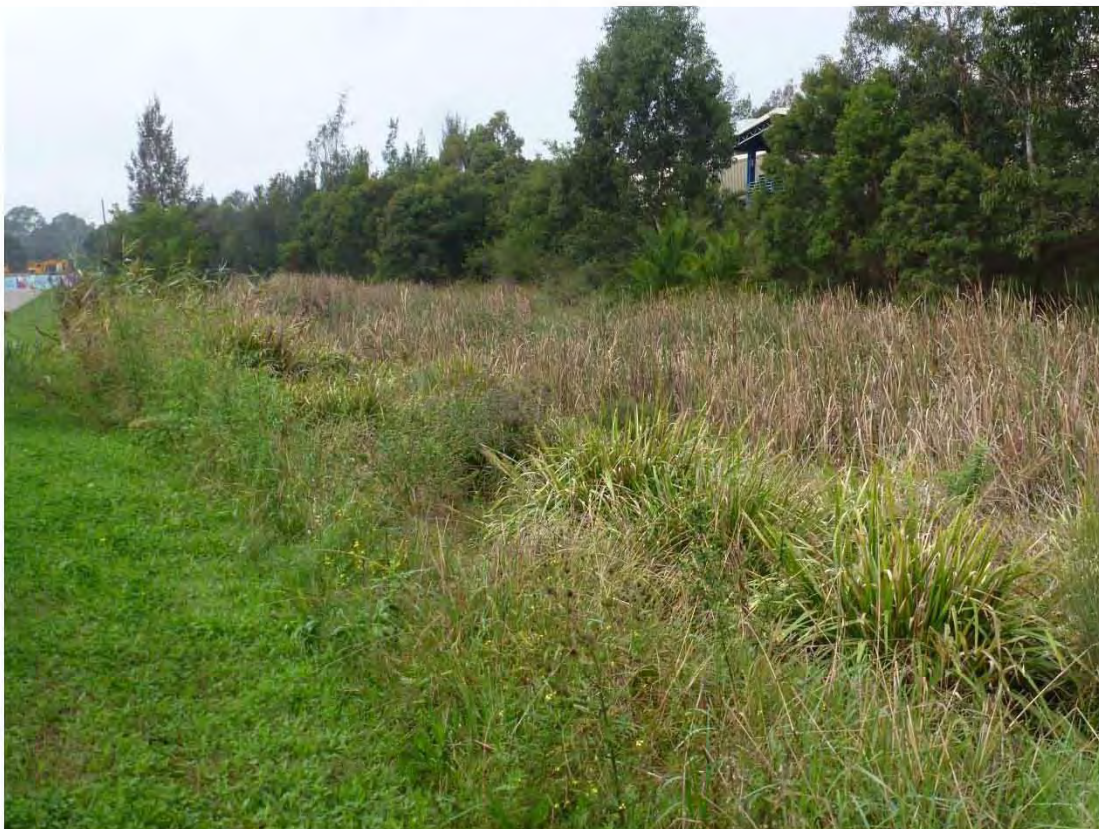
FIGURE 2.2

From east

From west

From northern riparian

From southern riparian

From northern riparian zone

From northern zone

The study site is a subsection of the NDC centred around the JJ Richards site and is shown in Figure 2.1. Figure 2.2 shows a cross section representation of the NDC at the study site.

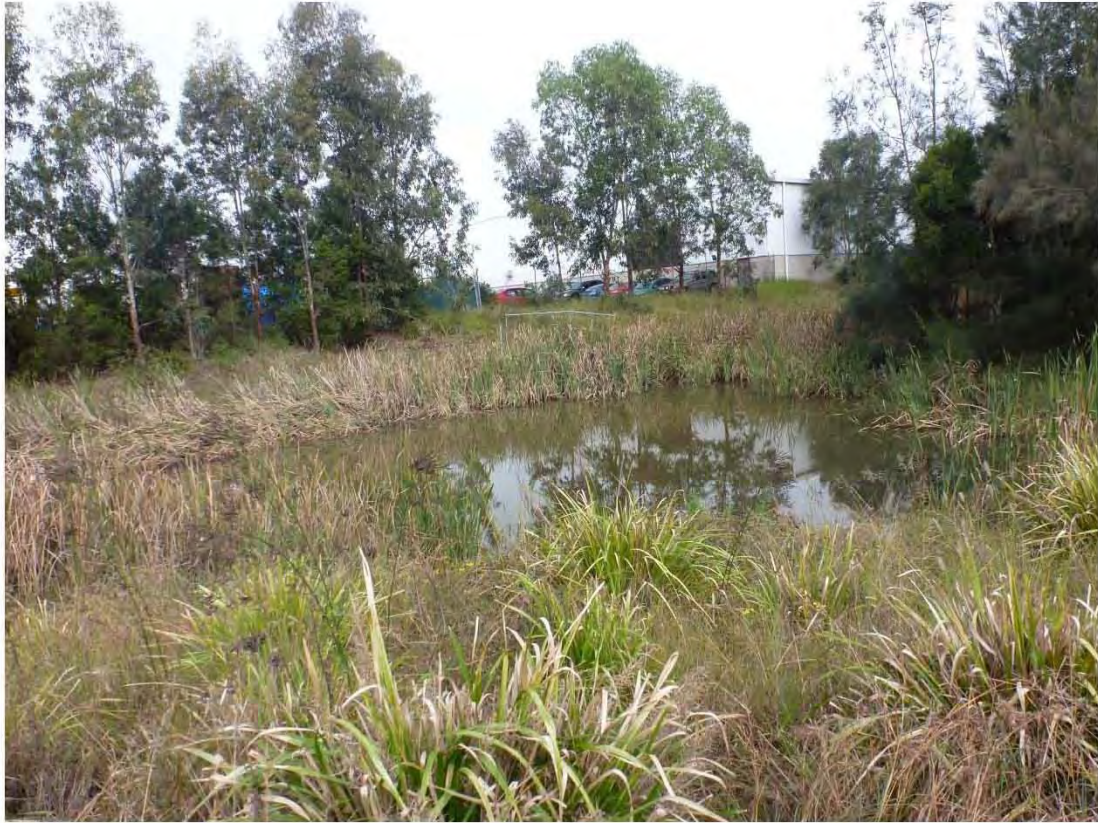
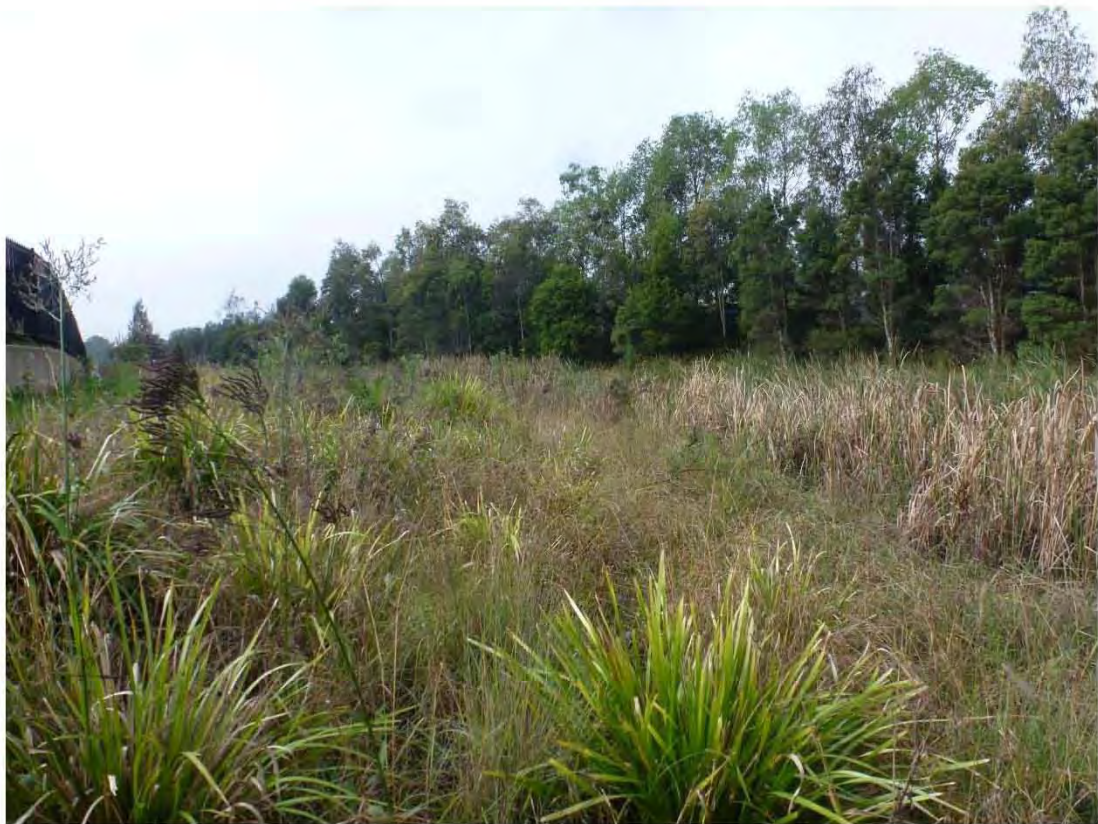
FIGURE 2.9

Figures 2.4-2.8 show photos of the Northern and Eastern riparian zones and stream channel at equal intervals along the NDC starting at Owen Street. A total of 34 flora species were identified along the entire NDC survey site and of these 15 were introduced species (refer to Table 1). **No TSCA or ROTAP species were identified.**

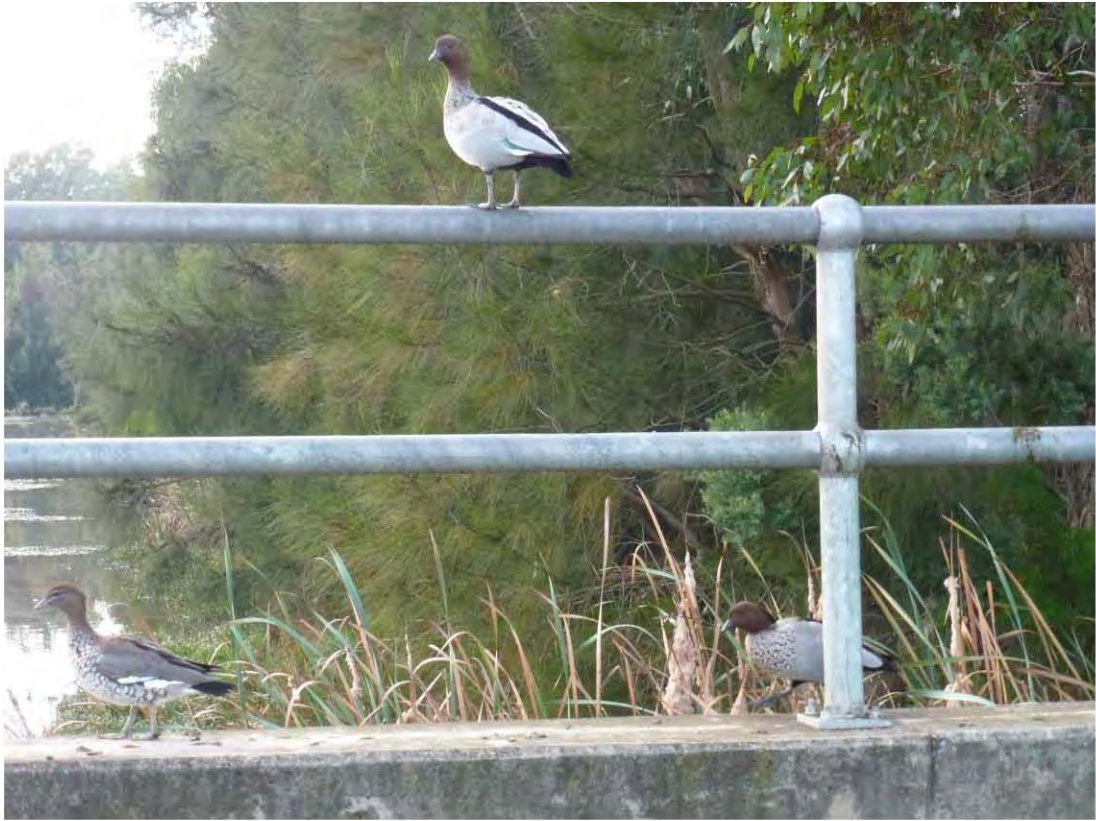
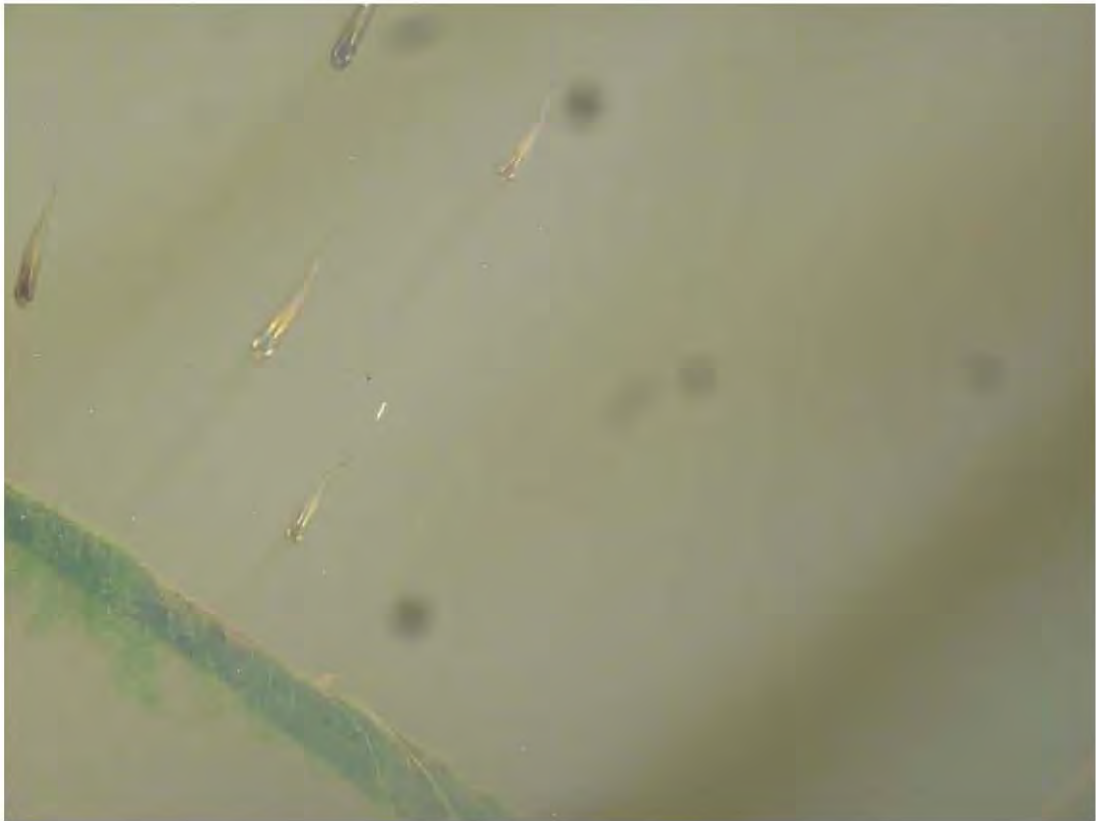
FIGURE 3.1

Only exotic *Gambusia* fish were collected and observed in the survey (refer to Figure 3.1 ii)). **No significant fish or their habitats listed under the Fisheries Management Act 1994 were found to occur in the NDC.**

No small mammals or any scats or marking were physically observed in the NDC. The Southern riparian zone was found to contain a small amount suitable tree hollows fallen logs and other critical small mammal and reptile habitat.

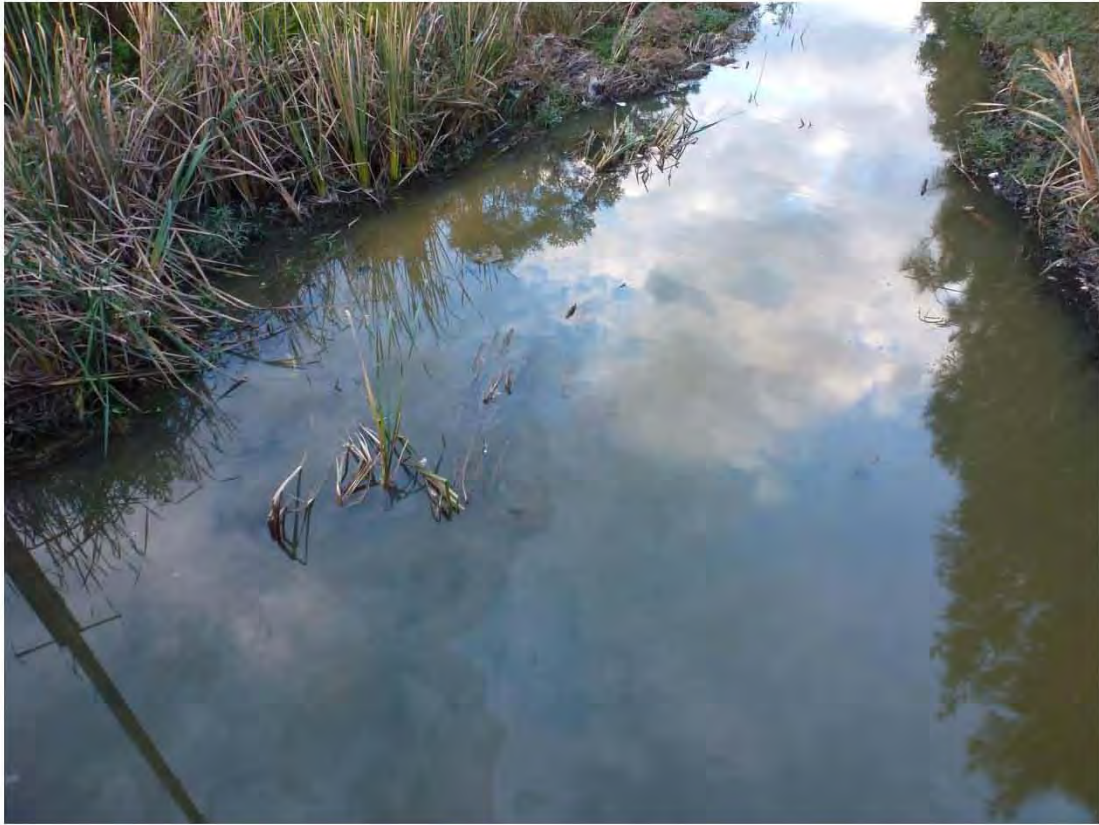
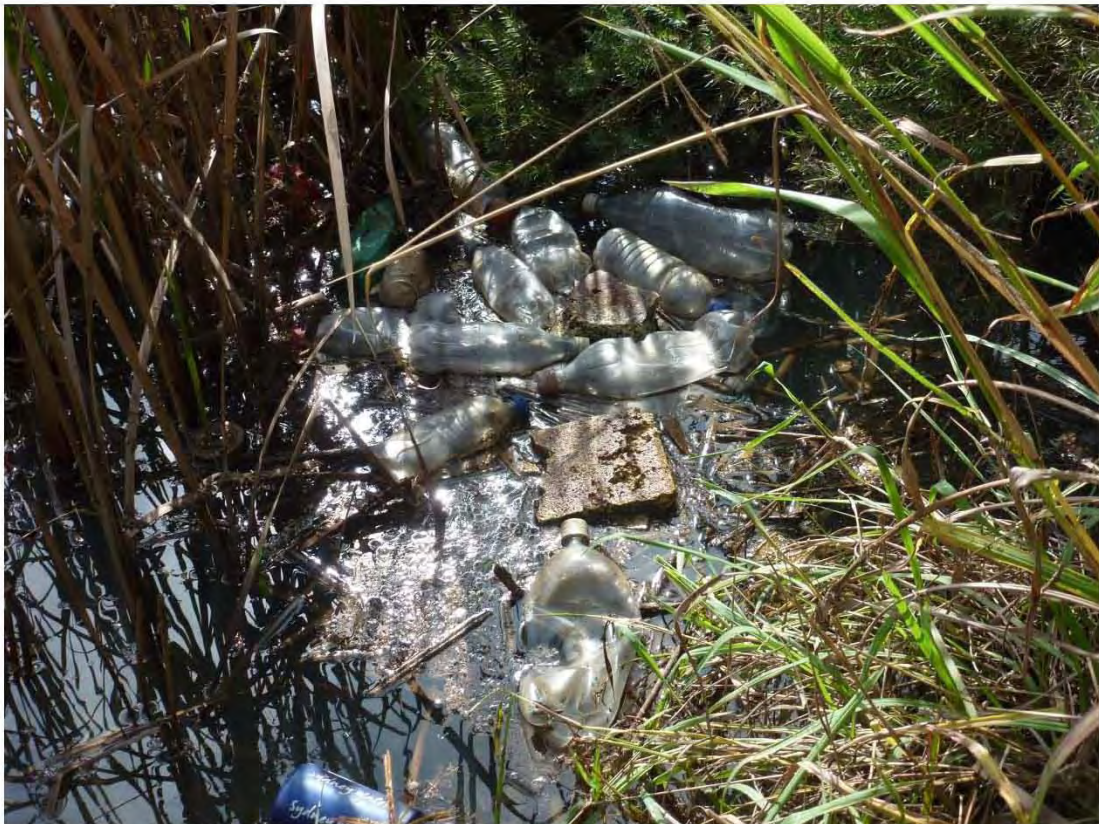
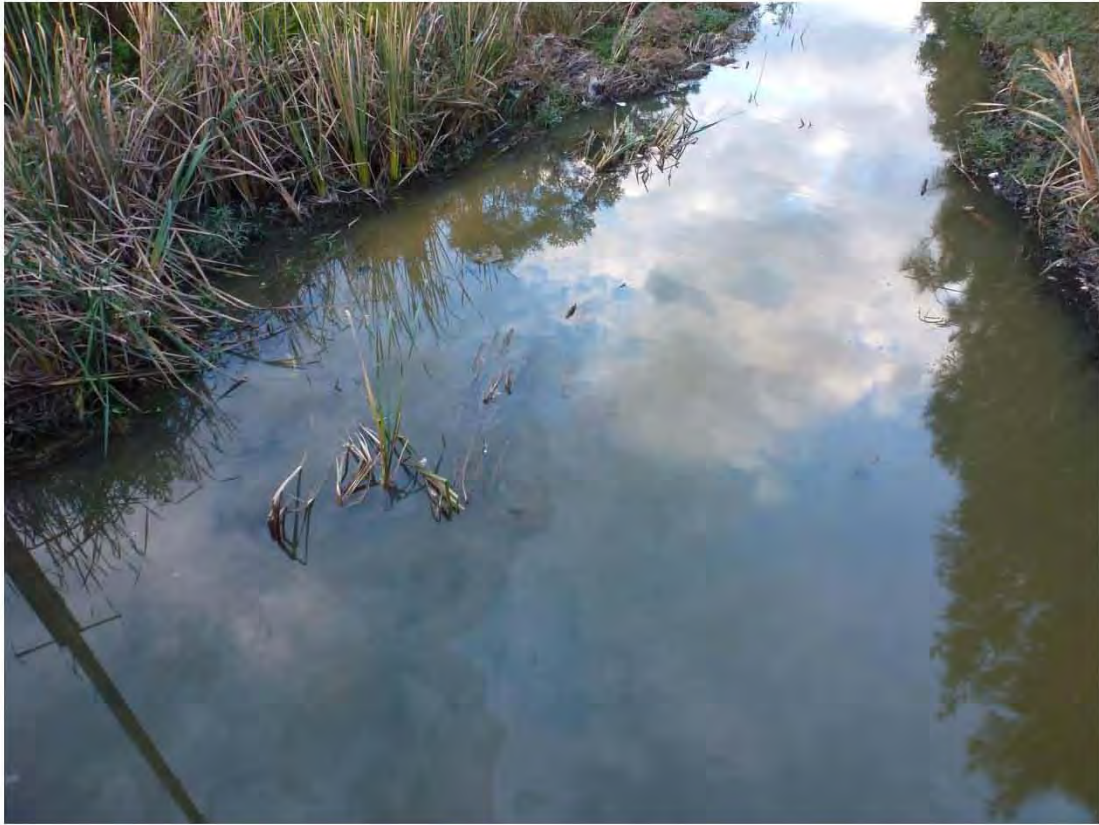
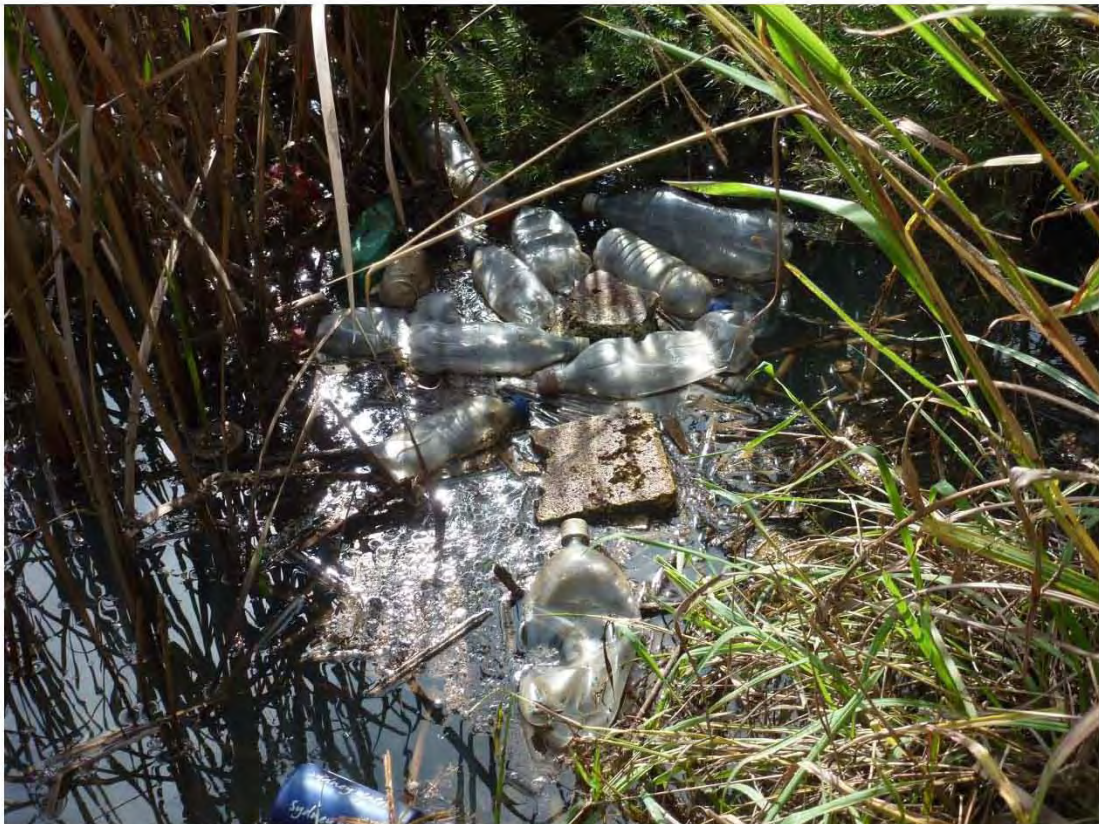
The polluted nature of the stream is further highlighted in Figure 4.2 i) where a stream surface scum layer can be visibly seen. Numerous plastic rubbish was observed along the entire length of the NDC refer to Figure 4.2 ii).

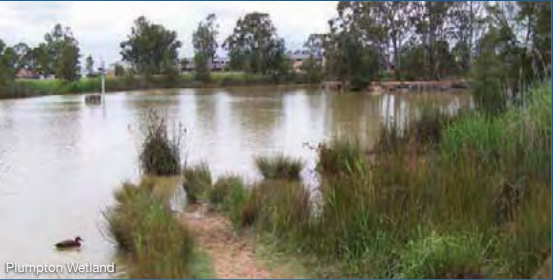
## CREEK RESTORATION

Blacktown Council is working on restoring many of our creeks to a more natural and stable state. Creek restoration creates habitat for local wildlife, reduces flood impacts and provides natural places for local residents to enjoy.

Recent creek restoration projects include:  
Angus Creek, Rooty Hill  
Lalor Creek at Troubadour Reserve, Kings Langley  
Waller Creek at Morgan Powell Reserve, Kings Langley

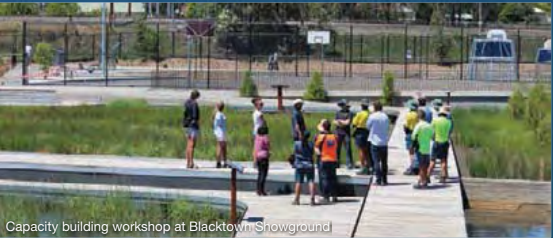
## WETLAND CONSTRUCTION AND MAINTENANCE

Council maintains many wetlands that have been designed to capture and treat stormwater. The treatment of stormwater reduces the amount of pollutants entering Blacktown waterways.

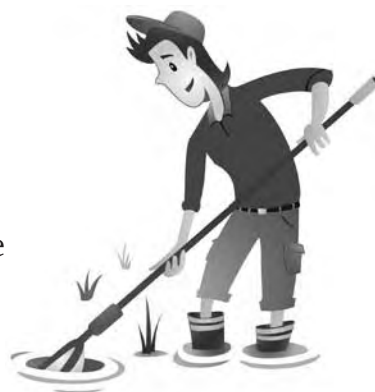
### Procedure for sweep sampling

Sweep sampling can occur along the edge of the stream and should include a range of habitats such as under logs and tree roots, and in fringing vegetation. Sample the top, edge and bottom of the water along at least 10 metres of stream.
