## **Report on Geotechnical Investigation**

### **Sports and Aquatic Centre**

**84, 86 and 90-98 The Boulevarde,  
Strathfield NSW**

**DP Project No. 224188.00**

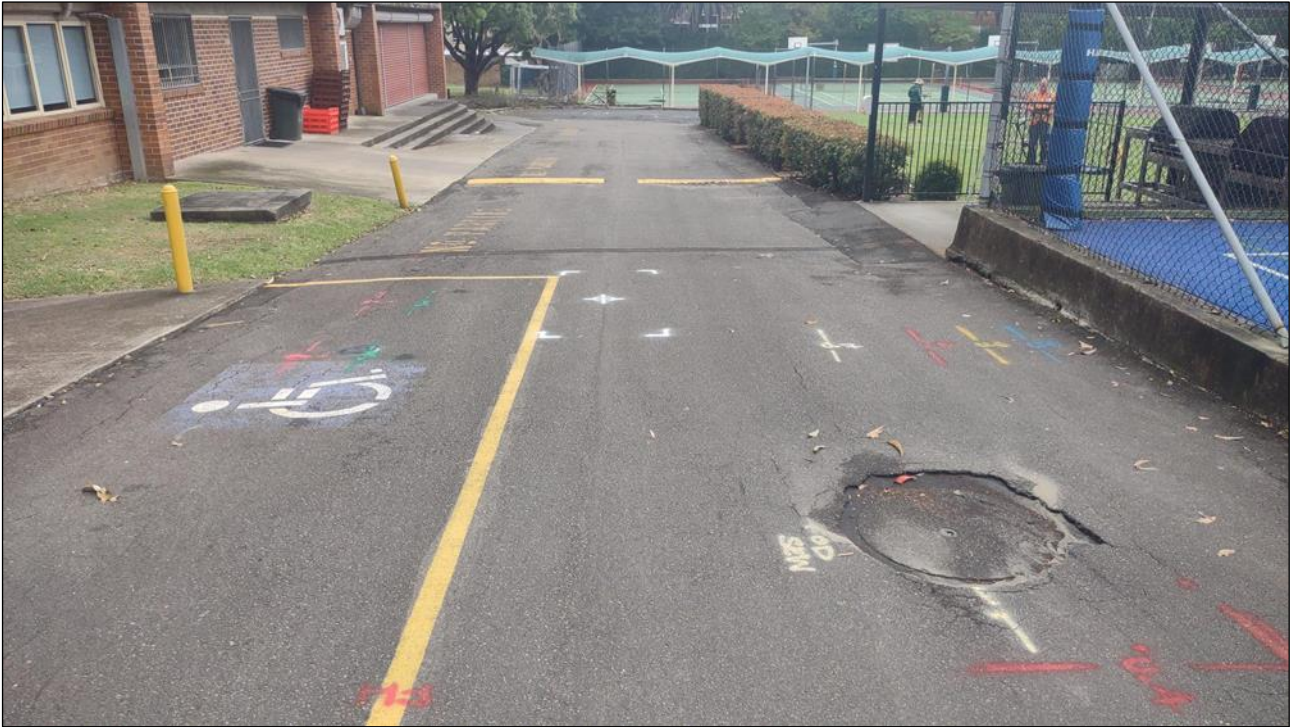
**Figure 2: View of the development site, looking north**

The ground surface across the development site gently slopes downwards in a north to north-easterly direction, with levels typically ranging between about RL 18 m and RL 16 m AHD. There are several abrupt changes in slope associated with retaining walls and batter slopes across the site to accommodate changes in levels around the existing buildings. Typical conditions of the development site are shown in Figure 3 below.

The development site was accessible via an asphalt driveway that connects to Jersey Road on the southern side of the school. To the south of the investigation area, within the school property, was a swimming pool with change room and brick building. The south-eastern section of the investigation area was occupied by an on-grade carpark and two small buildings. The northern portion of the investigation area was occupied by an open space playing field and tennis courts. These areas are relatively level which may indicate previous cut and fill to create a level surface. The existing school buildings are typically one to two storeys and are constructed of brick. The 1994 VAT building comprises a lower-level basement. The recent investigations confirmed the presence of fill in these areas.

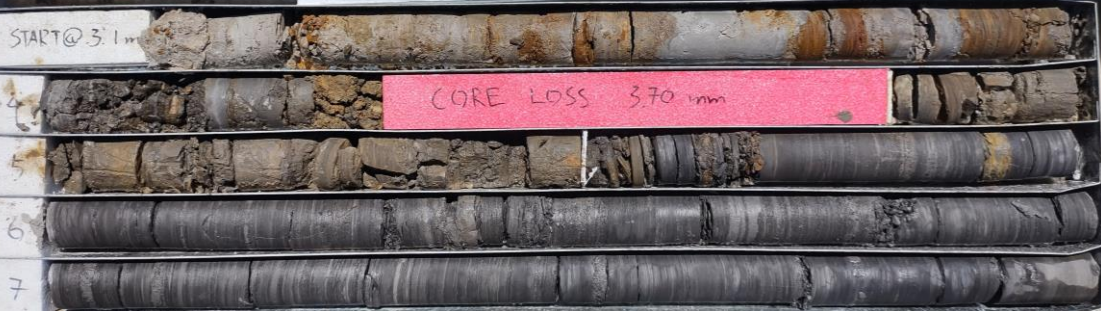
3.10 - 8.00m

Project No: 224188.00  
BH ID: 12  
Depth: 3.1 - 8.0  
Core Box No.: 1/2

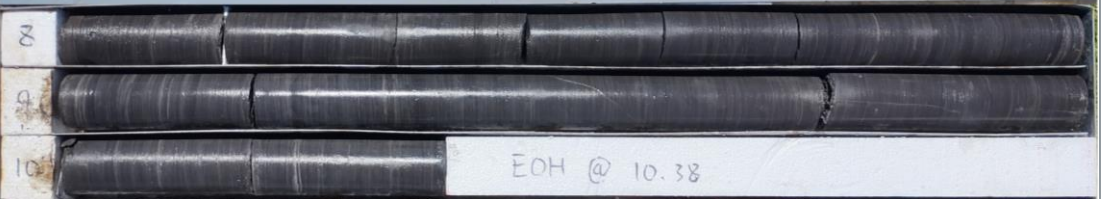
8.00 - 10.38m

Project No: 224188.00  
BH ID: 12  
Depth: 8 - 10.38  
Core Box No.: 2/2

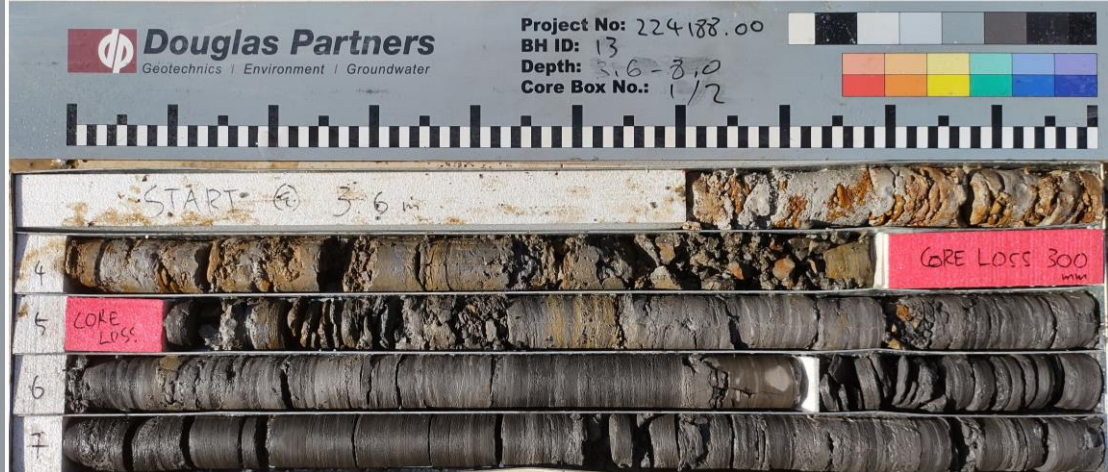
3.60 – 8.00m

| RL | Depth (m) | Description of Strata | Degree of Weathering | | | | | Graphic Log | Rock Strength | | | | | Water | Fracture Spacing (m) | Discontinuities | | Sampling & In Situ Testing | | | |
|---|---|---|---|---|---|---|---|---|---|---|---|---|---|---|---|---|---|---|---|---|---|
| | 3.74 | SHALE: pale grey and grey-brown, with approximately 15% interbedded ironstone and iron indurated bands, interbedded clay and decomposed seams, very low to low strength, distinctly weathered, generally highly fractured with fragmented beds, Ashfield Shale | | | | | | | | | | | | | | | | C | 84 | 10 | PL(A) = 0.12<br>PL(A) = 0.29 |
| | 5.38 | SHALE: dark-grey, medium strength, slightly weathered to fresh, slightly fractured, Ashfield Shale | | | | | | | | | | | | | | | | | | | |
