Report on  
Geotechnical Investigation

Lightweight Aggregate Project  
Plant 2, Austral Brick Site  
720 Wallgrove Road, Horsley Park

Prepared for  
Brickworks Ltd

Project 84821.00  
June 2015

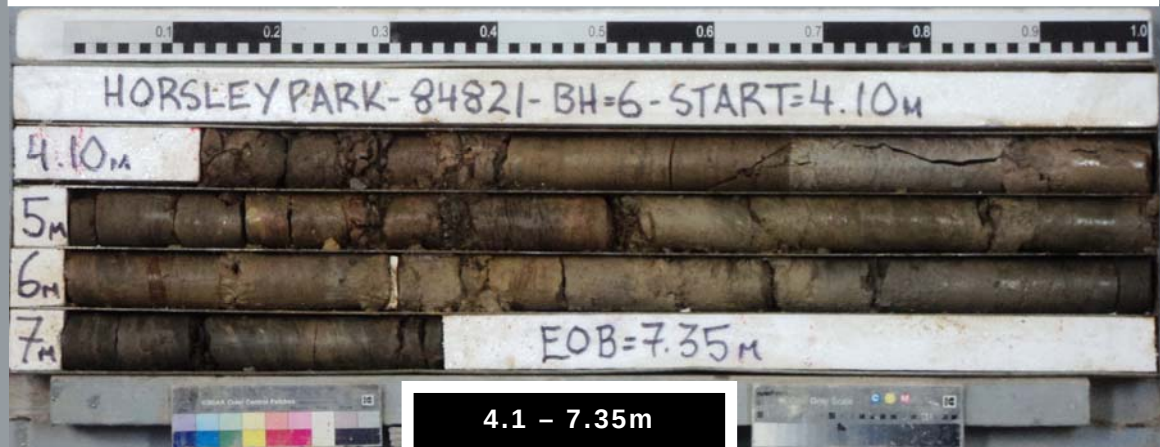
DOUGLAS PARTNERS PTY LTD  
PROPOSED AGGREGATE FACILITY – HORSLEY PARK  
BORE 6 PROJECT 84821 MAY 2015

Details of the subsurface conditions encountered are given on the borehole logs in Appendix C, together with colour photographs of the rock core and notes defining classification methods and descriptive terms.
