Lucas Heights Resource Recovery Park Project

Environmental Impact Statement

Appendix H – Surface water assessment

Surface Water Assessment

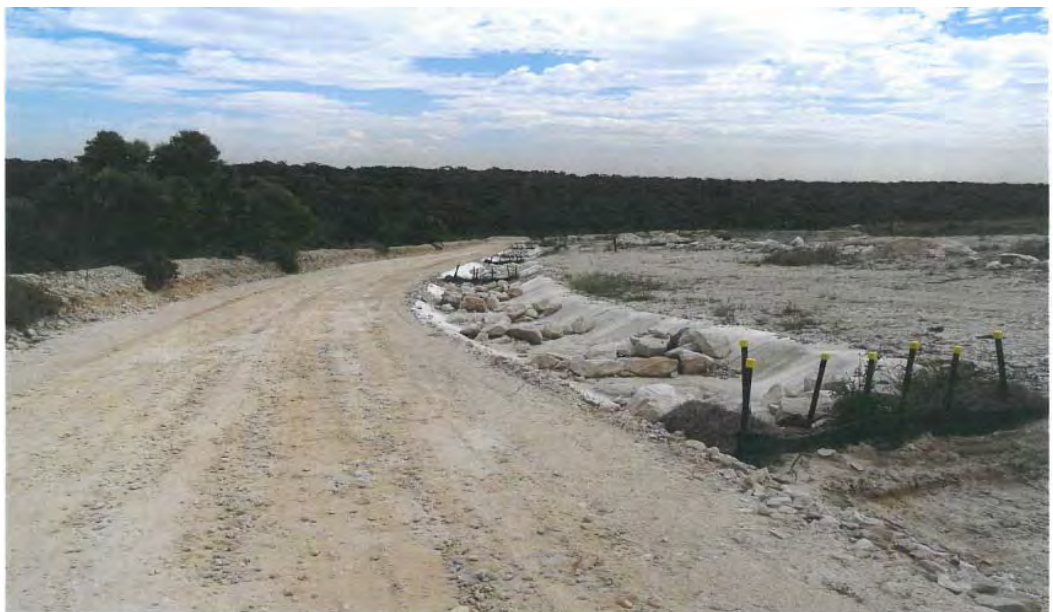
Figure 2.2 Lined drain along western perimeter haul road with siltation traps

- **Upgrade of main sediment basin** – in order to provide more capacity to deal with large storm events, the main sediment basin was upgraded and enlarged in 2013. As part of the upgrade, the dam was also de-silted. (refer Appendix B for photos of the main sedimentation basin)
- **Establish grassed areas** – grass was established on previously exposed areas to improve stormwater runoff quality.
- **Western perimeter haul road** – silt mesh fencing and siltation traps were installed along the western perimeter haul road to reduce sediments entering the main sedimentation basin. Geotextiles, hay bales and a rock lined drain were also installed to manage flow rates during high rainfall events. (Figure 2.2)

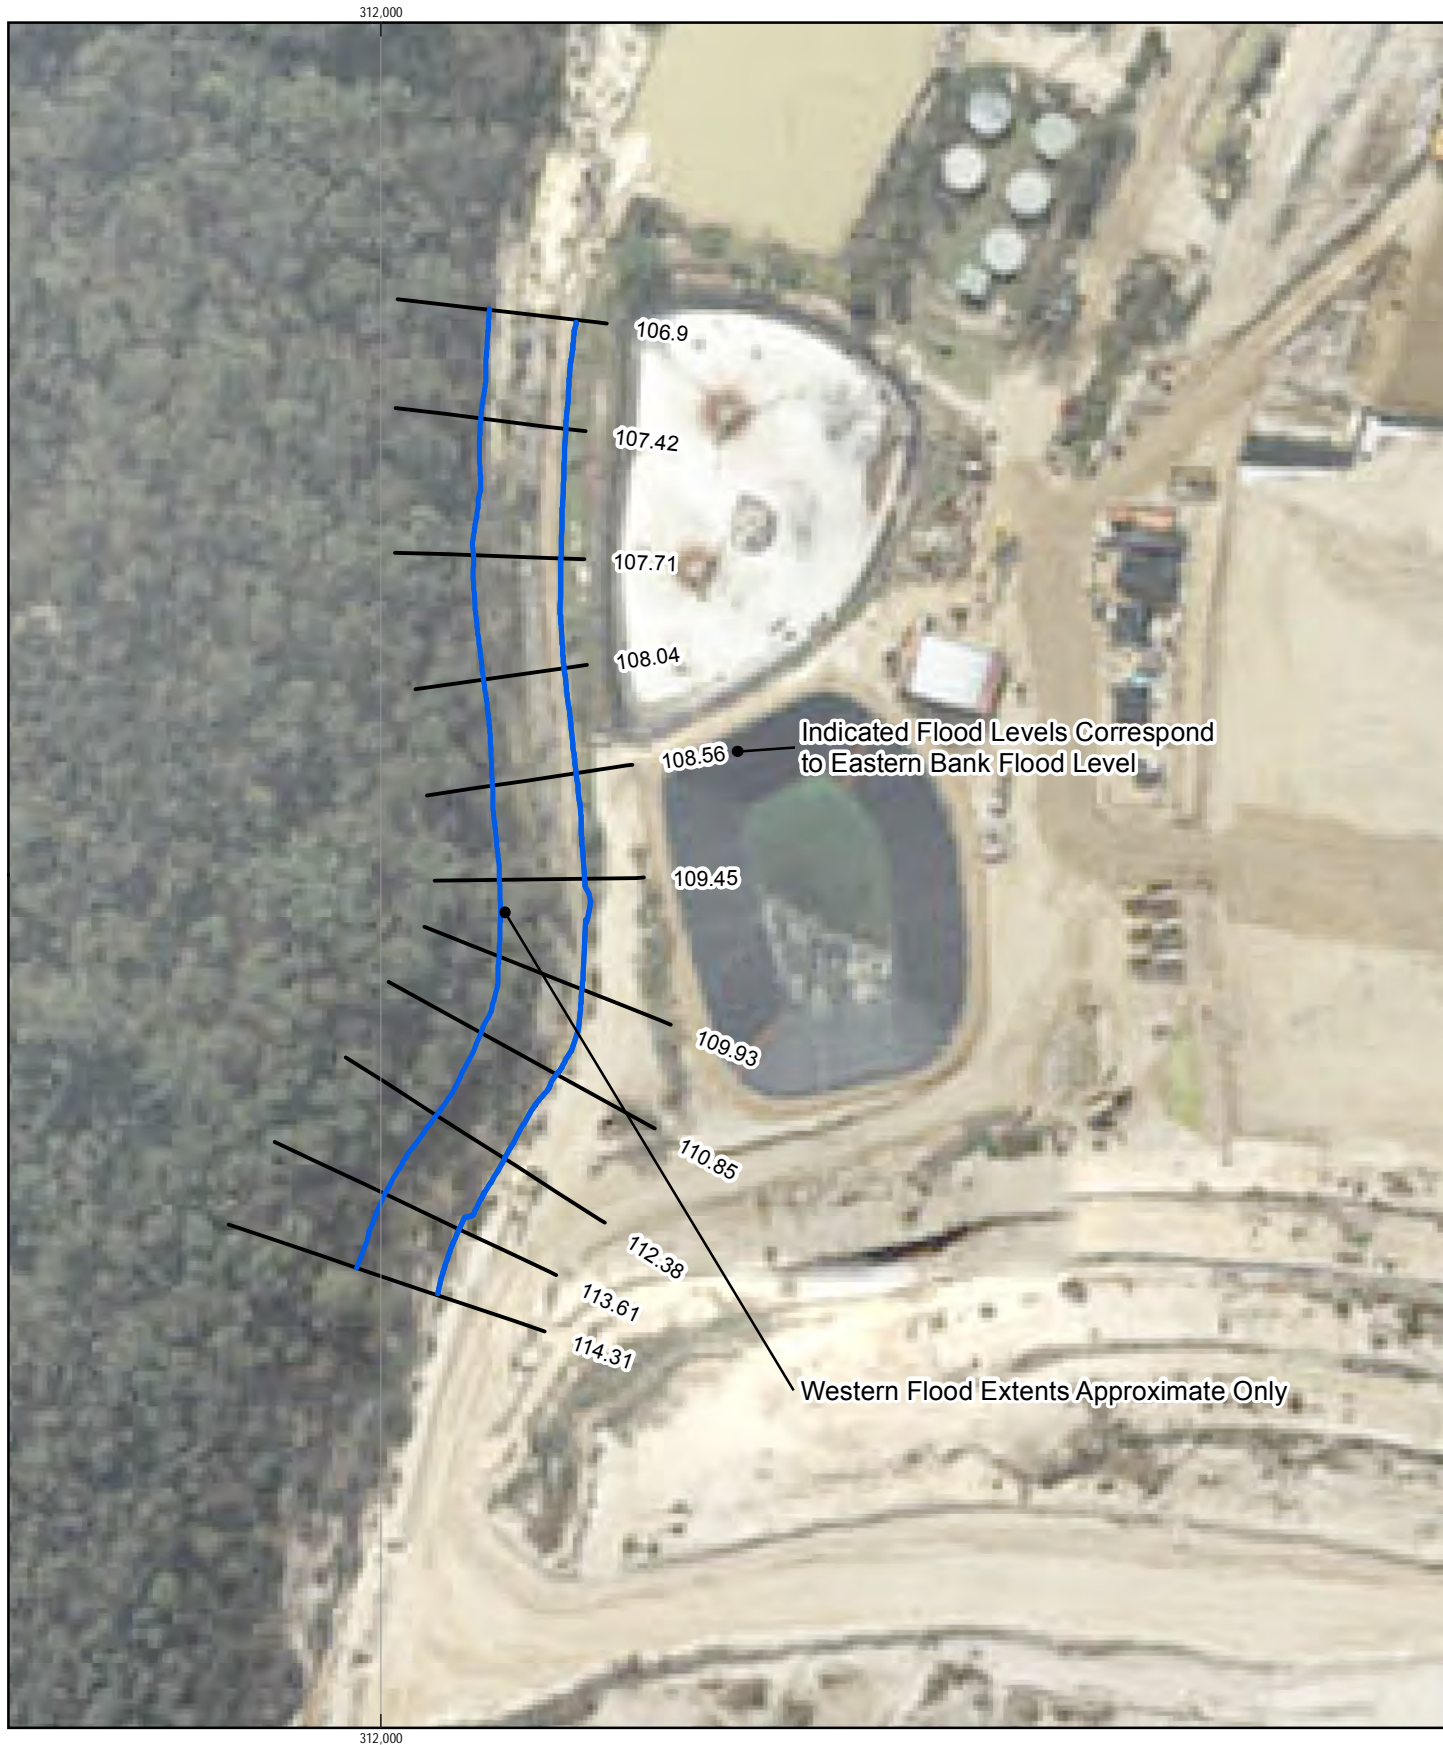
- 100yr ARI Event Flood Extents
- Hydraulic Model Cross Sections (Max 100-yr Water Level Labelled)
- ARRT GO Facilities Preliminary Boundaries

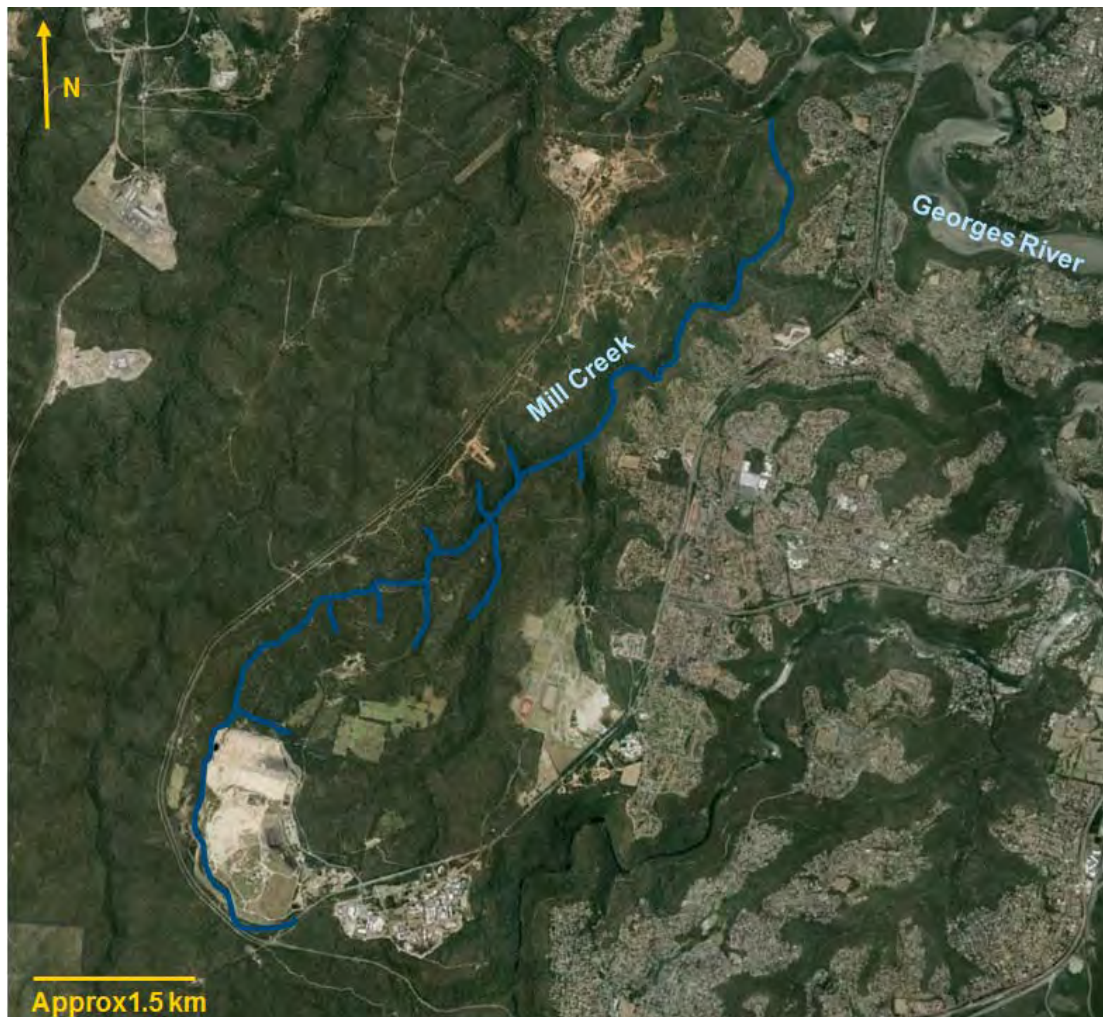
Figure 2.1 Locations of the LHRPP and Mill Creek

The locations of the LHRPP and Mill Creek are shown on Figure 2.1 below.

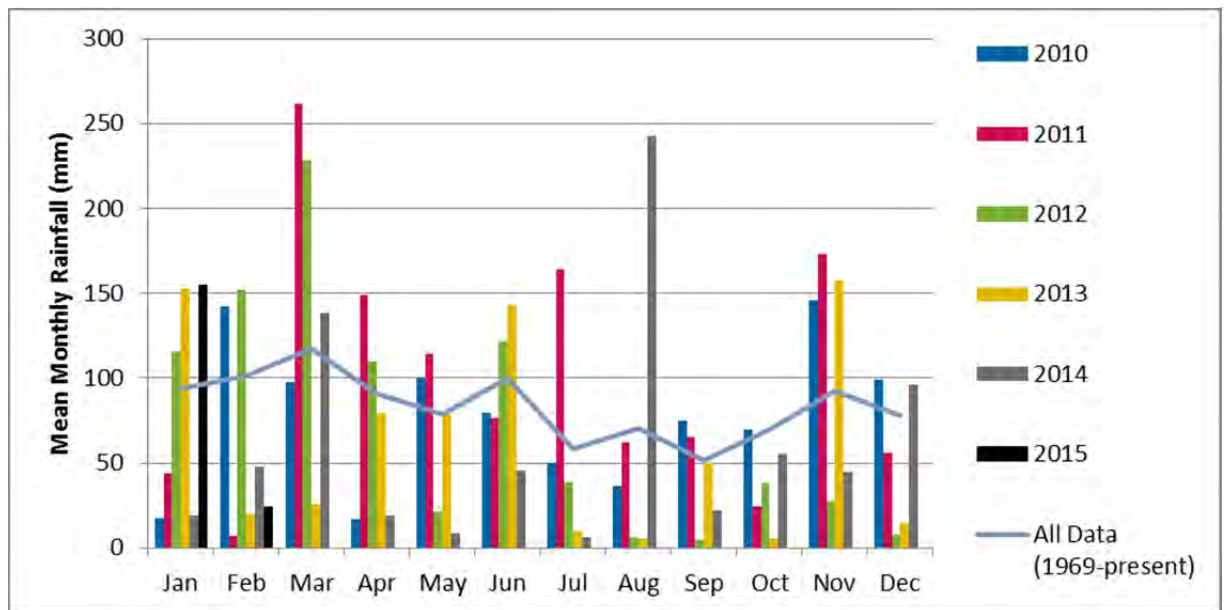
Figure 6.1 Mean monthly rainfall for years 2010 to 2015 and an average for all data available for Lucas Heights (ANSTO) Weather Station

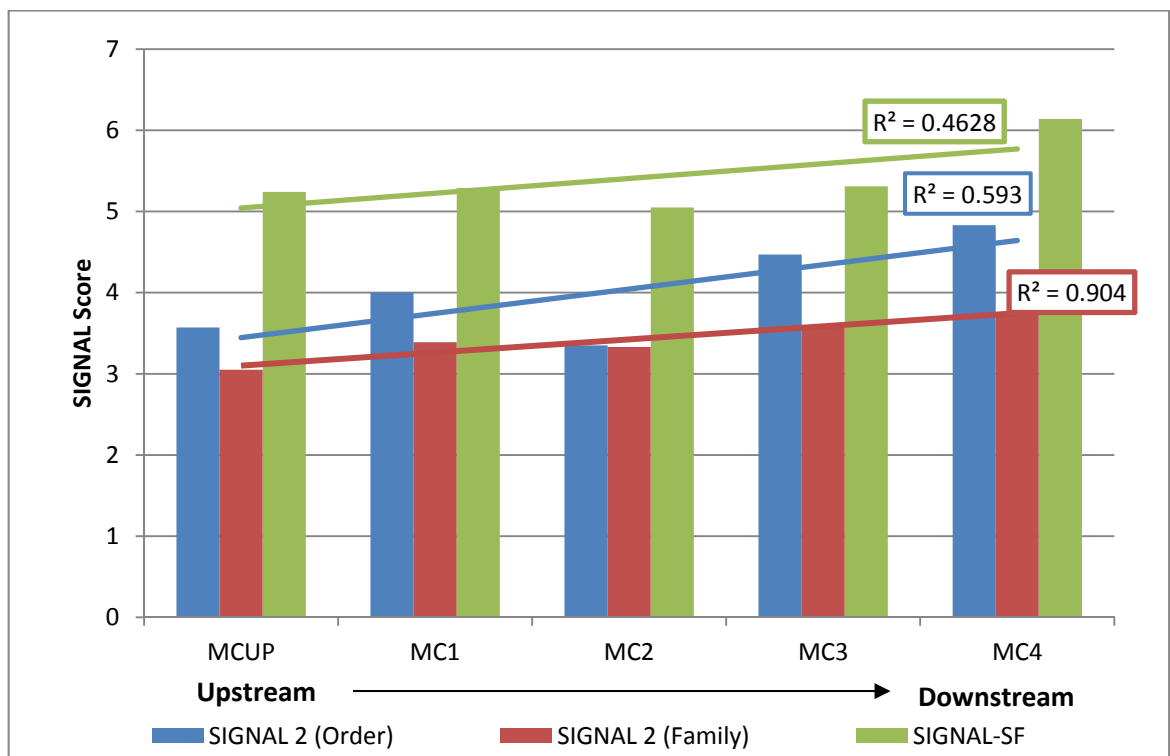
Figure 6.4 SIGNAL results displaying a linear trend line for each of the SIGNAL index scores

Figure 6.4 below presents the SIGNAL 2 (Order), SIGNAL 2 (Family) and SIGNAL-SF (Sydney Families) results.

Figure 6.4 below identifies that across all SIGNAL indices there was a general trend of increasing scores with increasing distance downstream. A linear trend line demonstrated that the SIGNAL 2 (Family) biotic index correlated most closely with this trend.

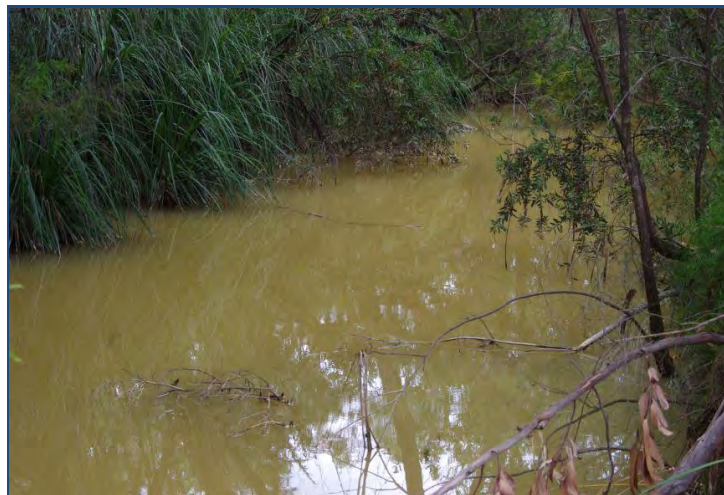
Upstream

Time	Temp. (°C)	pH	EC (µS/cm)	Dissolved Oxygen (% sat, mg/L)	Turb. (NTU)	Alkalinity (mg/L)
13:58	21.42	7.66	324	81.2	115	42

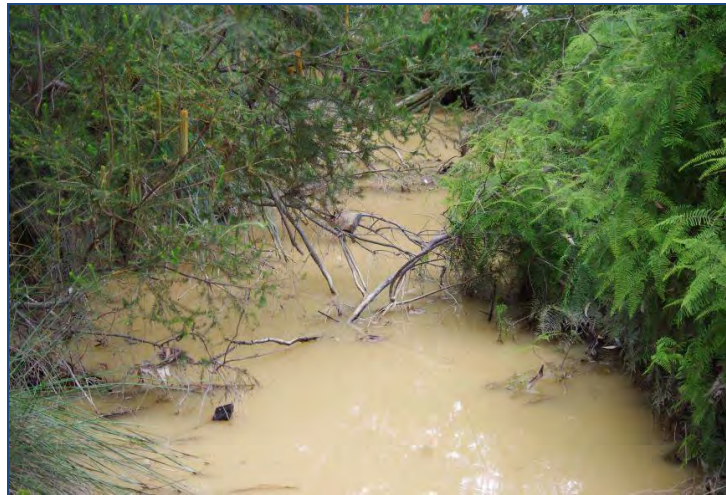
Upstream

Time	Temp. (°C)	pH	EC (µS/cm)	Dissolved Oxygen (% sat, mg/L)	Turb. (NTU)	Alkalinity (mg/L)
13:29	20.66	7.59	369	93.1	358	74

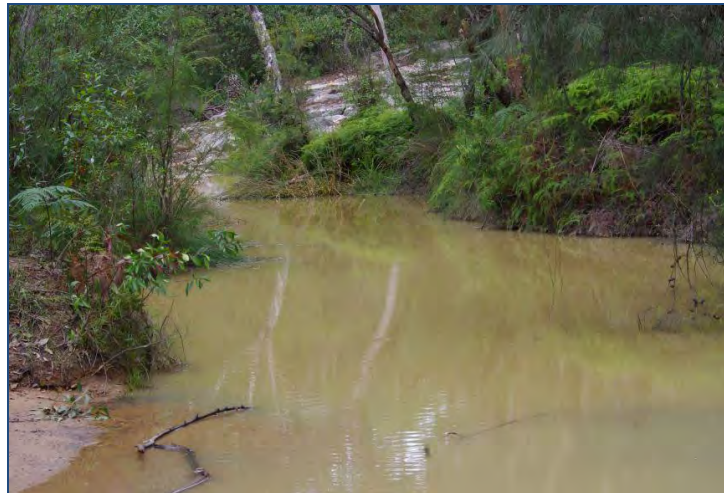
Upstream

Time	Temp. (°C)	pH	EC (µS/cm)	Dissolved Oxygen (% sat, mg/L)	Turb. (NTU)	Alkalinity (mg/L)
11:27	20.77	7.15	274	73.8	125	38

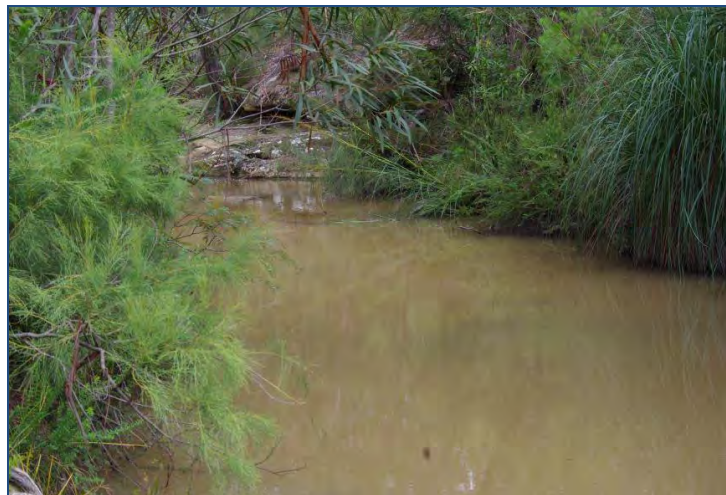
Upstream

Time	Temp. (°C)	pH	EC (µS/cm)	Dissolved Oxygen (% sat, mg/L)	Turb. (NTU)	Alkalinity (mg/L)
10:29	20.61	7.34	269	84.5	54.5	30.6

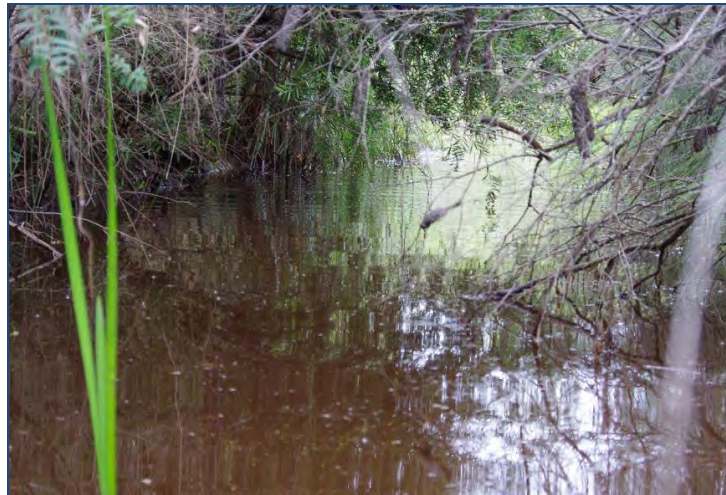
Upstream

Time	Temp. (°C)	pH	EC (µS/cm)	Dissolved Oxygen (% sat, mg/L)	Turb. (NTU)	Alkalinity (mg/L)
16:10	20.29	6.59	207	9.3	0.85	27.1

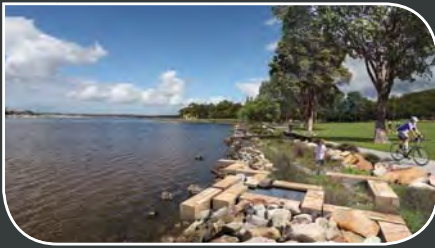
FAIRFIELD CITY COUNCIL BARAGoola ST BANK STABILISATION PROJECT

A 46m length of severely eroded creek bank has been stabilised using sandstone rocks, coir logs, in-stream large woody debris and landscaping works. An upstream bund has been constructed to control a localised break out point, resulting in creek flows being held within banks. The woody debris centralises creek flows during minor storm events and provides fauna habitat. Landscaping with native vegetation also provides important habitat for local wildlife and improves diversity, water quality and aesthetics of the area.
