# Appendix K – Contamination assessment

# SITA Australia Pty Ltd

## Lucas Heights Resource Recover Park Project

### Contamination Assessment

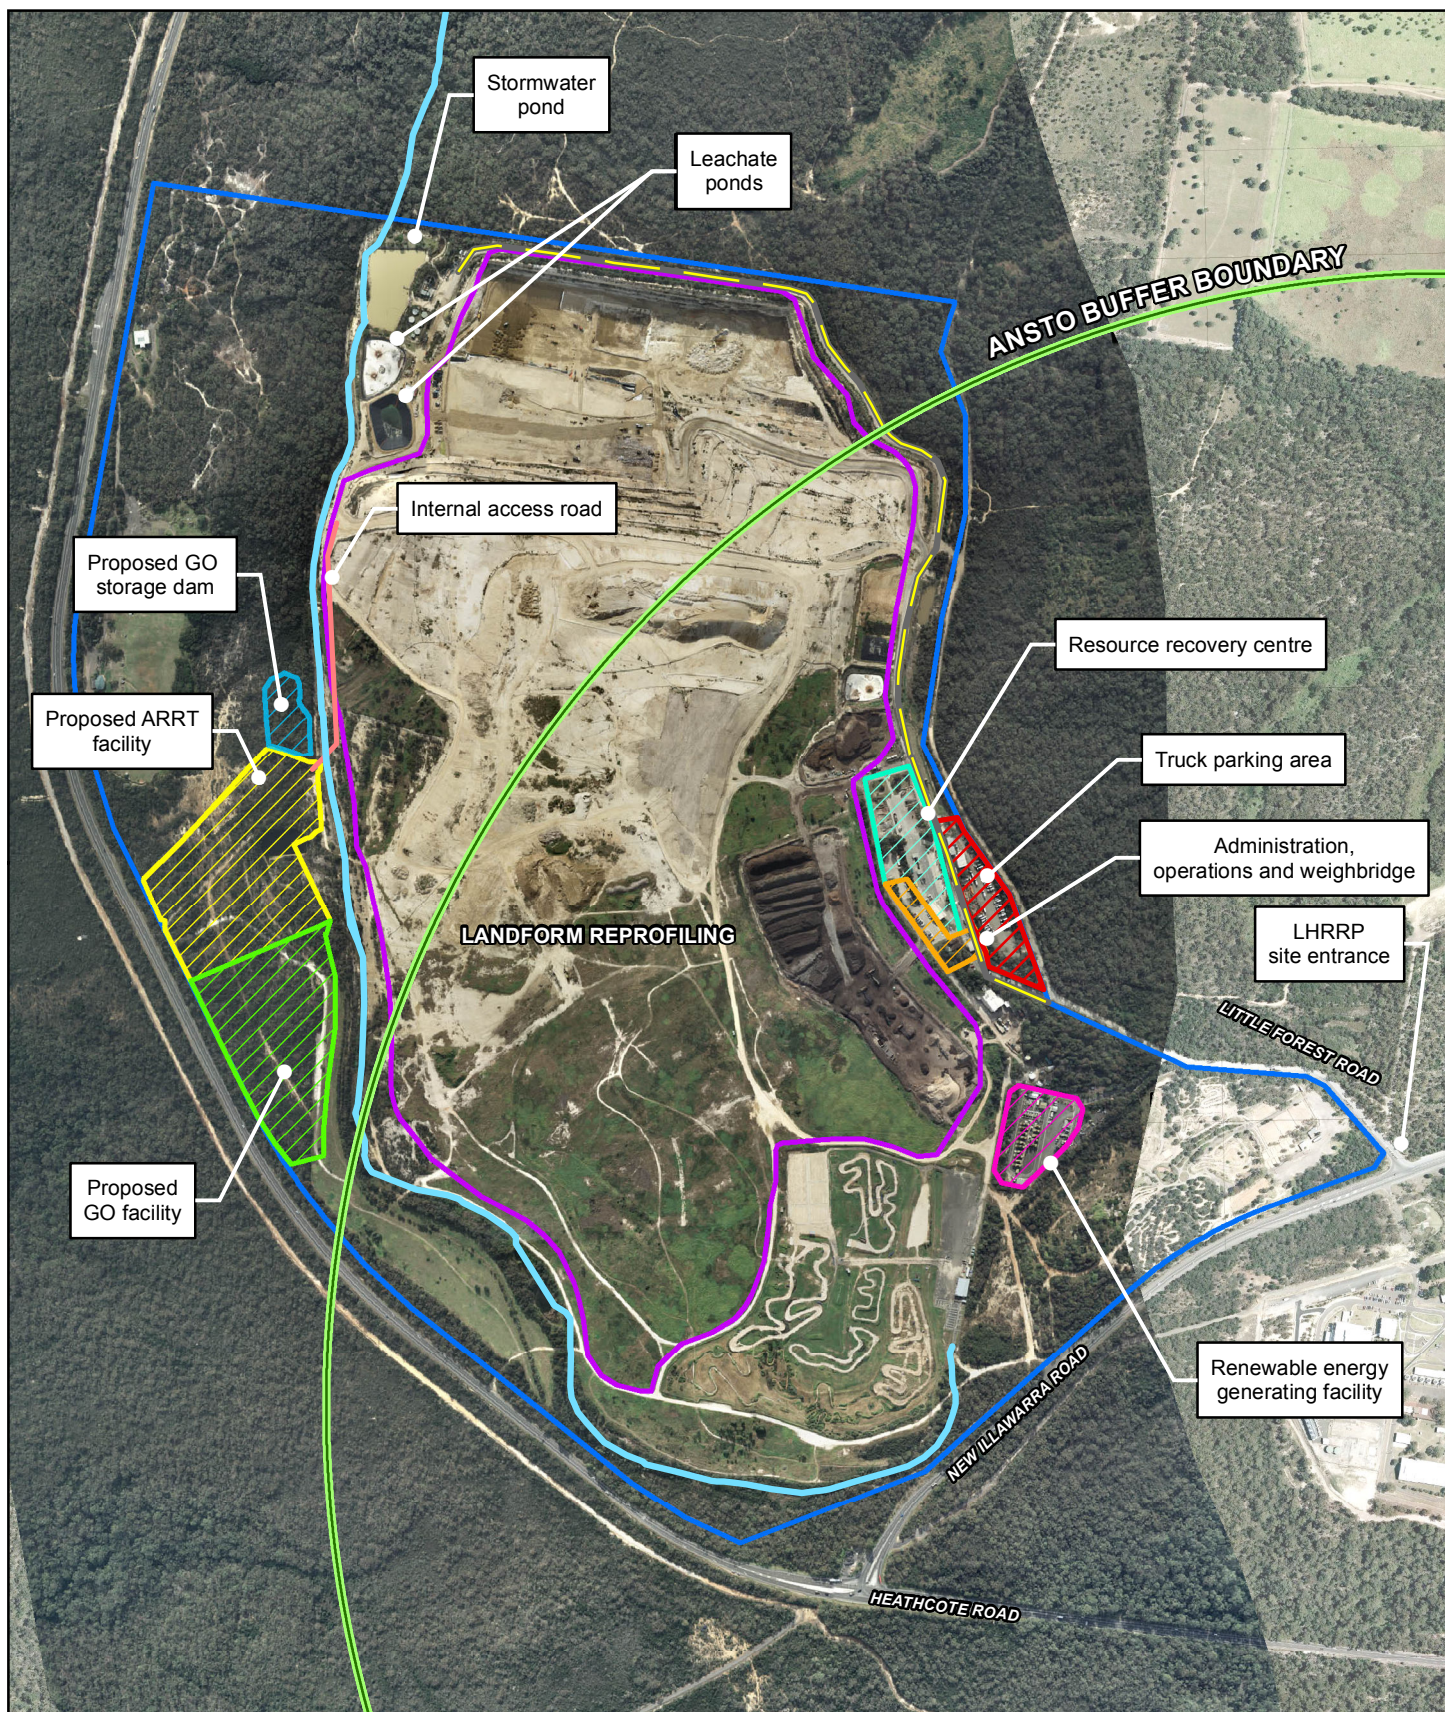
These key components of the proposal are shown on Figure 1.1. The proposed final landform and preliminary masterplan for the parkland is shown in Figure 1.2.

The EDL Landfill Gas power station (item 2) is also noted to be within the footprint of LHRRP, located east of the landfill reprofiling area (shown in Figure 1.1). According to the Lucas Heights EMP – *Landfill Gas Extraction System* (February 2012), EDL operates two landfill gas to electricity power plants. The one at LHRRP consists of 16 internal combustion engines each generating 1.25 MW. Each module is a self-contained unit consisting of the following components:

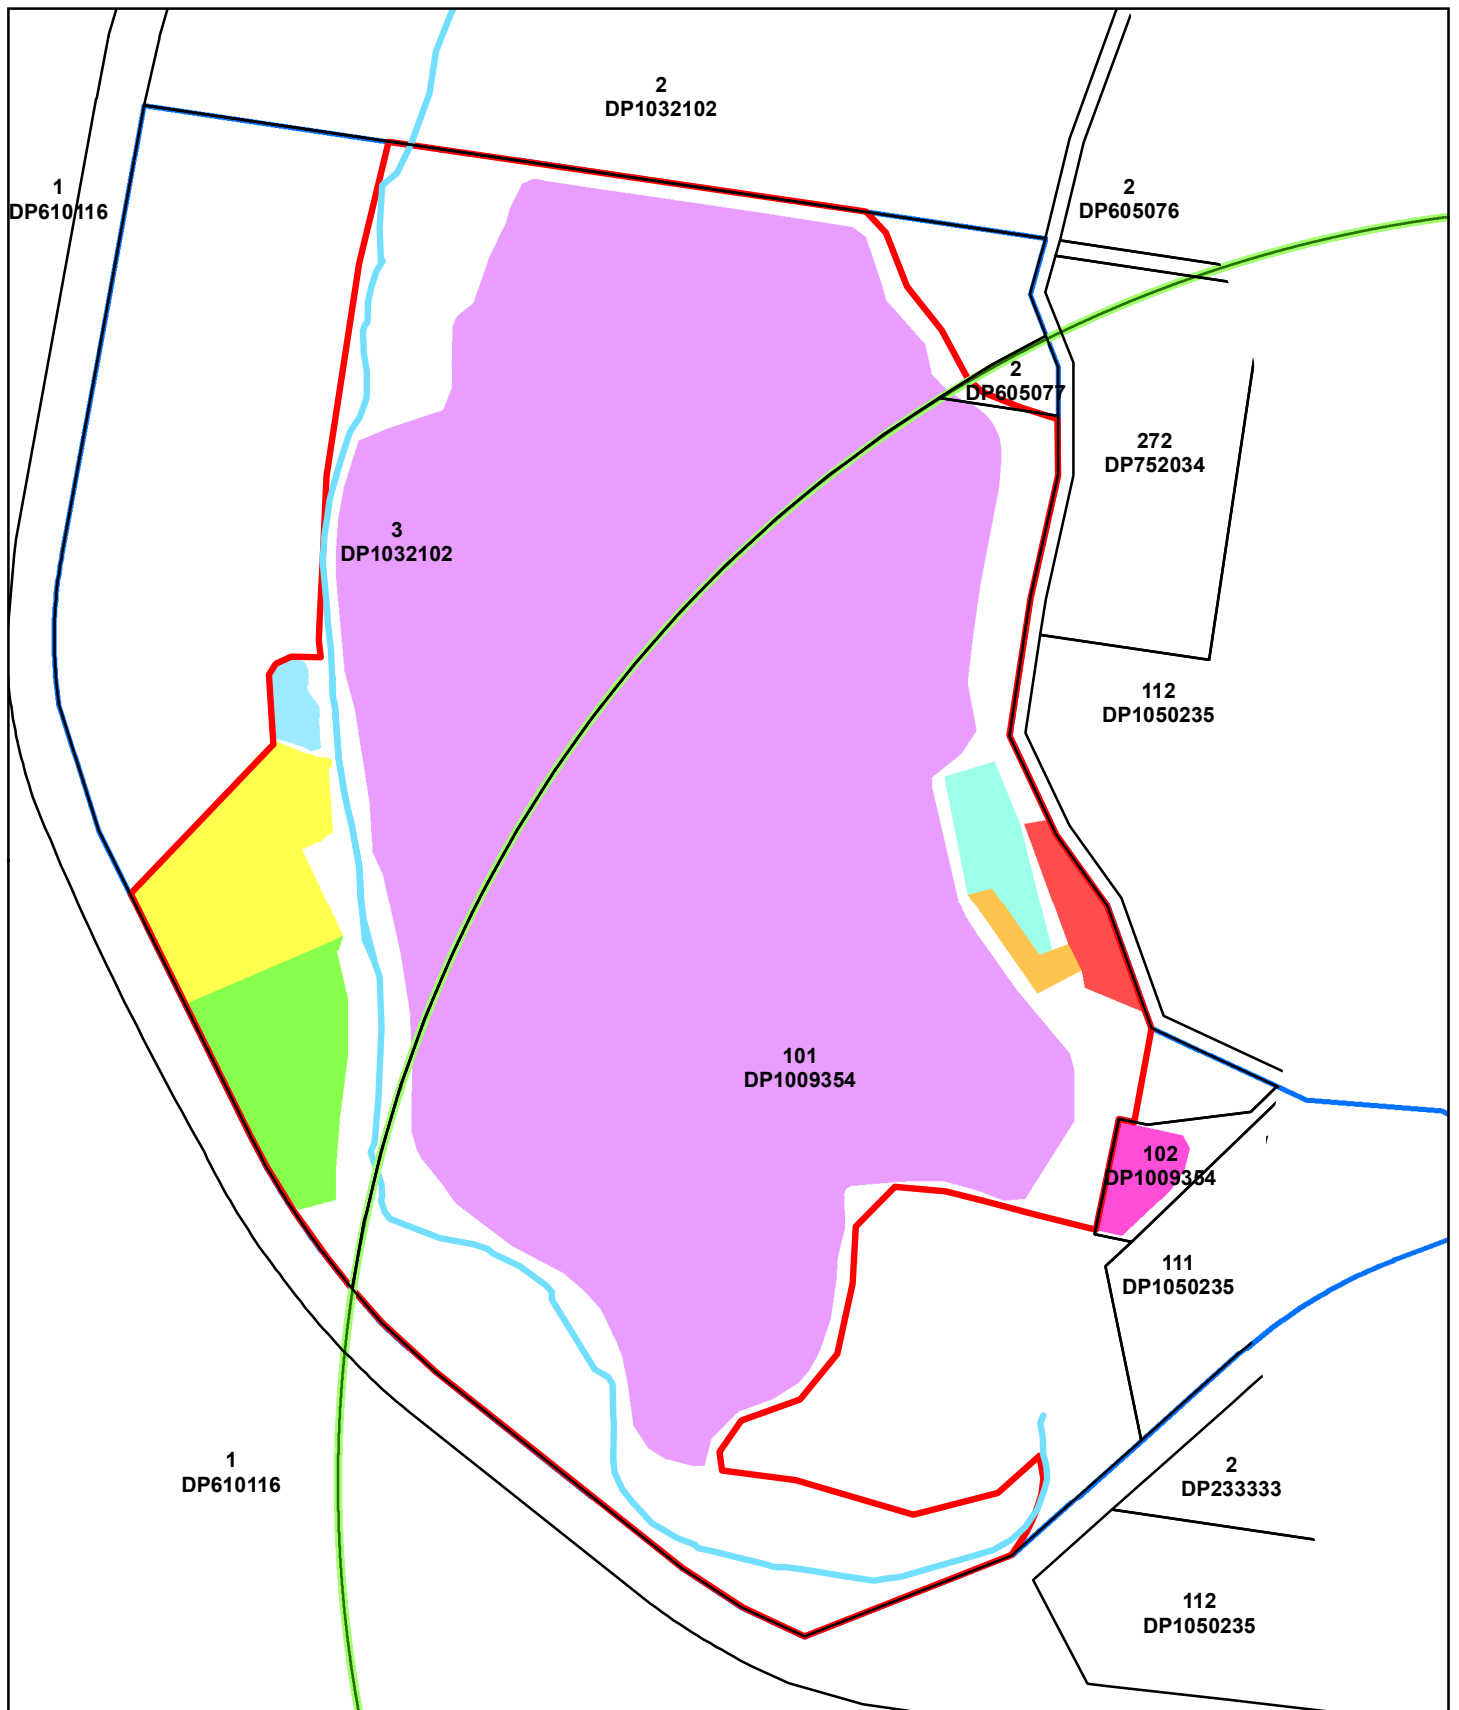
The western boundary of the proposed development is Heathcote Road and the site extends east across Mill Creek to the edge of the existing Menai residential area close to New Illawarra Road. The location of the proposed West Menai State Significant Site is shown on Figure 1.4.

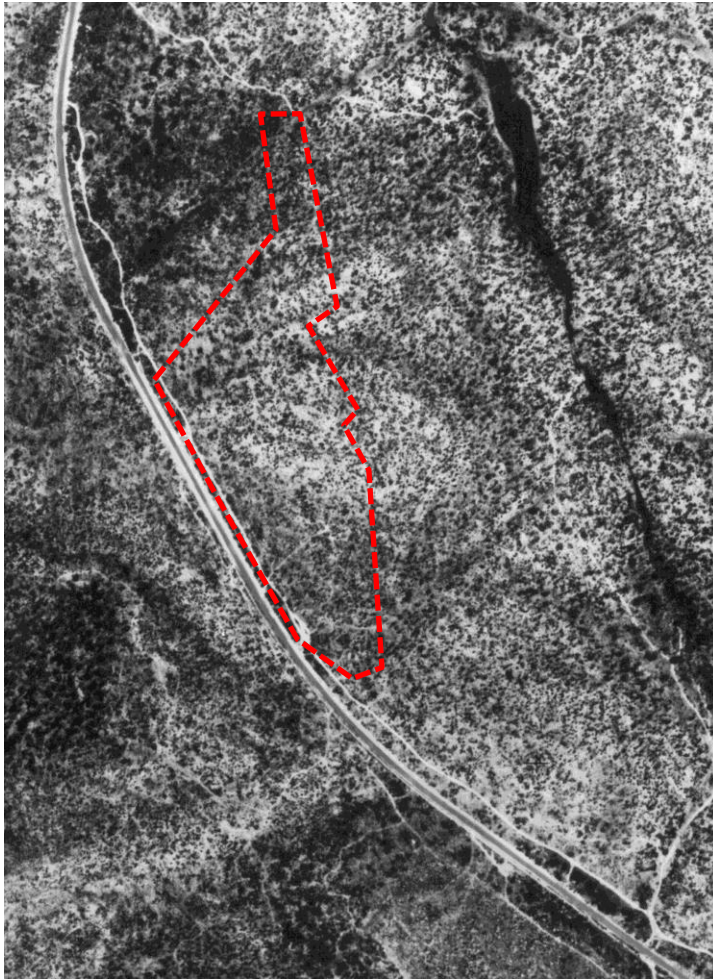
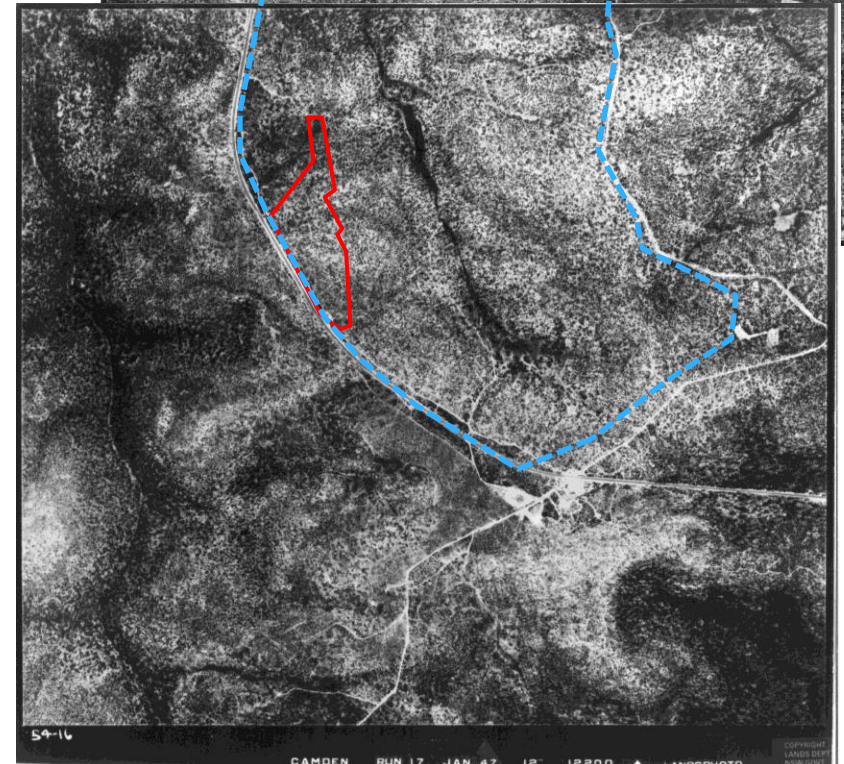
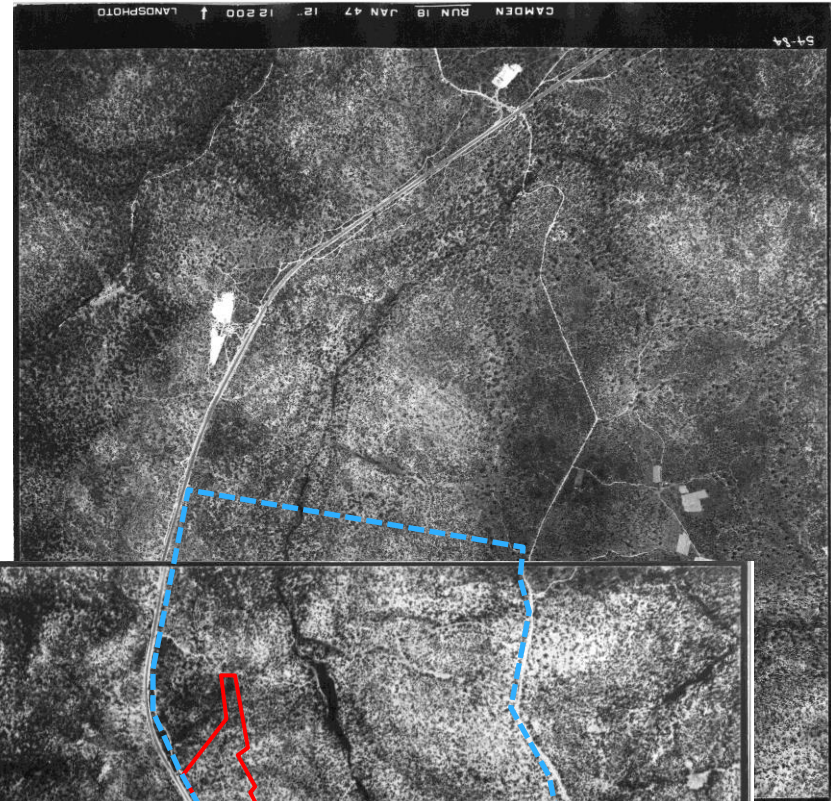
Photograph details	Description
1947 (black and white)	The approximate GO/ARRT facility area and LHRRP appeared undeveloped and covered in sparse vegetation. Mill Creek was clearly observed through the centre of the LHRRP. A minor vehicle track was observed in the western extent of the LHRRP site boundary, beyond which Heathcote Road was observed. A minor surface water drainage line was observed at the northern extent of the GO/ARRT facility area. The land surrounding the GO/ARRT facility area in all directions also appeared to be undeveloped and covered in sparse vegetation.
1961 (black and white)	The majority of the GO/ARRT facility area and the south eastern portion of the LHRRP had been cleared of vegetation and appeared as bare and undeveloped. The vegetation clearing extended a beyond the GO/ARRT facility area boundary to the north and south along Heathcote Road. The surrounding area appeared predominantly vegetated and undeveloped with the exception of vegetation clearing which had occurred along Little Forest Road, further east of the LHRRP.

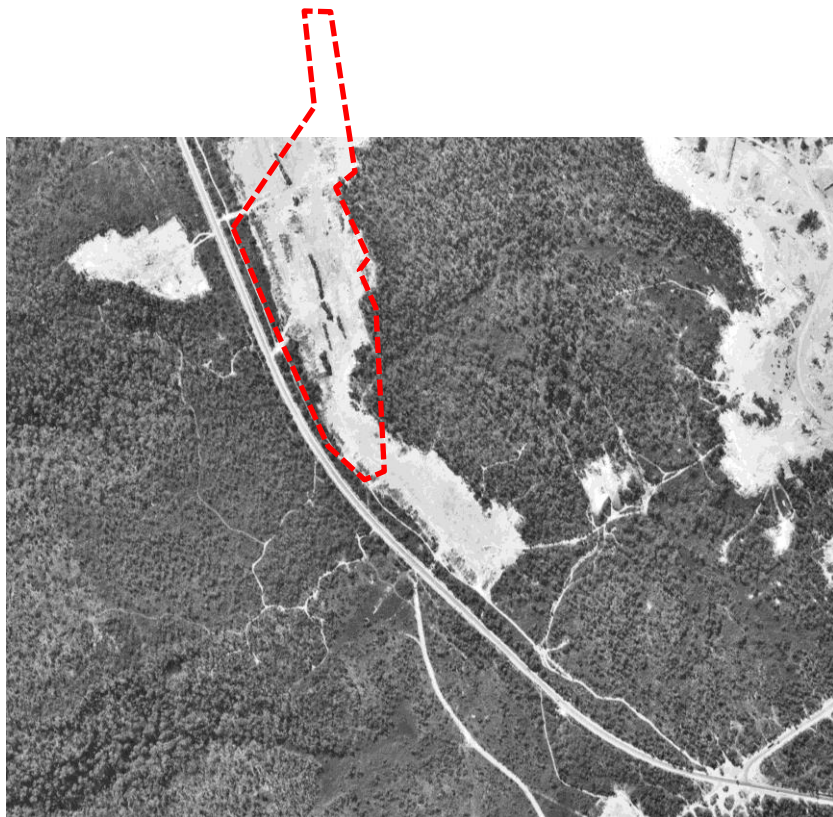
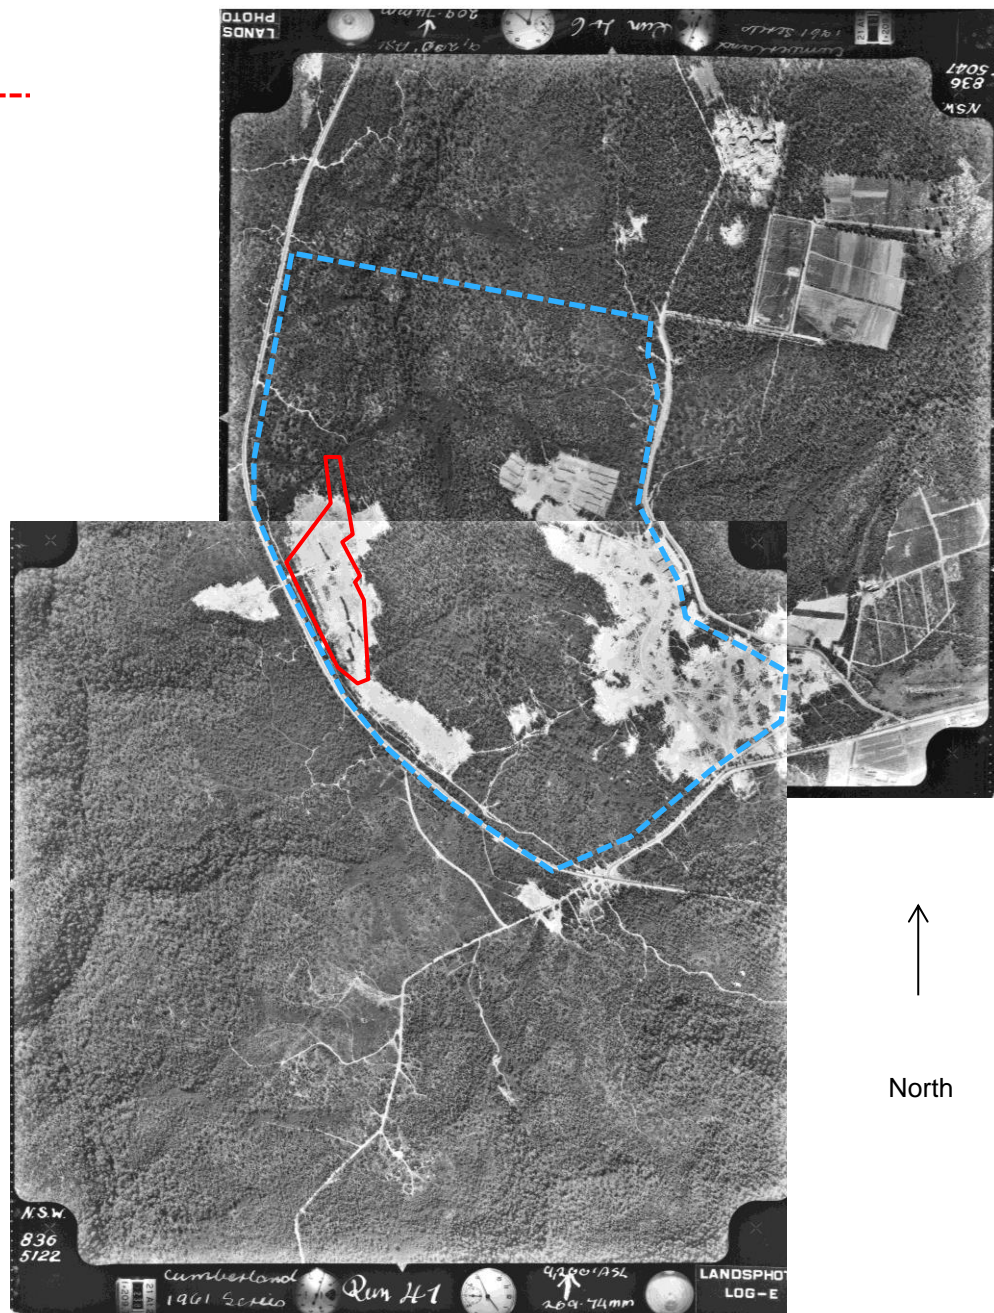
**1970**

1970 (black and white)	The GO/ARRT facility area remained clear of vegetation; with possible minor development or land use observed, the nature of

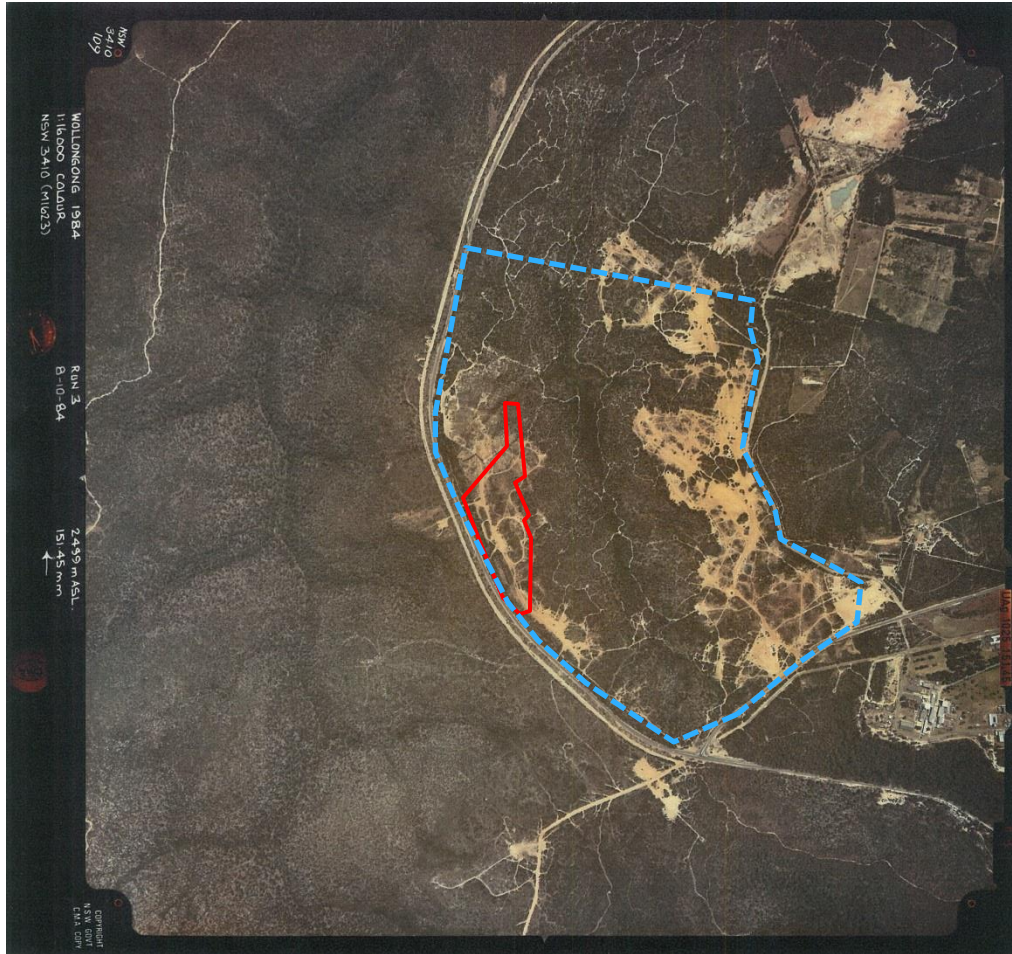
**1984**

Approximate site location -----  
Approximate LHRRP -----

Left: full photograph provided.  
Above: close up of site

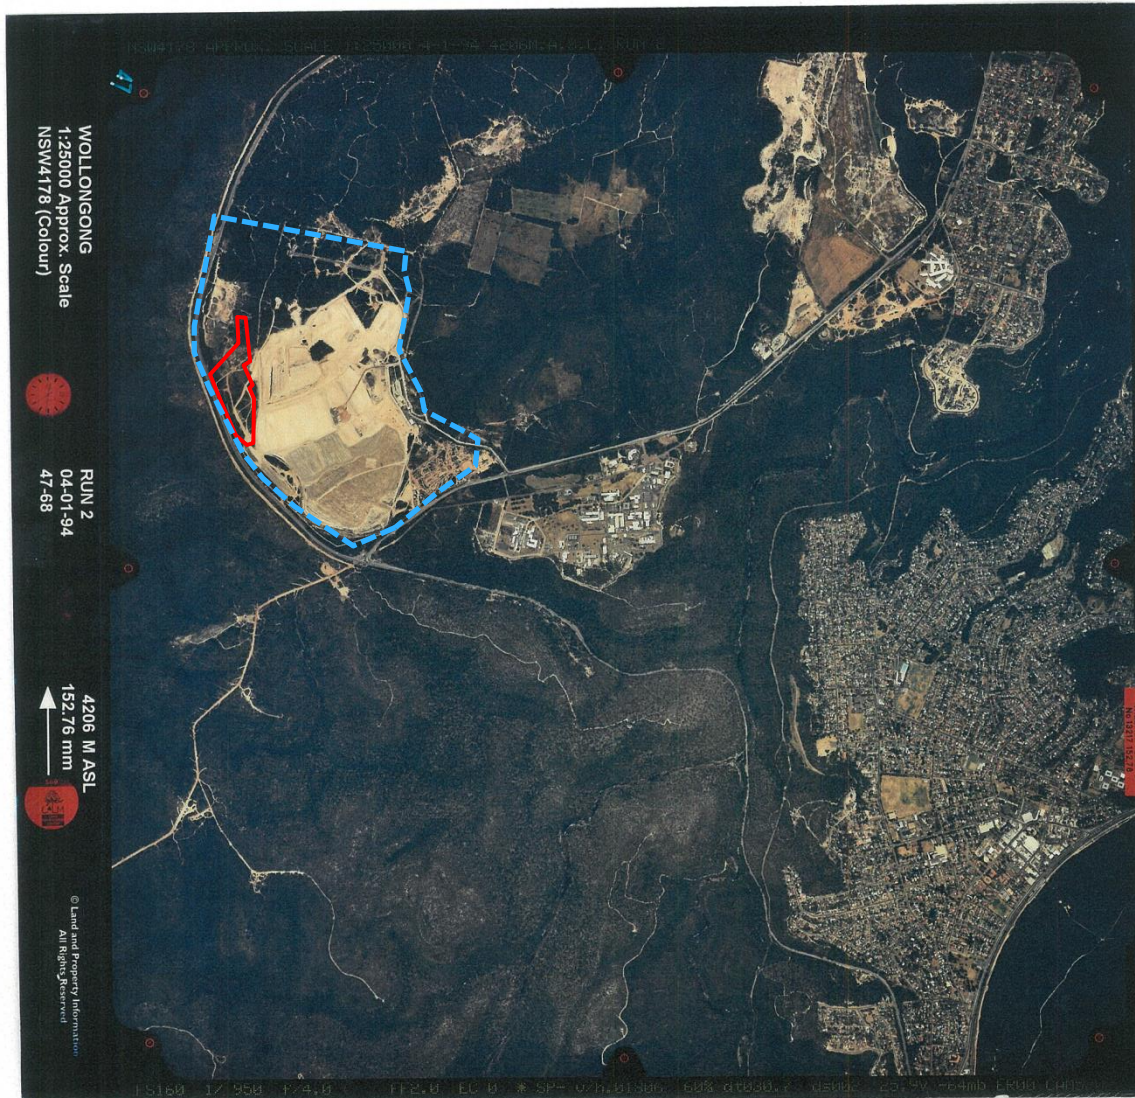
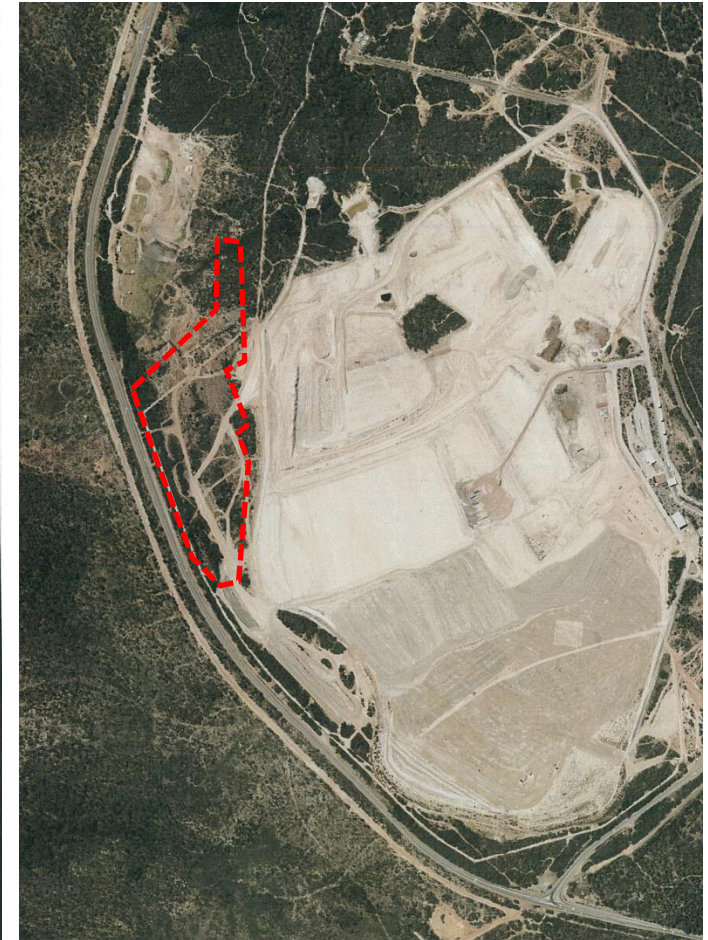
**1994**

1994 (colour)	The LHRRP landfill area was observed to extend across majority of the LHRRP. Extensive land clearing and topographical reforming had occurred between Heathcote Road and Little Forest Road. Vegetation had further regrown throughout most of the GO/ARRT facility area and the Sydney International Clay Target Association (SITCA) gun club on the western portion of the LHRRP was identifiable. Substantial dirt tracks throughout the GO/ARRT facility area had been widened and extended. The land surrounding the LHRRP appeared to remain predominantly vegetated.
2005 (colour)	The majority of the GO/ARRT facility area appeared unchanged from the 1994 photograph, with the exception of a small rounded pond towards the north-eastern extent of the LHRRP. Dirt tracks within the GO/ARRT facility area had a slightly changed layout. Landfill operations remained identifiable across majority of the LHRRP. A cleared portion of land on the north west portion of the site was noted and assumed to be the SICTA firing range.

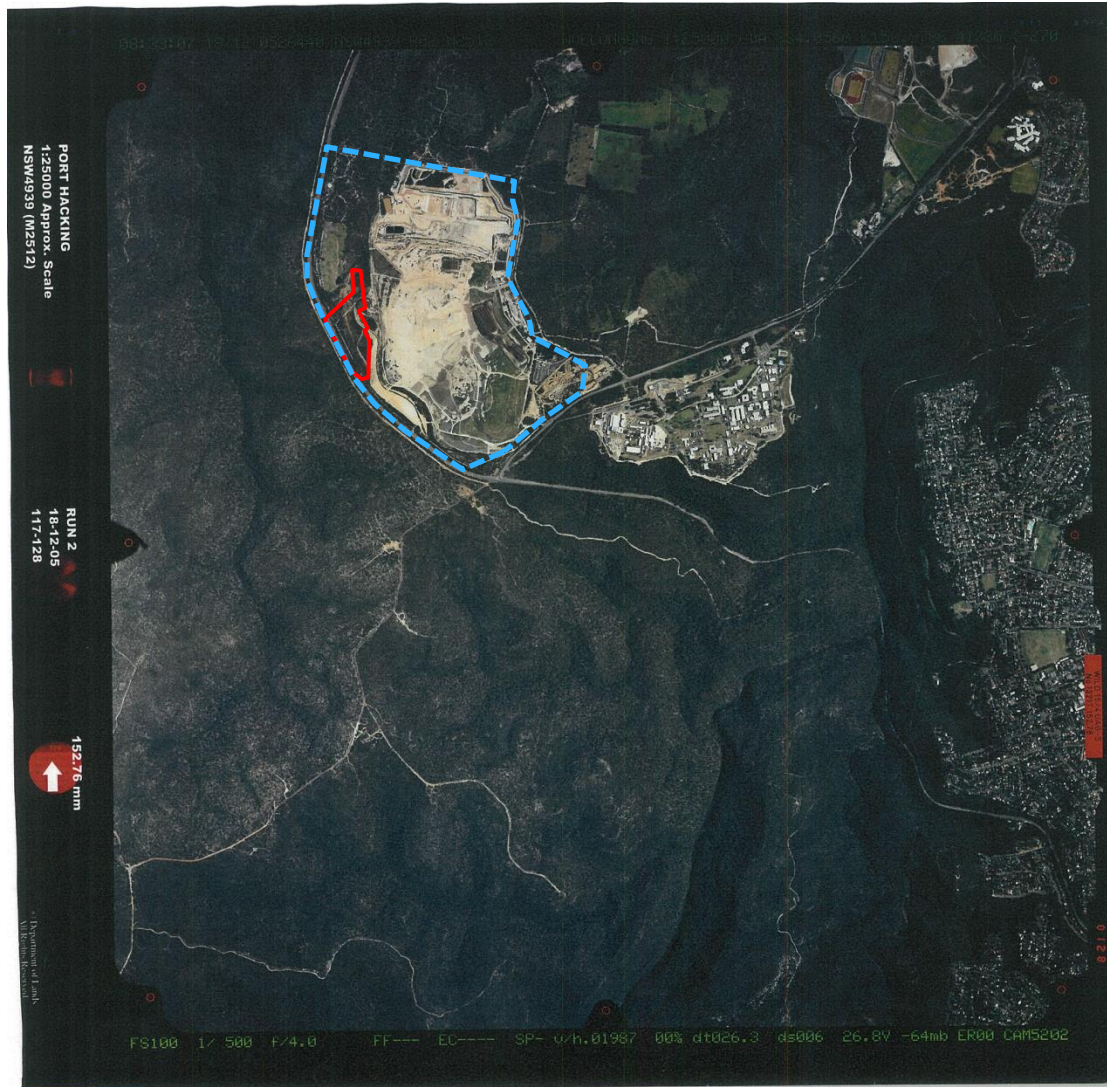
**2005**

Approximate site location -----  
Approximate LHRRP -----

Left: full photograph provided.  
Above: close up of site

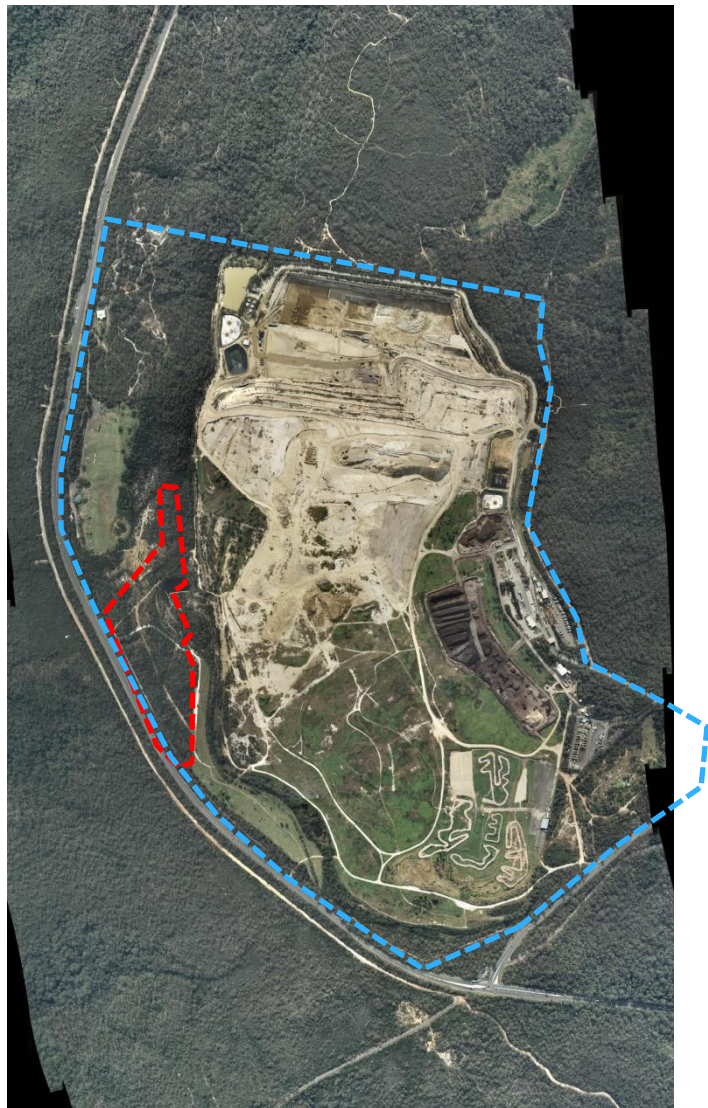
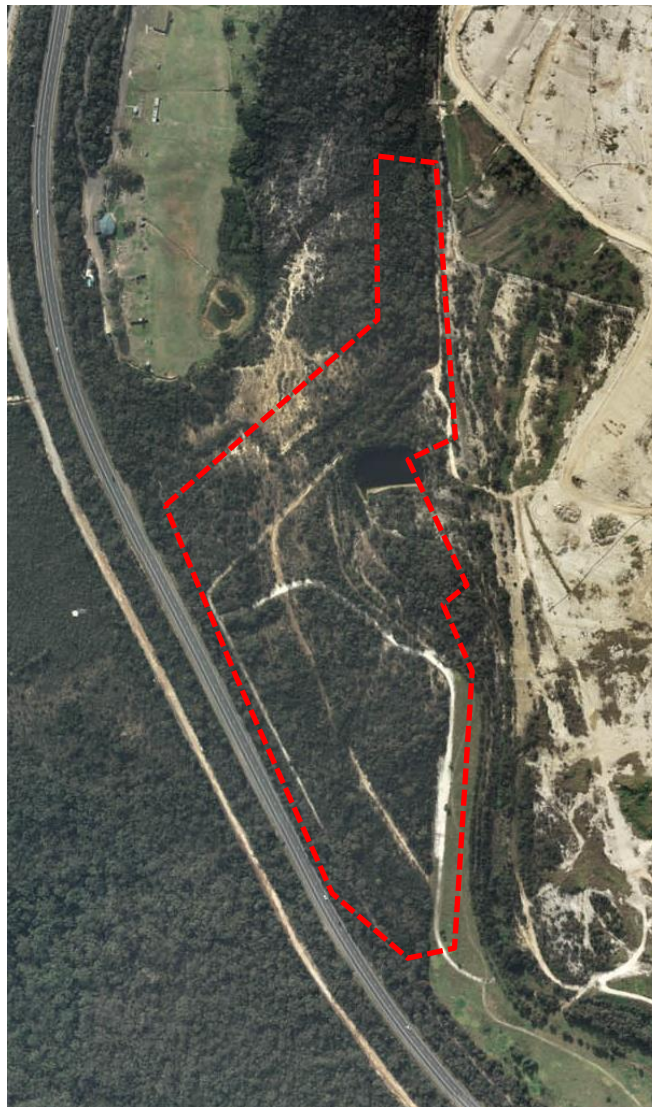
Approximate site location    - - - - -

Approximate LHRRP    - - - - -

Left: full photograph provided.  
Above: close up of site
