## **Groundwater Management Plan**

**Lucas Heights Resource Recovery Park**

**19 Little Forest Road, Lucas Heights NSW**

**Project 85988.06**

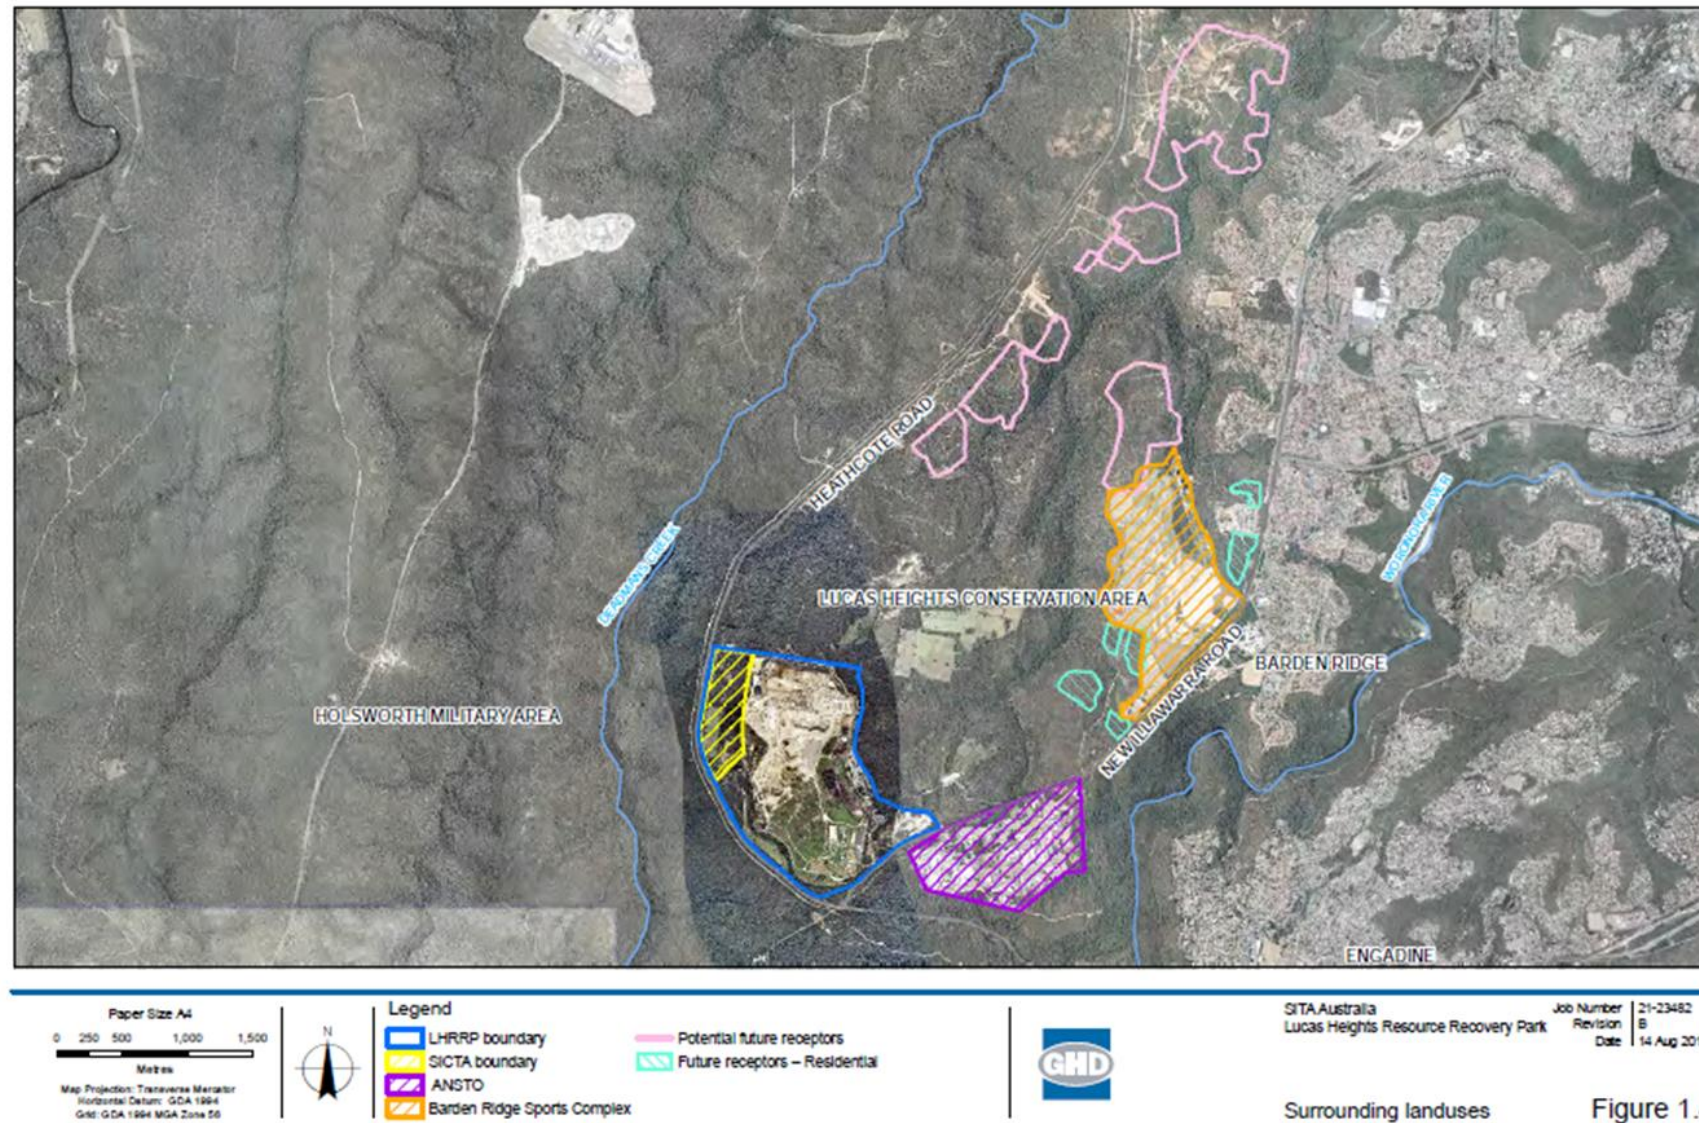
**Figure 1: Site location and surrounding features (GHD 2015)**

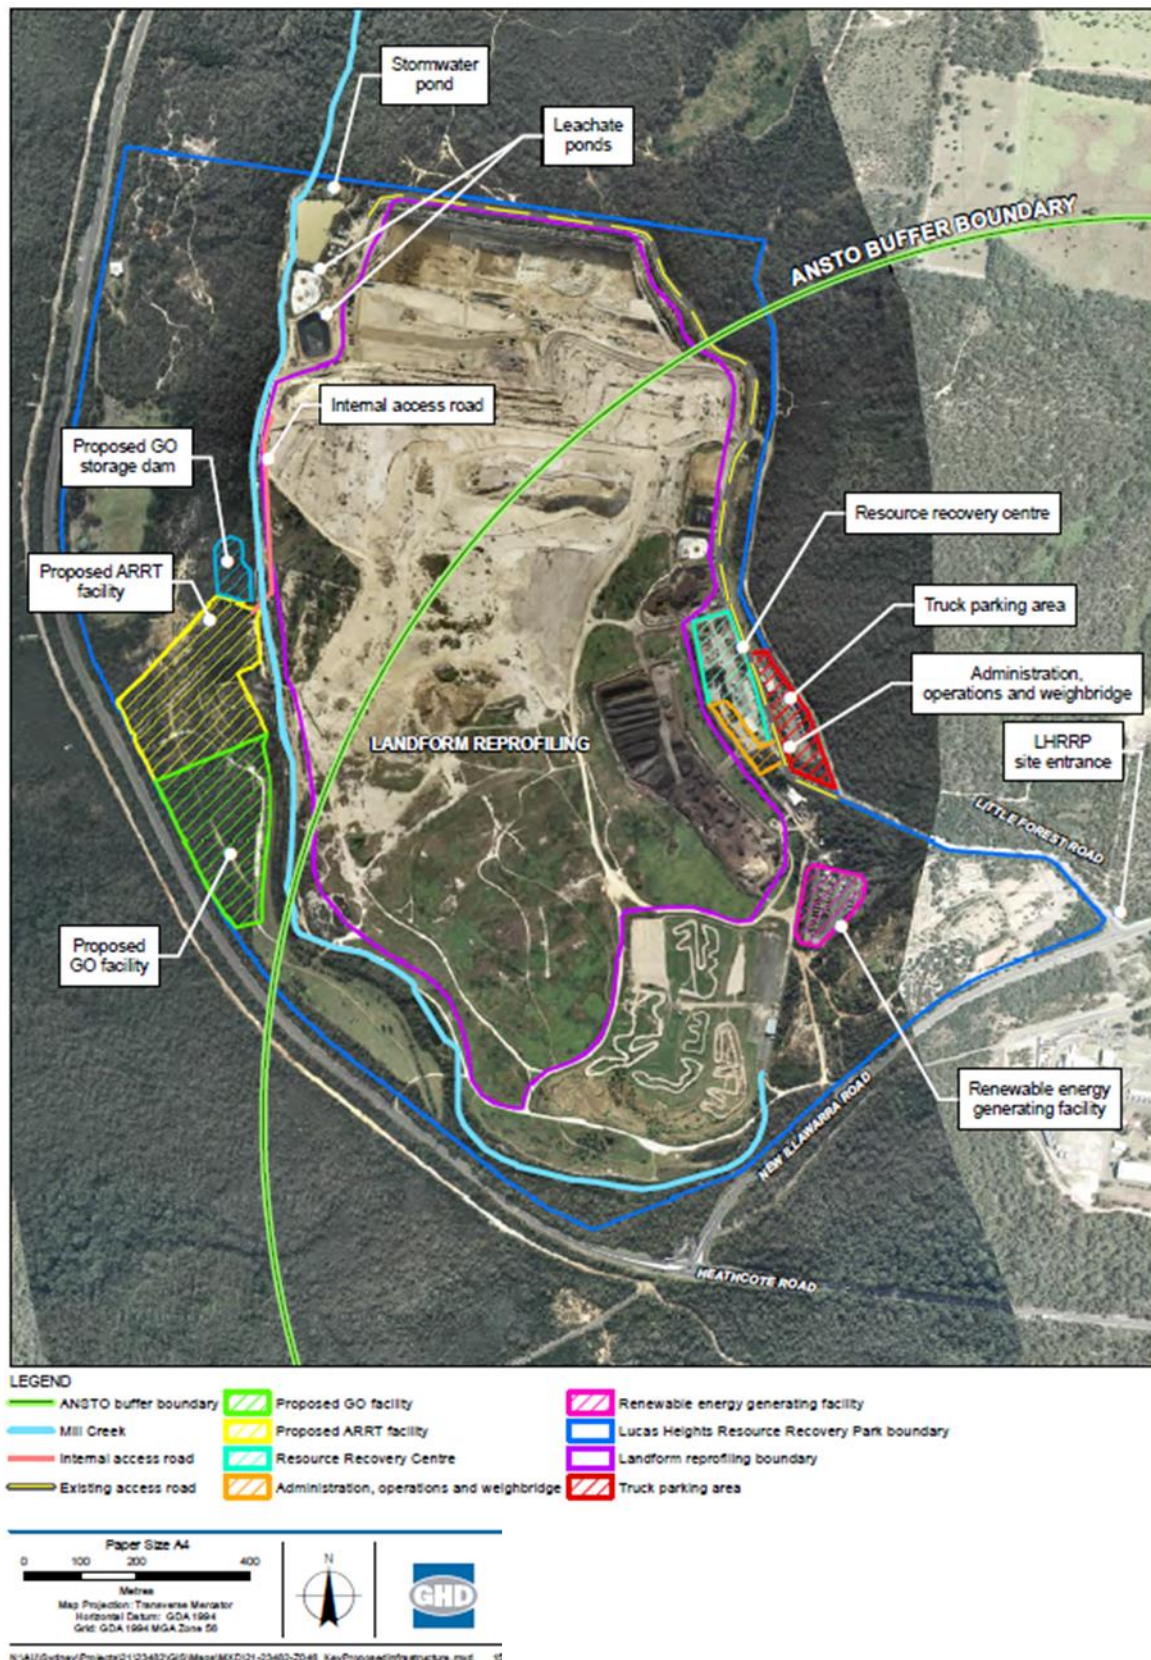
**Figure 2: Approved works (from GHD 2015)**

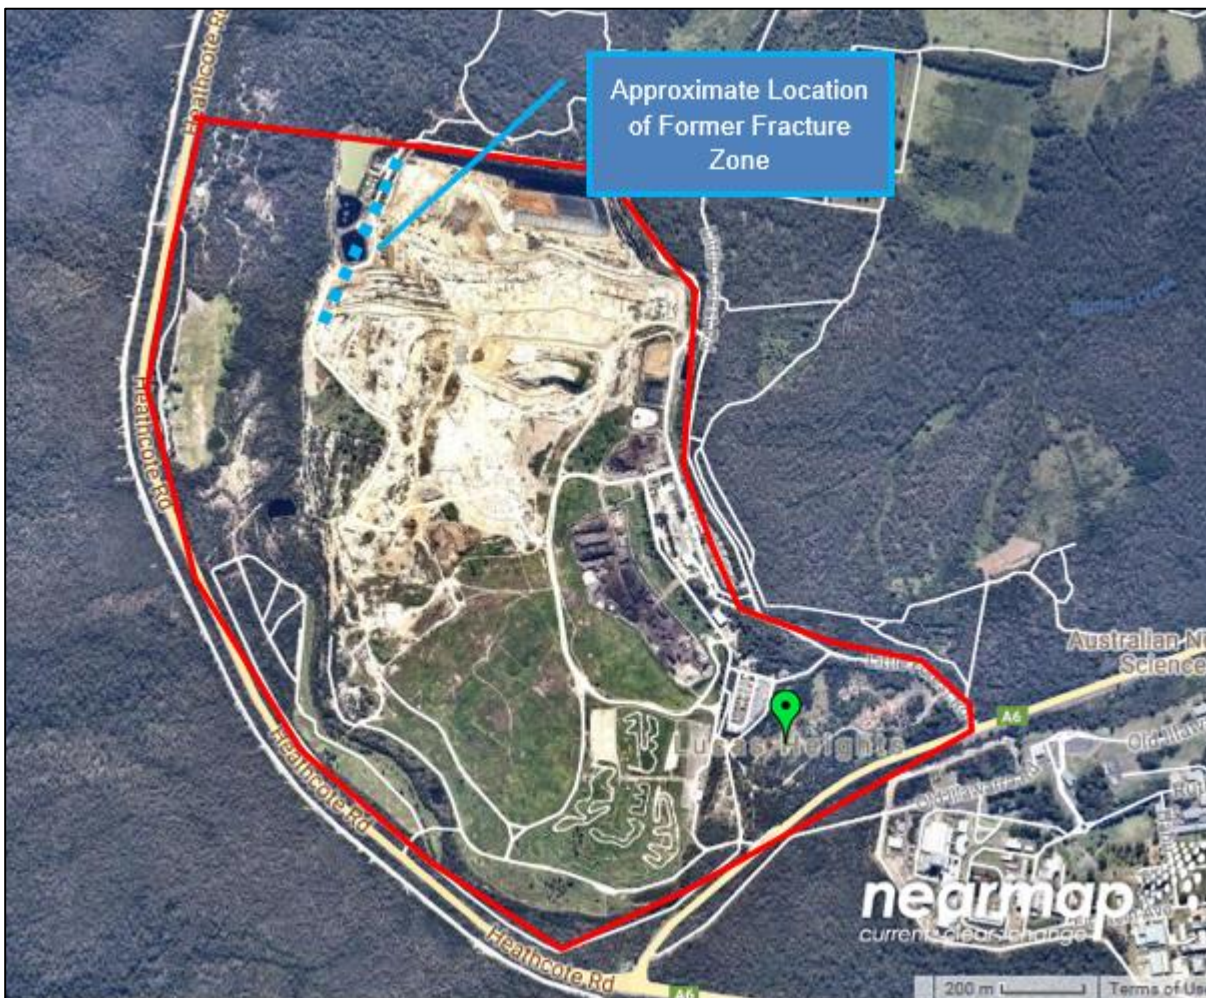
**Figure 3: Approximate location of former fracture zone**

Geological mapping undertaken in 2000 (Douglas 2000) indicated that a fractured zone approximately 15 m wide was present in the northern face of the landfill excavation (NE corner of landfill site, refer to Figure 3 for approximate location) which may have been induced by blasting. The permeability in the fracture zone would be expected to be higher than the surrounding lithology. It is noted that since 2000 the landfill batter has been excavated further, effectively removing the fracture zone (or the majority of it). This area was subsequently lined with a geo-synthetic liner and landfilled.

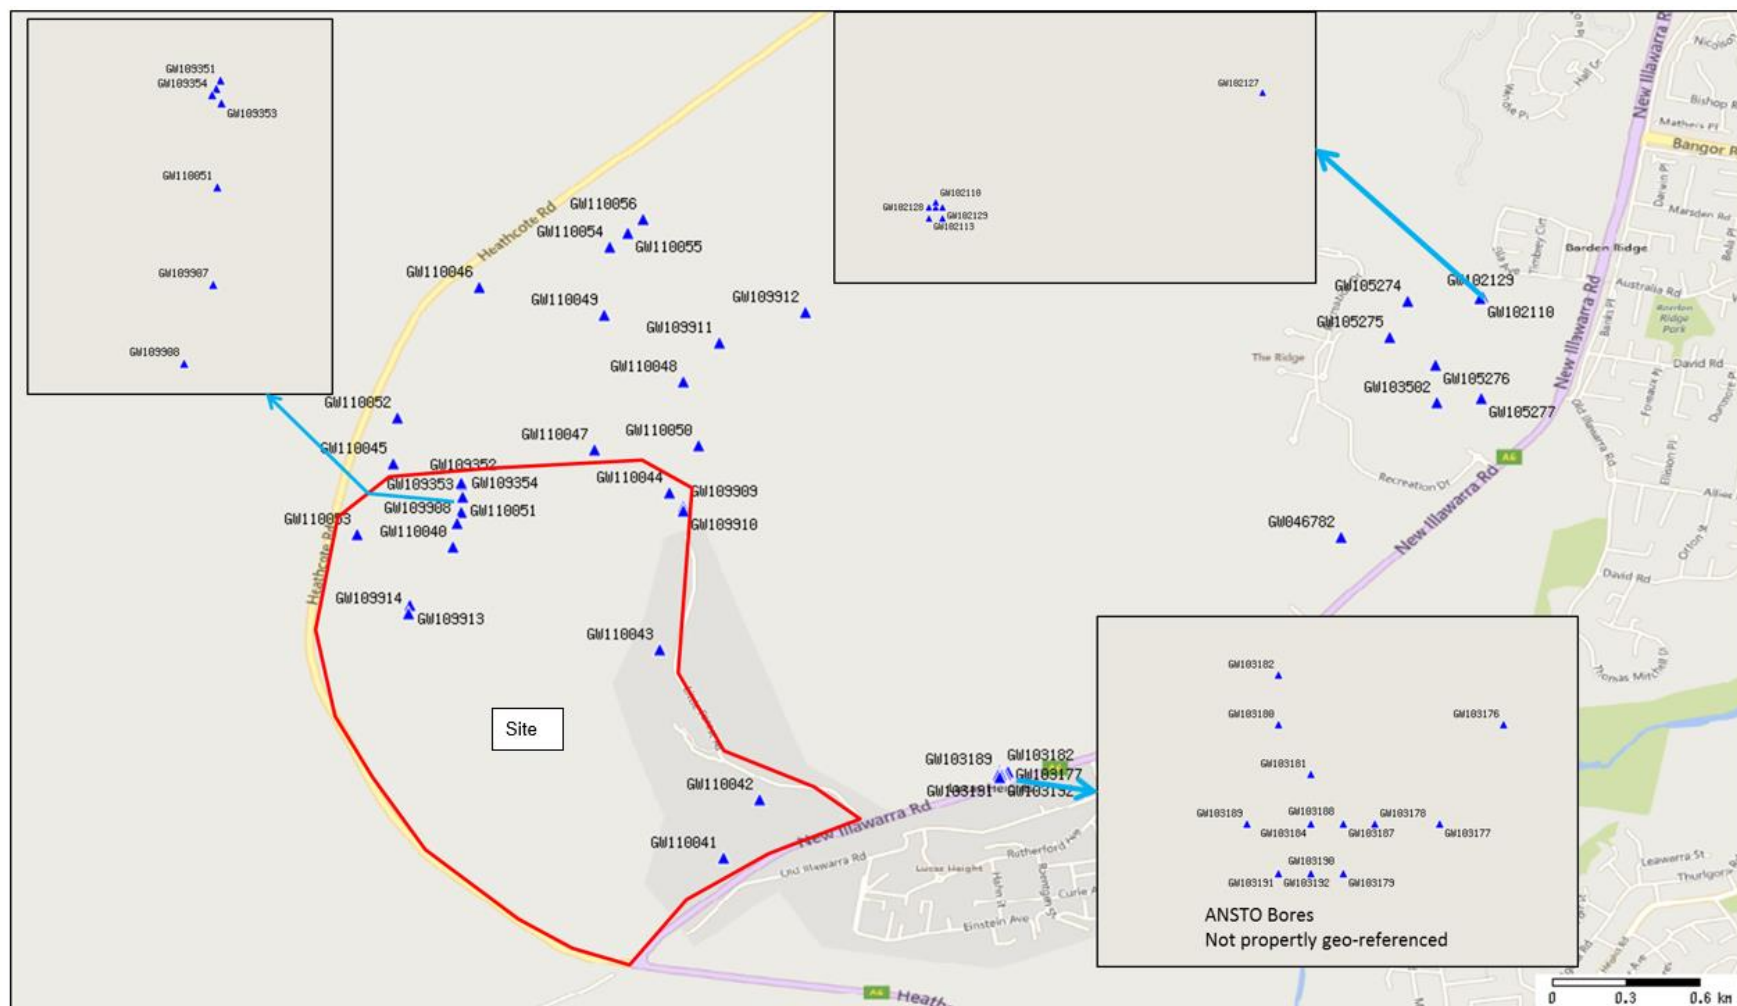
#### Figure 4: Registered groundwater bores

At present little use is made of the groundwater of the Woronora Plateau for either domestic or agricultural purposes. Douglas conducted a review of existing registered groundwater borehole records using the NSW Water Information Database. The location of the registered groundwater bores is presented in Figure 4 and the bore details are summarised in Table 1. The licenced groundwater bores are associated with three different properties and all are used for monitoring purposes. The majority of the bores are located within or to the north of the LHRRP, eleven of the bores were related to the former Lucas Heights Waste and Recycling Centre Lucas Heights Landfill located approximately 2.5 km north-east of the site and fifteen of the registered bores are associated with ANSTO which is located the south east of the LHRRP on the opposite side of New Illawarra Road.

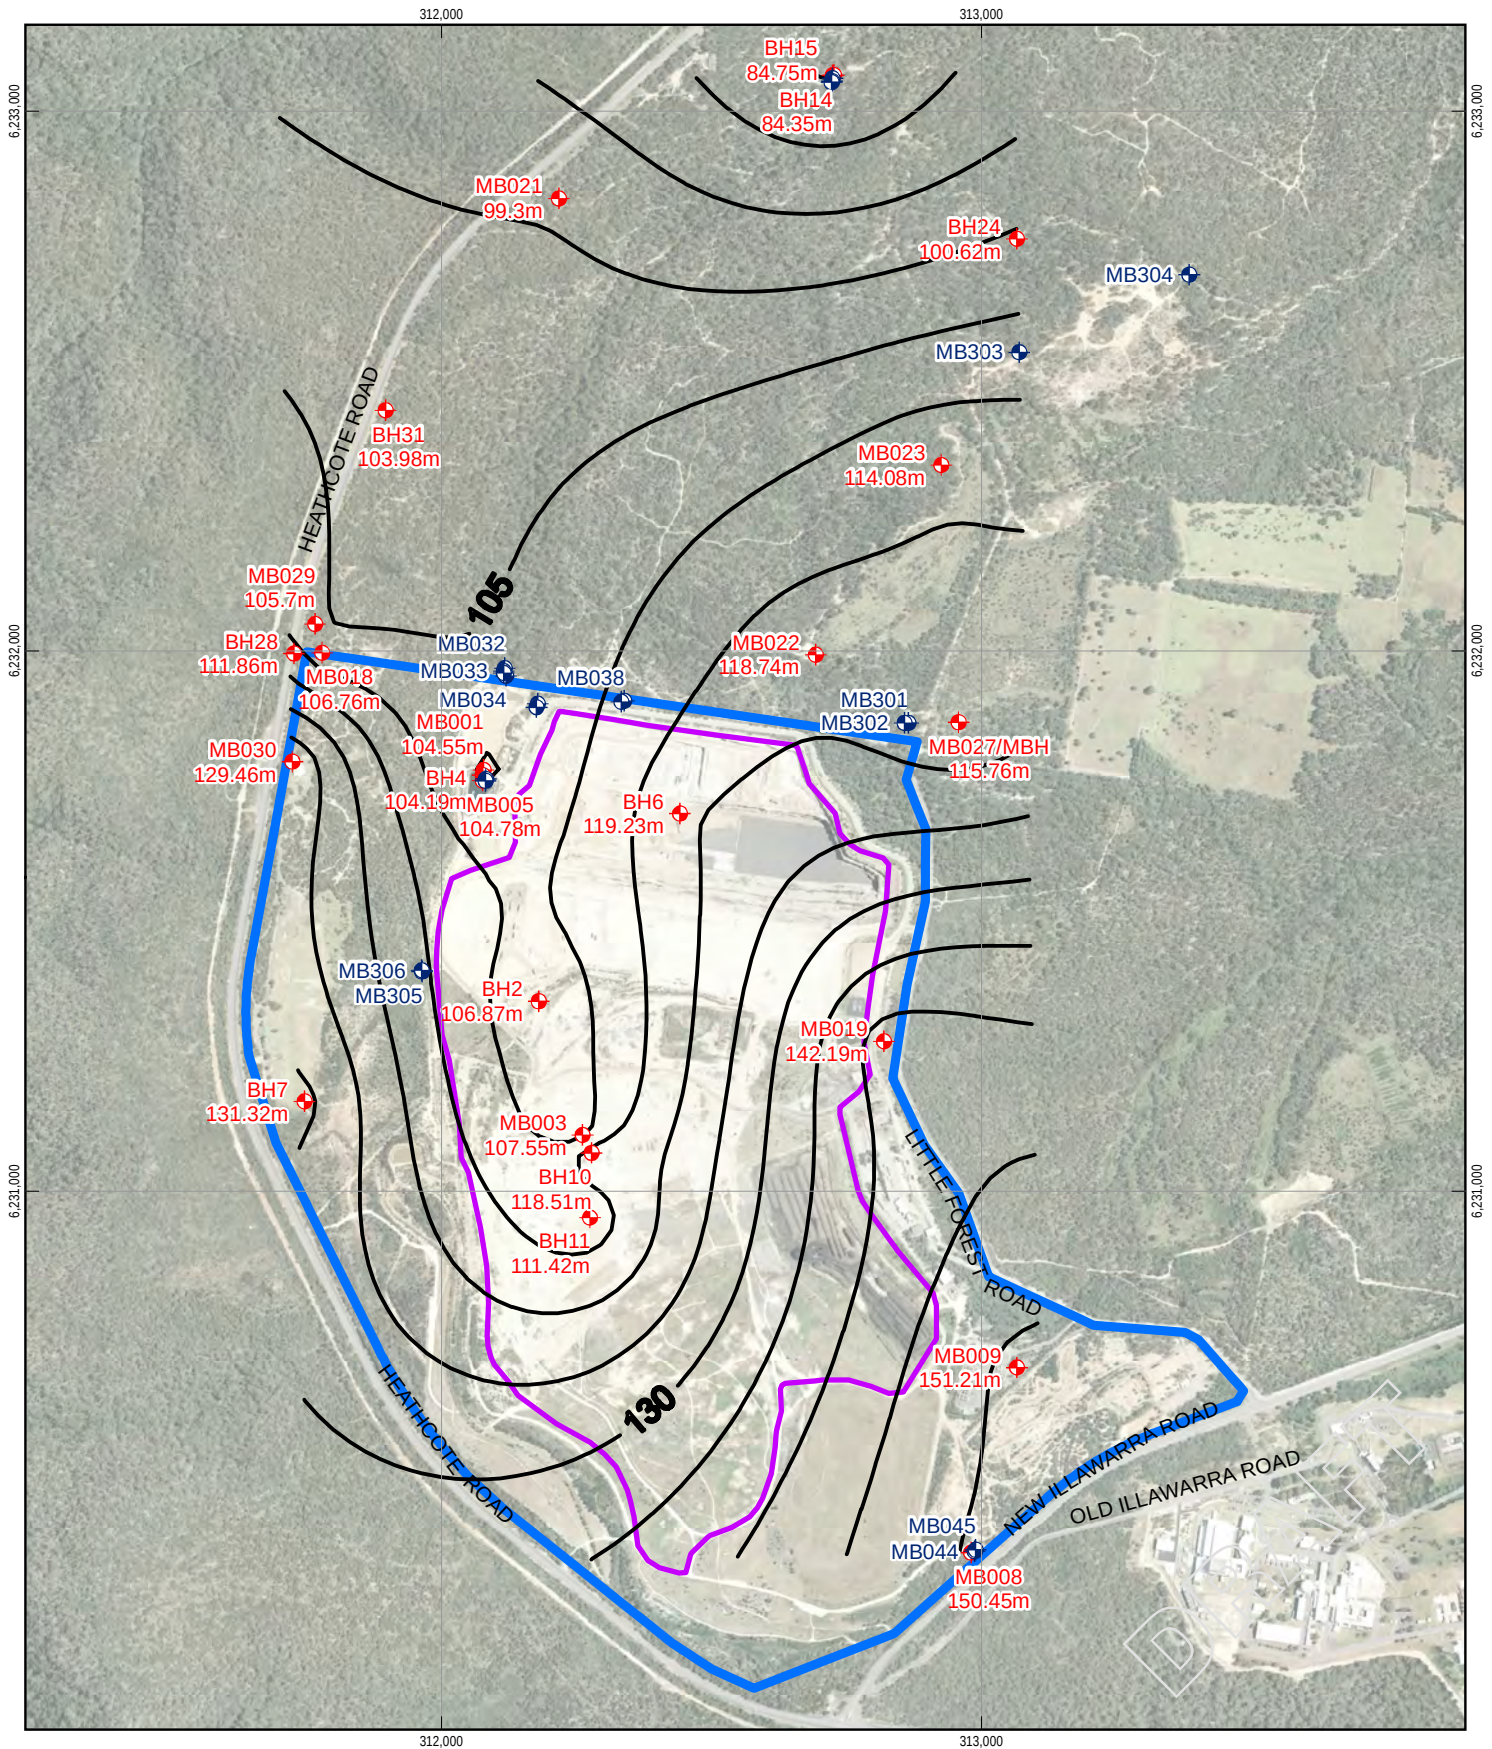
## 1992 interpreted groundwater contours Figure 1

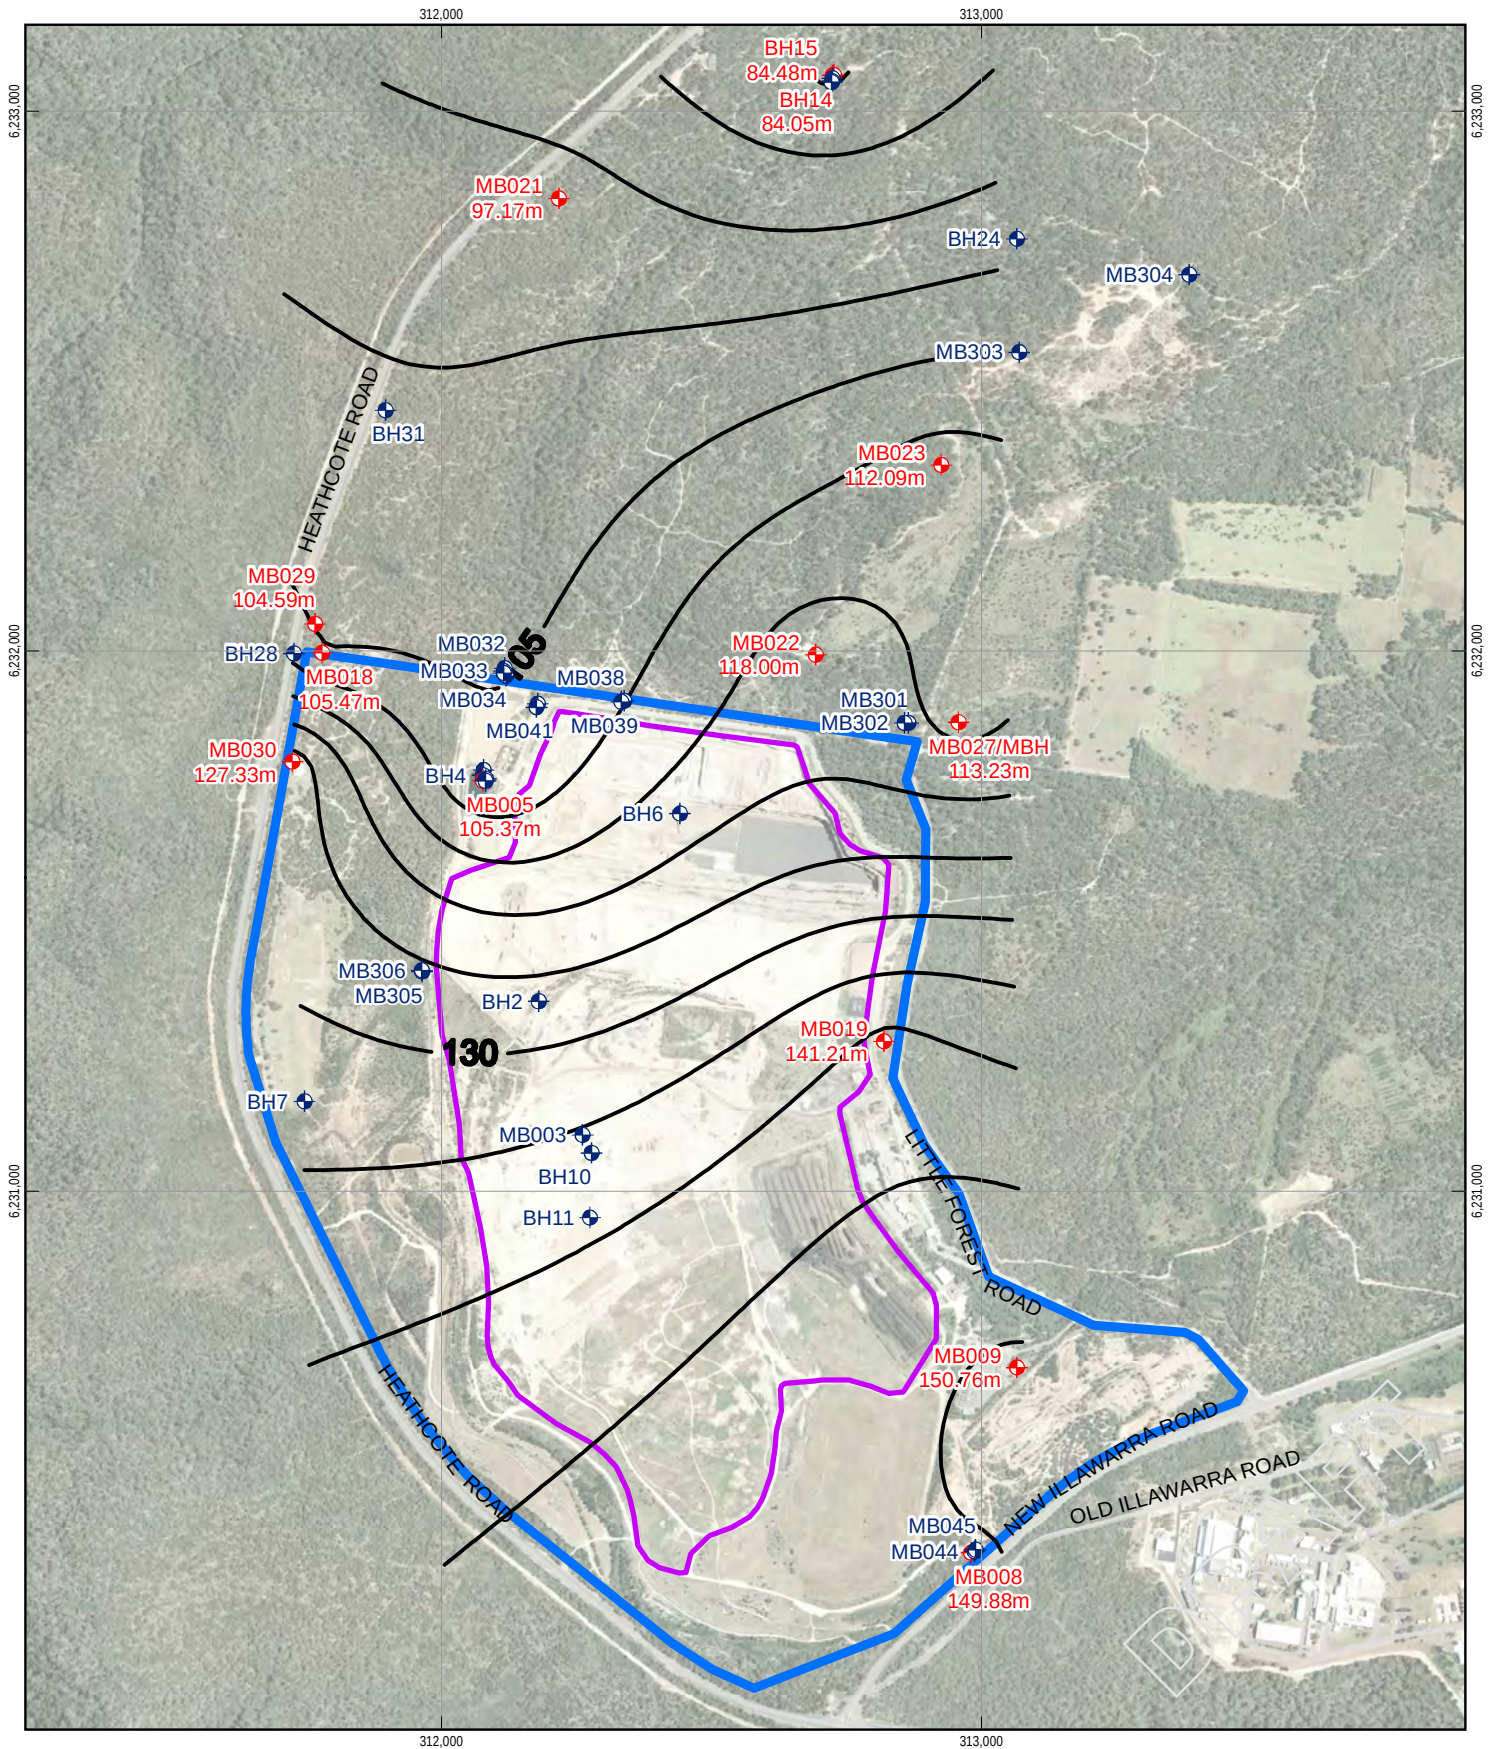
## 1997 interpreted groundwater contours Figure 1

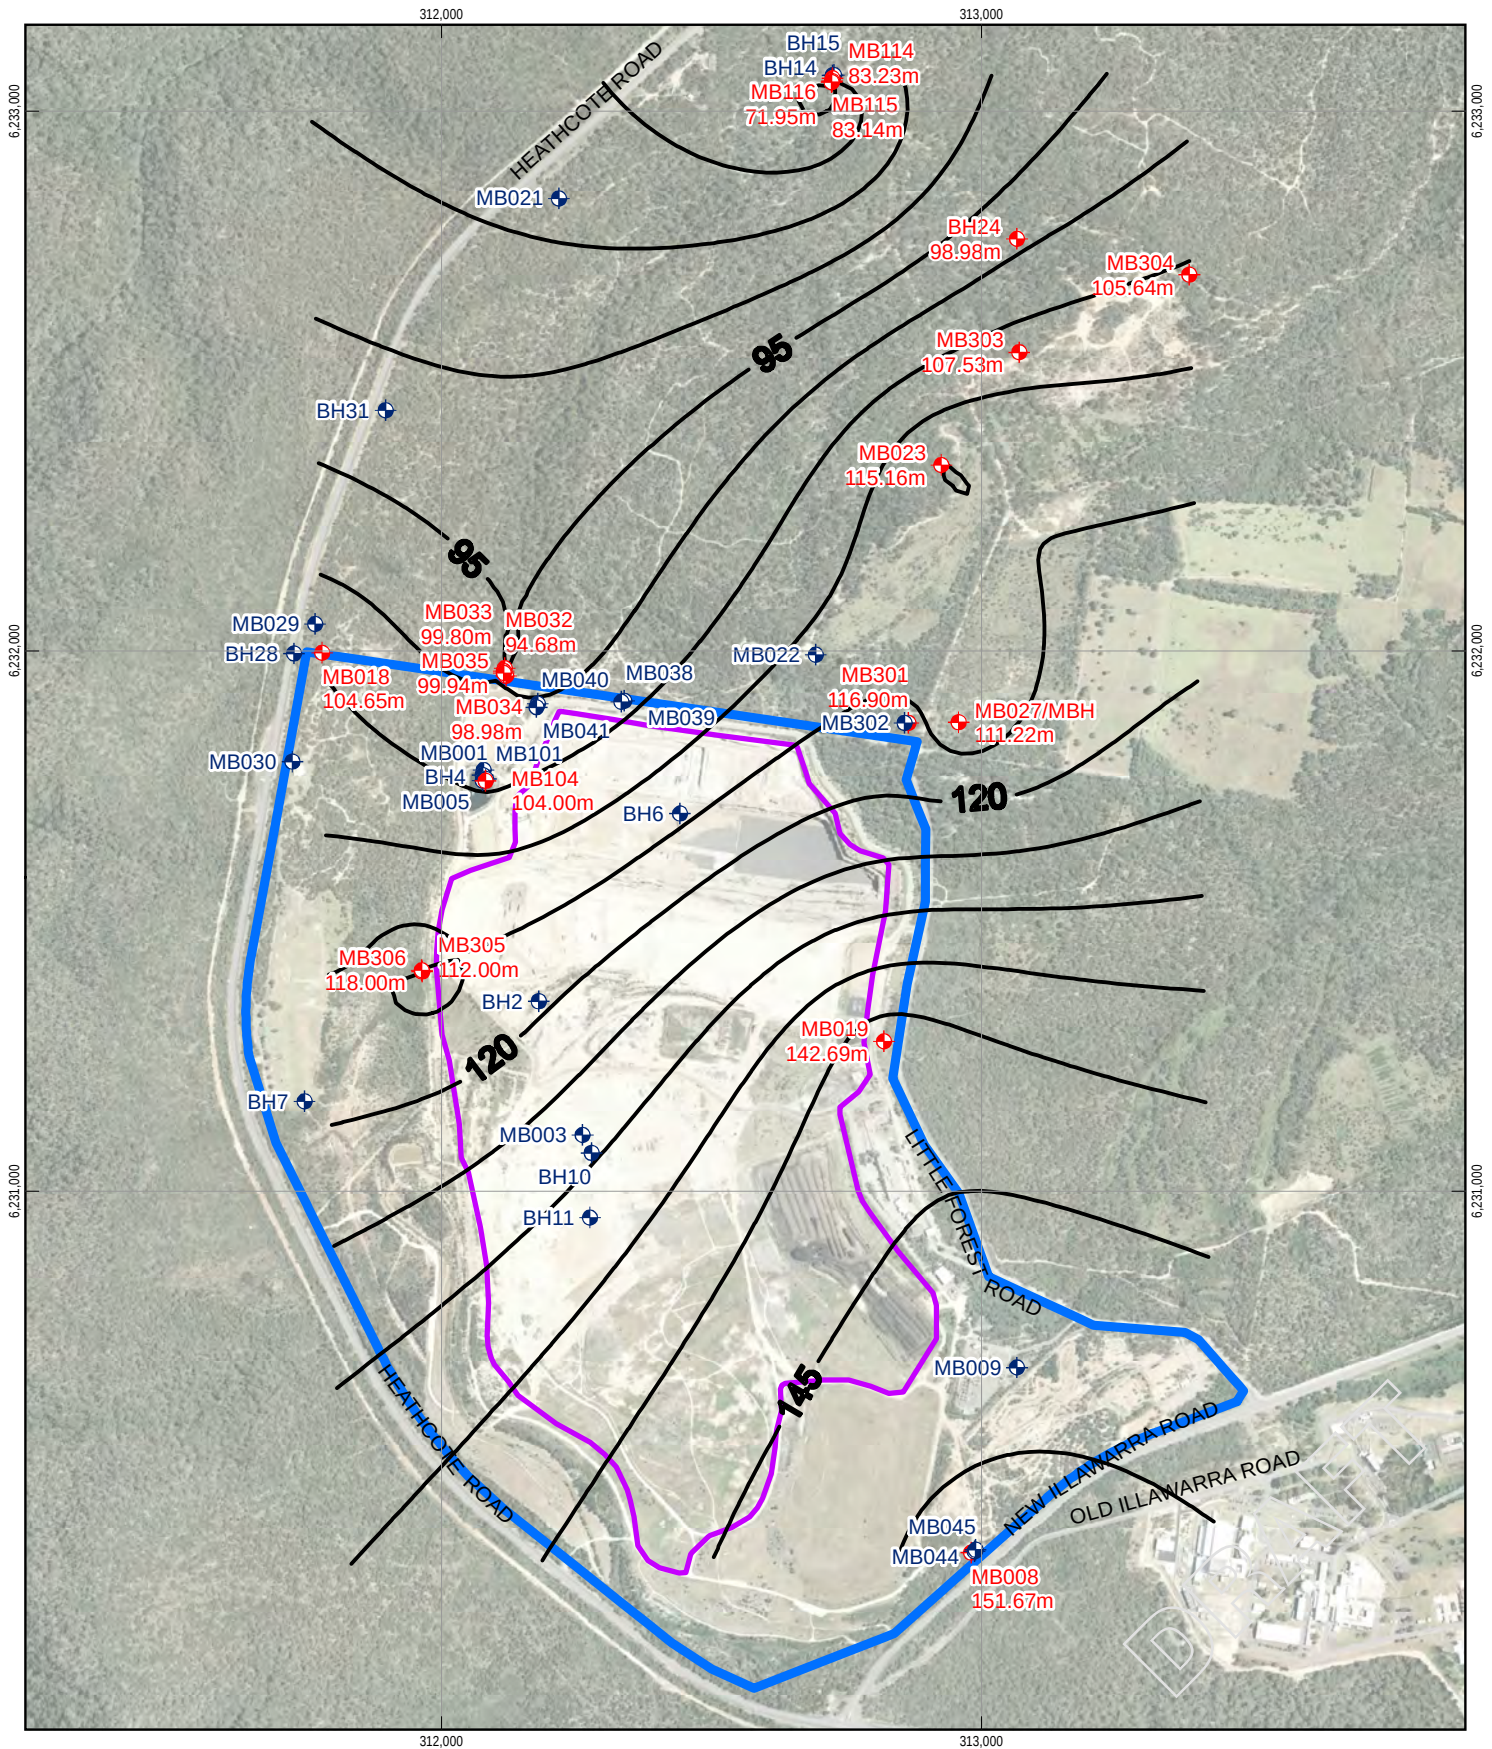
## 2005 interpreted groundwater contours Figure 1

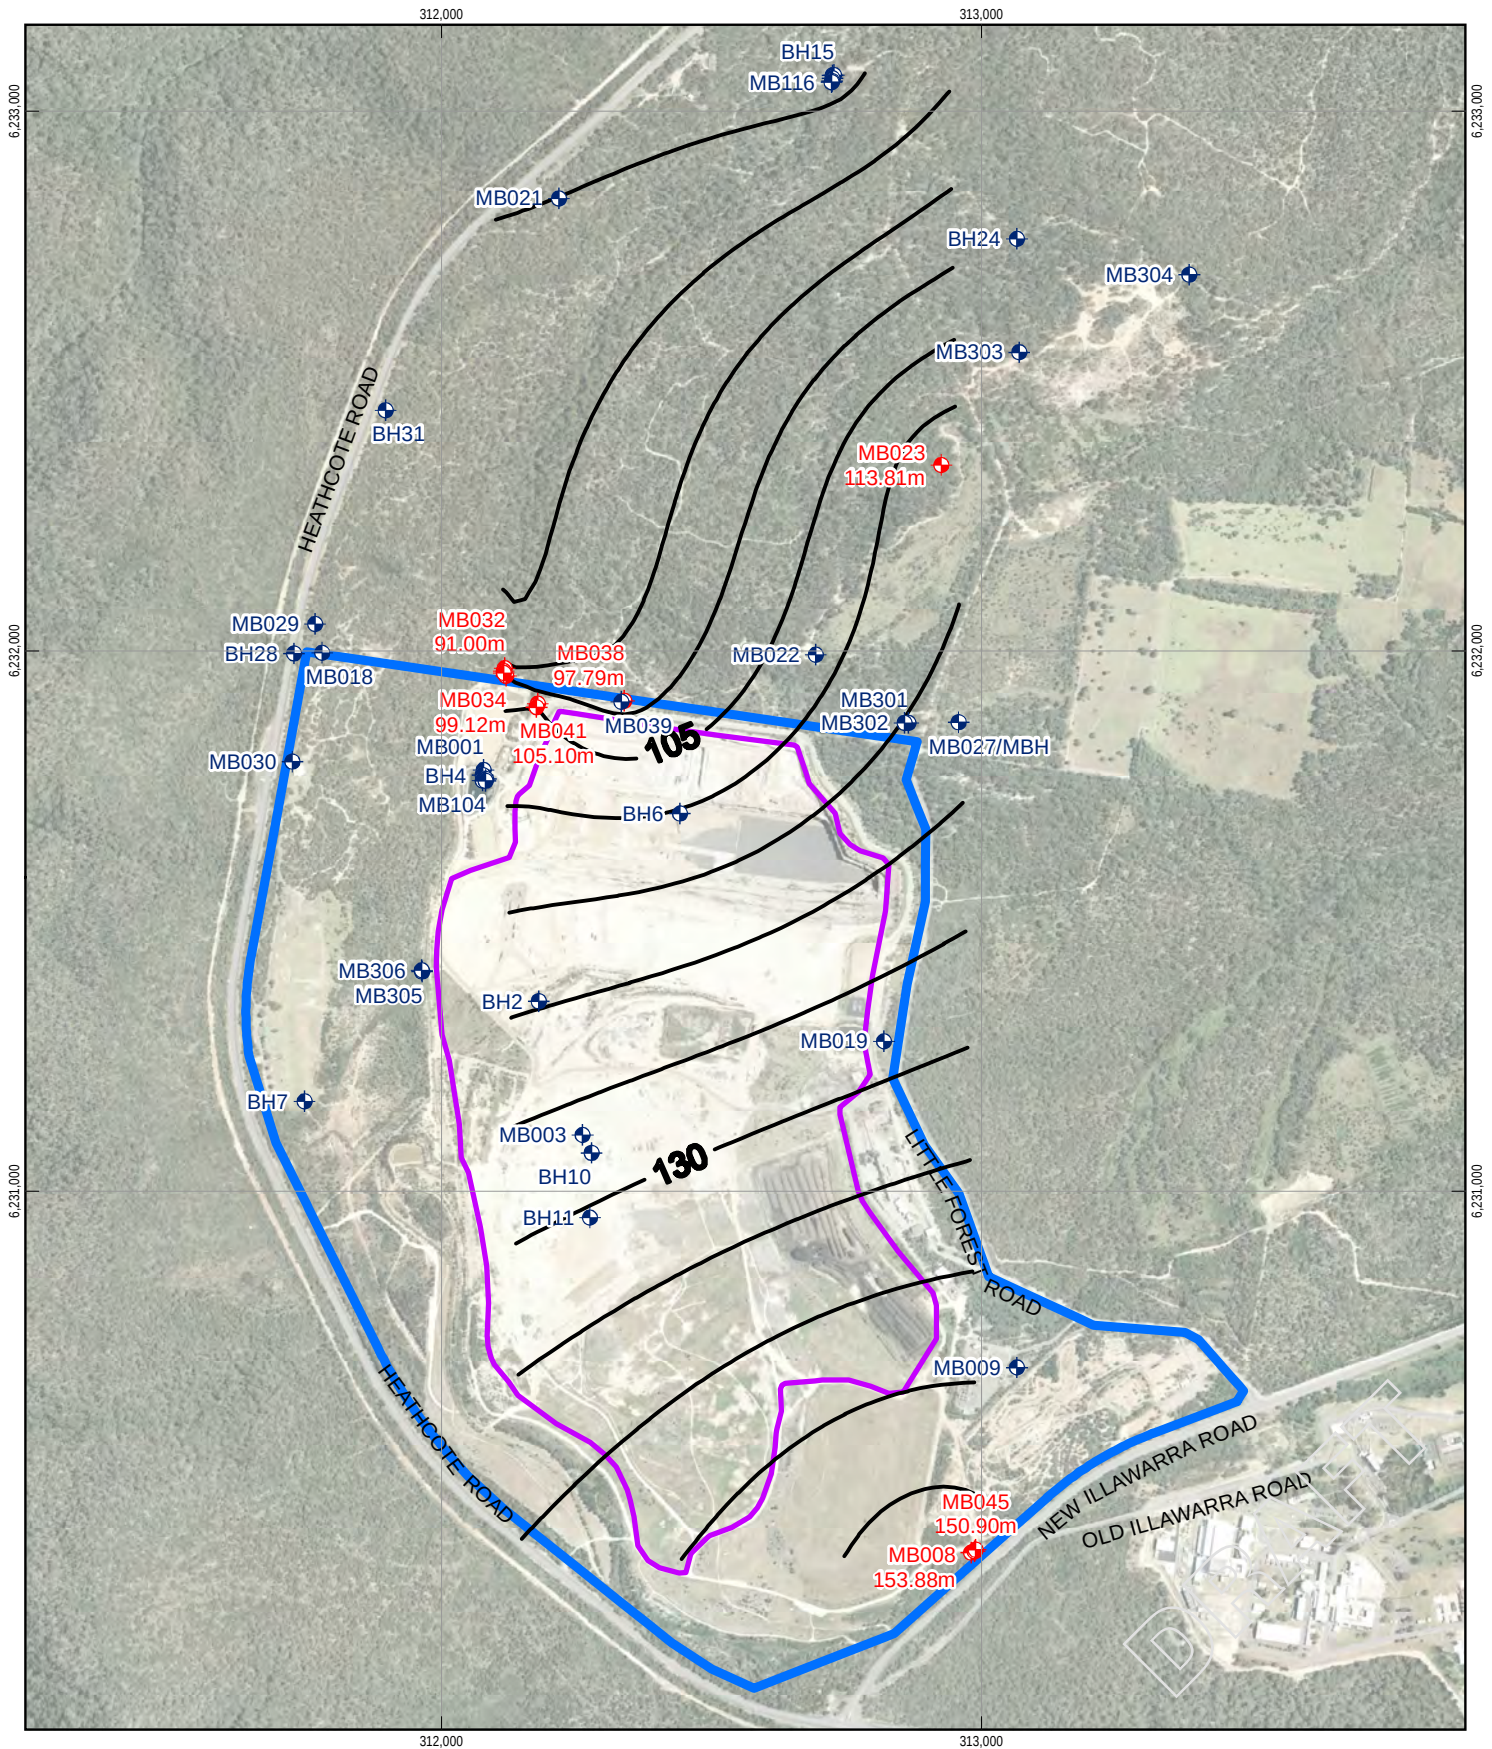
## 2014 interpreted groundwater contours Figure 1

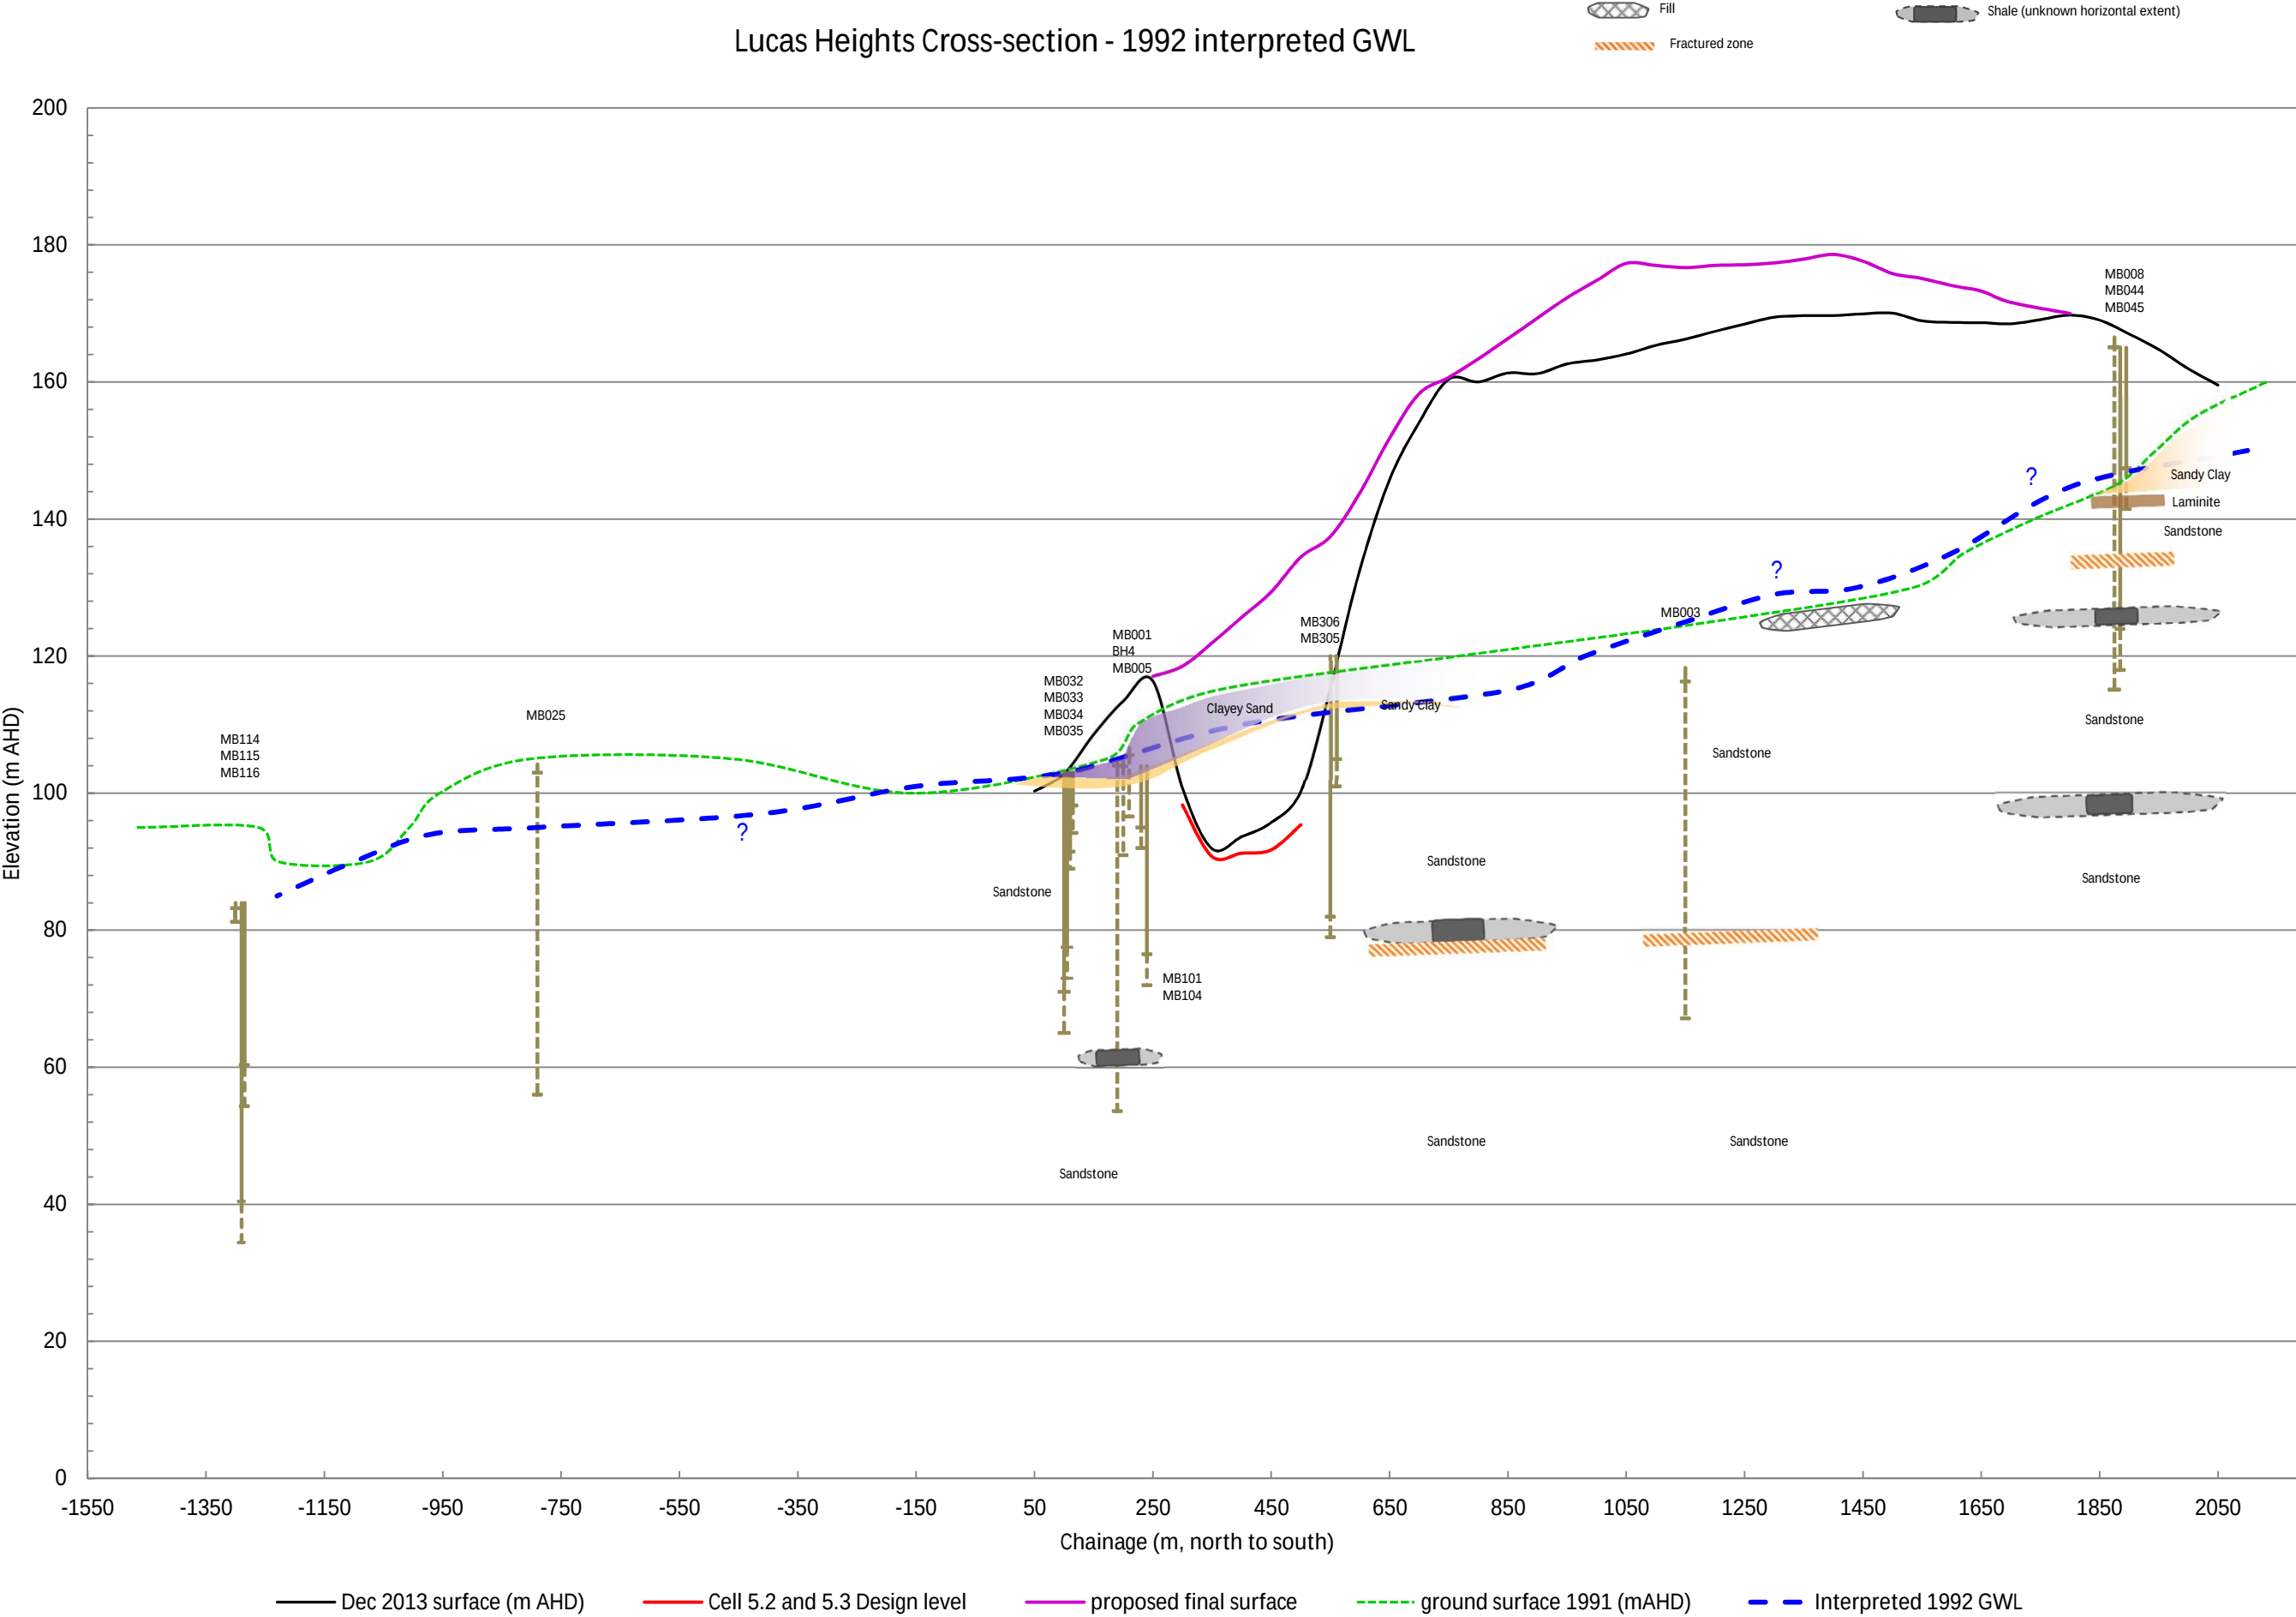
Lucas Heights Cross-section - 1992 interpreted GWL
