## **Groundwater Management Plan**

**Lucas Heights Resource Recovery Park**

**19 Little Forest Road, Lucas Heights NSW**

**Project 85988.06**

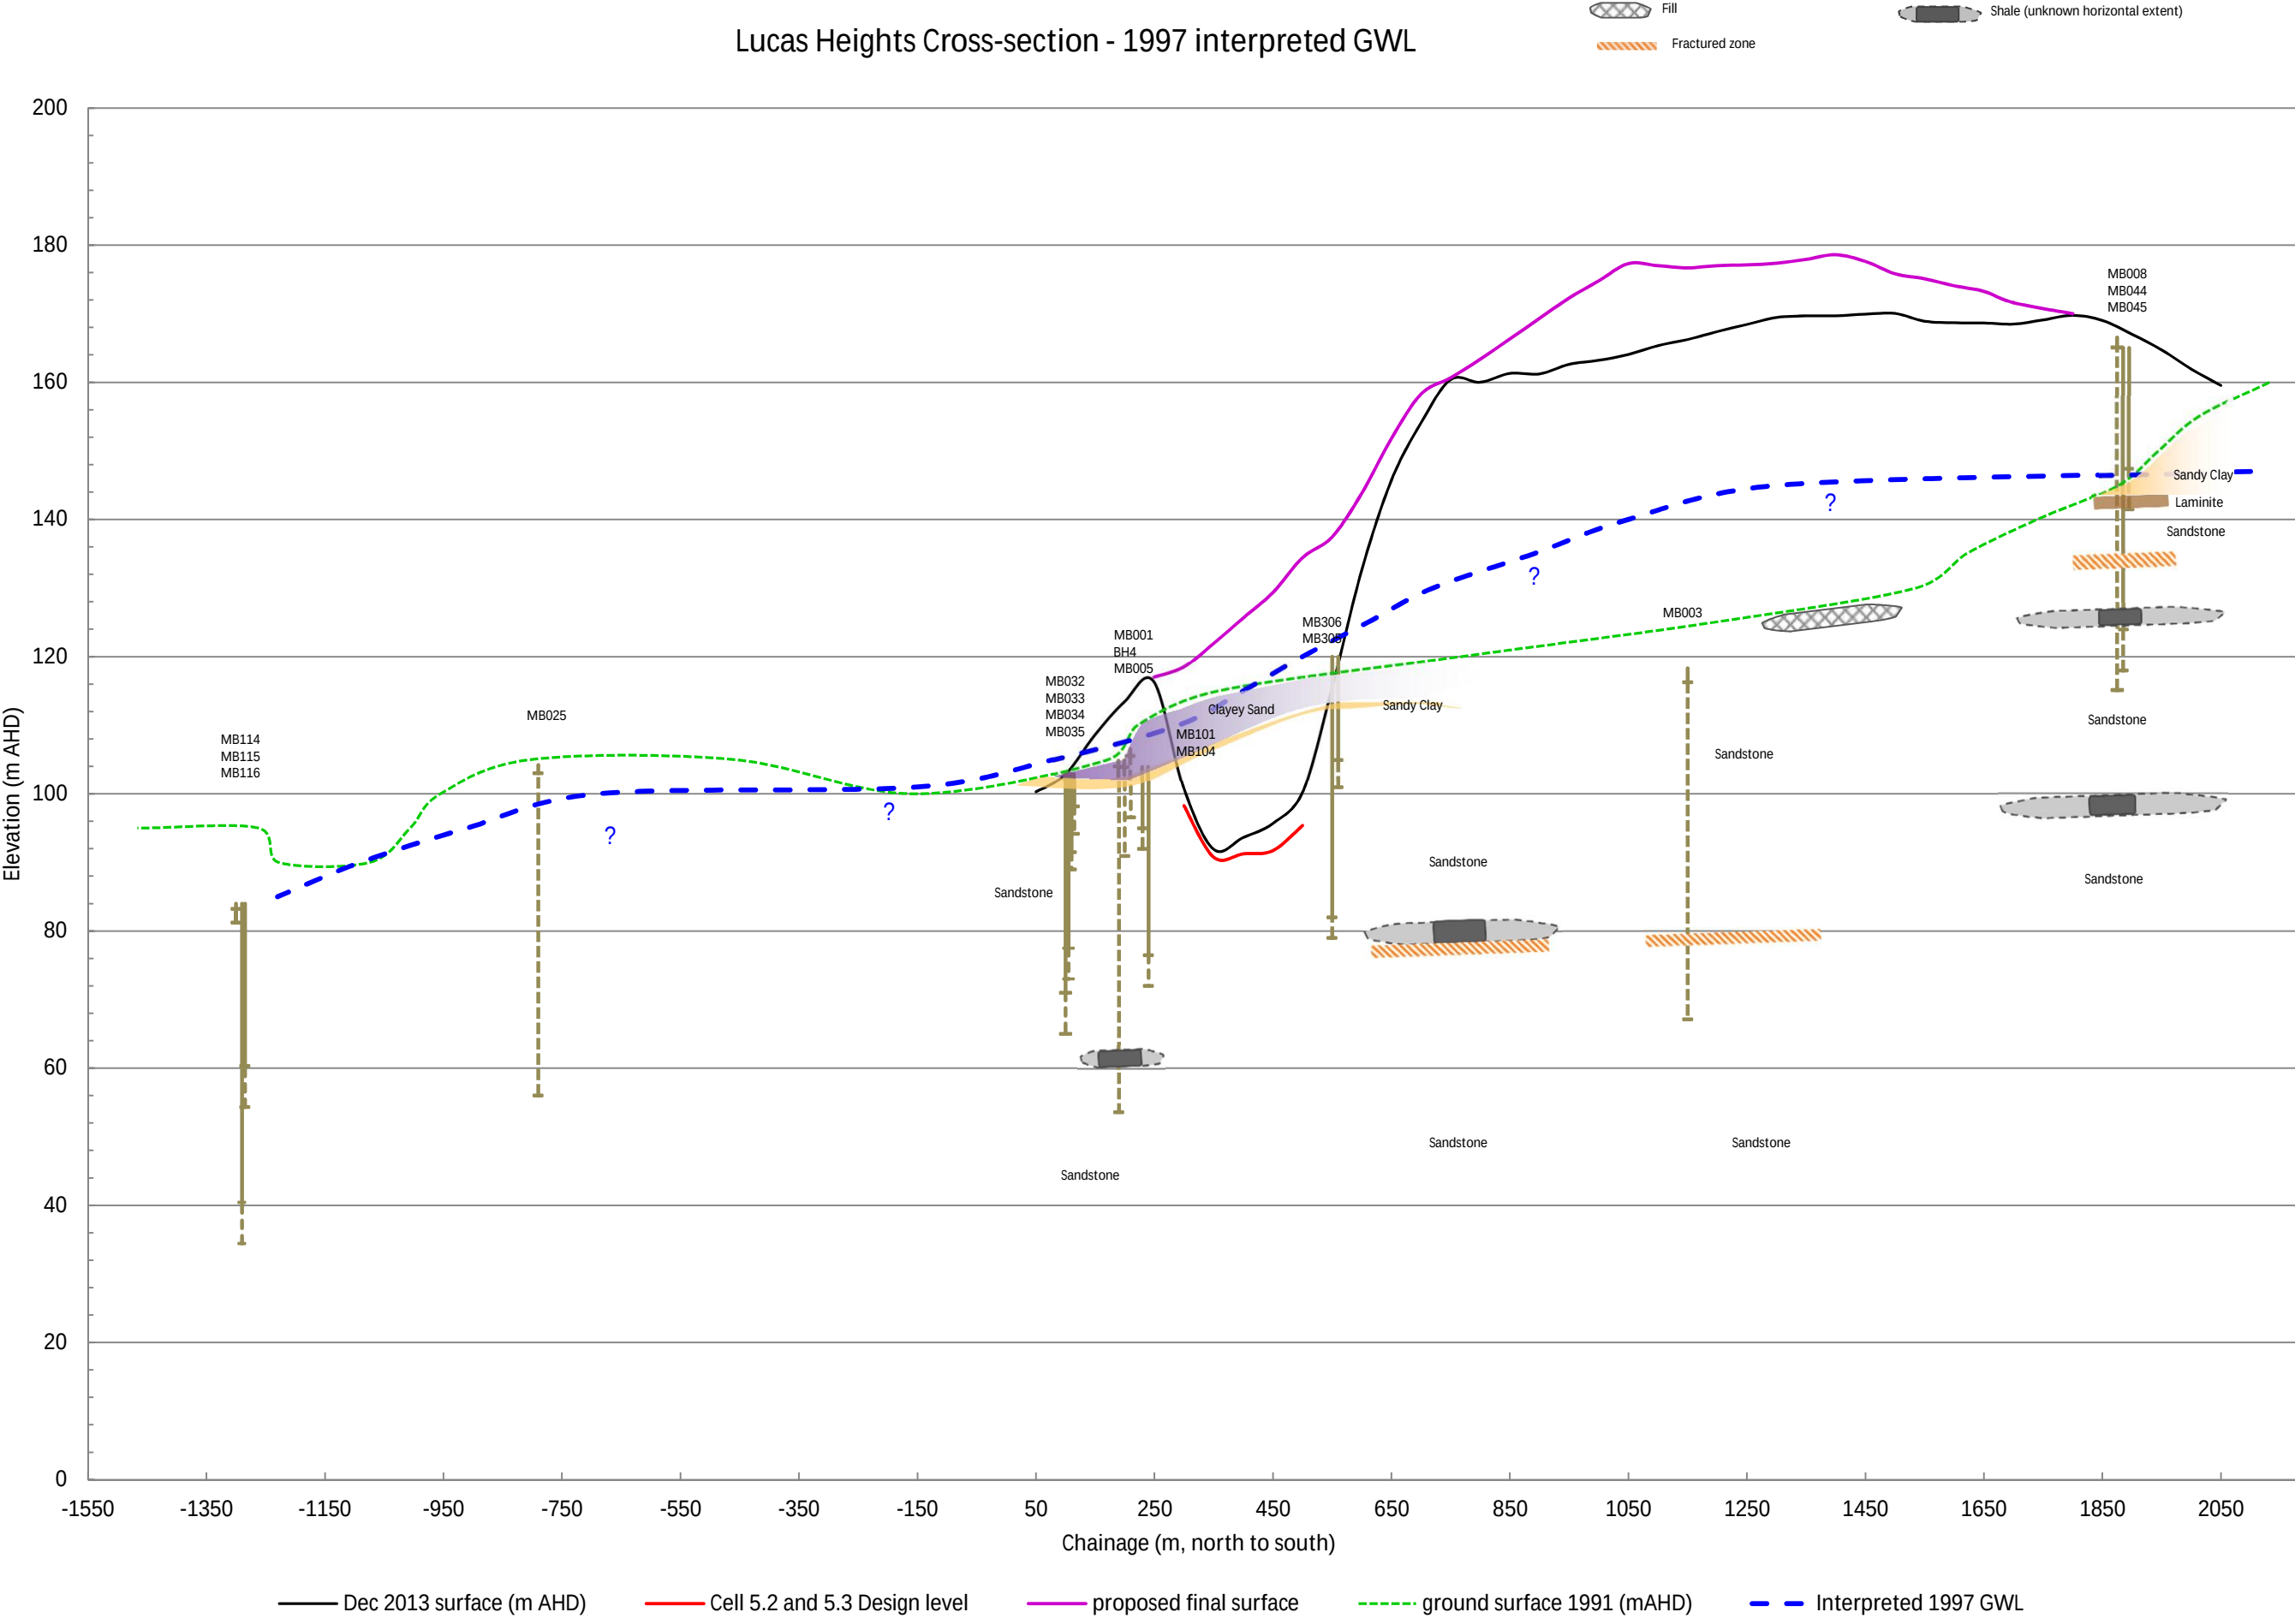
Lucas Heights Cross-section - 1997 interpreted GWL

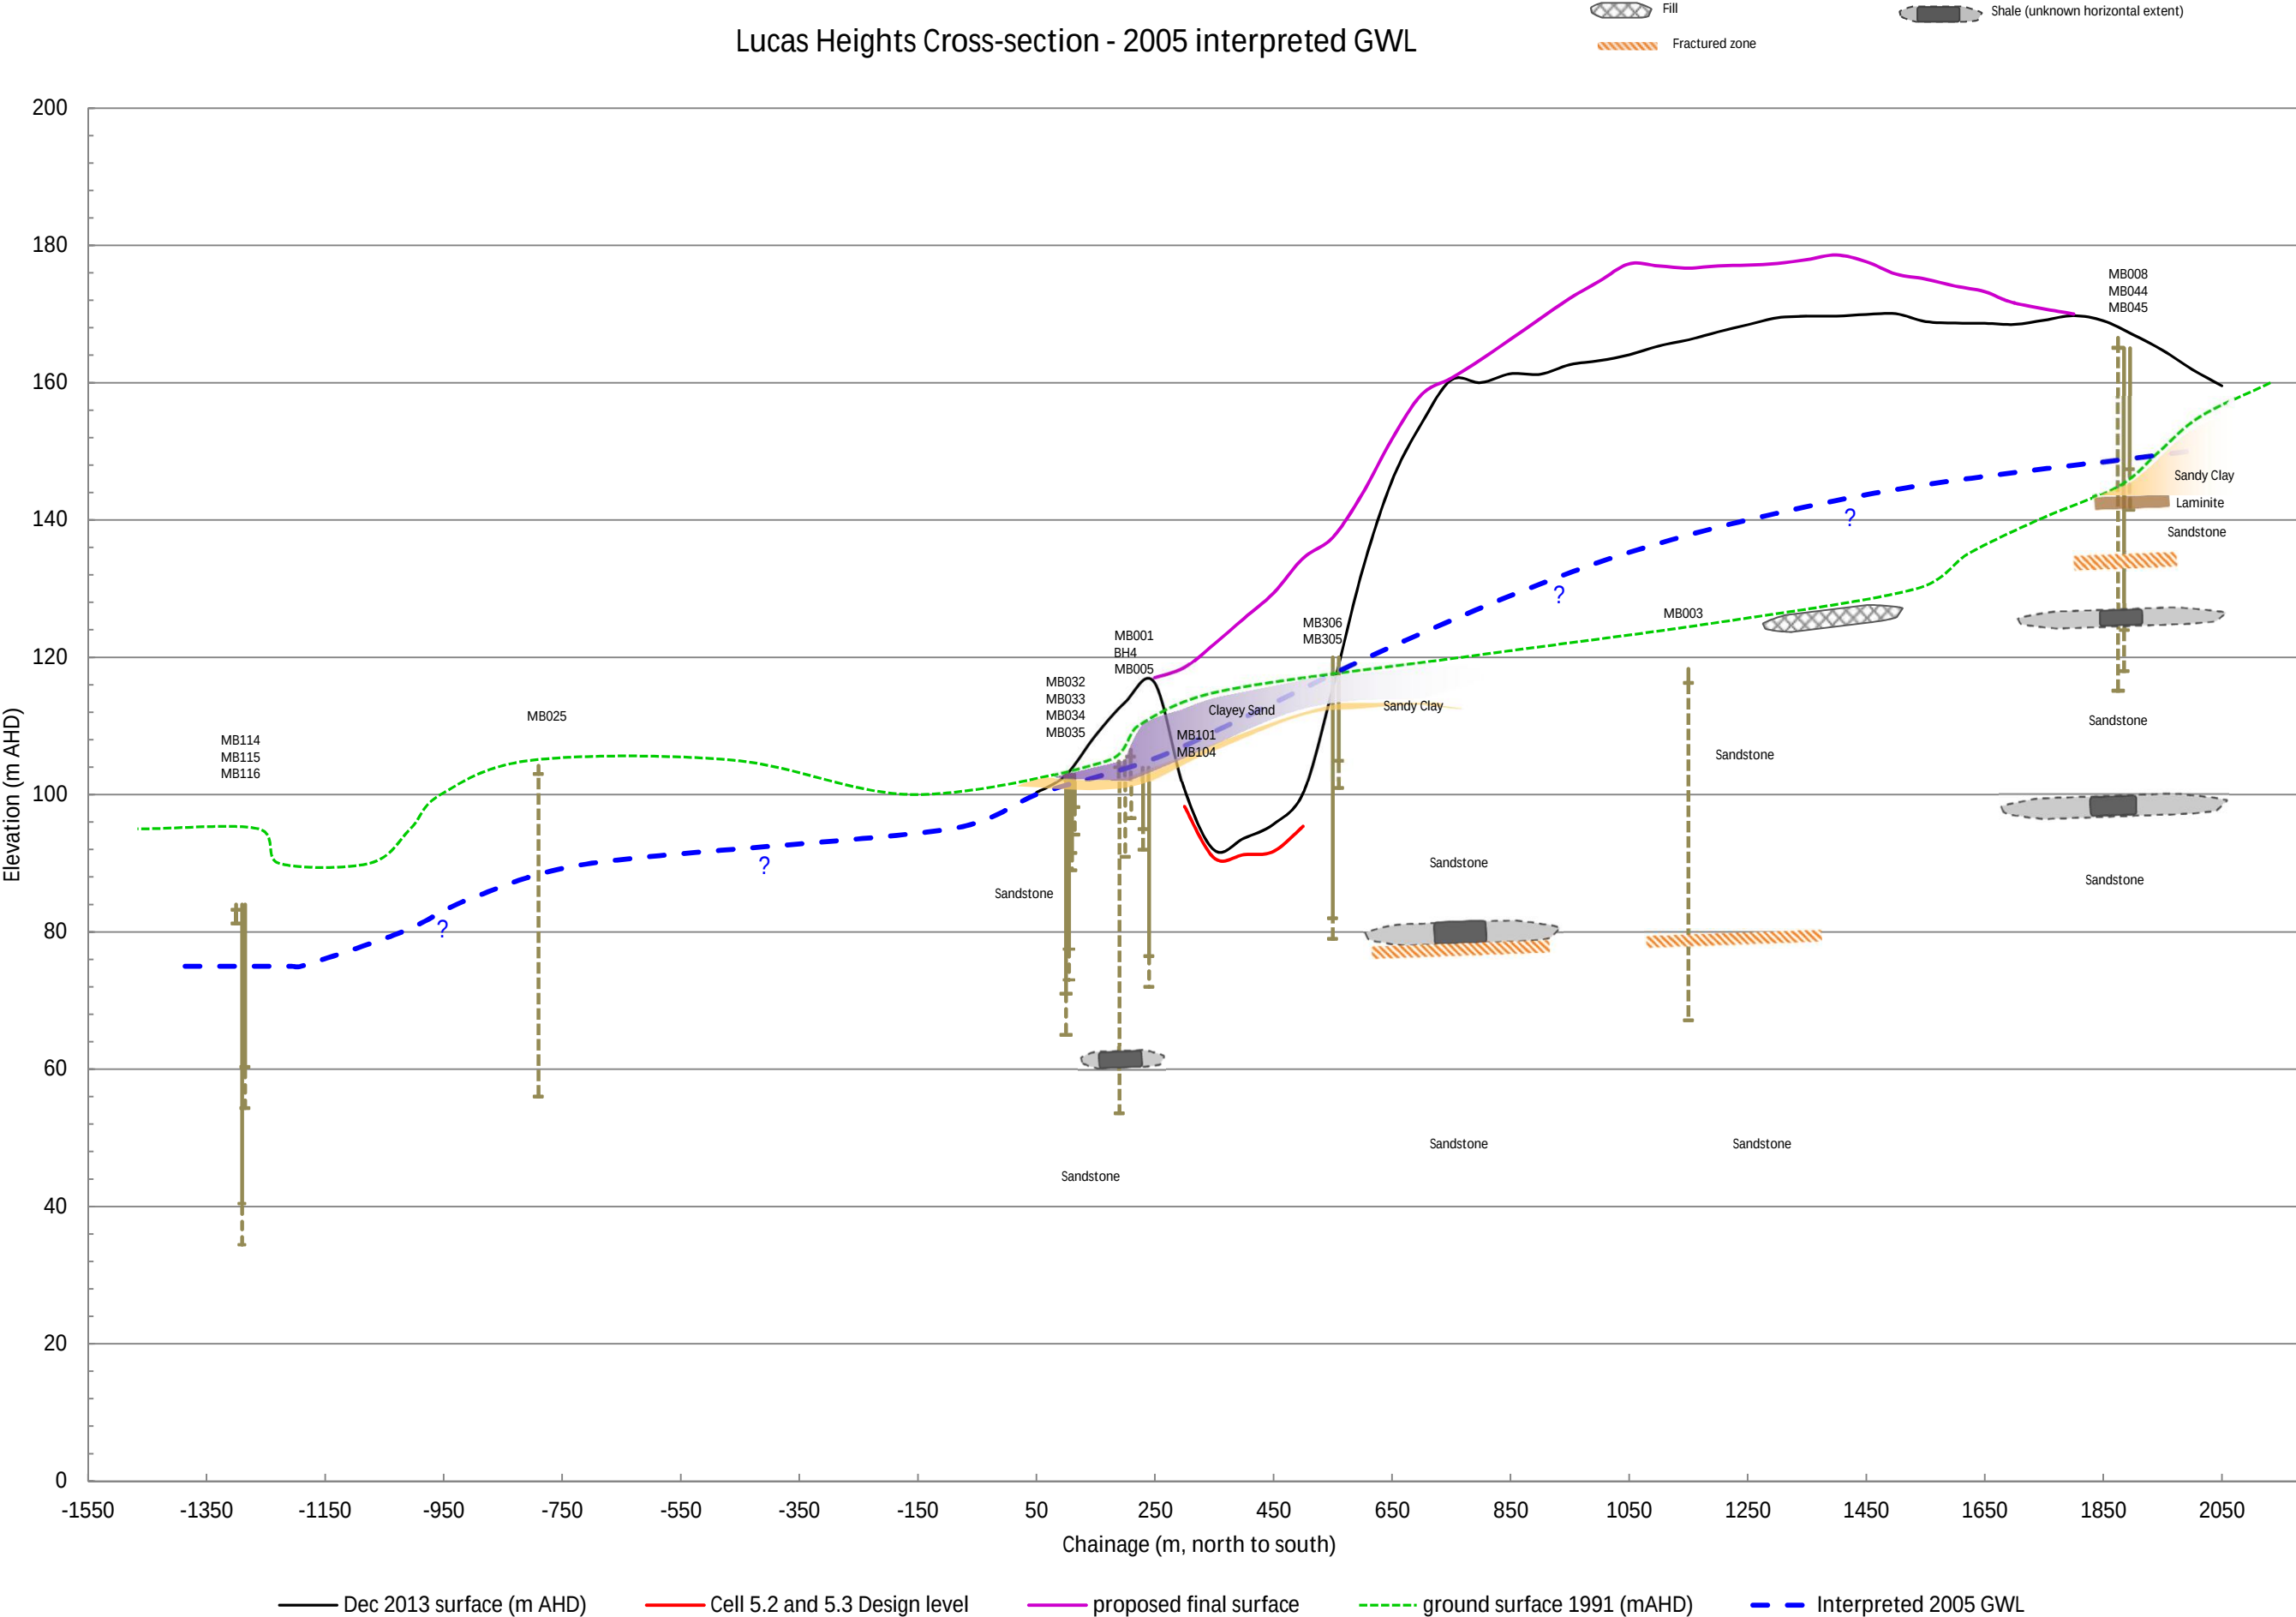
Lucas Heights Cross-section - 2005 interpreted GWL

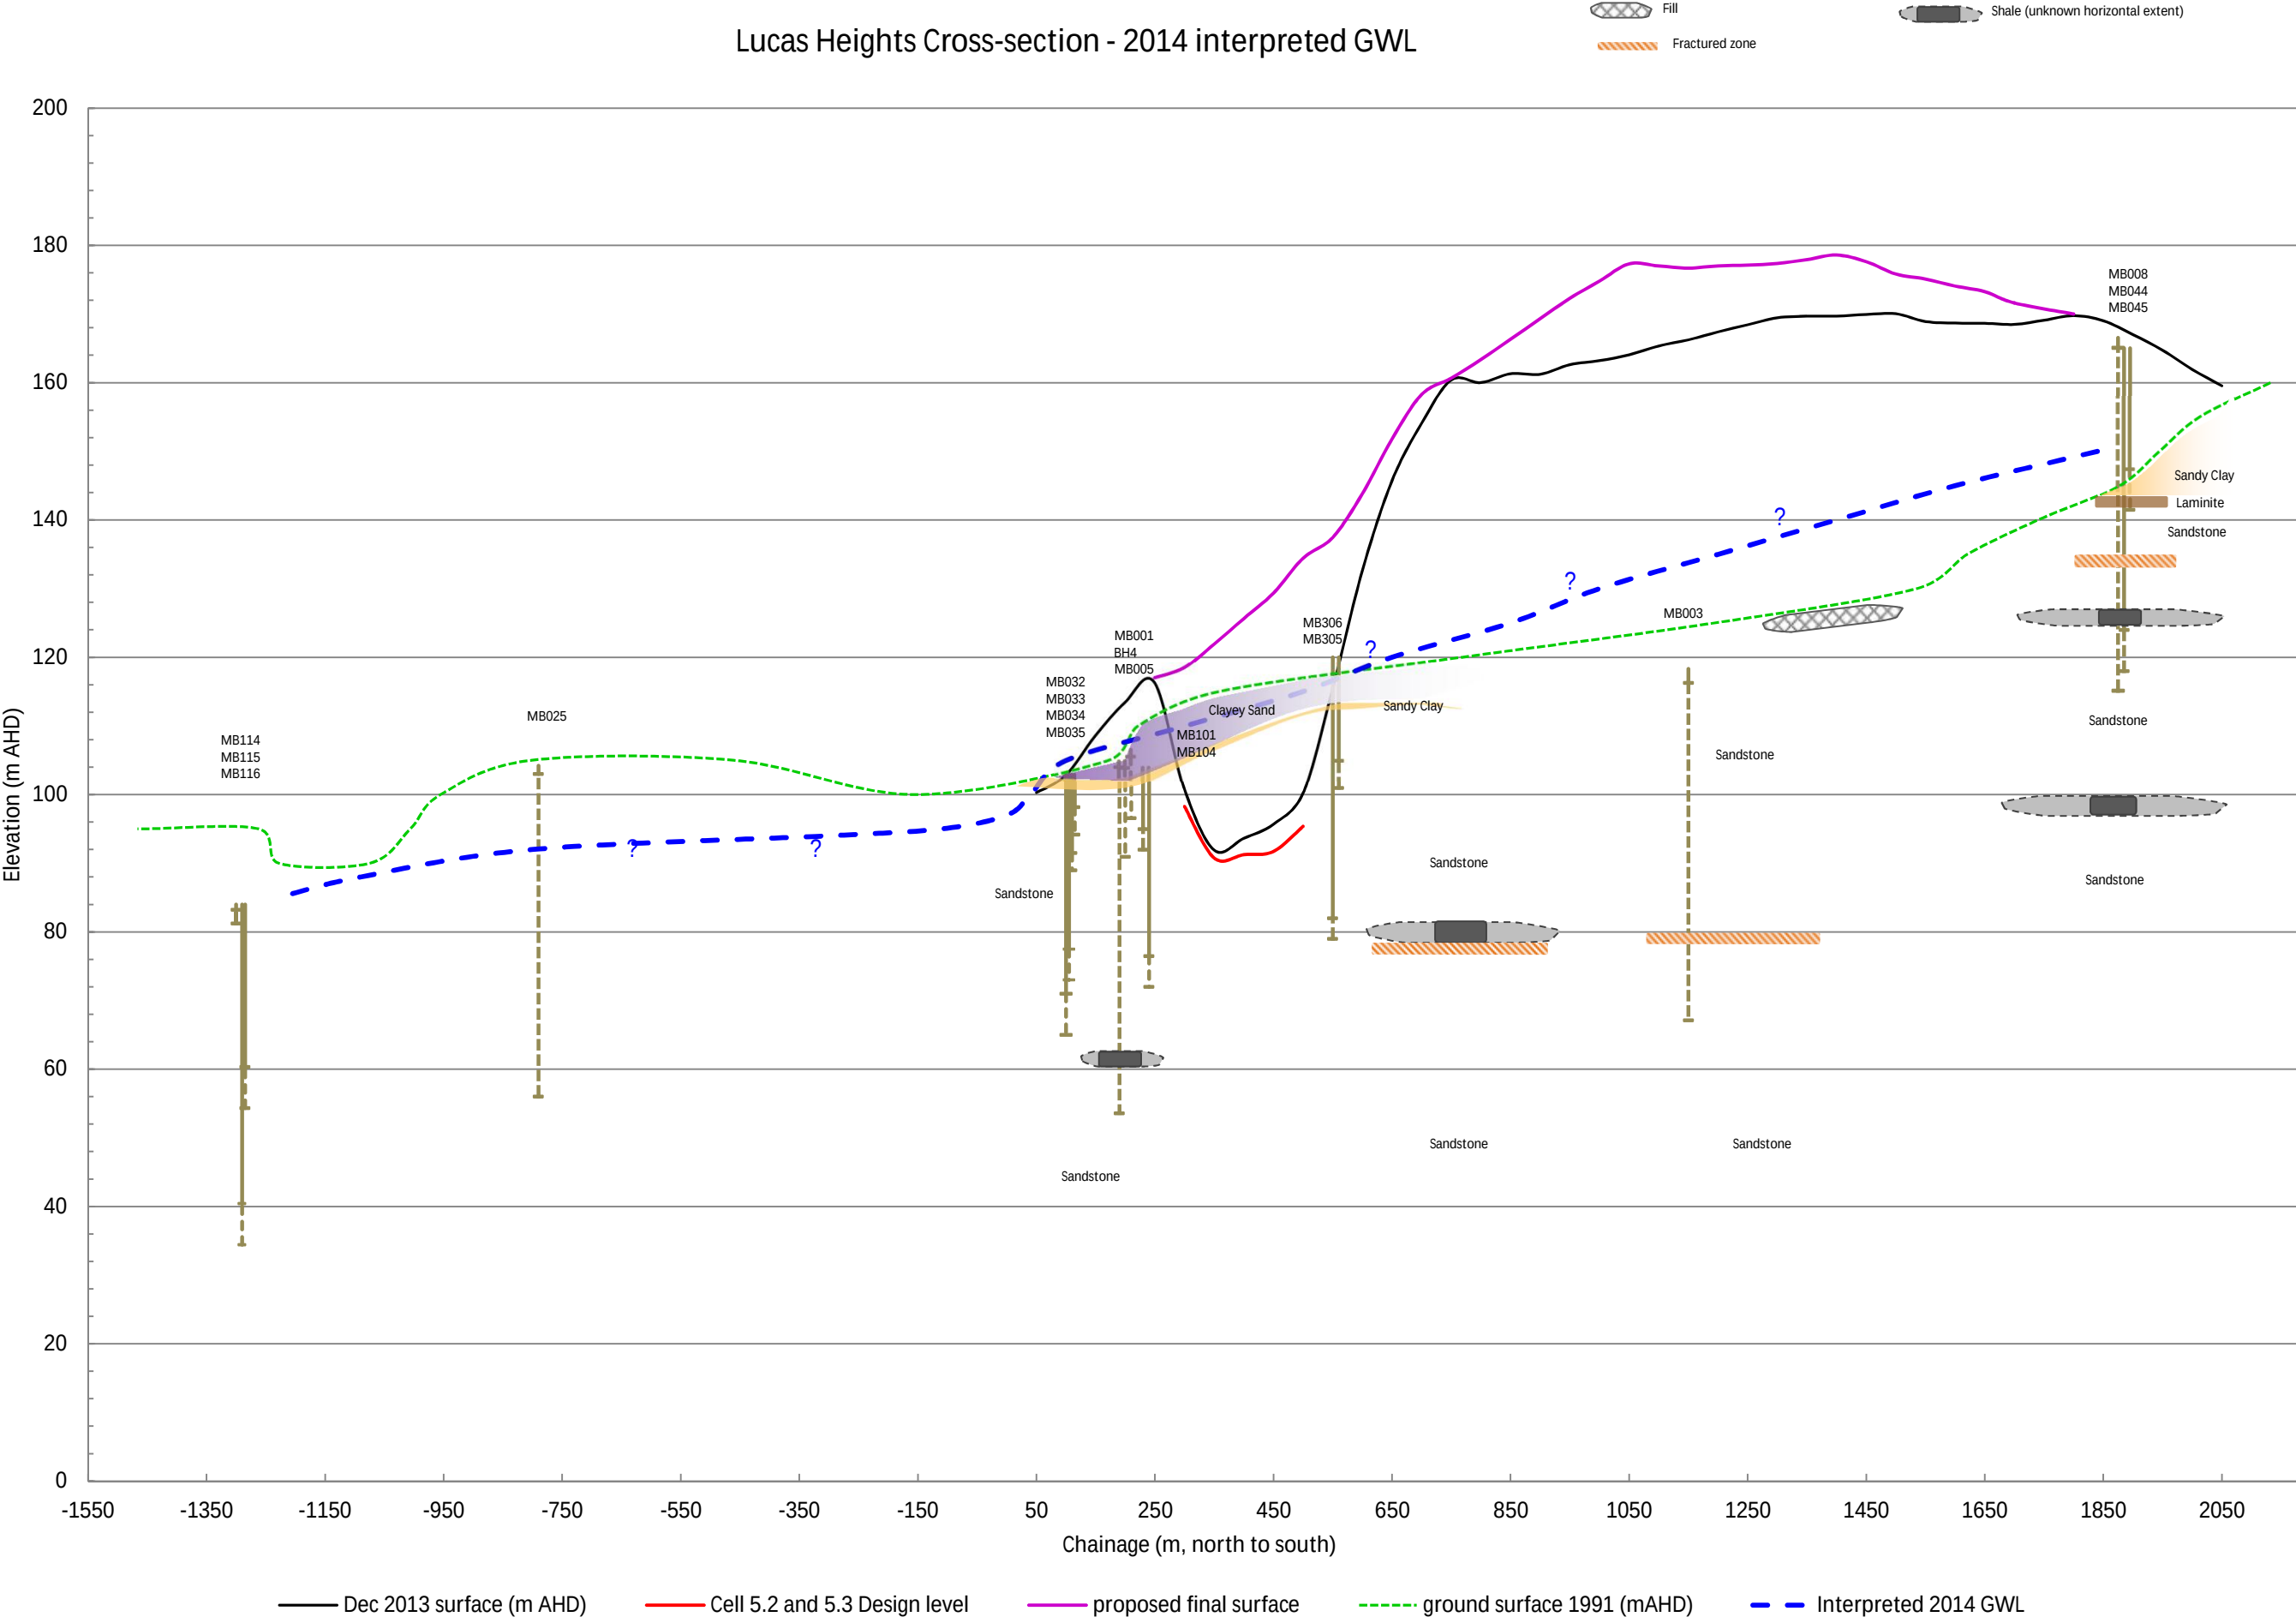
Lucas Heights Cross-section - 2014 interpreted GWL
