Report on  
Geotechnical Investigation

Sutherland Hospital Planning Project  
Kareena Road, Caringbah

Prepared for  
Health Infrastructure

Project 84311  
July 2014

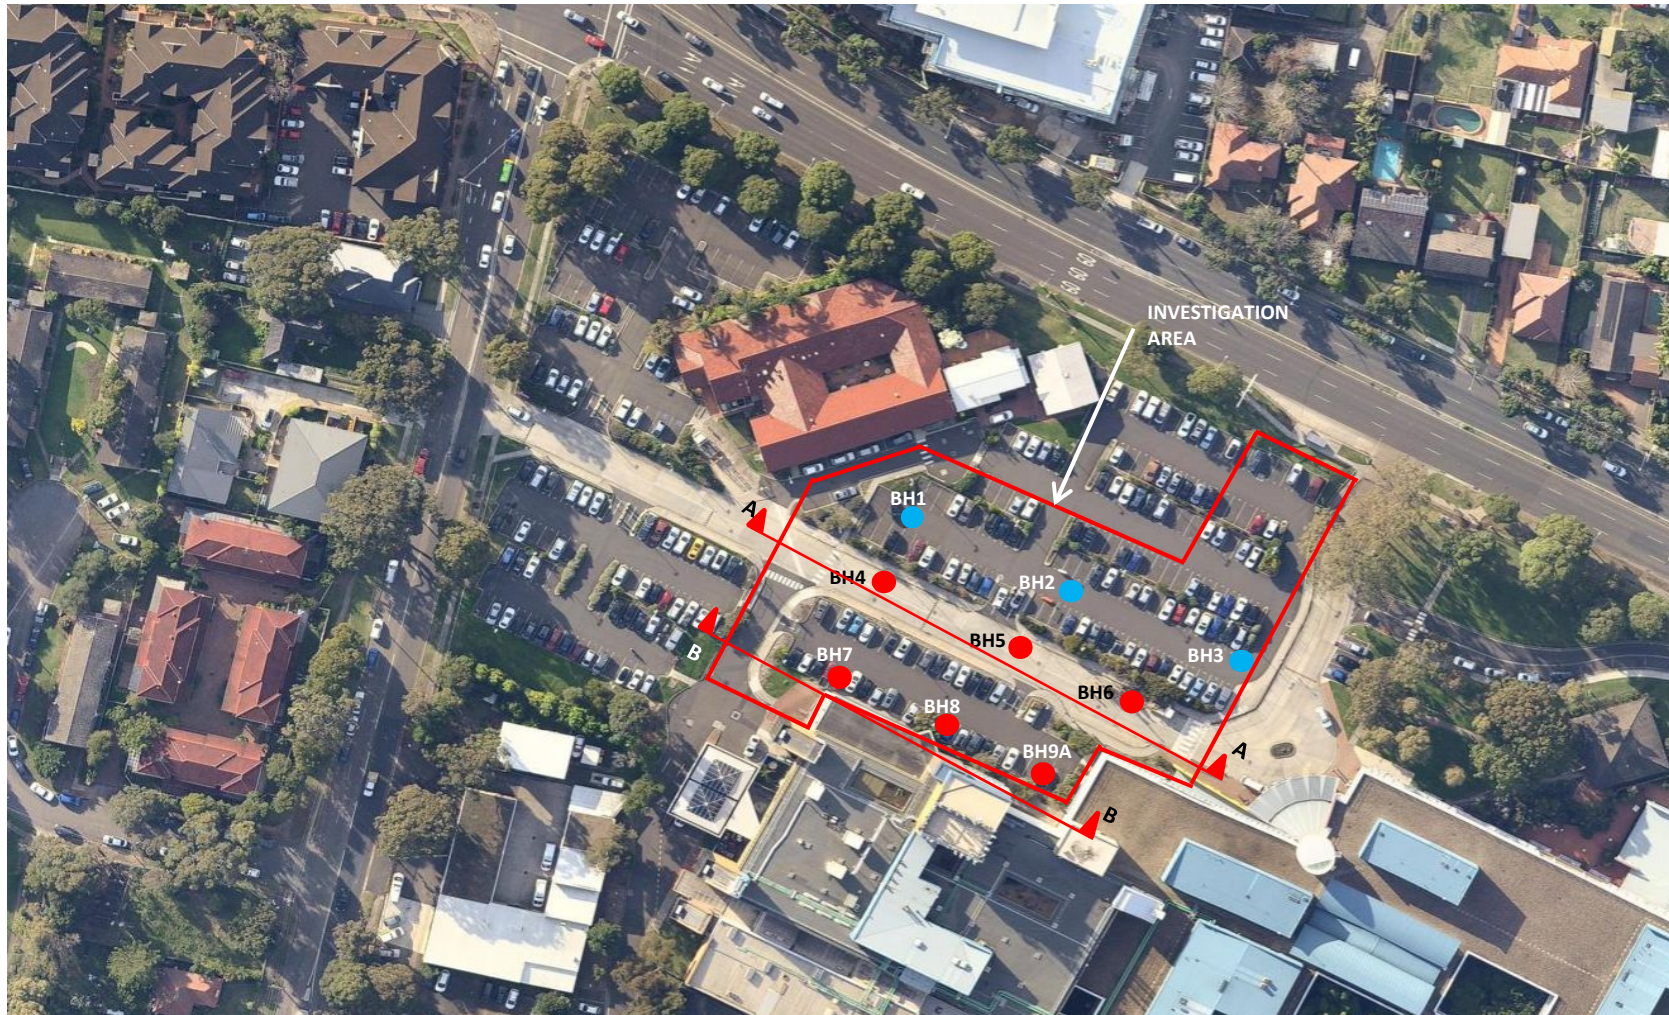
DWG No: G1

● Augered borehole

● Cored borehole

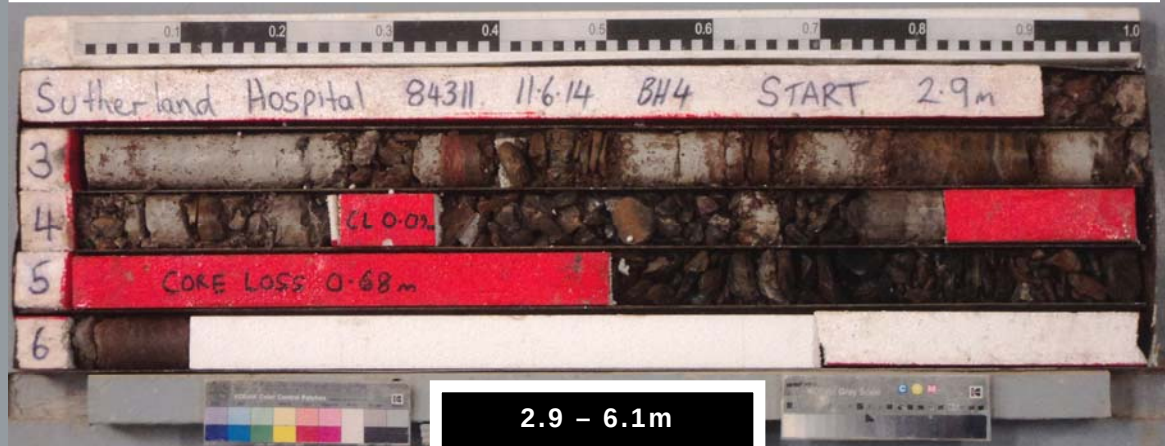
DOUGLAS PARTNERS PTY LTD  
SUTHERLAND HOSPITAL PLANNING PROJECT - CARINGBAH  
BORE 4 PROJECT 84311 JUN 2014
