Taronga Zoo
Sumatran Tigers
Heritage Impact Assessment
May 2015

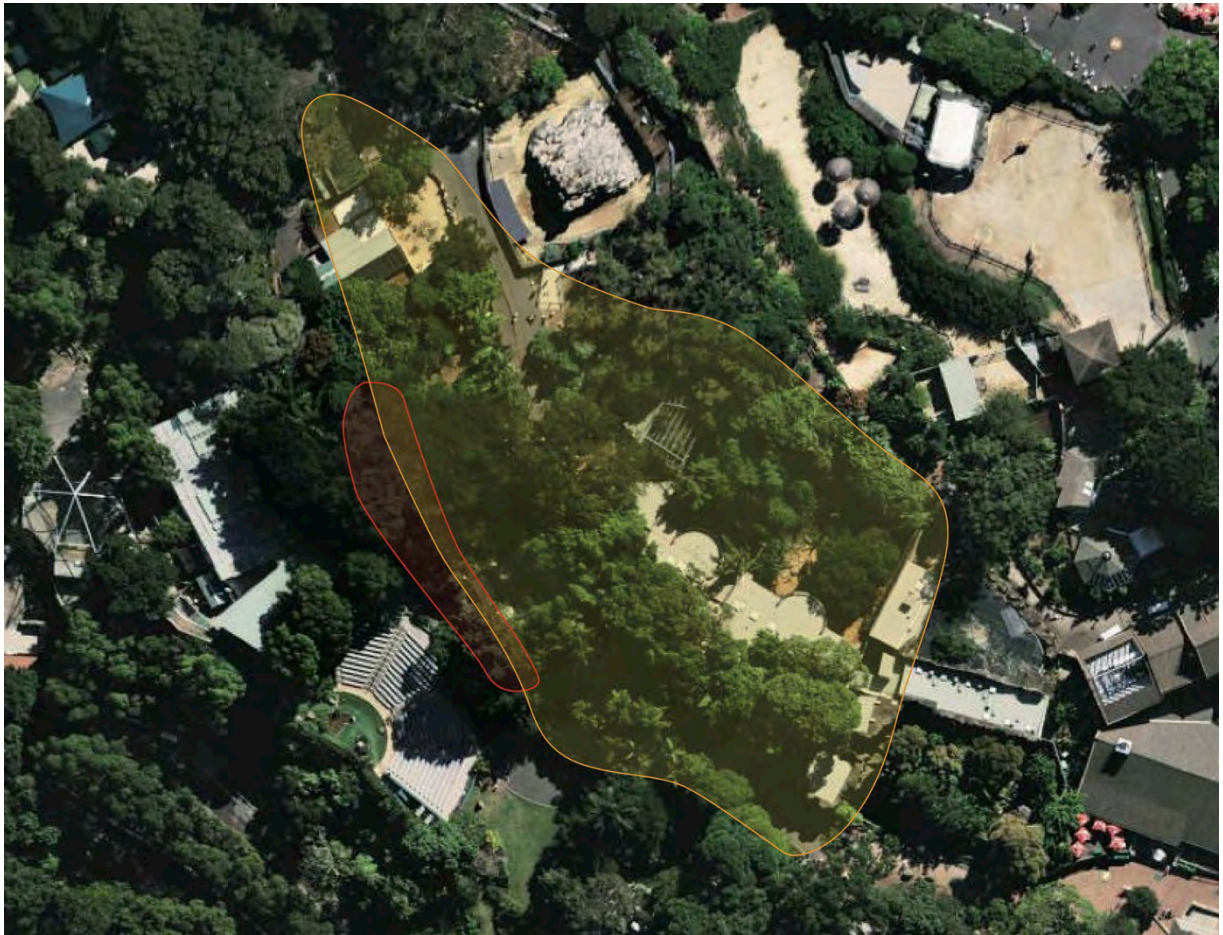
Figure 1.2 Aerial photo of Taronga Zoo showing the approximate study area shaded in yellow. The red shading indicates an area adjoining the site where trees are proposed to be removed as an early works package. Source: LPI SIX viewer annotated by Jean Rice Architect

The site is located near to the south western corner of Taronga Zoo (see Figures 1.1 and 1.2).

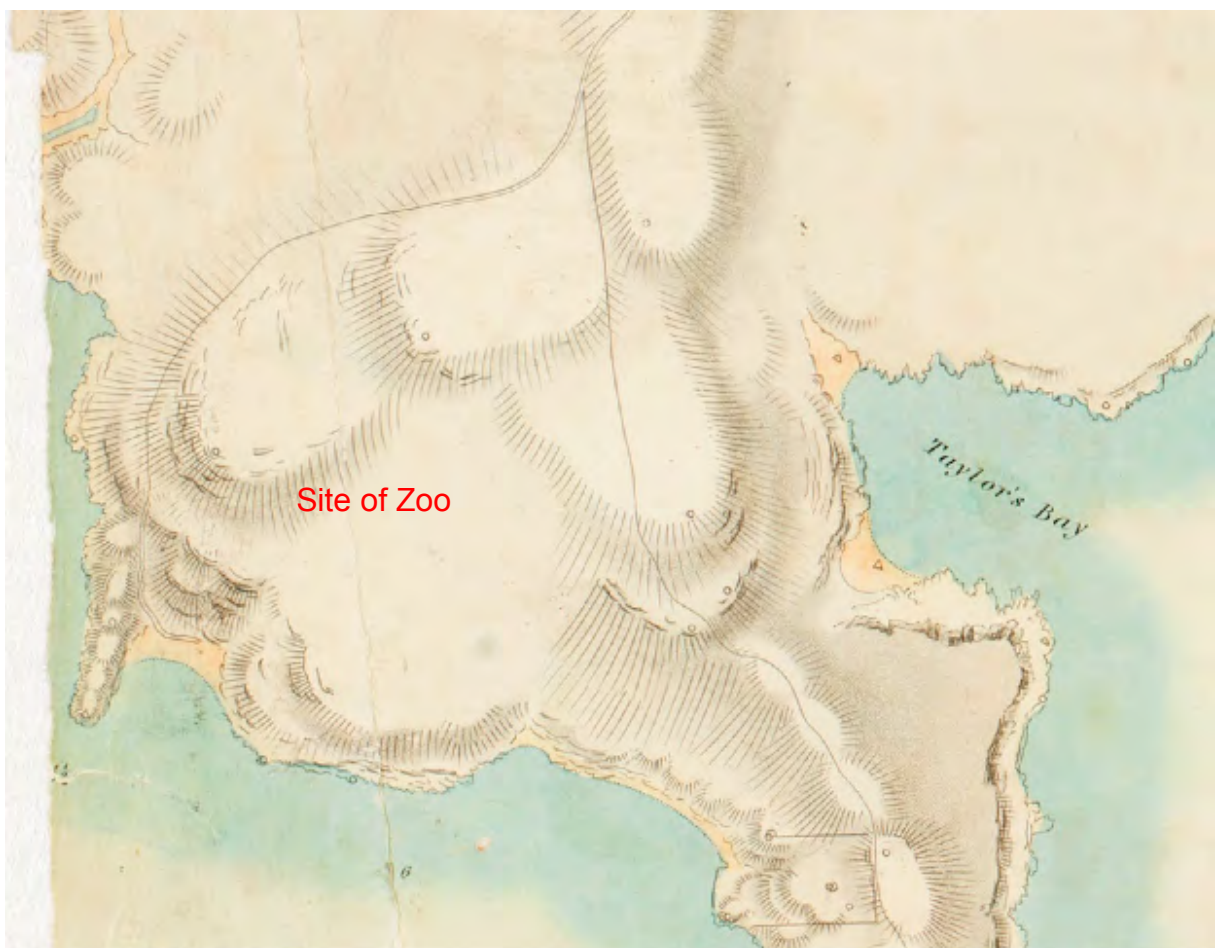
Figure 2.1 Extract from Thomas Mitchell's Trigonometrical Survey of Port Jackson dated 1853 showing Bradley's Head. The later location of the Zoo is indicated. Source: SLNSW Z/M4/811.15/1853/1

Nineteenth century maps, including the parish maps for Willoughby and surveys of Port Jackson give an indication of the landform prior to the establishment of the zoo. Three substantial portions of land were granted to Charles Jenkins. The trigonometrical survey of Port Jackson prepared by Sir Thomas Mitchell shows that paths led to the various promontories by the early 1850s. A track is shown to Whiting Beach and another to Bradley's Head.

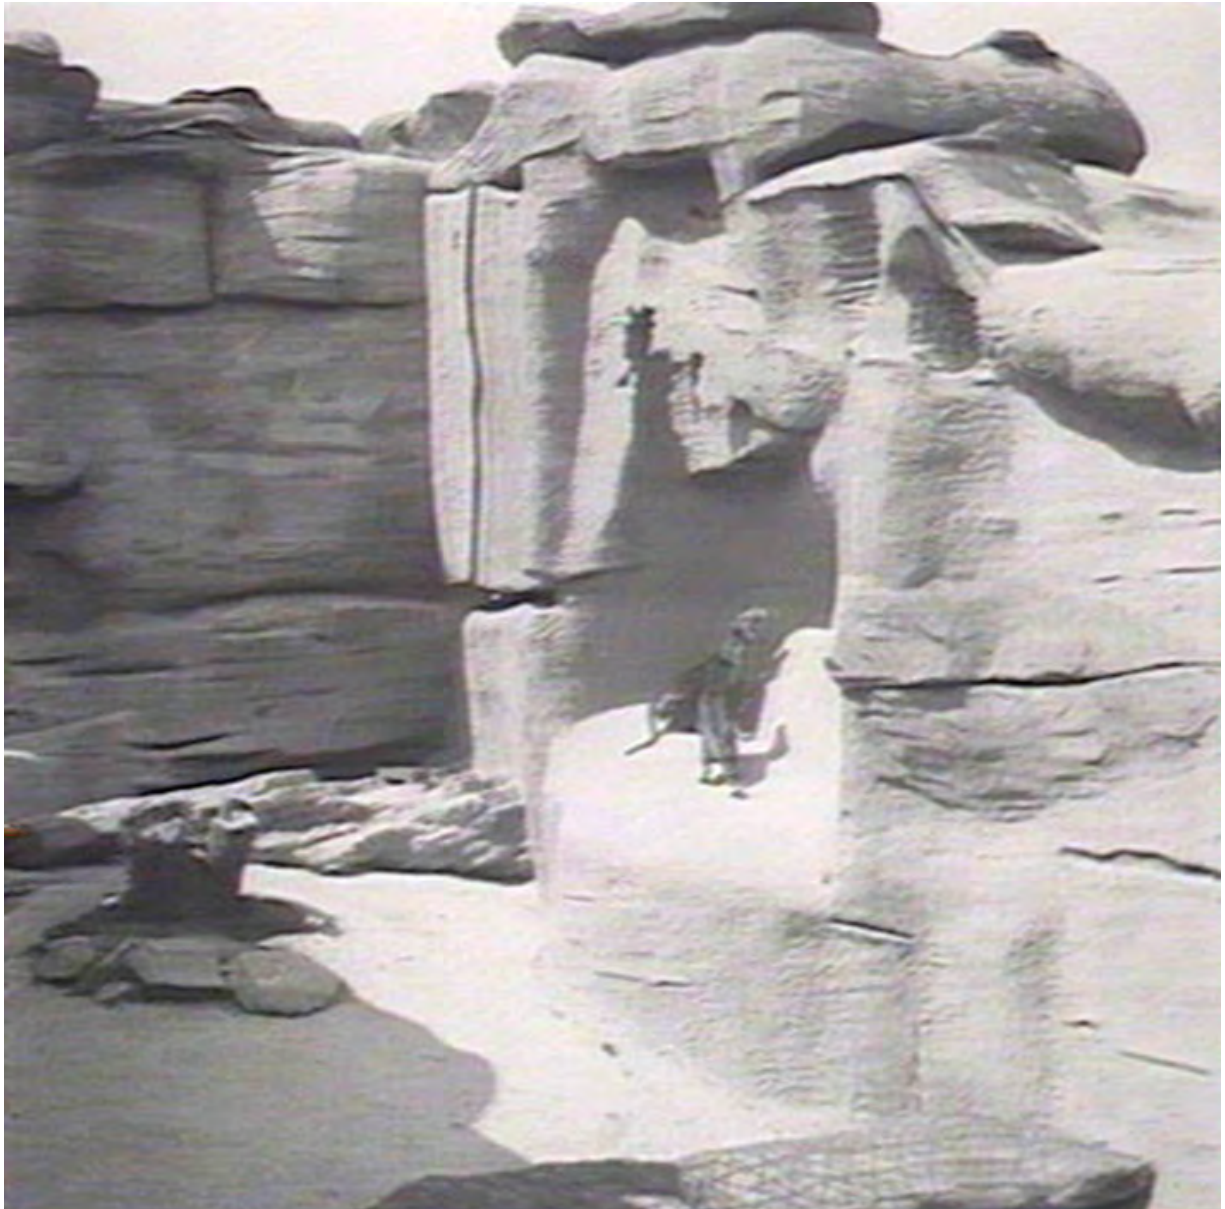
Figure 2.4 The Tiger's Pit, February 1917. The lions pit was to the right of this. Source: ML GPO1 still 18453

A series of photographs of the Zoological Gardens, that includes images of the lion and tiger enclosures taken in 1917, survives in the Government Printers Collection. One photo is labelled tiger's pit and the other shows a lion. These photos show mock rock enclosures that appear to incorporate sandstone rock shelves. Ledges were built for the animals to sit on so that they could be seen by onlookers. Later plans to alter the exhibits show that the mock rock separating the two enclosures contained a tunnel. The mock rock wall between the pits and the tunnel within it were removed in 1999.

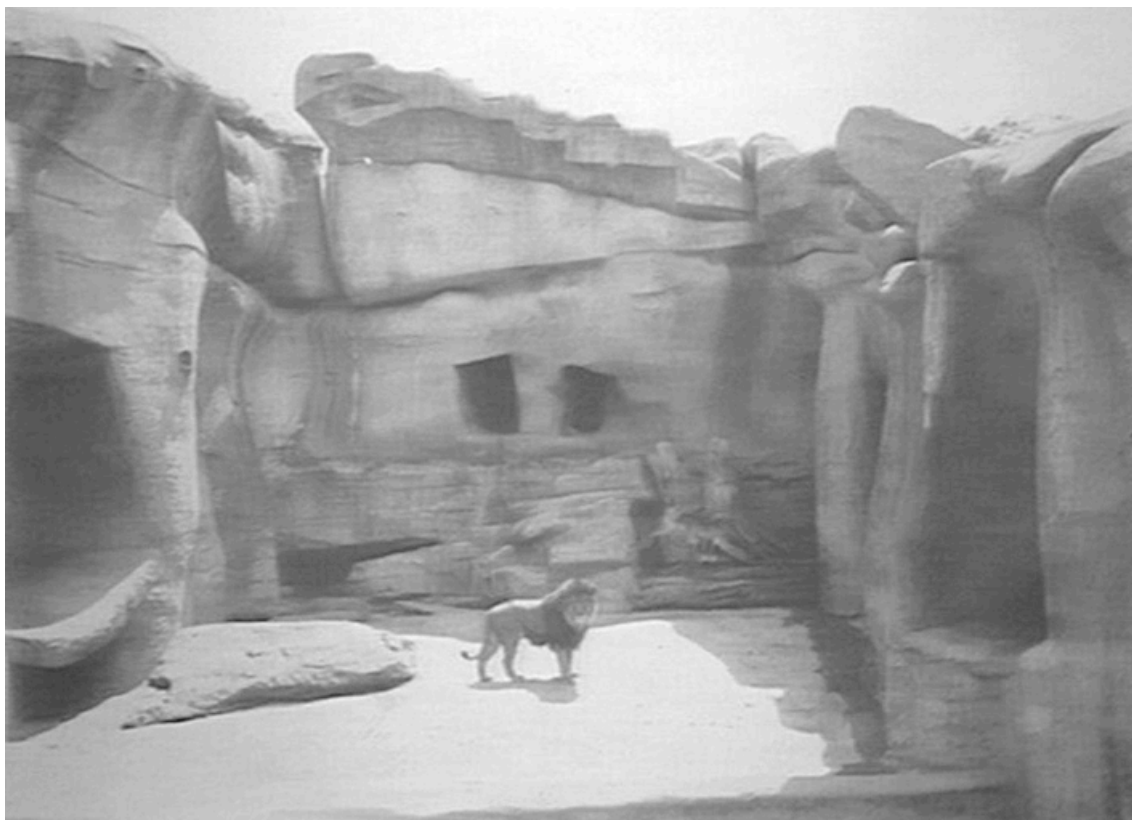
Figure 2.6 1924 view of the lion enclosure. The tiger enclosure was to the left. Source: ML GPO1 19127

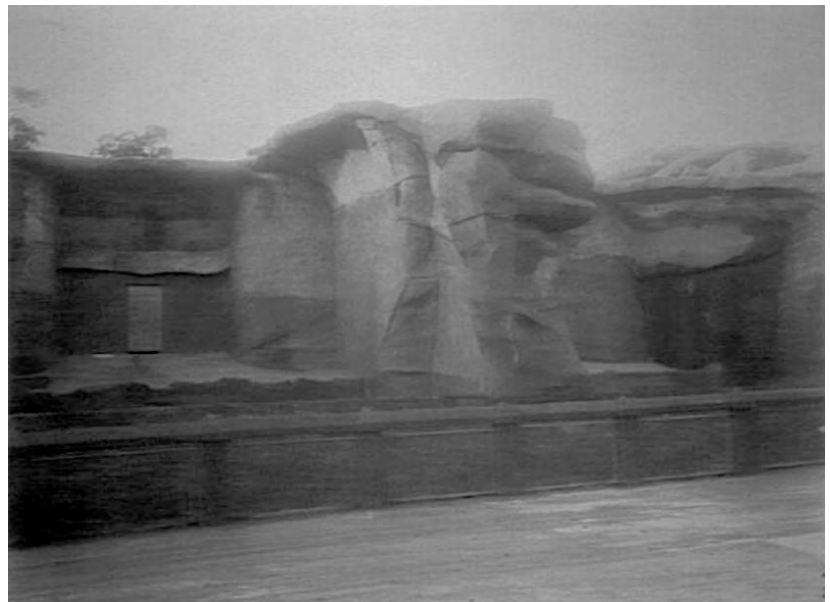
Figure 2.8 Part of the new carnivora house at Taronga Zoo, taken in 1925. The fence at the front is the fence in the photo of Premier Lang. The moat was behind the fence. Source: ML GPO1 15943

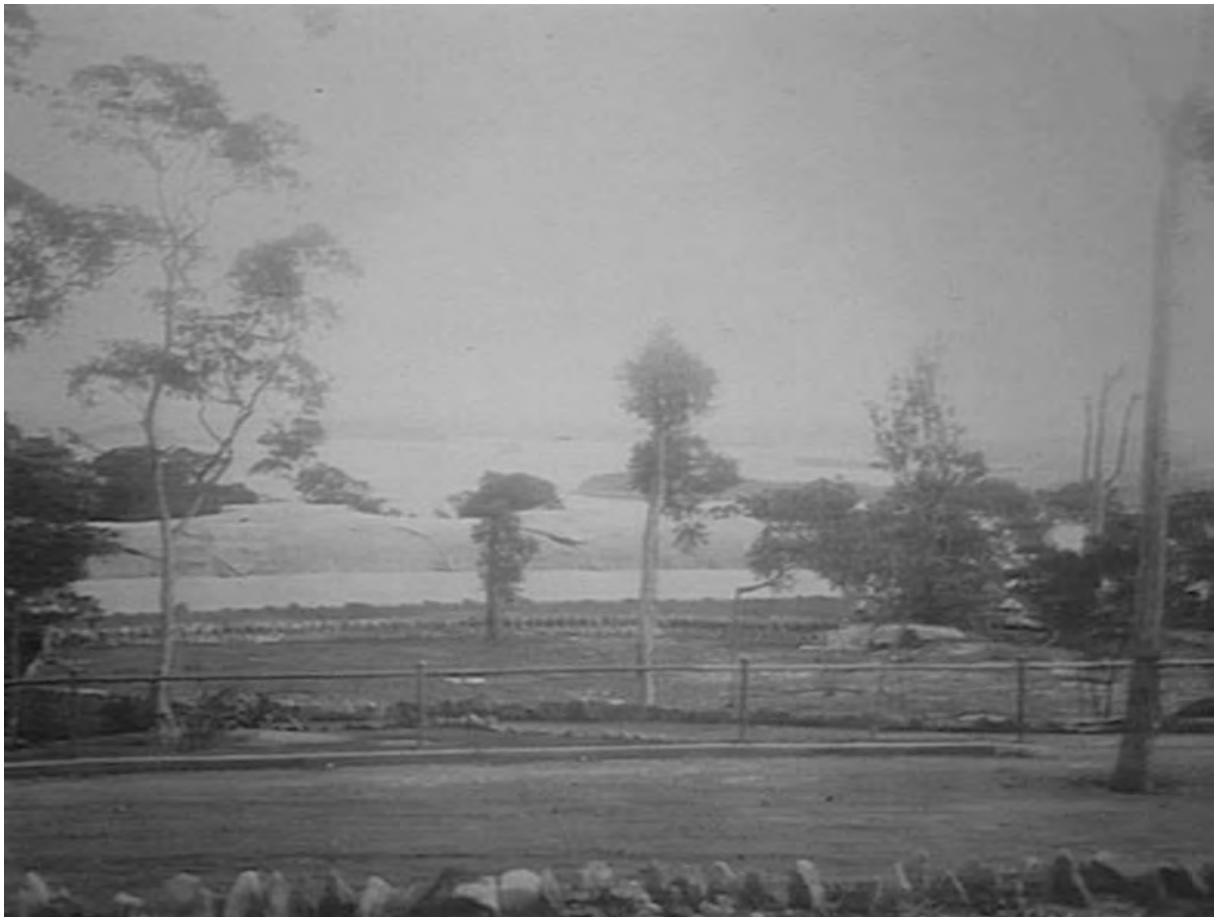
Figure 2.9 View looking southwest over the carnivora exhibit, taken in 1925. Source: ML GPO1 15950

Photographs of the new 'carnivora house', including a view from across the top the enclosures to the harbour were taken in June 1925

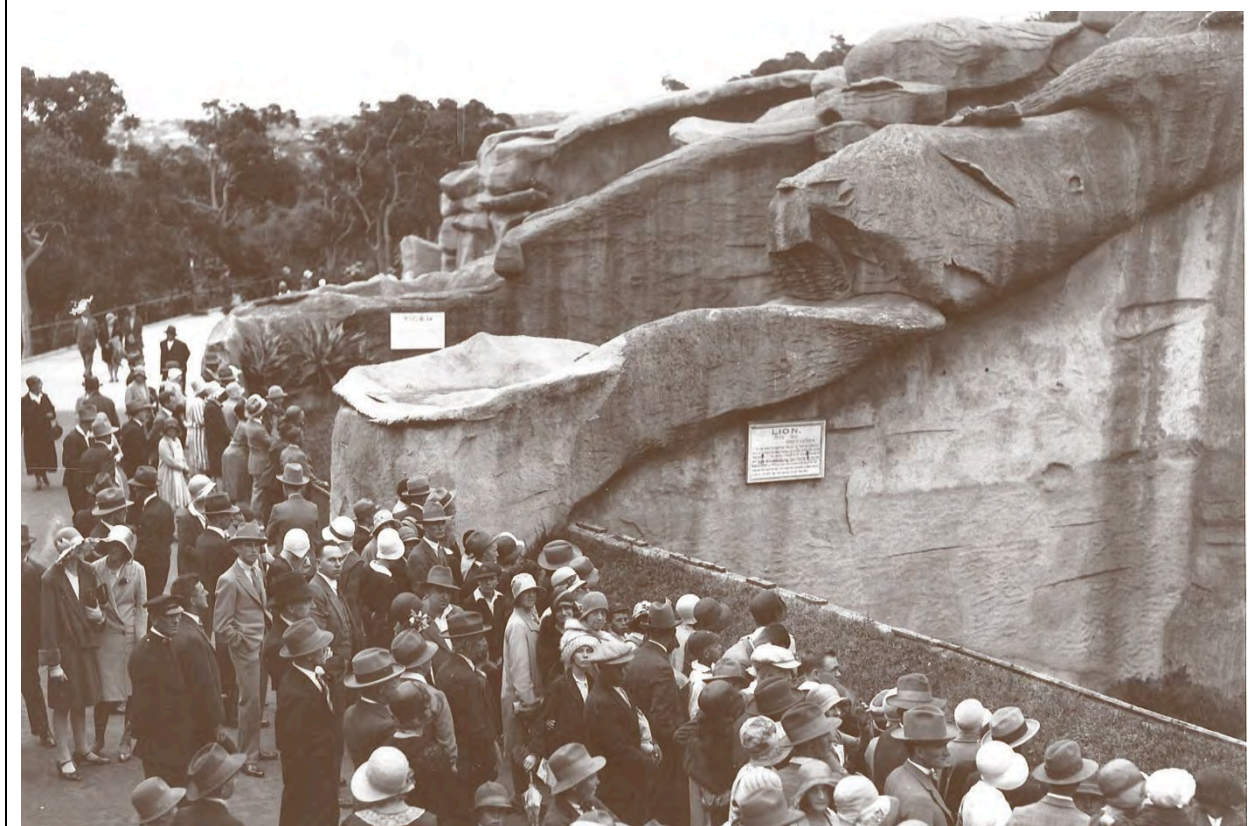
Figure 2.11 Crowds at the row of lions and tigers dens, March 1930. Source: GPO 1 still 22157

Photographs of the pumas and jaguars in their dens appear in the series of photographs of the Zoo taken in 1930 as did a view of the crowds at the row of five dens.¹⁰ The five dens and the adjacent pond can be seen in the circa 1930 aerial. The enclosures below the road on the bottom left of the photo are shown in the 1933 Zoo guide plan as being dingo / hyena enclosures. Although the grounds below the roadway had been used for picnics, the aboriginal hand stencils survived. Their location is shown below. The pond was filled in by 1943, as it does not appear on the wartime aerials.

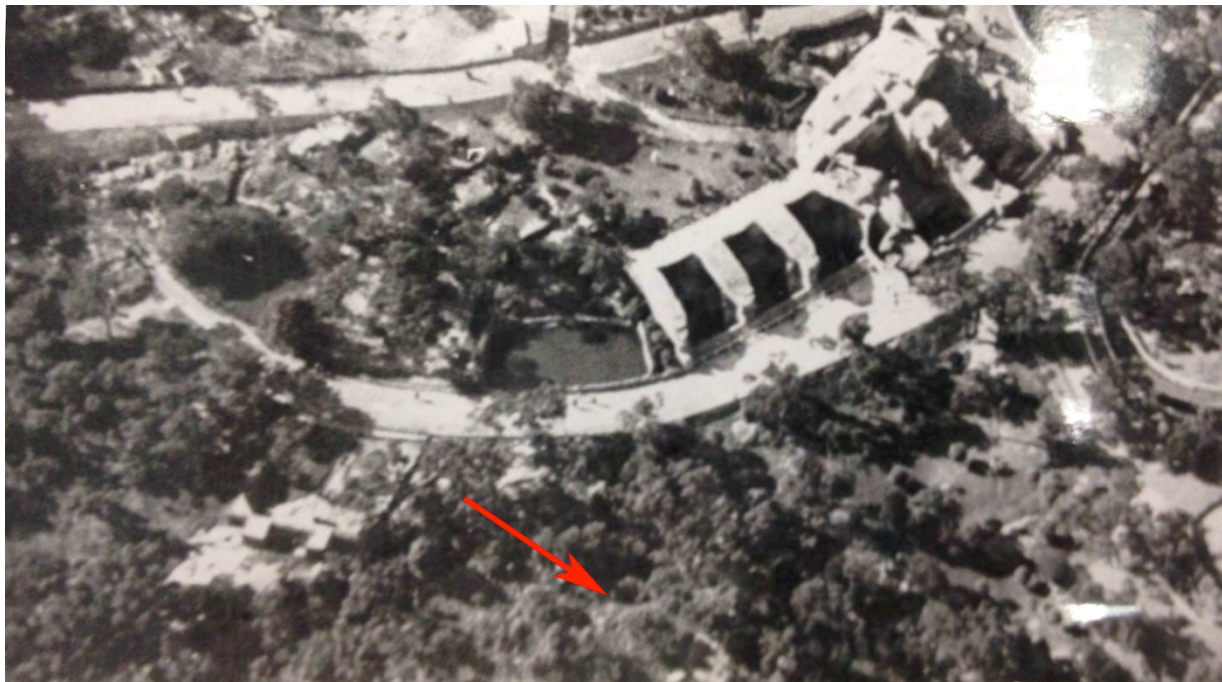
Figure 2.12 c1930 image with the Aboriginal site approximate location arrowed. Note the path to the rear of the upper right lion and tiger enclosures. Source: From copy held at the Heritage Design Services, GAO

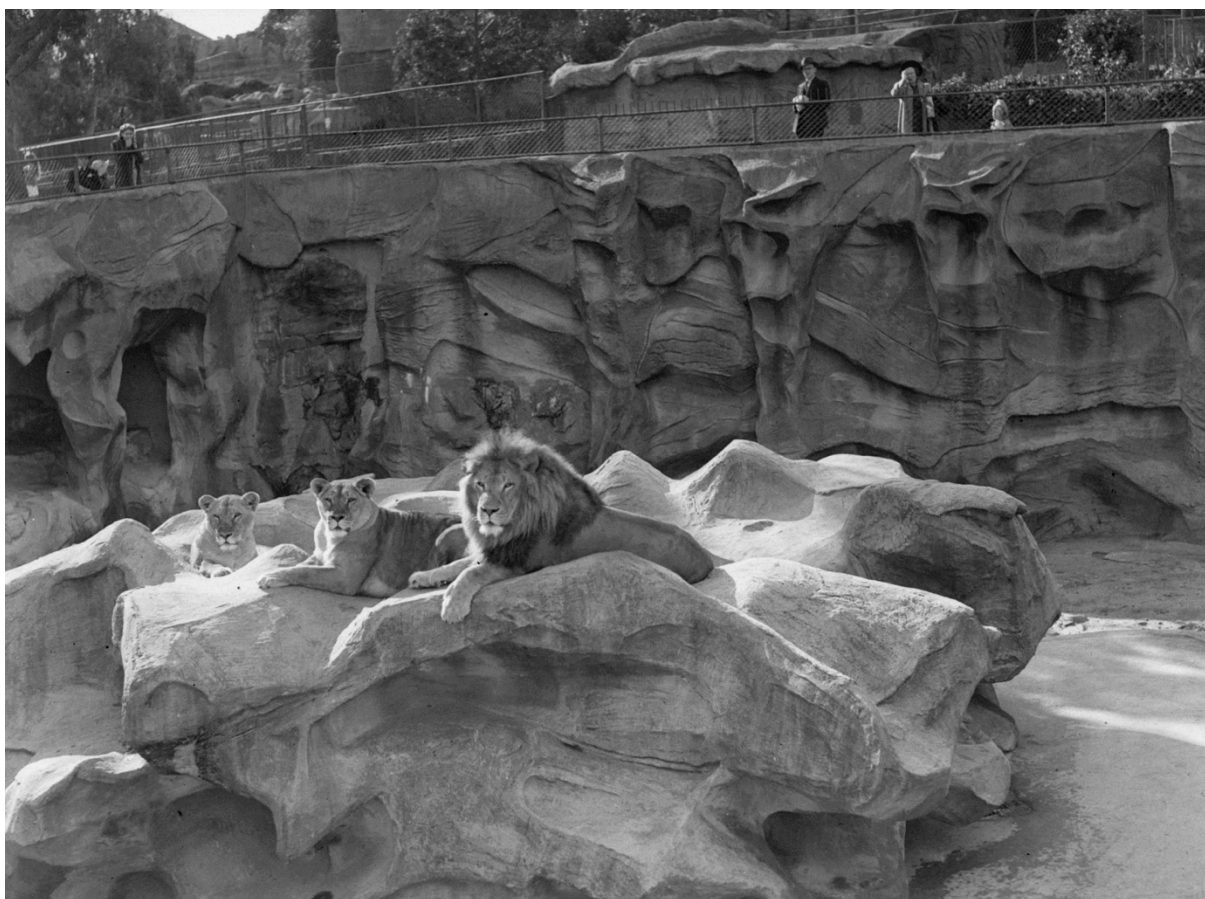
Figure 2.13 Lion Pit photographed in 1942 looking to the north. The map of Australia may be the concreted section to the RHS. Source: ML GPO 1 still 23527

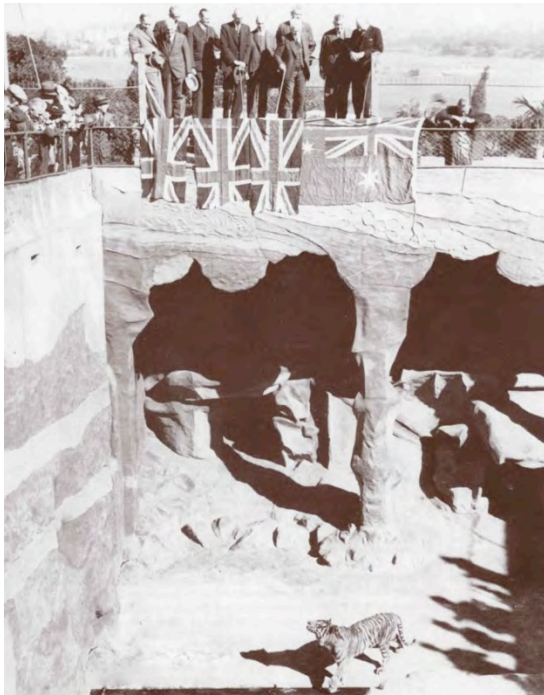
Figure 2.14 The official opening of the Tiger Pit, May 1939. Source: Taronga Zoo Archive.

This photo is taken looking south towards the harbour. The Lion pit would have been to the left of the tiger pit in this photo. There is an arcade like mock rock structure on the south side of the pit with the walkway over. The dignitaries are on a platform elevated above the usual walkway. The shadow of people on the right or west side of the pit can be seen in the photo.

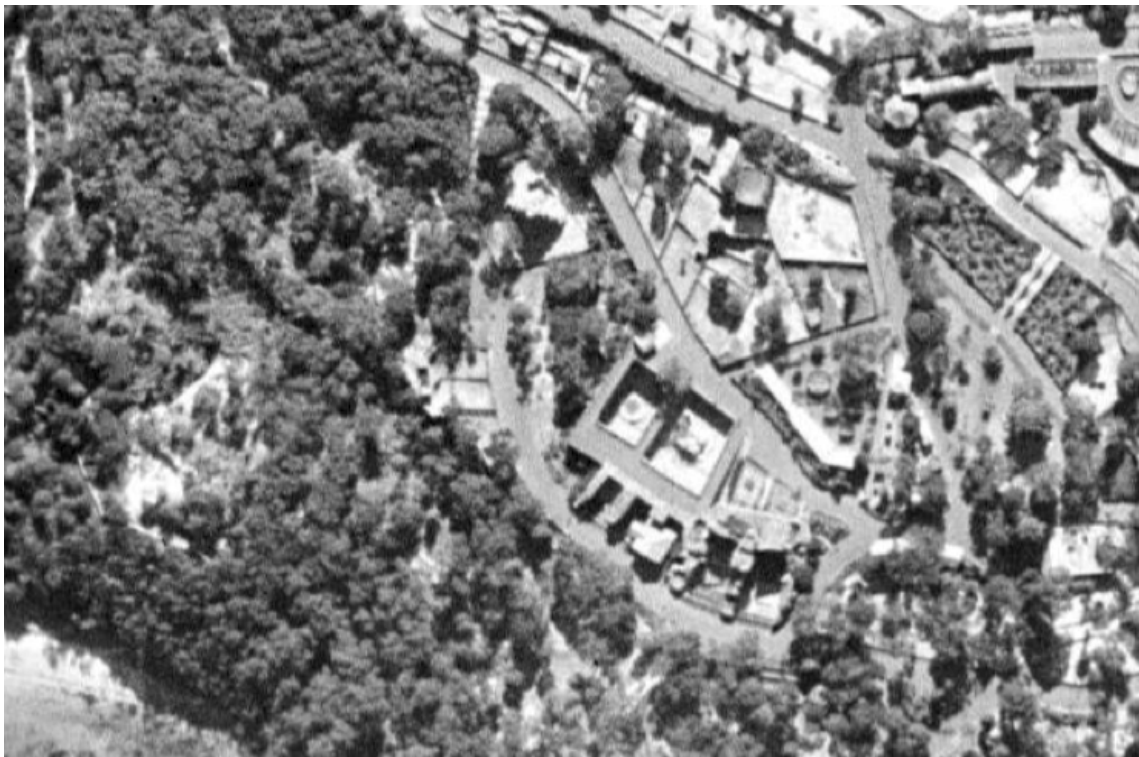
Figure 2.15 Extract from the 1943 aerial of Taronga Zoo showing the carnivore pits and the filled in pond to the west. The area between the tiger pit and Tahr Mountain was undeveloped appearing later in the 1956 and later guide maps as a lawn and garden. The southwest side of the lower pathway also remained undeveloped, probably still picnic grounds, except for the hyena and dingo enclosures and small jaguar and leopard enclosures added to the south by 1939. Source: SIX viewer

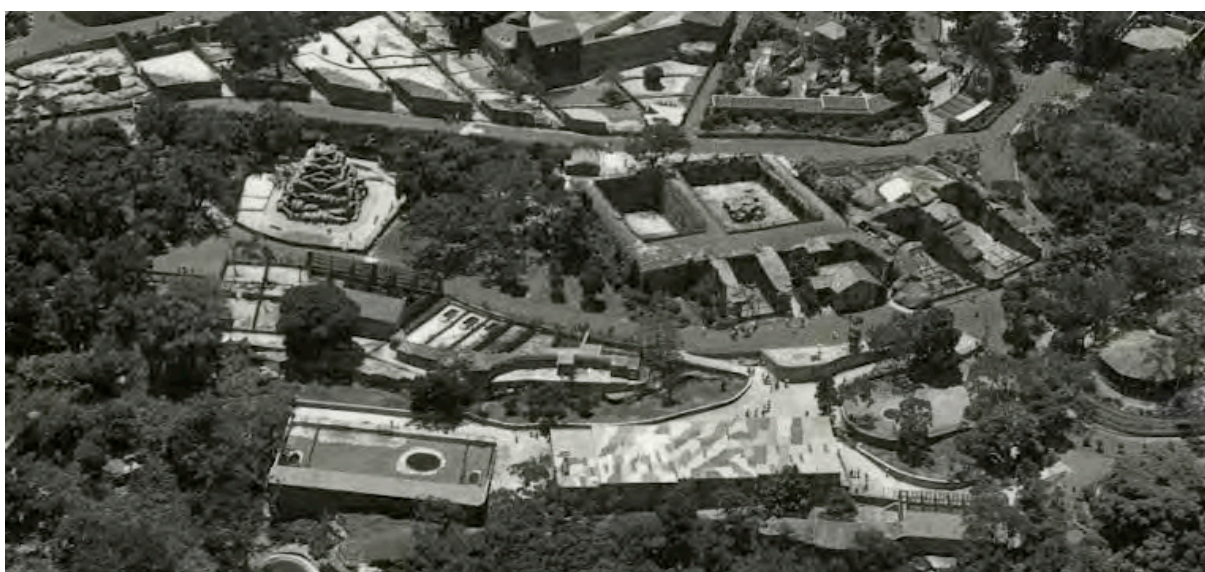
Figure 2.16 This c1962 aerial image from the south shows the early carnivore enclosures top right, the Tahr Mountain top left. Below the road is a series of enclosures extending around to the right to a ramp leading to a new lower level road and the Pere Davids Deer and Ape enclosures. The east wall of the upper right Lion enclosure is visible showing the shelters on that side (which may remain today) but the wall is in shadow and the shape of the openings is not clear. Source TZ Archives

The 1962 aerial shows the mock rock mountain erected for the mountain goats, built using unemployment relief funds in 1932, the tiger pit and the larger lion pit with the central rocky mound. The space between is trees and grass. The smaller three pits erected in 1925 had partially been demolished and a ladies retiring room built in the two eastmost pits and only the west pit remaining. The camouflage roofed sheds do not appear on the 1943 aerial and must be the Ape enclosure shown on the 1956 plan. Although the roof of the Ape exhibit has camouflage paint, the structure appears to postdate the war. The Pere Davids deer enclosure is further left (west) with an open yard and only the southern side of the exhibit roofed. Prior to the erection of these exhibits, this area had undergone little development, hence the survival of the Aboriginal hand stencils. The 1960 plan of the layout shows a similar arrangement.

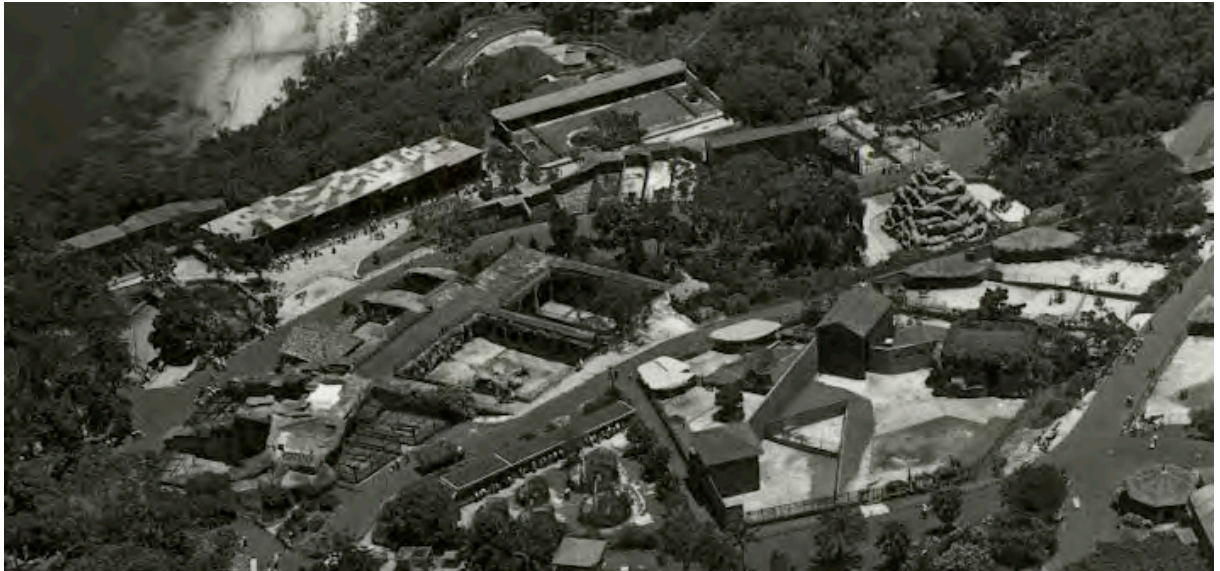
Figure 2.17 This c1962 aerial image from the north shows the early carnivore enclosures bottom left. The image shows the arcaded sides that formed shelters in the tiger and lion pits with the garden area to the right and Tahr Mountain centre right. The Ape and Pere David deer enclosures are at the top of the image. The level of the ground in the lion pit appears higher than that in the tiger pit behind. Source TZ Archives

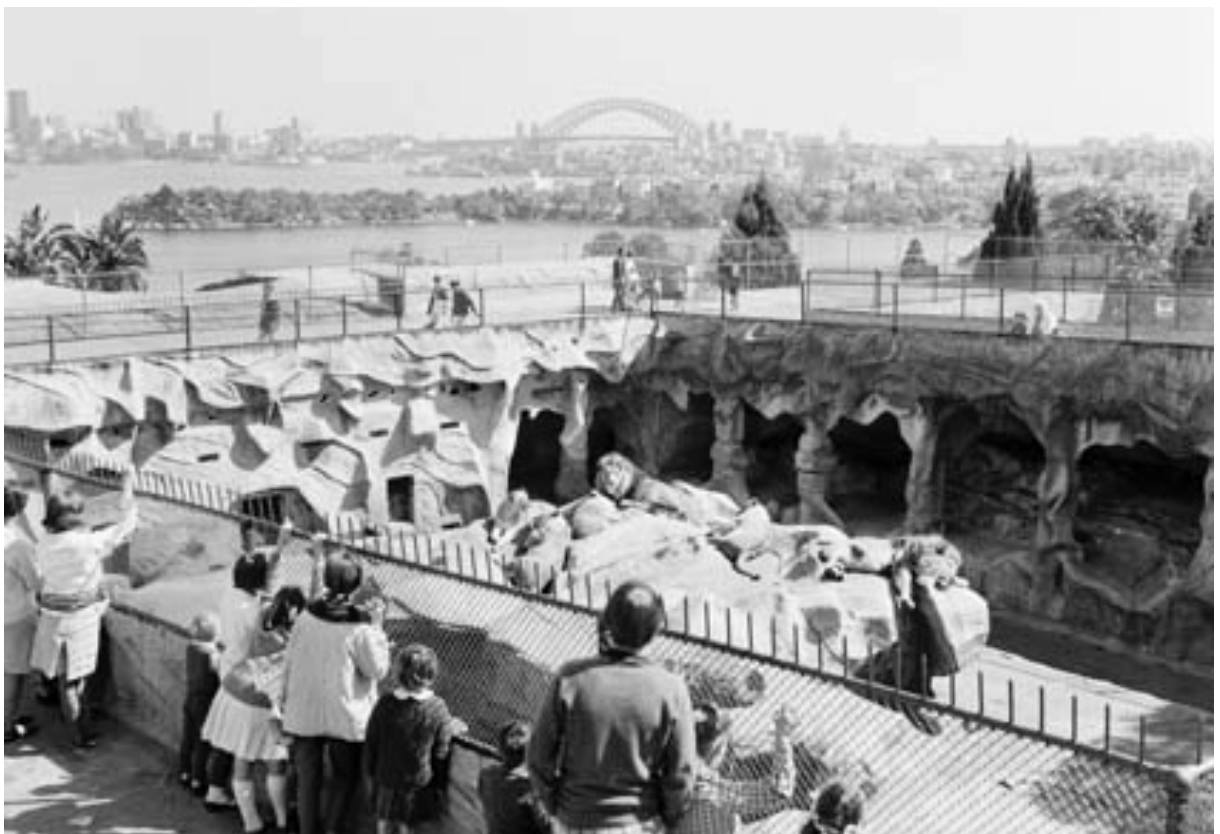
Figure 2.18 1966 view of the Lion Pit showing the mock rock and upper walkways. Note the arcade creating sheltered areas on the right and the doors to dens on the left. NAA

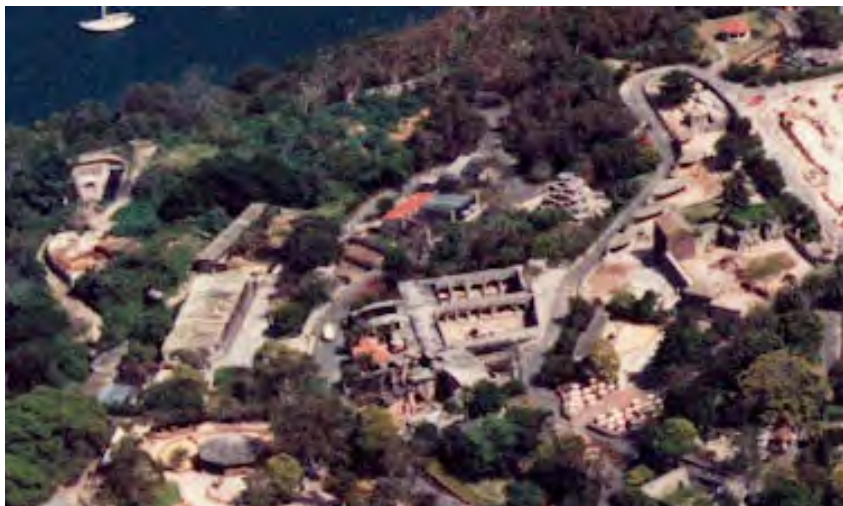
Figure 2.20 This 1979 aerial photo shows the area little changed with the tiger and lion pits with their arcaded shelters and high level walkways remaining. The lower level roads and exhibits are also unchanged. Source: Taronga Zoo Archive

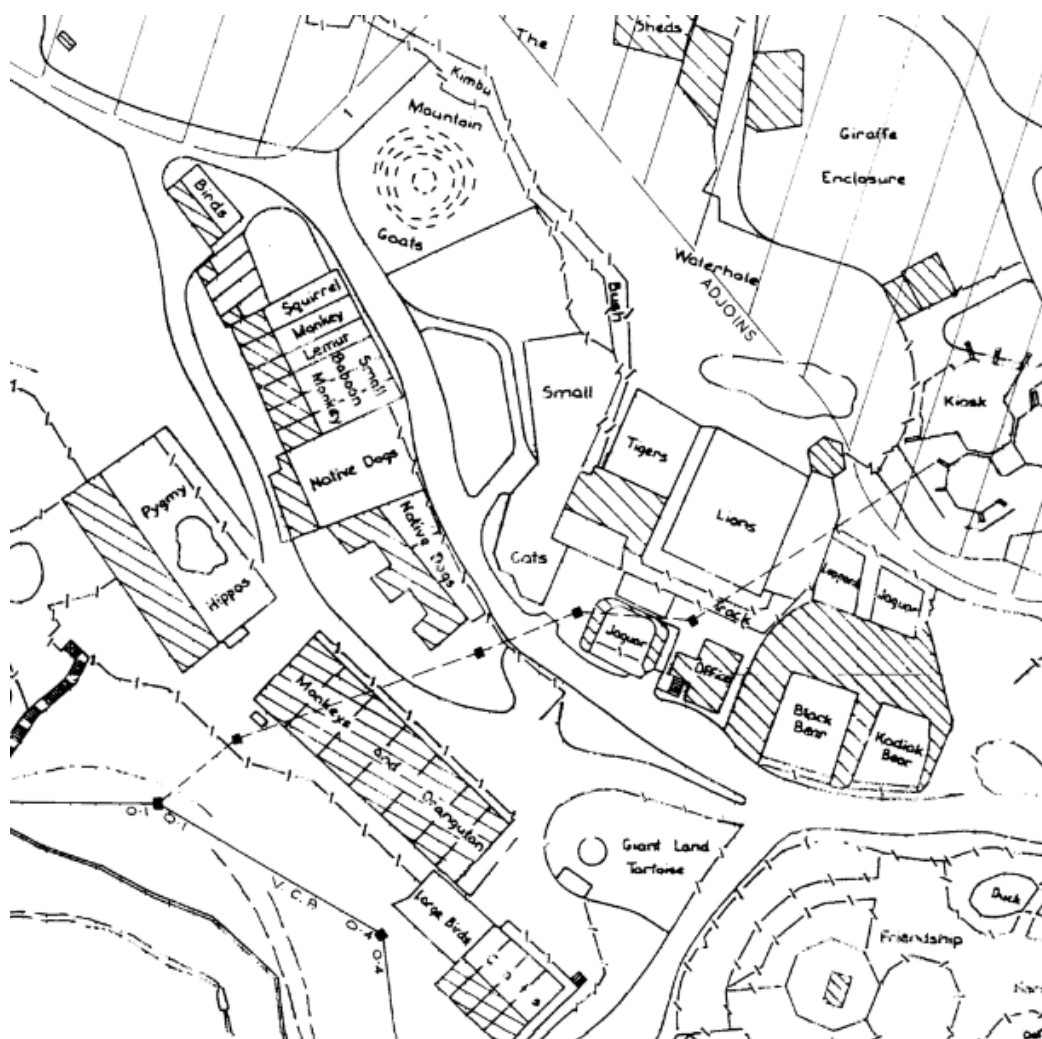
Figure 2.21 Carnivora pits at Taronga Zoo. The original Lion and Tiger pits are labelled Black Bear and Kodiak Bear. Source: Water Board diagram 1970s

During the 1970s the Kodiak Bears and the Black Bear were relocated into the original two carnivora pits. The Zoo had obtained bears from the Kodiak Island in Alaska in 1948 however in 1953 the male bear was killed by vandals. Other animals were also injured. A new mate for the female Kodiak arrived in 1954. The 1970s Water Board plan also shows that the WCs built within two of the three additional pits were now in use as offices and the one remaining pit was for jaguar. The Tiger and Lion pits remain with an area to the left for small cats. Changed uses of the small exhibits on the southwest side of the road are shown including birds, squirrel, monkey, lemur, small baboon monkey and several native dog enclosures. The new road below now meets up with the old road near the bird exhibit at top left. This means that the rock cutting on the route of this road must have been made at this time. Lower down the hill the former deer enclosure is shown as for the Pygmy Hippos and Monkeys and Orangutan are in the former Ape enclosure.

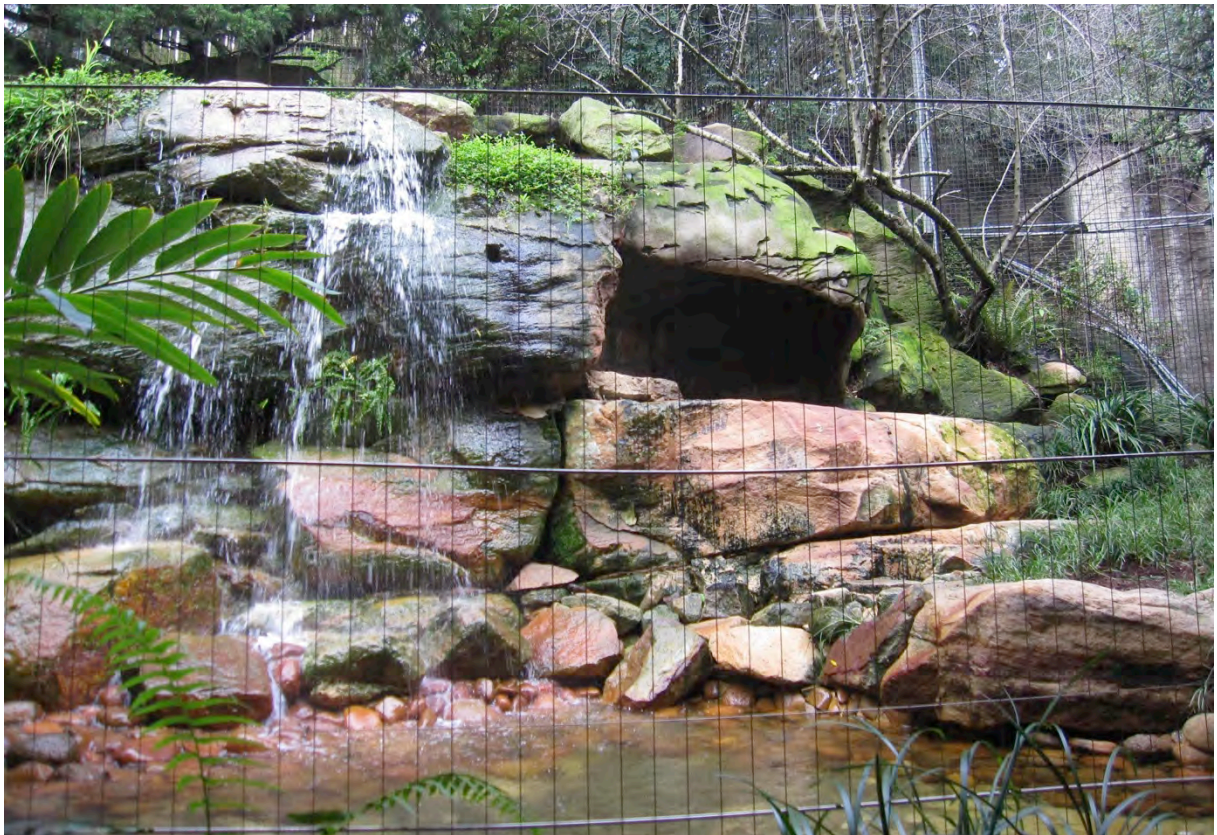
Figure 2.27 Natural rock ledges within the Snow Leopard exhibit which provide evidence of the character of the site until the initial phases of landscaping were undertaken for the Zoological Gardens. The feature also includes some mock rock which is difficult to distinguish from the natural sandstone. Jean Rice Architect

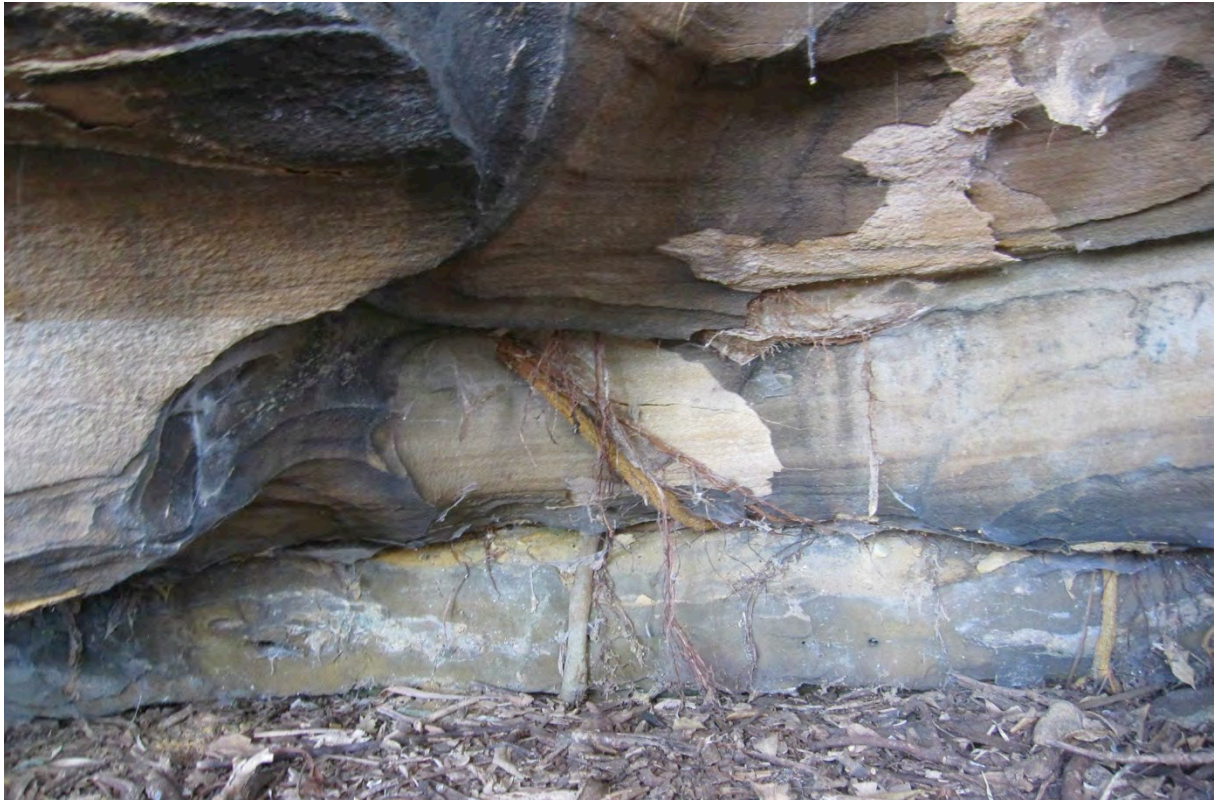
Figure 2.28 Site of the Aboriginal Hand Stencils as they appear today. Jean Rice Architect

Detailed site assessment revealed that the Aboriginal site has been badly affected by self-seeded figs and water seepage. There is an opportunity in the project to limit damage by removing the figs – removal of which is proposed for vehicle access on Birdshow Road. There is also an opportunity to improve drainage and limit salt damp activity in the rock shelter.

The Aboriginal Stencil site has already been impacted in the 1940s by the erection of a brick column to support the rock shelf above and damage by roots and water and associated salt activity. Specialist advice has been sought from Shreeji Consultants to determine the extent of set back required from the rock overhang to protect the Aboriginal site. This set back has been set at 3-3.6 m from the outer face of the cliff. There has been extensive collaboration during the design process and the proposal has been amended to avoid structural and construction impacts.

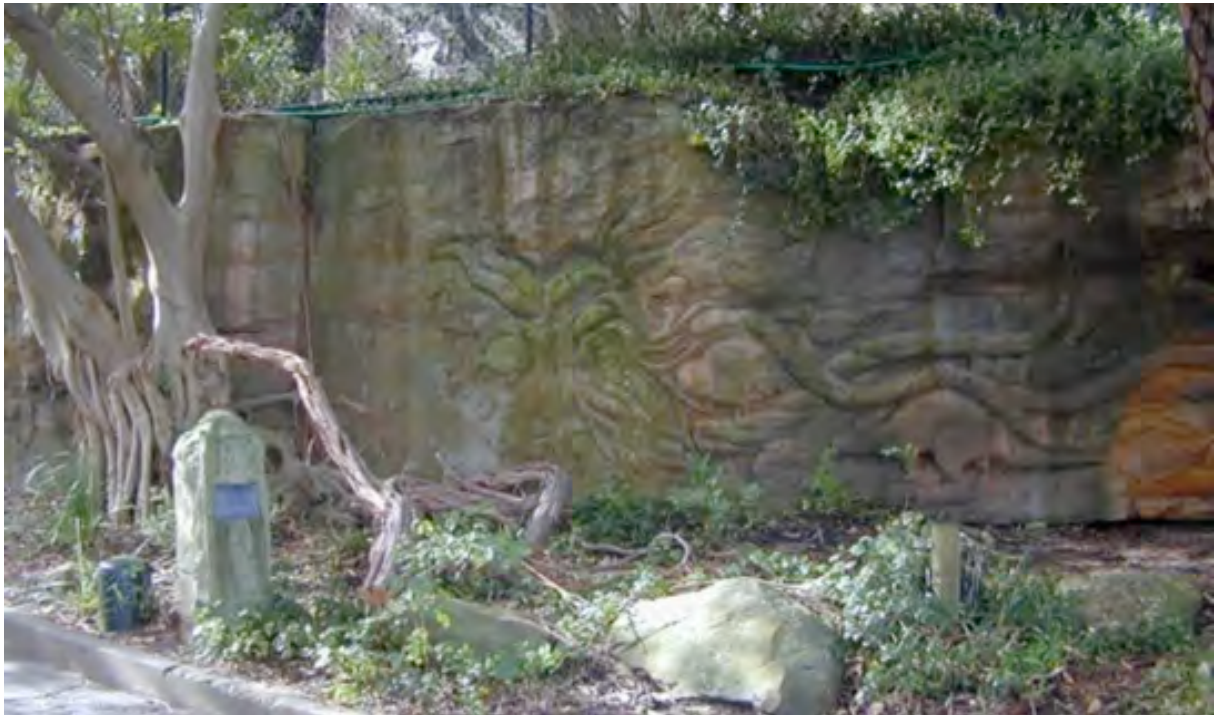
Figure 2.29 Sandstone Rock Face carved by Mick Leslie in 1981. The pier on the left of the photo has a plaque indicating the origin of the sculpture. Jean Rice Architect

Adjacent to the Aboriginal stencils is one of the series of carvings in the 'living' rock undertaken by the retired stone mason Mick Leslie. This rock face was formed in the 1970s when the adjacent road was built requiring a cutting in the natural sandstone. Four carvings were undertaken in the mid 1960s to mark the four zones of the Zoological Gardens however the whereabouts of these is now unknown. The fifth carving, undertaken in 1981 utilised Aboriginal motifs that reflect the long standing Aboriginal use of the site.

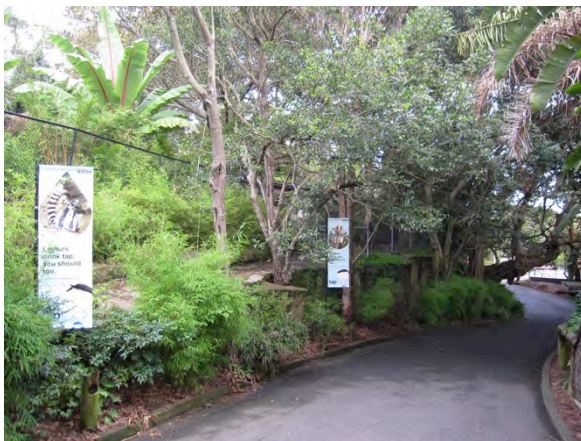
Figure 2.31 Birdshow Road from the west with the cutting on the left. Source: Jean Rice

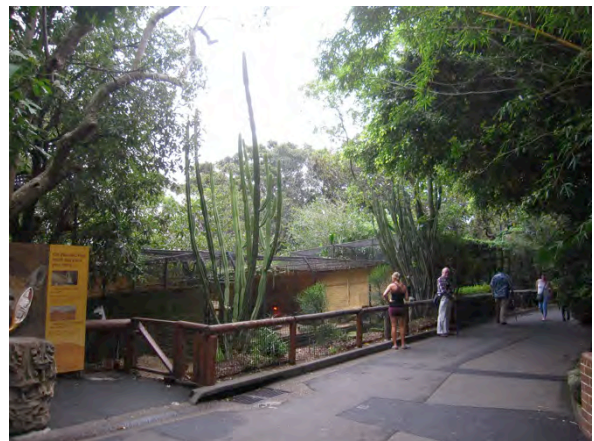
Figure 2.32 Dog Road from the east. Source: Jean Rice

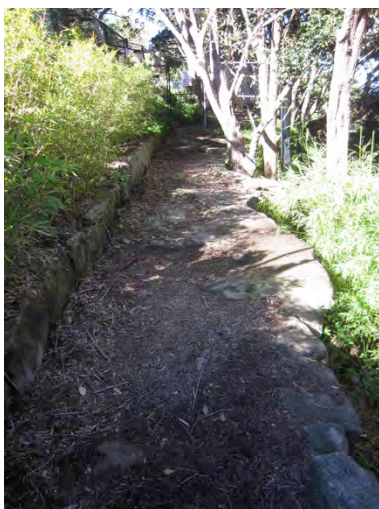
Figure 2.33 Path above cutting on Birdshow Road. Informal stone garden edging on left.

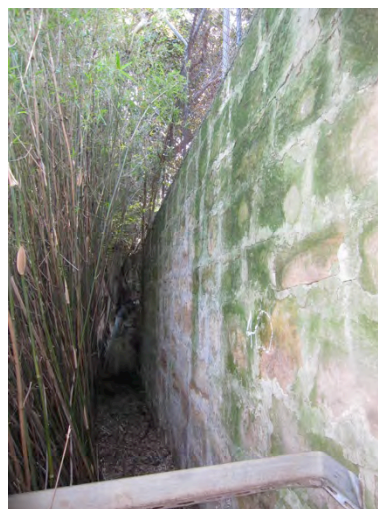
Figure 2.34 Formal stone retaining wall 63L opposite the amphitheatre across Birdshow Road.

There is an opportunity to conserve the ashlar stone retaining wall above Birdshow Road (63L). The wall is affected by small self-seeded figs and has been repointed in hard cement mortar in the past. There is an opportunity to poison the figs and repoint in compatible lime mortar and also to replace some stone that have fallen out of the base of the wall.

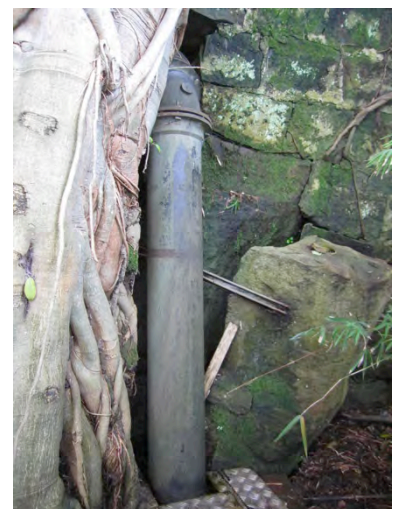
Figure 2.35 West end of wall 63L showing stormwater pipe and damage caused by fig tree roots.

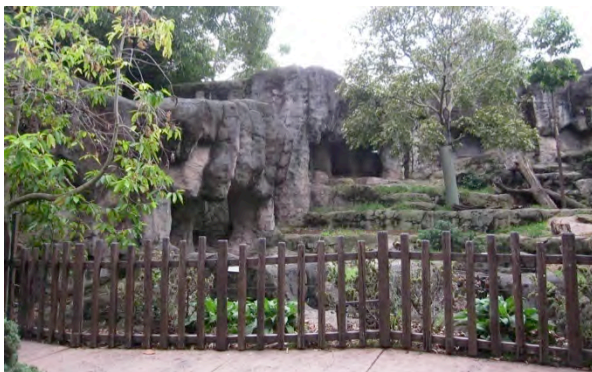
Figure 2.36 Upper Bear Pit (now Sun Bear). The mock rock in this photo was built in 1999. Source: Jean Rice

The Upper Bear Pit (**52B**) was originally the Lion and Tiger Exhibits built in 1916. The exhibits were viewed from below across a moat. They were surrounded by natural and mock rock on three sides. Dens and keepers facilities were built into the hillside on the upper side of the exhibits. By the 1970s the exhibit was used for bears but was little altered. In 1999 the exhibit was altered extensively with the removal of the division between the two pits and a tunnel that was concealed in the dividing mock rock wall. Only the moats and an area of mock rock to the right (east) of the exhibit remained unaltered. New mock rock walls were constructed and a viewing cave at the left (west). The floor of the exhibit was altered from flat to sloping or stepping up towards the rear (north) and new low retaining walls were built across the slope. Today the extent of the exhibit and the viewing arrangement over the moat is similar to the original. The three cats exhibits built to the west of exhibit 52B have all been demolished.

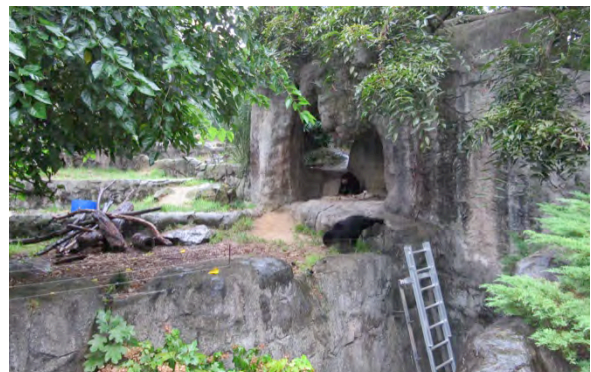
Figure 2.37 Part of the Upper Bear Pit believed to be original. The moat is at the front. Source: Jean Rice

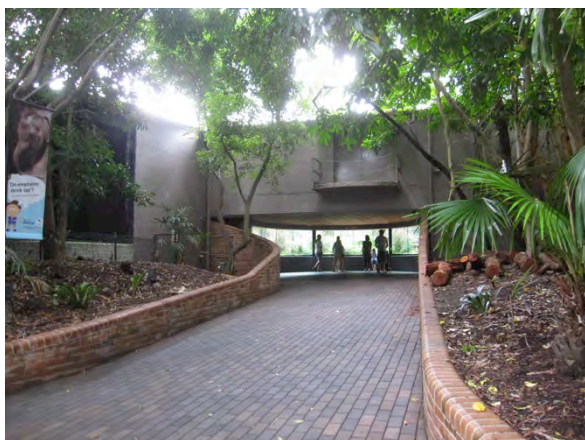
Figure 2.38 View from Dog Road of the Lion viewing window and dens and keepers areas above. Source: Jean Rice

The Lion exhibit was altered at the same time with viewing windows from the east and closure of the upper level walkways. At this time the exhibit is shown as having a mound at the centre. It is not known if this covers the mock rock mountain or if the mountain was removed. A couple of years later a similar curved low level viewing window was added to the Lion pit and dens and keepers facilities extended above. The Lion viewing window is at a higher level than the Tiger viewing window reflecting the original

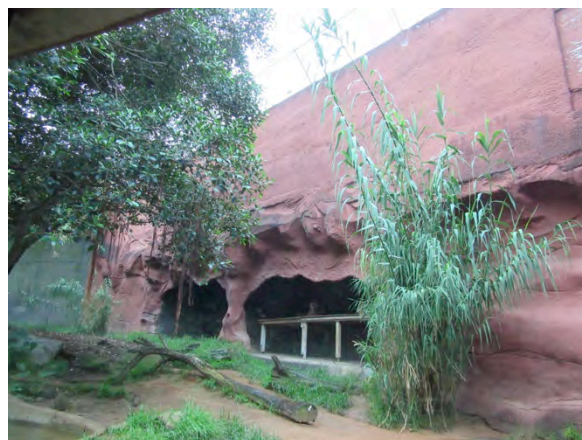
Figure 2.39 Mock rock caves on the east wall of the Lion exhibit. The plain upper brickwork may be where the 1991 viewing windows were. Source: Jean Rice

differing ground levels of these exhibits. It is not clear what, if any, of the original structures remain. The line of the outer walls matches the original configuration but there is little remaining of the high relief mock rock visible in early photos. The caves in the north wall of the Lion pit may be original but the mock rock on each side of the viewing window is less likely to be because of the extensive construction work over it. Further physical investigation of the site is needed to establish this.
