Taronga Zoo
Sumatran Tigers
Heritage Impact Assessment
May 2015

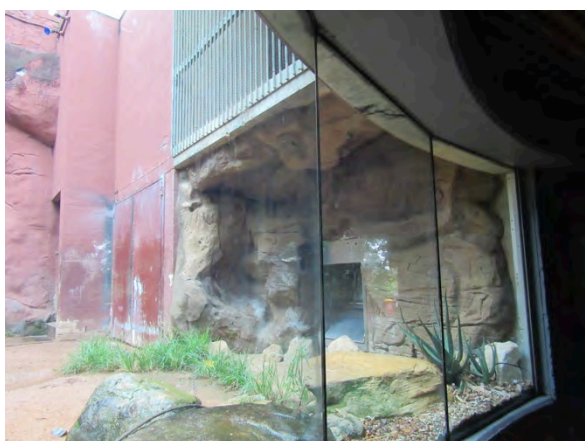
Figure 2.40 Mock rock to the right of the Lion viewing window. The window, masonry wall and dens over were built in 1992-93 so the mock rock may date from then. Source: Jean Rice

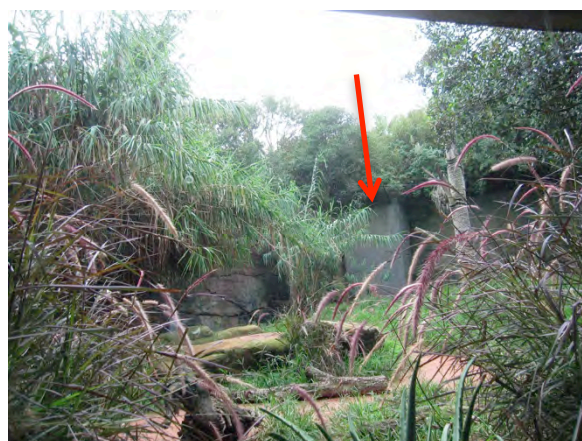
Figure 2.41 Northwest corner of the Lion exhibit. The stepped wall arrowed is where the arcade was removed in 1992-93. Source: Jean Rice

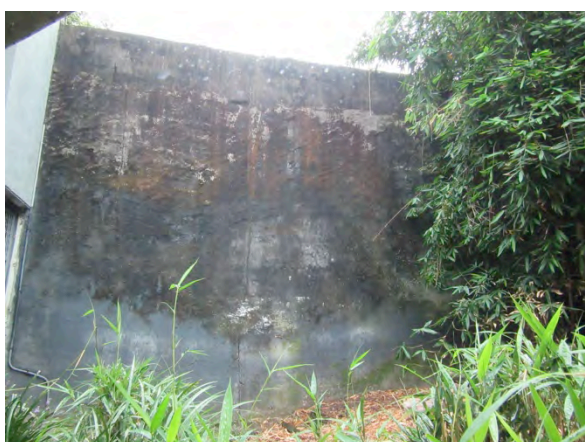
Figure 2.42 The west wall of the tiger exhibit. This was shown to be retained in 1991 drawings but does not have a mock rock finish. Source: Jean Rice

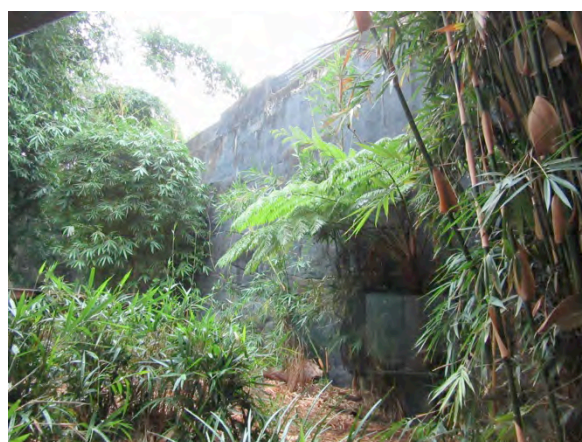
Figure 2.43 East wall of the Tiger exhibit. Corrugated iron has been added at the top of the wall. Source: Jean Rice

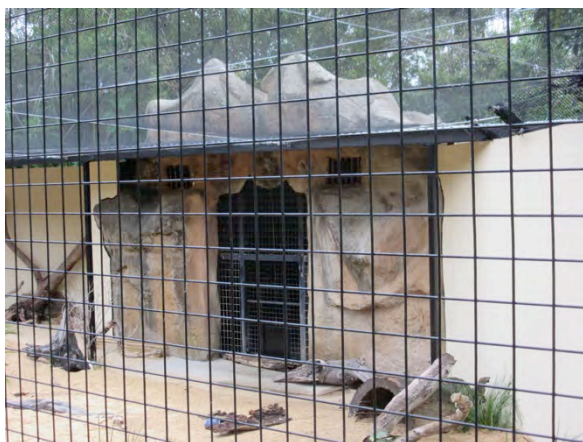
Figure 2.44 The former Pygmy Hippo mock rock den 98(B), now part of the Fennec fox exhibit. Source: Jean Rice

The c1939 Pygmy Hippo den (**98B**) is above the Tiger enclosure facing Waterhole Road. It is a mock rock structure which has recently been incorporated into a new Fennec Fox exhibit. The Fennec foxes were previously in an enclosure in the area which is proposed to be the new Sumatran tiger exhibit. The mock rock shelter remains intact and unaltered.

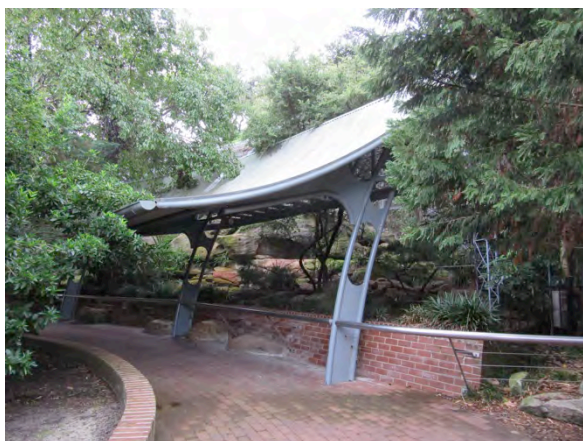
Figure 2.46 2015 view of the 1989 Snow Leopard enclosure. Source: Jean Rice

The Snow Leopard exhibit features a shelter, which is a modern steel structure built in 1989. It has a curved steel frame, which cantilevers over the exhibit and also follows the curve of the path. The roof is of curved corrugated steel. The enclosure itself is a mesh tension structure suspended over the natural and artificial rock features (**101B**). The natural gully was used to create a 'stream' and 'waterfall' which runs with recirculating water but gives a natural appearance. The low brick walls, brick paving, bridge and Himalayan themed plantings were part of the themed exhibit. The dens are simple brick buildings adjacent the Tigers exhibit and, in part, existed prior to the construction of the 1989 steel enclosure.

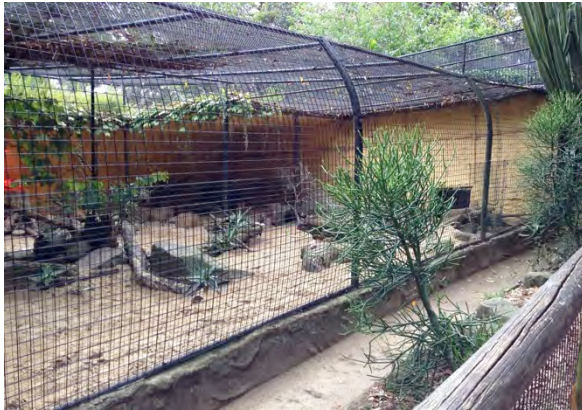
Figure 2.48 The eastmost of the former wild dog enclosures occupied recently by the Fennec foxes. Source: Jean Rice

There are several other exhibits in the area that are not listed. They are a series of small caged enclosures on the south side of Dog Road primarily built for various wild dog species displays. They each have mock rock shelters or dens along the south edge of the displays. These form an irregular row generally set back from the edge of the sandstone rock shelf with an informal path. There is a chain wire fence along the outer edge of the sandstone rock shelf. One exhibit den is built up to the edge of the sandstone immediately over the Aboriginal hand stencil site. It and many of the other shelters are disused. The side walls of that exhibit den have been roughly broken open to allow access between the paths on each side. This shelter is in poor condition with large cracks also caused by fig tree growth and as the floor is at a higher level water is channelled from the adjacent paths over the rock shelf at this point. The eastmost exhibit has most recently been used for the Fennec foxes recently relocated to the Pygmy Hippo shelter. The westmost of these exhibits is currently used for the Meerkats and these are soon to be moved to a new location. The front of these exhibits are generally pipe frames with black

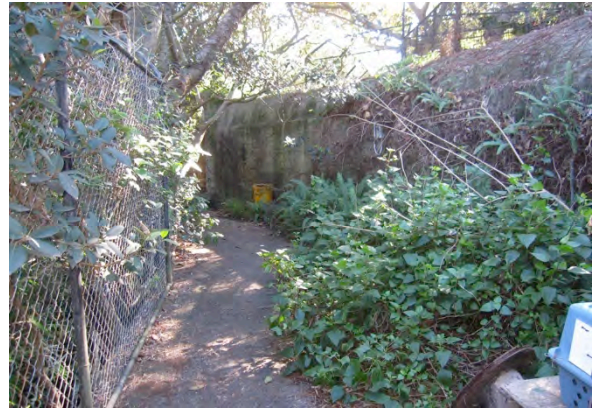
Figure 2.49 Typical rear view of the former wild dog enclosures showing the chain wire fence on the left, the informal path and the rear of the shelters on the right. Source: Jean Rice

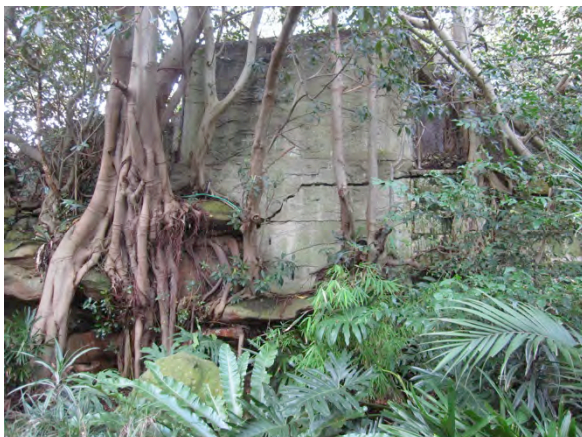
Figure 2.50 The disused den over the Aboriginal site viewed from Birdshow Road. Source: Jean Rice

The AMP recommends conserving the site and avoiding works above. However the rock face and concrete and brick structure above the site are now in poor condition and are a risk to the site. Works need to be undertaken to conserve the site. The AMP notes that if works above are required then the stability of rock shelf should be assessed, there should be no modification prior to consultation MLALC and that an AHIP Permit and consent is required. These steps are being undertaken separately prior to the SSD as the site is affected by the early works package.

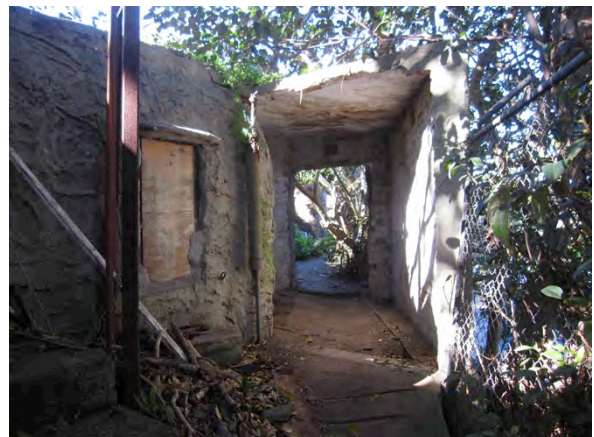
Figure 2.51 Rough openings made in the walls of the den over the Aboriginal site. Source: Jean Rice

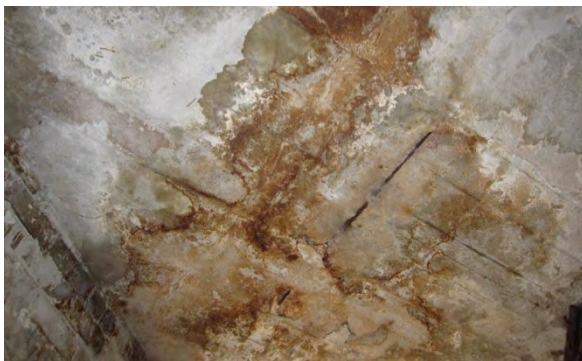
Figure 2.52 Deteriorated ceiling of the den over the Aboriginal site. Source: Jean Rice

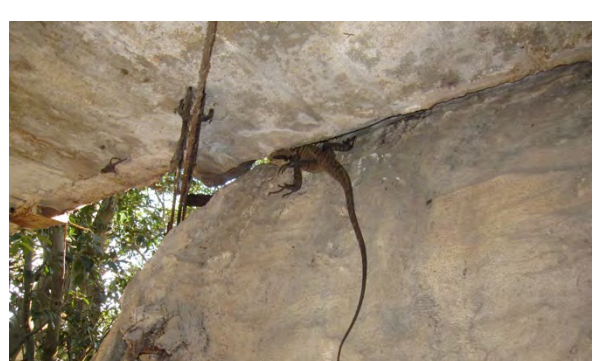
Figure 2.53 Crack between the wall and ceiling of the den over the Aboriginal site. Source: Jean Rice

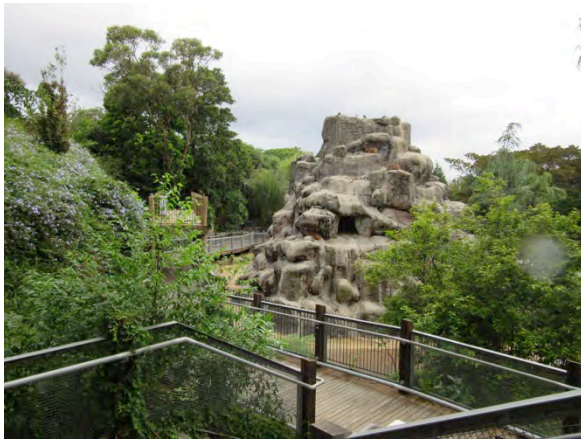
Figure 2.54 Tahr Mountain and the modern ramp adjacent. Source: Jean Rice

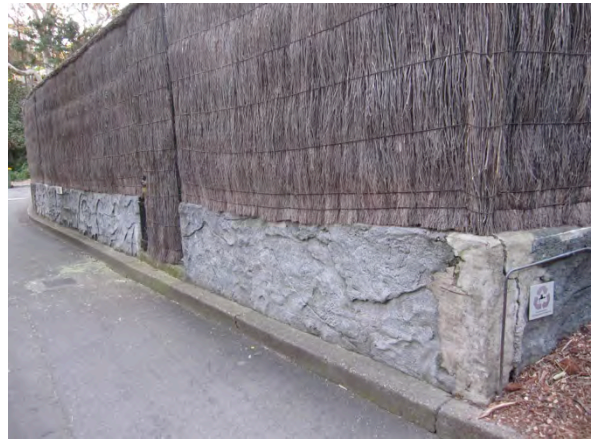
Figure 2.55 Low masonry wall around Tahr Mountain. Source: Jean Rice

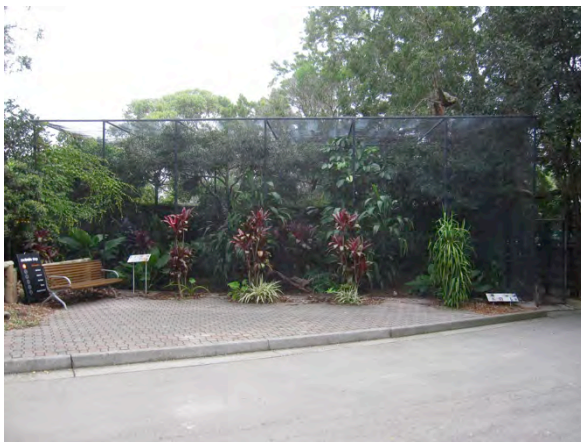
Figure 2.56 Bird Aviary and seating area from the north. Source: Jean Rice

The westmost exhibit in this area is a bird aviary that is a simple rectangular structure with a rear brick wall with a rendered mock rock finish, pipe frame and black chain mesh cladding. The front is set back from the road making a seating area and there are adjacent decorative tree plantings. Opposite this is Tahr Mountain which features a mock rock central 'mountain'. It is enclosed by a low rendered brick fence with a chain wire fence above this with some brush fencing attached. A modern ramp and stairs provides equitable access from the Waterhole Path and other higher level roads.

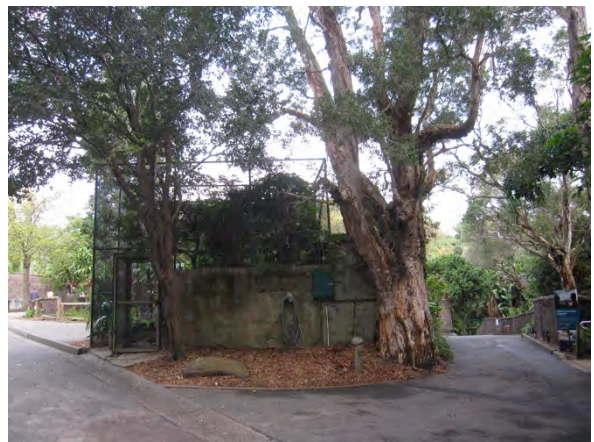
Figure 2.57 Bird aviary from the west. Source: Jean Rice

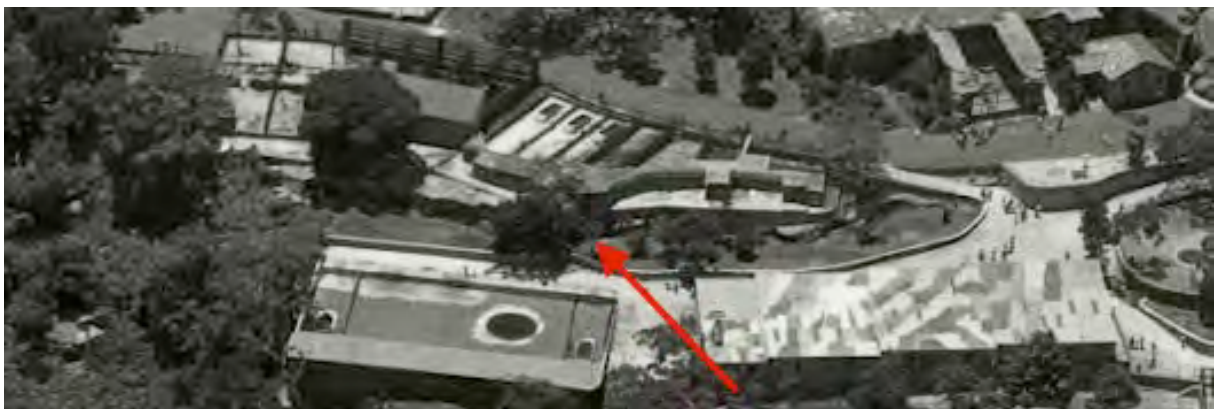
Figure 2.58 1962 aerial photo showing the Aboriginal site and adjacent fig arrowed and the large fig to the left in the Dhole exhibit. Source: Jean Rice

A 1962 aerial shows much less vegetation in this area. Since 1962 the area has become heavily vegetated with self seeded fig trees colonising the rock shelves and walls. In the garden bed between the Birdshow Road and rock shelves and in the rock features themselves are a series of self seeded fig trees. One is larger and evident in the 1962 aerial but the others have grown since then. Several have roots that go from the top of the rock shelves to the garden bed forming sculptural forms. The roots are also growing into fissures in the natural stonework and joints in the structures including the retaining wall.

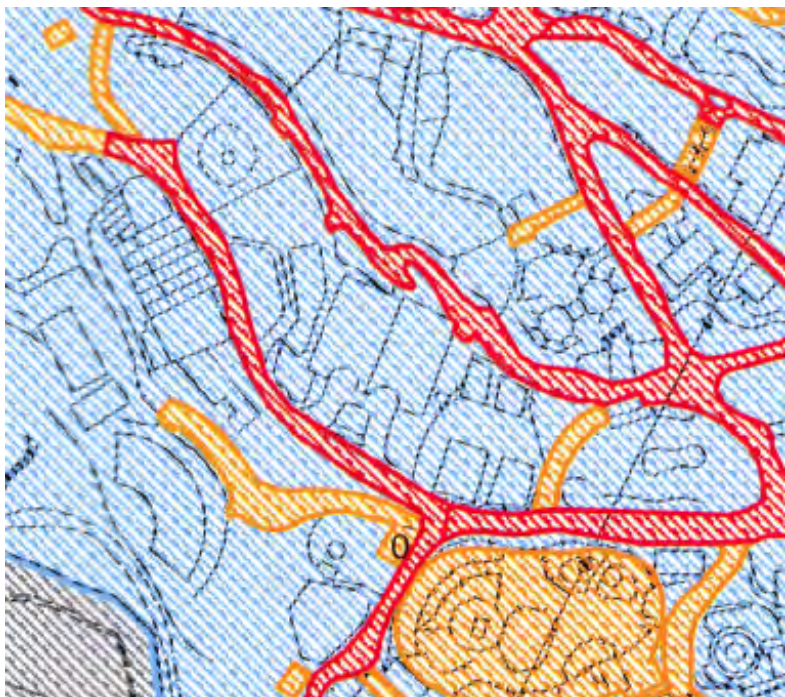
<p>Historical Archaeological Management Zones</p> <p>Zone A</p> <p>Unassessed area outside Zoo boundary wall</p> <p>Zone B</p> <p>Areas of extant original Zoo path layout</p> <p>Zone C</p> <p>Areas where subsurface evidence of previous European activity has potential to remain</p> <p>Zone D</p> <p>Areas where there is no potential for subsurface archaeological evidence to remain</p>

<p>Historical Archaeological Features</p>	
<p>Zone B (Zone 2) (Original path):</p> <p>Archaeological features identified in this zone should, where possible be retained in situ. Development plans should be designed to retain the features of this zone in their original condition. If the proposed development must destroy the features in this zone then provision needs to be made for an archaeological investigation, which may include monitoring, test or full excavation, prior to the commencement of work.</p>	<p>High archaeological sensitivity / potential and medium research potential.</p> <p>Avoid disturbance. Any excavation requires archaeological supervision in accordance with an excavation permit or exemption.</p>

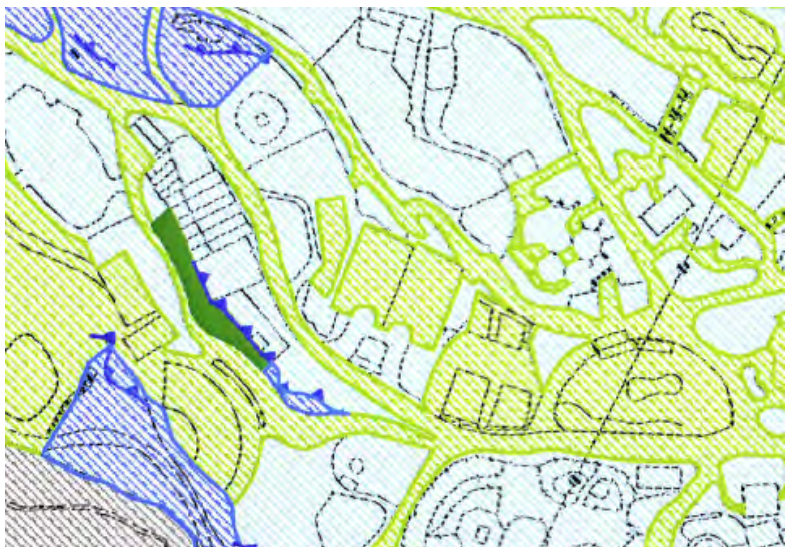
<p>Aboriginal Archaeological Management Zones</p> <p>Zone 1 Identified art site</p> <p>Zone 2 Unassessed area outside Zoo boundary wall</p> <p>Zone 3 Rock surfaces unmodified by European development Areas of original bushland unmodified by European development</p> <p>Zone 4 Areas heavily modified by European development</p> <p>Zone 5 Areas which have previously been excavated down to bedrock, or culturally sterile soil profiles</p>
<p>Aboriginal Archaeological Features</p> <p>There are five Aboriginal Archaeological Zones in Taronga Zoo four of which occur in the vicinity of the proposal</p>	
<p>Zone 1: Identified Art Site</p> <p>Very high archaeological sensitivity / potential.</p>	<p>Conserve site and avoid works above. If required assess stability of rock shelf, no modification prior to consultation MLALC, AHIP Permit and consent required.</p>
<p>Zone 3: Sandstone ridges and ledges not modified by European development.</p> <p>High archaeological sensitivity / potential.</p> <p>Potential for concealed intact sites.</p>	<p>If subsurface disturbance proposed obtain "preliminary research permit", test trench, MLALC to monitor. If relic found AHIP required.</p>

<p>Zone 4: Areas heavily modified by European development but not excavated to bedrock.</p> <p>Low archaeological sensitivity / potential.</p>	<p>Brief contractors if subsurface disturbance proposed and if relics exposed cease work and report to MLALC and NPWS and act as for Zone 3.</p>
<p>Zone 5: Areas previously excavated to bedrock.</p> <p>No archaeological sensitivity / potential.</p> <p>Culturally sterile.</p>	<p>No further Aboriginal archaeological input required. Act as for Zone 3 if any relic is found (unlikely).</p>

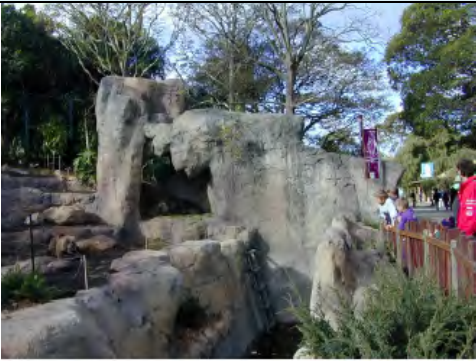
<p>Concrete mock rock formation modified extensively 1999 / 2000 for Kodiak bears. It is believed that only the section in this photo at the southeast corner and the moats are original</p> <p>See also 88L</p>
62B Cats of Asia Local	1923-39

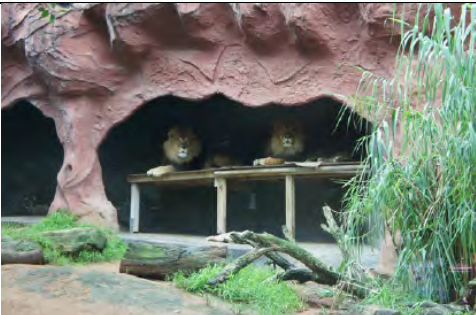
Concrete mock rock formation. Most of the other fabric is altered but these shelters may be original. Historic images of this east side of the enclosure are not clear enough to establish with certainty if these are original.
63L Sandstone Retaining Wall Local	1913-1916

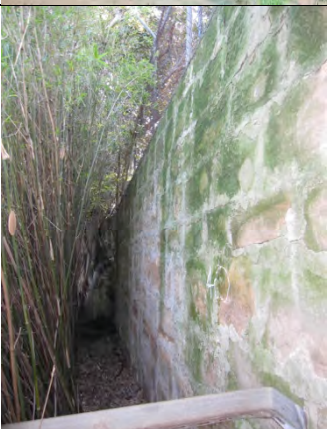
<p>Ashlar block retaining wall opposite Bird show Partially located behind bamboo plantings.</p> <p>The eastern end of the wall is built above a natural rock shelf. Over the rock shelf the wall changes to a mock rock rendered wall.</p>
66A Aboriginal Hand Stencil NPWS Site #45-6-1959	Predates the site's establishment as a zoo

There is an opportunity to conserve the ashlar stone retaining wall above Birdshow Road (63L). The wall is affected by small self-seeded figs and has been repointed in hard cement mortar in the past. There is an opportunity to poison the figs and repoint in compatible lime mortar and also to replace some stone that have fallen out of the base of the wall.

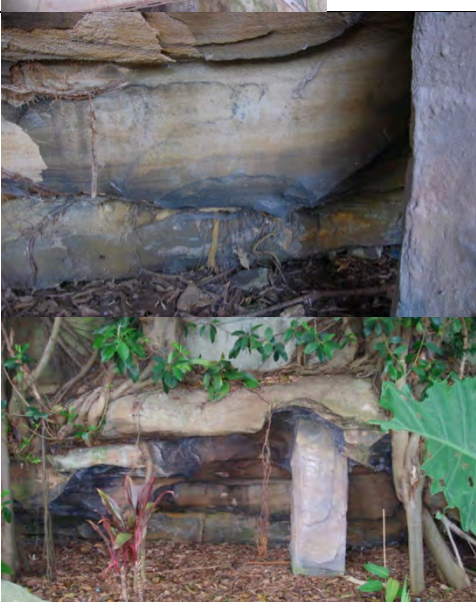
<p>The shallow small, overhang that contains the hand stencils is part of a larger, semi-quarried, sandstone face opposite the Bird Show. Only two remain of seven or eight white hand stencils originally noted on the rear wall. Refer to AMP.</p>

Detailed site assessment revealed that the Aboriginal site has been badly affected by self-seeded figs and water seepage. There is an opportunity in the project to limit damage by removing the figs – removal of which is proposed for vehicle access on Birdshow Road. There is also an opportunity to improve drainage and limit salt damp activity in the rock shelter.

The Aboriginal Stencil site has already been impacted in the 1940s by the erection of a brick column to support the rock shelf above and damage by roots and water and associated salt activity. Specialist advice has been sought from Shreeji Consultants to determine the extent of set back required from the rock overhang to protect the Aboriginal site. This set back has been set at 3-3.6 m from the outer face of the cliff. There has been extensive collaboration during the design process and the proposal has been amended to avoid structural and construction impacts.

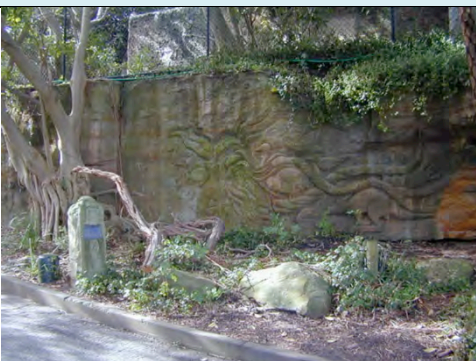
Stone Carvings by M. Leslie. This modern artwork has hand stencils and is an acknowledgment of the presence of the Aboriginal site in the vicinity. Refer to AMP.
68L Rock Faces Local	Predate Zoo but cutting made late 1960s / early 1970s

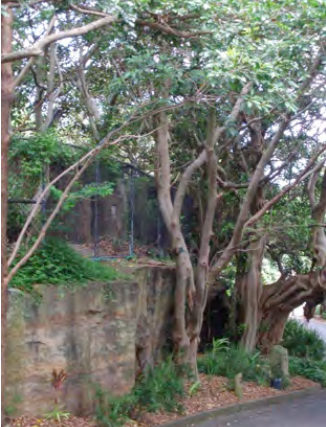
Rock faces at western roadway between bird show and Centennial picnic grounds. The rock face is a cutting, probably made for the current road in the late 1960s.
69L Natural Rock Benches Local	Predate Zoo

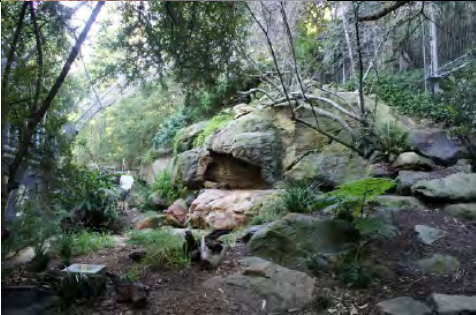
At Snow Leopard Exhibit. The area was part of a garden until it became a small cats enclosure in the 1970s. See also 101B
71L Broad-leafed paperbarks Local	Unknown – possibly Le Souef or slightly later

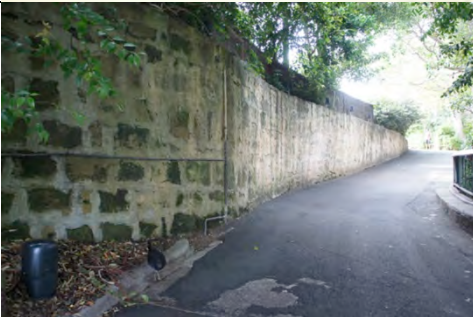
Rendered stone wall opposite Aldabra Tortoise Enclosure. This was probably built in the late 1940s when this areas was developed.
88L Rockwork Local	Predates Zoo but modified 1999 / 2000

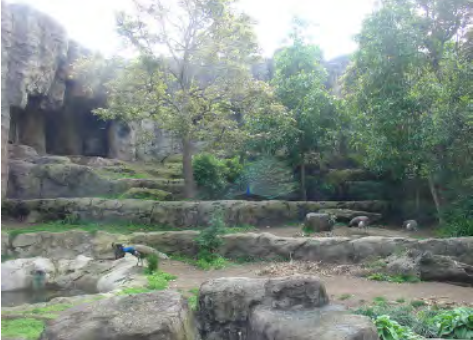
In Kodiak bear pits. It is difficult to distinguish the natural rock from the mock rock which was added in 1915 / 1916. Mock rock is now mostly from 1999 including the walls running across the enclosure in the photograph. See also 52B
98B Pygmy Hippo Enclosure Local	1930s

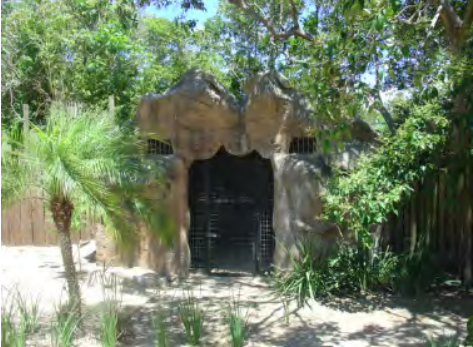
Date not confirmed. Not in 1930 aerial but in 1943 aerial. Shown as echidnas in 1956 but not shown on earlier guides. Possibly built in conjunction with tiger pit in 1939. Altered in 2015 as Fennec Fox Enclosure.

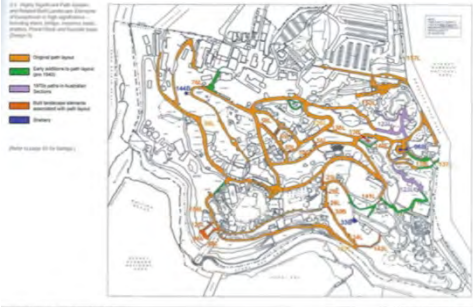
99L Original Early Paths State	1913-14

Early pathway alignment dating from pre-1940 Layout, including main paths following contours, paths and stairs linking levels, original balustrades and concrete kerb and gutters.

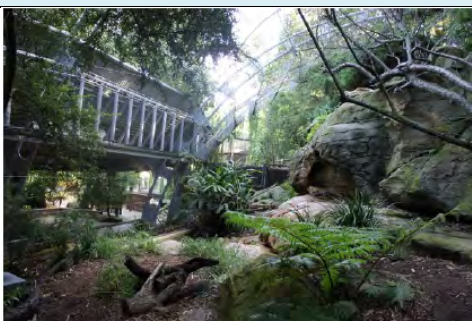
Heritage Items within the site			
Item / Significance	Date/Original	Image	Comment
101B Snow Leopard, Stone Features Local	Altered / enhanced in 1990

See also 69L for rock shelves and earlier rockwork
175L Firewheel Tree <i>Stenocarpus sinuatus</i> Local	Unknown – possibly post WWII

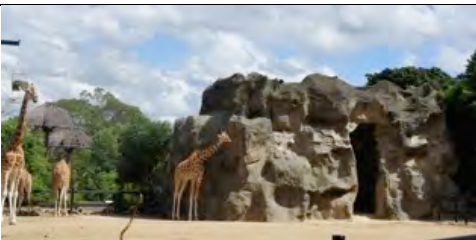
Refurbishment works to grotto house undertaken 2009.

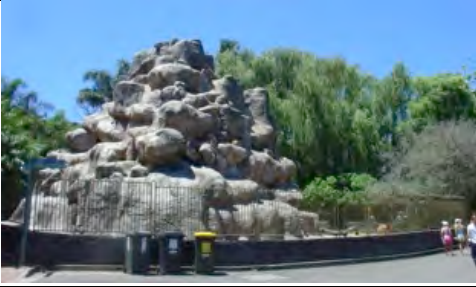
Heritage Items in the Vicinity			
Item / Significance	Date/Original	Image	Comment
70B Tahr Mountain State	1932

Tahr Mountain – mock rock mountain structure built of concrete. Ground works undertaken 2007. Front wall of enclosure proposed to be slightly altered.
73L Low Retaining Wall Local	C1916-1926

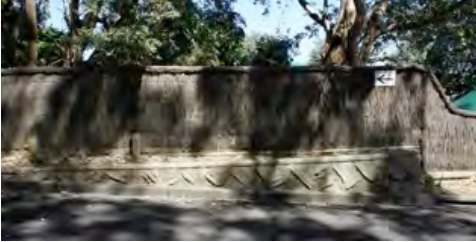
Low retaining wall at Roar and Snore (formerly known as the Centenary Lawn Picnic ground)
104L Bird Free Flight Amphitheatre Local	1998

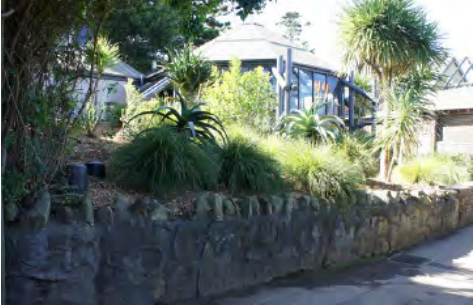
Roughly rendered masonry wall above the site with rustic stone cresting, west of former Safari Lodge, now Parents' Room.
180L Fig Tree Ficus nymphaeifolia ? Local	Probably post 1951

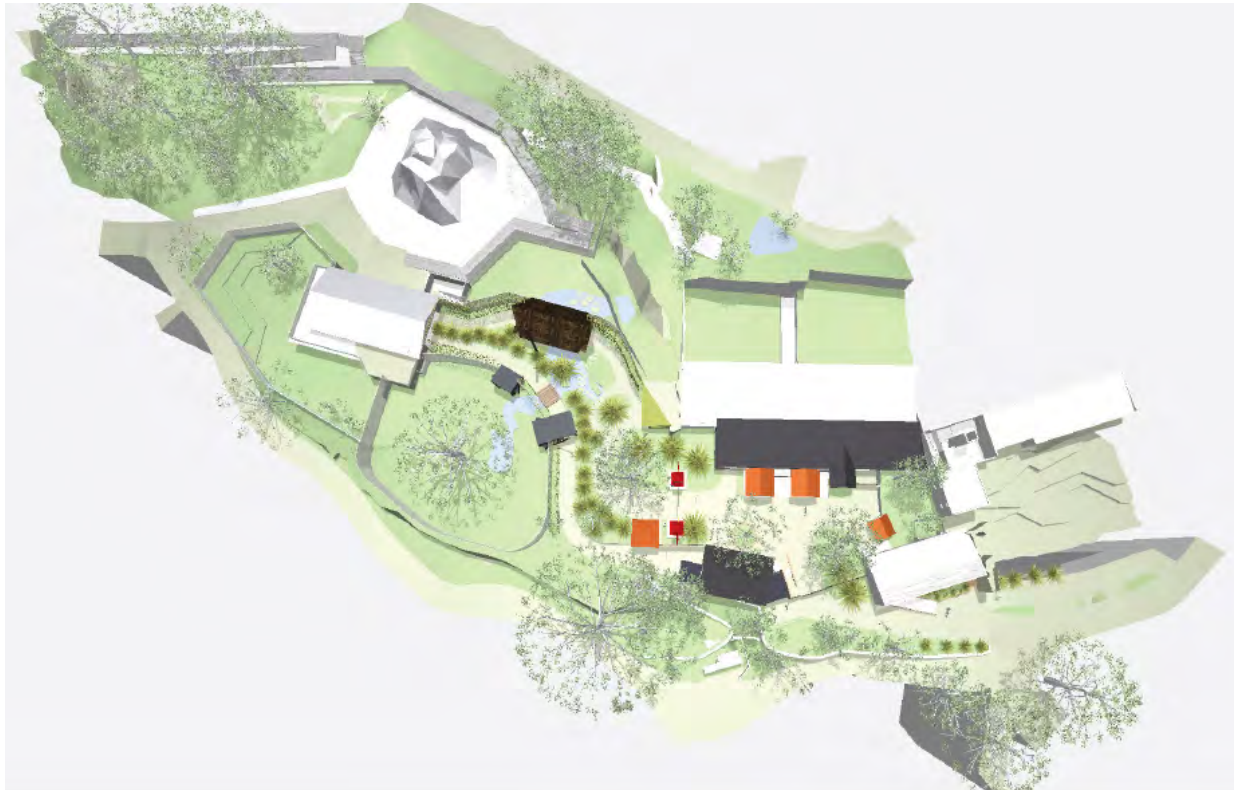
Figure 4.1 Proposed Sumatran Tiger Exhibit – Schematic Design, Lahznimmo Architects. Note that the coloured extent of this drawing is greater than the site of the proposed works. A more detailed plan follows later in this report.

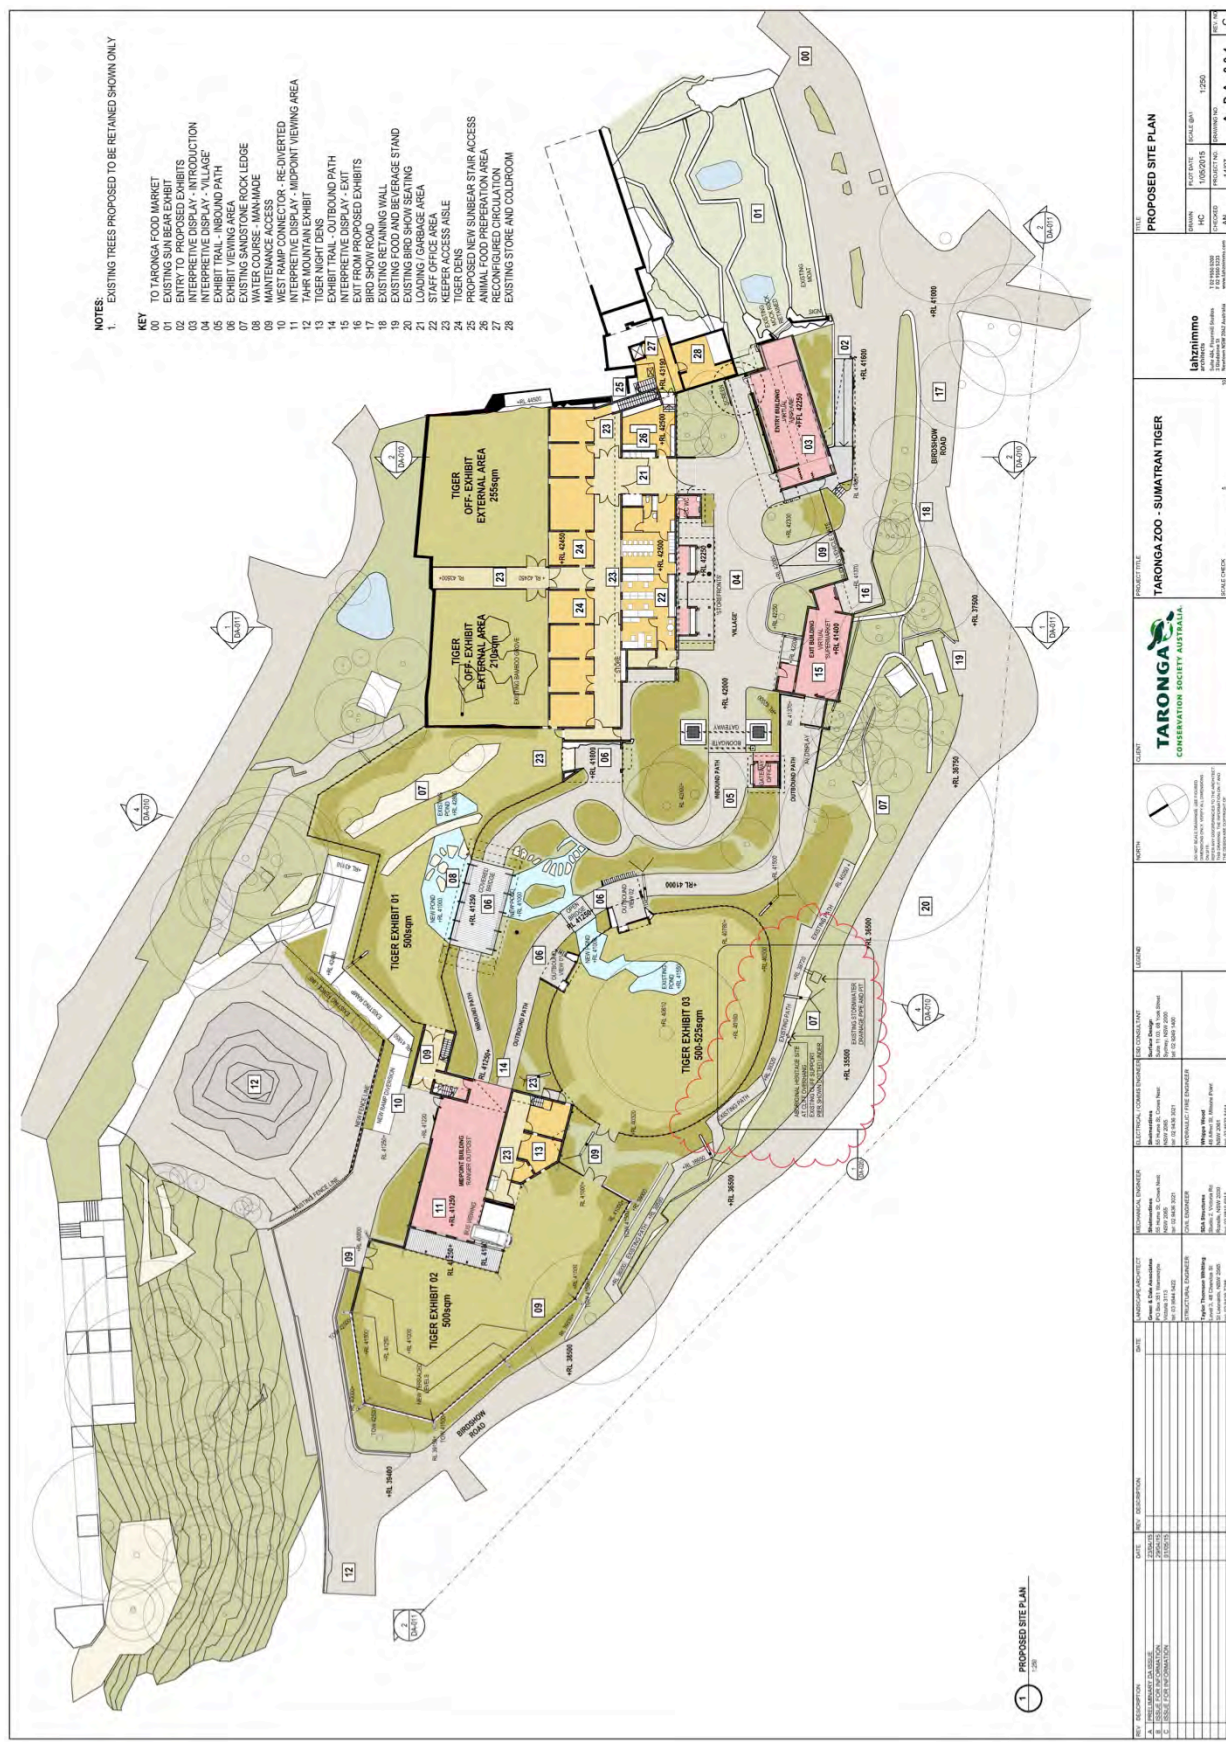
Figure 4.2 Proposed Sumatran Tiger Exhibit – Schematic Design, Lahzimmu Architects, dated 1/05/2015. The area indicated by a red cloud (centre / bottom) is the Aboriginal site and there is a separate detail for this area with protection measures.

As the subject area contains an Aboriginal site there has been liaison during the project to minimise the impact on the site and any Aboriginal archaeological resource generally. The design has been revised to avoid and protect the site with the aim of there being no negative heritage impact. Structural elements have been located to be outside an exclusion area / set back. Mitigative measures are recommended to ensure protection during works.
