# Contamination and Remediation

132 McCredie Road, Guildford West NSW 2161

Doc No. 60735340\_ContaminationRemediation\_20250211

Client: Goodman Property Services (Aust) Pty Ltd

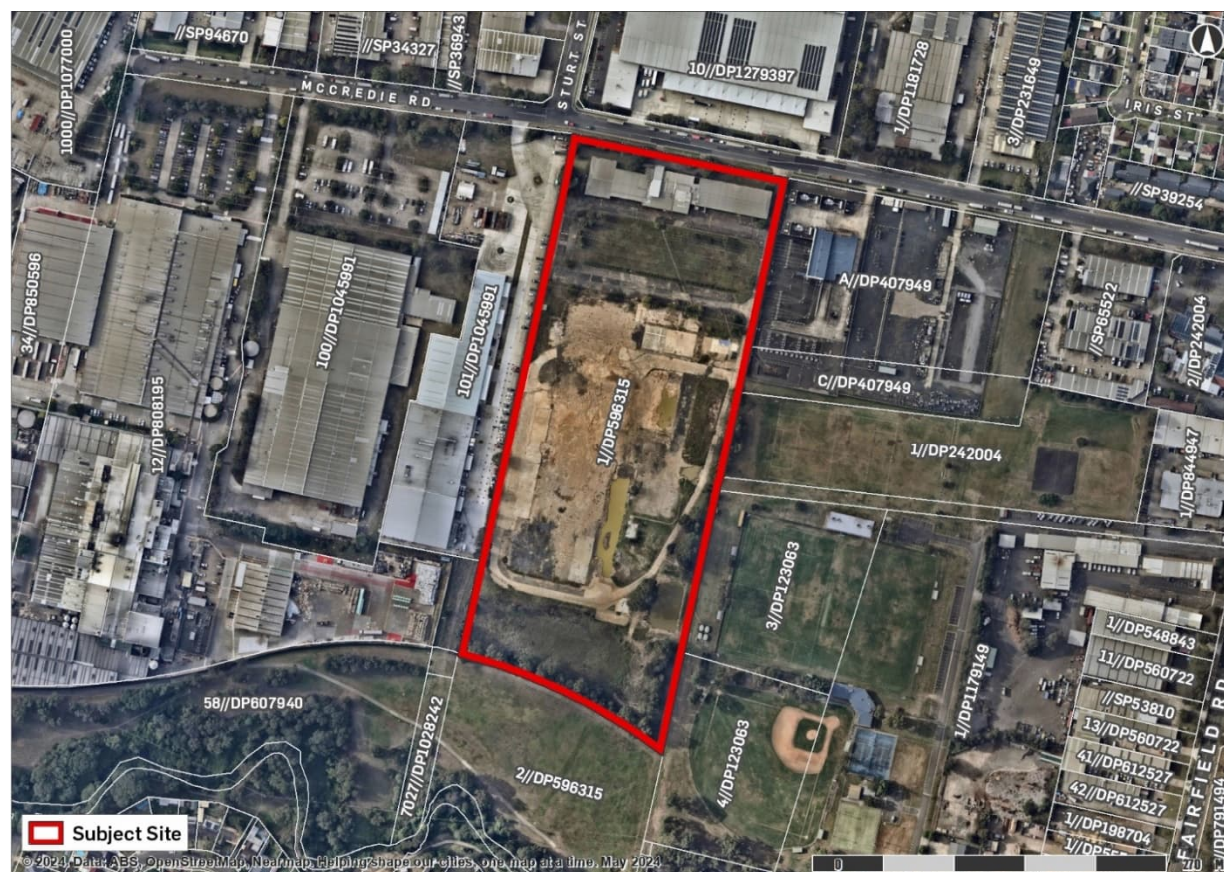
**Figure 1 Site Aerial**

The site has a net developable area of 71,710 sqm and is currently vacant. It previously operated as a Castrol Lubricants facility. However, the majority of the site has now been cleared and subject to category 1 remediation works. A single storey office building is located on the northern portion of the site fronting McCredie Road. The building is vacant.

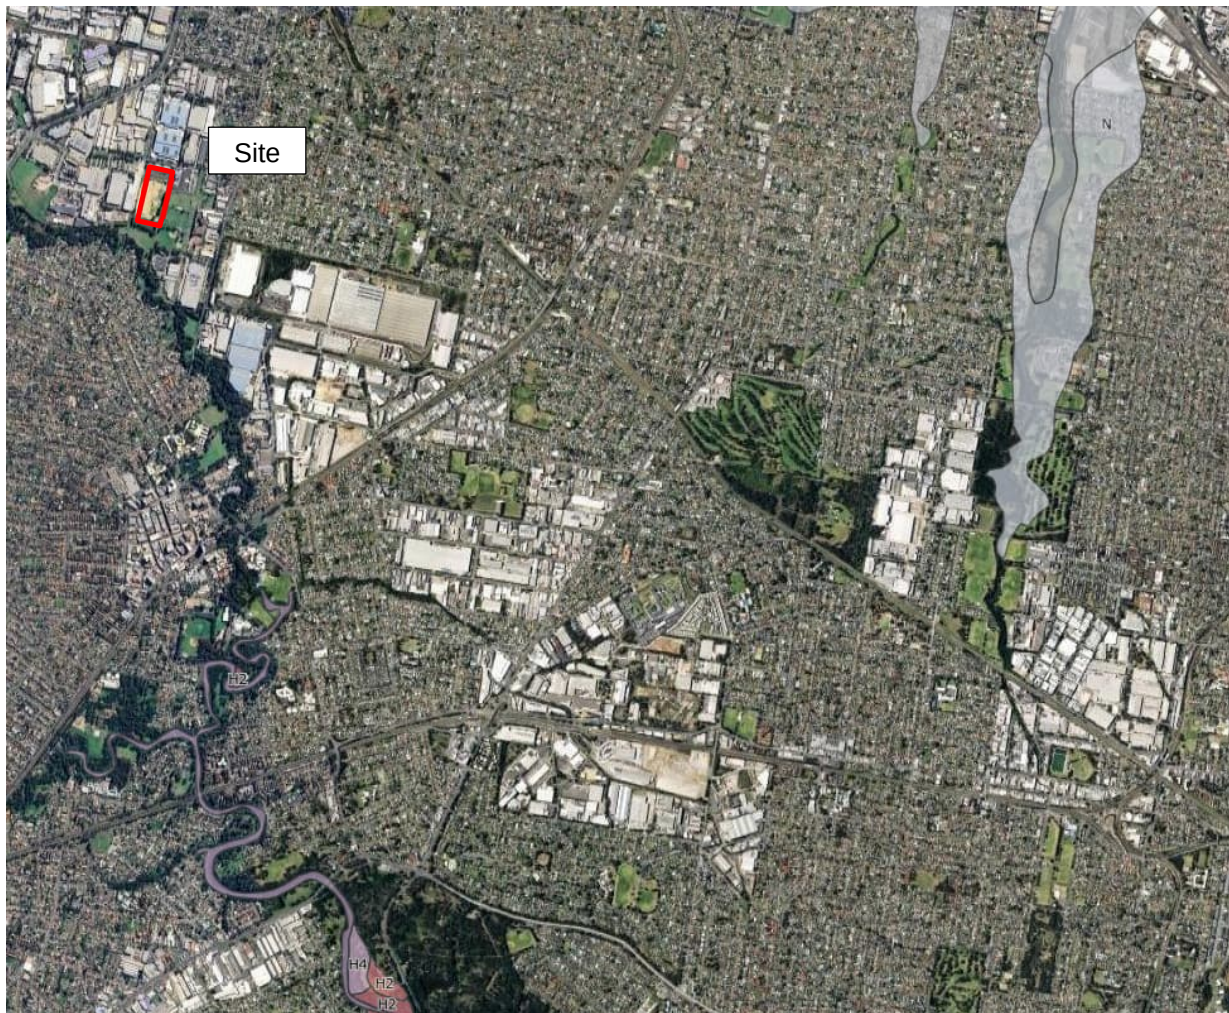
Figure 3 Acid sulfate soil mapping closest to the site (2.3 km south and 4.7 km east)

Based on a review of <https://www.environment.nsw.gov.au/eSpade2Webapp#> on 5 September 2024 (see Figure 3 below), the site is not subject to acid sulfate soil.

Given the above, the site does not require an ASS management plan for redevelopment activities or during operation and maintenance following redevelopment.

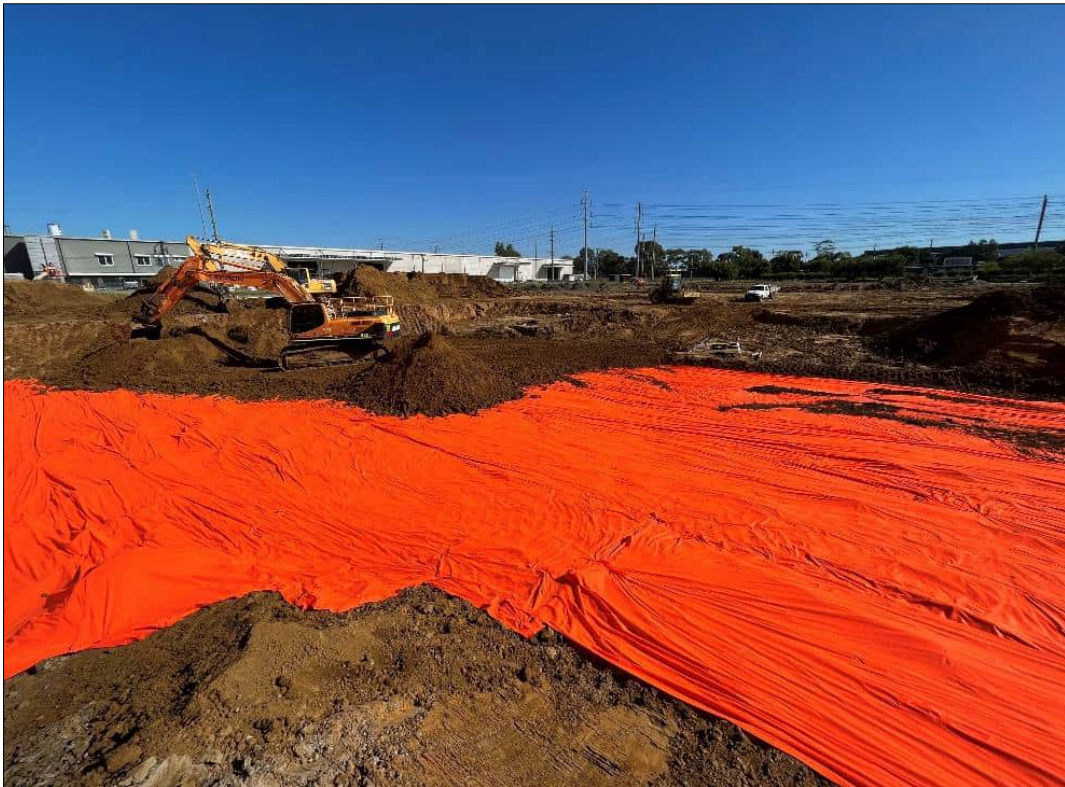
**Photo 1: Orange, Mesh Geotextile Marker Layer Present Overlaying Asbestos Containment Cell**

As part of the remediation program marker and capping layers were installed above an asbestos containment cell constructed in the centre of the site, as pictured in **Photo 1** below. The vast majority of ACM and asbestos impacted fill present on the site has been relocated into, and capped within, the containment cell. Detail of the capping layers are shown on the site survey (**Figure 3**), which comprised (in descending order):

- 3.0 m of natural soil; and
- An orange, mesh geotextile marker layer.

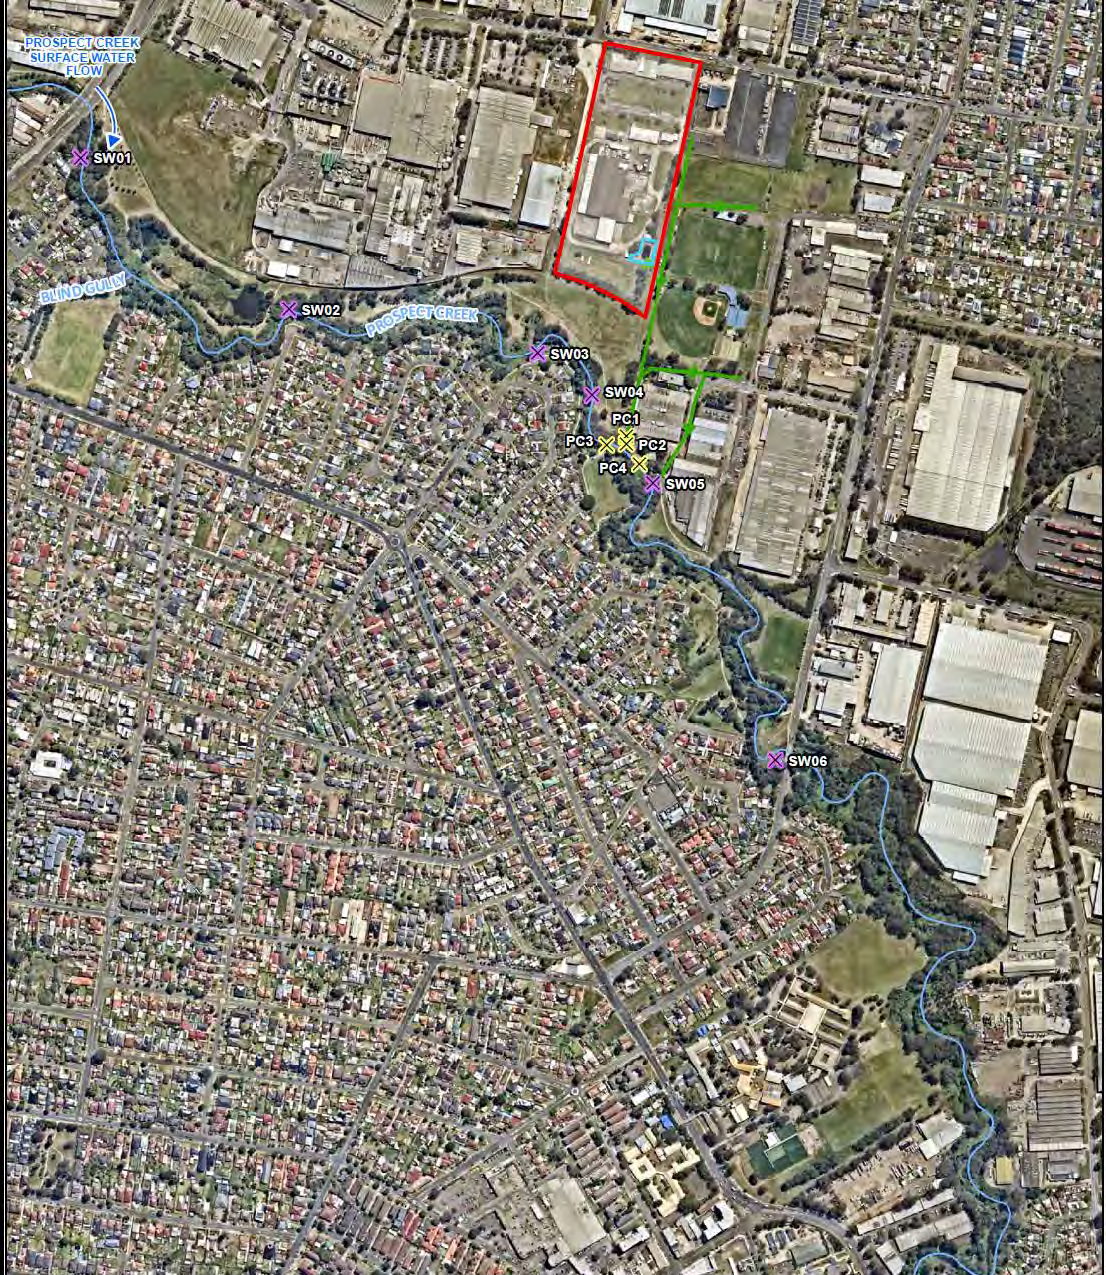
| <b>Legend:</b><br>Approximate Site Boundary<br><b>Sample Location</b><br>Surface Water, Kleinfelder 2020 - ESA<br>Surface Water, JBS&G 2021<br>Settlement Pond<br>Stormwater Pipe Network (Indicative) | Scale 1:10,000<br><br>Coord. Sys. GDA 1994 MGA Zone 56<br><br>Job No: 59279<br>Client: BP Australia Pty Ltd | BP Castrol Facility<br>132 McCredie Road<br>Guildford, NSW<br><b>PROSPECT CREEK PFAS<br/> BASELINE SAMPLE LOCATIONS</b> |

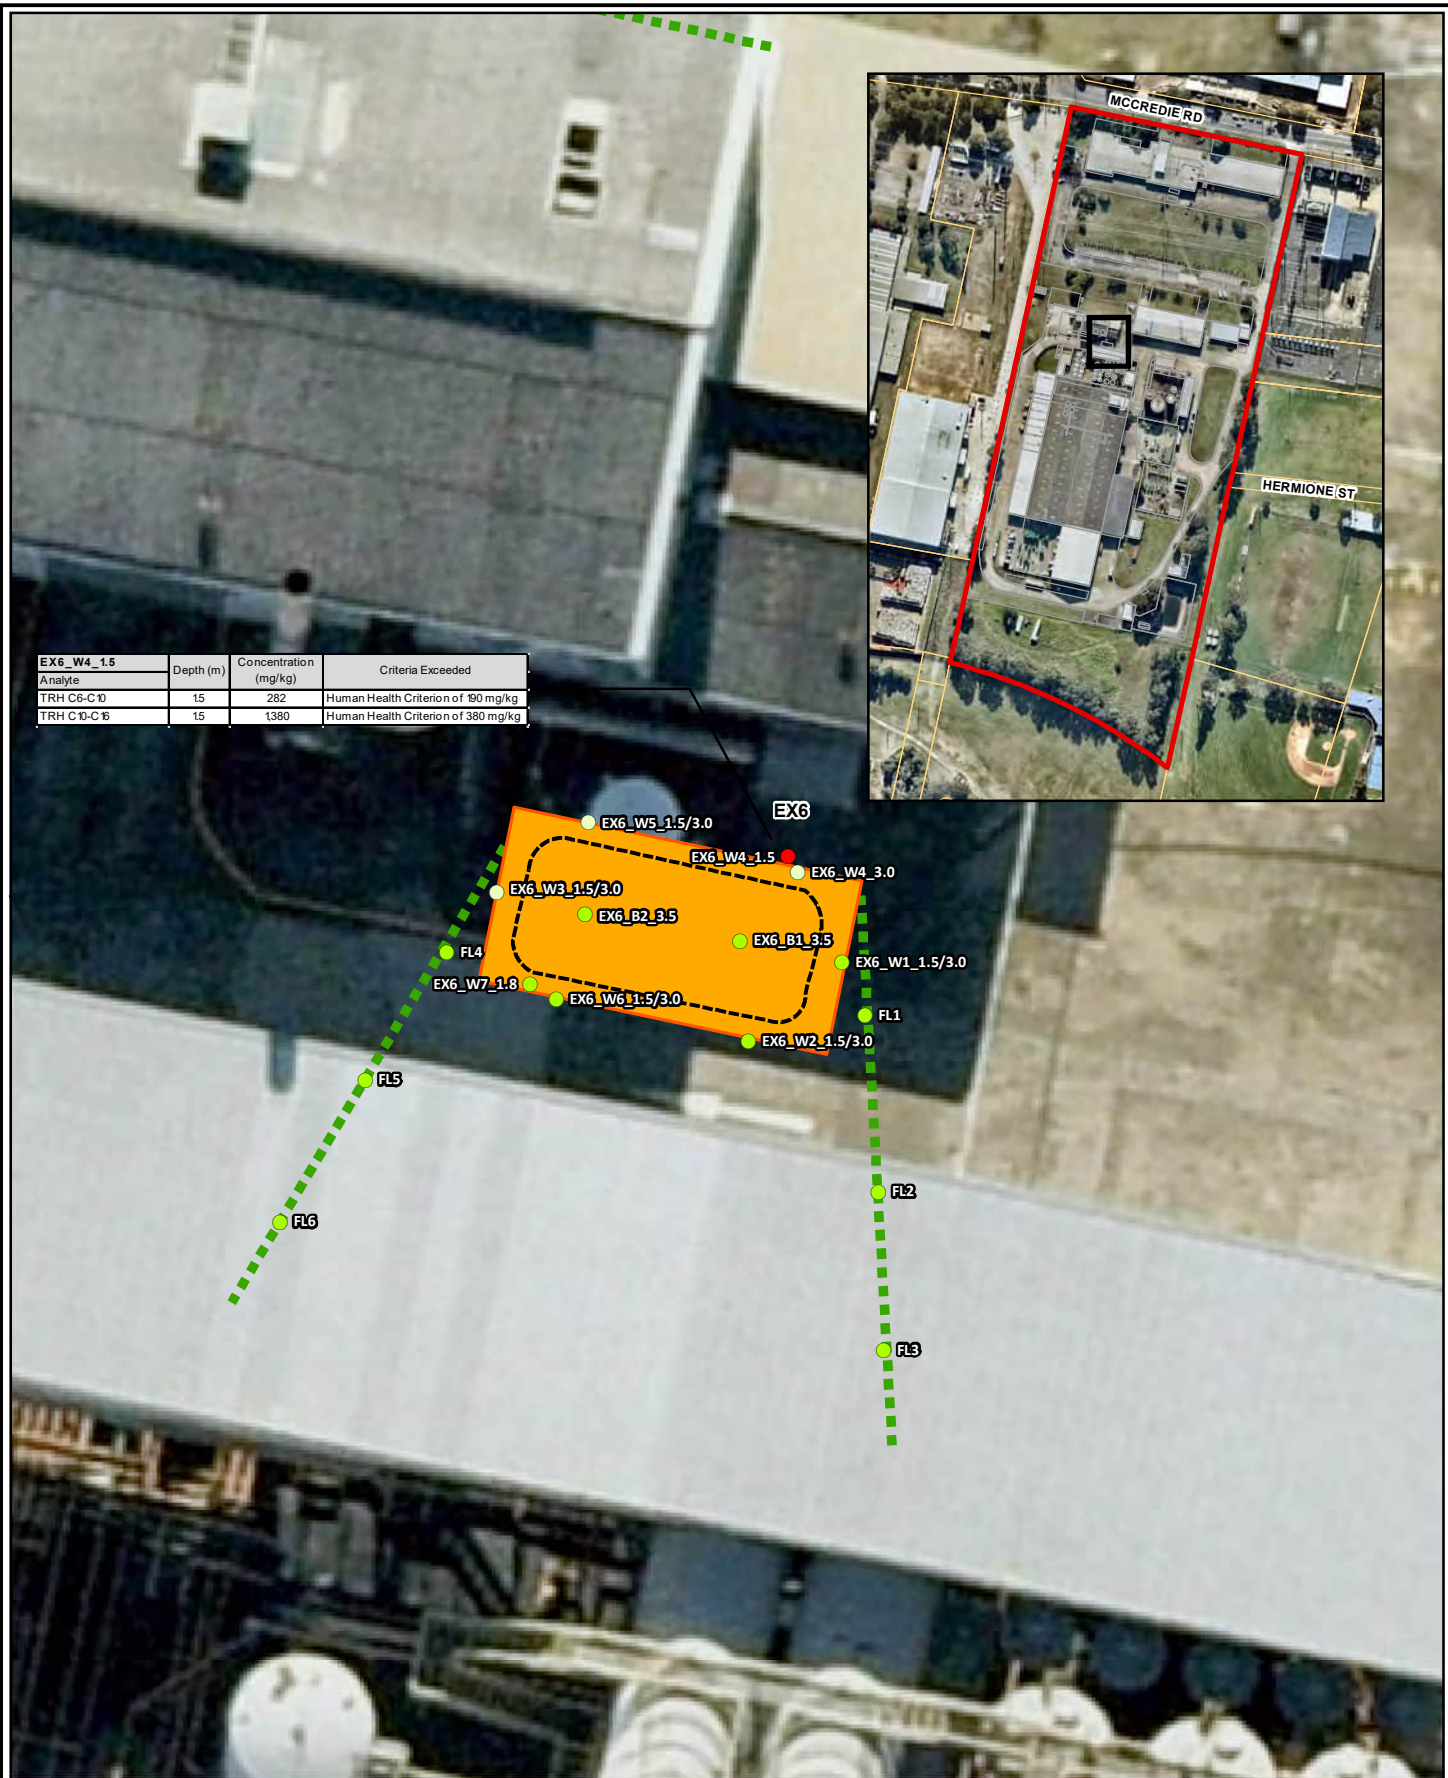
| <b>Legend:</b><br>Approximate Site Boundary<br>NSW Cadastre (2022)<br><b>Remediation Area</b><br>Excavation Area 6 (Base Depth 3.5m)<br>Excavation Features<br>Fuel Lines<br><b>Sample Location</b><br>Sample Location – Passed<br>Sample Location – (No longer in-situ)<br>Sample Location – Health Exceedance (No longer in-situ) | Scale 1:150<br> | | <b>BP Castrol Facility</b><br>132 McCredie Road<br>Guildford, NSW |
| | Coord. Sys. GDA 1994 MGA Zone 56<br> | | <b>EXCAVATION 6 - SAMPLE LOCATIONS AND HEALTH EXCEEDANCES</b> |

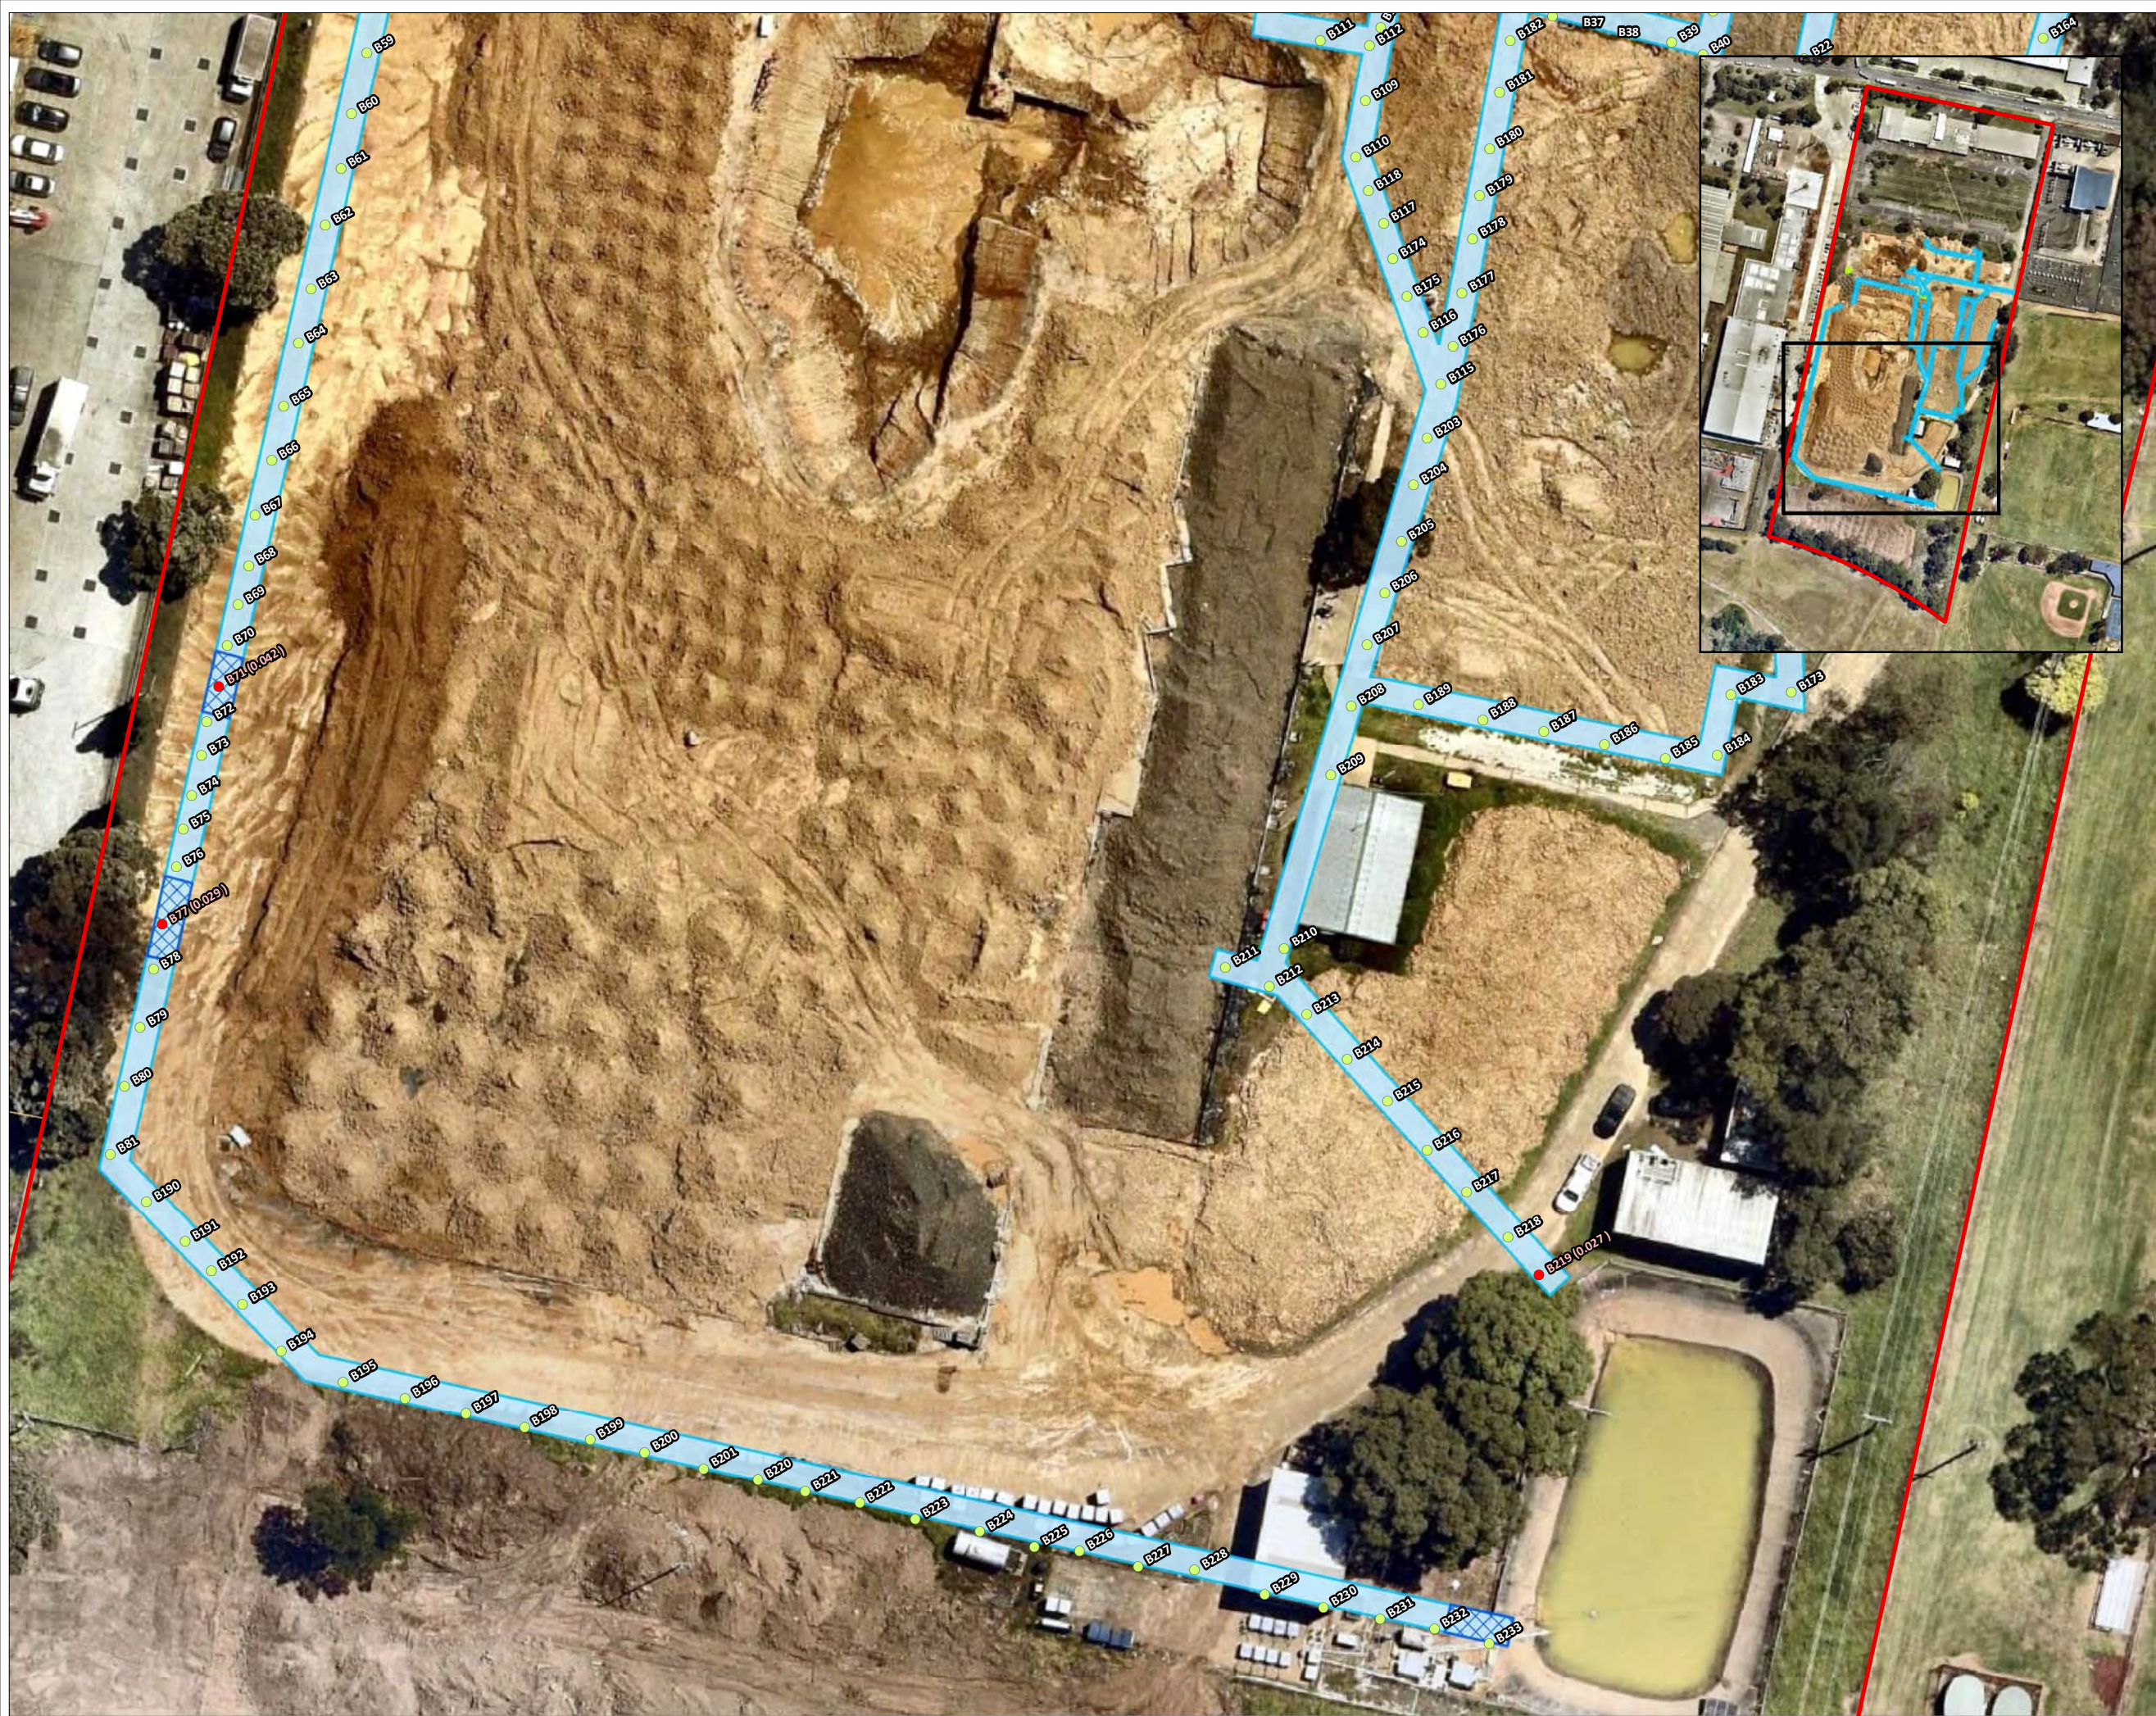
FIGURE 4C

- Approximate Site Boundary
- NSW Cadastre (2022)
- Remediation Area**
- Drain Trenches
- Excavation 16
- Trench and stockpile material mixed with PAC and backfilled. Concrete pipes affected by PFAS disposed to landfill
- Sample Location**
- Sample Location - Passed
- Sample Location - Health

**DRAIN SAMPLE LOCATIONS (SOUTH PORTION)**

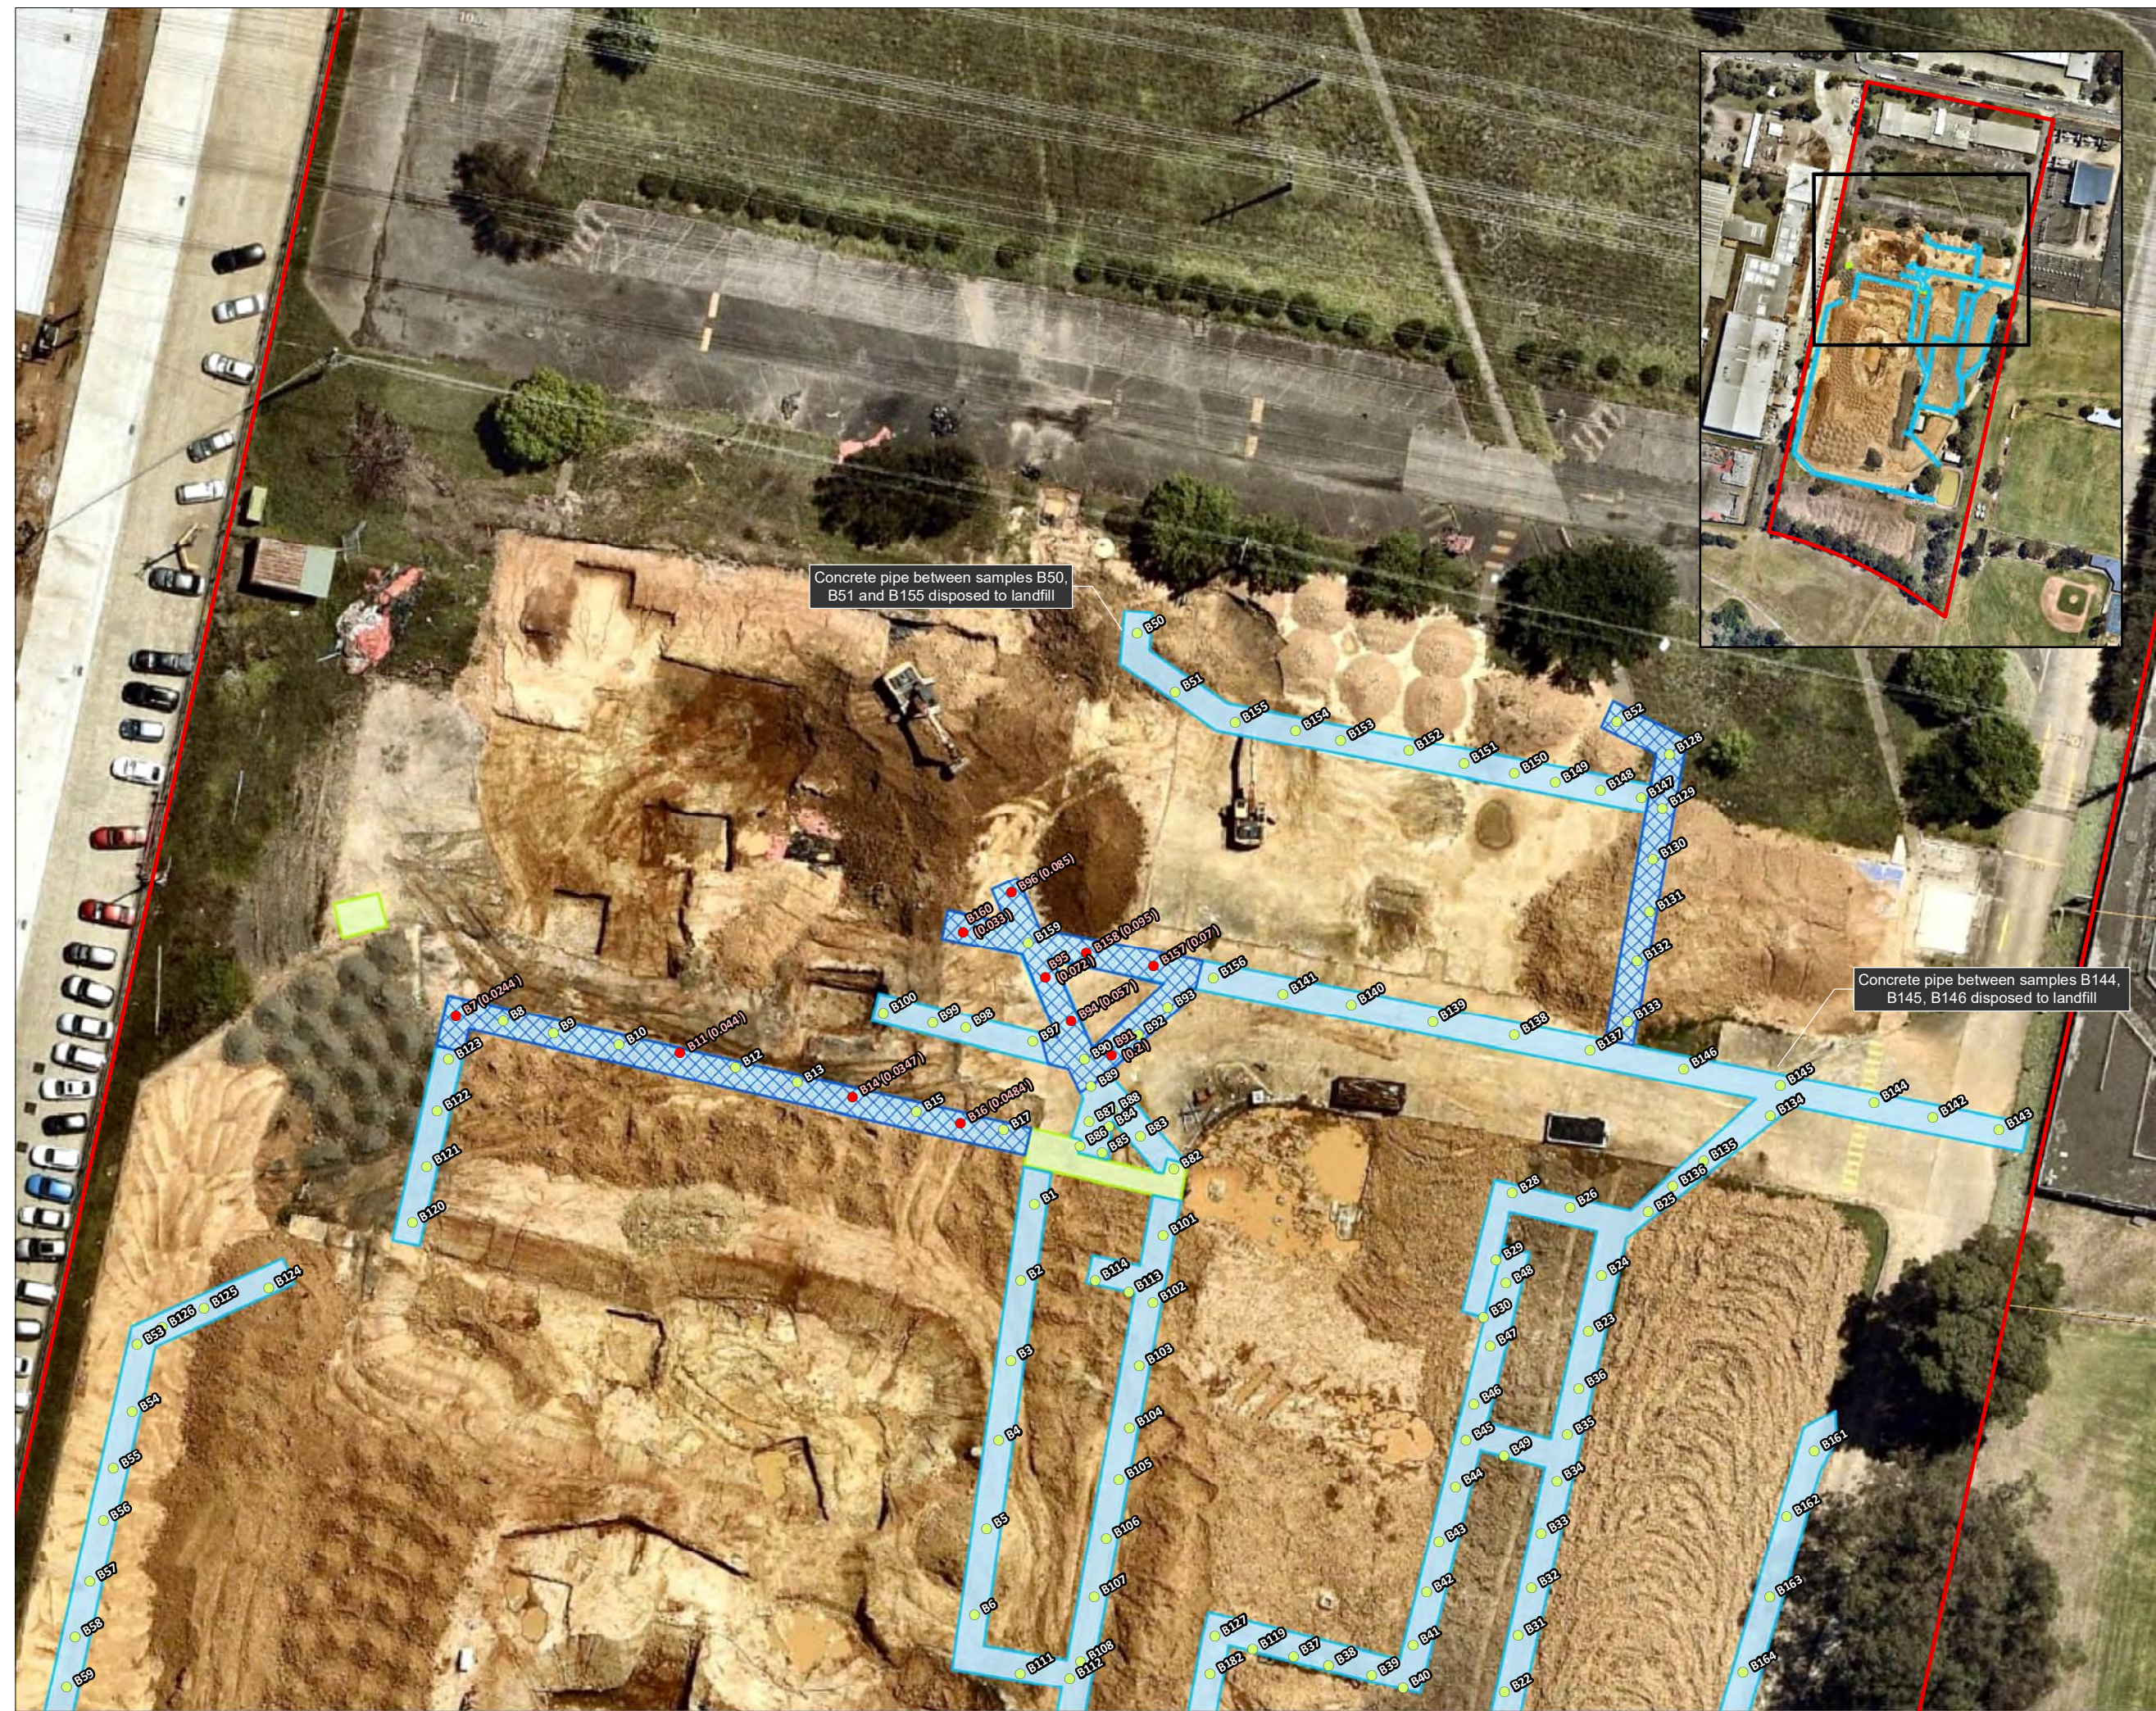
FIGURE 4A

- Approximate Site Boundary
- NSW Cadastre (2022)
- Remediation Area**
  - Drain Trenches
  - Excavation 16
    - Trench and stockpile material mixed with PAC and backfilled. Concrete pipes affected by PFAS disposed to landfill
- Sample Location**
  - Sample Location - Passed
  - Sample Location - Health

**DRAIN SAMPLE LOCATIONS**  
(NORTH PORTION)

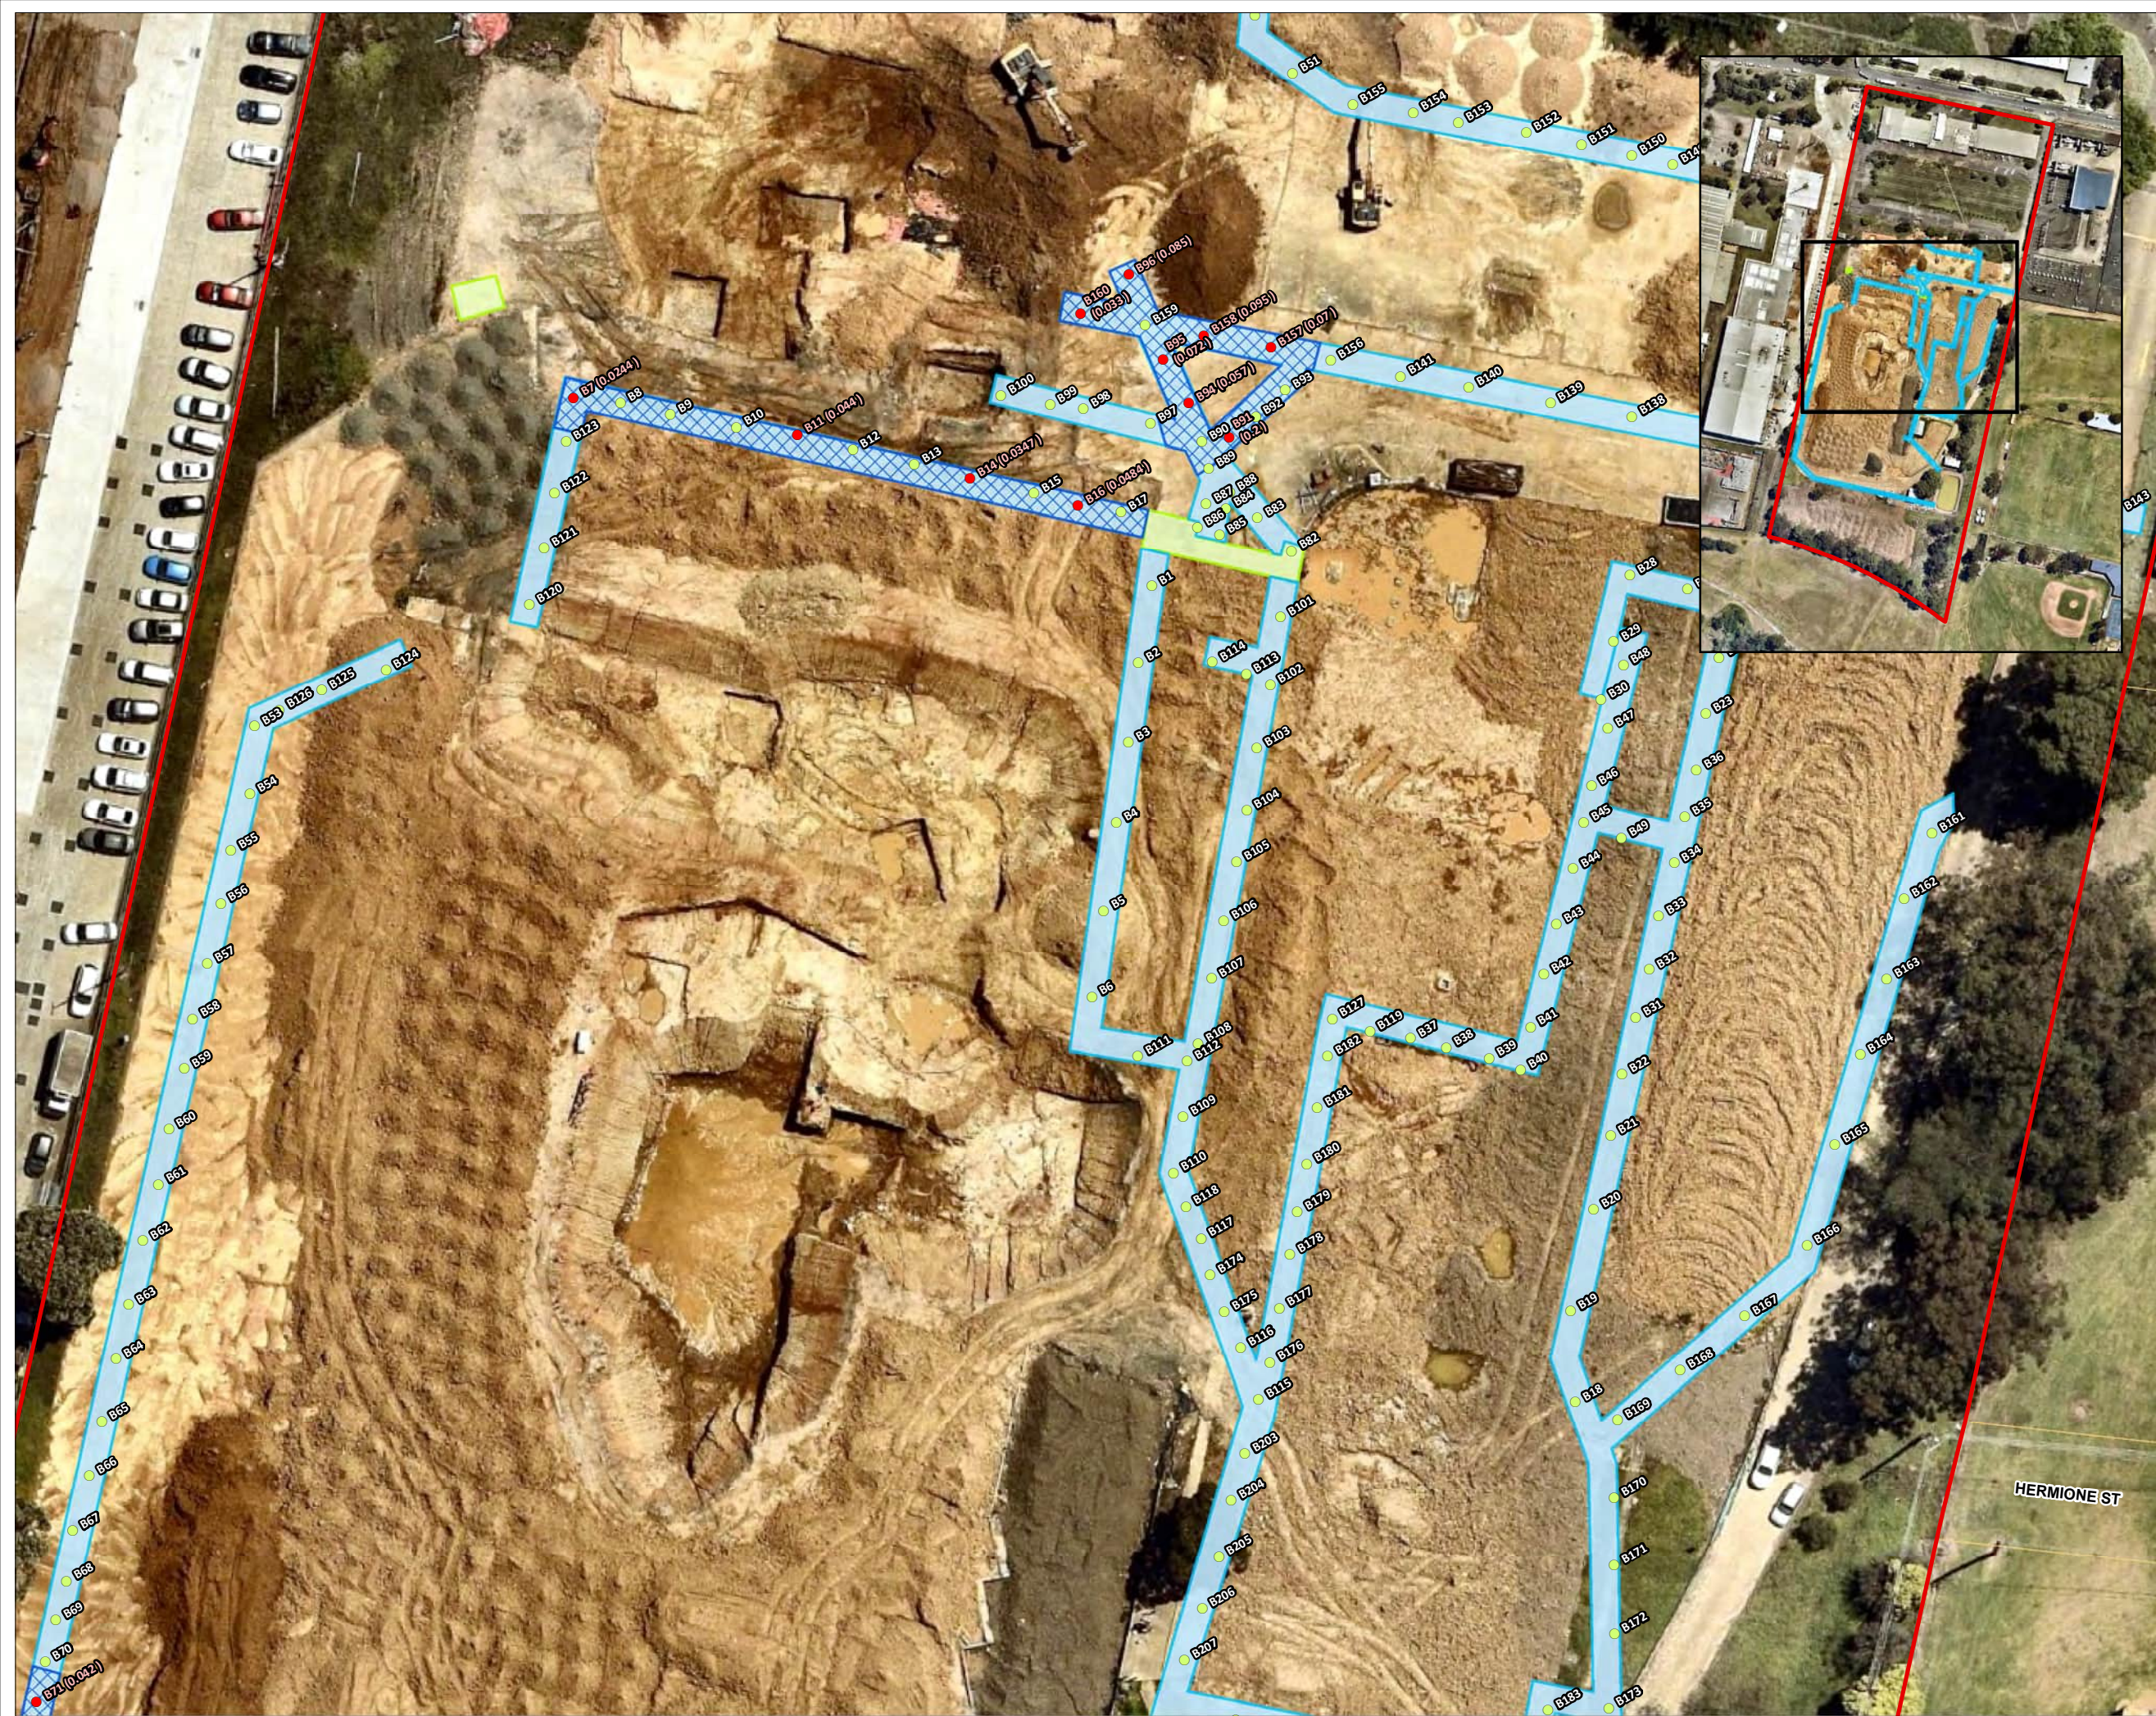
**FIGURE 4B**

- Approximate Site Boundary
- NSW Cadastre (2022)
- Remediation Area**
- Drain Trenches
- Excavation 16
- Trench and stockpile material mixed with PAC and backfilled. Concrete pipes affected by PFAS disposed to landfill
- Sample Location**
- Sample Location - Passed
- Sample Location - Health
- (PFOS concentrations noted on figure labelled "Sample Code (PFOS mg/kg)")
- PFOS Leaching Criteria = (0.024 mg/kg)**

**DRAIN SAMPLE LOCATIONS (CENTRAL PORTION)**

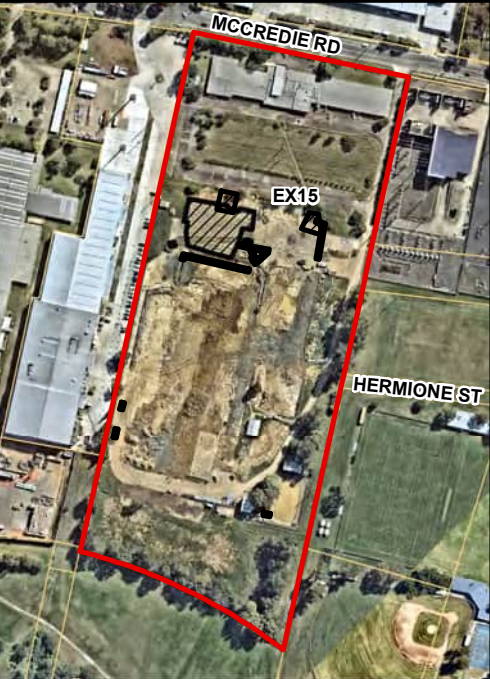
**FIGURE 24**

- Legend:**
- Approximate Site Boundary
  - NSW Cadastre (DFSI, 2021)
- Remediation Area**
- Powder Activated Carbon Treated Soils

**LOCATION OF POWDER**  
**ACTIVATED**  
**CARBON TREATED SOILS**

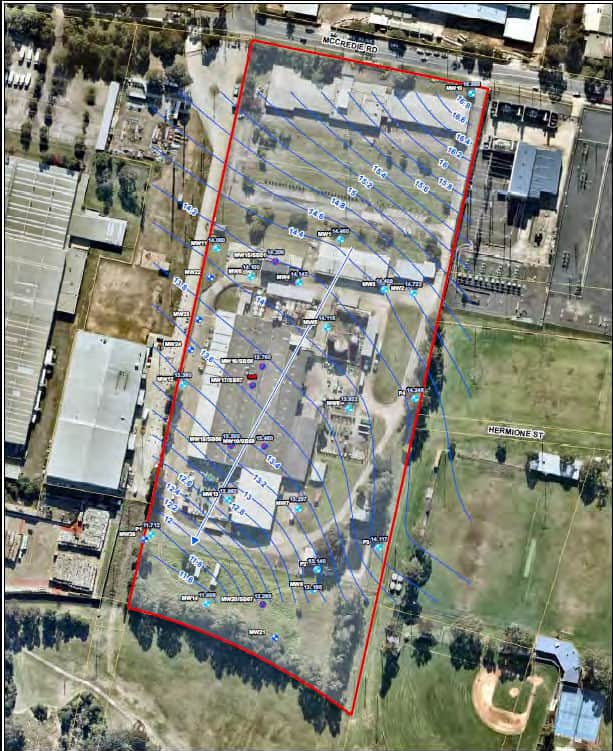
**FIGURE 4**

- ▭ Approximate Site Boundary
- ▭ NSW Cadastre (DPG, 2021)
- Sample Location**
  - Monitoring Well, Kleinfielder 2020 - EGA
  - Borehole / Monitoring Well, Kleinfielder 2020 - EGA
  - Monitoring Well, Kleinfielder 2021 - Pre. Rem. EGA
  - Groundwater Contour September 2021 (mAHD)
  - Inferred Groundwater Flow Direction
