24 October 2024

Ref: E36788BTlet.Rev1-ASS

**DESKTOP ACID SULFATE SOIL ASSESSMENT  
PROPOSED SENIORS CARE ACCOMMODATION FACILITY DEVELOPMENT  
28 MARRICKVILLE AVENUE & 46 PINE STREET, MARRICKVILLE, NSW**

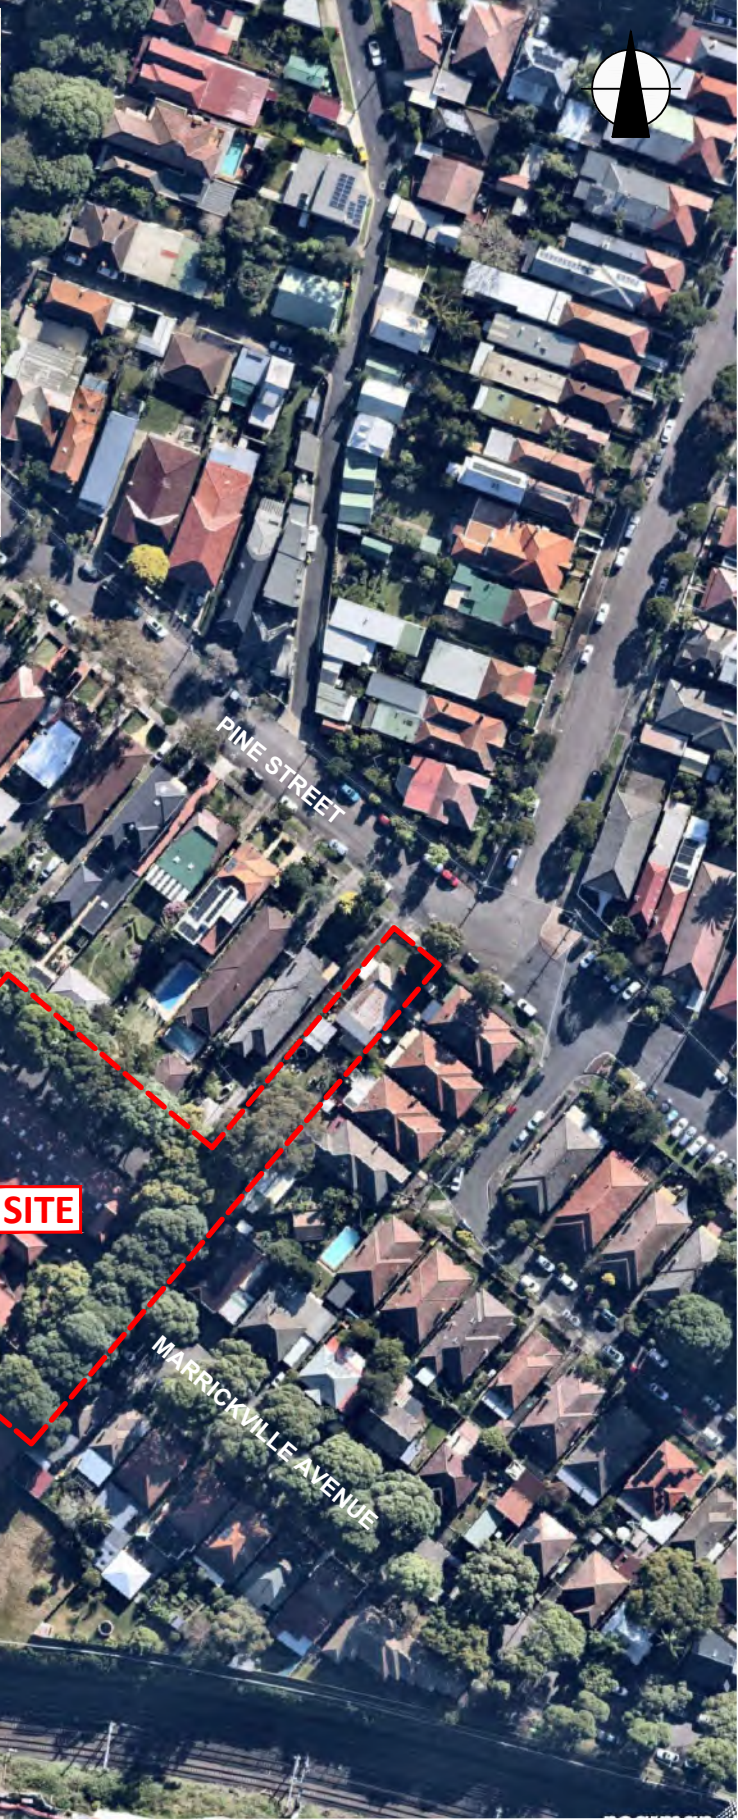
The Maronite Sisters of the Holy Family Village ('the client') commissioned JK Environments (JKE) to undertake a desktop acid sulfate soil (ASS) assessment for the proposed seniors care accommodation facility development at 28 Marrickville Avenue and 46 Pine Street, Marrickville, NSW ('the site'). The site is identified as part of Lot 101 in DP1091233 and Lot 1 in DP980526. The site location is shown on Figure 1 and the investigation was confined to the proposed development area as shown on Figure 2 attached in the appendices.
