# Wenona School

## Wenona Archimedes Building

## Geotechnical Investigation

29 April 2015

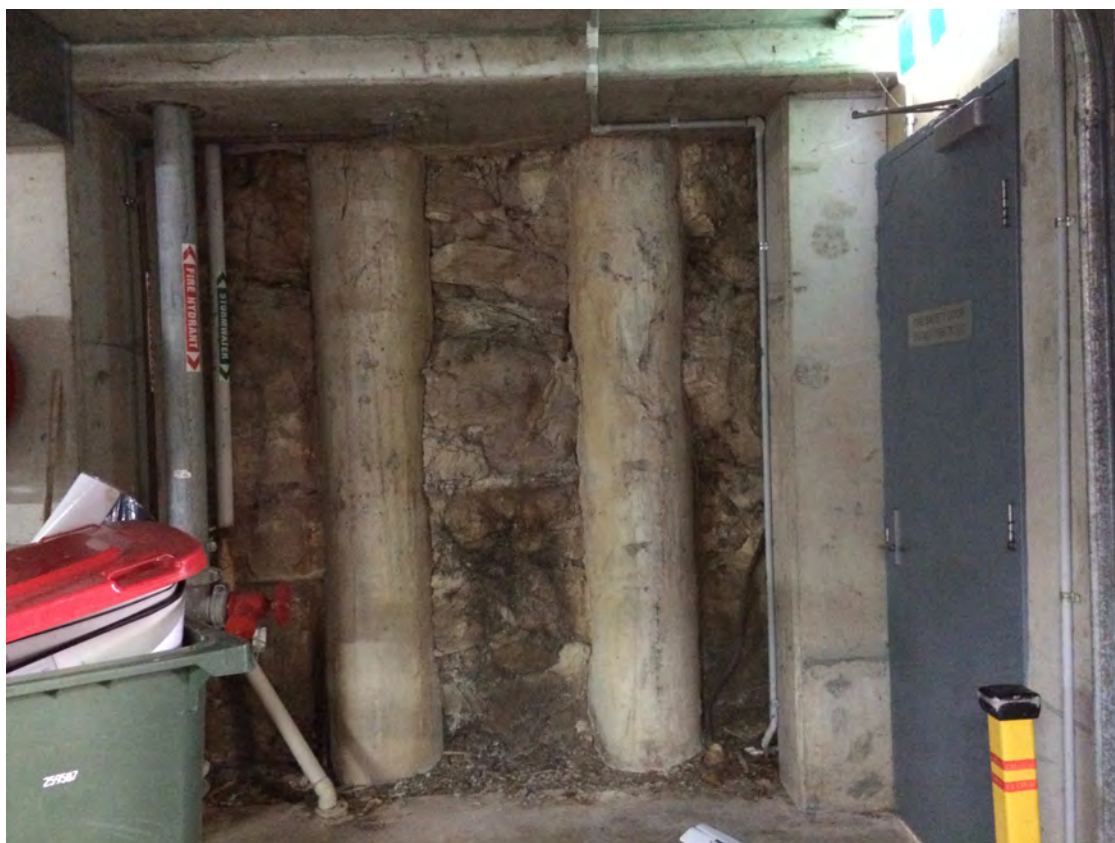
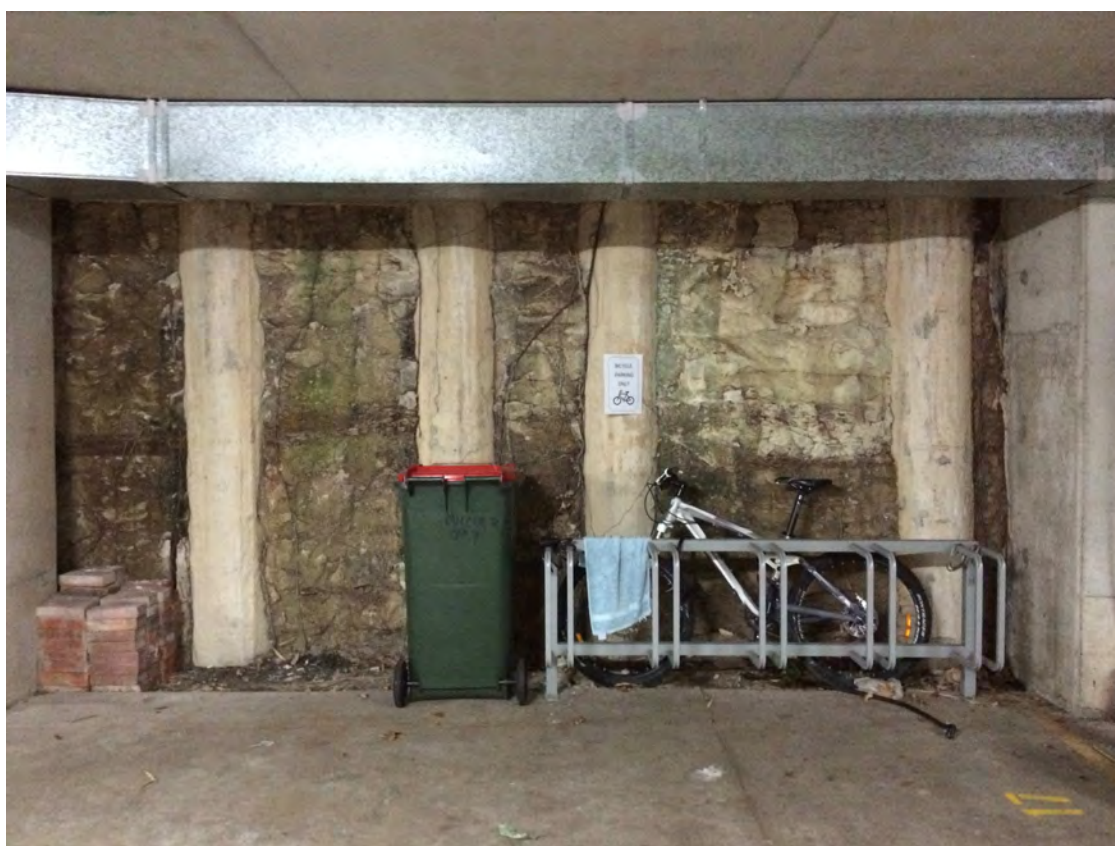
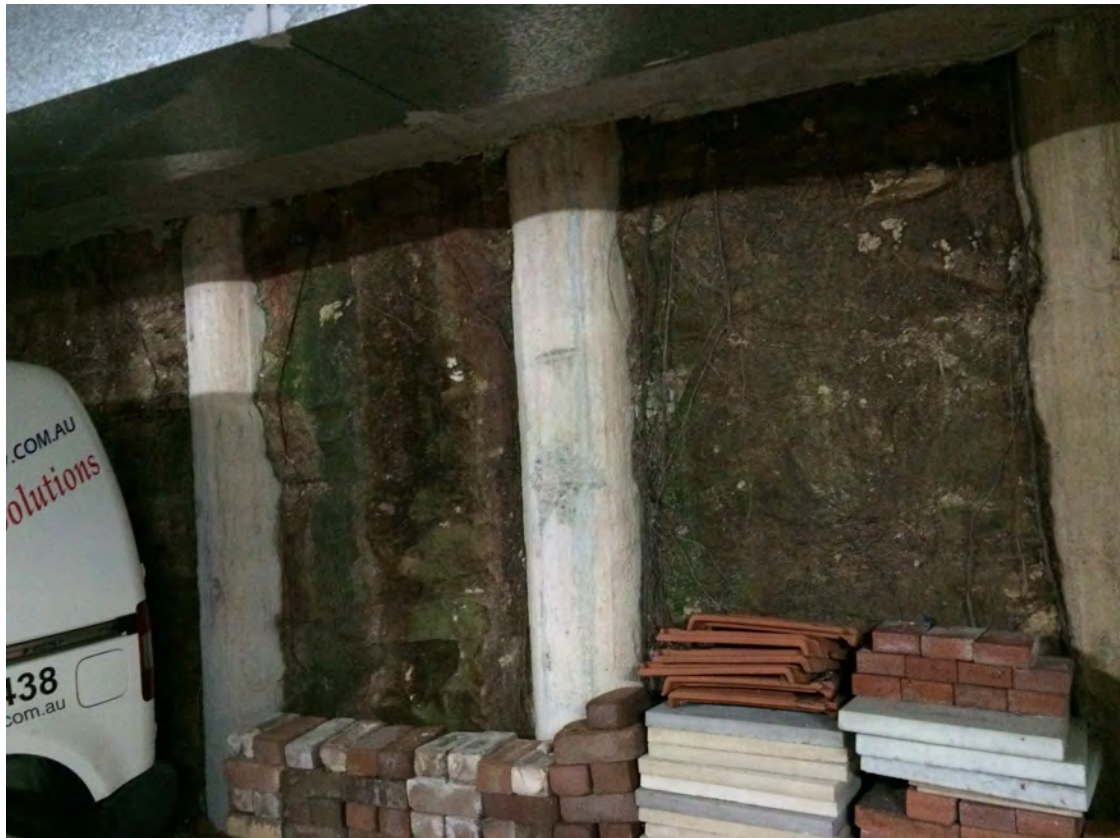
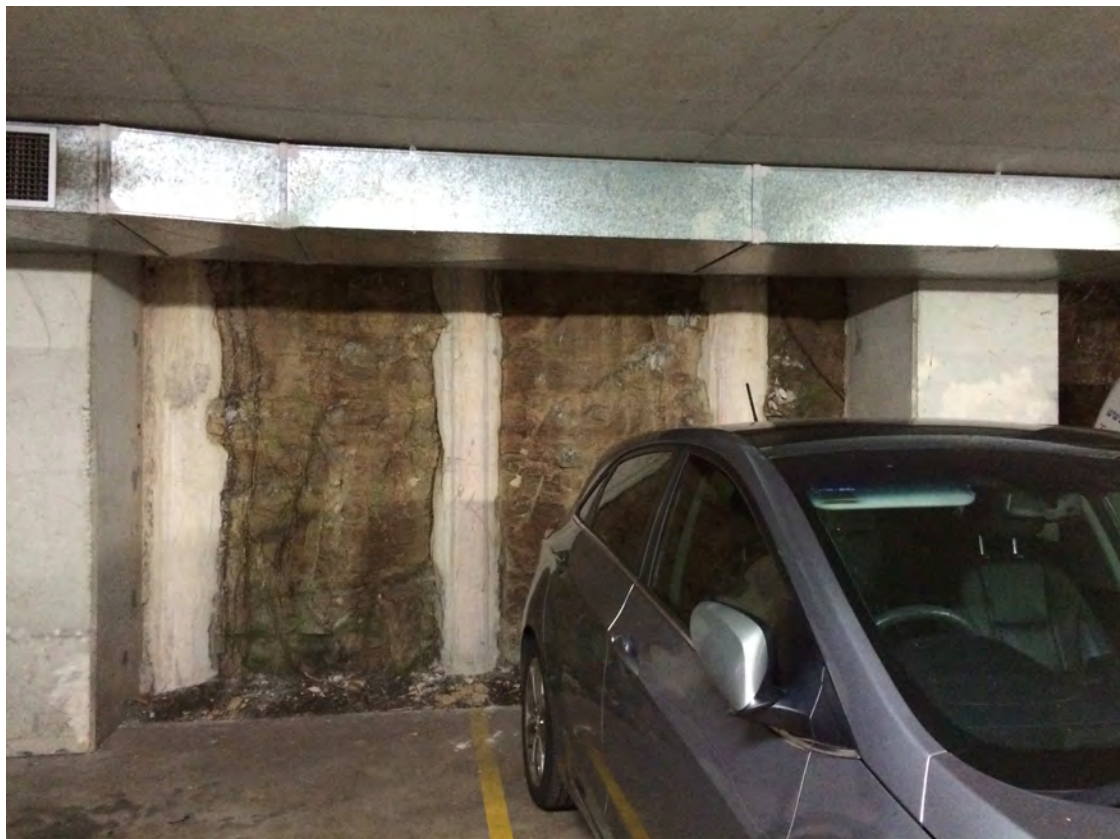
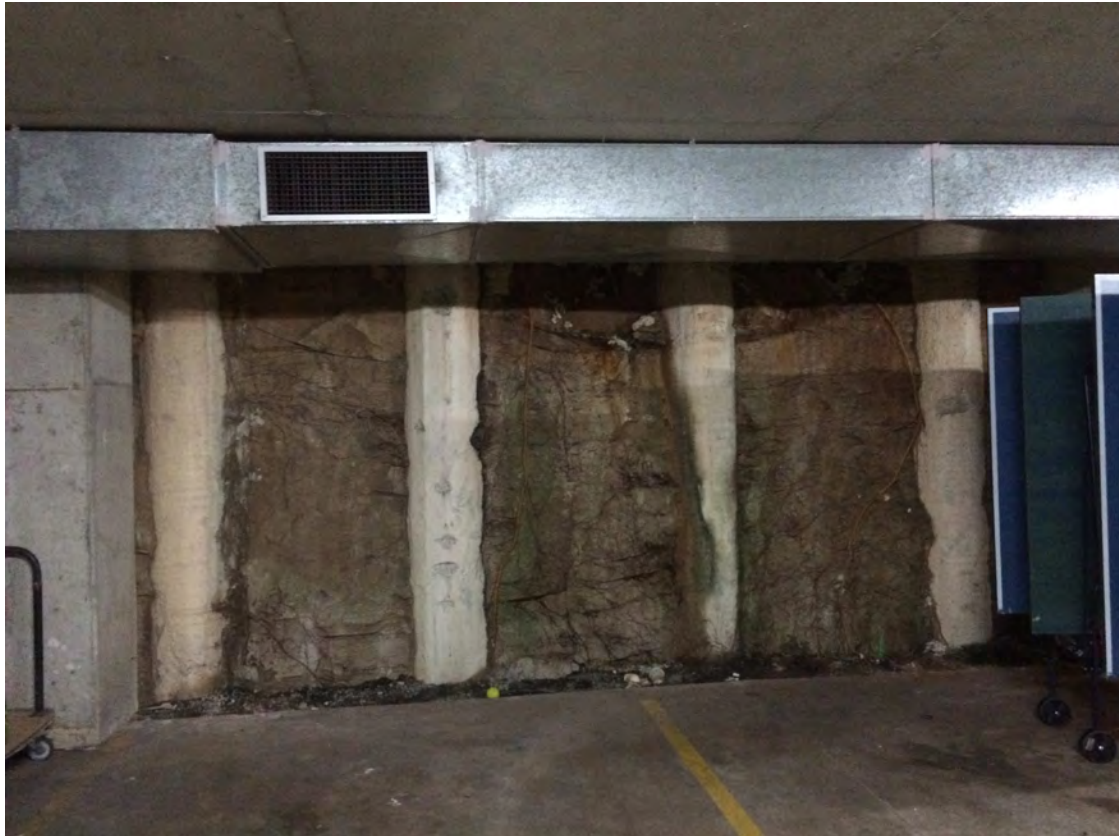
Photo 1: Northern wall east end – 1 of 5

Photo 1: Northern wall – 2 of 5

Photo 3: Northern wall – 3 of 5

Photo 4: Northern wall – 4 of 5

Photo 5: Northern wall near the western end– 5 of 5

Appendix B presents photographs of the exposed rock faces observed within basement of the adjacent school building. The photographs were sequenced from the eastern end of the northern wall to the eastern end of the exposed rock at the southern wall.

The exposed sandstone is typically fine to coarse grained, slightly weathered to fresh, low to medium strength, usually cross bedded. Overall the bedding ranges from sub-horizontal to an apparent dip to south approximately 10-20°. Exposed rock surfaces have become oxidised and discoloured. Seepage staining and roots attached to rock surfaces were observed at the northern and western walls and also at the south western corner. The north western and south western corners are damp/wet from seepage. The southern wall is generally dry. Sandstone erosion was observed at the southern wall.

It should be noted that in the adjacent basement, the Unit 2b Sandstone Class IV was supported by soldier piles on two sides of the basement wall (northern and western) but unsupported on the southern wall. We understand that it is proposed to create a sandstone wall feature in the proposed basement. This appears to be feasible. However, erosion and staining of the existing exposed sandstone in adjacent basement should be noted. If adverse jointing are also present bolts, mesh and shotcrete will be required to be installed on the face of the sandstone.

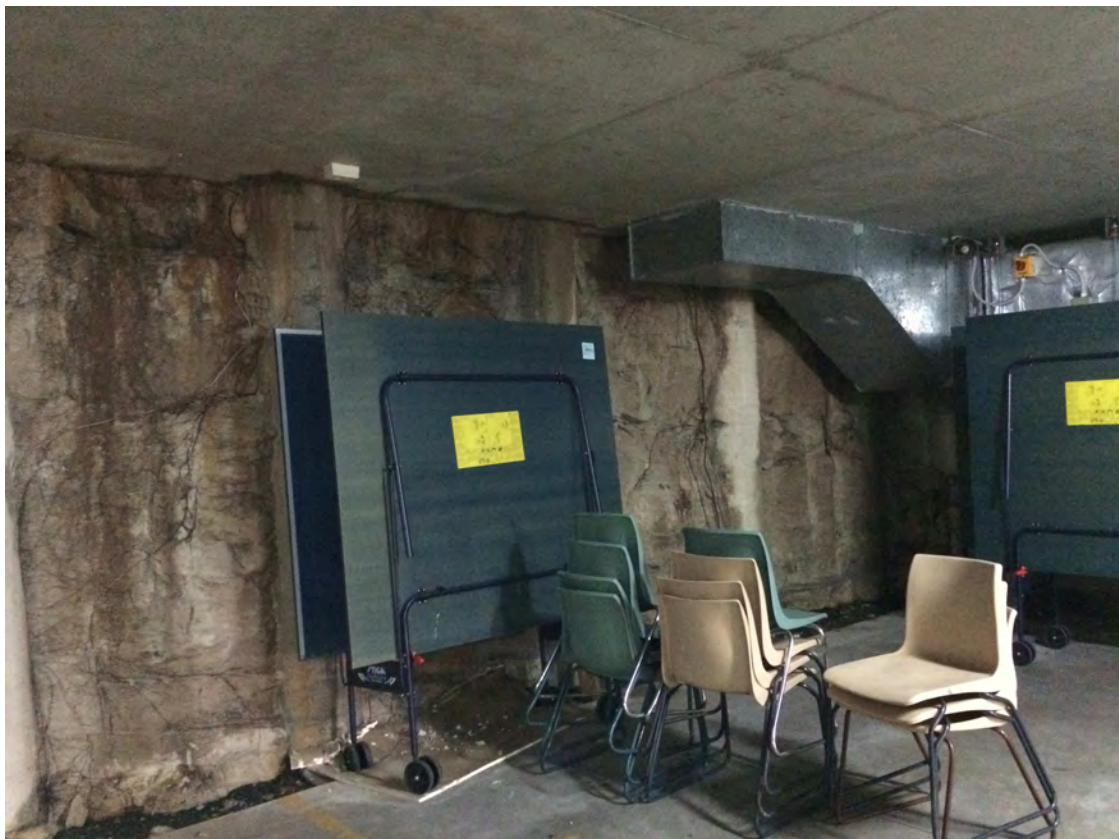
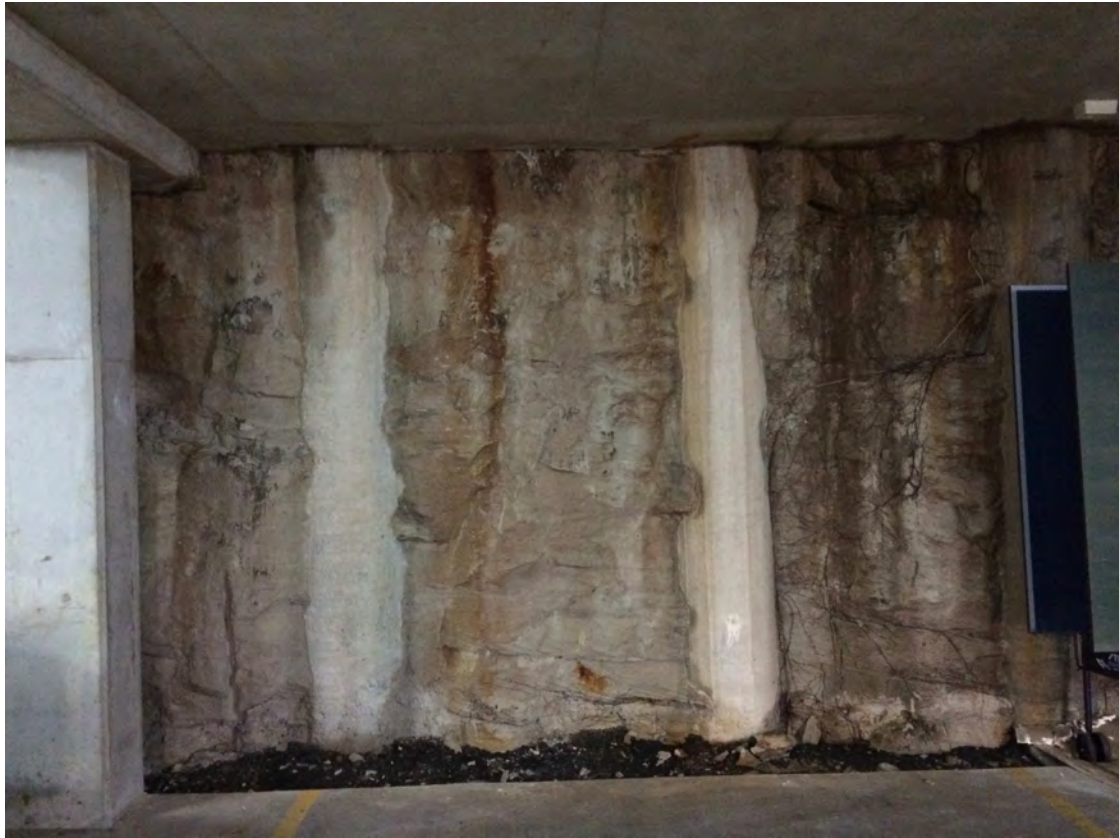
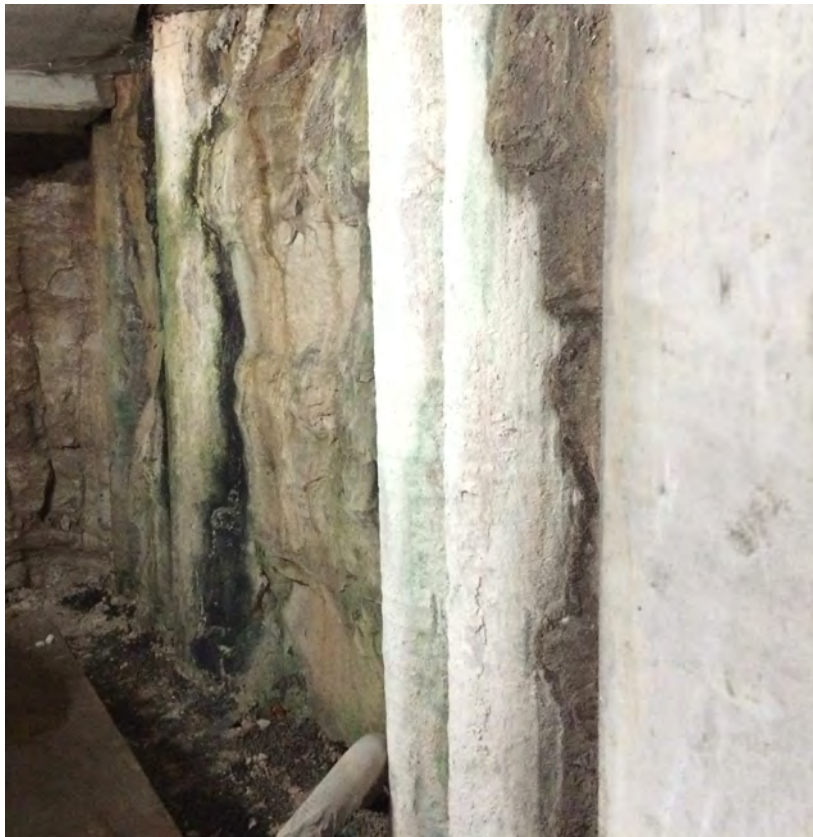
Photo 6: Western wall northern end– 1 of 3

Photo 7: Western wall – 2 of 3

Photo 8: Western wall southern end – 3 of 3

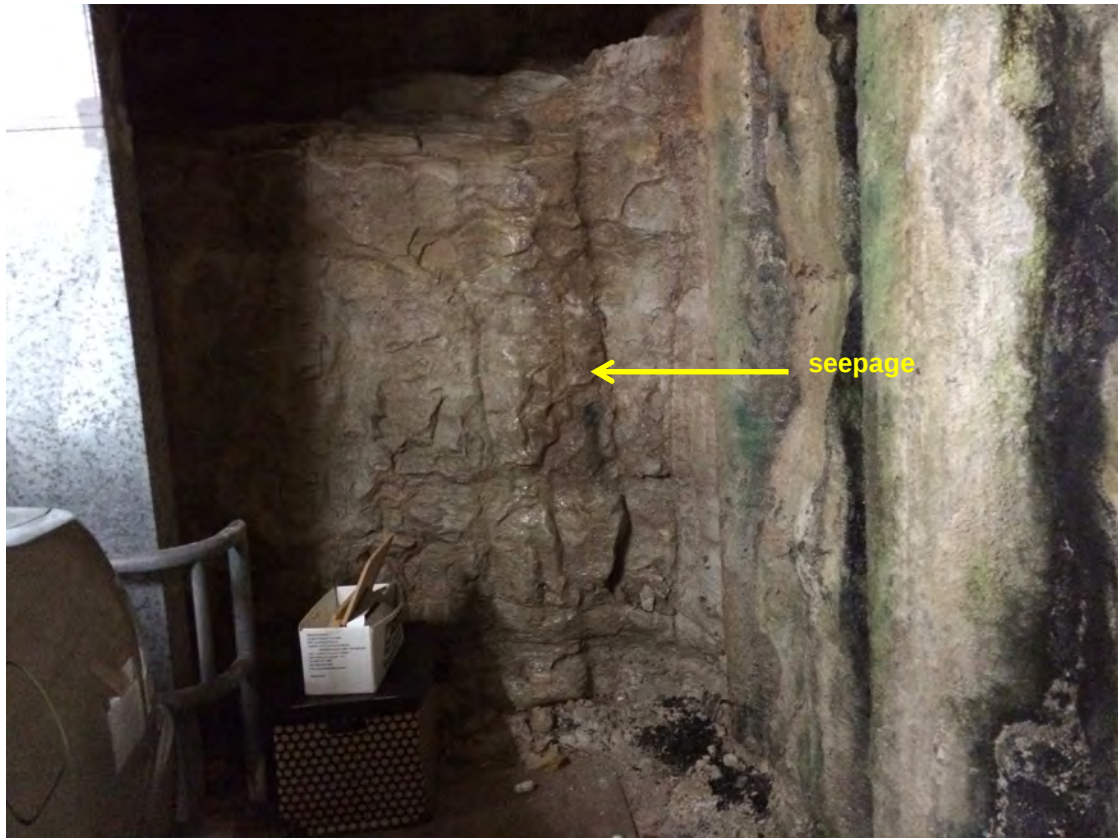
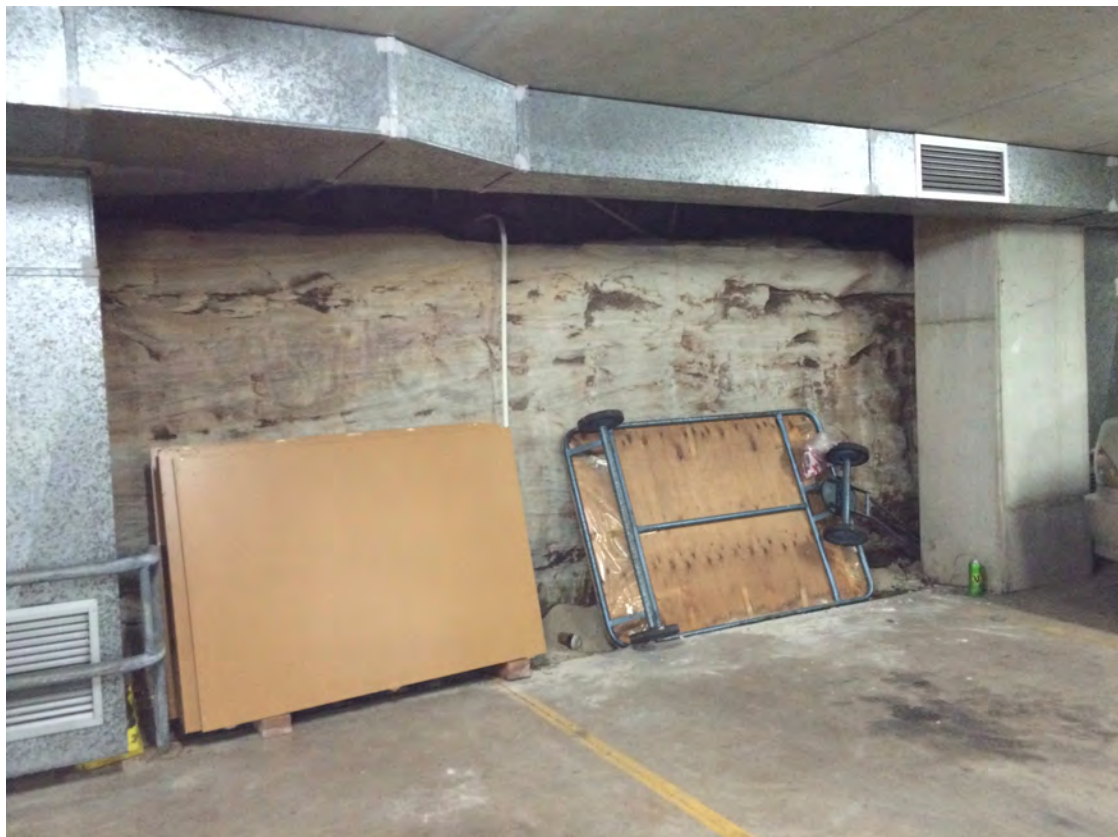
Photo 9: Southern wall western end – 1 of 3

Photo 10: Southern wall – 2 of 3

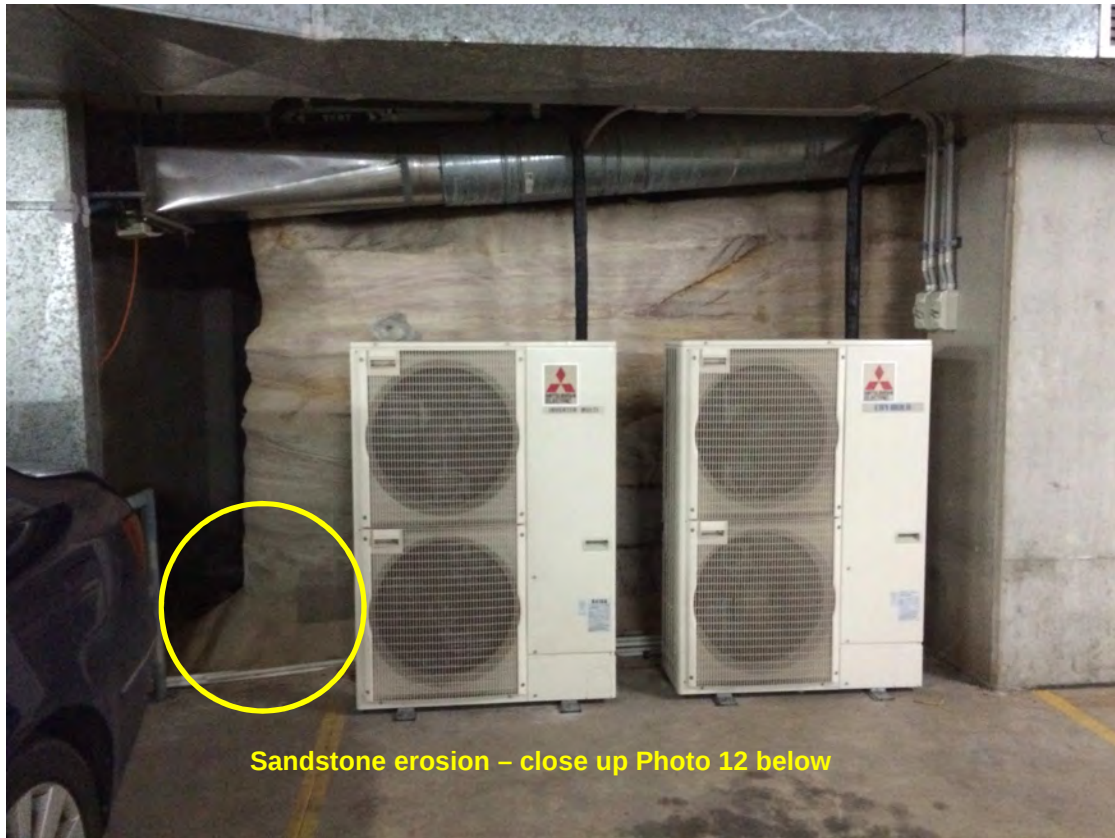
Sandstone erosion – close up Photo 12 below

Photo 11: Southern wall eastern end– 3 of 3

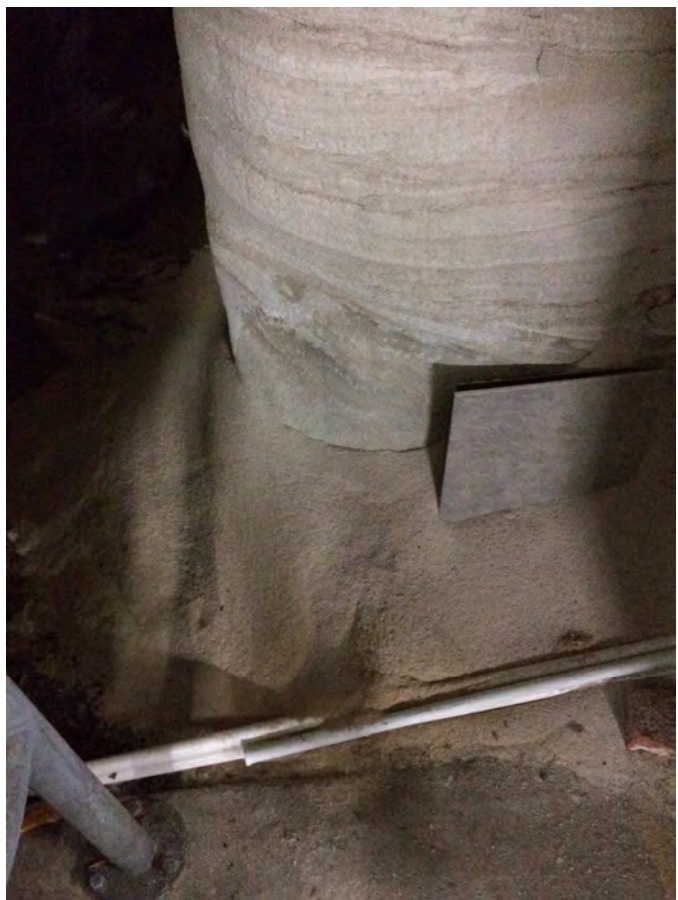
Photo 12: Close up of sandstone erosion at the southern wall
